1. Report No. FHWA/TX-13/9-1002-12-6		2. Government Accession No.		3. Recipient's Catalog No.	
4. Title and Subtitle MASH Full-Scale Crash Testing of 4-ft Mounting Height, 24"×30" Chevron Sign Installed on 5.5H:1V Slope Ditch				5. Report Date Published: March 2013

***MASH* Full-Scale Crash Testing of 4-ft Mounting Height 24"×30" Chevron
Sign Installed on 5.5H:1V Slope Ditch**

Report 9-1002-12-6
Project 9-1002-12
Project Title: Roadside Safety Device Crash Testing Program

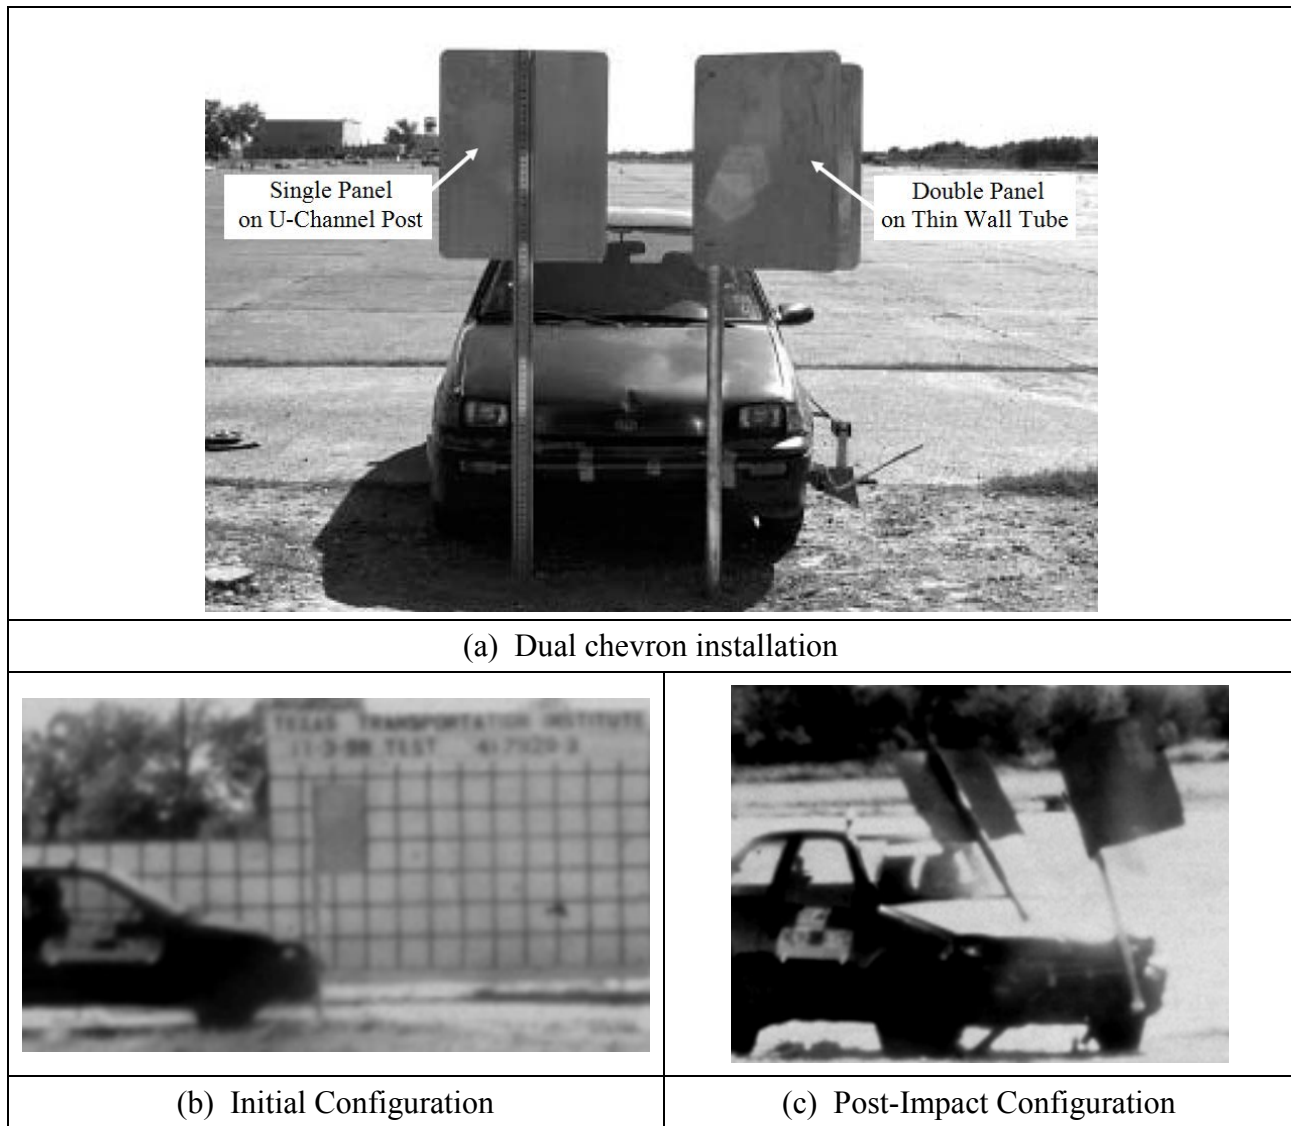
Figure 1.1. Dual Chevron Support Test No. 417929-3.

Table 1.2 summarizes the TxDOT standards for chevron installation based on mounting height and sign size. These research projects highlighted two very distinct support post behaviors during a vehicle impact. In Test No. 417929-3, the post yielded at bumper level, pulled out of the socket, and was carried away by the vehicle. No contact occurred between the post and the vehicle’s occupant compartment. However, in both Test nos. 405231-7 and 405231-9, the post had secondary contact with the roof of the passenger car after yielding at bumper level and being pulled out the foundation socket. These two different post-impact behaviors are related to the different mass of the systems and, more importantly, the height or length of the post.

In Test no. 417929-3, which had a mounting height of 4 ft and a sign height of 30 inches, the total height of the support post was 78 inches. Considering a bumper impact location at approximately 22 inches from ground level, the effective post height above the bumper was approximately 56 inches (see Figure 1.3[a]). In Test nos. 405231-7 and 405231-9, the mounting height was 7 ft and the sign height was 48 inches. Figure 1.3(b) shows that the effective post height above the vehicle bumper was approximately 110 inches.

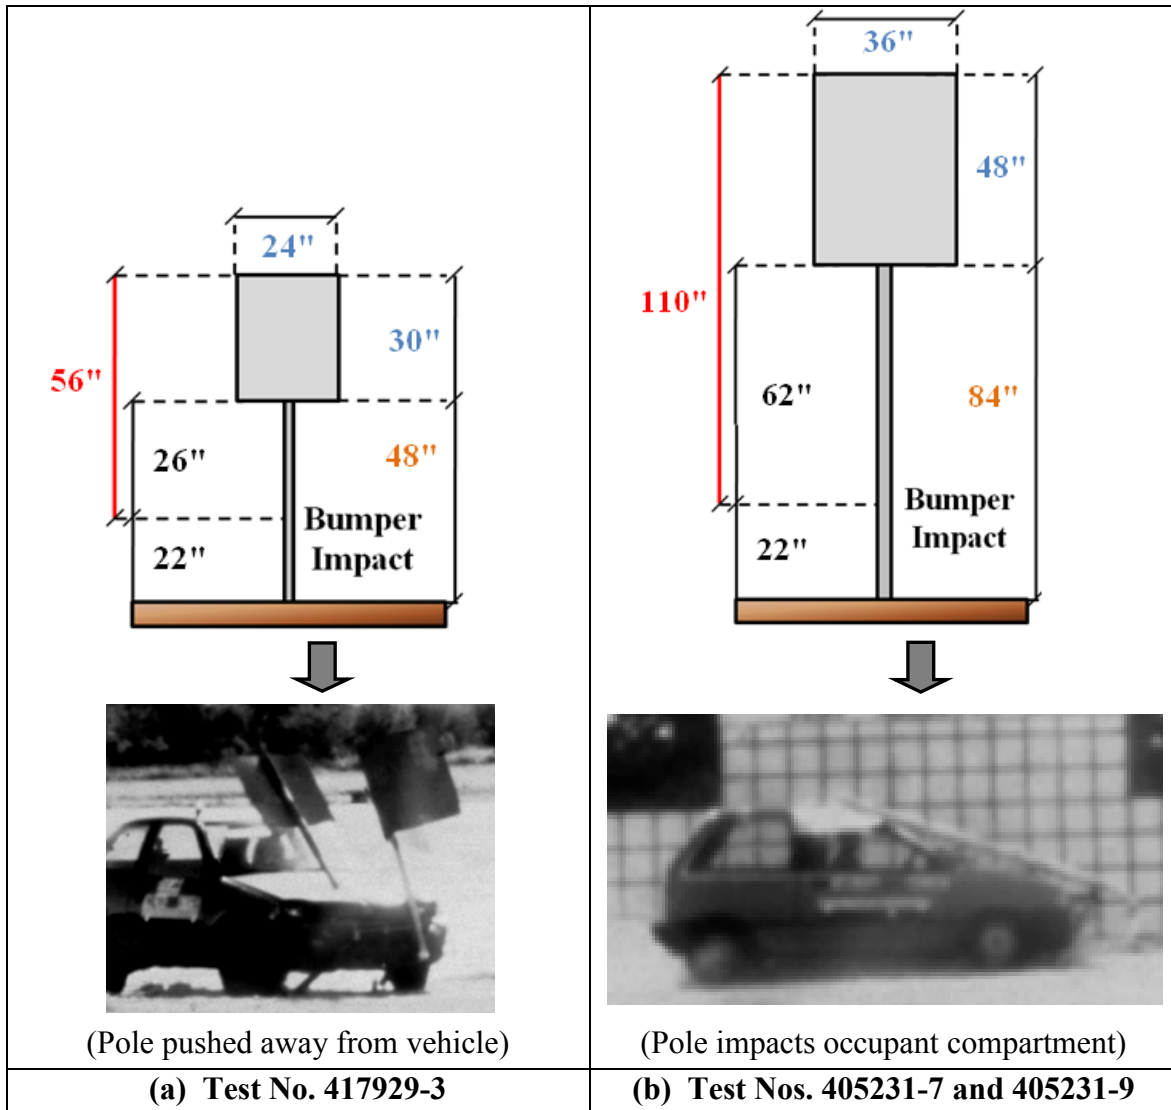
Figure 1.3. Support System’s Effective Height and Post-Impact Pole System Behavior.

The post-impact behavior of the sign support system has been evaluated for effective post heights of 56 inches and 110 inches above the bumper in projects FHWA/TX-01/1792-2 and 405231-1F, respectively (8, 9). The lower effective height resulted in no secondary post contact and the higher effective height resulted in contact with the vehicle roof. Effective post heights between these two values have not been investigated, and there exists a possibility that an intermediate effective post height could result in the sign support contacting the windshield of the vehicle. Since it is common practice for TxDOT to install chevron signs in ditches at a 4-ft mounting height and a lateral offset between 2 and 8 ft from the pavement edge, and this practice results in effective post heights between those tested, TxDOT research project 0-6363 recommended that this installation practice be evaluated. Under TxDOT project 0-6363, TTI researchers performed vehicle dynamics simulations to determine bumper trajectories for passenger cars entering a ditch with 6H:1V slopes at different speeds (40 and 60 mi/h) and angles (5, 10, and 25 degrees). A 6H:1V slope ditch was chosen in conjunction with TxDOT personnel because it was considered to represent a reasonable and typical design condition in Texas. Lateral offsets between 2 ft and 8 ft from the slope break point were considered based on TxDOT standard practice. The trajectory analyses were performed using a computer program called CarSim® (10).

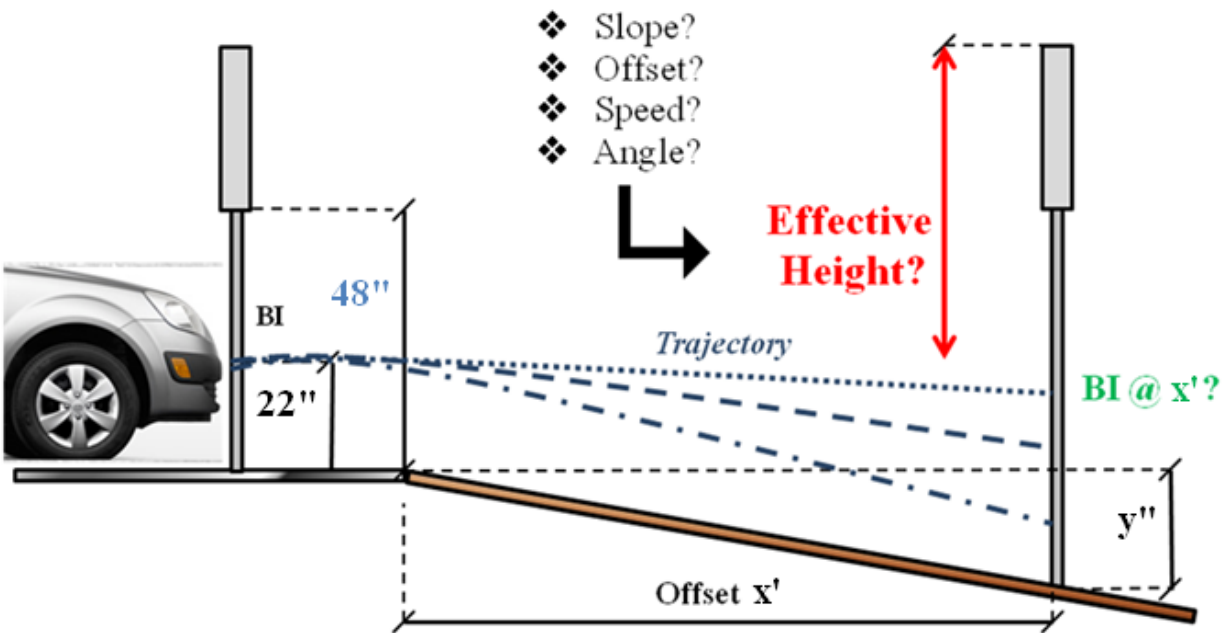
Figure 1.4. Effective Pole Height Variation for Chevron Installation in Ditch.

A common TxDOT practice is to install chevron sign systems in roadside ditches. For this type of installation, TxDOT standards specify that the sign mounting height be established from the pavement surface. Once a sign support system is installed on a slope, the local mounting height of the sign (calculated from ground level at the location of installation) will be greater than that for the same system installed on flat, level ground. For a general installation of a sign support system on a slope at an offset distance “x” from the slope break point, the depth “y” of the ditch at the particular installation location contributes to an increase in the length of the support post and local mounting height of the sign (see [Figure 1.4](#)).

The bumper trajectory and offset distance of the chevron installation from the slope break point determine the height of bumper contact above the local ground elevation. Consequently, the effective height of the post above the bumper can vary.

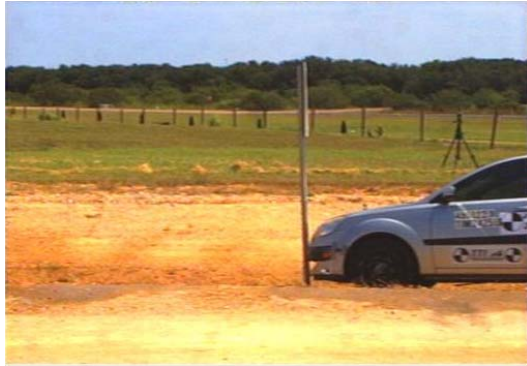
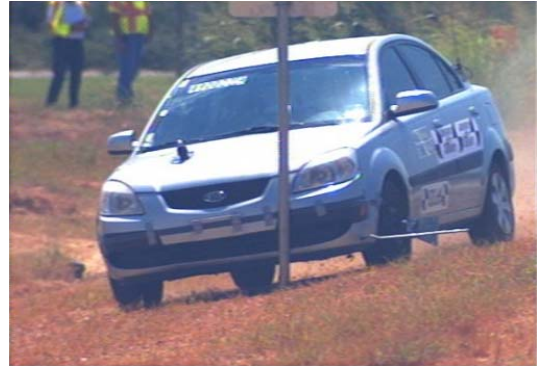
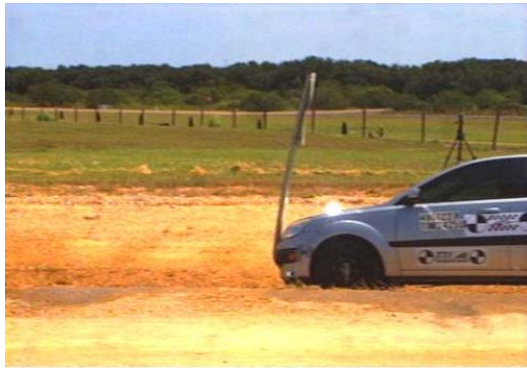
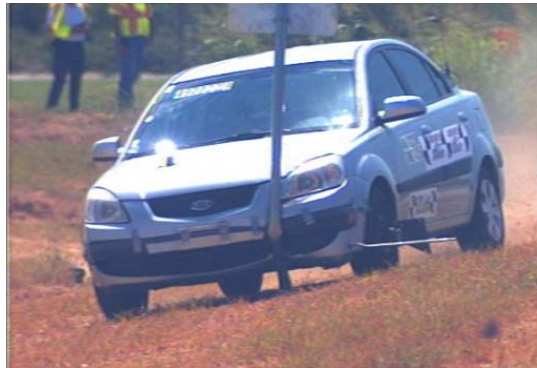
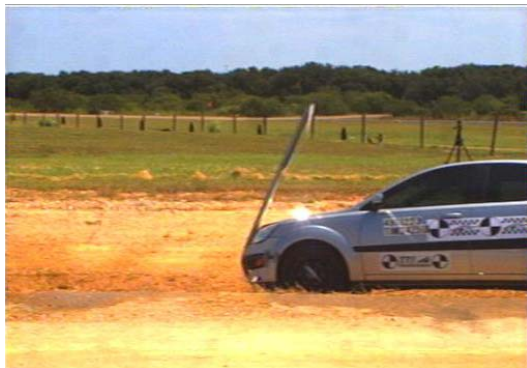
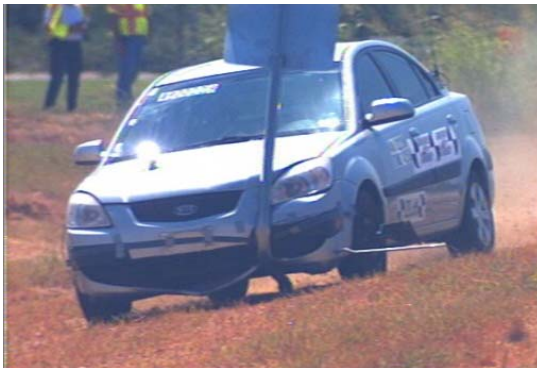
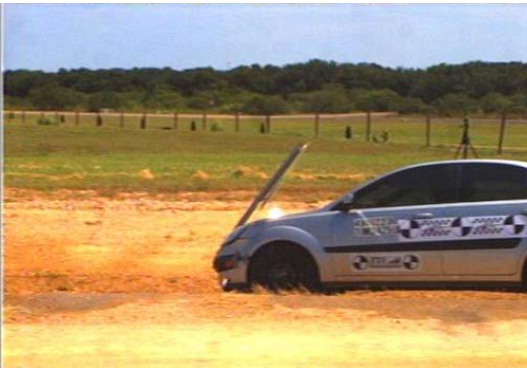
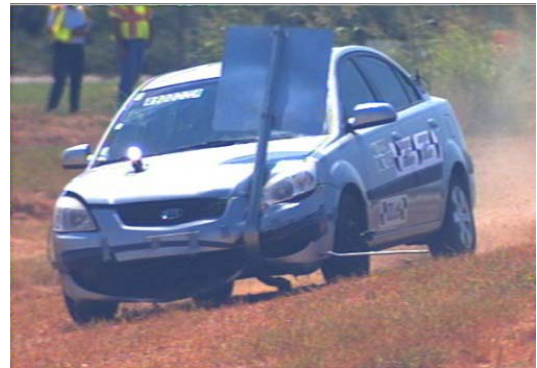
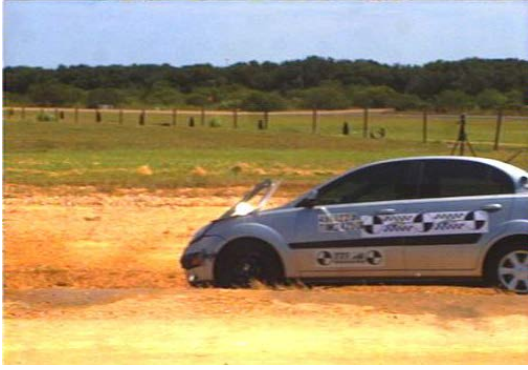
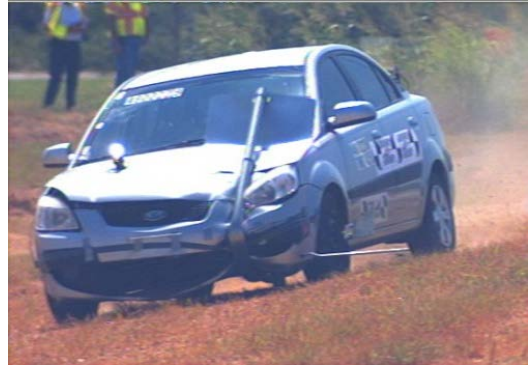
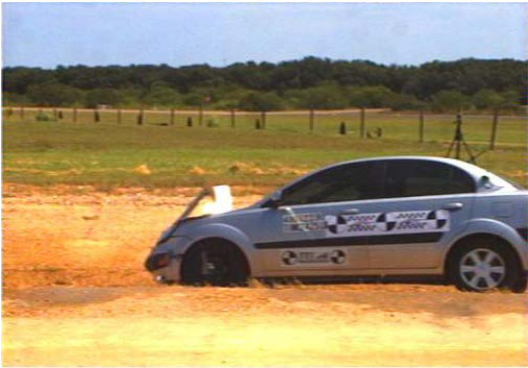
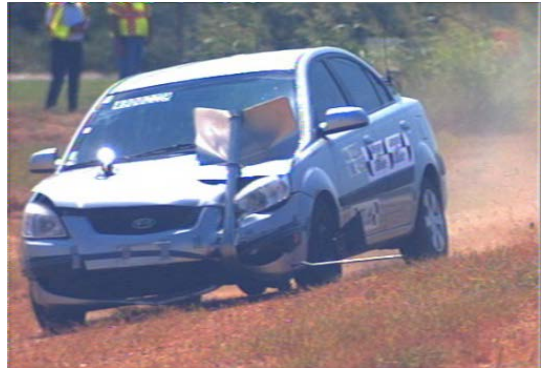
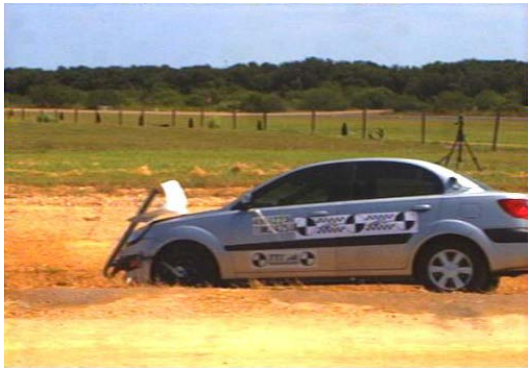
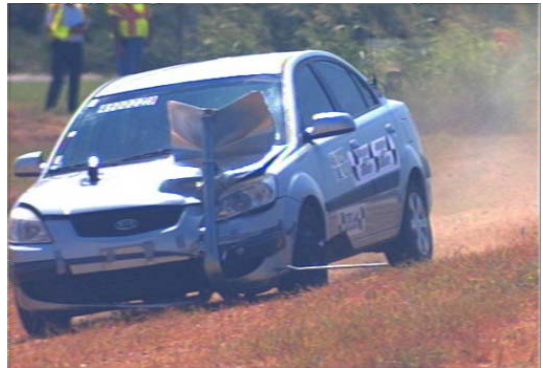
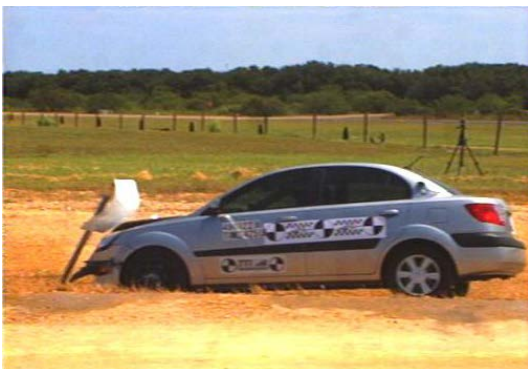
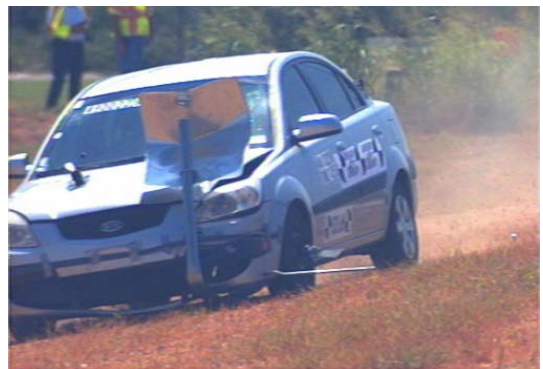
Figure C1. Sequential Photographs for Test No. 490022-9.

The 2007 Kia Rio small passenger car, traveling at an impact speed of 61.4 mi/h, impacted the chevron sign support 18 inches from the vehicle's centerline, on the driver's side. The encroachment angle at time of the release of the guide cable as the vehicle entered the ditch was 10.0 degrees. At 0.0035 s after impact, the sign support began to deflect. At 0.042 s, the sign impacted the hood of the vehicle and began to fold. The sign post ruptured at 0.065 s. At 0.070 s, the sign post lost contact with the front of the vehicle, and at 0.077 s, the top sign bracket slid off the sign post. Brakes on the vehicle were applied 0.54 s after impact, and the vehicle subsequently came to rest 187 ft downstream of impact. [Figure C1](#) in [Appendix C](#) shows sequential photographs of the test period.
