CRASH TEST AND EVALUATION OF LOCKING ARCHITECTURAL MAILBOXES

Test Report No. 9-1002-12-9

TEXAS A&M TRANSPORTATION INSTITUTE
COLLEGE STATION, TEXAS

TEXAS DEPARTMENT OF TRANSPORTATION

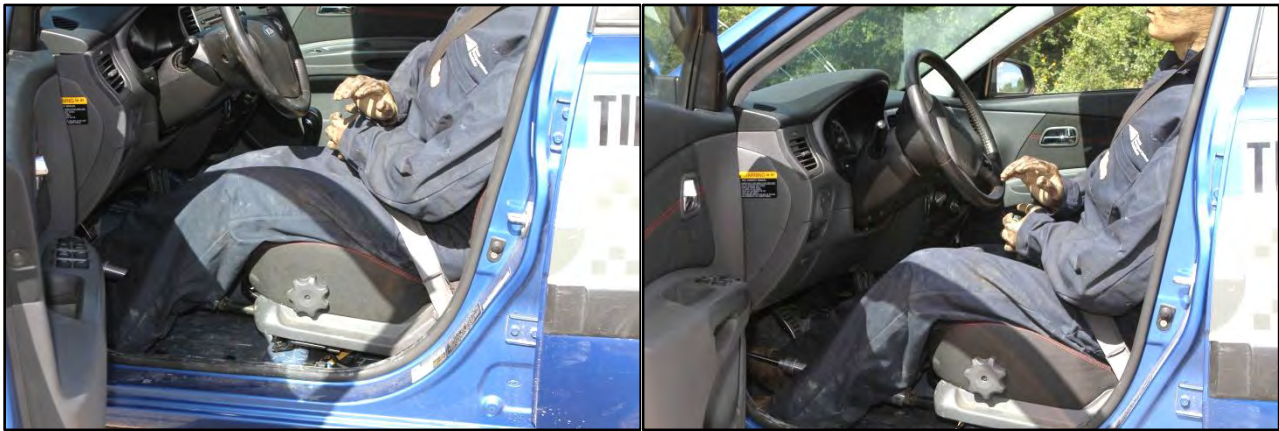
Figure 4.8 shows damage to the exterior of the vehicle, and Figure 4.9 shows the interior of the vehicle. A very small dent was noted on the hood and bumper. There was no contact of any components of the mailbox system with the windshield. Tables A2 and A3 in Appendix A provide exterior crush and occupant compartment measurements for the vehicle.

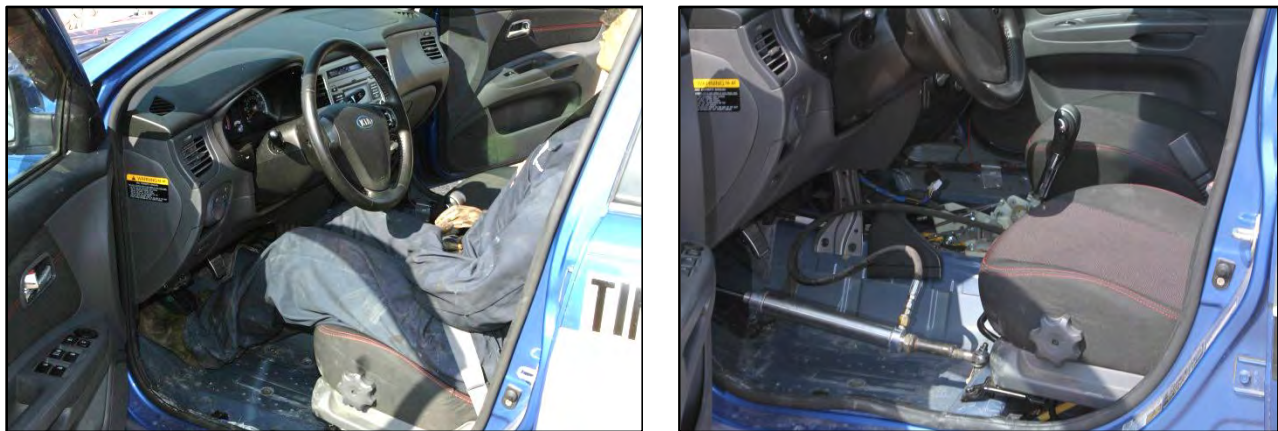
Figure 5.8 shows damage to the exterior of the vehicle, and Figure 5.9 shows the interior of the vehicle. The hood and bumper were dented. There was no contact of any components of the mailbox system with the windshield. Tables C2 and C3 in Appendix C provide exterior crush and occupant compartment measurements.

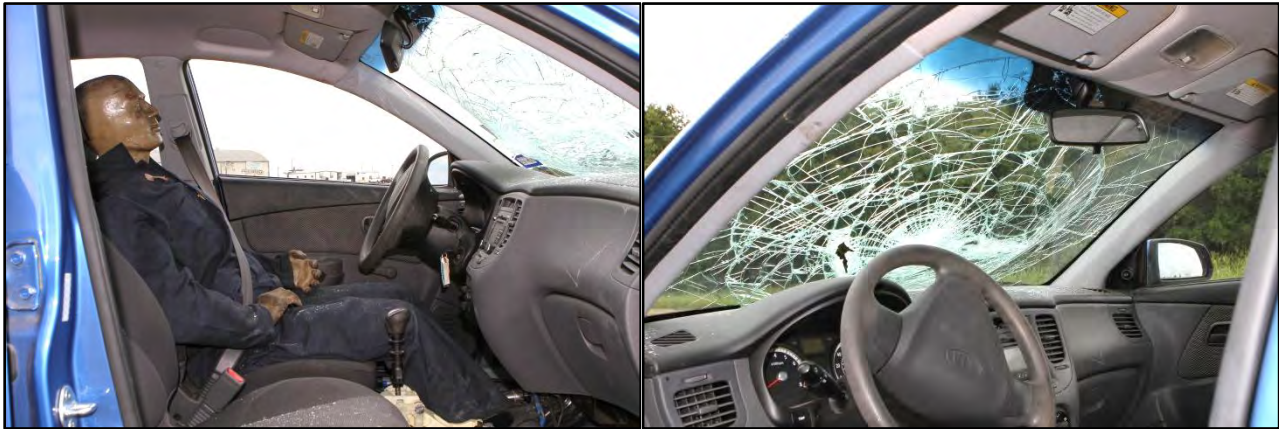
Figure 5.16. Interior of Vehicle after Test No. 490023-9-4.

The windshield sustained four cuts. One cut was 19 inches long, a second was 4.5 inches long, a third was 2 inches long, and the fourth was 3 inches long. The windshield was depressed 4.5 inches toward the occupant compartment over an area measuring 30 inches × 36 inches. [Figure 5.15](#) shows damage to the exterior of the vehicle, and [Figure 5.16](#) shows the interior of the vehicle. [Tables D2](#) and [D3](#) in [Appendix D](#) provide exterior crush and occupant compartment measurements.

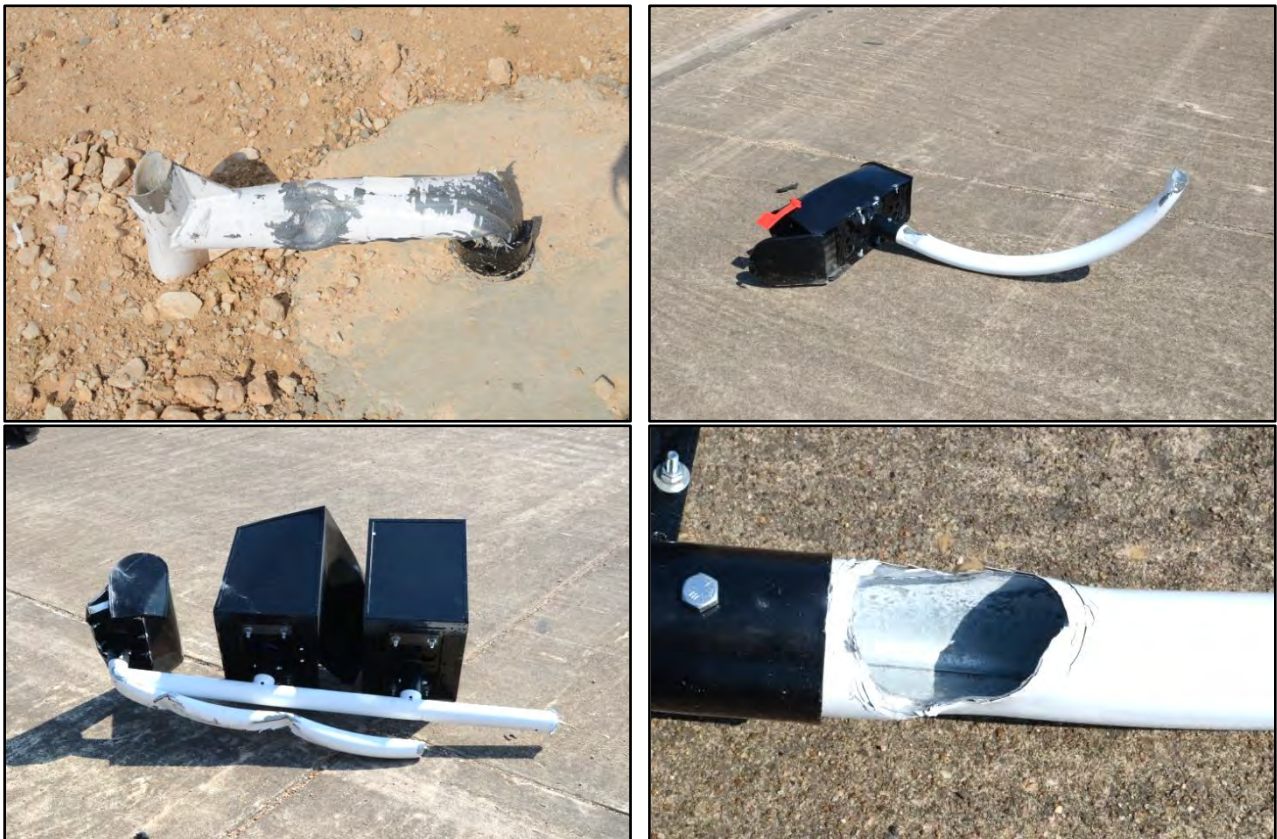
Figure 6.8. Installation after Test No. 490023-9-5.

[Figures 6.7](#) and [6.8](#) show damage to the mailbox installation. The mailboxes remained attached to the support post; however, the support post fractured into three pieces. The support post pulled up inside the socket, but did not completely pull out of the socket. The piece remaining in the socket was deformed 90 degrees at ground level. One of the standard mailboxes and a piece of the support post came to rest 177 ft downstream of impact and 14 ft to the left of centerline of the vehicle path. The two locking architectural mailboxes, the second

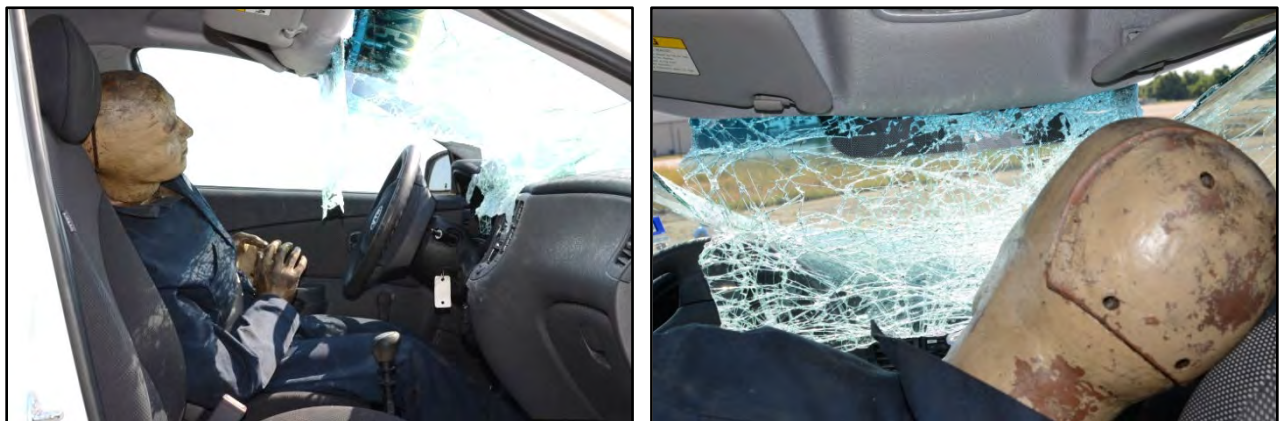
Figure 6.10. Interior of Vehicle for Test No. 490023-9-5.

The windshield of the vehicle sustained an open tear measuring 14 inches \times 24 inches. The roof of the vehicle was deformed downward into the occupant compartment 4.75 inches. Figure 6.9 shows damage to the exterior of the vehicle, and Figure 6.10 shows the interior of the vehicle. Tables E2 and E3 in Appendix E provide exterior crush and occupant compartment measurements.

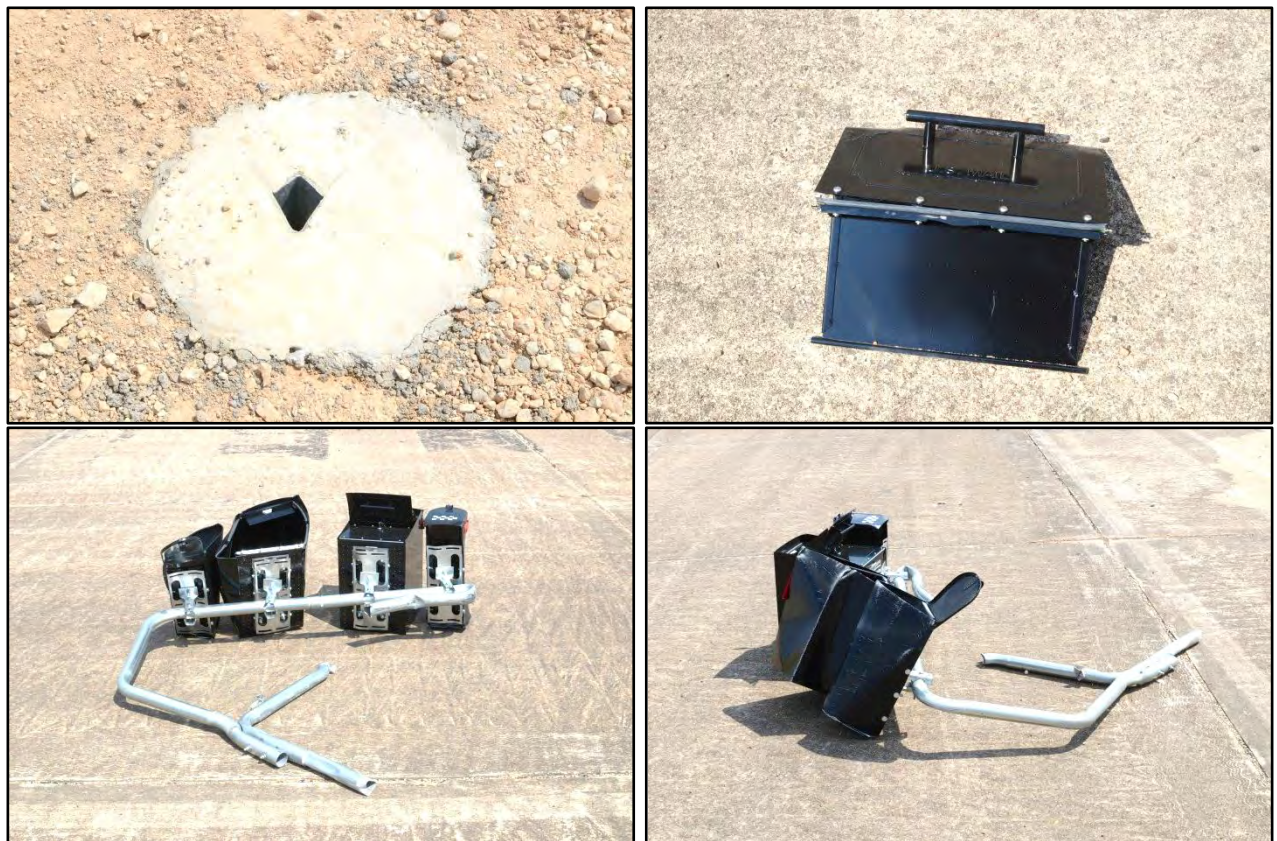
Figure 6.21. Installation after Test No. 490023-9-6.

[Figures 6.20](#) and [6.21](#) show damage to the mailbox installation. The support pulled out of the foundation socket and was fractured on the impact side. The mailboxes remained attached

Results: The multiple-mount support yielded to the 1100C vehicle and pulled out of the foundation socket. (PASS)

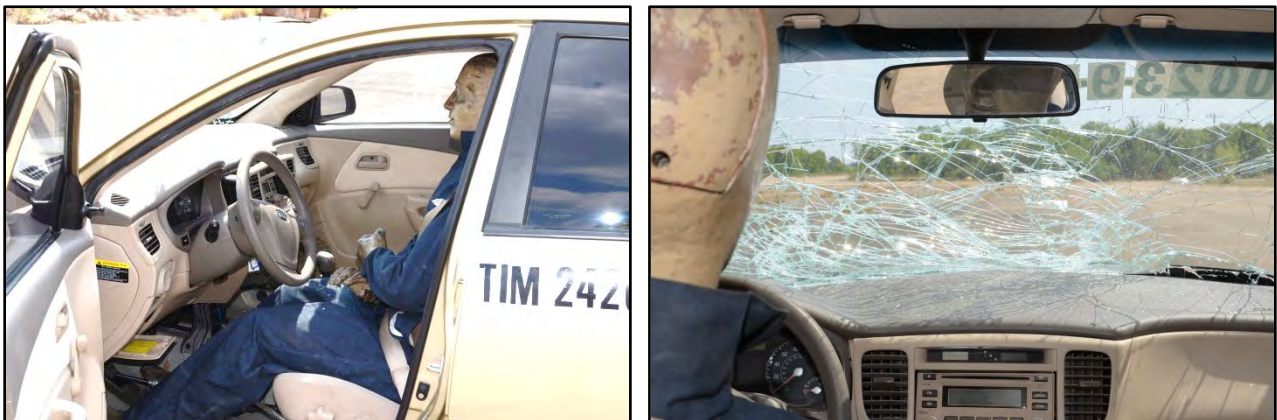
Figure 6.23. Interior of Vehicle for Test No. 490023-9-6.

The hood of the vehicle was dented and pushed downward. The windshield was shattered and pushed into the occupant compartment 3.5 inches and there were several small tears at the bottom edge of the windshield behind the dashboard. [Figure 6.22](#) shows damage to the exterior of the vehicle, and [Figure 6.23](#) shows the interior of the vehicle. [Tables F2](#) and [F3](#) in [Appendix F](#) provide exterior crush and occupant compartment measurements.

Results: Contact of the locking architectural mailboxes and standard mailboxes on multiple-mount support with the windshield caused several small tears at the base of the windshield. (FAIL)

Maximum occupant compartment deformation was 3.5 inches in the windshield on the driver's side. (FAIL)
