CRASH TEST AND EVALUATION OF TEMPORARY WOOD SIGN SUPPORT SYSTEM FOR LARGE GUIDE SIGNS

Test Report 9-1002-15-4

TEXAS A&M TRANSPORTATION INSTITUTE
COLLEGE STATION, TEXAS

TEXAS DEPARTMENT OF TRANSPORTATION

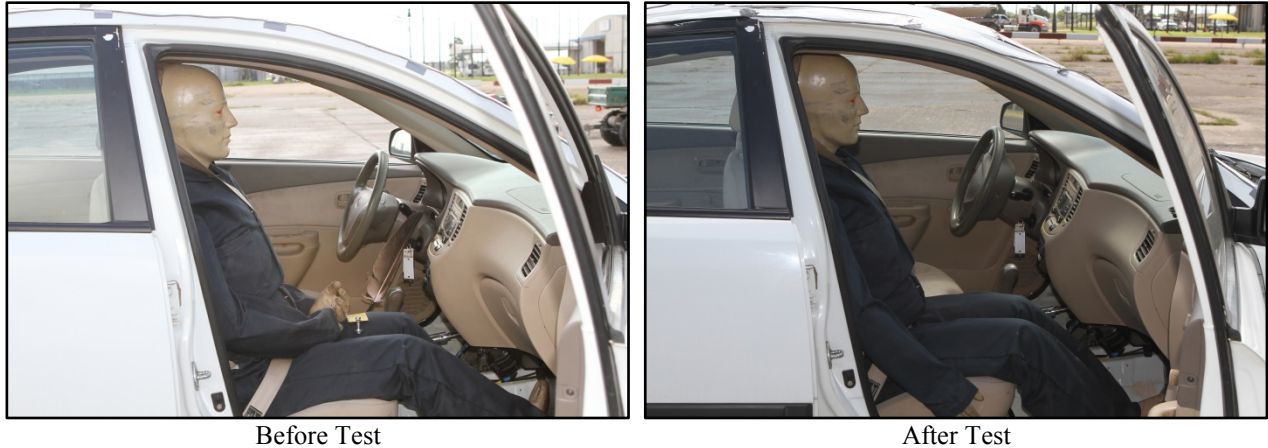
Figure 5.6. Interior of Vehicle for Test No. 490025-4-1.

Damage to the vehicle is shown in Figure 5.5. The front bumper, hood, roof, and right C-post were deformed. The windshield sustained stress cracks radiating from the right corner of the roof, and the rear glass was shattered. Maximum external crush to the vehicle was 2.5 inches in the roof and 2.0 inches in the front plane at the right front corner of the bumper at bumper height. Figure 5.6 shows the interior of the vehicle before and after the test. Maximum occupant compartment deformation was 2.5 inches in the roof. Exterior vehicle crush and occupant compartment measurements are shown in Appendix C2, Tables C.2 and C.3.

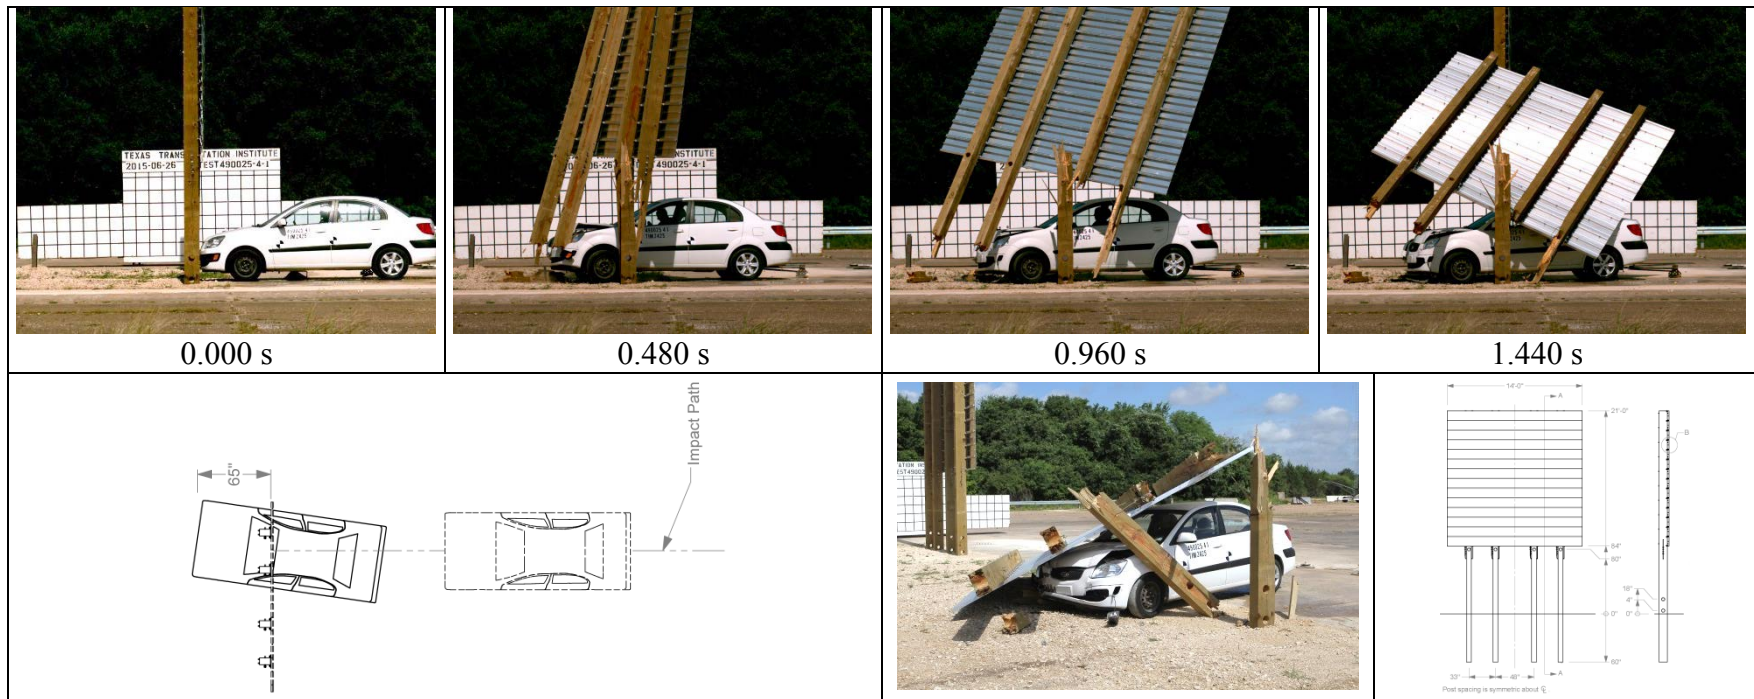
Results: The Temporary Wood Sign Support for Large Guide Signs readily activated by fracturing in various design locations. (PASS)

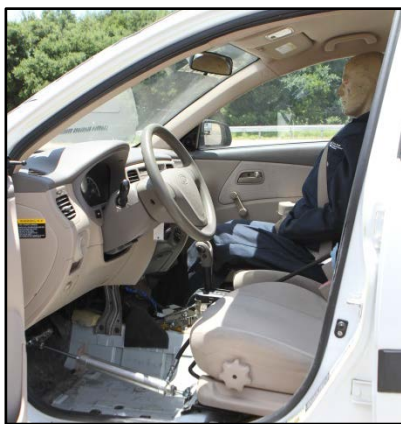
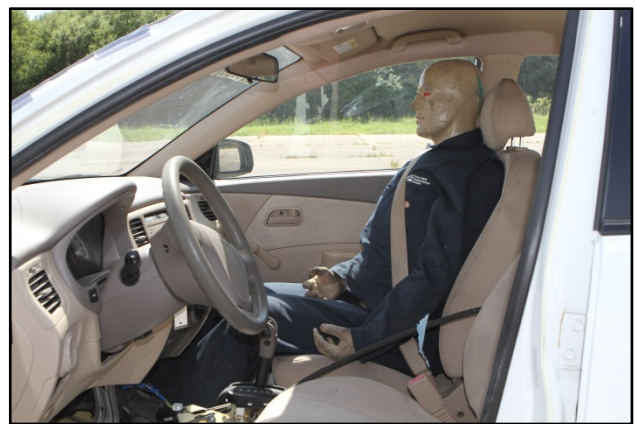
Figure 6.6. Interior of Vehicle for Test No. 490025-4-2.

Damage to the vehicle is shown in Figure 6.5. The front bumper, hood, and roof were deformed. The windshield sustained a crack radiating from the left front corner of the roof. Maximum external deformation of the vehicle was 3.26 inches in the front plane at the left quarter point of the bumper at bumper height. No occupant compartment deformation was noted. Figure 6.6 shows the interior of the vehicle. Exterior vehicle crush and occupant compartment measurements are shown in Appendix D2, Tables D.2 and D.3.
