CRASH TESTING AND EVALUATION OF MULTIPLE MAILBOX SUPPORTS FOR USE WITH LOCKING ARCHITECTURAL MAILBOXES

Test Report 9-1002-15-7

TEXAS A&M TRANSPORTATION INSTITUTE
COLLEGE STATION, TEXAS

TEXAS DEPARTMENT OF TRANSPORTATION

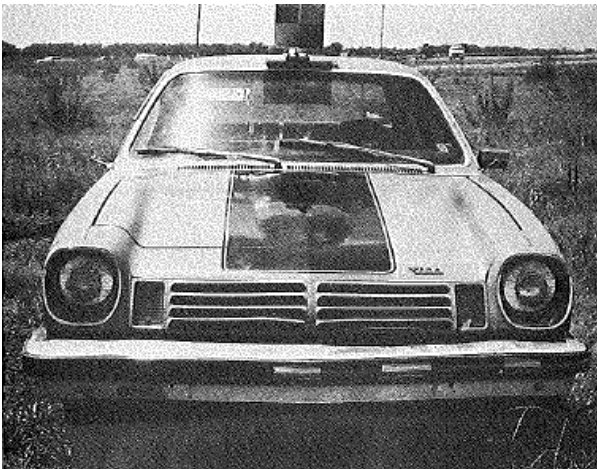
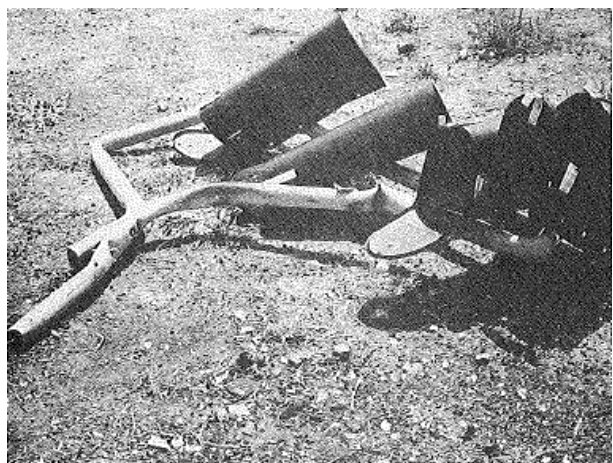
Figure 2.3. (a) Vehicle and (b) Test Article after Test No. 1 (3).

The test was conducted at 60 mi/h with a 1974 Chevrolet Vega weighing 2320 lb (Figure 2.2). The impact point on the vehicle was 15 inches to the left of the center of the bumper. The change in momentum of the vehicle during impact with the design was well below the preferable limit of 750 lb-s recommended in TRC No. 191 (Table 2.1). The system was proven acceptable for up to four mailboxes. There was no penetration of the passenger compartment by the test article and the windshield remained unbroken after the impact event. Vehicle and test article deformation after test are reported in Figure 2.3(a) and (b), respectively. The vehicle sustained only minor damage and was still operable at the end of the test.

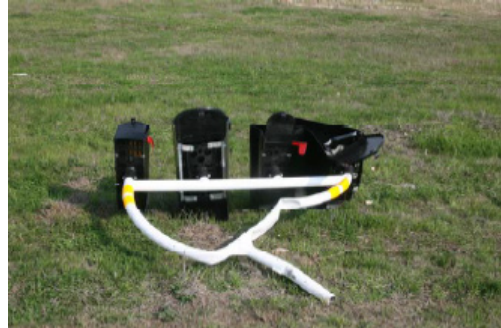
Figure 2.6. (a) Vehicle and (b) Test Article after Test No. 452106-2 (5).Based on these crash test results, the researchers concluded that the Shur-Tite® multiple-mailbox mount successfully passed all requirements of the *NCHRP Report 350* safety evaluation criteria.

The vehicle sustained minimal damage to the hood and bumper as shown in Figure 2.6(a). The front bumper had a slight indentation at the point of contact with the support, and the hood had an indentation on the impact side that measured 33.5 inches long \times 5.9 inches wide. The windshield

was shattered over an area approximately 31.5 inches in diameter and was deformed 3.2 inches inward toward the occupant compartment. Some of the mailboxes were deformed, but all remained attached to the support. The vertical section of the support was deformed 11.8 inches from the end, and the arc of the support was severely deformed (Figure 2.6[b]).

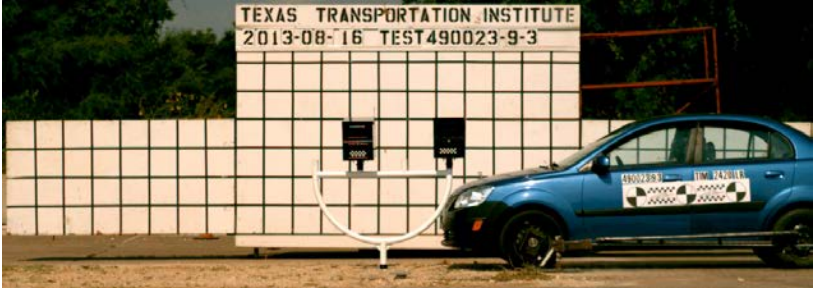
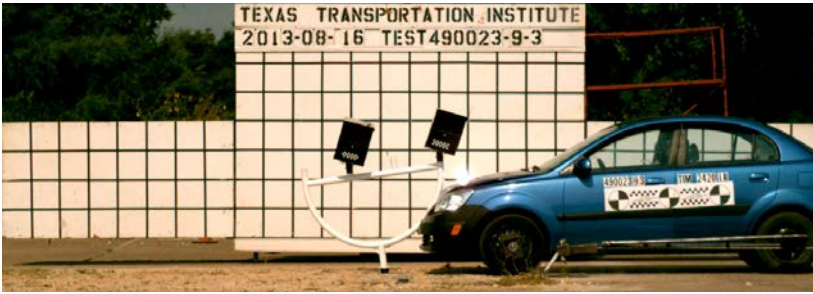
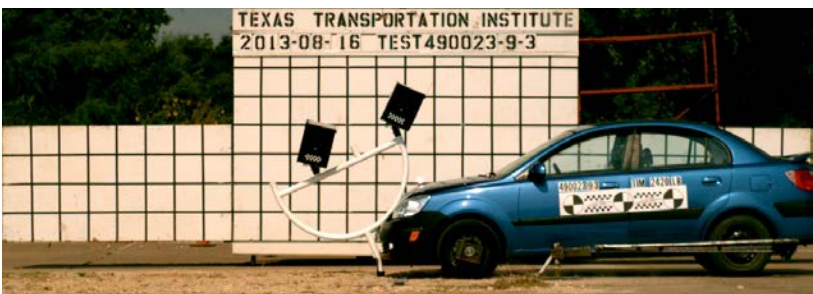
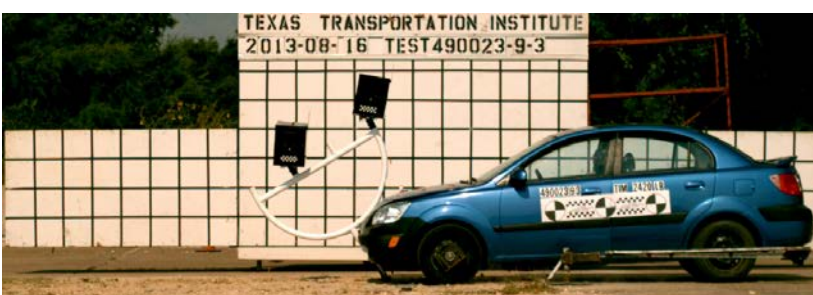
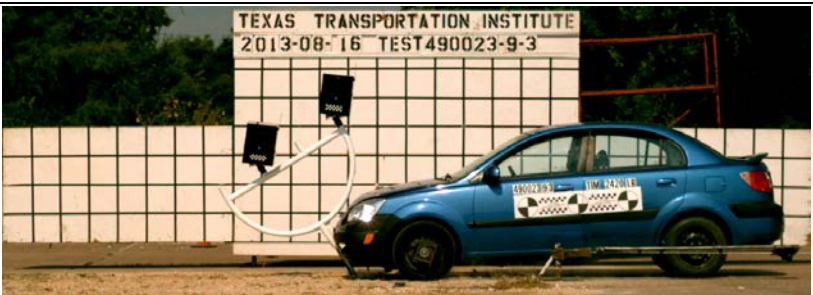
Figure 2.8. Sequential Photographs for Test No. 490023-9-3 (I).

Figure 2.7. Details of the Dual Locking Architectural Mailbox on Shur-Tite® Multiple-Mailbox Mount Post (I). This configuration was tested with a passenger car at both low speed (Test No. 490023-9-3) and high speed (Test No. 490023-9-4). In the low-speed test, the vehicle lifted the support out of the foundation socket as designed and pushed it forward of the vehicle (Figure 2.8). The mailboxes remained attached to the support, and there was no contact with the vehicle windshield. Vehicle damage was minor and occupant risk parameters were below preferred values. The SHUR-TITE® multiple-mount support post with dual locking architectural mailboxes met all applicable *MASH* criteria for Test 3-60.

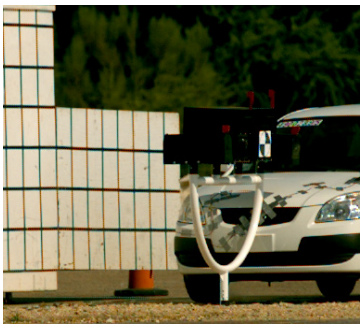
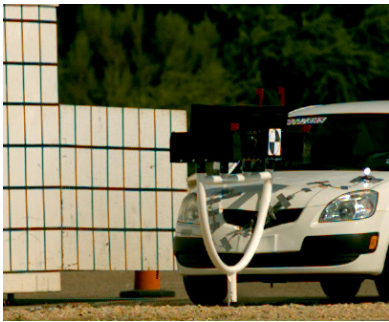
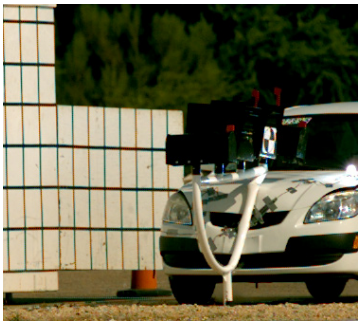
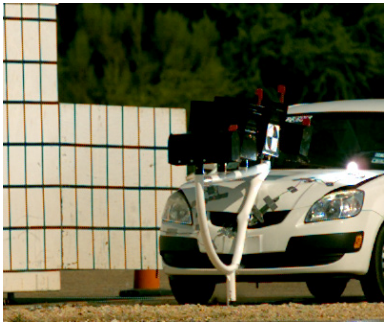
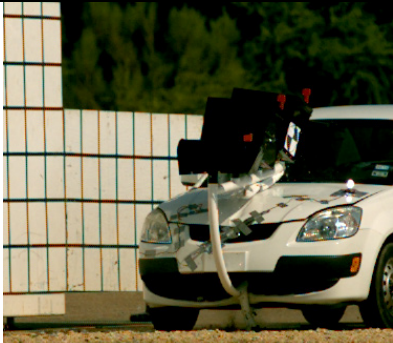
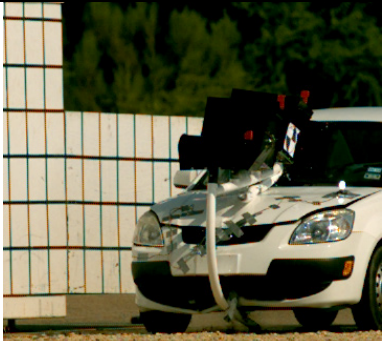
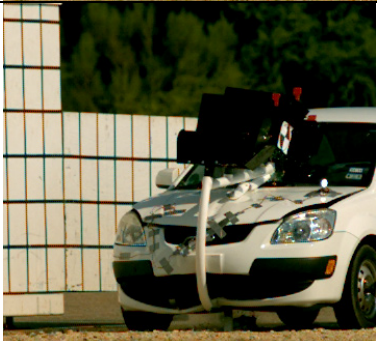
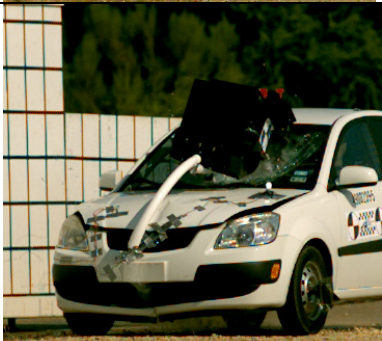
Figure 2.11. Sequential Photographs for Test No. 490023-9-5 (I).

In the high-speed test of the combination mailbox configuration on the SHUR-TITE® multiple-mount support post, the support did not release from the foundation socket. The support fractured into multiple pieces, leaving the foundation stub partially embedded in the foundation socket (Figure 2.11). The fractured support and mailboxes impacted and created a large hole in the vehicle windshield (Figure 2.12). Consequently, the SHUR-TITE® multiple-mount support post with a combination of standard and locking architectural mailboxes did not satisfy MASH criteria for Test 3-61.

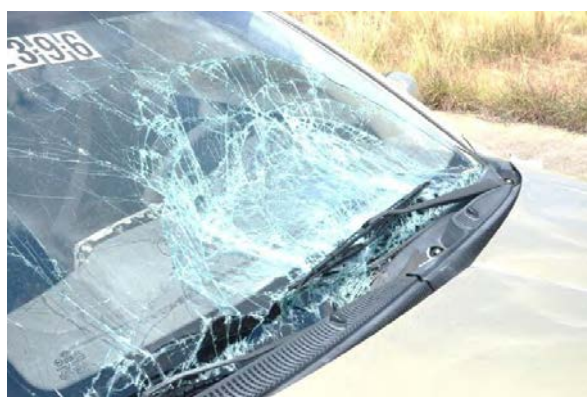
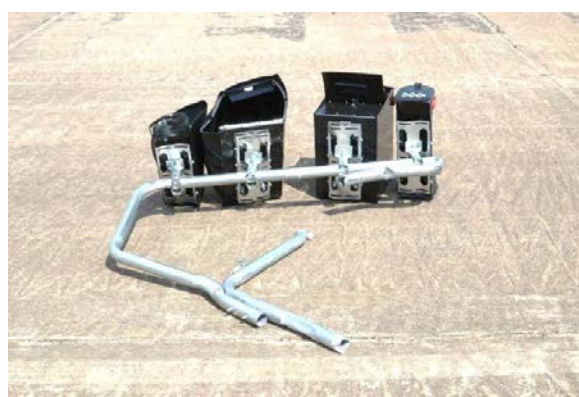
Figure 2.15. (a) Vehicle and (b) Test Article after Test No. 490023-9-6 (I).

In the high-speed test of the combination mailbox configuration on the formed thin-wall steel tube multiple-mount support post, the support released from the foundation socket as designed but fractured in the impacted region (Figure 2.14). The ruptured support and attached mailboxes contacted and shattered the windshield of the vehicle. Maximum deformation of the windshield was 3.5 inches, which exceeds the *MASH* threshold (Figure 2.15). Also, there were several small tears at the base of the windshield behind the dashboard. Consequently, the formed thin-wall steel tube multiple-mount support post with a combination of standard and locking architectural mailboxes did not satisfy *MASH* criteria for Test 3-61.

Results of the crash testing suggested further research was required to develop a multiple-mailbox support that can be used with the larger, heavier lockable mailboxes. Possible modifications included increasing the strength of the support post to facilitate release of the support from the foundation, and to prevent localized collapse and/or rupture of the support during impact.

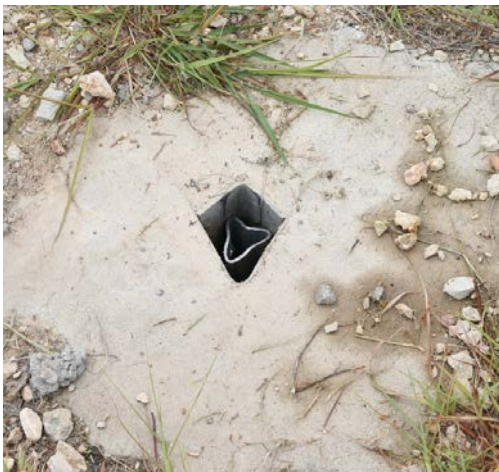
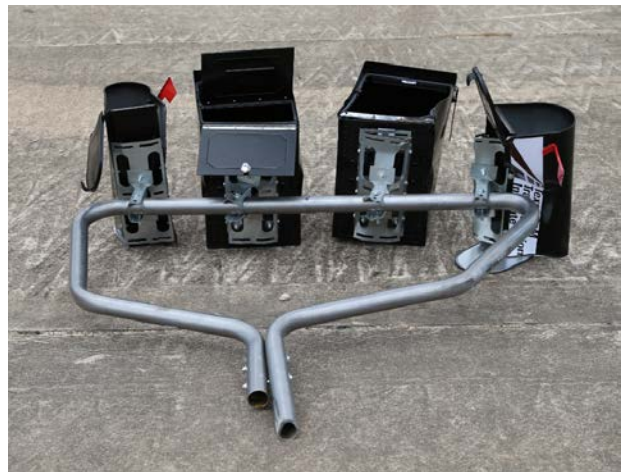
Figure 5.8. Installation after Test No. 490025-3-2.

Figures 5.7 and 5.8 show the damage to the multiple-mailbox support installation. The support post lifted out of the socket as designed. The support post and the mailboxes were deformed, as were the brackets attaching the mailboxes to the support post. The mailboxes remained attached to the support post and the assembly came to rest behind the vehicle 184 ft downstream and 4 ft left of impact, with the support base pointing left relative to the vehicle path.

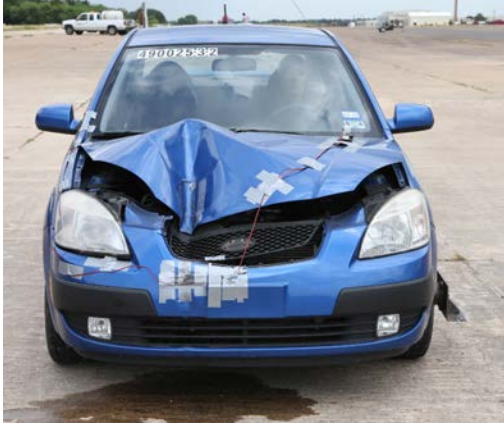
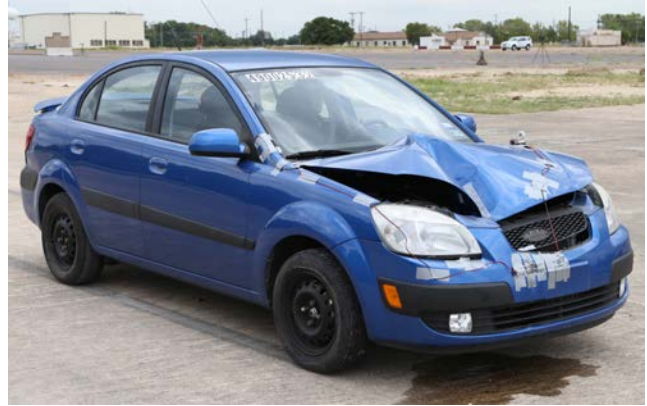
Figure 5.9. Vehicle after Test No. 490025-3-2.

Figure 5.9 shows damage to the exterior of the vehicle, and Figure 5.10 shows the interior of the vehicle after the test. The hood, bumper, and grill were deformed. The maximum hood deformation was 8 inches. There was no contact of any components of the mailbox system with the windshield. Tables B.2 and B.3 in Appendix B.1 provide exterior crush and occupant compartment measurements, respectively.

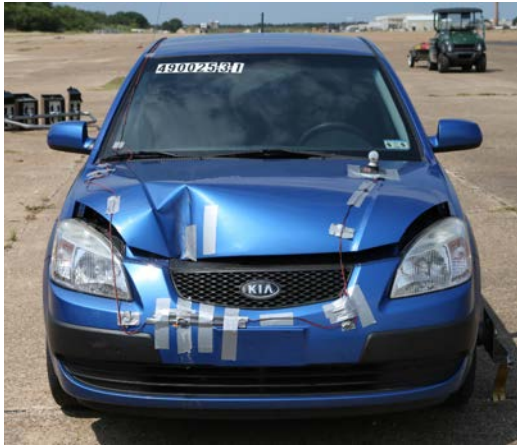
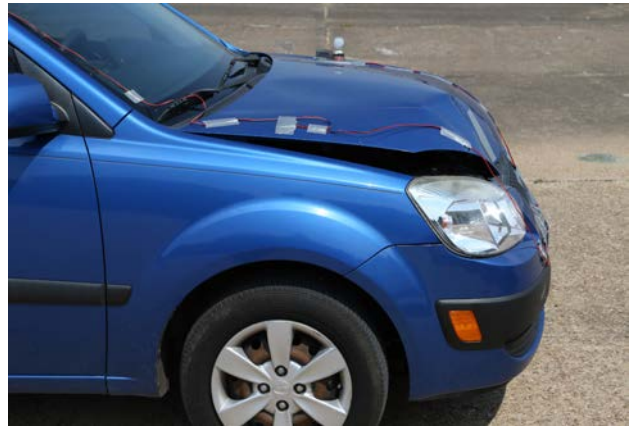
Figure 5.16. Vehicle after Test No. 490025-3-1.

Figure 5.16 shows damage to the exterior of the vehicle, and Figure 5.17 shows the interior of the vehicle after the test. The hood and bumper were deformed. The maximum hood deformation was 3.25 inches. There was no contact of any components of the mailbox system with the windshield. Tables C.2 and C.3 in Appendix C.1 provide exterior crush and occupant compartment measurements, respectively.

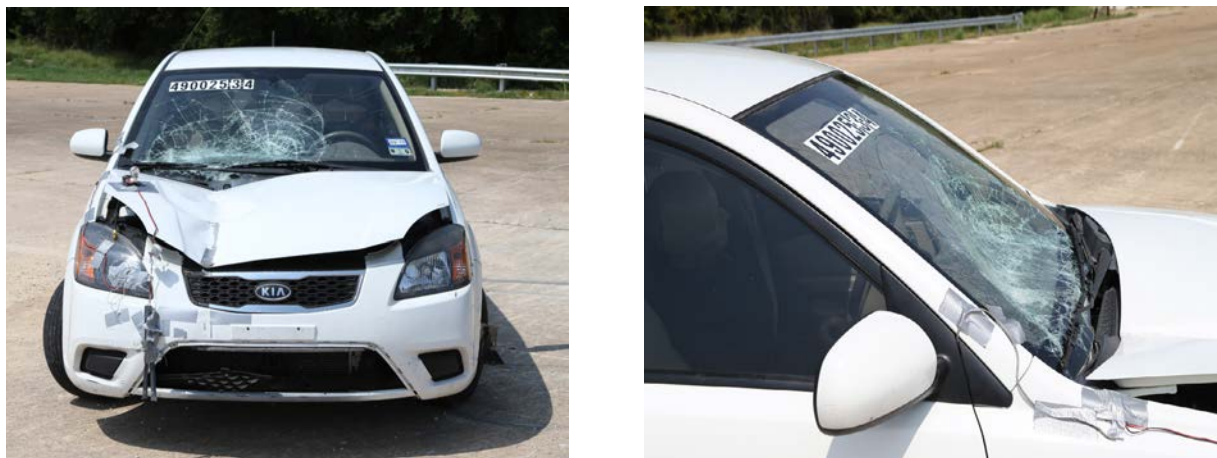
Figure 6.9. Vehicle after Test No. 490025-3-4.

Figure 6.9 shows damage to the exterior of the vehicle, and Figure 6.10 shows the interior of the vehicle after the test. The hood, bumper, and grill were deformed. The maximum hood deformation was 3 inches. The windshield was shattered and deformed due to contact with the mailboxes and support. Maximum windshield deformation was 3 inches. Tables D.2 and D.3 in Appendix D.1 provide exterior crush and occupant compartment measurements.

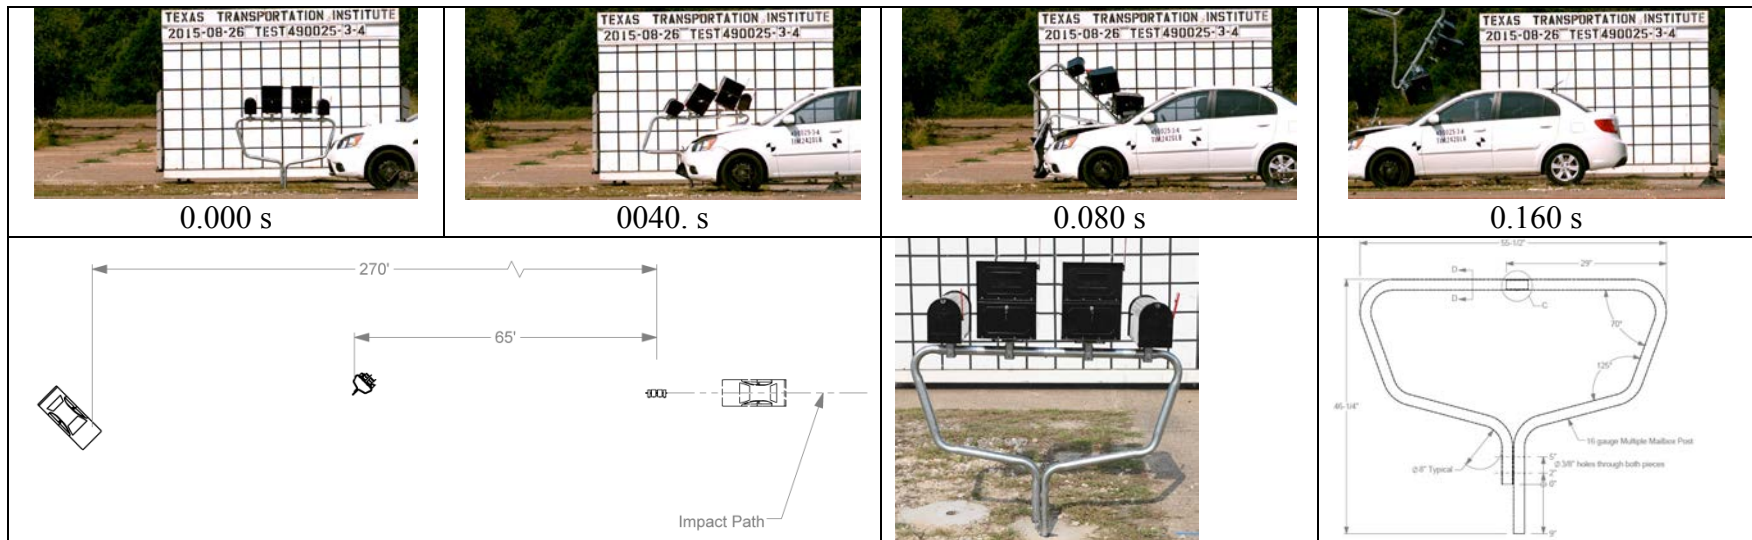
Results: The multiple-mount post with attached locking architectural and standard mailboxes activated by yielding to the vehicle and lifting out of the foundation socket. (PASS)

Results: The locking architectural and the standard mailboxes remained attached to the support post. The door of the locking architectural mailboxes detached from the mailbox, but did not show potential for penetrating the occupant compartment, or present hazard to other traffic. The mailbox installation did not penetrate or show potential for penetrating the occupant compartment, nor present hazard to others in the area. (PASS)

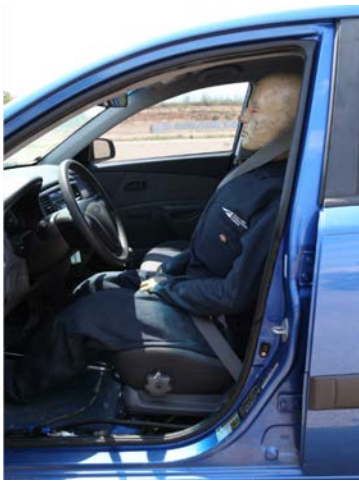
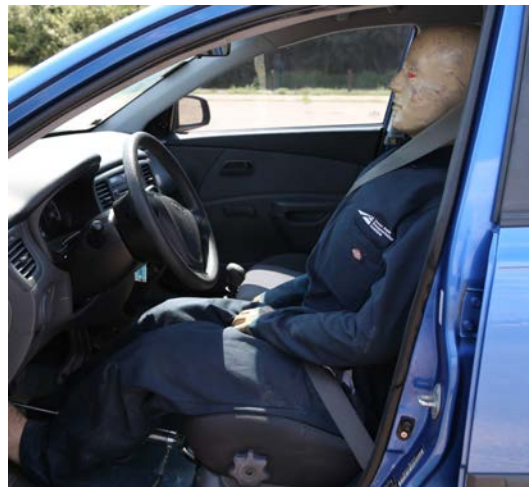
Figure 6.18. Interior of Vehicle for Test No. 490025-3-3.

Figure 6.17 shows the damage to the exterior of the vehicle, and Figure 6.18 shows the interior of the vehicle after the test. The hood, bumper, and grill were deformed. The maximum hood deformation was 3.5 inches. There was no contact of any components of the mailbox system with the windshield. Tables E.2 and E.3 in Appendix E.1 provide exterior crush and occupant compartment measurements, respectively.

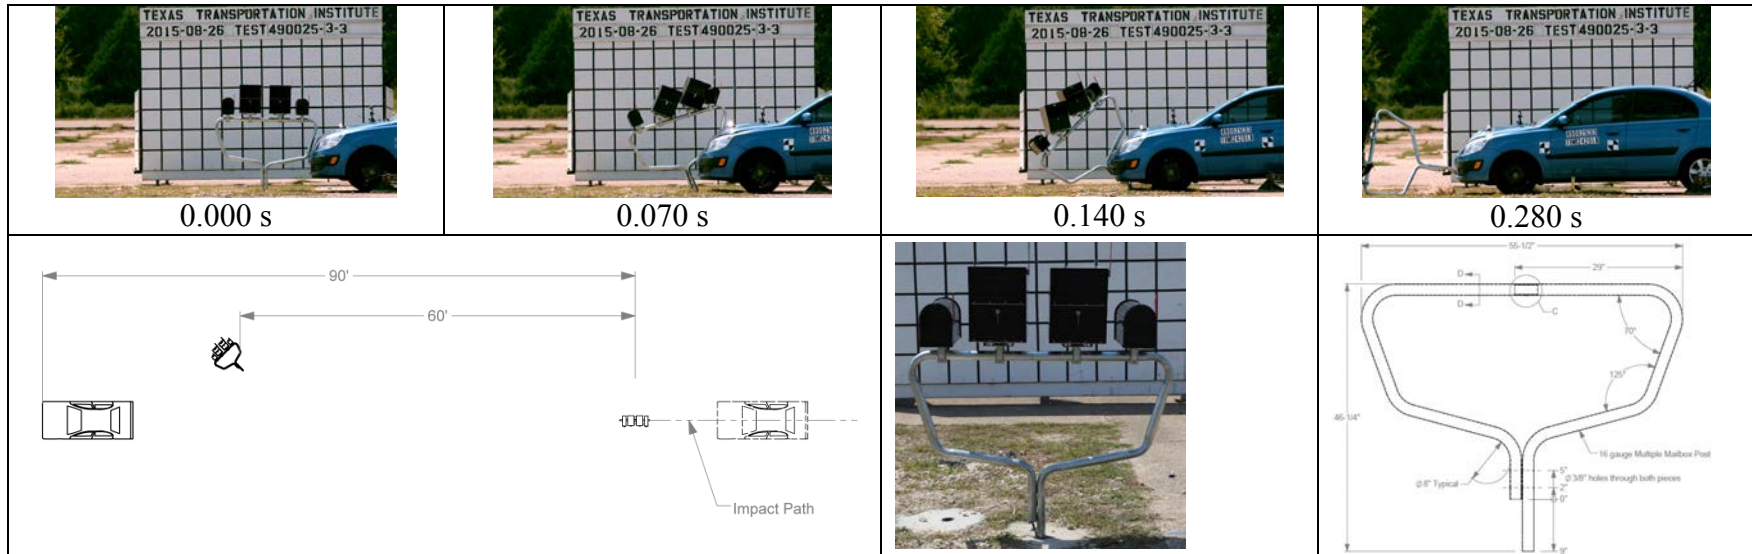
Results: The multiple-mount post with attached locking architectural and standard mailboxes activated by yielding to the vehicle and lifting out of the foundation socket. (PASS)

Results: The locking architectural and the standard mailboxes remained attached to the support post. The mailbox installation did not penetrate or show potential for penetrating the occupant compartment, nor present hazard to others in the area. (PASS)
