MASH EVALUATION OF TxDOT HIGH-MOUNTING-HEIGHT TEMPORARY WORK ZONE SIGN SUPPORT SYSTEM

Test Report 9-1002-15-8

**TEXAS A&M TRANSPORTATION INSTITUTE
COLLEGE STATION, TEXAS**

TEXAS DEPARTMENT OF TRANSPORTATION

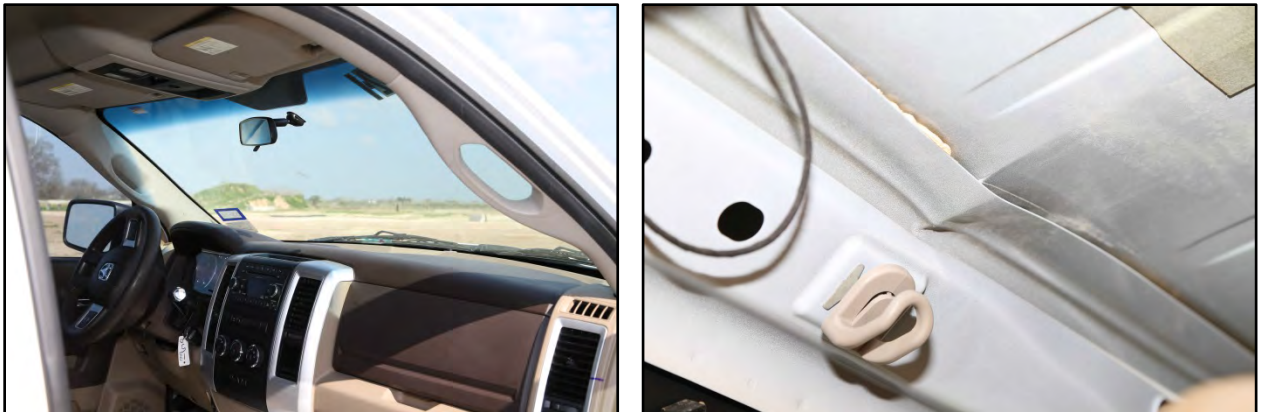
Figure 5.6. Interior of Test Vehicle after Test No. 490026-2-1.

Figure 5.5 shows the damage sustained by the vehicle. The bumper, hood, grill, and roof were damaged. Maximum exterior crush to the vehicle was 2.5 inches in the front plane at the right quarter point at bumper height. On the rear of the roof, there was a 16-inch long scratch that ended in a 5-inch long tear on the outer surface. The cut did not extend into the passenger compartment. The interior roof in the area of the cut was only dented approximately 1 inch, as shown in Figure 5.6. No other occupant compartment deformation or intrusion was noted. Tables A.3 and A.4 in Appendix A1 provide exterior crush and occupant compartment measurements.

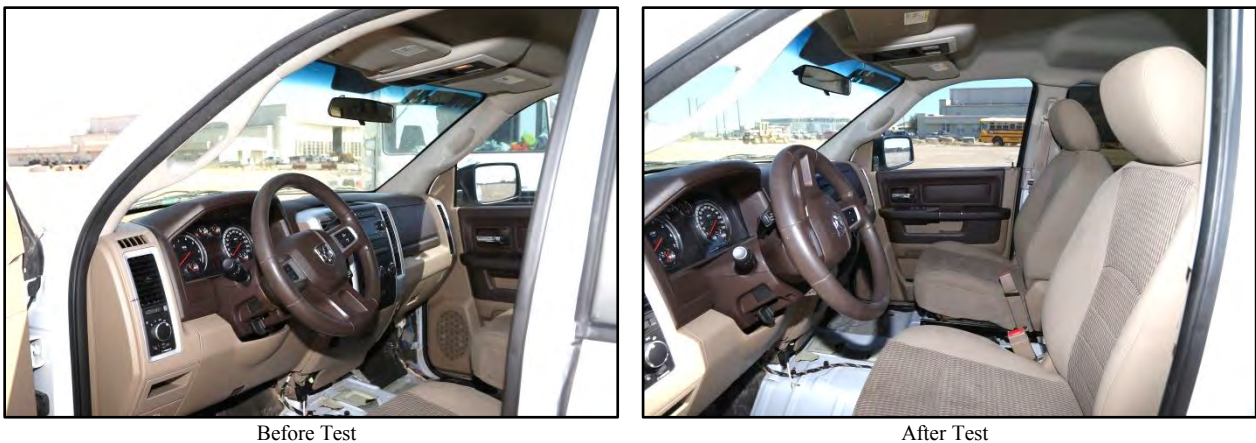
Figure 6.6. Interior of Test Vehicle for Test No. 490026-2-2.

at the left quarter point at bumper height. On the left side of the roof of the cab, there was a 10-inch long dent on the outer surface, but no penetration into the passenger compartment. Figure 6.6 shows the interior of the vehicle. No occupant compartment deformation or intrusion was noted. Tables B.3 and B.4 in Appendix B1 provide exterior crush and occupant compartment measurements.

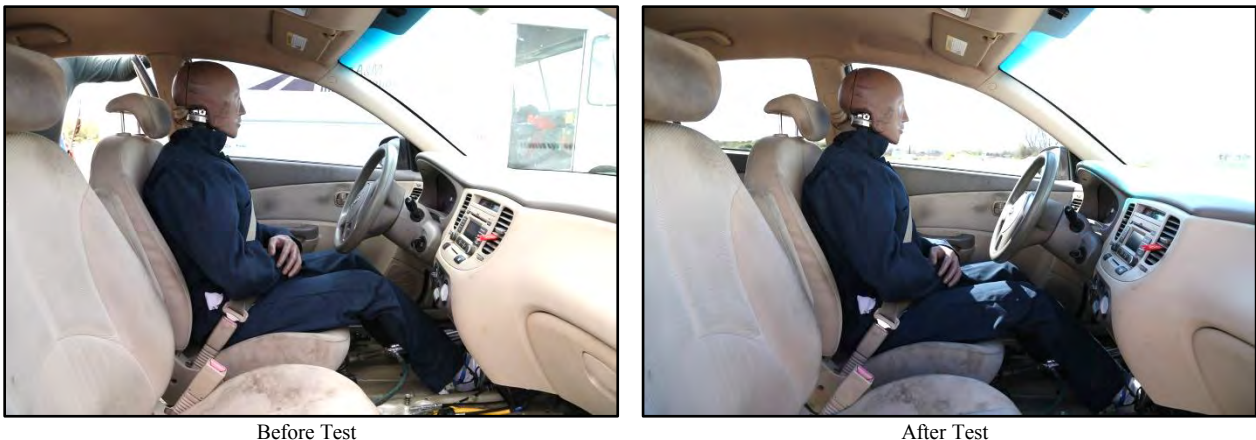
Figure 6.18. Interior of Test Vehicle for Test No. 490026-2-6.

Figure 6.17 shows the damage sustained by the vehicle. The 1100C vehicle sustained only scrapes to the bumper and hood with no measureable exterior vehicle deformation. Figure 6.18 shows the interior of the vehicle. No occupant compartment penetration, deformation, or intrusion was noted. Tables D.2 and D.3 in Appendix D1 provide exterior crush and occupant compartment measurements.

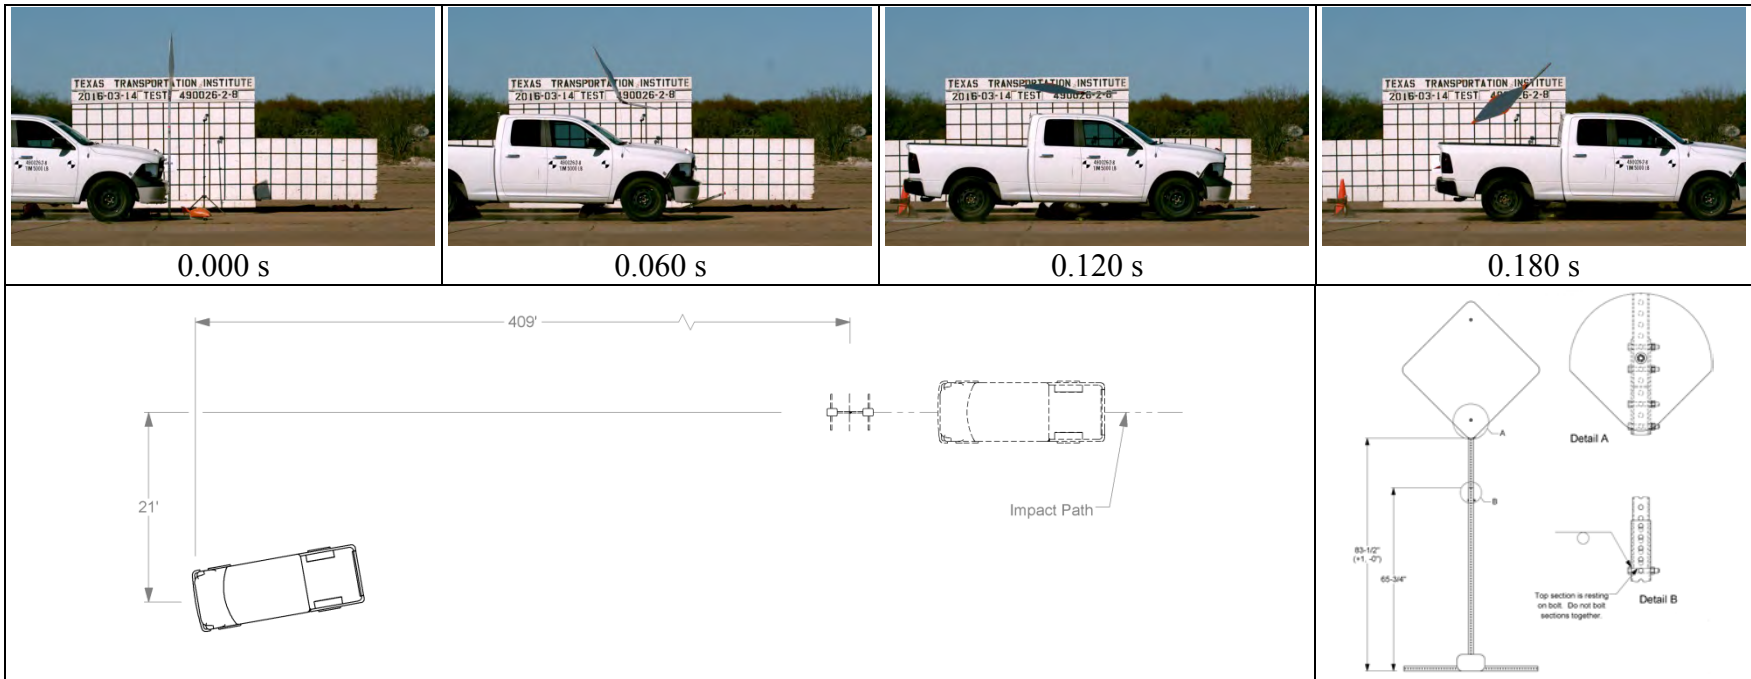
Figure 6.25. Summary of Results for MASH Test 3-72 at 0 Degrees on the Option B Temporary Work Zone Sign Support.

Figure 6.25 provides a summary of the results of the test. The slip connection of Option B temporary work zone sign supports performed as designed and the top of the system released from the lower section. The lower section of the vertical support fractured but did not penetrate or show potential for penetrating the vehicle. No occupant compartment deformation or intrusion was noted. The fractured pieces of the Option B temporary work zone sign support did not block the driver's view and would not cause the driver to lose control of the 2270P vehicle. The 2270P vehicle remained upright during and after the collision event. The 2270P vehicle came to rest 409 ft behind the installation.

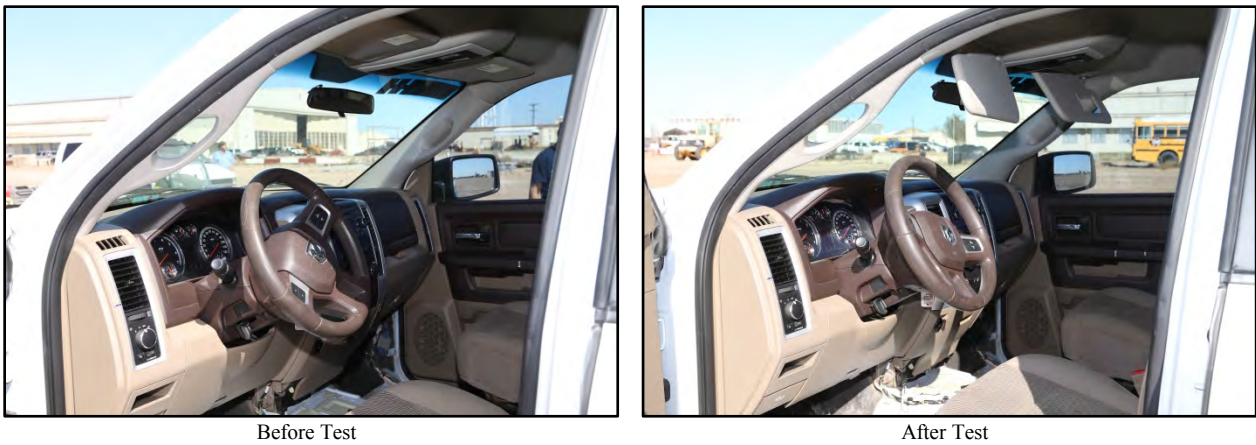
Figure 7.6. Interior of Test Vehicle for Test No. 490026-2-3.

Figure 7.5 shows the damage sustained by the vehicle. The bumper, hood, and roof were scraped. Maximum exterior crush to the vehicle was 6 inches in the front plane at the centerline at bumper height. There was a 3-inch long dent on the outer surface of the front of the roof of the cab, but it did not extend into the passenger compartment. Figure 7.6 shows the interior of the vehicle. No occupant compartment deformation or intrusion was noted. Tables F.3 and F.4 in Appendix F1 provide exterior crush and occupant compartment measurements.

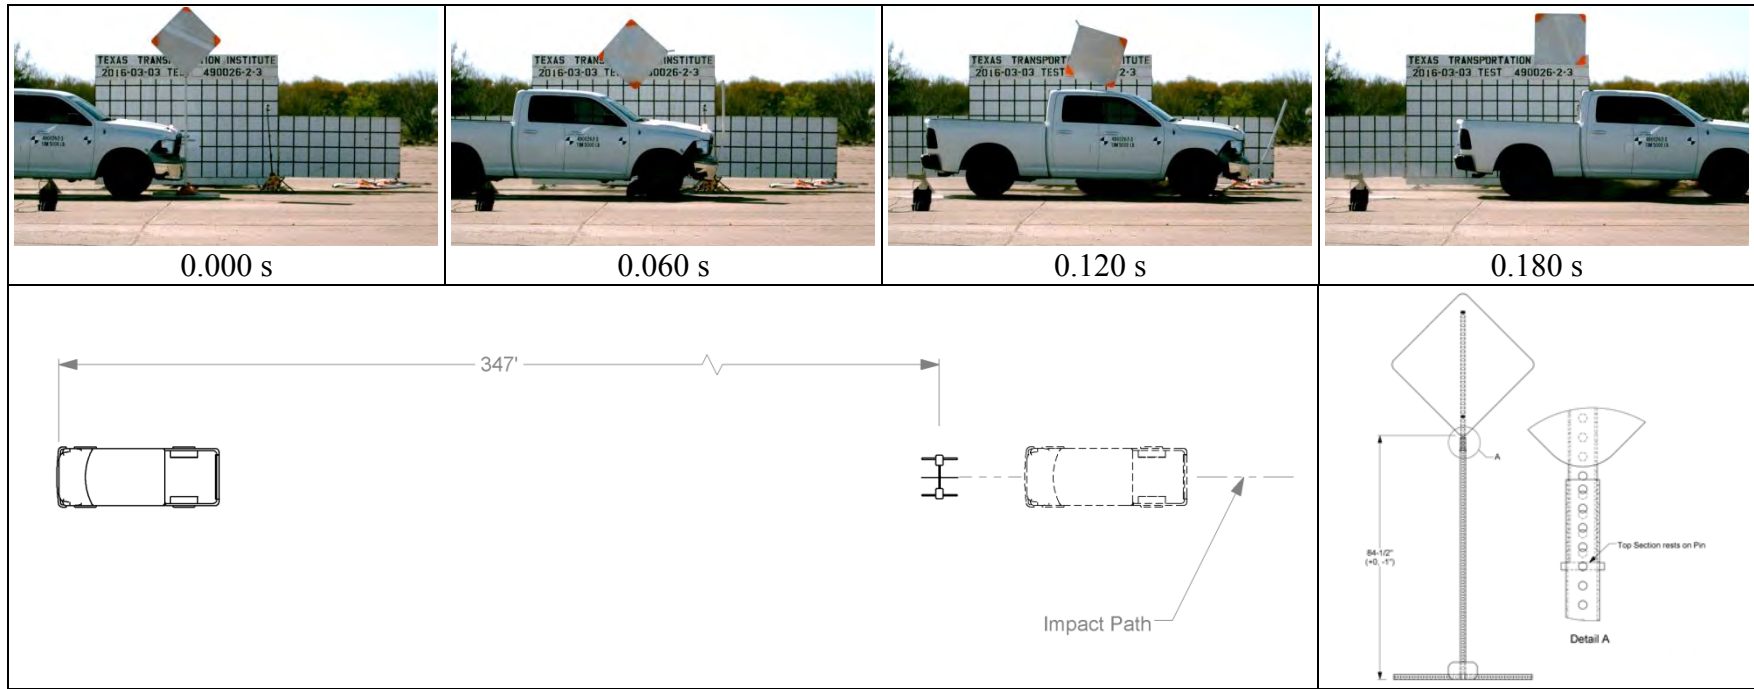
Figure 7.7. Summary of Results for MASH Test 3-72 at 90 Degrees on the Option C Temporary Work Zone Sign Support.

Figure 7.7 provides a summary of the results of the test. The slip connection for Option C temporary work zone sign support performed as designed and the top of the system released from the lower section. The sign panel contacted the roof; however, it did not cause any tears or penetration. The resulting roof deformation was within *MASH* criteria.

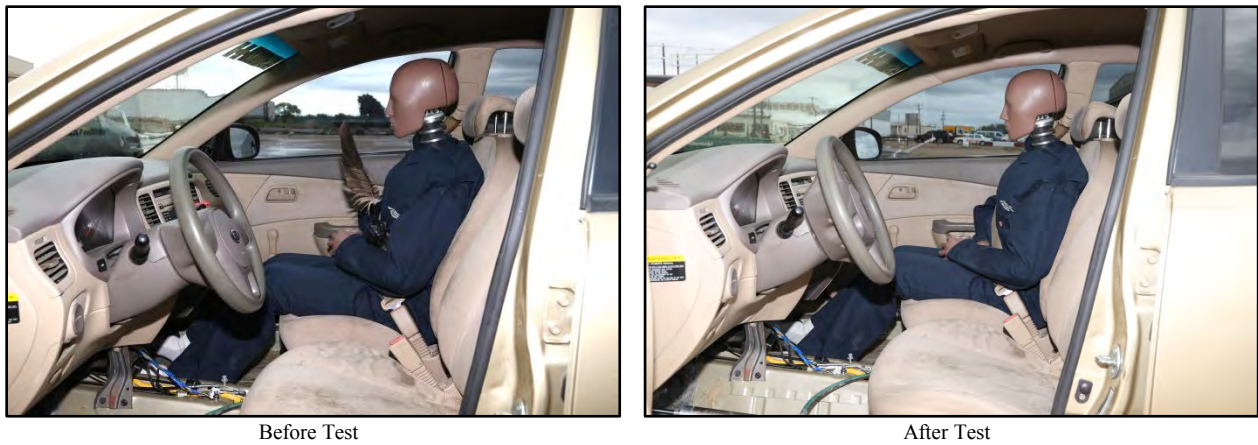
Figure 7.12. Interior of Test Vehicle for Test No. 490026-2-5.

Figure 7.11 shows the damage sustained by the vehicle. The 1100C vehicle sustained only scrapes to the bumper and hood with no measureable exterior vehicle deformation. Figure 7.12 shows the interior of the vehicle. No occupant compartment deformation or intrusion was noted. Tables G.2 and G.3 in Appendix G1 provides exterior crush and occupant compartment measurements.

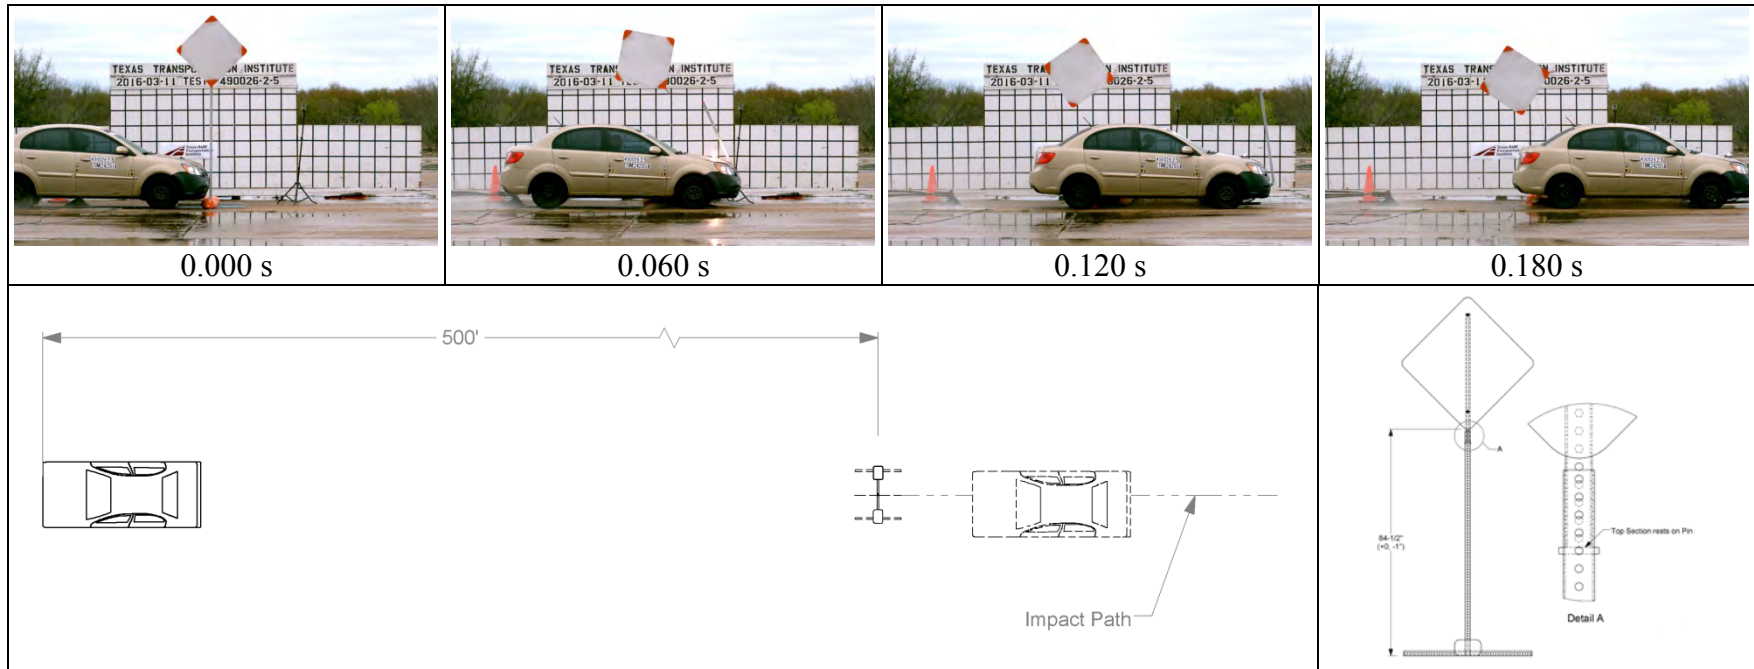
Figure 7.13. Summary of Results for MASH Test 3-71 at 90 Degrees on the Option C Temporary Work Zone Sign Support.

Figure 7.13 provides a summary of the results of the test. The slip connection of Option C temporary work zone sign support performed as designed and the top of the system released from the lower section at vehicle impact. The support structure contacted the bumper and hood, but the sign panel did not contact the roof of the vehicle.

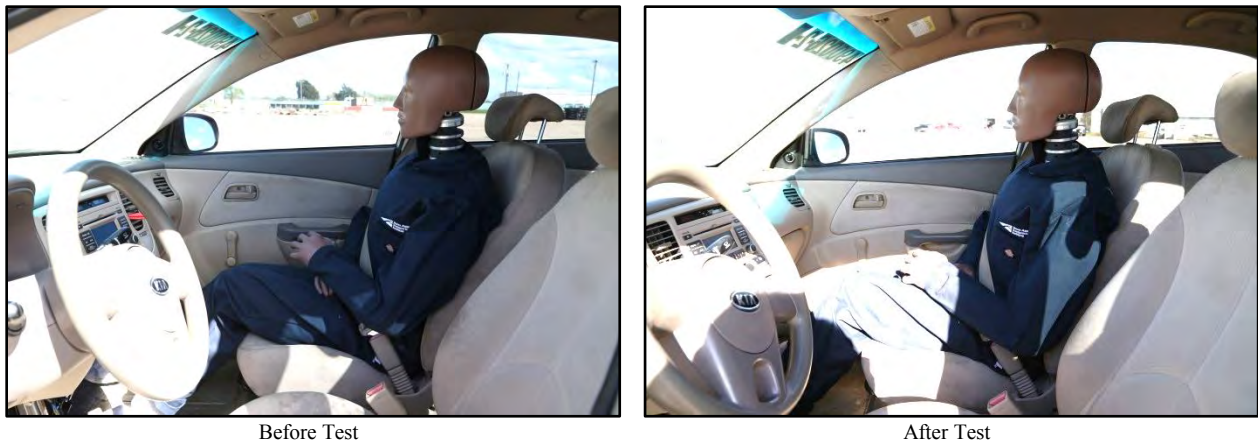
Figure 7.18. Interior of Test Vehicle for Test No. 490026-2-7.

Figure 7.17 shows the damage sustained by the vehicle. The 1100C vehicle sustained only scrapes to the bumper and hood with no measureable exterior vehicle deformation. Figure 7.18 shows the interior of the vehicle. No occupant compartment deformation or intrusion was noted. Tables H.2 and H.3 in Appendix H1 provides exterior crush and occupant compartment measurements.

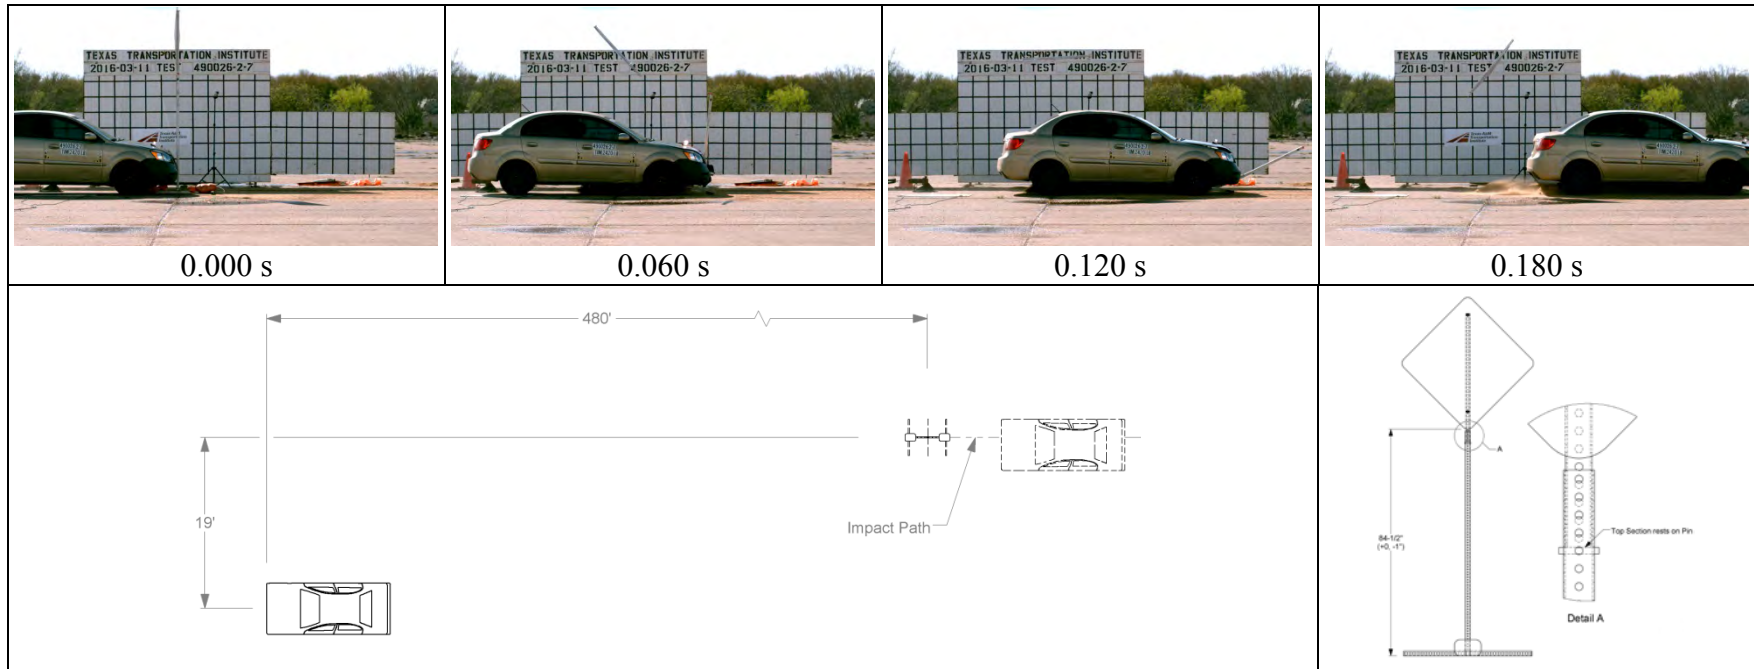
Figure 7.19. Summary of Results for MASH Test 3-71 at 0 Degrees on the Option C Temporary Work Zone Sign Support.

Figure 7.19 provides a summary of the results of the test. The slip connection of Option C temporary work zone sign support performed as designed and the top of the system released from the lower section. The support structure contacted the bumper and hood, but the sign panel did not contact the roof of the vehicle.

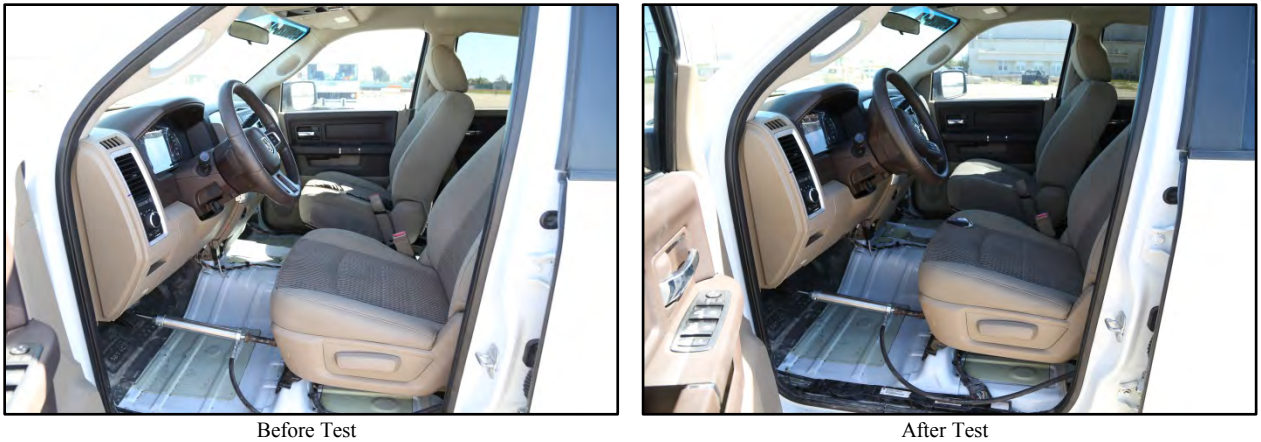
Figure 7.24. Interior of Test Vehicle for Test No. 490026-2-9.

Figure 7.23 shows the damage sustained by the vehicle. The bumper and hood were scraped. Maximum exterior crush to the vehicle was 3.5 inches in the front plane at the left quarter point at bumper height. Figure 7.24 shows the interior of the vehicle. No occupant compartment deformation or intrusion was noted. Tables I.3 and I.4 in Appendix I1 provides exterior crush and occupant compartment measurements.

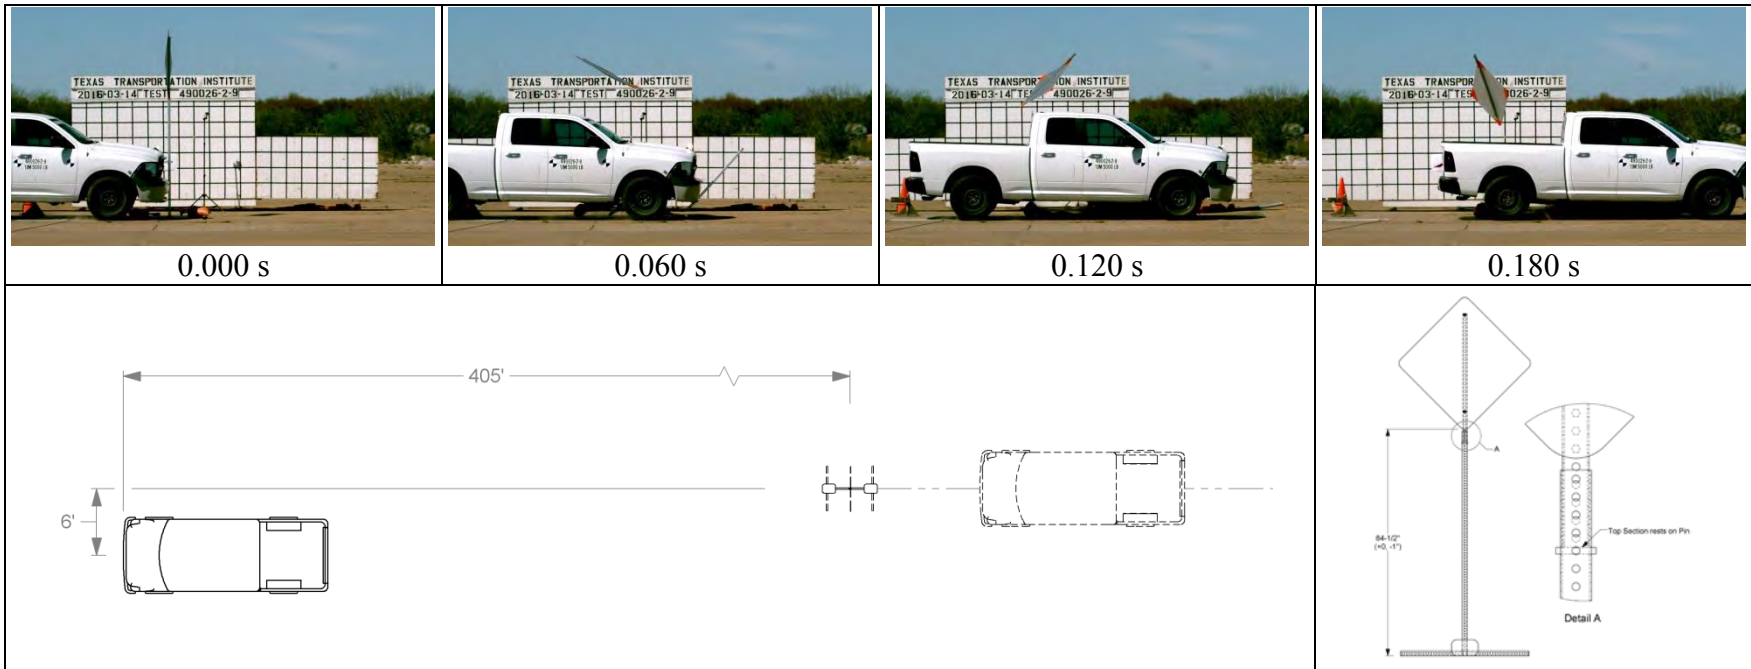
Figure 7.25. Summary of Results for MASH Test 3-72 at 0 Degrees on the Option C Temporary Work Zone Sign Support.

Figure 7.25 provides a summary of the results of the test. The slip connection for Option C temporary work zone sign support performed as designed, and the top of the system released from the lower section at vehicle impact. The released and fractured pieces gave no concern for penetration or intrusion into the vehicle. The sign panel did not contact the roof. The 2270P vehicle remained upright during and after the collision event. The 2270P vehicle came to rest 405 ft behind the Option C temporary work zone sign support.
