# DEVELOPMENT OF A *MASH* TL-3 MEDIAN BARRIER GATE

**Research/Test Report 9-1002-2**

1. Report No. FHWA/TX-11/9-1002-2		2. Government Accession No.		3. Recipient's Catalog No.	
4. Title and Subtitle <b>DEVELOPMENT OF A MASH TL-3 MEDIAN BARRIER GATE</b>				5. Report Date February 2011 Published June 2011

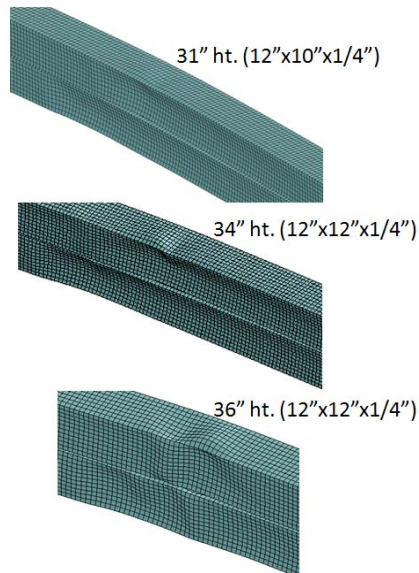
**Figure 2.3. Rail Deformation and Deflection Results.**

Rail Height	Max. Dynamic Deflection	Max. Static Deflection
31" (12"x10"x1/4")	12.25"	9.5"
34" (12"x12"x1/4")	11.75"	9"
36" (12"x12"x1/4")	12"	9"

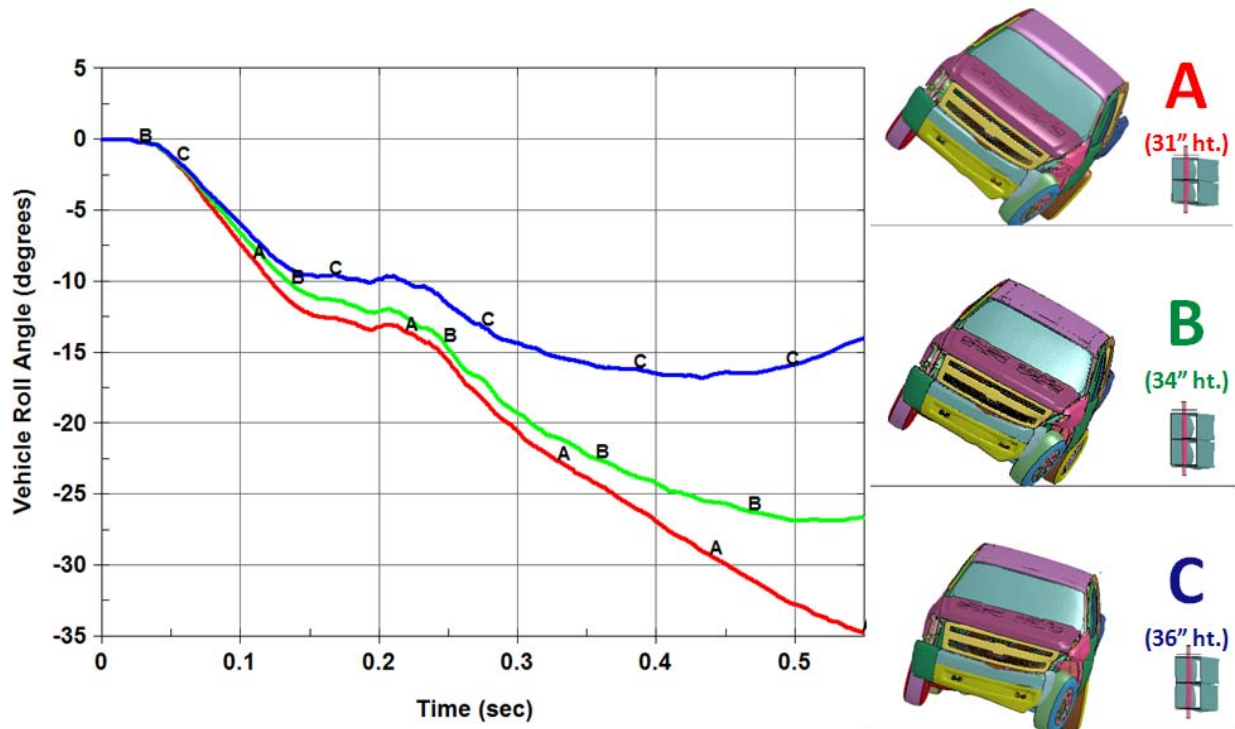
**Figure 2.4. Vehicle Roll Angle Results.**

Figure 2.4 shows vehicle roll angle versus time. At time of termination of the simulation runs (0.55 seconds), the vehicle roll angle for the 31 inch rail height was 35 degrees and still increasing. Vehicle rollover for this configuration is likely. The vehicle was very stable in the impact with the 36 inch rail height, with a maximum roll angle of only 17 degrees. The vehicle was also successfully redirected in the simulation with the 34 inch rail height, but the vehicle had a higher roll angle of 27 degrees.

Results showed that a 12-inch  $\times$  10-inch tube section was not feasible as a rail member for the new median barrier gate. It was not capable of redirecting the pickup truck in a stable manner at its maximum height of 31 inches. Thus, further evaluation efforts focused on the 12-inch  $\times$  12-inch steel tube sections.

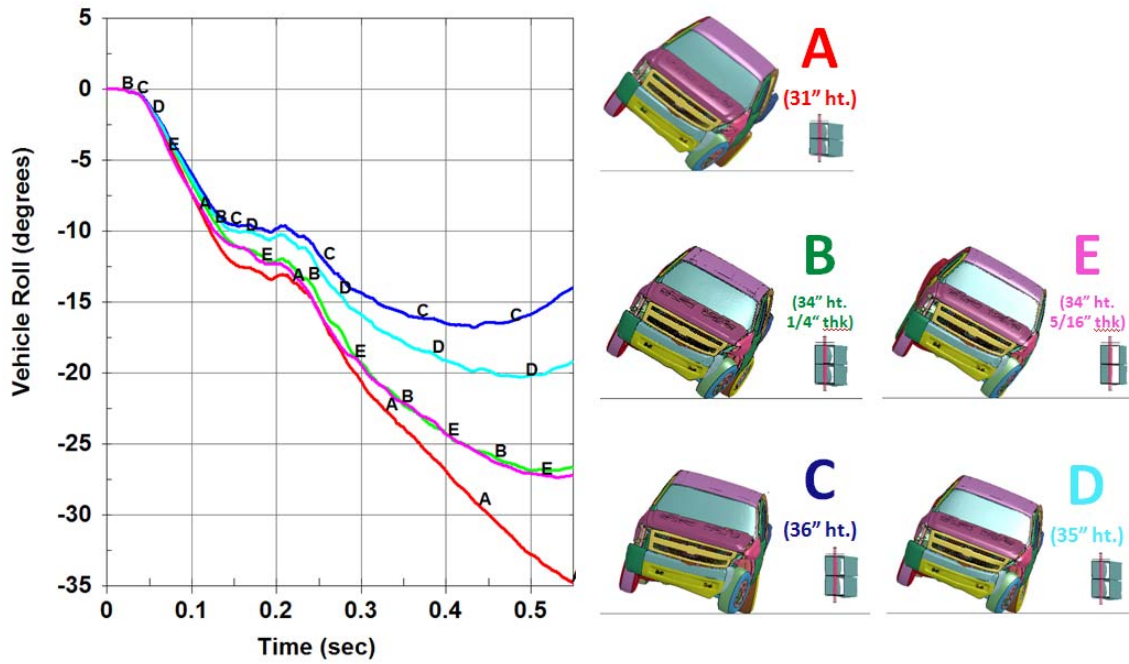
Figure 2.5. Predicted Vehicle Roll Outcomes for Different Rail Configurations.

Figure 2.5 shows vehicle roll angle versus time for these additional simulations superimposed on the results from the previous simulations. Results from the two cases with different rail thickness (cases B and E) are similar in terms of vehicle roll angle, indicating that the increase in rail thickness did not affect vehicle stability. Consequently, there was no compelling reason to adopt a thicker, heavier, more costly rail section. It was concluded that the 12-inch  $\times$  12-inch  $\times$  1/4-inch tube section was the optimal choice as a rail member for the new median barrier gate. Not only does it provide adequate strength to contain and redirect the pickup truck, it is a lighter and less expensive section than the 8-inch  $\times$  8-inch  $\times$  1/2-inch tube section used in the EOS (refer to Table 2.1).

The rail height selected for the new median barrier gate was 35 inches. The pickup truck was stably redirected at this rail height as shown in Figure 2.5. Further, this is the maximum height that can be achieved with the stacked 12-inch  $\times$  12-inch  $\times$  1/4-tubes when constrained by a maximum clear opening of 11 inches between the ground and bottom of the rail to reduce potential for vehicle snagging.

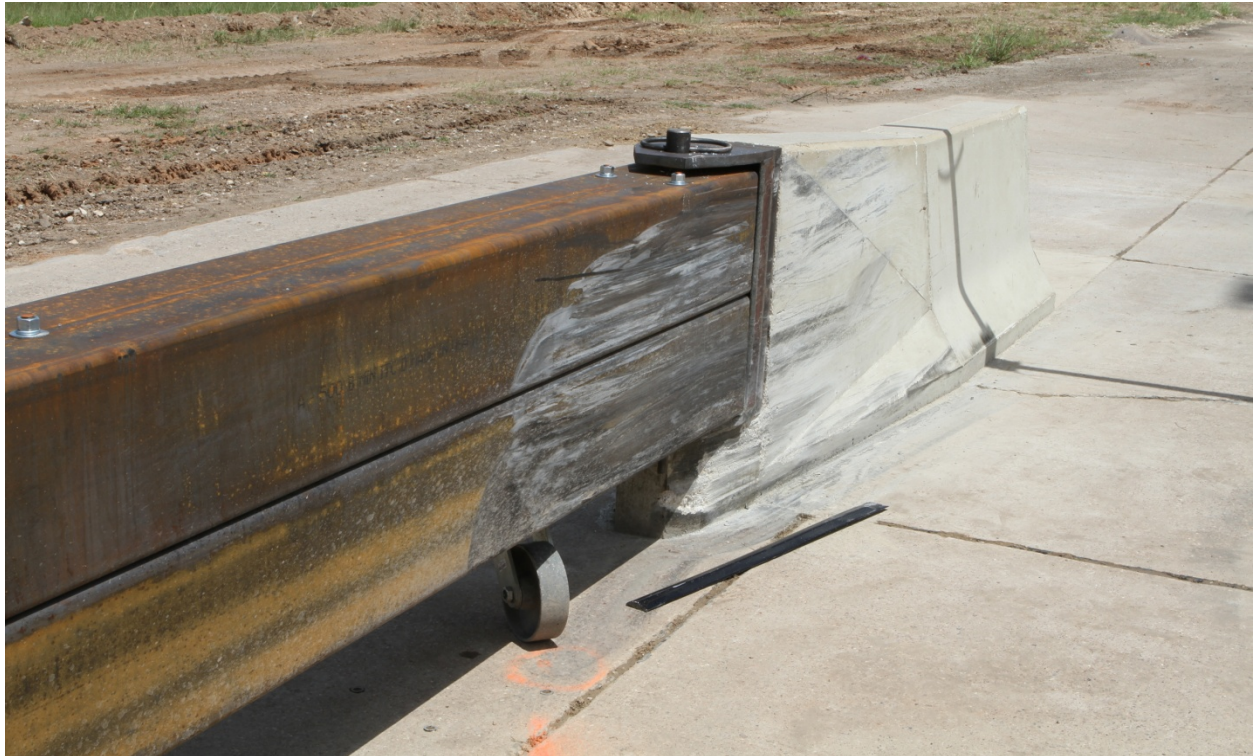
**Figure 6.4. TxDOT Median Barrier Gate after Test No. 420020-6.**

Damage to the gate itself was only cosmetic and consisted of scuff marks as shown in [Figures 6.3 and 6.4](#). The end of the upstream concrete parapet sustained two thin stress cracks on the field side. Minor concrete spalling was observed on the field side of the end of the downstream concrete parapet. No rebar was exposed and the spall was considered to be cosmetic in nature. The vehicle was in contact with the installation 10.2 ft. No measurable dynamic or permanent deflection was noted.

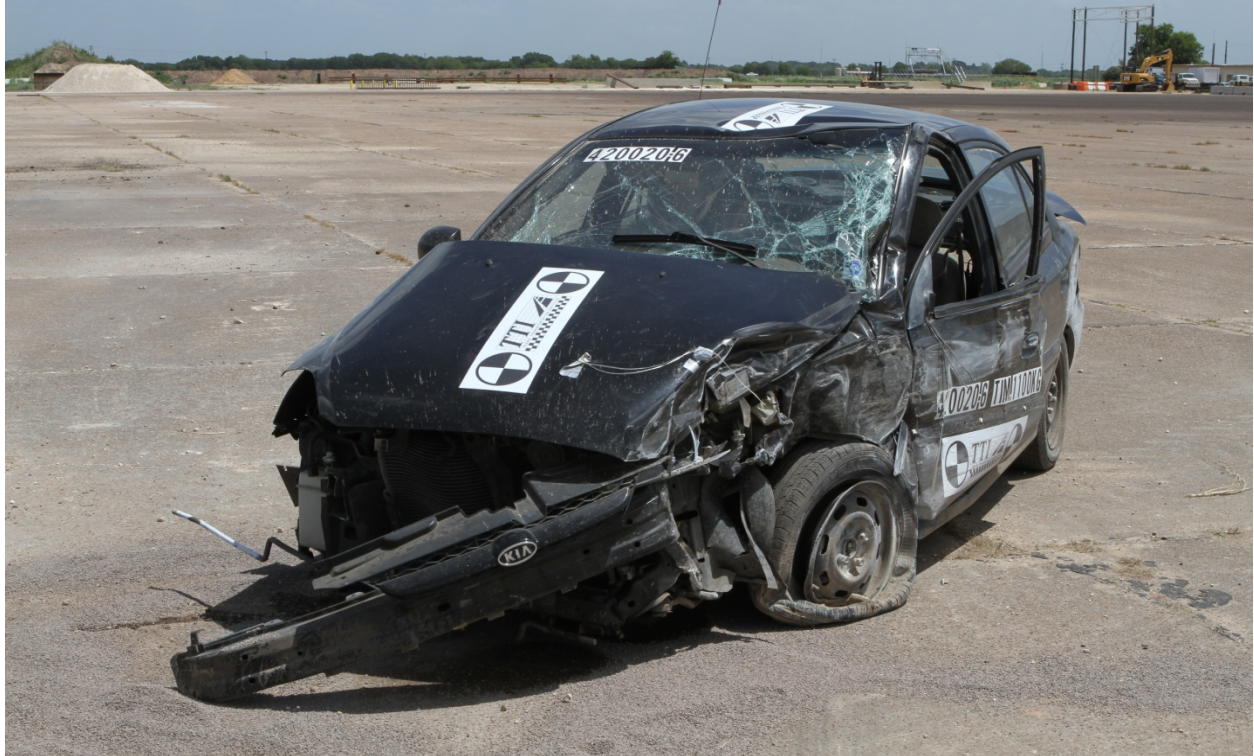
**Figure 6.5. Vehicle after Test No. 420020-6.**

As shown in [Figure 6.5](#), the vehicle sustained damage to the front and left side. The left front strut, strut tower, and A-post were deformed. Also damaged were the front bumper, hood, grill, radiator and support, left front fender, left front tire and wheel rim, left front door and glass, the left rear door, and left rear quarter panel. The roof was deformed and the windshield sustained stress cracking. Maximum exterior crush to the vehicle was 12.0 inches in the side plane at the left front corner at bumper height. Maximum occupant compartment deformation was 3.0 inches in the firewall area near the toe pan on the driver side. [Figure 6.6](#) shows photographs of the interior of the vehicle. Exterior crush and occupant compartment deformation measurements are provided in [Appendix C, Tables C1 and C2](#).

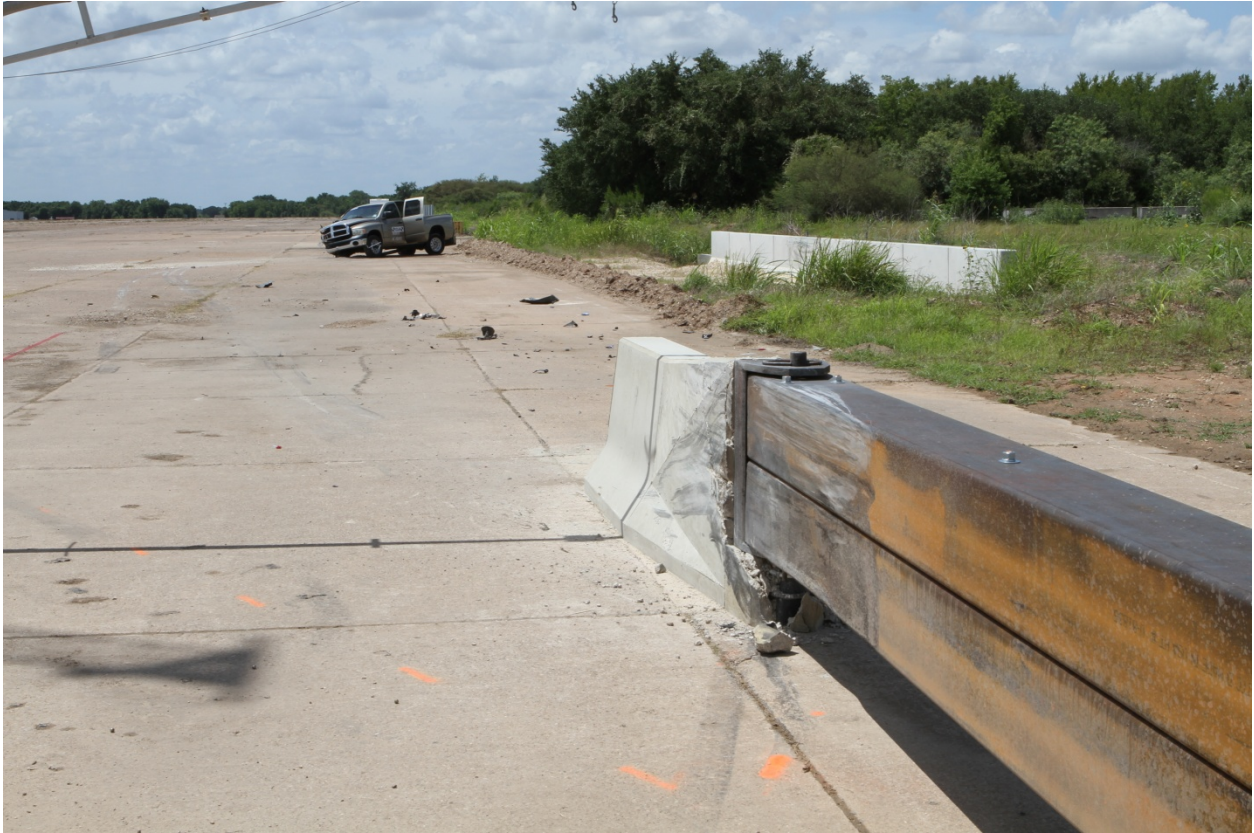
**Figure 8.3. Position of Vehicle/Gate after Test No. 420020-8.**

The lower toe and end of the concrete barrier sustained significant damage, as shown in [Figures 8.3](#) and [8.4](#). The concrete was cracked and fell away from the reinforcement in the toe of the concrete barrier and also from the field side of the barrier. The concrete on the end of the traffic face of the barrier was cracked, but remained in place. The end bracket was pushed toward the field side 1.0 inch. Tire marks were present along the traffic face of the steel gate and traffic face of the concrete barrier for a distance of 11.75 ft. Working width, maximum dynamic deflection, and maximum permanent deformation were 1.25 inches.

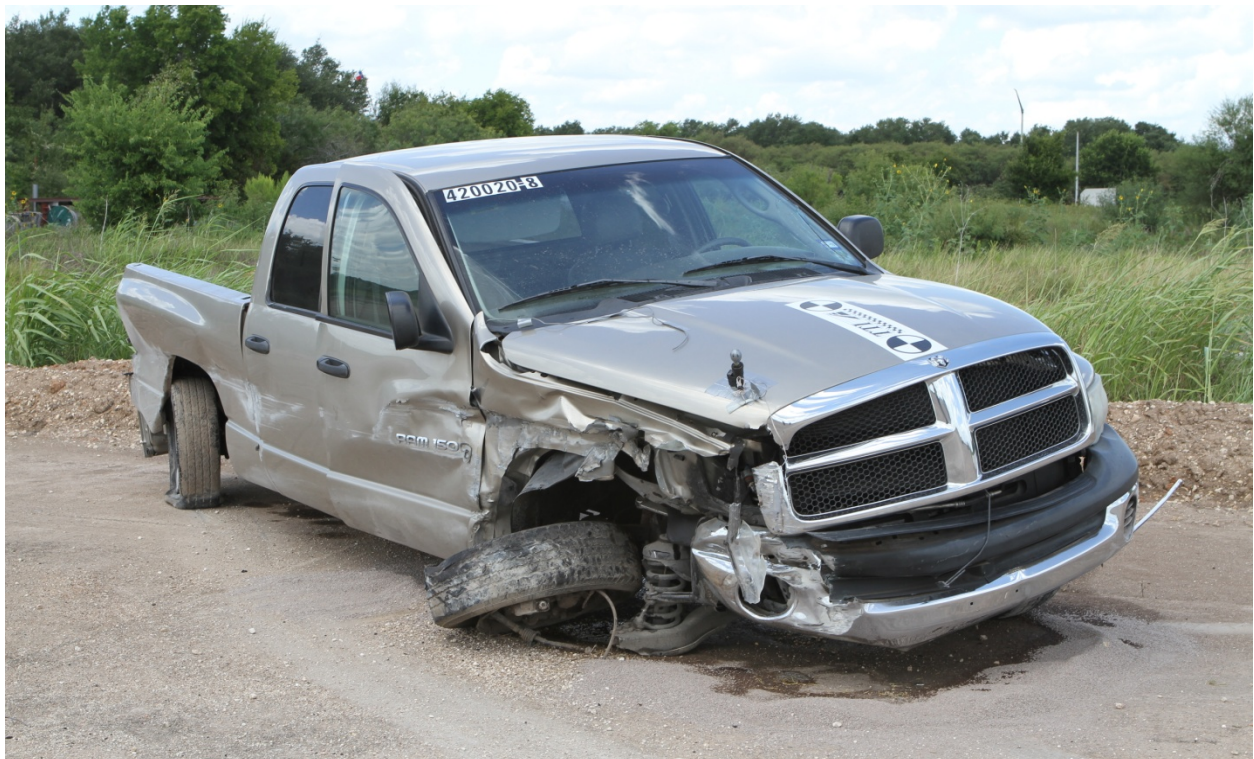
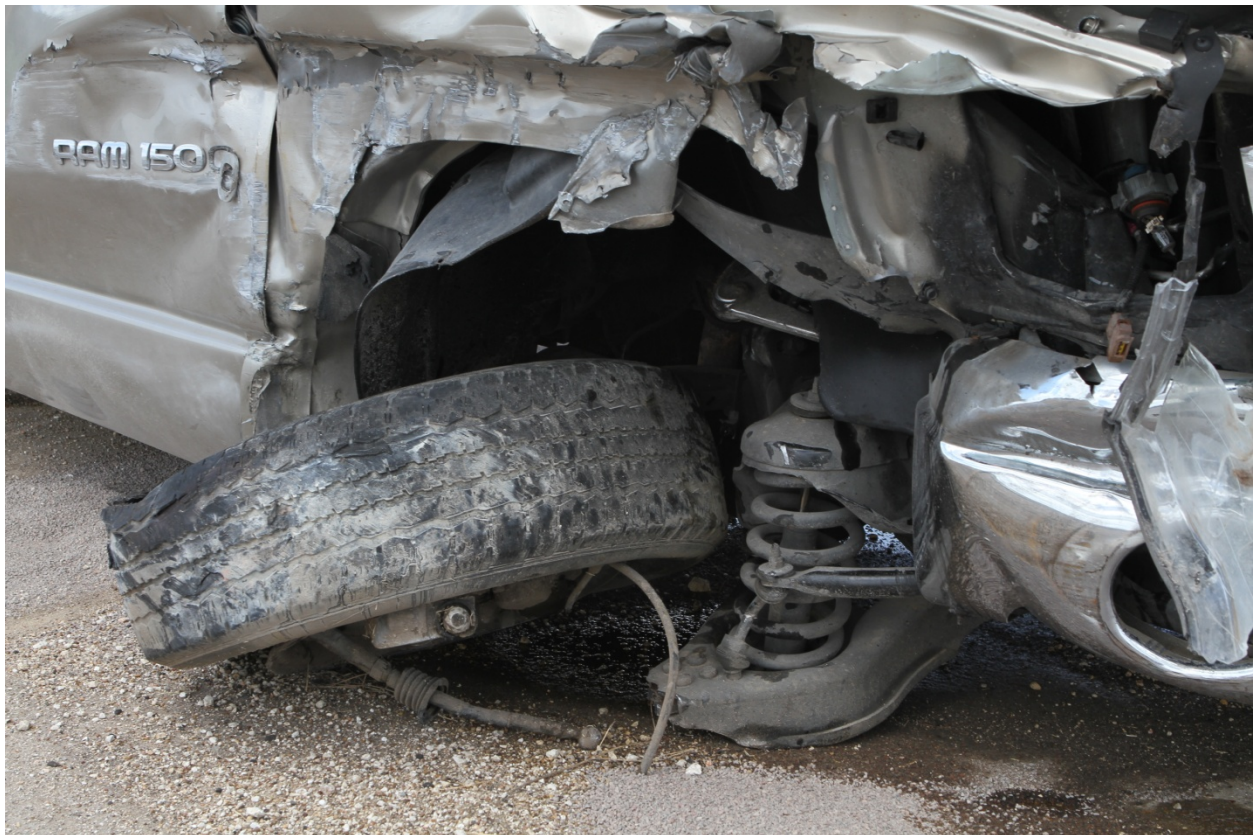
**Figure 8.5. Vehicle after Test No. 420020-8.**

[Figure 8.5](#) shows the damage to the vehicle, which was mostly in the right front quarter in the side plane. The right upper and lower ball joint, right tie rod end, right frame rail, right front upper and lower A-arms, drive shaft, rear axle, and rear U-bolts and springs were damaged. Also damaged were the front bumper, hood, grill, right front fender, right front tire and wheel rim, right front and rear doors, right rear cab, right rear exterior bed, right rear tire and wheel rim, rear bumper, and tailgate. The windshield sustained stress cracks. Maximum exterior crush to the vehicle was 19 inches in the side plane at the right front corner at bumper height. Maximum occupant compartment deformation was 5.25 inches in the right firewall area near the toe pan on the front passenger side. [Figure 8.6](#) shows photographs of the interior of the vehicle. Exterior crush and occupant compartment deformation are provided in [Appendix C, Tables C7](#) and [C8](#).
