Technical Report Documentation Page	
1. Report No. FHW A /TX-04/9-8132-1	2. Government Accession No.	3. Recipient's Catalog No.	
4. Title and Subtitle		5. Report Date	
TESTING AND EVALUATION OF	F THE FLORIDA JERSEY	February 2004	
SAFETY SHAPED BRIDGE RAIL		6. Performing Organization Code

TESTING AND EVALUATION OF THE FLORIDA JERSEY SAFETY SHAPED BRIDGE RAIL

February 2004

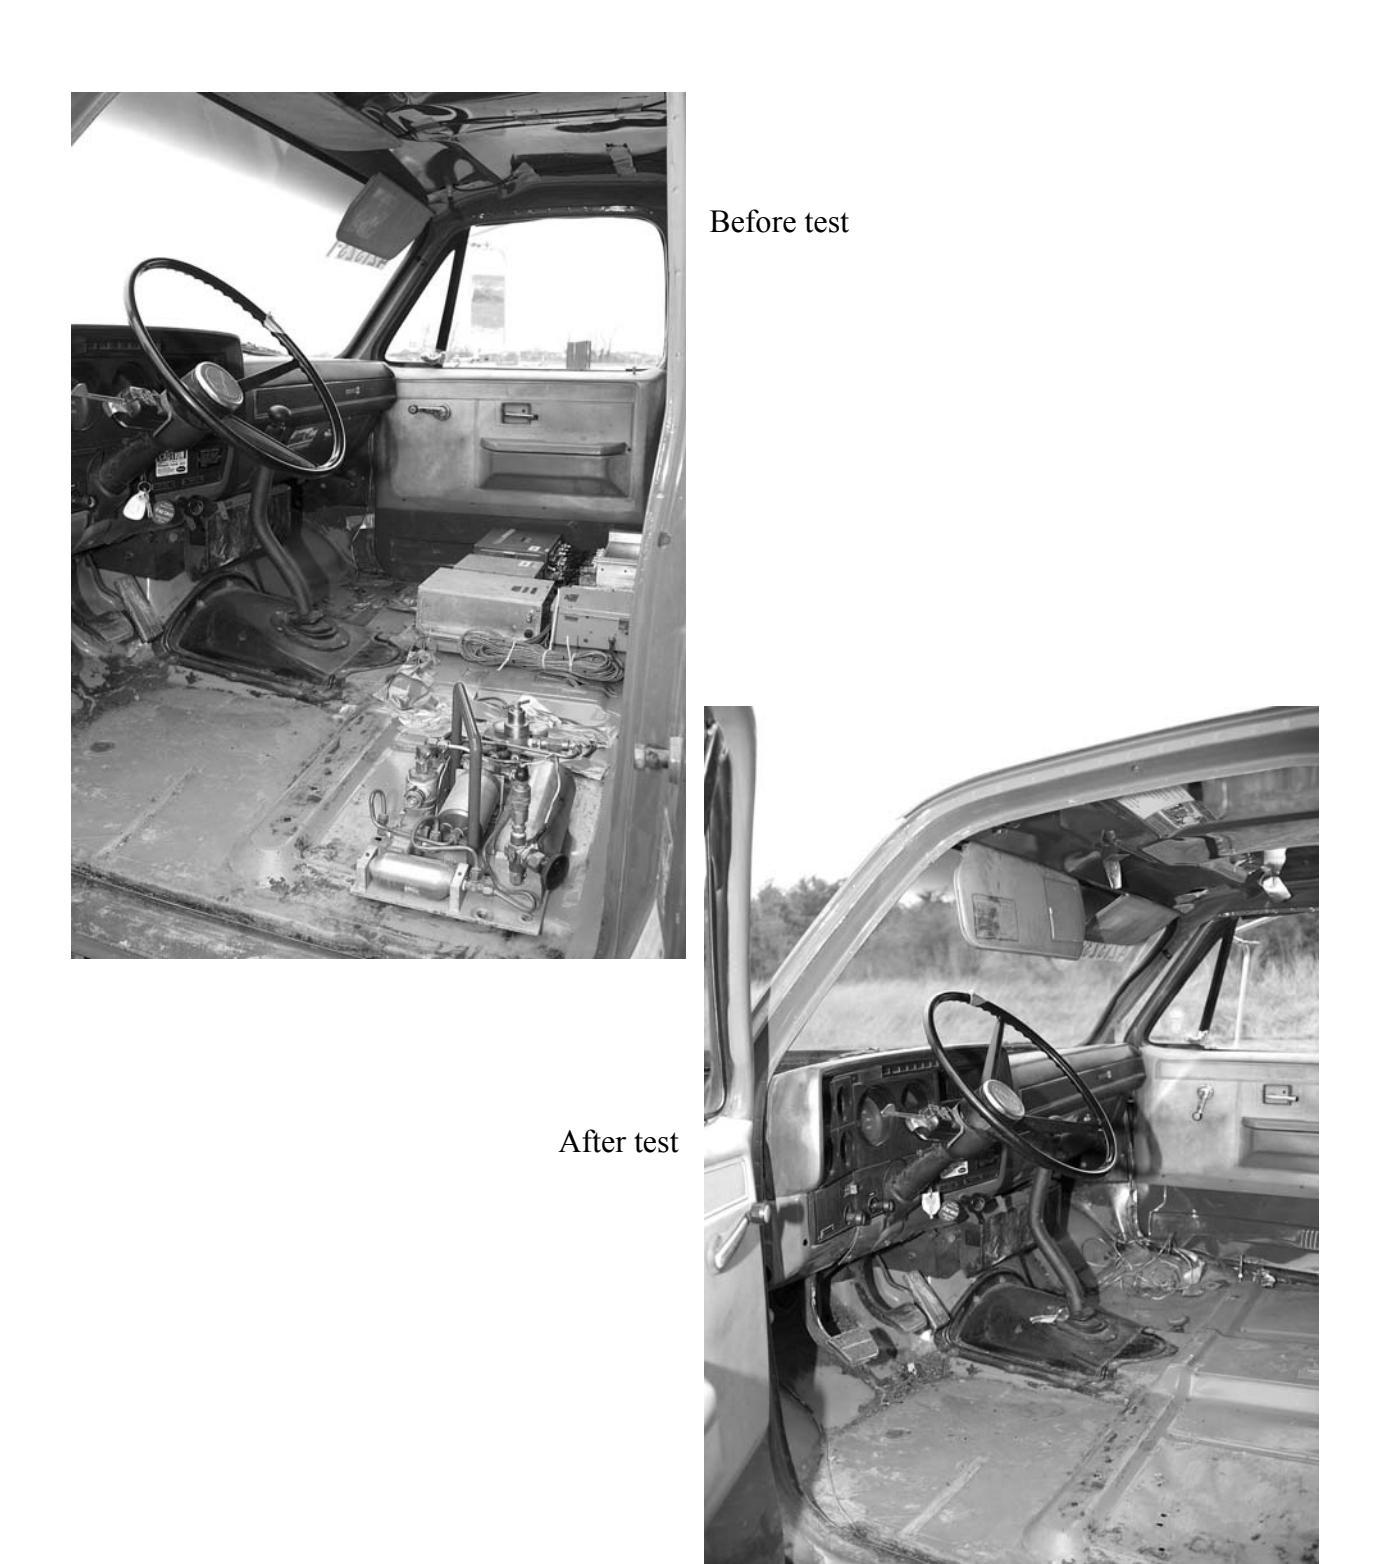
Figure 9. Interior of Vehicle for Test 421323-1.

Figure 8 shows damage to the vehicle. The front axle was separated from the truck and the right rear wheel rim was bent. The lower right side of the cab and box were deformed. No measurable occupant compartment deformation occurred. Figure 9 shows photographs of the interior of the vehicle.

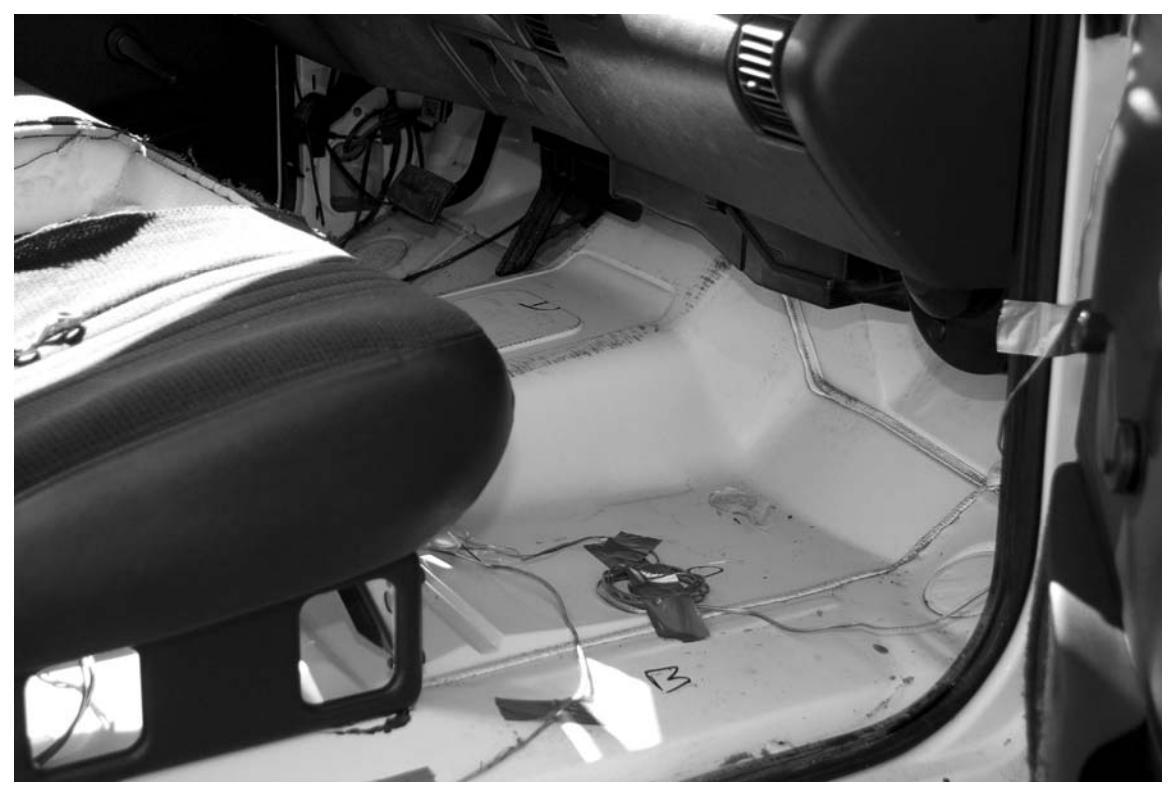
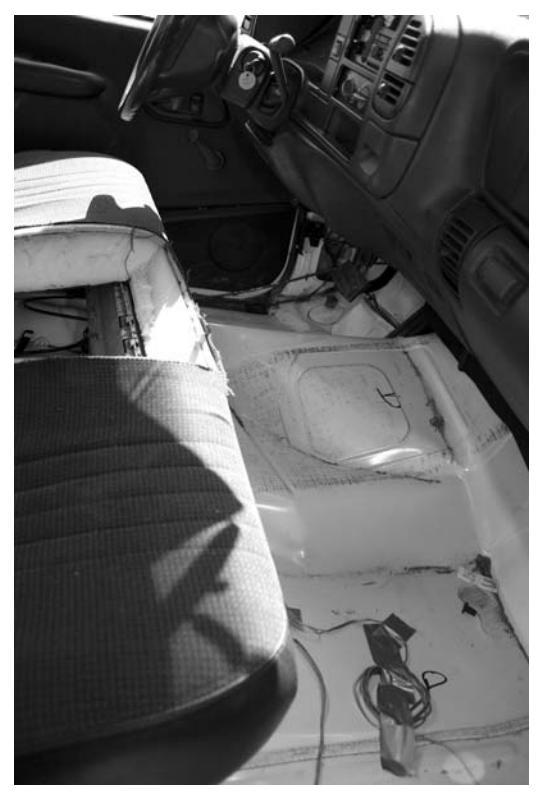
Figure 16. Interior of Vehicle for Test 421323-2.

Figure 15 shows the damage to the vehicle. Structural damage was imparted to the left outer tie rod end, lower A-arm and spindle, front of the frame rail, and the firewall and floor pan. The inner rim of the left wheel separated from the outer rim. Also damaged were the front bumper, grill, radiator, left front quarter panel, left door, left rear exterior bed, left rear tire, and the right rear of the bed. The windshield also sustained stress cracks and the door glass was broken out. Maximum exterior crush to the pickup was 25.2 inches (640 mm) in the side plane at the left front corner just above bumper height. Maximum occupant compartment deformation was 3.4 inches (87 mm) in the left side firewall area. Figure 16 shows photographs of the interior of the vehicle. Tables 3 and 4 in Appendix C show exterior crush profile and occupant compartment deformation.

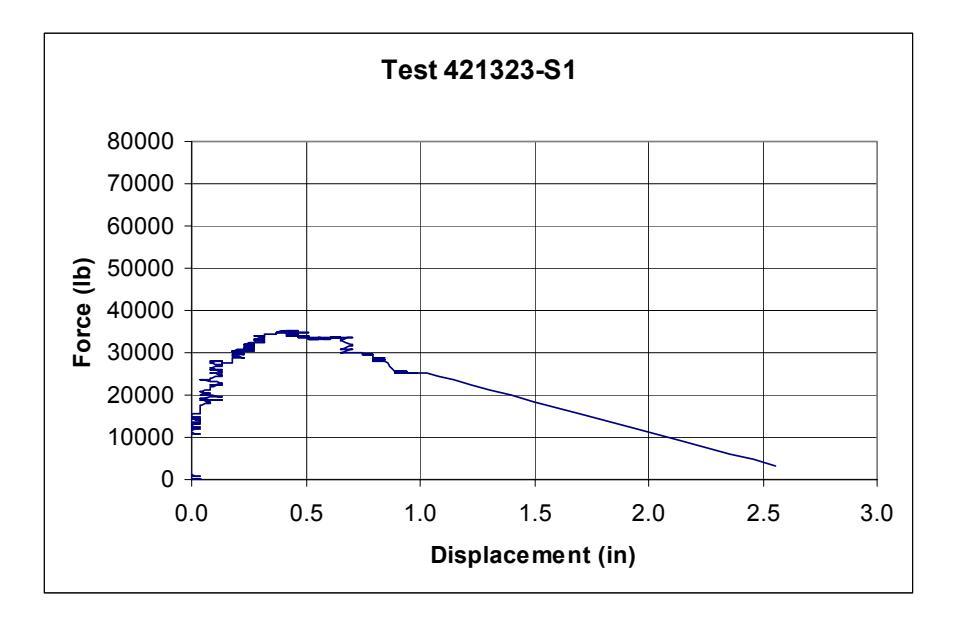
Figure 19. Results of Test 421323-S1.

Test S-1 was on the upstream end of the test installation and was intended to represent the loading at a construction joint. The maximum load attained was 35.1 kips (156 kN). The anticipated load from the yield line analysis was 41.5 kips (185 kN). Subsequent review of the installation showed the last stirrup was approximately 6 inches (152 mm) from the end of the parapet wall and likely contributed to the lower fracture load. Figure 19 shows the results of the static test S-1. Figure 20 shows the failure mode.

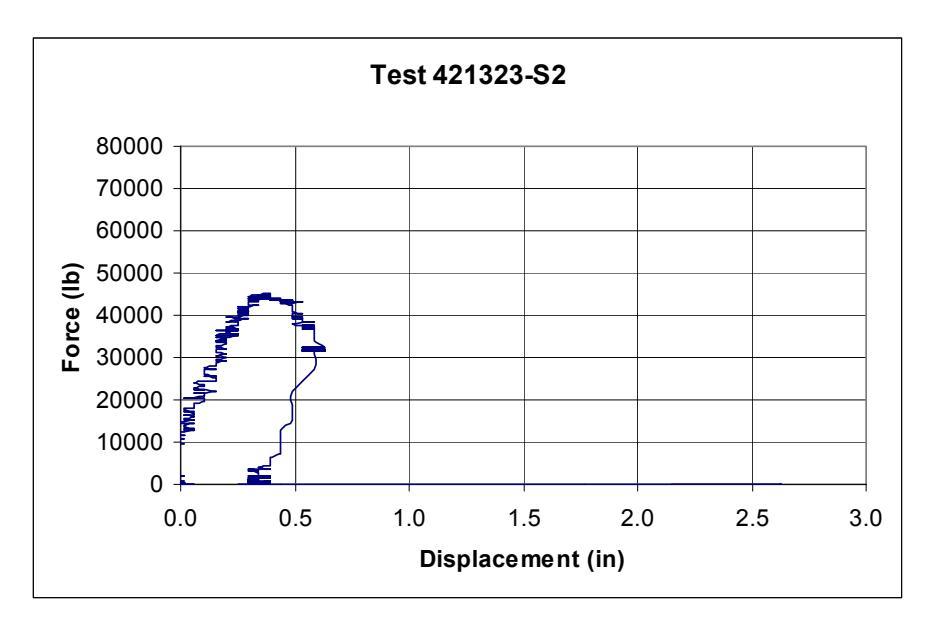
Figure 21. Results for Test 421323-S2.

Visual inspection of the bridge parapet after the TL-4 test did not reveal any perceptible cracking. Since the test setup was readily available, the impact region of the barrier was statically tested to failure at the expansion joint. The maximum load was 45.1 kips (201 kN) and the test results are shown in Figure 21 below. Figure 22 shows the failure mode.

The damage from the single-unit truck impact at an expansion joint appeared to be limited to surface scarring of the concrete – no visible cracks were identified. A static test at this location would serve two purposes: 1) it would verify that visual inspections may be acceptable for determining structural integrity after an impact and 2) stirrup placement was verified before concrete placement and actual load should more closely match the predicted design load. The ultimate static load at this location was 45.1 kips (201 kN), predicted was again 41.1 kips (183 kN). Therefore the actual load exceeded the yield line analysis prediction by approximately 10 percent.

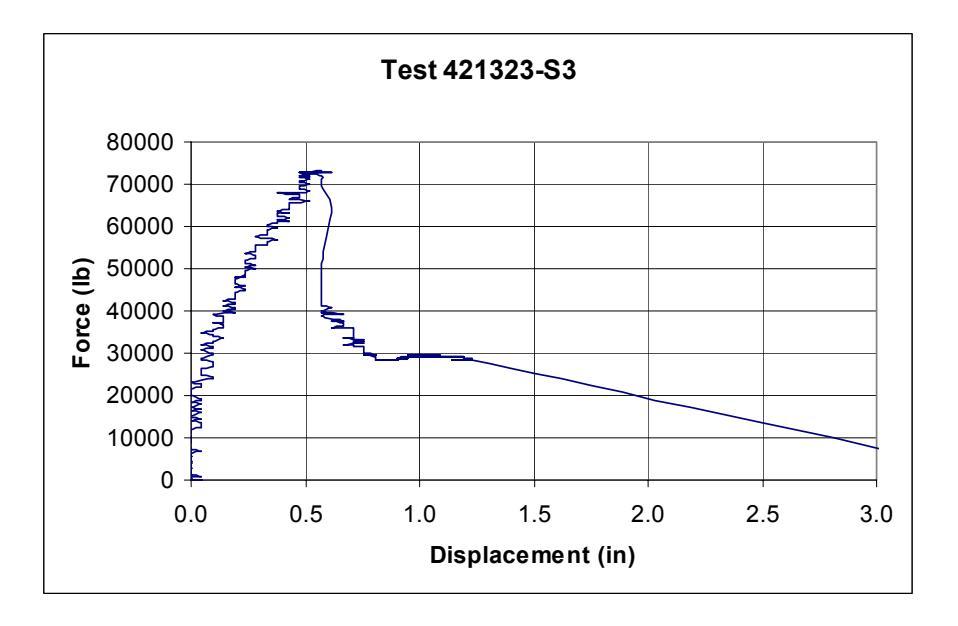
Figure 24. Results of Test 421323-S3.

Test S-3 was at mid-span of the undamaged rail section as shown in Figure 23. The predicted failure load was 62.1 kips (276 kN). The maximum load obtained was 73.1 kips (325 kN). Figure 24 shows test results. Yield lines were confined to the upper, slender portion of the parapet as shown in Figure 25.
