1. Report Number TX-92/953-1F		2. Government Accession No.		3. Recipient's Catalog No.	
4. Title and Subtitle El Paso Moisture Barrier Study				5. Report Date August 31, 1992

EL PASO MOISTURE BARRIER STUDY

Research Study No. 2-24D-88C-953

Texas Transportation Institute
Texas A&M University
College Station, Texas 77843

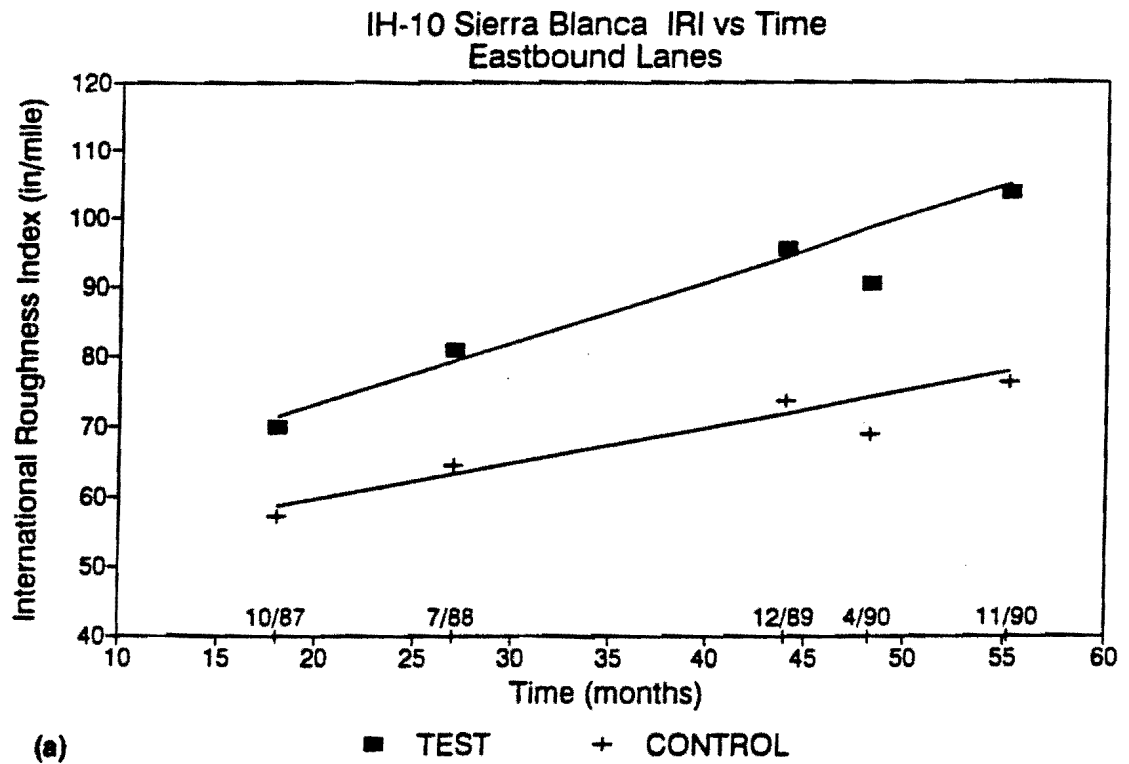
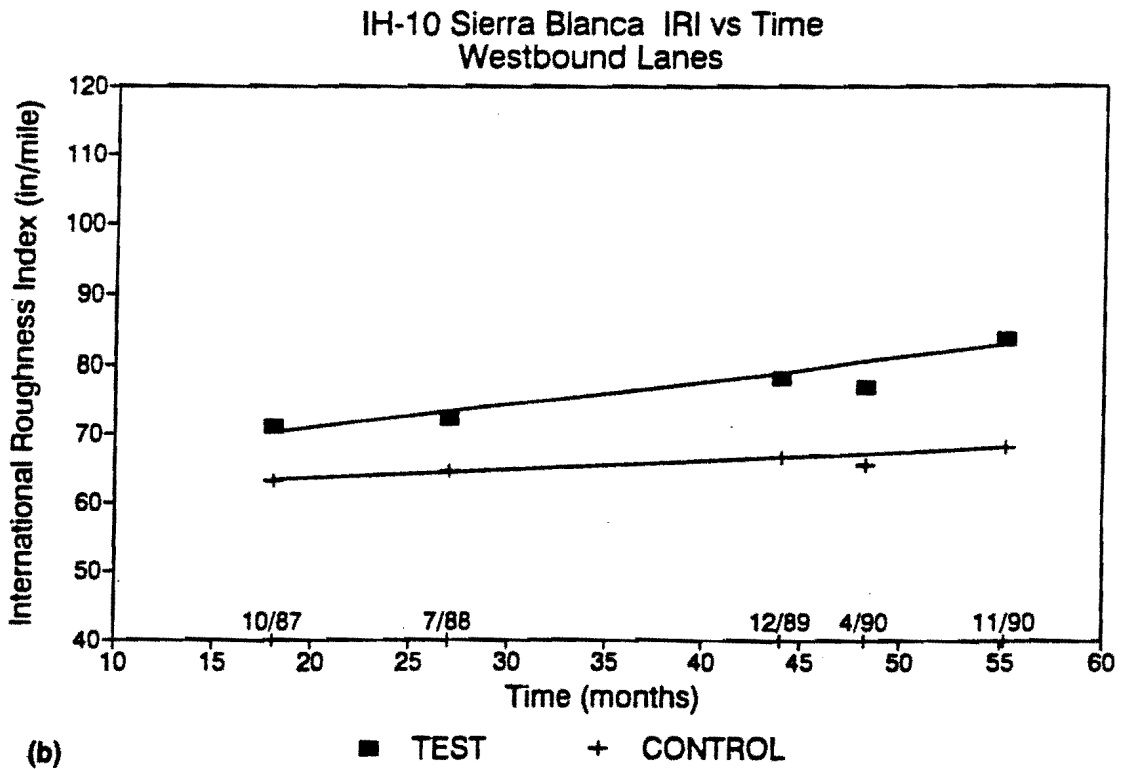
Figure 7. IH-10 Sierra Blanca IRI vs Time, (a) Eastbound Lanes, (b) Westbound Lanes.

Changes of mean roughness with time: Profilometer measurements began in August 1987 and continued to the present time. The mean values of the roughness for this period, in terms of SI, IRI and Bump Height computed for test and control sections are illustrated in Figures 6 through 8.

The moisture barrier test sections indicate rates of roughness development of approximately twice that of the control sections as indicated by the SI and IRI parameters. This occurs as the barrier sections are found in areas where clays are predominant and closest to the surface. This is illustrated in Figures 6 and 7 and demonstrated more clearly in Figure 9, where the longitudinal distribution of roughness is examined. Due to the sensitivity of the SI to short wavelengths and the IRI to both short and medium wavelengths, it may be concluded that roughness in this wavelength range is developing over areas of expansive clay.

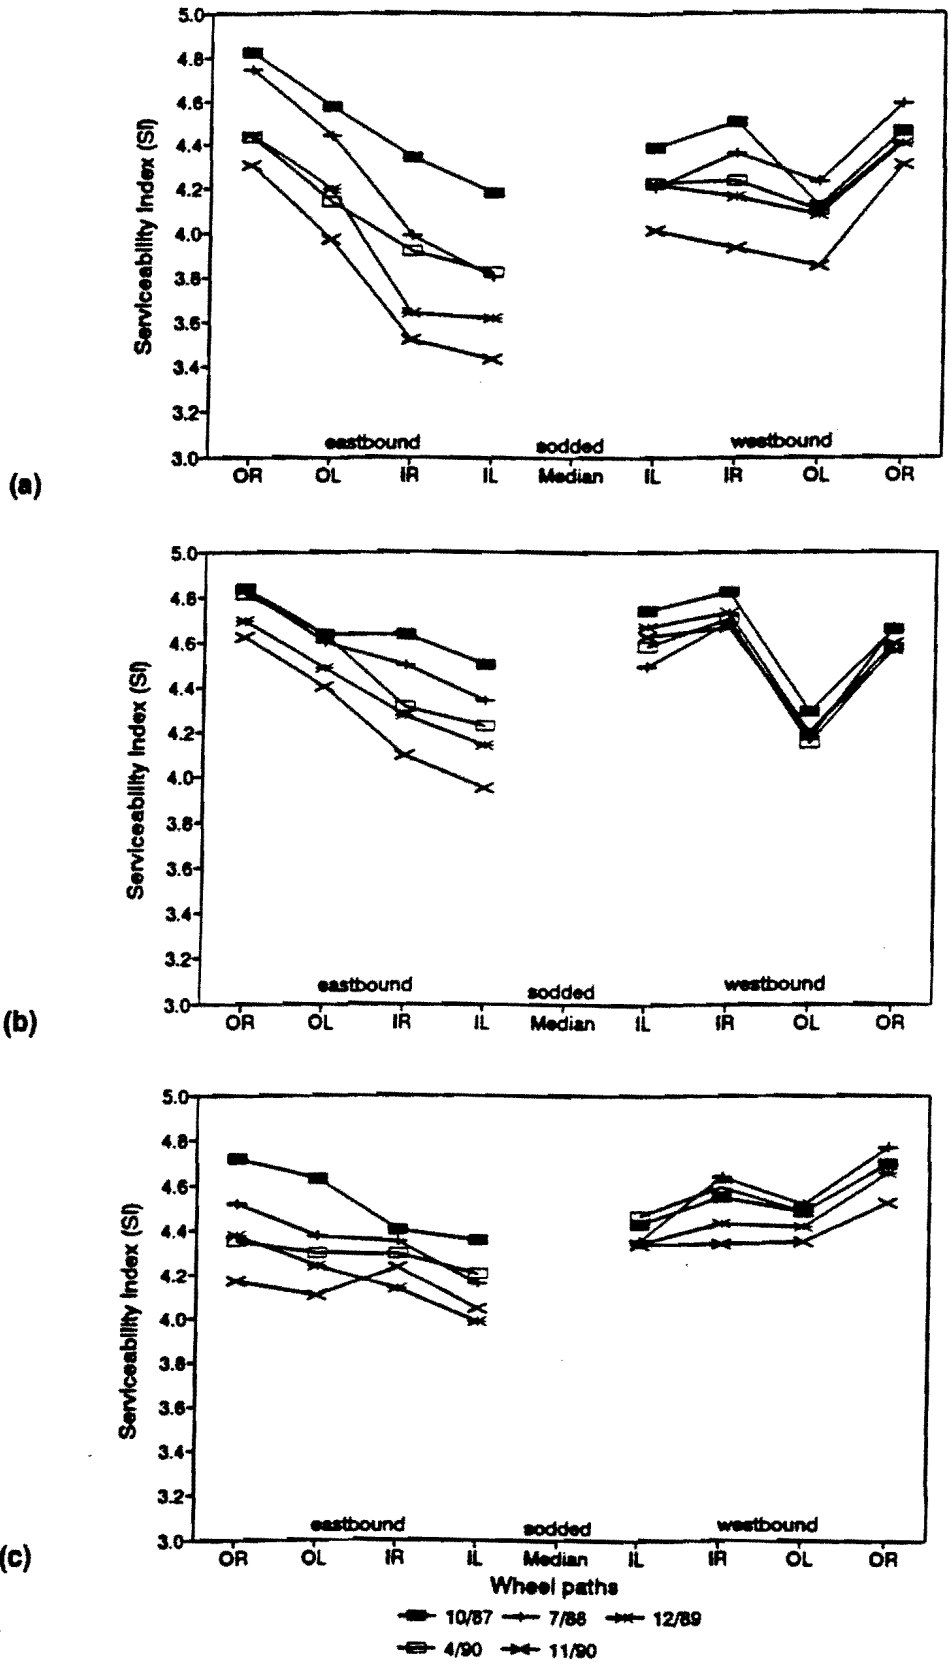
Figure 12. IH-10 Sierra Blanca SI Cross-Section, (a) Test, (b) East Control, (c) West Control.

Distribution of roughness across lanes: The distribution of roughness across traffic lanes is characterized by the mean value of roughness of 128 ft. lengths in the wheelpaths of each lane. The SI distributions across lanes for the test, east control and west control sections are illustrated in Figures 12a through 12c, respectively. The IRI distributions are illustrated in the same order in Figures 13a through 13c and similarly, the Bump Height distributions in Figures 14a through 14c. The trend of roughness observed at the barrier test and east control sections indicate an increase in roughness from the outside to the inside wheelpaths. In the west control sections this trend is reversed and in some cases appears to be relatively constant over the pavement surface.
