Implementation: Mitigation of High Sulfate Soils in Texas
Development of Design and Construction Guidelines

Final Report 5-6618

Texas Department of Transportation

August 2016

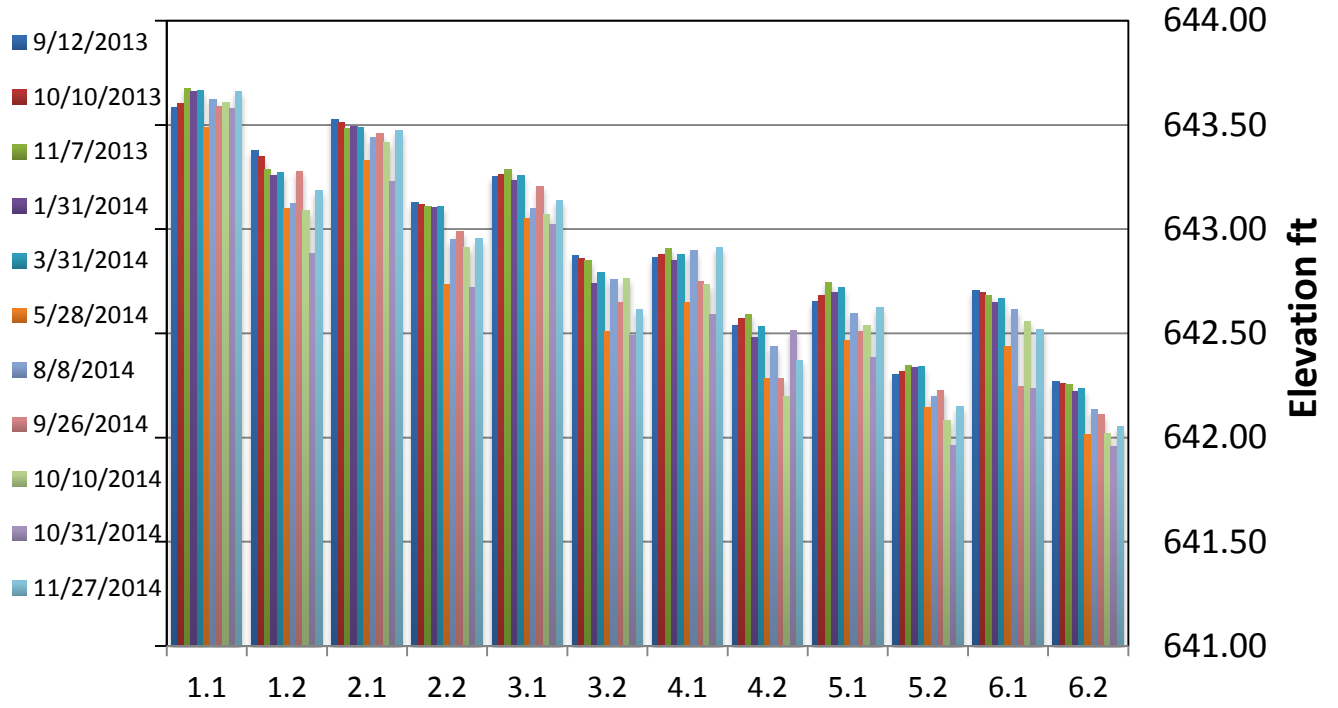
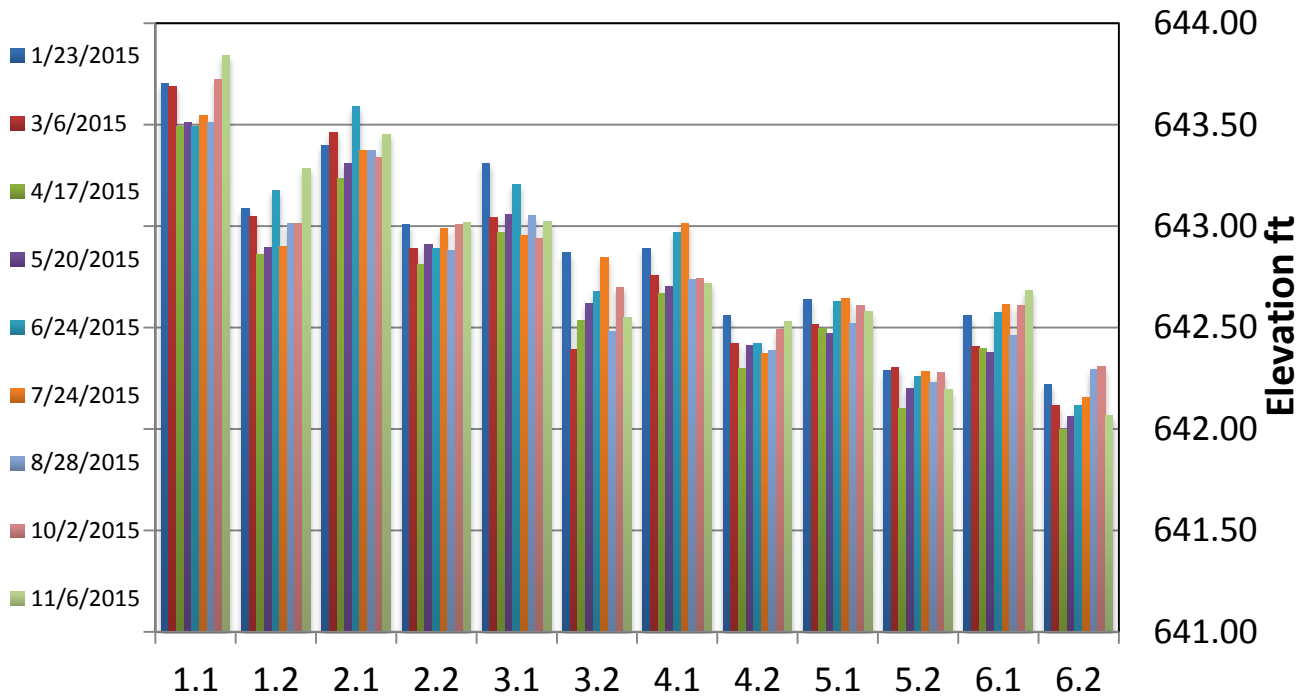
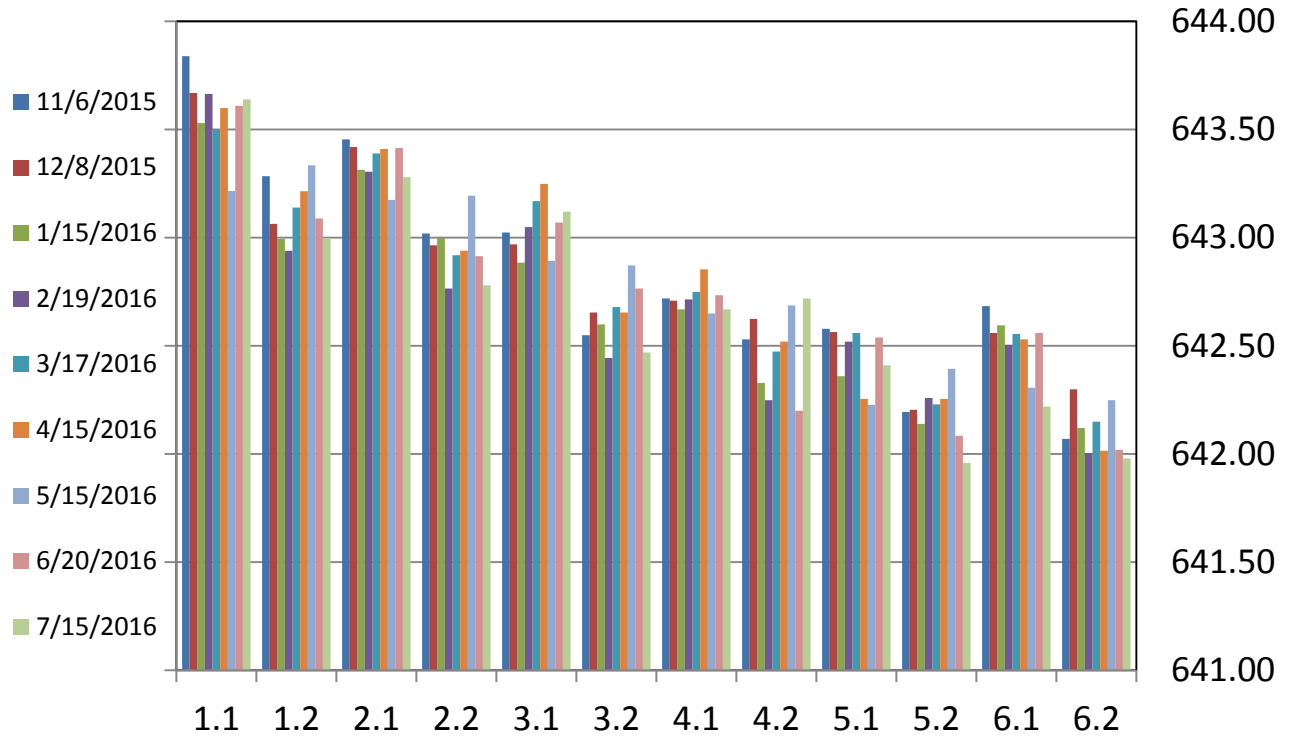
Test section 3 also known to be the control section is monitored for deformations occurring due to the formation of ettringite mineral. The variation of elevations of the test pins located at test section 3 are highlighted in Figure 6 which are recorded during the fiscal year of 2014, Figure 7 during fiscal year of 2015 and Figure 8 during the fiscal year of 2016. Deformations associated with elevation change are captured and analyzed.

Figure 6: Elevations at test section 3 during the year of 2014

Figure 7: Elevations at test section 3 during the year of 2015

Figure 8: Elevations at test section 3 during the year of 2016

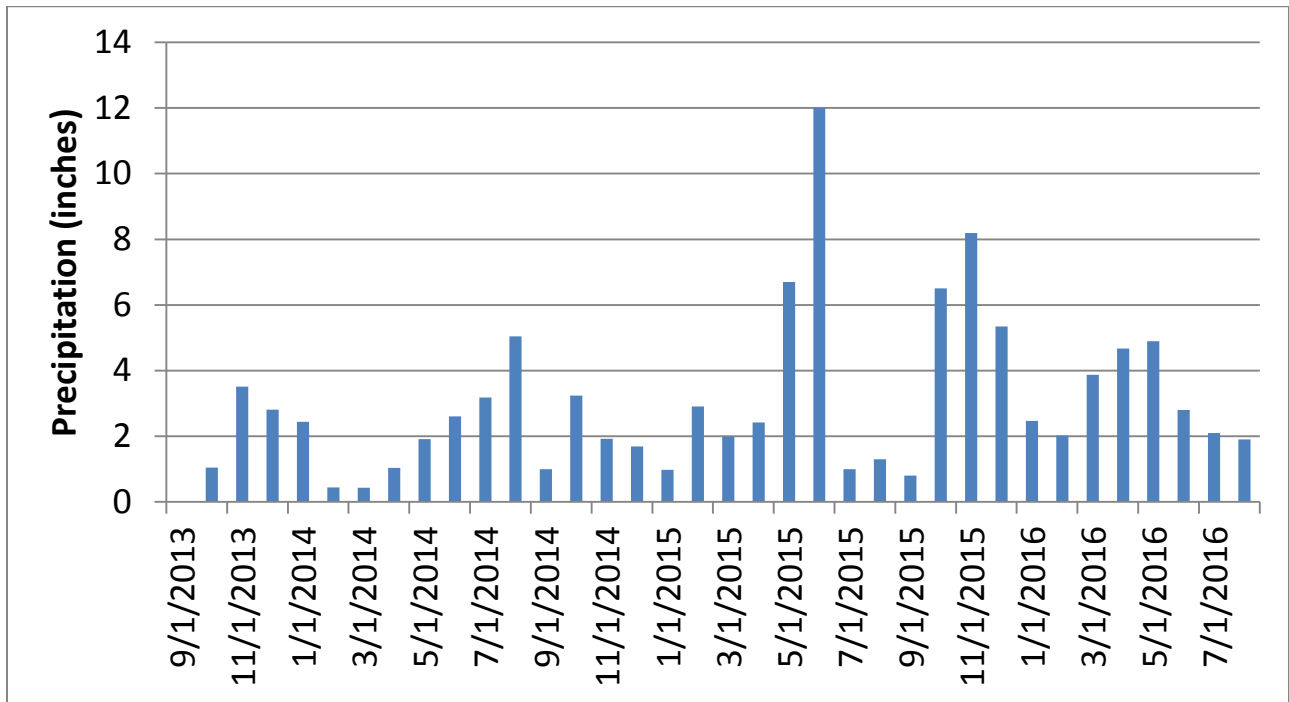
Much of the deformations recorded are associated due to the severe moisture fluctuation associated from varying climatic conditions. Rainfall data collected from Savoy, Texas is presented in Figure 11. A peak rainfall close to 12 inches has been observed during the month of May, 2015. Similarly, maximum and average temperatures recorded have been presented in Figure 12. It is observed that the far pavement section has been subjected to significant wash out due to the tremendous downpour of rainfall in June, 2015 and in the following recent months.

Figure 11: Precipitation at Savoy, Texas (near US 82 Highway)

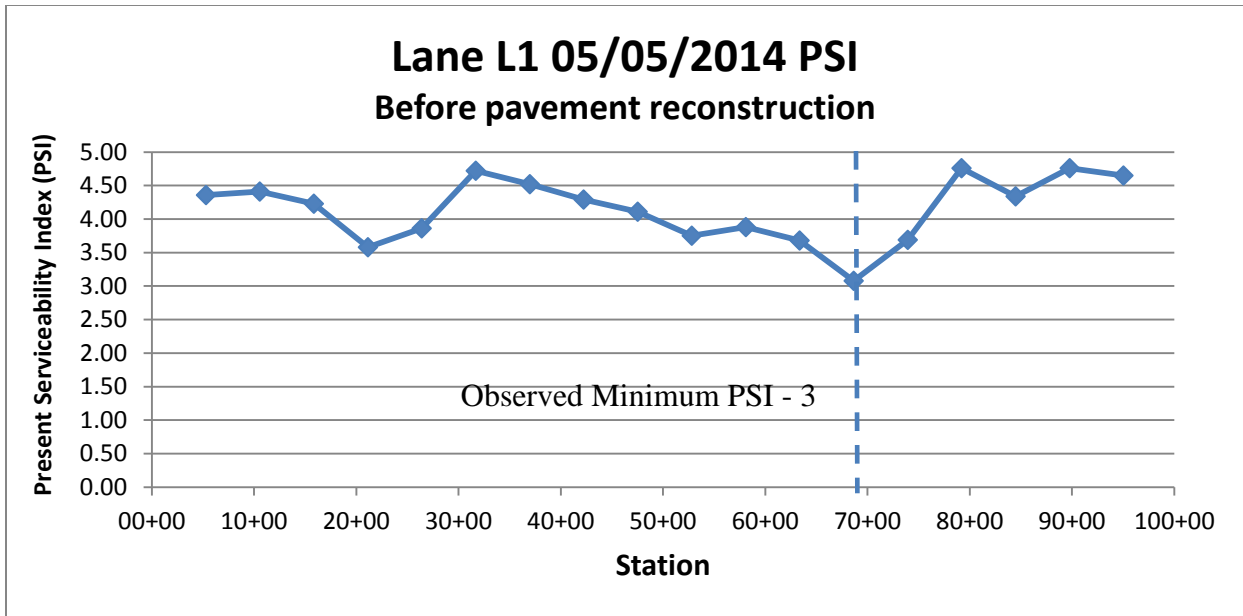
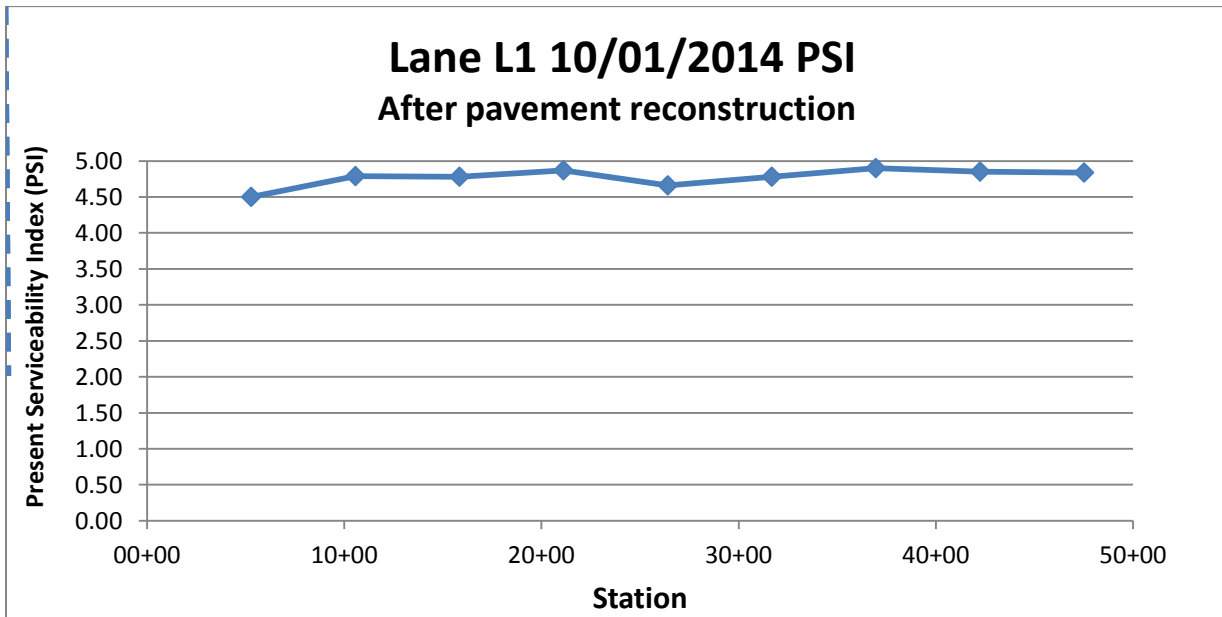
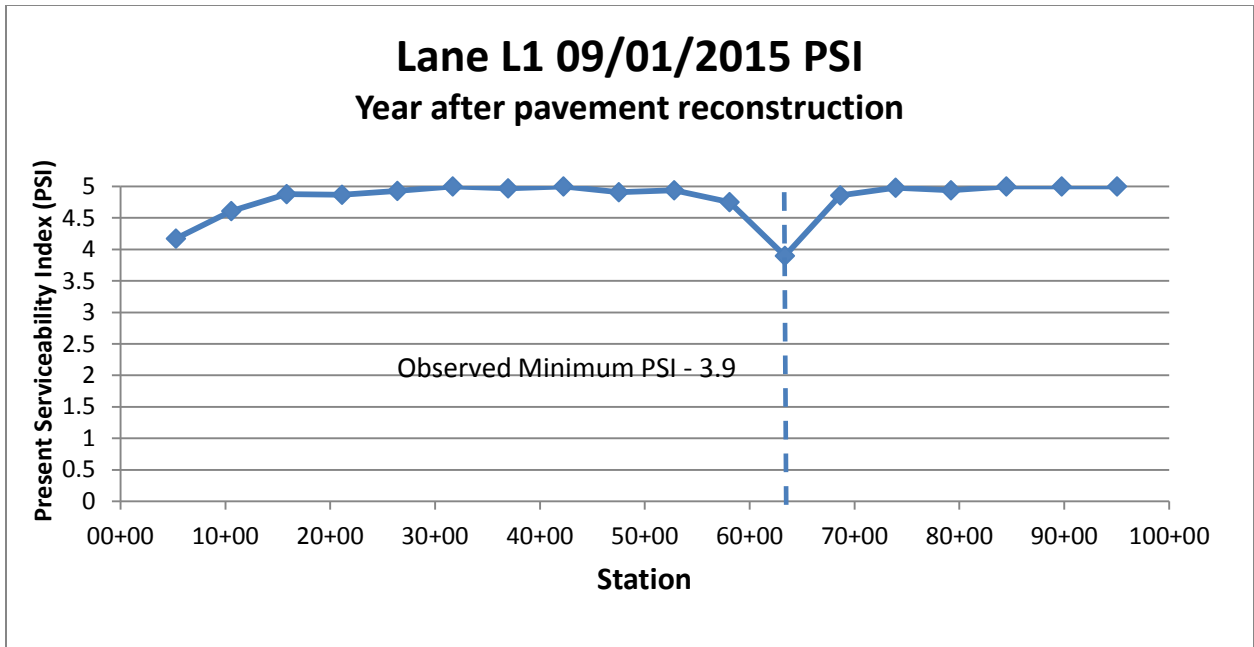
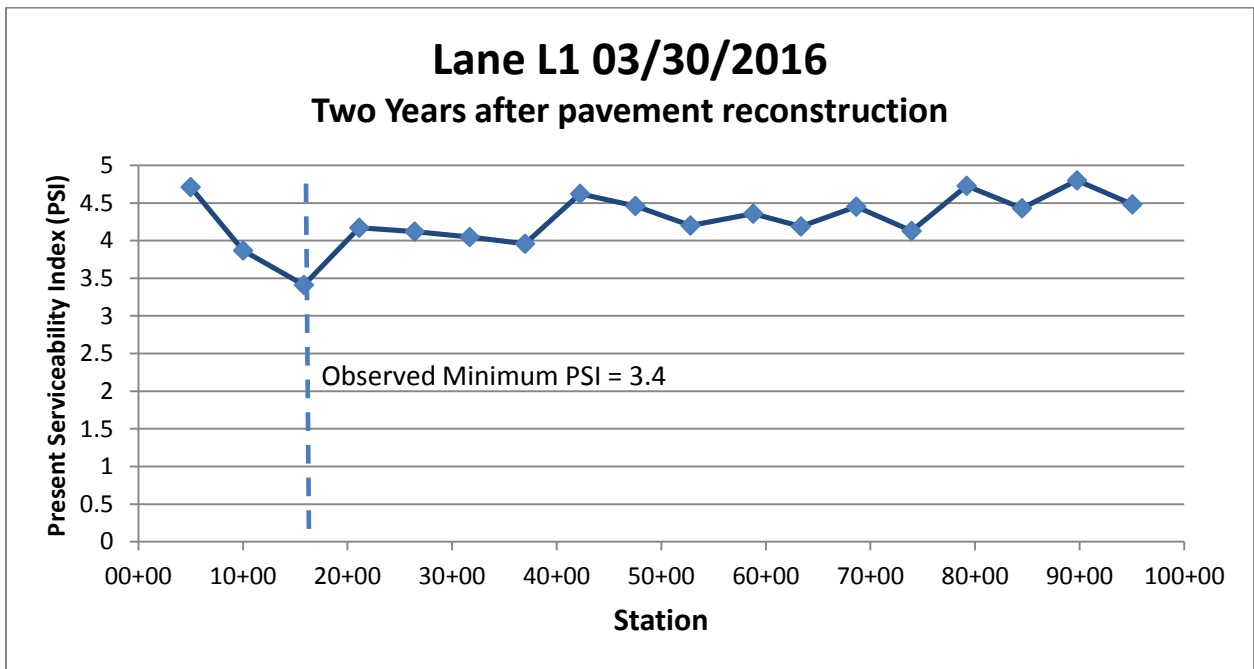
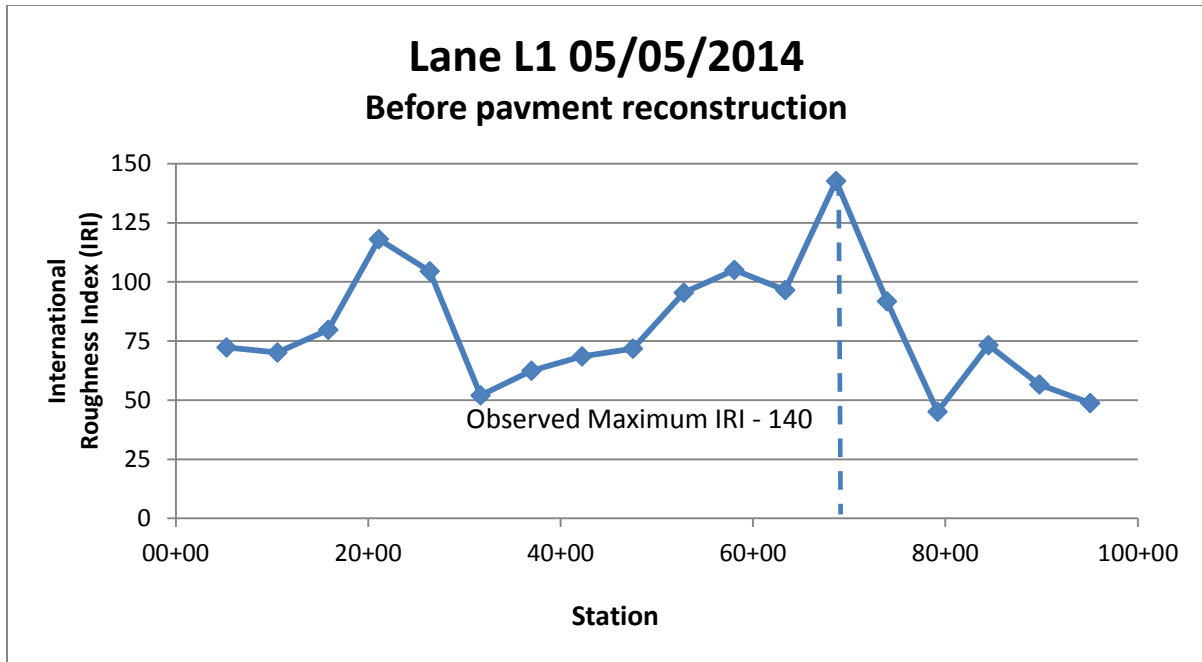
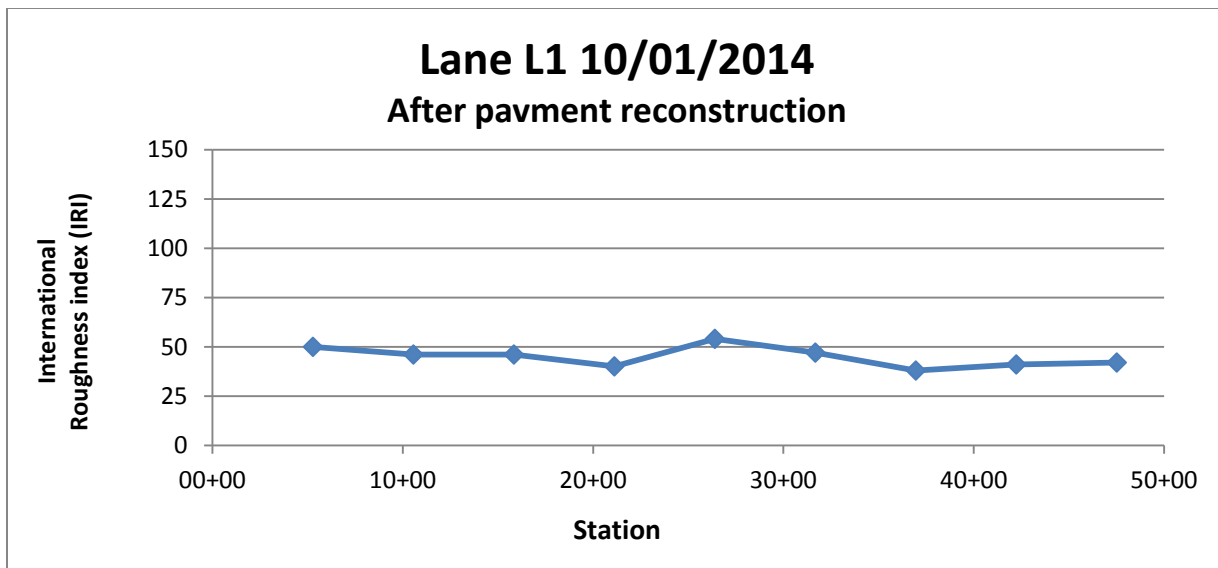
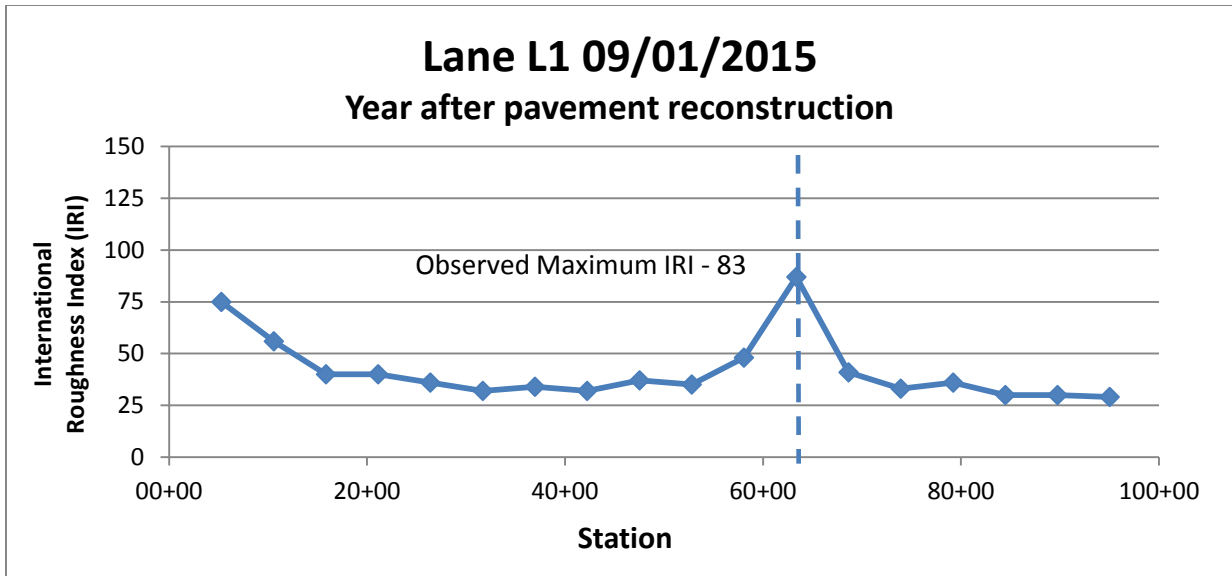
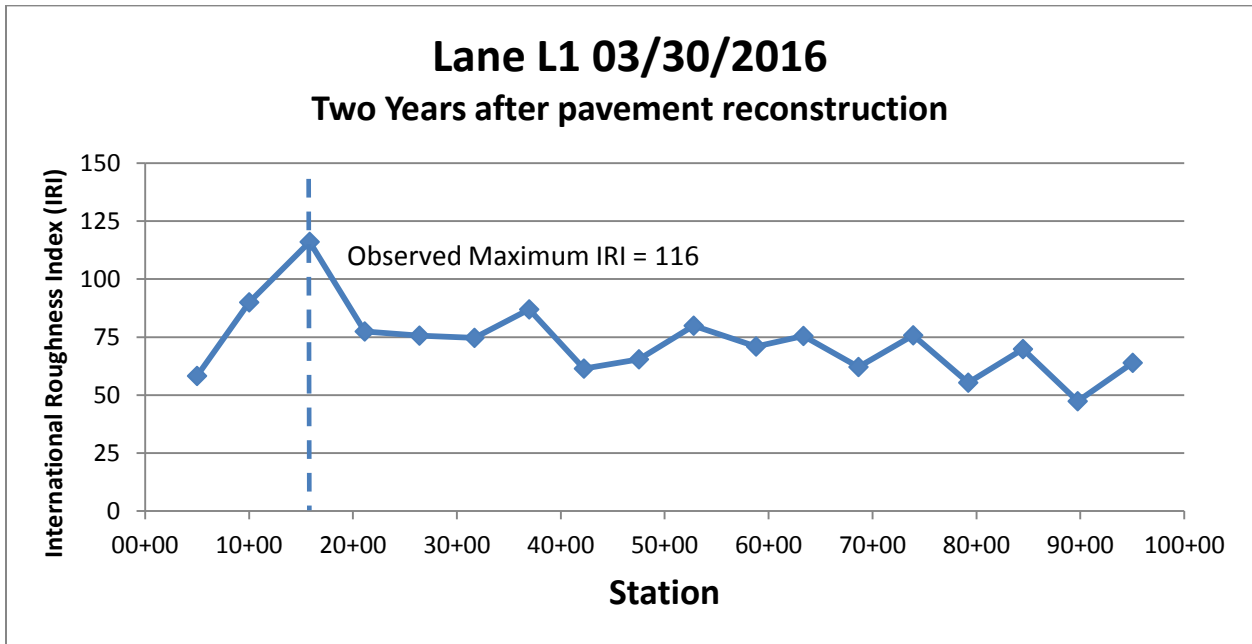
International Roughness Index can be determined and is represented by inch/miles. From the figure it can be noted that the IRI value is uniform throughout the test section except for an increase in roughness at 0.9 mile mark. These PSI and IRI indices will be monitored throughout the project period and utilized in performance analysis of pavement. The profiler data has been analyzed over a period of 05/05/2014 till 08/01/2016. A PSI value closer to 5 and IRI values less than 40 represent a healthy pavement.

Surface profiler data obtained at different time periods was helpful to analyze the pavement performance before and after reconstruction. Initial profiler data from 05/05/2014 revealed the damaged pavement profile and the corresponding deformations at different stations can be observed from Figures 19 and 23. During the period of 08/01/2014, the pavement has been repaved and the PSI values varied from 4.5 to 5 as shown in Figures 17 and 20; representing a healthy pavement profile. Recent profiler data (09/01/2015) as presented in Figures 18 and 21, shows that the PSI and IRI values are exhibiting healthy trends since pavement construction, except at station 65+00 where the PSI value reduced to 3.9 and IRI value increased to 83. Figures 22 and 26 reveal that, the current condition of the pavement section is deteriorating, which could be attributed to the formation of Ettringite.

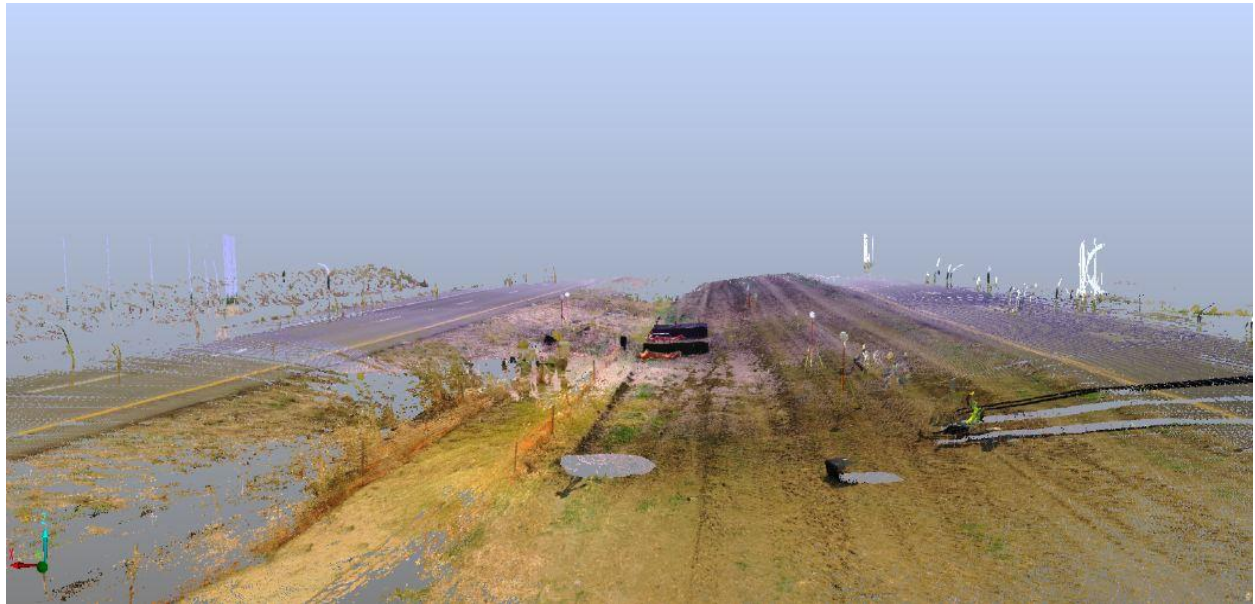
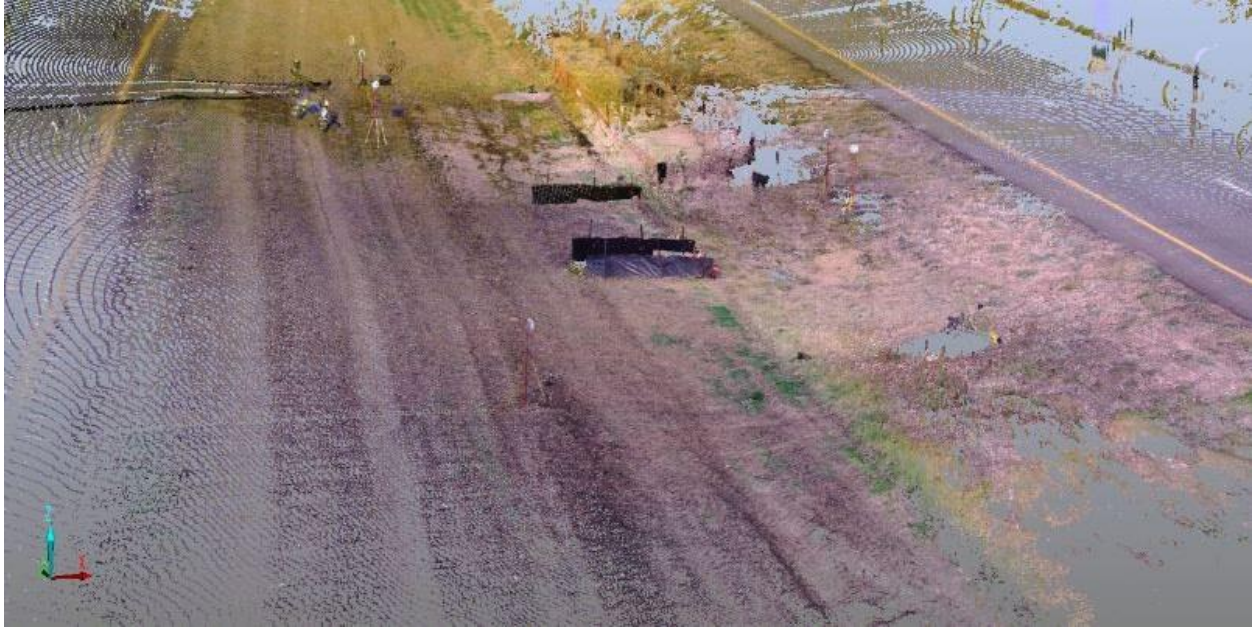
Figure 28 (a) (b) 3D reconstructed images of test section 3 using SCENE software

Initial scans showed considerable disturbances from the grass blades present at the site. LiDAR investigations are conducted at Test section 1 and 2 as shown in Figure 29 (a) and (b) below.
