1. Report No. FHWA/TX-08/1401-1		2. Government Accession No.		3. Recipient's Catalog No.	
4. Title and Subtitle <b>Bending Fatigue Response of Grouted Stay Cables</b>				5. Report Date July 2008

## **Bending Fatigue Response of Grouted Stay Cables**

CTR Research Report:	0-1401-1
Report Date:	July 2008
Research Project:	0-1401
Research Project Title:	Determination of Fatigue Damage in Stay Cables
Sponsoring Agency:	Texas Department of Transportation
Performing Agency:	Center for Transportation Research at The University of Texas at Austin

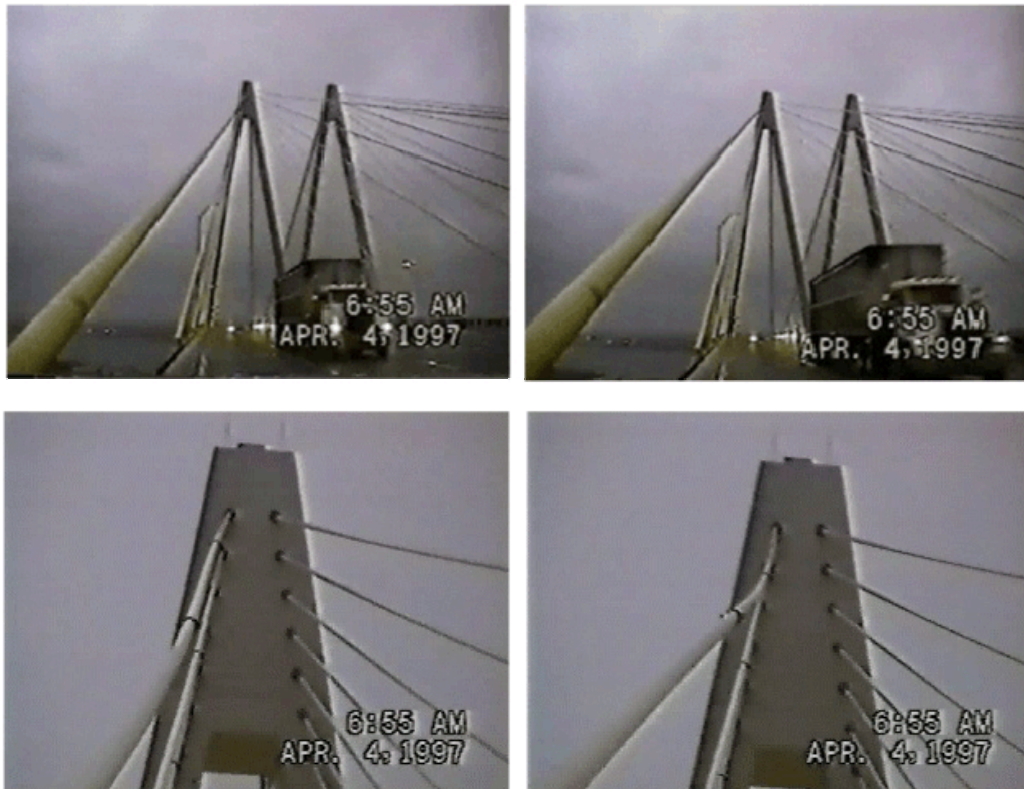
Large-amplitude stay cable vibrations were observed on the Fred Hartman Bridge numerous times since its opening in 1995. One of the first estimates (Poston 1998) of the amplitude of these vibrations is from visual observations during a four-day period between 1 April and 4 April 1997 (Table 1.2). Video taken on 4 April 1997 (Figure 1.4) show the large-amplitude deformations of cable 24 during this event. At 650 ft, cable 24 is the longest cable on the bridge.

**Figure 1.4 Stay Cable Vibrations – Fred Hartman Bridge**

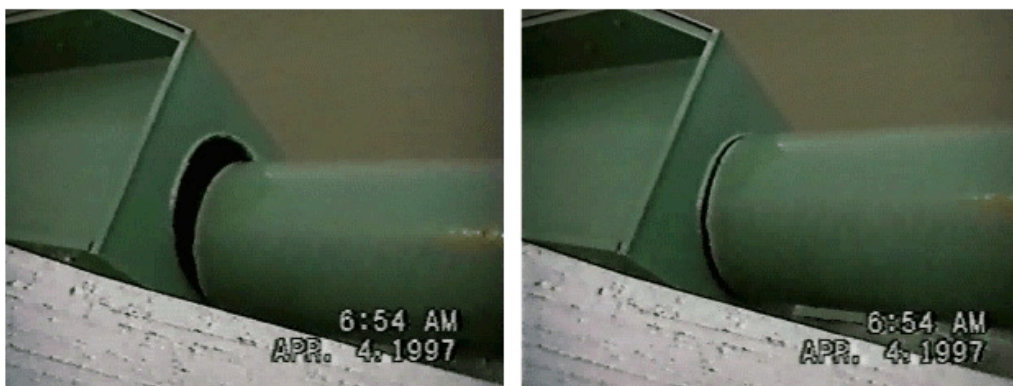
These large-amplitude vibrations caused visual damage to the Fred Hartman Bridge. Broken guide pipes (Figure 1.5) were found on more than 100 of the 192 cables. The broken guide pipes are a visual indication of the forces and displacements generated by these events and the damage that might occur. Of great concern is the possible hidden fatigue damage of the stay cables and the anchorage. The stays would have to be dismantled to detect damage reliably. Nondestructive inspection techniques are not applicable due to the limited access at the anchorages and the grout surrounding the strand.

**Figure 1.5 Broken Guide Pipe – Fred Hartman Bridge**

WDP (Witthoft et al. 2001) developed the designs to repair the existing damage and to minimize future cable vibrations. The broken guide pipes were strengthened with stiffeners. A temporary solution to control the cable vibrations was the installation of restrainers (Figure 1.6). The restrainers connect the stay cables and allow vibration energy to be transferred between adjacent stays. These restrainers proved to be a very effective means of reducing the cable displacements and were left in place on the bridge.

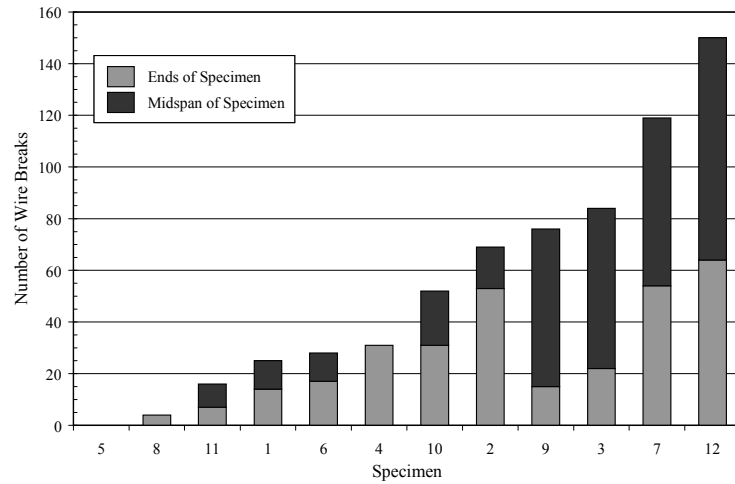
**Figure 3.2 Number of Wire Breaks Observed in Cable-Stay Specimens**

Among the experimental parameters considered in this set of experiments, the fatigue life of the cable-stay specimens appeared to be most sensitive to two. The ungrouted specimens (Specimens 5 and 8) experienced far fewer wire breaks than the grouted specimens (Figure 3.2). In addition, the fatigue life was considerably longer for the three specimens that were subjected to lower-amplitude displacement cycles during the fatigue tests (Specimens 4, 10, and 11).

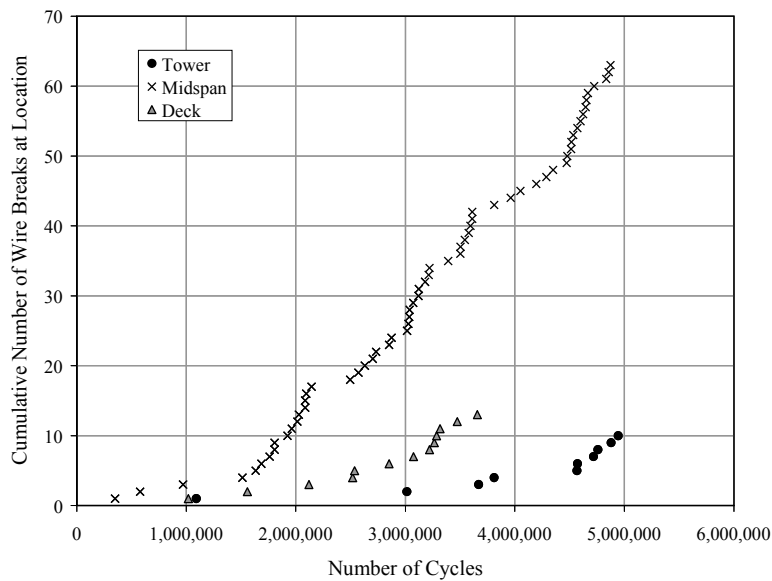
The results of the fatigue tests are summarized in Table 3.1. It should be noted that damage within the test specimens accumulated gradually with the number of loading cycles at the beginning of the fatigue tests (Figure 3.3). The presence of one or two wire breaks had essentially no impact on the structural integrity of the stay-cable specimens. However, the rate of damage did increase during the fatigue tests, and this increase occurred at a different number of loading cycles for different specimens and for different locations within the same specimen.

**Figure 3.3 Wire Breaks Detected from Acoustic Data – Specimen 3**

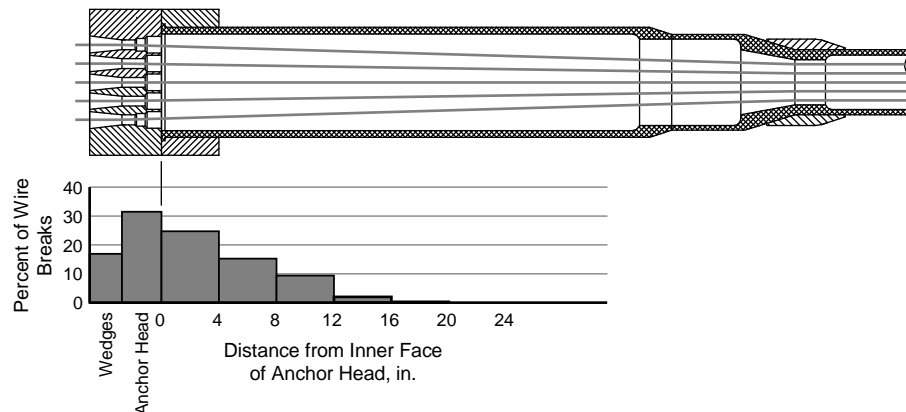
Three hundred eight wire breaks were identified at the ends of the cable-stay specimens. Nearly 50% of the wire breaks (Figure 3.4) occurred within the anchor head, with more than 15% within the wedges. Approximately 25% of the wire breaks were located within the threaded nut used in phase 1 or the smooth end sleeve used in phase 2. The remaining wire breaks were distributed along the transition region. All wire breaks occurred within 20 in. of the inside face of the anchor head.

**Figure 3.4 Distribution of Observed Wire Breaks at Ends of Stay-Cable Specimens**

As shown in Figure 3.4, approximately 50% of the wire breaks observed at the ends of the stay-cable specimens occurred within the anchor head. In most cases, the failures in this region were caused by fretting of adjacent wires within the strand. The teeth of the wedges initiated only 6% of the total number of wire breaks. All wire breaks occurred within 16 in. of the inside face of the anchor head. Near the loading clamp, more than 50% of the wire breaks were within  $\pm 5$  in. of the centerline of the actuator and all wire breaks were within  $\pm 20$  in. of the centerline (Figure 3.5). Less than 10% of the wire breaks occurred beyond the PE cushion used as a transition between the PE pipe and the steel clamp.

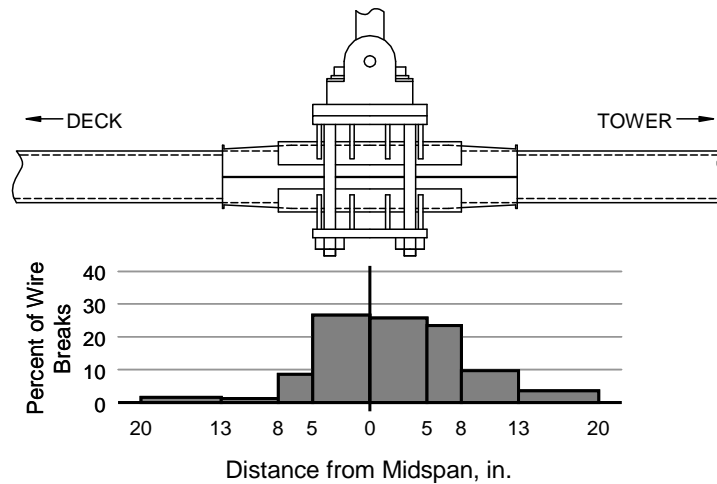
Three hundred forty-two wire breaks were observed at midspan of the test specimens (Figure 3.5). Nearly 85% of the wire breaks occurred within the metal clamp used to attach the hydraulic actuator to the test specimens, with more than 50% of the wire breaks directly beneath the head of the actuator. Only 5% of the wire breaks occurred beyond the PE cushion and all wire breaks were within 20 in. of midspan.

**Figure 3.5 Distribution of Wire Breaks at Midspan of Stay-Cable Specimens**

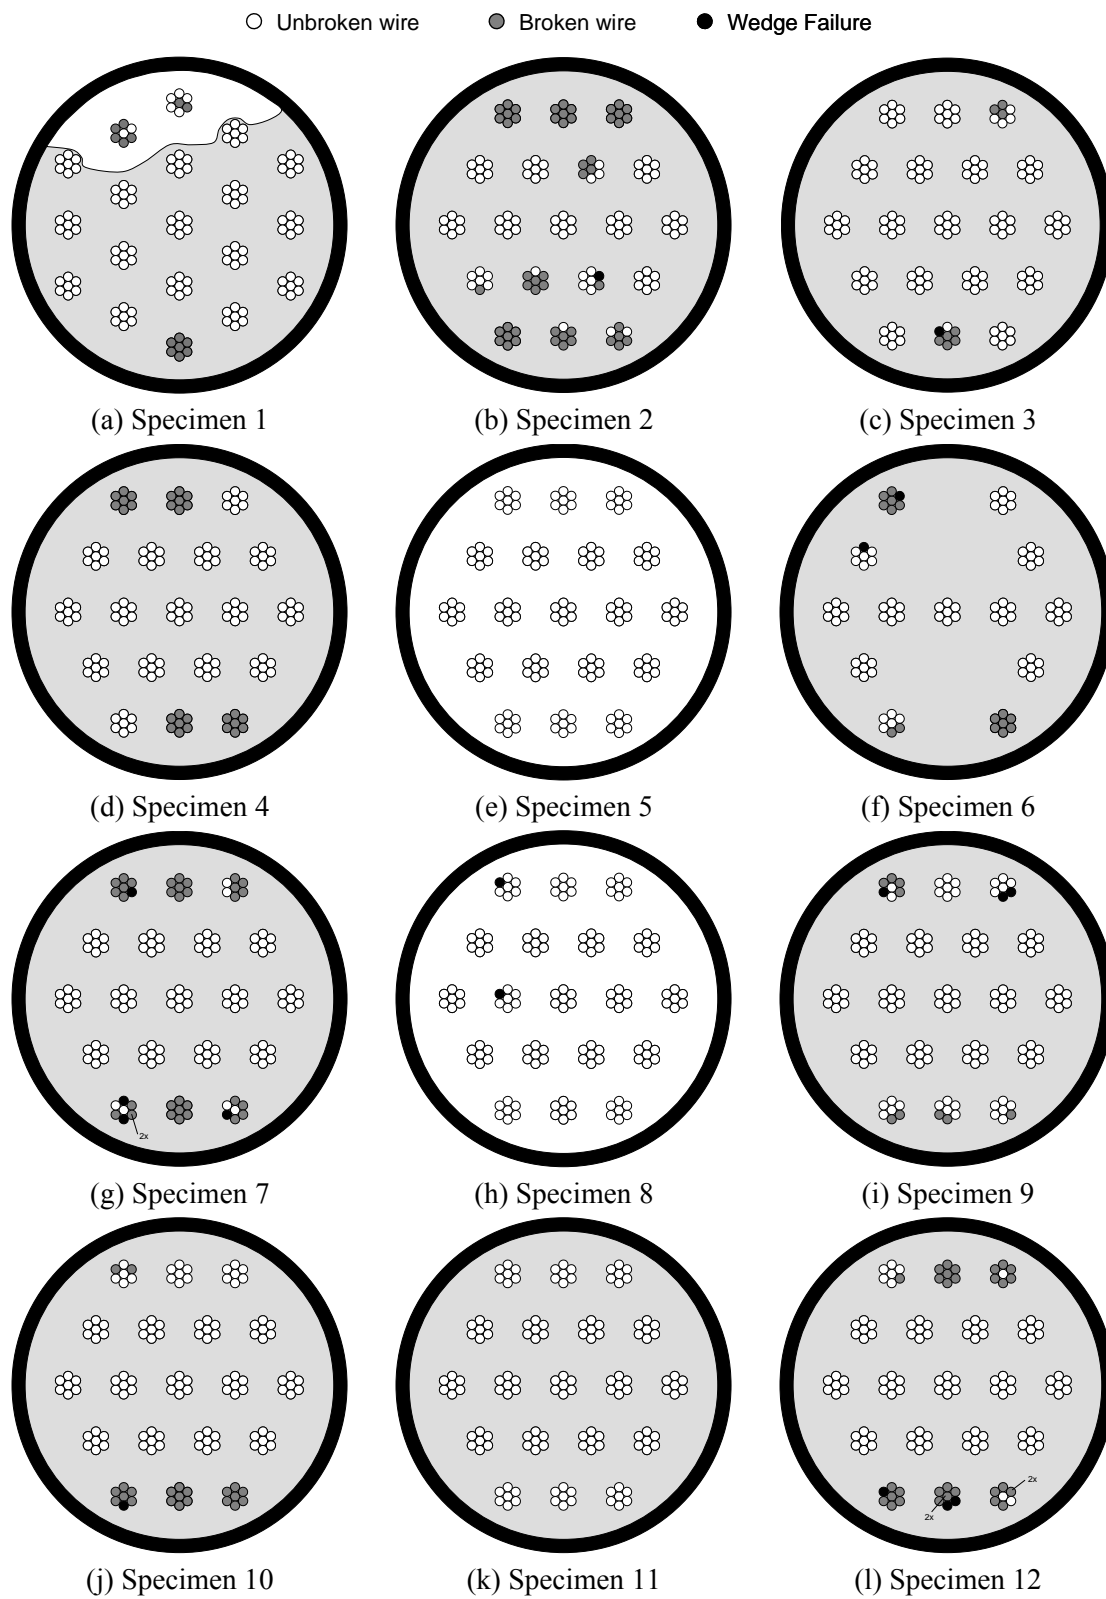
**Figure 3.6 Summary of Wire Breaks at Tower End of Stay-Cable Specimens**

The distributions of wire breaks within the cross sections at each end and at midspan are summarized in Figure 3.6 through Figure 3.8. For the grouted test specimens, the wire breaks at the ends tended to occur in the layers of strand at the top or bottom of the cross section. Only in Specimens 1, 2, 6, and 12 did the wire breaks occur in an inner layer of strand. The large number of wire breaks in the top and bottom layers of Specimens 2 and 12 likely caused the damage to spread to the inner layers. However, in Specimen 1, the presence of the grout void seems to have influenced the damage pattern. Specimen 8, which was ungrouted, was the only specimen to experience wire breaks in the middle layer of strands.

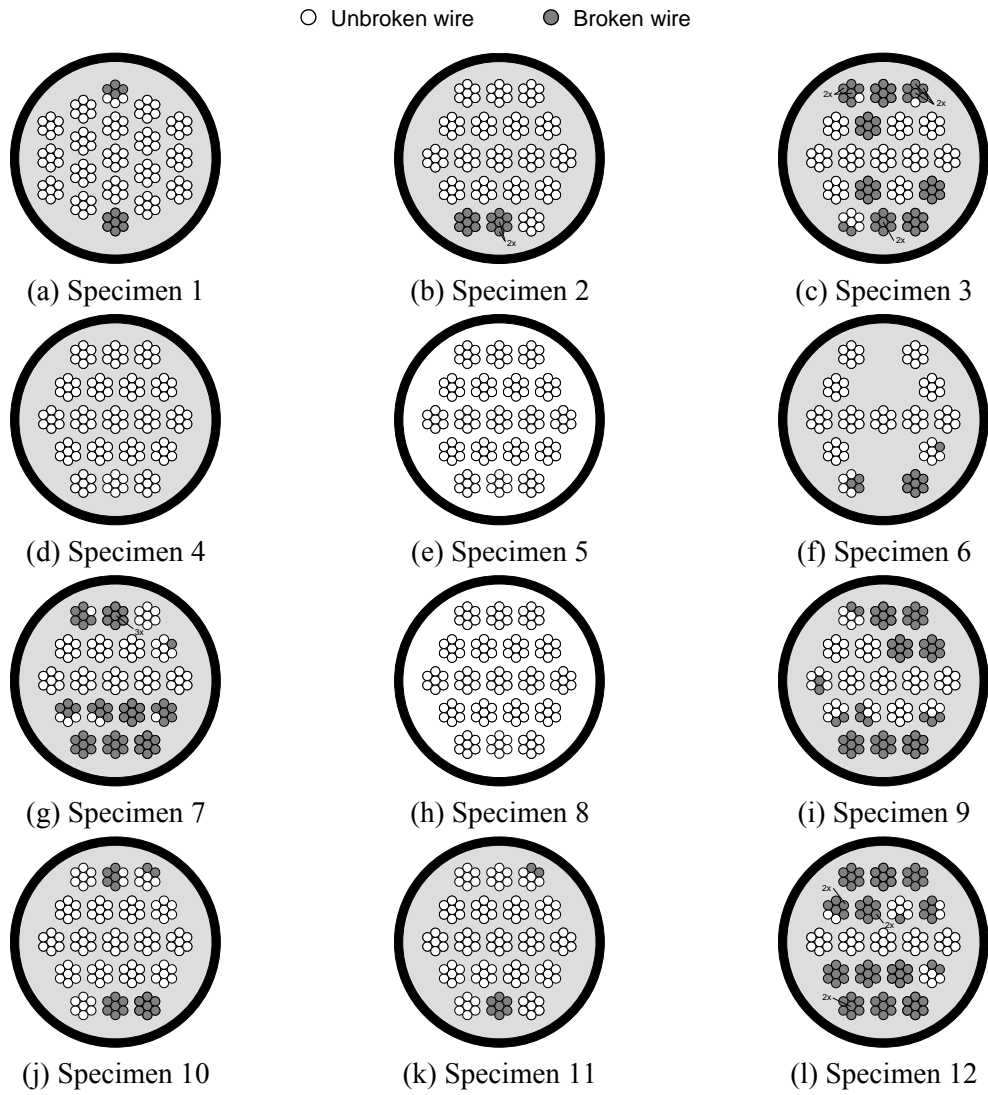
**Figure 3.8 Summary of Wire Breaks at Midspan of Stay-Cable Specimens**

At midspan, wire breaks in the inner layers of strands were more common, especially when most of the wires in the outer layer fractured. Corroded fretting product was often observed in the vicinity of the wire breaks (Figure 3.9). The amount of observed corrosion tended to increase as the number of wire breaks increased.

The reductions in dynamic stiffness for the grouted specimens seem to be closely related to the number of wire breaks experienced at midspan. Specimens 7, 9, and 12 experienced more than 60 wire breaks at midspan (Figure 3.8) and exhibited the most pronounced reductions in dynamic stiffness. In contrast, Specimens 1, 2, and 6 experienced 16 or fewer wire breaks at midspan and exhibited better fatigue performance. These trends seem to indicate that Strand A exhibited better bending fatigue performance than Strand B, but data from Specimen 3 are not available to confirm this trend.

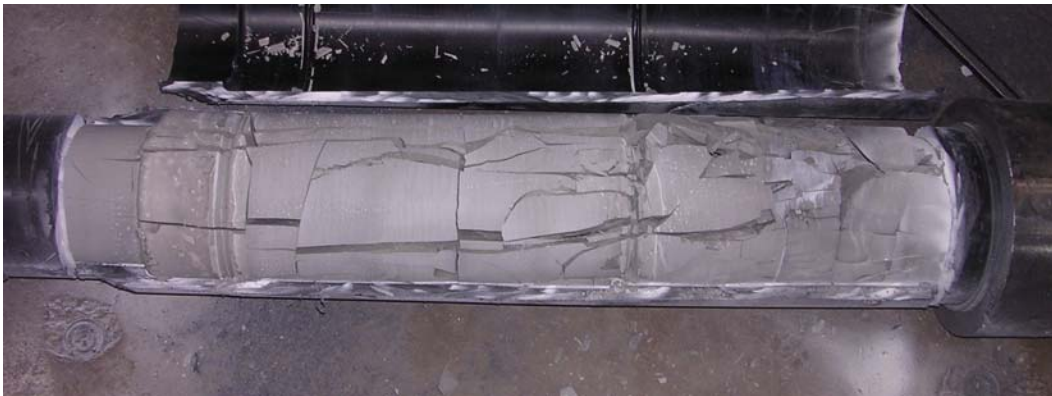
In the vicinity of wire breaks, the grout was often severely cracked (Figure 3.10 and Figure 3.11). Longitudinal cracks in the grout were characteristic of wire breaks, whereas fine circumferential cracks were observed in regions that were undamaged (Figure 3.12). These circumferential cracks were representative of cracks observed along the free length of the cables on the Fred Hartman Bridge (Figure 3.13). The width of the circumferential cracks in the test specimens tended to increase with time as the grout was exposed to the environment. These cracks were believed to be caused by shrinkage of the grout.

**Figure 3.10 Condition of Grout at Deck End Immediately after Removing PE Pipe – Specimen 10**

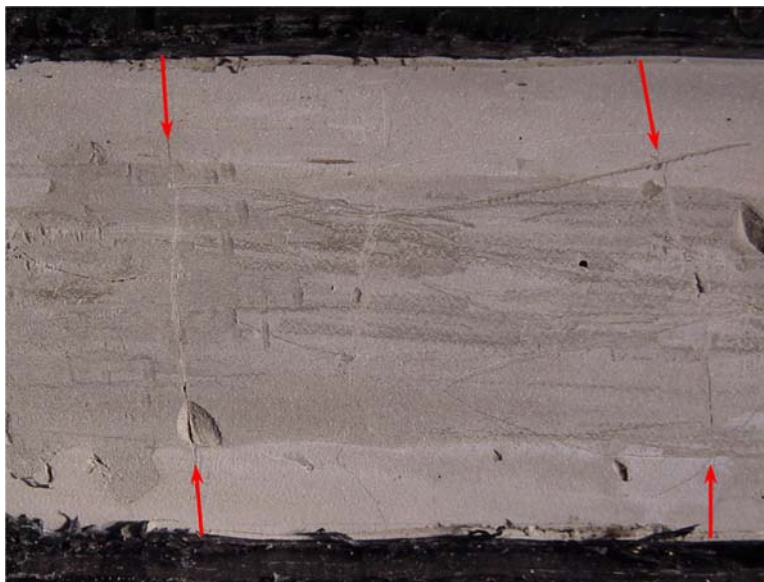
**Figure 3.12 Hairline Transverse Grout Cracks – Specimen 1**

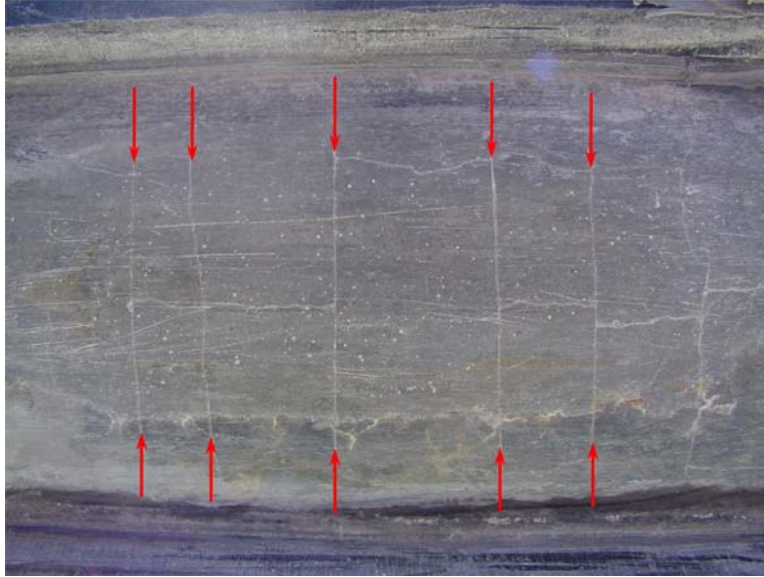
**Figure 3.13 Hairline Transverse Grout Cracks - Fred Hartman Bridge**

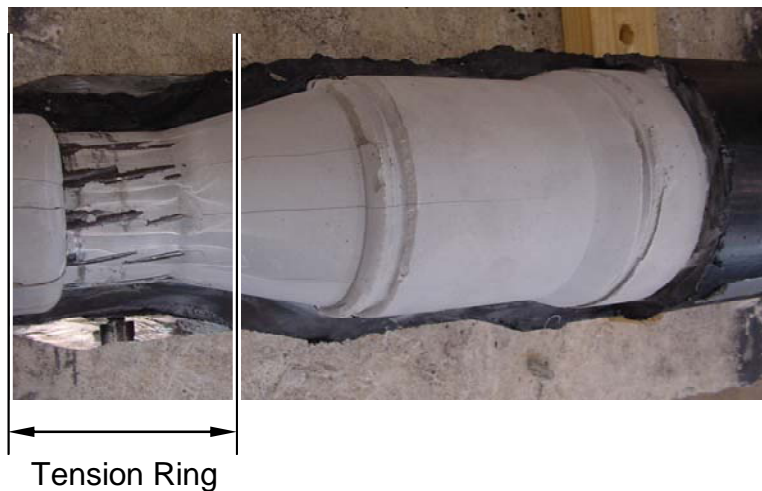
The strands were observed to be most severely congested in the vicinity of the tension ring (Figure 3.14). The strands around the perimeter of the cross section were not encased in grout at this location.

**Figure 3.14 Exposed Strand at Tension Ring – Specimen 1**

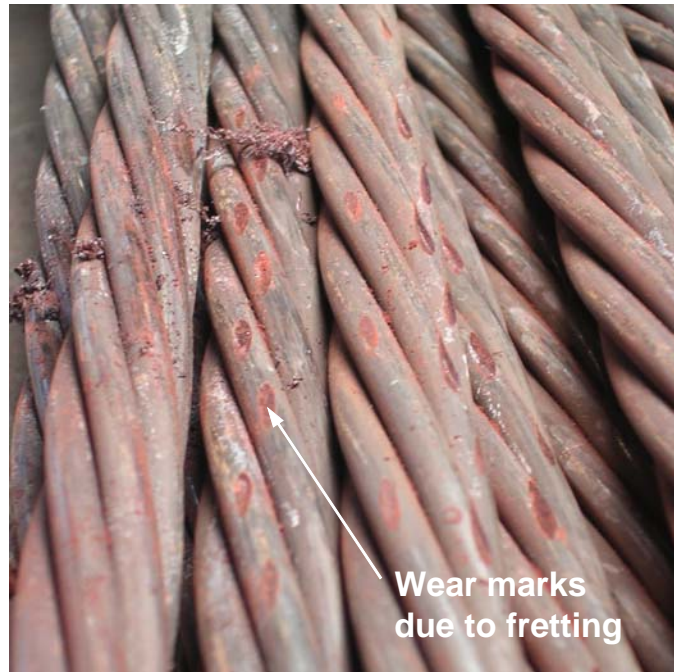
The response of the two ungrouted specimens is plotted in Figure 3.18. Both specimens experienced more than 5 million cycles with less than a 10% decrease in the average dynamic stiffness. These data also support the hypothesis that Strand A exhibited better bending fatigue performance than Strand B, but one of the strands in Specimen 8 was misaligned, and significant fretting damage was observed during the fatigue test near the tension rings (Figure 3.19). However, in spite of this observed damage, the wire breaks occurred within the anchor head for Specimen 8.

**Figure 3.19 Reduction of Cross-Sectional Area of Strands Due to Fretting – Specimen 8**

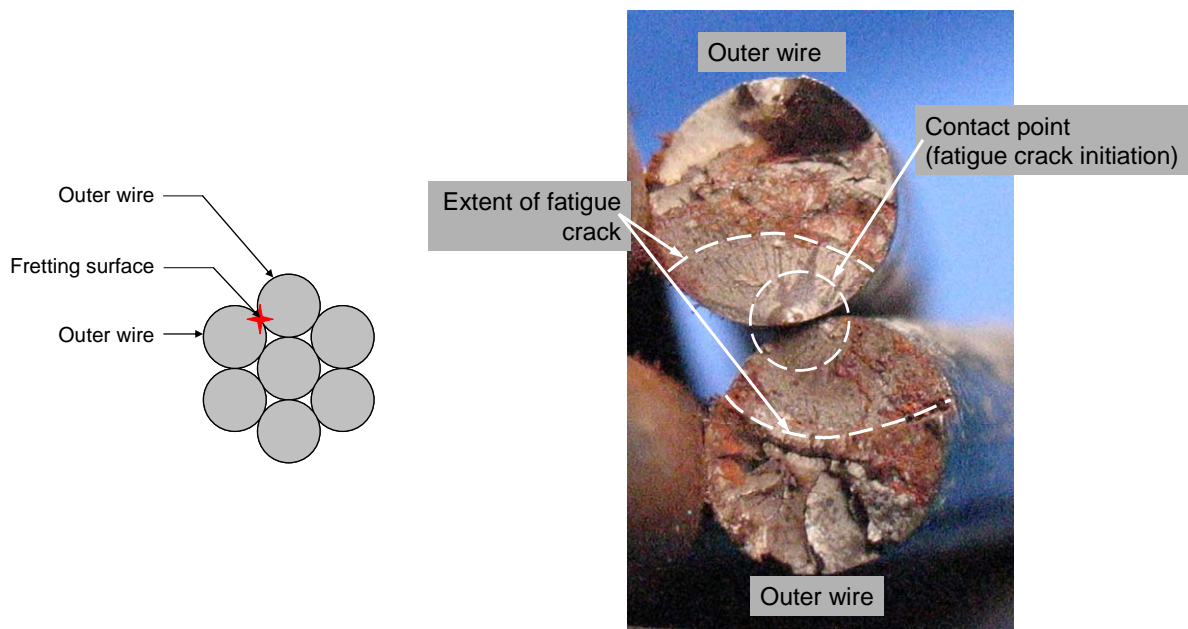
Two types of fretting fatigue failures were most common. The first type occurred due to fretting between the center wire and an outer wire, as shown in Figure 3.20. This type of fretting can lead to fracture of the center wire, the outer wire, or both wires at the contact point. The second type of fatigue failure was due to fretting between two adjacent outer wires as shown in Figure 3.21. Failures caused by fretting of adjacent wires in the strand, center-outer and outer-outer, represented nearly 90% of the observed wire breaks.

**Figure 3.21 Fretting between Adjacent Outer Wires**

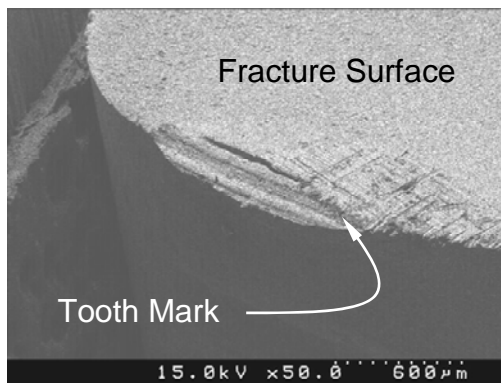
A third, less common type of fatigue failure was observed where the fatigue crack initiated at a point that was not in contact with other wires in the strand. The point where the first tooth on the wedge engaged the strand often served as the initiation point for this type of crack (Figure 3.22 through Figure 3.24). This type of fretting failure represented approximately 6% of the total.

**Figure 3.23 Fracture Initiation**

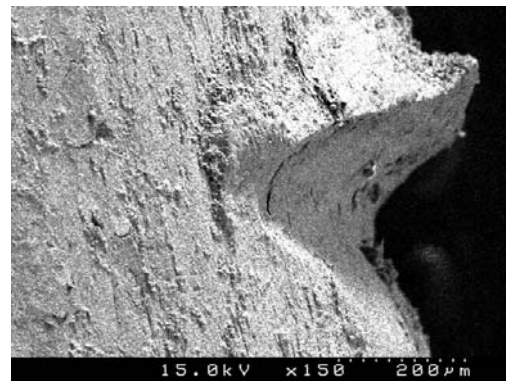
**Figure 3.24 Typical Tooth Mark**

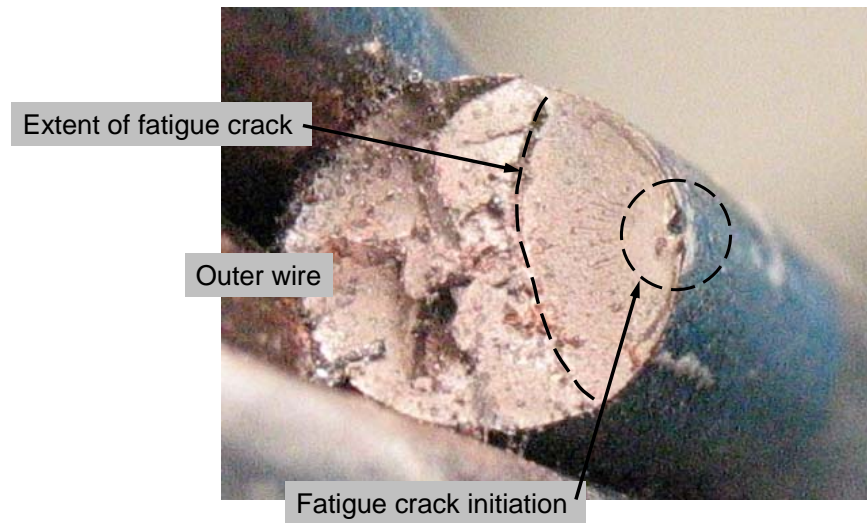
Occasionally fatigue failures were also observed to initiate at a point where an exterior wire was not in contact with the other wires in the strand. It is unknown what caused this type of failure, although possible sources are corrosion, defects on the wire, or fretting with the helical spacer wire (Figure 3.25). The remaining 5% of the wire breaks were in this category.

**Figure 3.25 Fatigue Failure Caused by External Source**

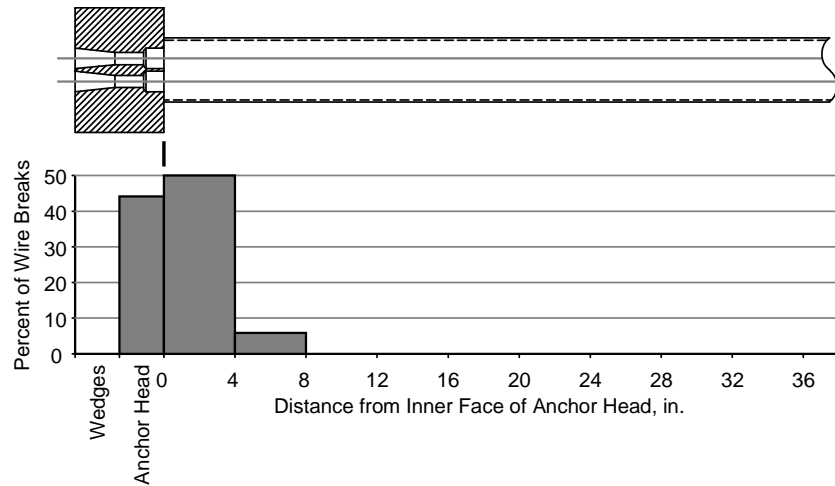
**Figure 4.1 Distribution of Observed Wire Breaks at North End of Small-Diameter Specimens**

Due to the location of the applied transverse loads, damage in the small-diameter specimens was concentrated near the north end (Table 4.1). At least half the wires fractured at this location in each of the test specimens, and all the wires fractured in Specimen 1. Approximately 45% of the wire breaks occurred within the north anchor head and 50% of the wire breaks occurred within 4 in. of the inside face of the anchor head (Figure 4.1). All wire breaks occurred within 8 in. of the inside face of the anchor head.

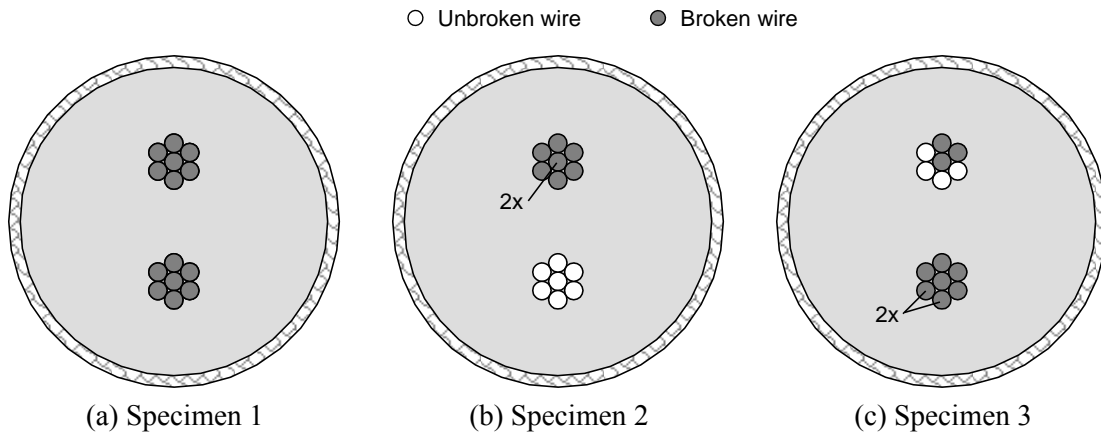
**Figure 4.2 Summary of Wire Breaks at North End of Small-Diameter Specimens**

The distributions of wire breaks within the cross section are shown in Figure 4.2. Multiple wire breaks were observed in individual wires in Specimens 2 and 3. The level of damage was extremely high in all three specimens at the conclusion of the fatigue tests.

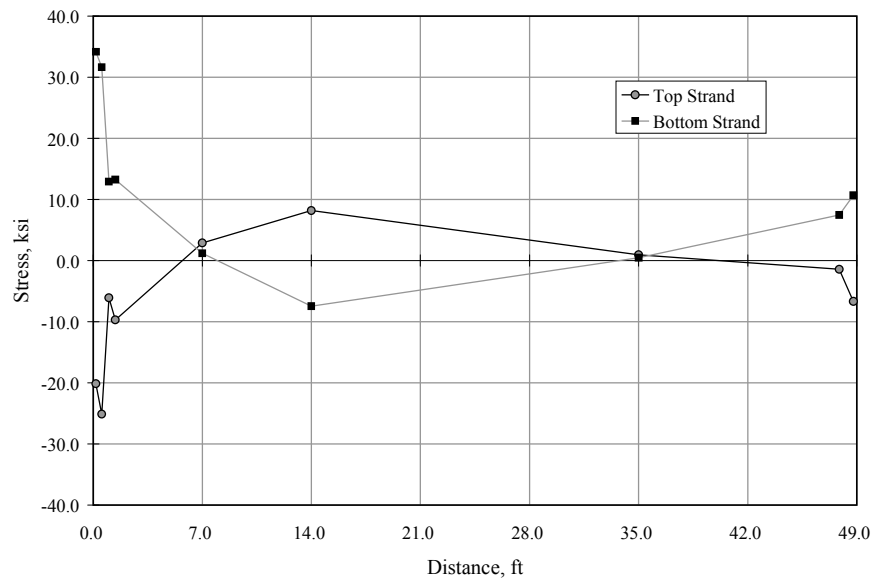
**Figure 4.10 Variation of Maximum Stress along Length of Specimen 3 after 2,000 Fatigue Cycles**

The most complete set of data was obtained for Specimen 3 (Section E.3.2). The data indicated that the highest stresses occurred near the north anchor head (Figure 4.10), as expected. However, for closely-spaced gages, the magnitude of the stress did not always decrease with distance along the span. These trends were also believed to be caused by cracking of the grout.

The stress data plotted in Figure 4.10 indicate a maximum bending stress of approximately 35 ksi in the strand near the north anchor head. The first wire break in Specimen 3 was detected after 415,000 fatigue cycles. This fatigue life is consistent with the range observed for strand tested in air at this stress range (Appendix A).

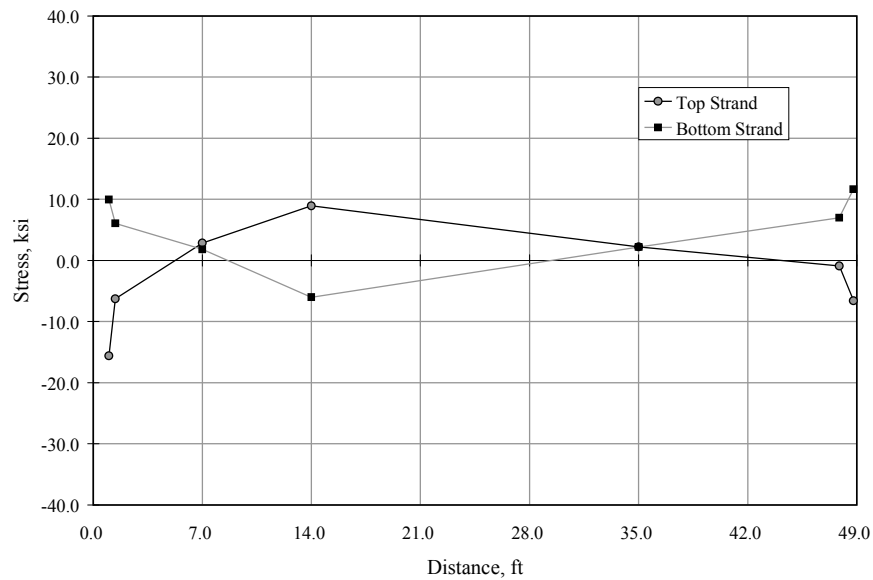
**Figure 4.11 Variation of Maximum Stress along Length of Specimen 3 after 750,000 Fatigue Cycles**

The gages in the immediate vicinity of the anchor heads tended to fail after several hundred thousand fatigue cycles. Therefore, it was not possible to monitor changes in these stress levels as damage accumulated. However, the stresses at other locations did not vary considerably with the number of cycles (Figure 4.11).

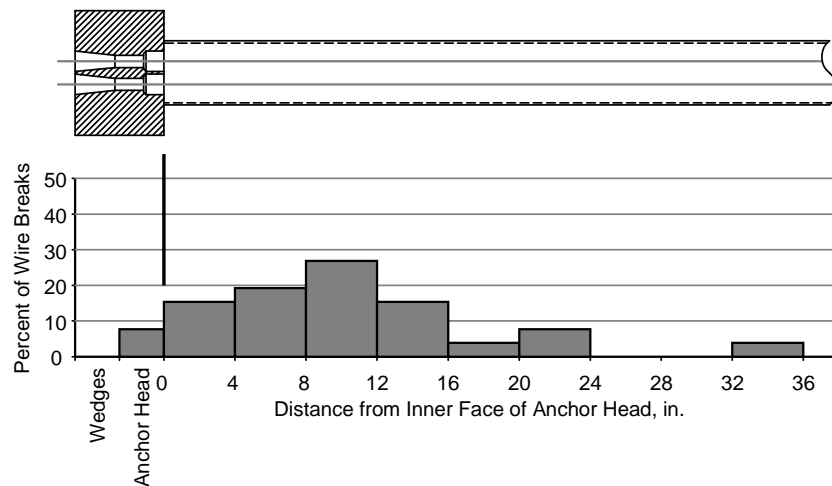
**Figure 4.12 Distribution of Wire Breaks Detected by Acoustic Sensors at North End of Small-Diameter Specimens**

The longitudinal distribution of wire breaks detected by the acoustic sensors at the north end is shown in Figure 4.12, respectively. All the wire breaks were reported within 3 ft of the inside face of the anchor head; however, the centroid of the actual distribution of wire breaks was closer to the inside face of the anchor head (Figure 4.1).

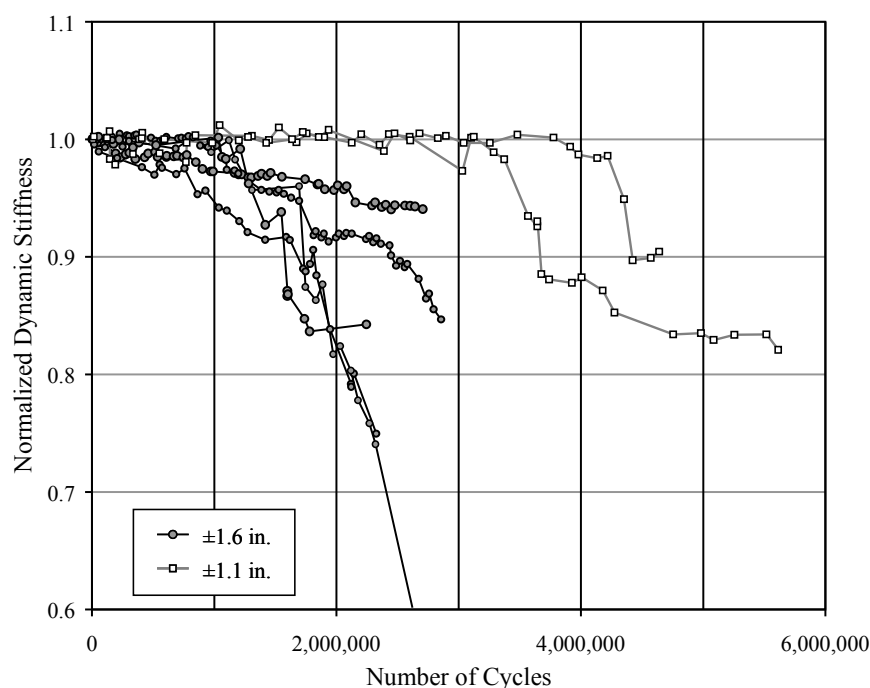
**Figure 7.1 Sensitivity of Average Dynamic Stiffness for Grouted Specimens with Nineteen Strands to Displacement Amplitude during Fatigue Tests**

Reducing the amplitude of the displacements had the largest influence on increasing the fatigue life of grouted stay cables of the parameters studied (Figure 7.1). Reducing the displacement amplitude by 30% increased the number of loading cycles corresponding to a 10% reduction in stiffness from approximately 1.5 million to approximately 4 million in the test specimens. TxDOT has already accomplished much larger reductions in displacement amplitude on the Fred Hartman Bridge by installing dampers and cable restrainers. While the local bending issues identified in Section 7.1 are introduced by

these vibration mitigation methods, the risk of fatigue damage due to low-amplitude, local bending is much lower than the risk of fatigue damage due to large-amplitude vibrations.

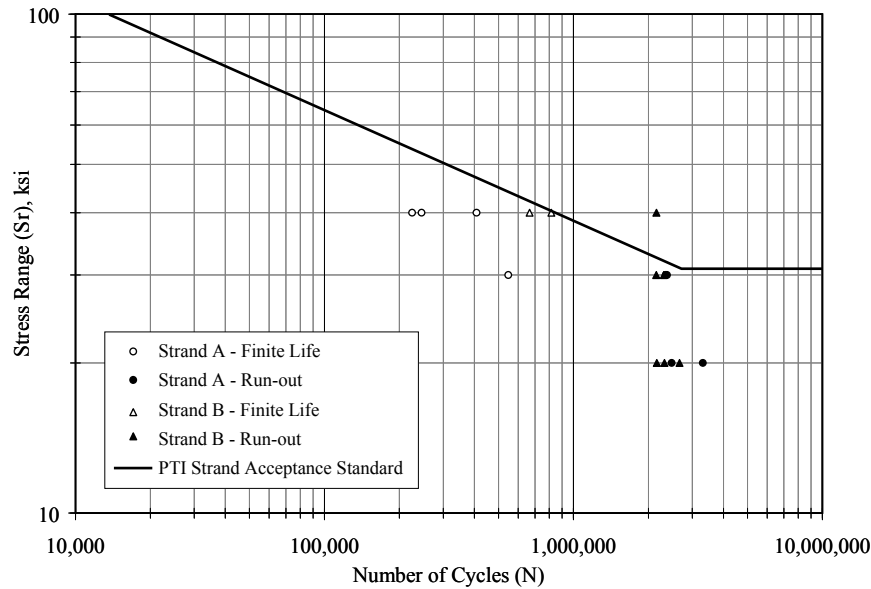
**Figure A.7 Comparison of Fatigue Characteristics of Strand and PTI Strand Acceptance Model**

The fatigue life of Strand A is clearly less than the PTI acceptance fatigue model at a stress range of 40 ksi. In contrast, the fatigue life of Strand B is closer to the requirements in the PTI Guide Specifications. For a stress range of 40 ksi, specimen B-5 exceeded the required number of loading cycles (847,000) and specimen B-1 was within 5%. However, based on the available data, neither strand satisfies the acceptance fatigue requirements in the PTI Guide Specifications.

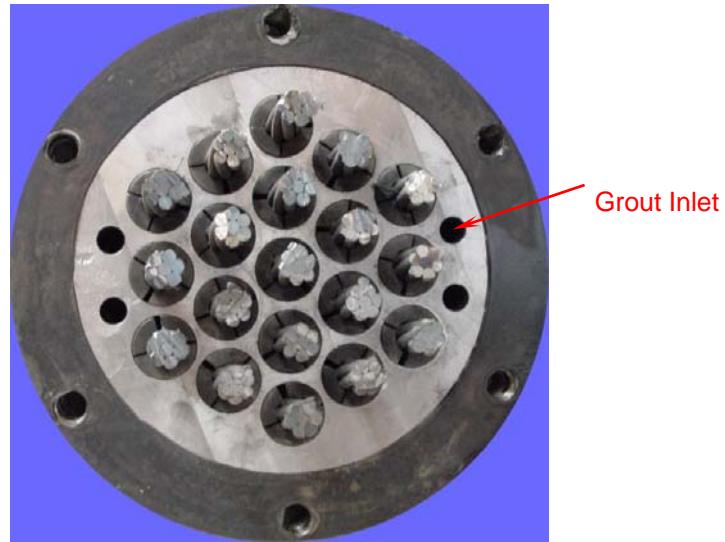
**Figure B.32 Anchor Head Orientation for Specimen 1**

The anchor heads were fabricated with four grout inlets, as shown in Figure B.32. During the construction of Specimen 1, the grout inlets were oriented horizontally. This orientation of the anchor head caused the formation of an unintentional grout void at the tower end of the specimen. In all subsequent tests, the anchor heads were positioned such that the grout inlets were oriented vertically (Figure B.33) and these grout voids were avoided. However, there are no mechanical aids on the bridge anchorage that ensure correct orientation of the anchor heads and the orientation was not indicated on the construction drawings for the Fred Hartman Bridge. Furthermore, the anchor heads used for some of the larger stays on the Fred Hartman Bridge had grout outlets within the strand pattern, which means that it is common to have strands positioned above the grout inlet.

The grout used to construct Specimen 1 did not include the anti-bleed admixture. The bleed water likely contributed to the presence of the grout void at the tower end of Specimen 1.

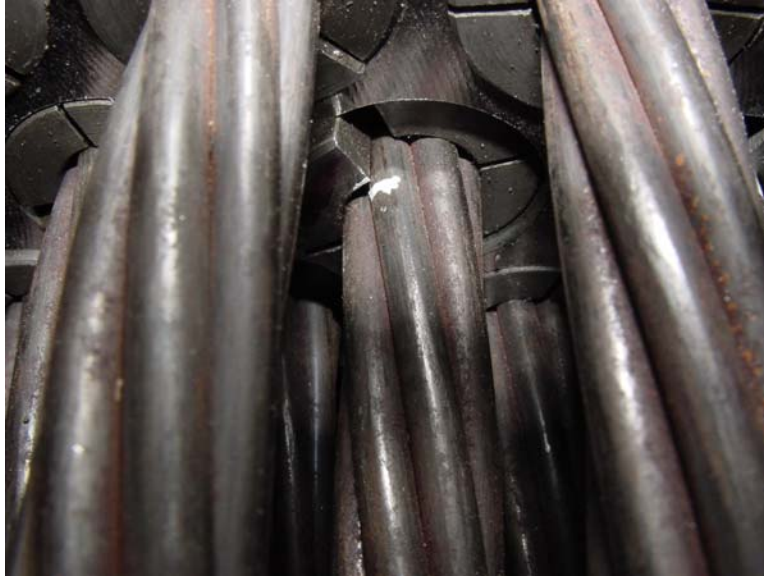
**Figure B.34 Unequally Seated Wedges at the Deck End of Specimen 1**

The spring shown at the end of the mono-strand ram in Figure B.24 was not used during the initial stressing of each strand for Specimen 1. As a result, the wedges for some of the strands were seated unevenly at the deck end (Figure B.34). The wedges were marked after the initial stressing, and no movement of the wedges was observed during the final stressing or the fatigue test. Using the spring during the initial stressing provided even seating of the wedges in subsequent specimens.

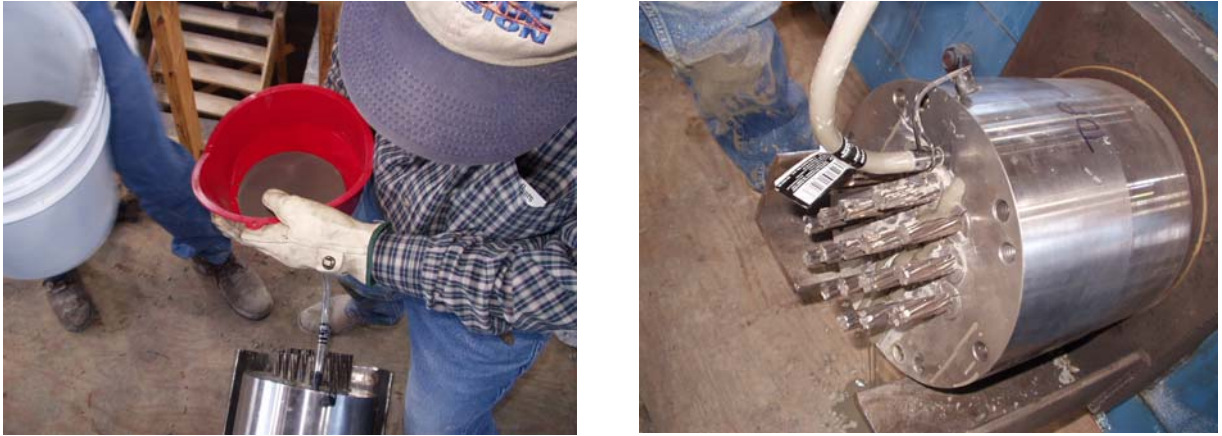
**Figure B.39 Procedure Used to Fill the Intentional Grout Void at the Tower End of Specimen 9**

Specimen 9 was grouted along the entire length; however, a grout outlet was deliberately placed approximately 2 ft from the tower anchor head. This was done to generate a grout void in the specimen. A void had been identified near the tower anchor head of one stay on the Fred Hartman Bridge. TxDOT personnel were interested in testing the efficacy of a proposed method to fill the void and determining if the added grout influenced the fatigue life of the stay.

The volume of the intentional void was approximately 6 in<sup>3</sup>. Ten days after the main grouting of the stay, this void was filled with SikaGrout 300 PT, a non-bleed, high-flow, sand-free grout mixture. The grout in this region was a mixture of SikaGrout and tap water. The ratio of water to grout mix, by weight, was 0.27, which corresponds to the highest amount of water recommended by the manufacturers. A funnel and tube system was attached to a grout inlet hole in the tower anchor head and gravity was used to fill the void as shown in Figure B.39.

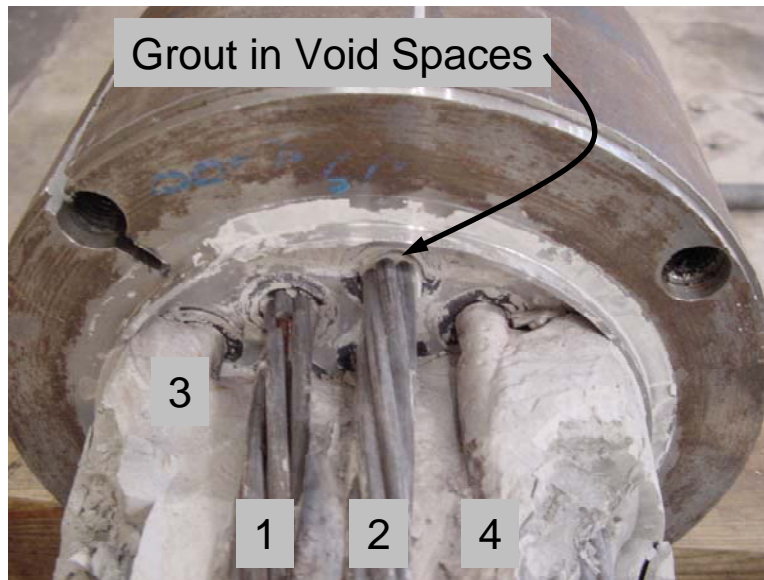
**Figure D.4 Exposed Strand within Grout Void at Tower End of Specimen 1**

When the PE transition pipe was removed, a large grout void was observed near the anchor head at the tower end of the specimen (Figure D.3). The void was approximately 20 in. long and had a maximum depth of 1.5 in. Strands 1 and 2 were fully exposed within the grout void along a length of approximately 12 in. (Figure D.4). A very thin layer of grout covered strands 3 and 4.

It is unclear whether strands 1 and 2 were in contact with grout at some point during the grouting operation. The openings in the anchor head for strands 1 and 2 were fully grouted (Figure D.4), which is an indication that the entire stay cable was initially grouted and that the grout void is a result of a bleed-water concentration at the top of the specimen. Excessive bleed water was also observed on the top surface of the grout cubes. This suggests that the sections of the strand exposed within the void were at one time exposed to bleed water. However, no significant signs of corrosion were found on the exposed strands in the grout void or on the anchor head. The surface corrosion seen in Figure D.4 is light surface corrosion that was found on the shim plate.

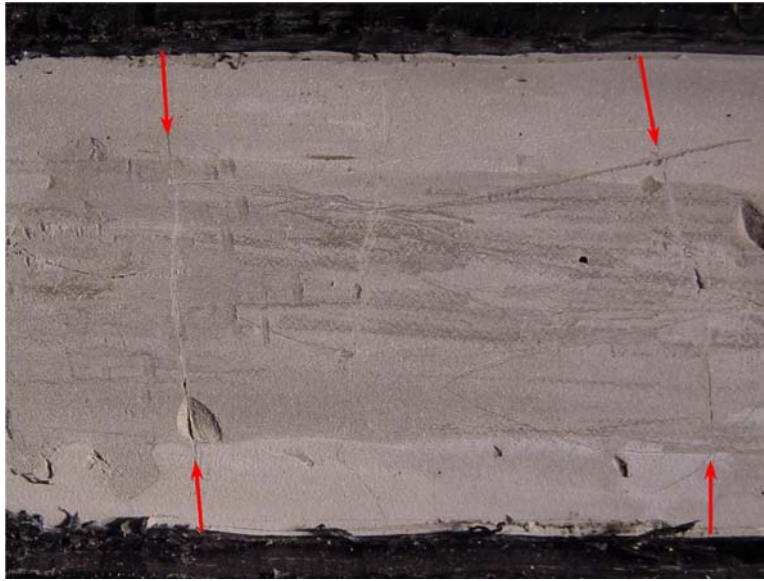
Several windows were cut into the PE pipe during the fatigue test of Specimen 1. Shortly after the windows were opened, fine, parallel, transverse cracks formed in the grout (Figure D.6). These hairline cracks were caused by shrinkage of the grout in the exposed area. Similar shrinkage cracks (Dowd 2001 ) were found in all the windows that were cut into the actual stay cables of the Fred Hartman Bridge (Figure D.7) and in a previous investigation of stay cables (Hamilton 1995).

**Figure D.6 Hairline Transverse Grout Cracks – Specimen 1**

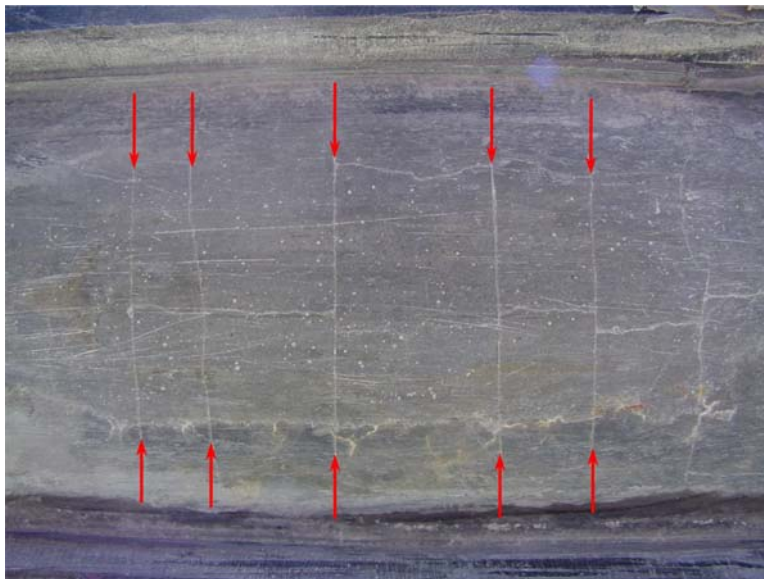
**Figure D.7 Hairline Transverse Grout Cracks - Fred Hartman Bridge**

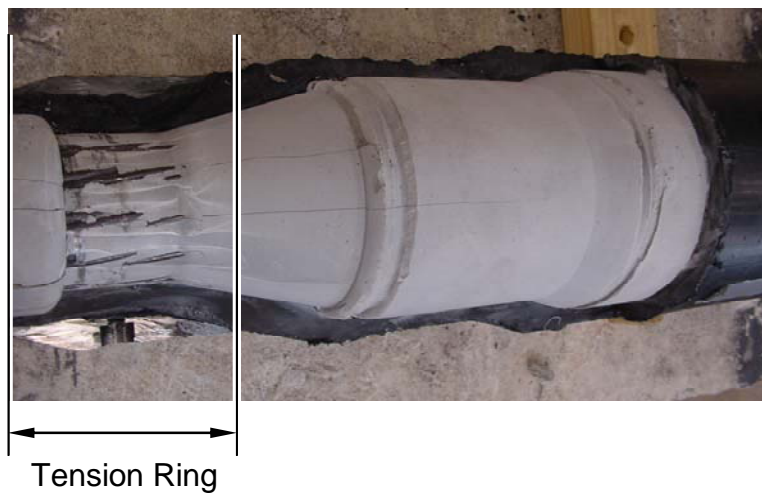
The PE pipe was also removed near the tension ring. The condition of the grout was good, and only a few longitudinal were observed (Figure D.9). However, due to the very tight spacing of the strand in this area, the surface of the strand was not covered with grout. Therefore, the potential for corrosion of the strand is higher in this region.

**Figure D.9 Exposed Strand at Tension Ring – Specimen 1**

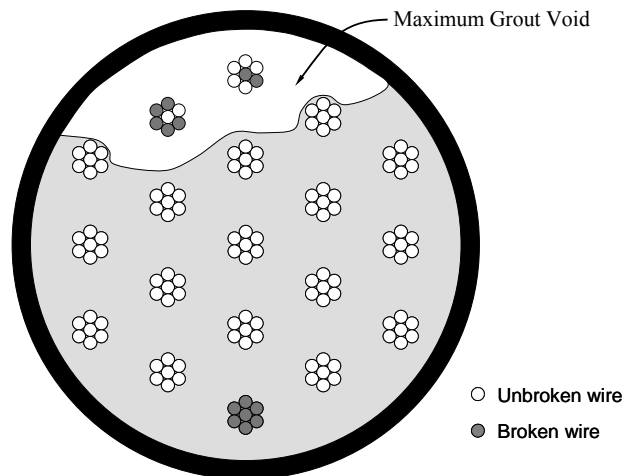
**Figure D.10 Distribution of Wire Breaks near Tower End – Specimen 1**

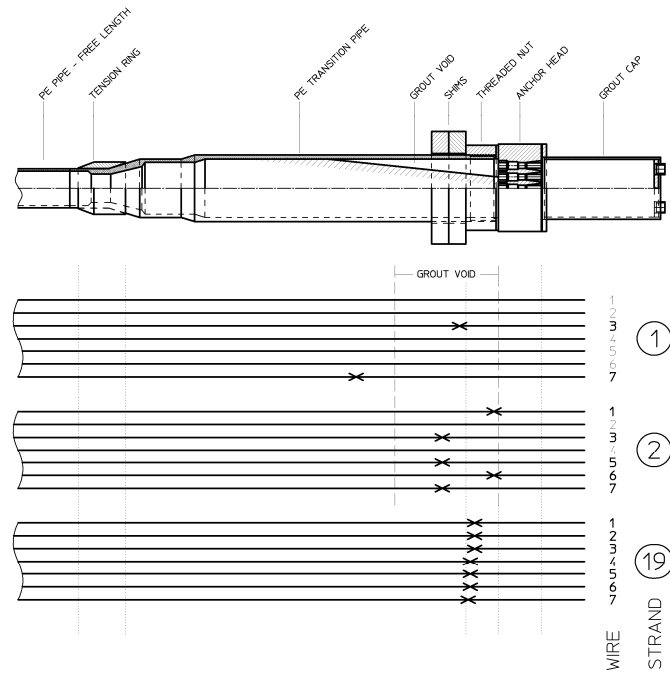
**Figure D.11 Location of Wire Breaks near Tower End – Specimen 1**

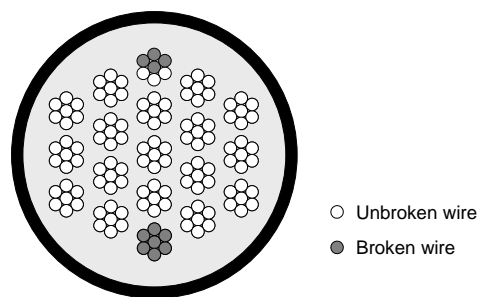
Under the loading point, the eleven wire breaks occurred in the strands at the top and bottom of the cross section (Figure D.12). Interestingly, both strands also experienced fractures in the tower anchorage region. All breaks were located in a 23-in. window, with a bias towards the deck anchorage side (Figure D.13).

**Figure D.12 Distribution of Wire Breaks near Midspan – Specimen 1**

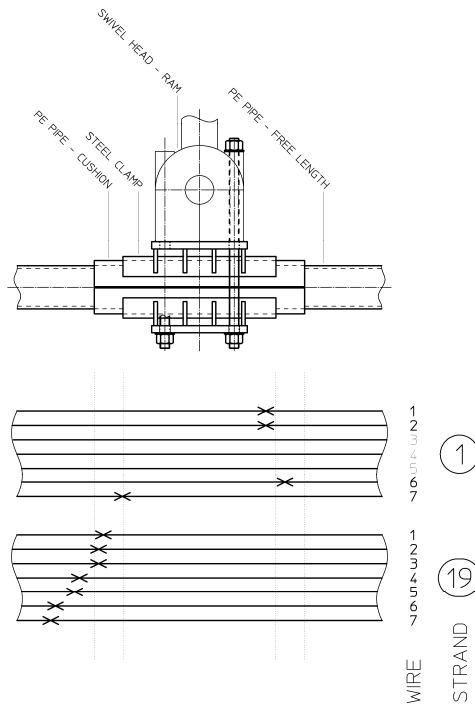
**Figure D.13 Location of Wire Breaks near Midspan – Specimen 1**
