1. Report No. FHWA/TX-08/1401-1		2. Government Accession No.		3. Recipient's Catalog No.	
4. Title and Subtitle <b>Bending Fatigue Response of Grouted Stay Cables</b>				5. Report Date July 2008

## **Bending Fatigue Response of Grouted Stay Cables**

CTR Research Report:	0-1401-1
Report Date:	July 2008
Research Project:	0-1401
Research Project Title:	Determination of Fatigue Damage in Stay Cables
Sponsoring Agency:	Texas Department of Transportation
Performing Agency:	Center for Transportation Research at The University of Texas at Austin

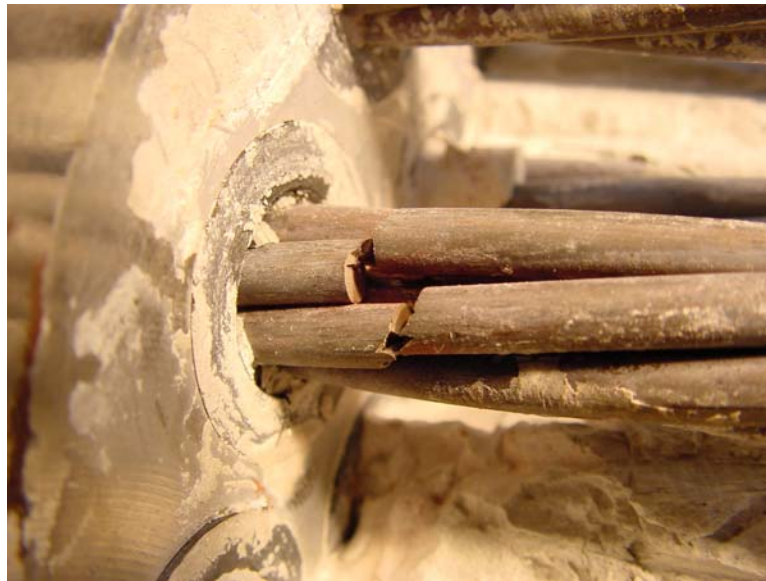
The wire fractures that occurred within the grout void at the tower end did not exhibit any signs of corrosion. Figure D.14 shows the wire fractures that occurred in strand 2 at the tower end.

**Figure D.14 Wire Breaks in Strand 2 near Tower End of Specimen 1**

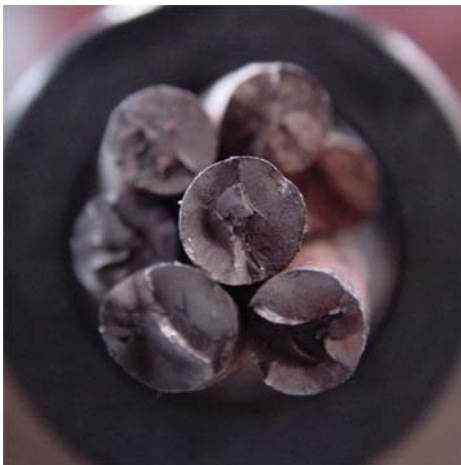
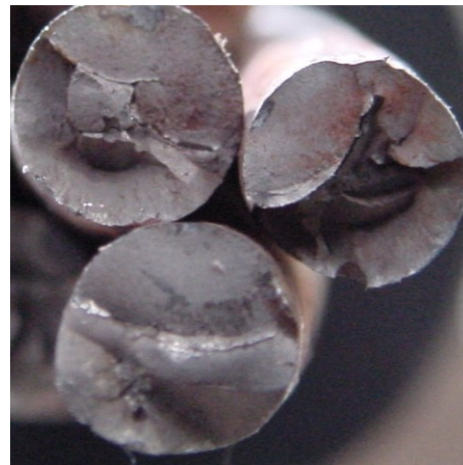
The area around the wire breaks on strand 19 at the tower end exhibited orange surface corrosion (Figure D.15) characteristic of corroded fretting product. The contact points, which served as initiation points for fretting fatigue, are clearly visible in Figure D.16. Orange surface corrosion was also observed along the contact points of strand 1 near midspan (Figure D.17).

**Figure D.16 Fracture Surfaces for Strand 19 at the Tower End of Specimen 1**

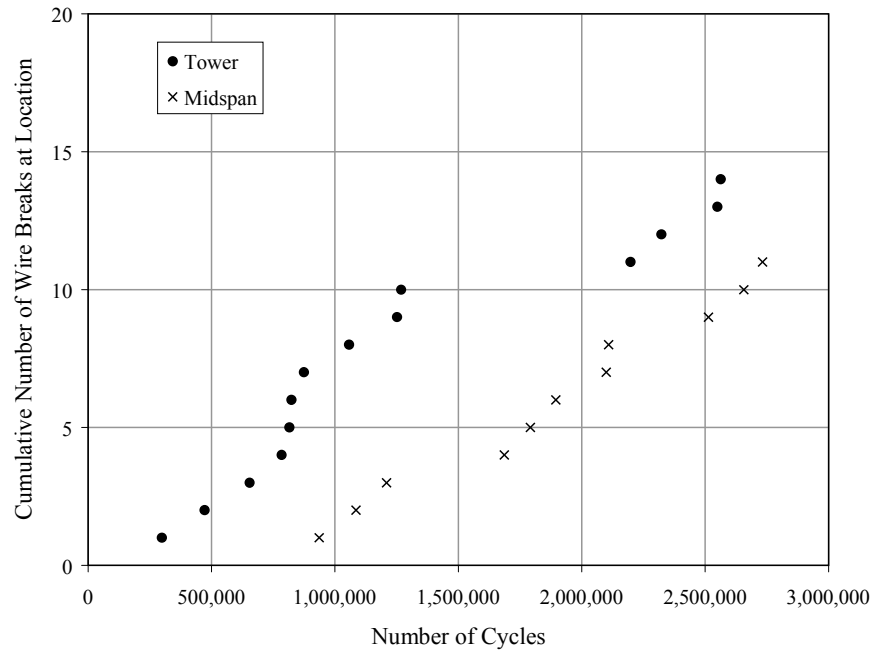
Four acoustic sensors were used to monitor the fatigue response of Specimen 1, and twenty-five wire breaks were detected (Table D.2). The number and distribution of wire breaks matched those observed during the autopsy of the test specimen. The first wire break was detected after 300,000 fatigue cycles (Figure D.18).

**Figure D.18 Wire Breaks Detected from Acoustic Data – Specimen 1**

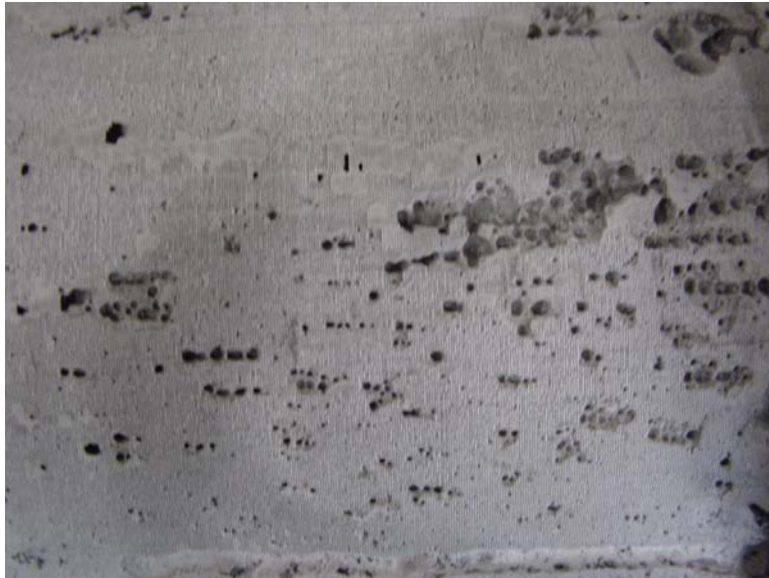
An anti-bleed admixture was mixed with the grout for Specimen 2. Closely spaced air voids (Figure D.20) were observed at the deck end when the PE pipe was removed, but a grout void was not present at the tower end. The research team noted that it was much easier to chip the grout immediately after removing the PE pipe than after the grout had been exposed to the environment for several days. However, no measurements were taken to verify this observation.

**Figure D.20 Air Voids in Grout near the Deck End – Specimen 2**

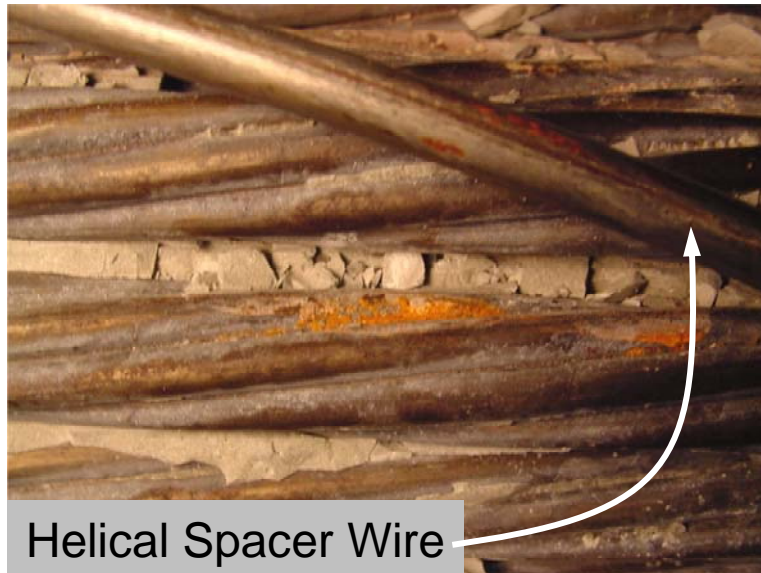
There were some localized signs of orange corrosion on some intact strands, as well as some fine corrosion spots on the helical spacer wire. Figure D.21 shows a typical example of this type of corrosion from midspan of the test specimen.

**Figure D.21 Localized Corrosion on Strand and Helical Spacer Wire – Specimen 2**

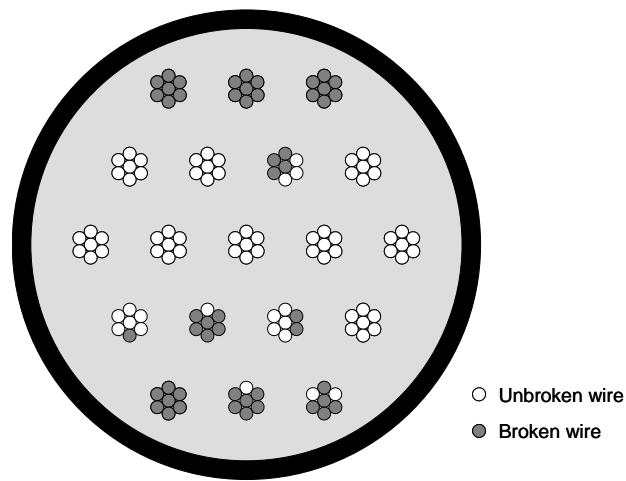
The fifty-two wire breaks near the tower end were distributed among ten different strands (Figure D.22), which were located near the top and bottom of the cross section. Figure D.23 shows the longitudinal location of the wire breaks. Most of the fractures occurred within the anchor head. All breaks occurred within 3.25 in. of the inside face of the anchor head. Representative examples of the breaks within the anchor head are shown in Figure D.24 for strand 1. The fracture surfaces, with the fatigue cracks and the points of initiation, can be clearly identified in this photograph.

**Figure D.22 Distribution of Wire Breaks near Tower End – Specimen 2**

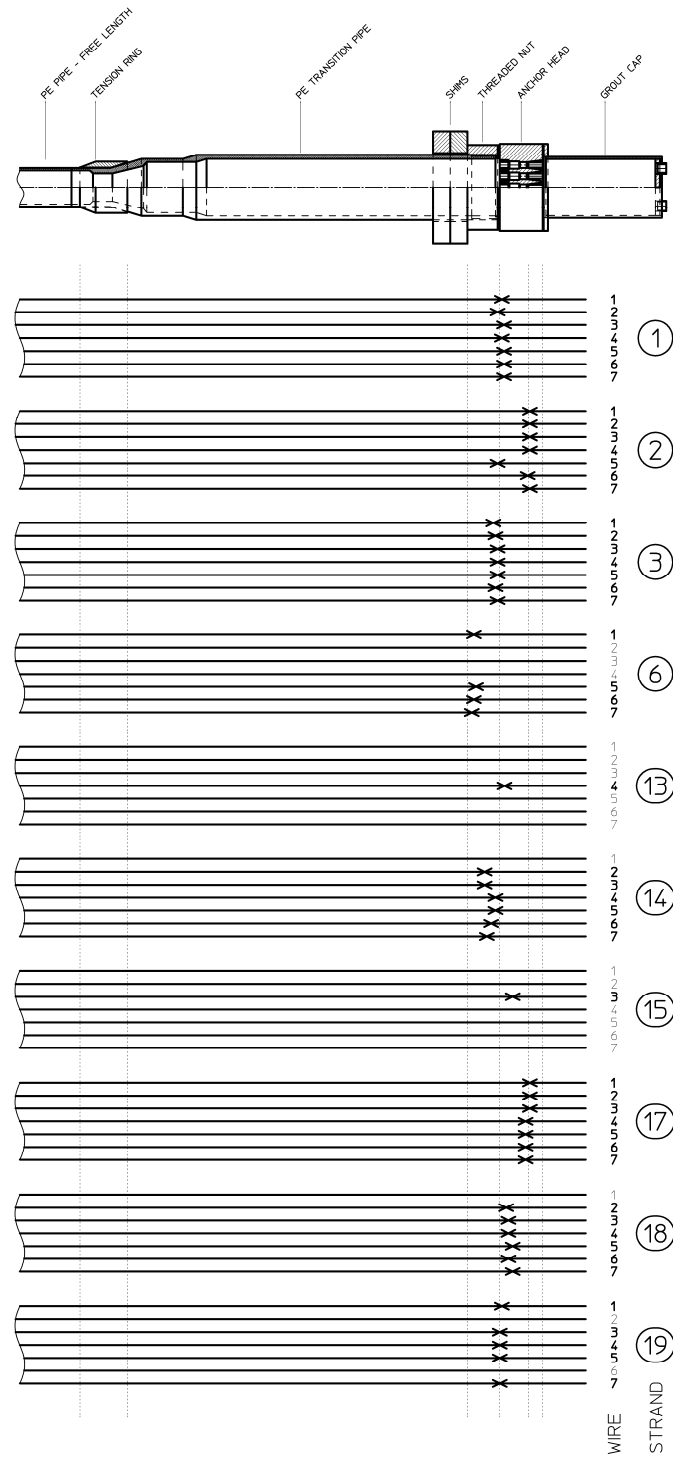
Figure D.23 Location of Wire Breaks near Tower End – Specimen 2

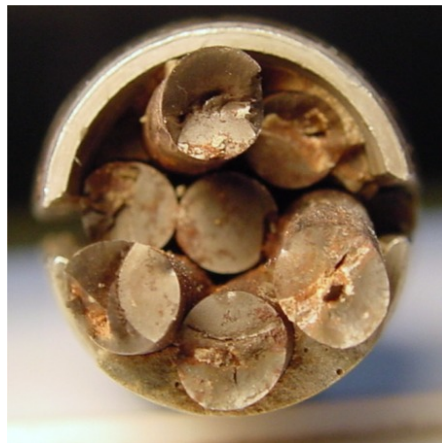
Photographs of strand 2 near the tower end (Figure D.25) provide examples of the breaks that occurred just beyond the wedges. These breaks were not initiated by the teeth marks on the wires caused by the wedges, but initiated just beyond the gripping area. Figure D.26 indicates that all the breaks initiated at contact points with the center wire and none of the fractures appears to have been initiated from the outside surface of the strand.

**Figure D.26 Fracture Surfaces for Strand 2 near Tower End – Specimen 2**

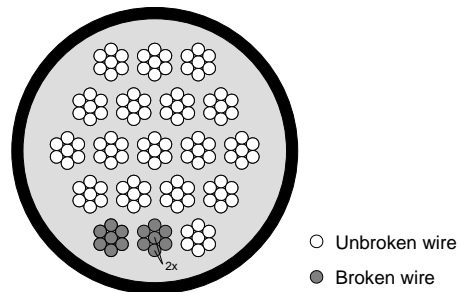
Near midspan, the sixteen wire breaks occurred in strands 17 and 18, which were both in the bottom layer of strands (Figure D.27). All breaks were located in a 10-in. window, with a bias towards the deck side. Interestingly, wires 4 and 7 of strand 18 experienced two fractures within the same strand (Figure D.28).

**Figure D.27 Distribution of Wire Breaks near Midspan – Specimen 2**

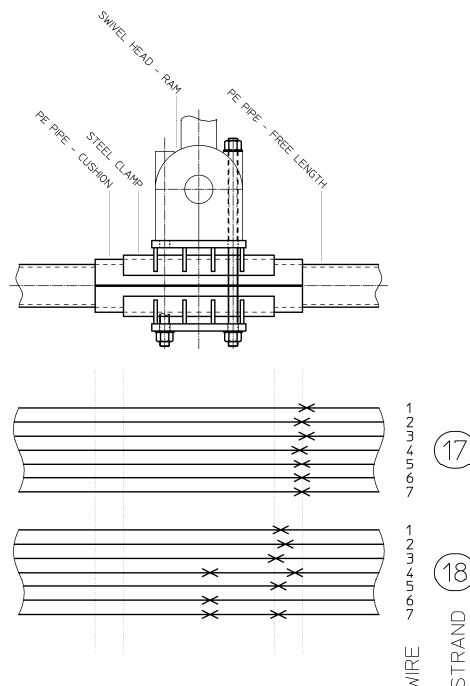
**Figure D.28 Location of Wire Breaks near Midspan – Specimen 2**

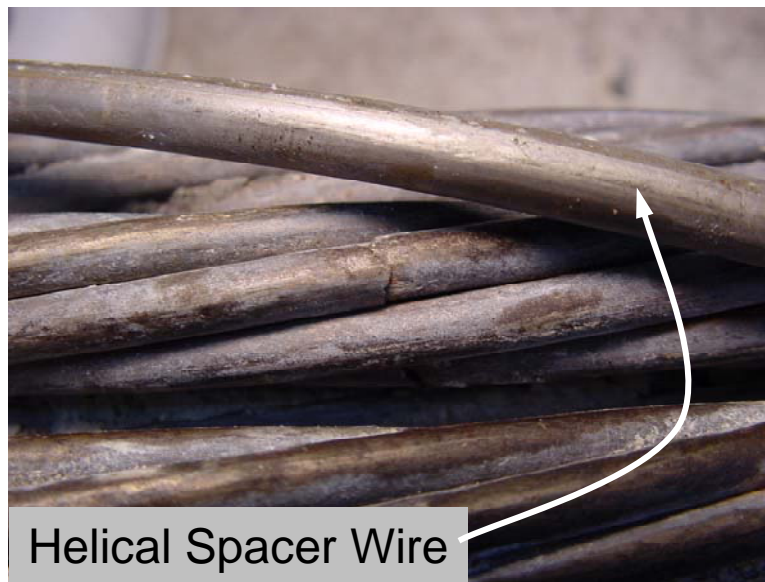
One of the fractures in strand 18 occurred near a possible contact point with the helical spacer wire as shown in Figure D.29. The fracture surface for that wire indicates; however, that the fracture was initiated at the contact point with the center wire, which was also fractured (Figure D.30). The fatigue crack is also significantly larger than on all other failure locations, which indicates that the tension in the strand was negligible at the time of fracture. Consequently, this fracture was the second fracture that occurred on this particular wire.

**Figure D.29 Wire Break Close to Helical Spacer near Midspan – Specimen 2**

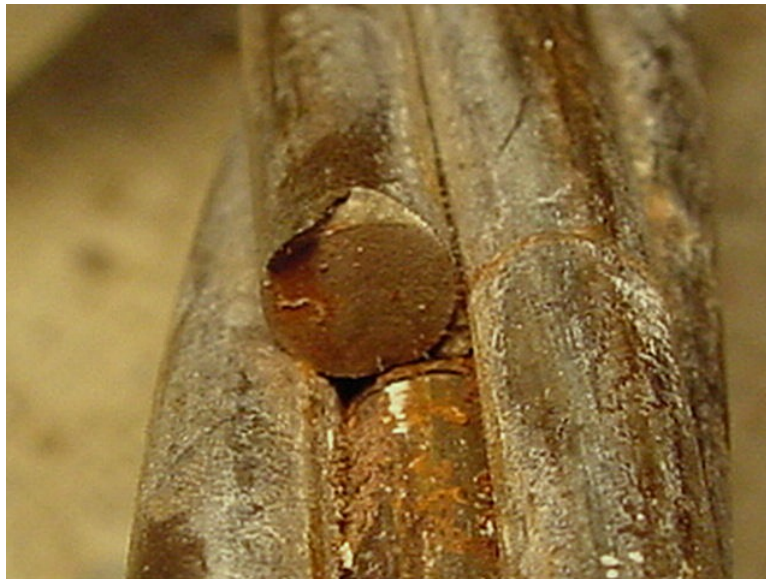
**Figure D.30 Detail of Fractured Wires shown in Figure D.29**

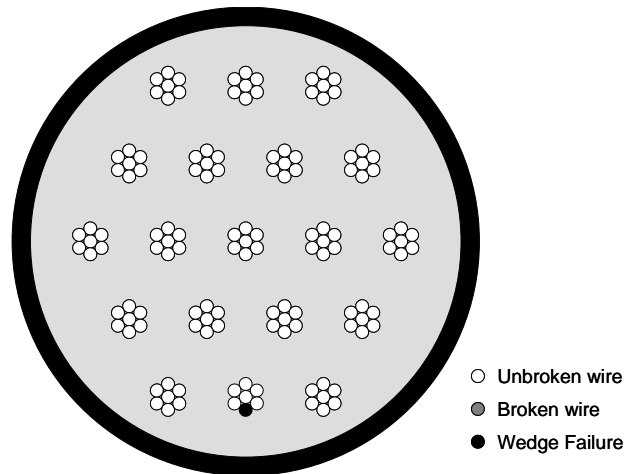
The break at the deck anchorage was found in strand 17 (Figure D.31). The break was initiated at the first tooth of the wedge (Figure D.32). Figure D.33 shows a fairly rounded tooth mark on the wire.

**Figure D.31 Distribution of Wire Breaks near Deck End – Specimen 2**

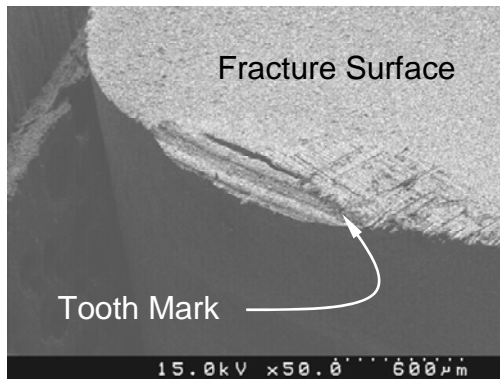
**Figure D.32 Fracture Initiation**

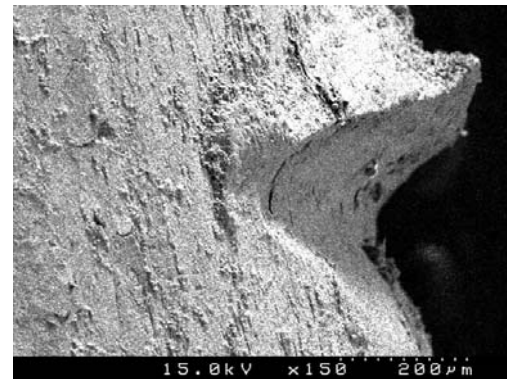
**Figure D.33 Typical Tooth Mark**

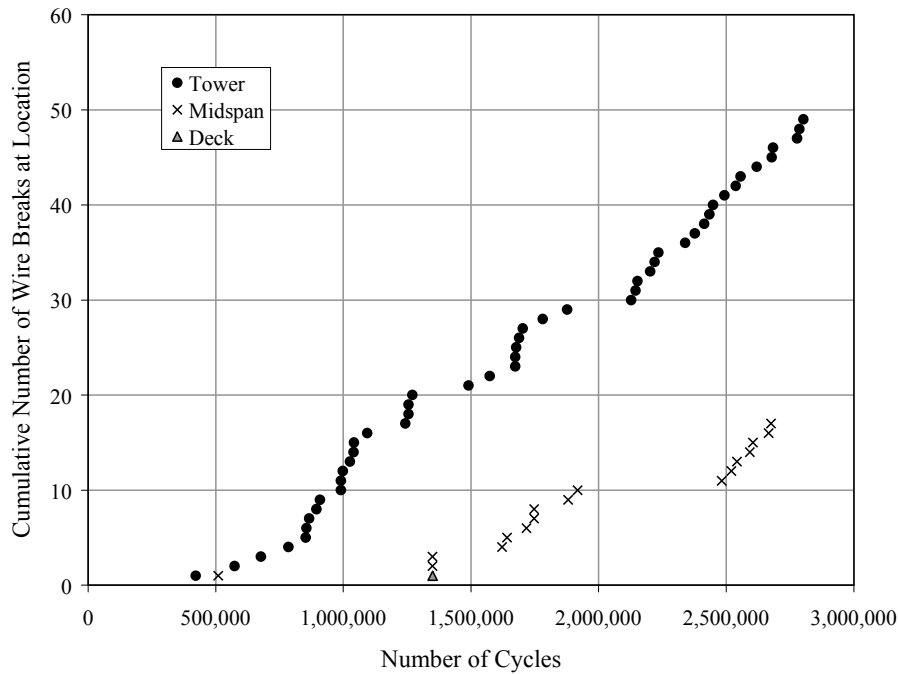
The acoustic sensors detected sixty-seven wire breaks during the fatigue test for Specimen 2 (Table D.2). Slight variations in the number and distribution of wire breaks existed between those detected by the acoustic sensors and those observed during the autopsy of the test specimen. The number of wire breaks reported at the tower end was three fewer than observed and the number of breaks reported at midspan was one more than observed. The first wire break was detected after 420,000 fatigue cycles (Figure D.34).

**Figure D.34 Wire Breaks Detected from Acoustic Data – Specimen 2**

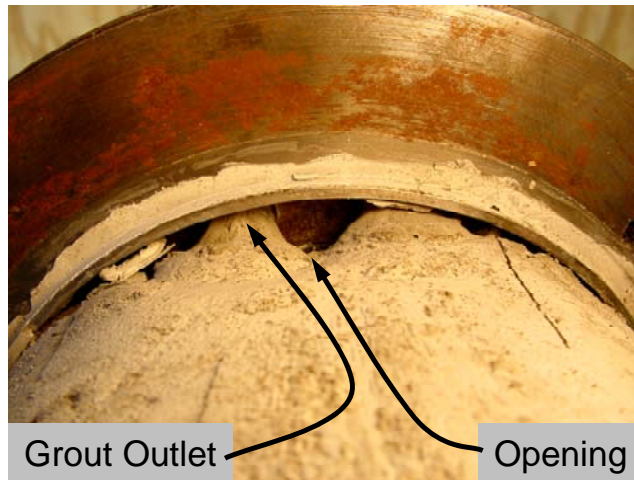
Small grout voids, which partially exposed an opening in the anchor head, were observed at the tower end of Specimen 3 (Figure D.36). Closely spaced air voids were observed at both ends of the specimen (Figure D.37).

**Figure D.36 Air Voids at Tower End of Specimen 3**

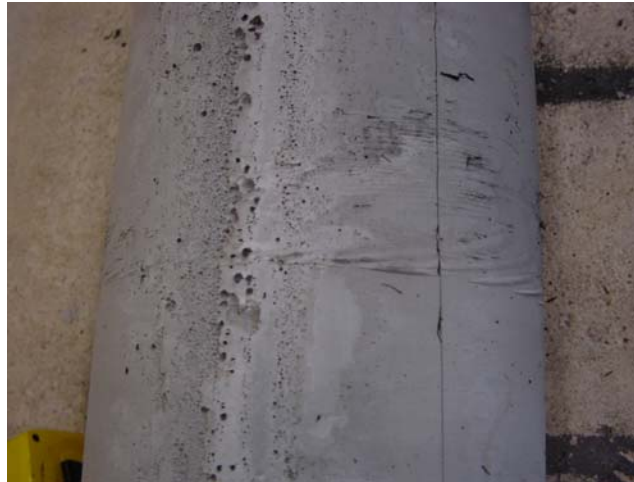
**Figure D.37 Distributed Air Voids at Tower End of Specimen 3**

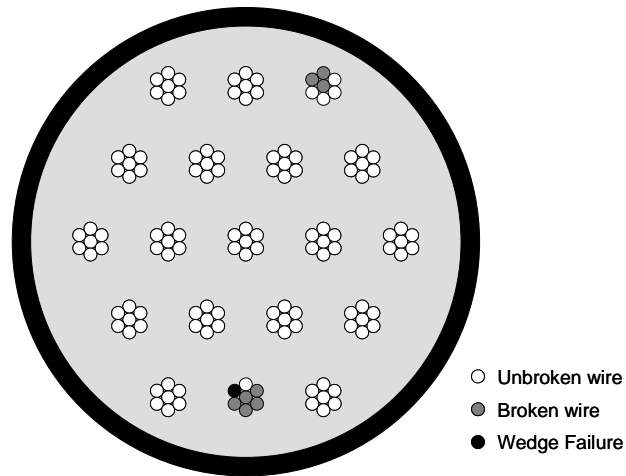
All the fractures near the tower end occurred within the anchor head and were concentrated in two strands (Figure D.38). No breaks occurred at the contact points of the intentionally crossed strands. Figure D.39 shows the longitudinal location of the wire breaks. One of the wire breaks in strand 18 initiated at the first tooth mark from the wedge. All other wire breaks initiated at the contact points between adjacent strands.

**Figure D.38 Distribution of Wire Breaks near Tower End – Specimen 3**

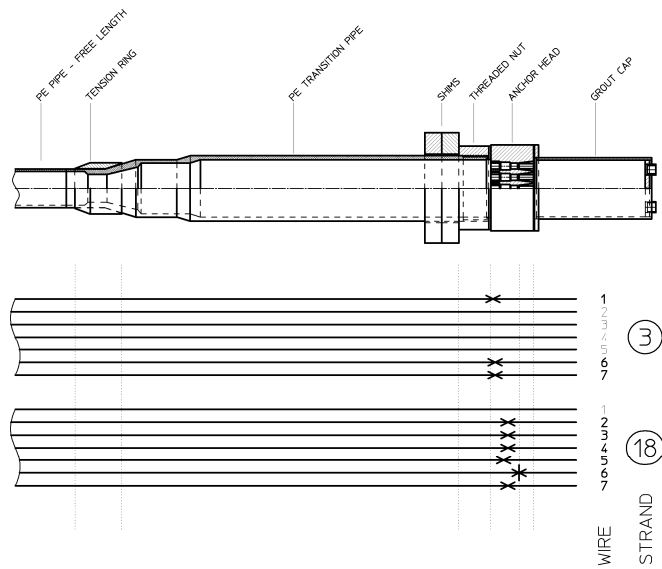
**Figure D.39 Location of Wire Breaks near Tower End – Specimen 3**

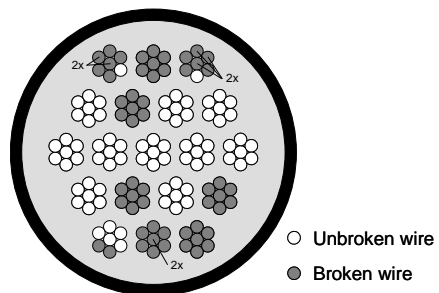
Near midspan, the sixty-two wire breaks occurred in nine different strands (Figure D.40). Six wires fractured at two locations. The distances between the multiple wire breaks varied from 5 in. in strand 1 to 16 in. in strand 18. All breaks were located in a 20-in. window under the loading point, with a slight tendency towards the tower end (Figure D.41).

**Figure D.40 Distribution of Wire Breaks near Midspan – Specimen 3**

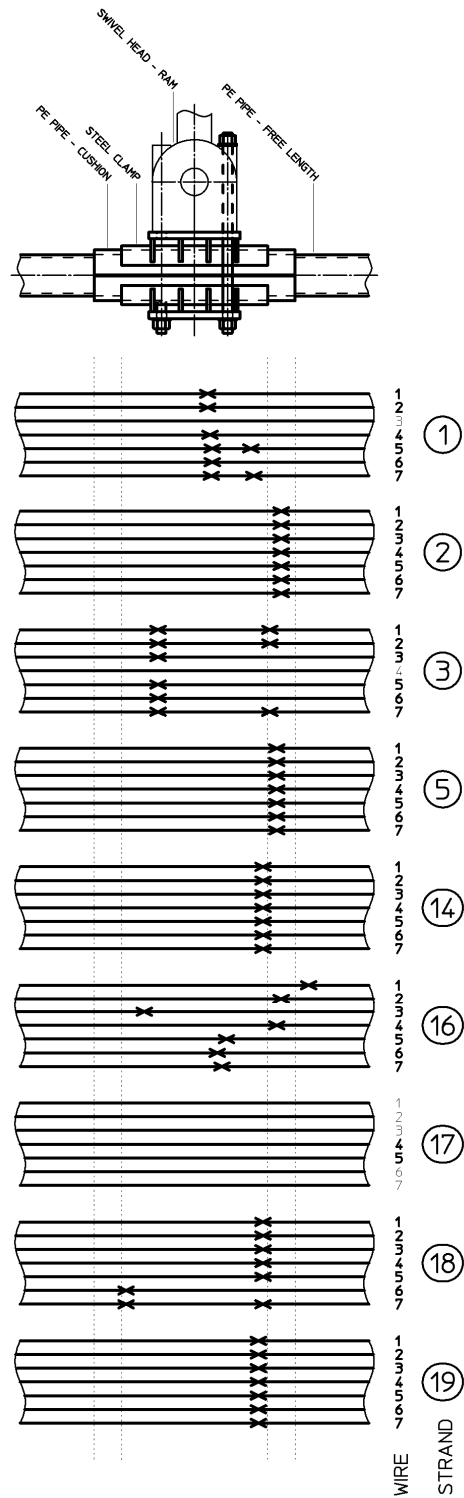
Figure D.41 Location of Wire Breaks near Midspan – Specimen 3

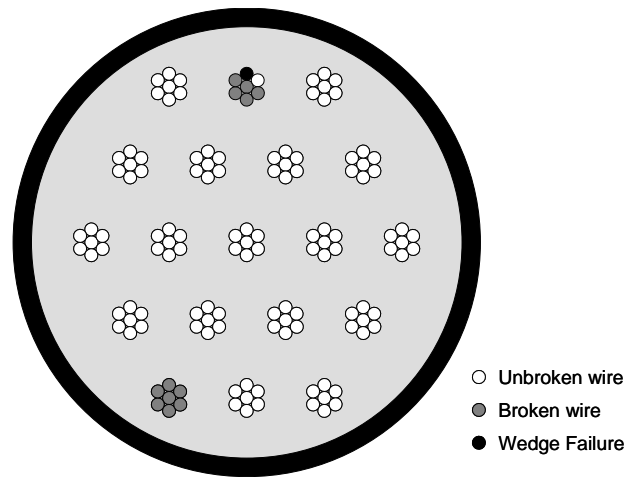
Near the deck end of the specimen, the fractures occurred in strands 2 and 17 (Figure D.42). Figure D.43 shows the longitudinal location of the wire breaks. The breaks in strand 17 occurred within 2 in. of the inside face of the anchor head. Five of the six breaks in strand 2 occurred within the anchor head, and one of the breaks occurred at the first tooth mark from the wedge. No wire breaks occurred at the contact points of the intentionally crossed strands.

**Figure D.42 Distribution of Wire Breaks near Deck End – Specimen 3**

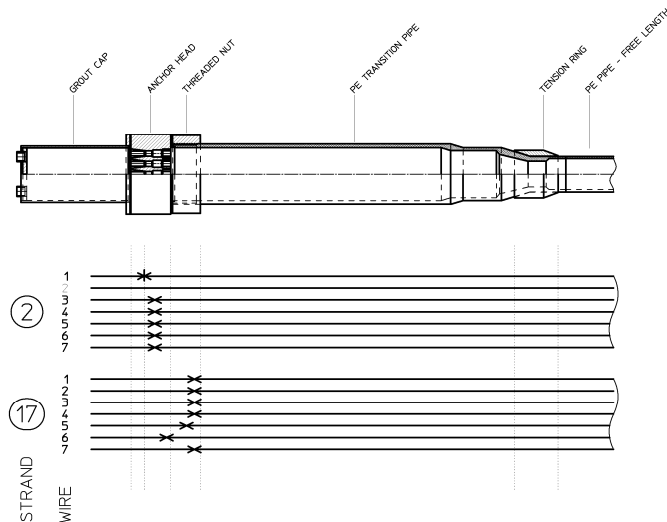
**Figure D.43 Location of Wire Breaks near Deck End – Specimen 3**

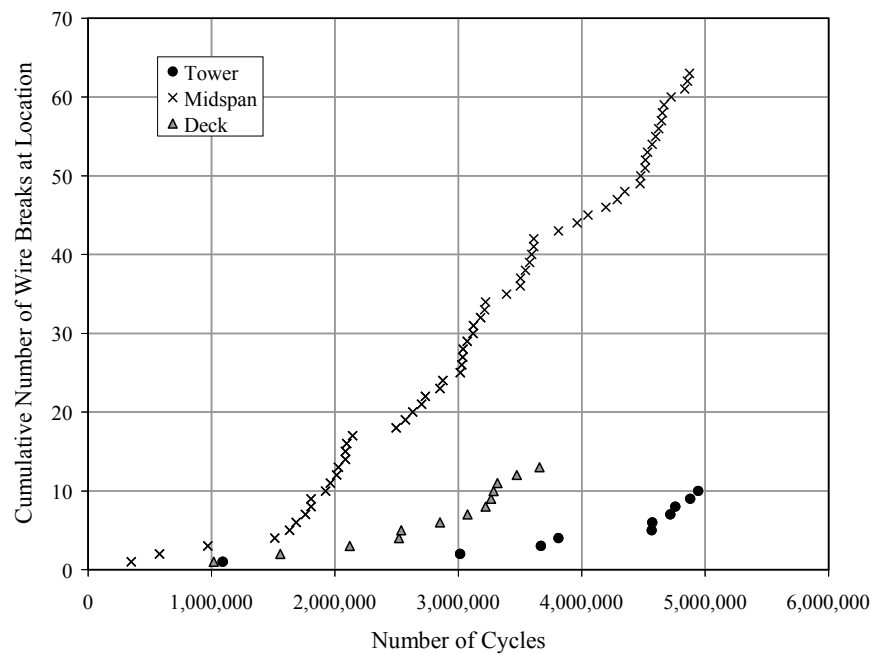
The acoustic sensors detected eighty-six wire breaks during the fatigue test for Specimen 3 (Table D.4). Slight variations in the number of wire breaks existed between those detected by the acoustic sensors and those observed during the autopsy of the test specimen. The acoustic sensors detected one more wire break at the tower end and at midspan than was observed. The first wire break was detected after 350,000 fatigue cycles (Figure D.44).

**Figure D.44 Wire Breaks Detected from Acoustic Data – Specimen 3**

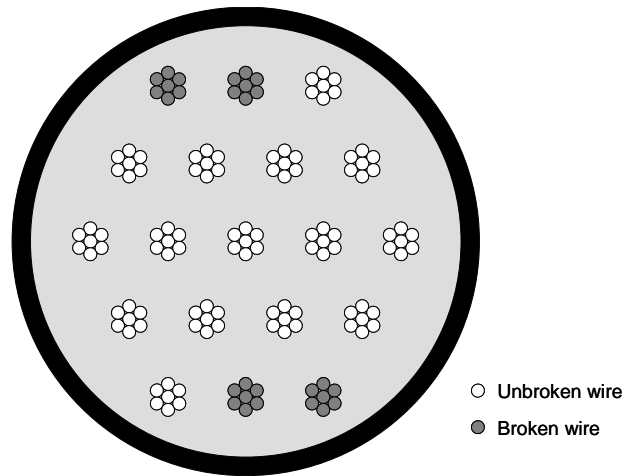
Thirty-one wire breaks were identified during the autopsy of Specimen 4. Twenty-eight wire breaks occurred near the tower anchorage and three occurred near the deck anchorage. Near the tower end, all seven wires fractured in each of four strands (Figure D.45). All breaks occurred within  $\pm 0.5$  in. of the inside face of the anchor head (Figure D.46). The three fractures near the deck end occurred in strand 18 (Figure D.47). All breaks occurred within  $\pm 0.5$  in. of the inside face of the anchor head (Figure D.48).

**Figure D.45 Distribution of Wire Breaks near Tower End – Specimen 4**

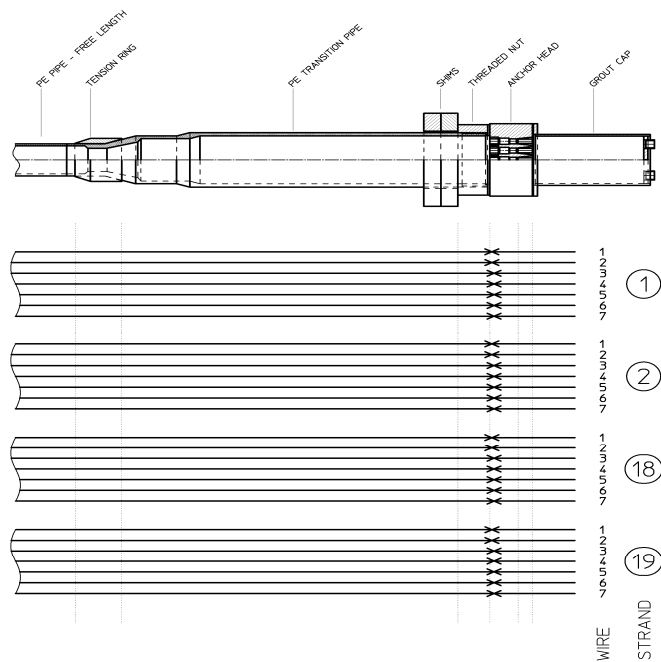
**Figure D.46 Location of Wire Breaks near Tower End – Specimen 4**

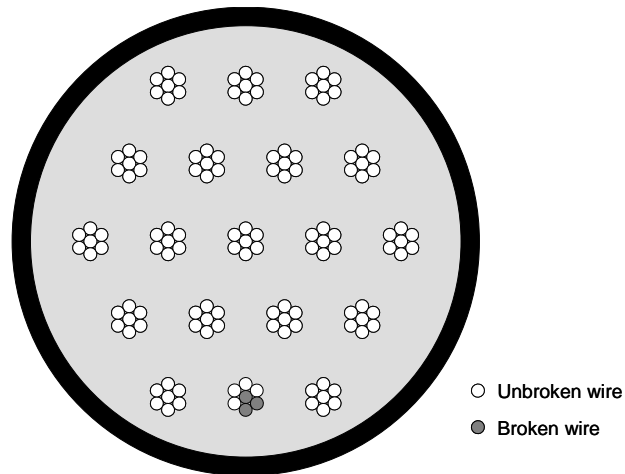
**Figure D.47 Distribution of Wire Breaks near Deck End – Specimen 4**

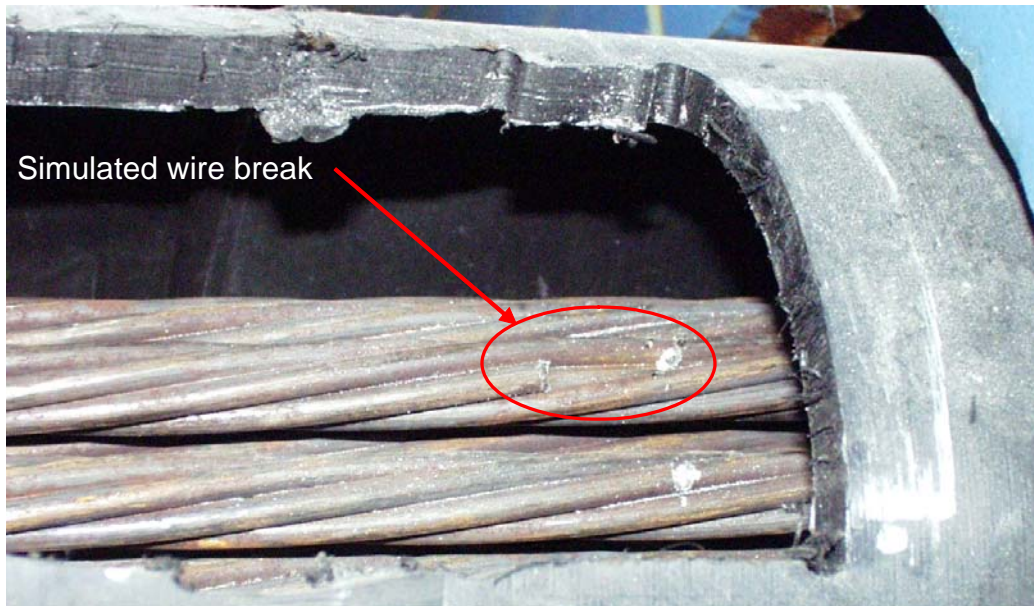
**Figure D.52 Simulated Wire Break in Specimen 5**

Specimen 5 did not experience any wire breaks during the fatigue tests. To ensure accurate calibration of the Soundprint® monitoring system, the research team intentionally generated two wire breaks (Figure D.52). A Dremel tool was used to cut the wires, and then the cable was displaced until the damaged wire broke. The acoustic monitoring system accurately captured the simulated wire breaks.

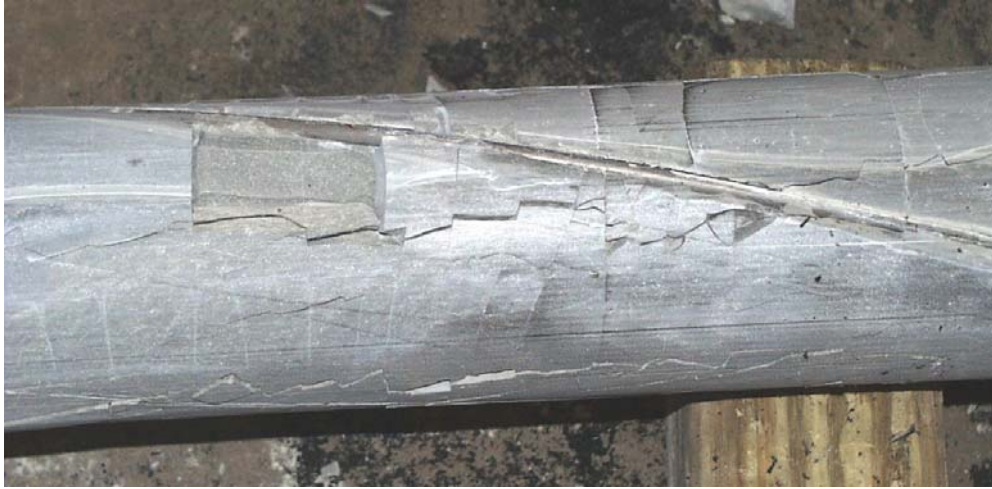
**Figure D.59 Grout near Midspan of Specimen 6**

The grout near midspan exhibited severe longitudinal cracks characteristic of wire breaks (Figure D.59). Thin, parallel circumferential cracks were also observed. As with the other portions of the stay, the cracking in the center portion of the specimen became more severe after exposure to the air.

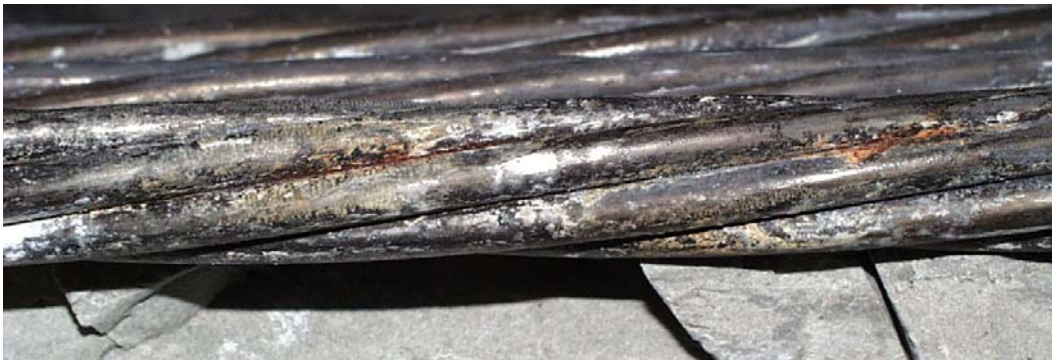
**Figure D.61 Corrosion on Strand 19 near Tower Anchor Head – Specimen 6**

In the case of Specimen 6, the evidence of fretting near the wire breaks at the tower anchor head was more severe than the evidence of fretting found elsewhere. In some places, corrosion was evident on the exterior of the strand and was accompanied by a white substance that coated the strand, shown in Figure D.61. In this region, corrosion was also seen on the grout surface at the interface between the grout and the strand (Figure D.62).

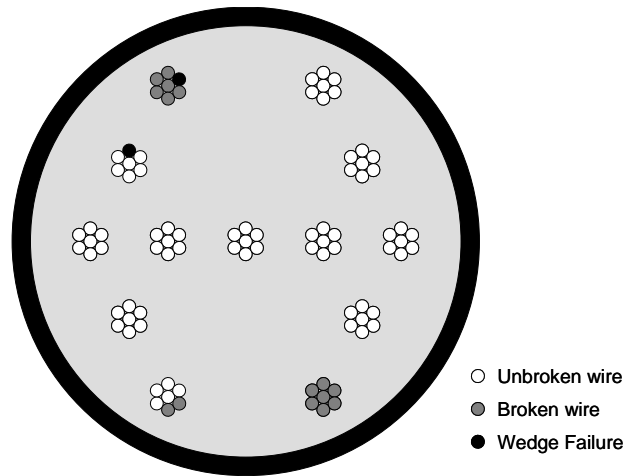
**Figure D.63 Distribution of Wire Breaks near Tower End – Specimen 6**

Twenty-eight wire breaks were identified during the autopsy of Specimen 6. Seventeen wire breaks occurred near the tower anchorage and eleven occurred near the loading point. The seventeen wire breaks near the tower end were distributed among four strands (Figure D.63). Figure D.64 shows the longitudinal location of wire breaks near the tower anchorage. Nearly all breaks at the tower end of the specimen occurred within 2 in. of the inside face of the anchor head in the region confined by the smooth end sleeve. Examples of wire breaks occurring in this region are shown in Figure D.65 and Figure D.66.

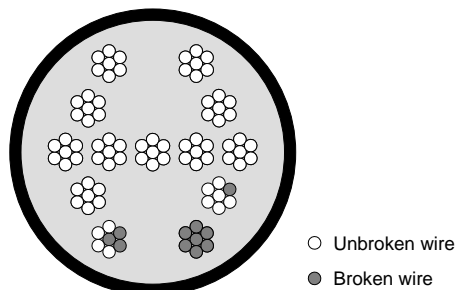
**Figure D.67 Distribution of Wire Breaks near Midspan – Specimen 6**

At midspan, the eleven wire breaks occurred in three strands (Figure D.67). The longitudinal distribution of the breaks is shown in Figure D.68. All breaks occurred beyond the tapered polyethylene cushioning pipe.

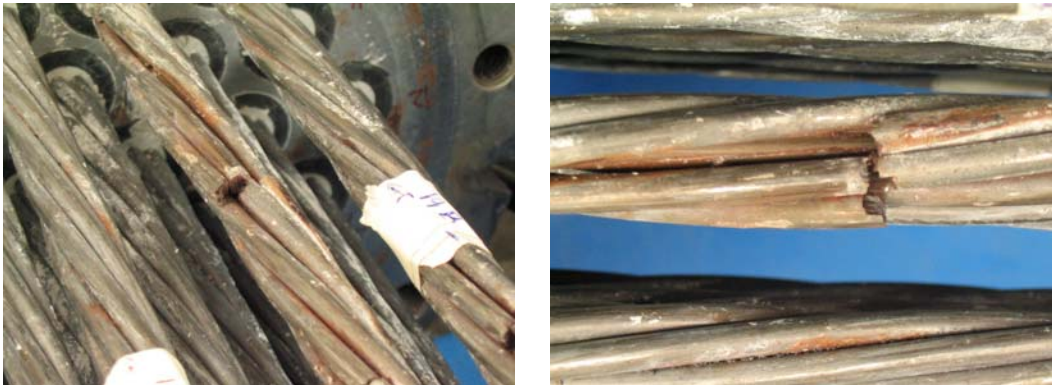
**Figure D.76 Corrosion Observed near Tower Anchorage on Strand 18 – Specimen 7**

Most of the corrosion and corroded fretting product observed after removing the PE pipe was in the vicinity of the wire breaks. Figure D.76 shows a typical example of the corroded fretting product found in these areas.

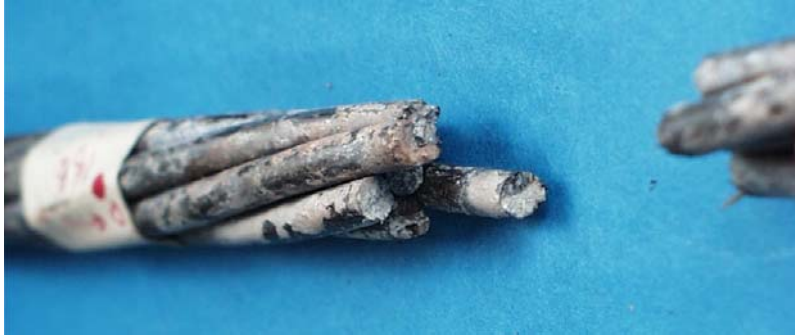
**Figure D.77 White Substance on Surface of Strand 17 at Midspan – Specimen 7**

In the center of the stay, a white substance was found near most wire breaks (Figure D.78). In addition to the white substance, red-orange corroded fretting product was typically observed between the wires in the strands in which wire breaks occurred. The corroded fretting product was often not visible on the surface of the strand.

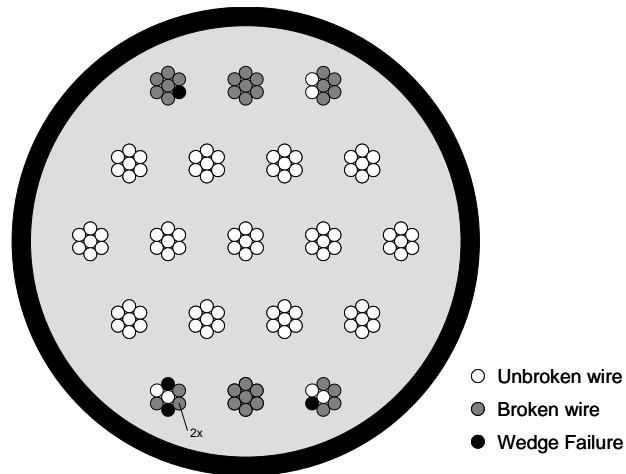
**Figure D.79 Distribution of Wire Breaks near Tower End – Specimen 7**

The thirty-seven wire breaks near the tower end were distributed among six strands (Figure D.79). Figure D.80 shows the longitudinal location of wire breaks near the tower anchorage. A majority of the breaks occurred within 9 in. of the inside face of the anchor head. Wire breaks in Specimen 7 occurred as far as 16 in. from the face of the anchor head.

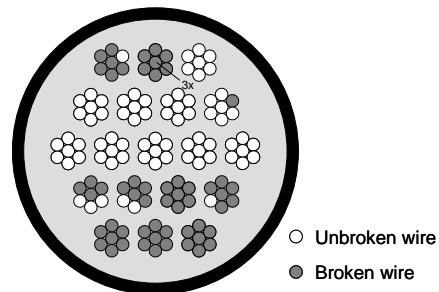
**Figure D.82 Distribution of Wire Breaks near Midspan – Specimen 7**

Figure D.82 shows the distribution of the wire breaks among ten strands at midspan. The longitudinal distribution of the breaks at midspan is shown in Figure D.83 and Figure D.84. The breaks tend to be centered near the edge of the load plate where the clamp is bolted to the cable. The center wire in strand 2 fractured in three places.

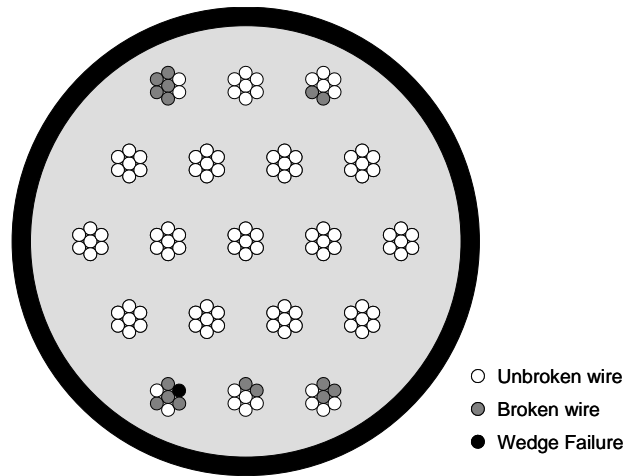
**Figure D.85 Distribution of Wire Breaks near Deck End – Specimen 7**

The seventeen wire breaks near the deck end were distributed among five strands (Figure D.85). Figure D.86 shows the longitudinal location of wire breaks near the deck anchorage. Most of the wire breaks occurred within 4 in. of the inside face of the anchor head or inside the anchor head. One wire in strand 18 broke approximately 14 in. from the inside face of the anchor head.

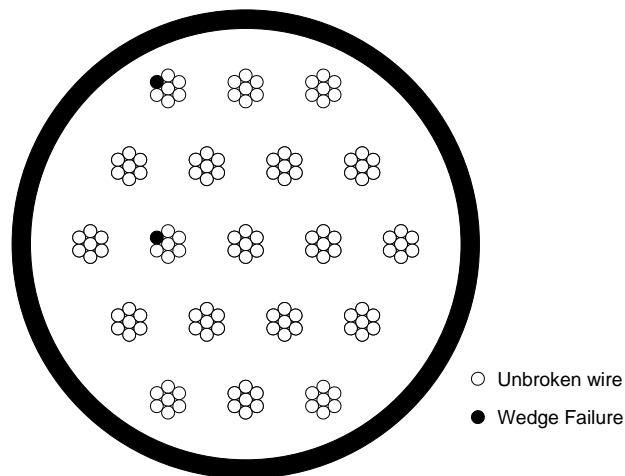
**Figure D.94 Distribution of Wire Breaks near Tower End – Specimen 8**

Four wire breaks were identified during the autopsy of Specimen 8. Two wire breaks occurred near the tower anchorage and two occurred near the deck anchorage. The two wire breaks near the tower end occurred in two strands (Figure D.94). Both wire breaks occurred at the contact point between the strand and the wedge (Figure D.95 and Figure D.96). Scraping was evident on the strand which is caused by the teeth as the strand is pulled through the wedge during stressing (Figure D.97).

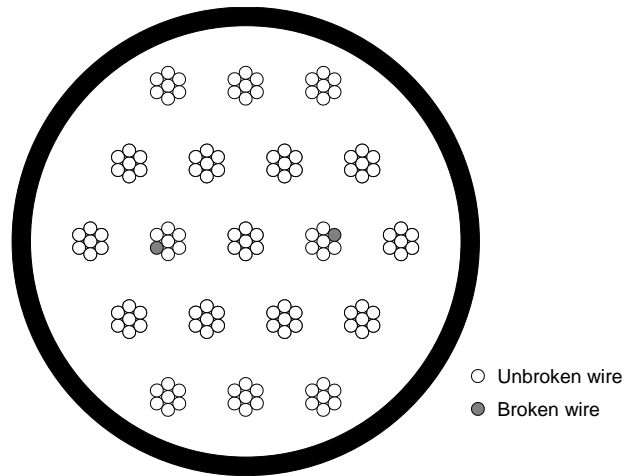
**Figure D.98 Distribution of Wire Breaks near Deck End – Specimen 8**

At the deck end, the two wire breaks were distributed in two strands (Figure D.98). Both breaks occurred in the center layer of strands. Figure D.99 shows the longitudinal location of each wire break near the deck anchorage and photographs are shown in Figure D.100 and Figure D.101. The fracture in strand 9 initiated within the wedge, but was caused by fretting against an adjacent wire.

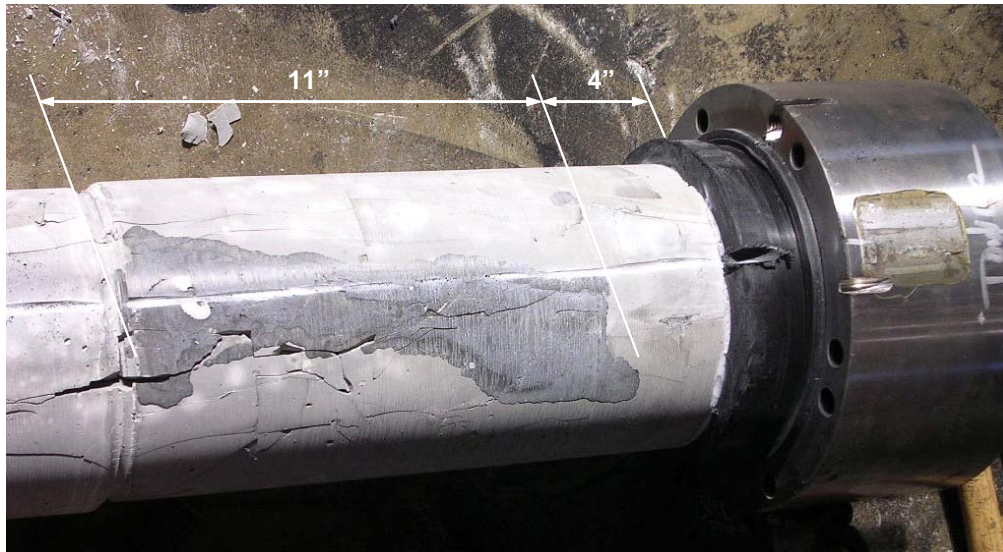
**Figure D.105 Intentional Grout Lens at Tower End – Specimen 9**

An intentional grout void was created at the tower end during the initial grouting of Specimen 9. This void was filled with SikaGrout 300 PT one week later to investigate the effects of filling a grout void, which had been identified by TxDOT personnel on the Fred Hartman Bridge. The SikaGrout, identified by its darker color, formed a lens on the surface of the original grout approximately 11 in. long starting 4 in. from the anchor head (Figure D.105) and ending at the ring formed by the weld in the polyethylene transition pipe. This lens ranged from 1/16 in. thick near the anchor head to 1/32 in. thick at the far end of the lens.

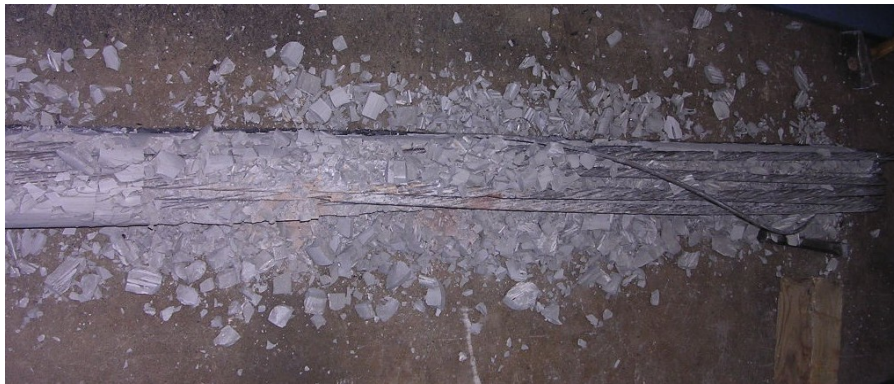
**Figure D.107 Condition of Grout under Load Point – Specimen 9**

The grout at the deck end of the stay was homogeneous and relatively uncracked, consistent with finding no wire breaks outside the anchor head. The grout in the center section, under the load point, was heavily damaged (Figure D.107).

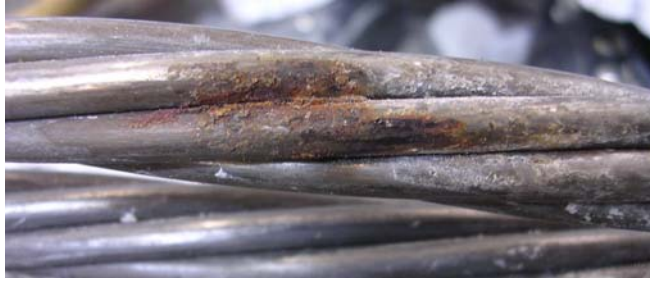
**Figure D.108 Corrosion on Surface of Strand near Tower End – Specimen 9**

Near the anchorages, corrosion was generally mild and found only near wire breaks. Several spots of heavy corrosion that were unaccompanied by wire breaks were found near the tower anchorage as seen in Figure D.108. These areas were all located under the intentional grout void.

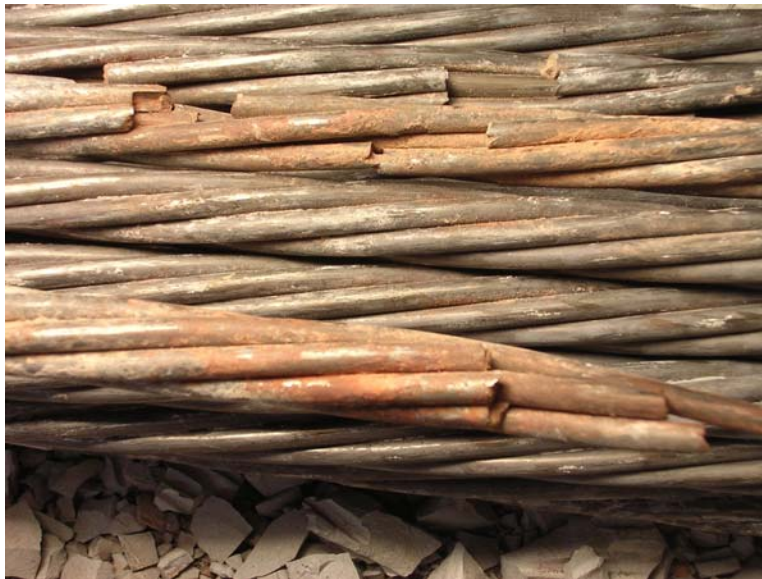
**Figure D.109 Corrosion on Surface of Strand near Midspan – Specimen 9**

Extensive corrosion was observed in the region near the center of the stay. Heavy, red-orange corroded fretting product near wire breaks (Figure D.109) was accompanied by black and red pitting corrosion in several places. Several breaks appeared to initiate at these points of pitting corrosion. White powder and grout coated many of the strands and obscured some fracture surfaces in this region. The amount of fretting residue tended to be more severe when all (or nearly all) the wires of a strand had fractured, which may indicate that such corrosion forms after wire breaks occur.

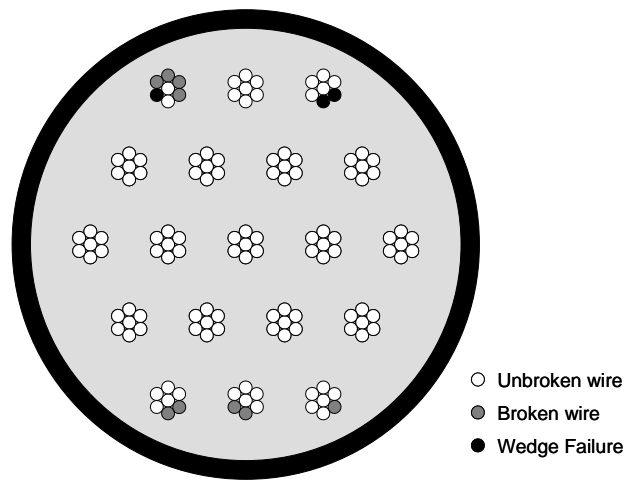
**Figure D.110 Distribution of Wire Breaks near Tower End – Specimen 9**

The twelve wire breaks near the tower end were distributed among five strands, which were distributed along the extreme fibers of the cross section (Figure D.110). Figure D.111 shows the location of each wire break near the tower anchorage. Three wires broke inside the anchor head at the contact point between the wedge and the strand. Two wire breaks in strand 1 occurred 15 in. from the anchor head at the location of a weld in the polyethylene transition pipe.

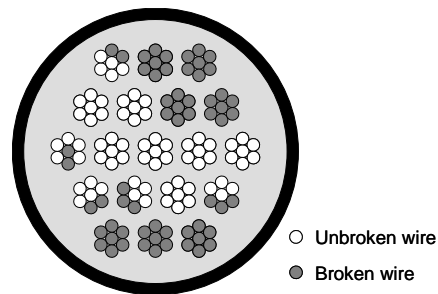
**Figure D.112 Distribution of Wire Breaks near Midspan – Specimen 9**

Figure D.112 shows the distribution of wire breaks at midspan. The sixty-one breaks occurred in twelve strands. Specimen 9 was the only stay to experience wire breaks within the middle layer of strands under the load point. Figure D.113 and Figure D.114 show the location of each wire break relative to the load point.

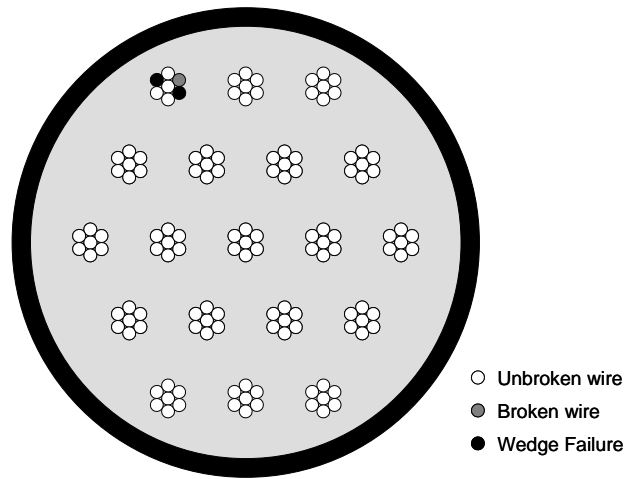
**Figure D.115 Distribution of Wire Breaks near Deck End – Specimen 9**

The three wire breaks at the deck end were concentrated in a single strand (Figure D.115). As shown in Figure D.116, all three breaks occurred within the anchor head. Two breaks were initiated by the first wedge tooth and one break occurred at the front of the polyethylene bushing at the face of the anchor head.

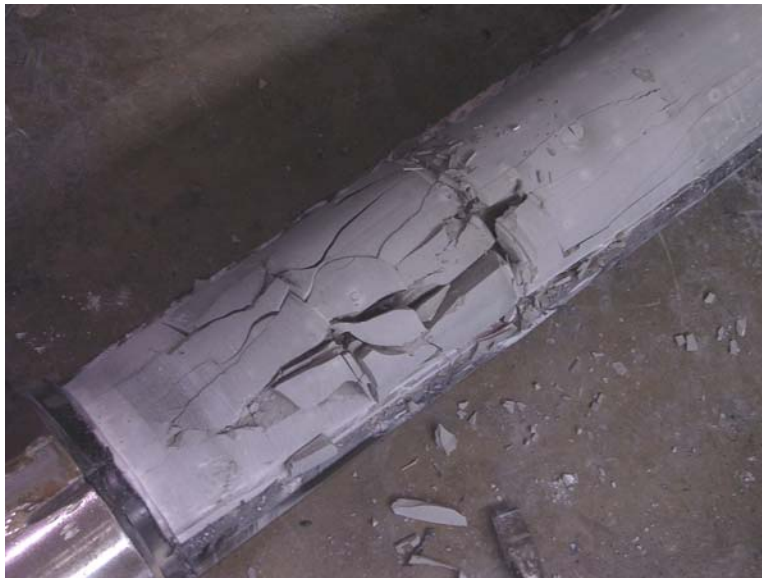
**Figure D.120 Condition of Grout at Tower End Immediately after Removing PE Pipe – Specimen 10**

Figure D.120 shows the condition of the grout at the tower end immediately after removing the PE transition pipe. Severe longitudinal cracks were observed, which indicate wire breaks in the region. Apart from the cracking, no other visual imperfections in the grout were observed. Figure D.121 shows the condition of the grout under the load point. The grout in this region was also severely cracked. Figure D.122 shows the condition of the grout at the deck end. Large longitudinal cracks were observed, despite the fact that no wire breaks were found outside of the anchor head. This level of cracking was not expected, and may be due to the large-amplitude cycles at the beginning of the fatigue test.
