1. Report No. FHWA/TX-08/1401-1		2. Government Accession No.		3. Recipient's Catalog No.	
4. Title and Subtitle <b>Bending Fatigue Response of Grouted Stay Cables</b>				5. Report Date July 2008

## **Bending Fatigue Response of Grouted Stay Cables**

CTR Research Report:	0-1401-1
Report Date:	July 2008
Research Project:	0-1401
Research Project Title:	Determination of Fatigue Damage in Stay Cables
Sponsoring Agency:	Texas Department of Transportation
Performing Agency:	Center for Transportation Research at The University of Texas at Austin

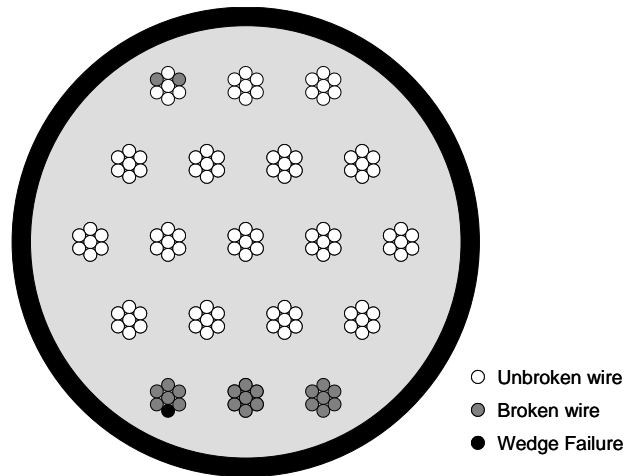
**Figure D.125 Distribution of Wire Breaks near Tower End – Specimen 10**

The twenty-three wire breaks near the tower end were distributed among four strands (Figure D.125). Most of the breaks at the tower end occurred on the bottom layer of strands. In addition to the twenty-three wire breaks, a fatigue crack was found  $3\frac{3}{4}$  in. from the inside face of the anchor head on wire 4 of strand 18. The wire was not fractured at this point because the wire had fractured  $4\frac{3}{4}$  in. away and there was not enough tension in the wire to cause the second crack to fracture before the fatigue test was stopped. Figure D.126 shows the longitudinal location of each wire break relative to the tower anchorage.

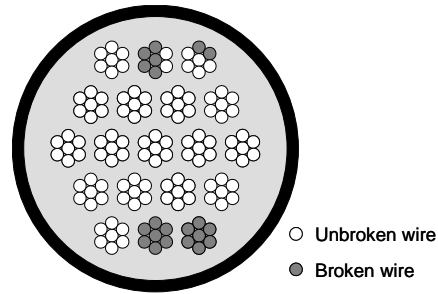
**Figure D.127 Distribution of Wire Breaks near Midspan – Specimen 10**

Figure D.127 shows the distribution of wire breaks near midspan. The twenty-one breaks occurred in four strands. Figure D.128 shows the location of each wire break relative to the load point. The breaks all occurred within the clamp region, and tended to occur between the edge of the load plate and the end of the steel clamp.

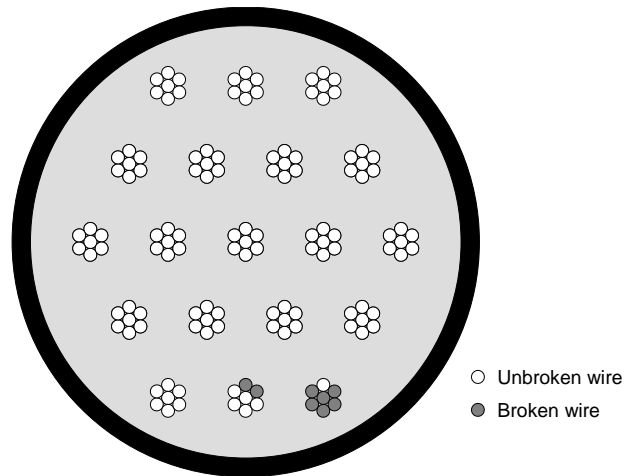
**Figure D.129 Distribution of Wire Breaks near Deck End – Specimen 10**

The eight wire breaks at the deck end were distributed in two strands (Figure D.129). All wire breaks occurred within the anchor head, but no wires fractured at the wedges (Figure D.130).

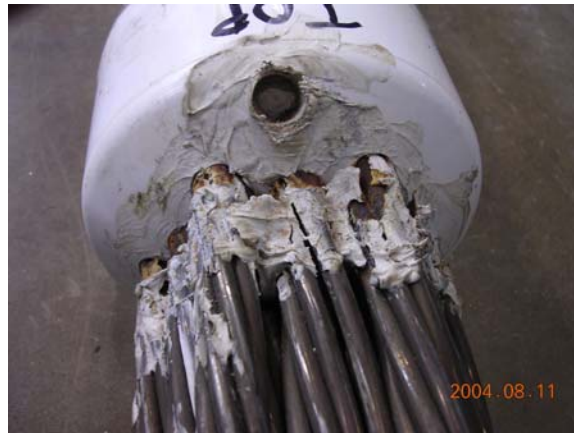
**Figure D.137 Corrosion at Interface between Grout and Caulk near Midspan – Specimen 11**

Like the grouted specimens, corrosion of the reinforcement was observed at the interface of the grout and the caulk (Figure D.137). Modest amounts of corroded fretting product were also observed near midspan (Figure D.138), but were not present near the deck end.

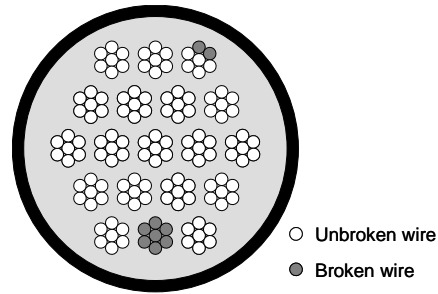
Sixteen wire breaks were identified during the autopsy of Specimen 11. Nine occurred near the loading point, and seven occurred near the deck anchorage. The nine wire breaks at midspan occurred in two strands (Figure D.139). Failure of all wires in strand 18 at midspan led to the termination of the fatigue test (Figure D.140).

**Figure D.139 Distribution of Wire Breaks near Midspan – Specimen 11**

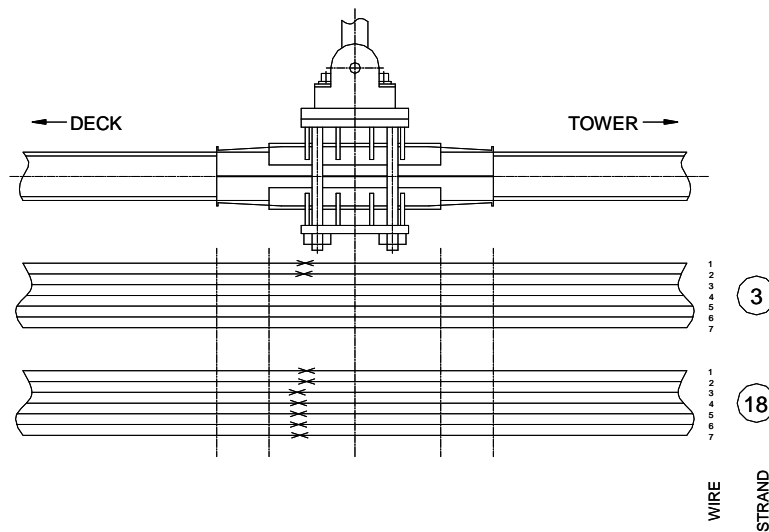
**Figure D.140 Location of Wire Breaks near Midspan – Specimen 11**

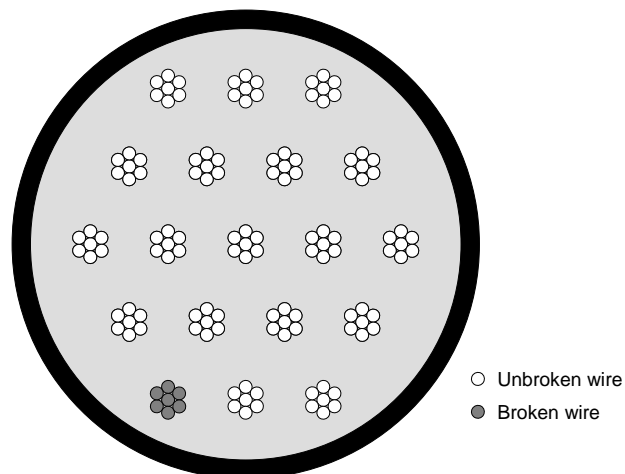
The seven wire breaks near the deck end were concentrated in strand 17 (Figure D.141). All wires fractured near the inside end of the smooth end sleeve (Figure D.142).

**Figure D.141 Distribution of Wire Breaks near Deck End – Specimen 11**

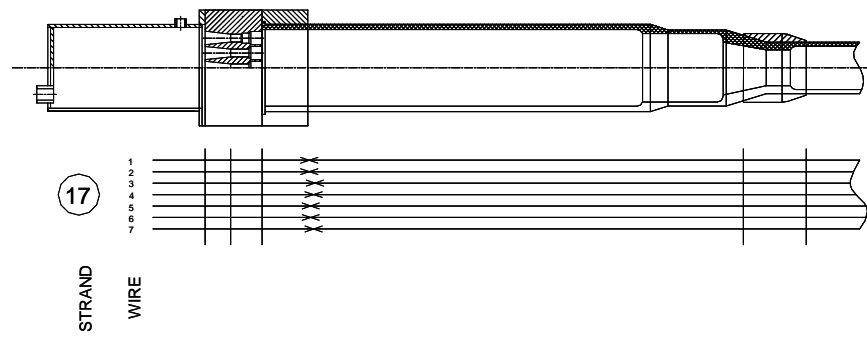
**Figure D.142 Location of Wire Breaks near Deck End – Specimen 11**

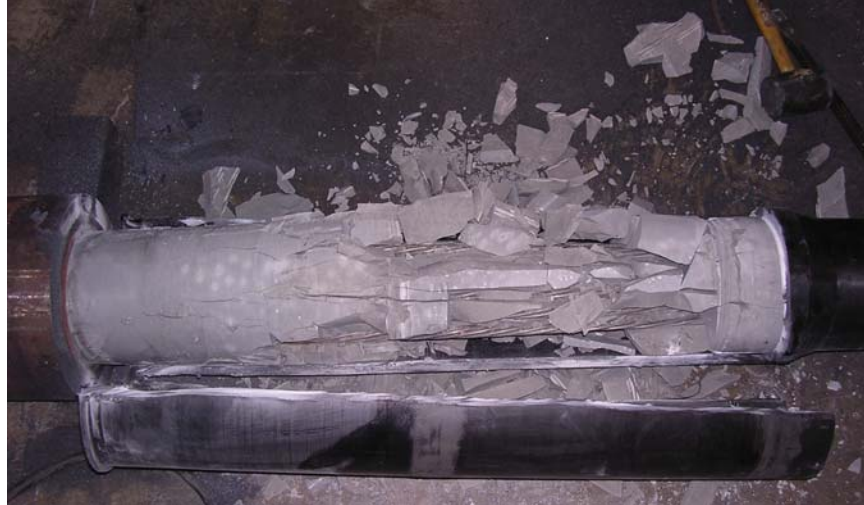
Due to the large number of wire breaks, the grout was severely cracked at the conclusion of the fatigue test. Photographs of the condition of the grout at midspan and the deck end are shown in Figure D.146 and Figure D.147, respectively.

**Figure D.147 Condition of Grout near Deck End – Specimen 12**

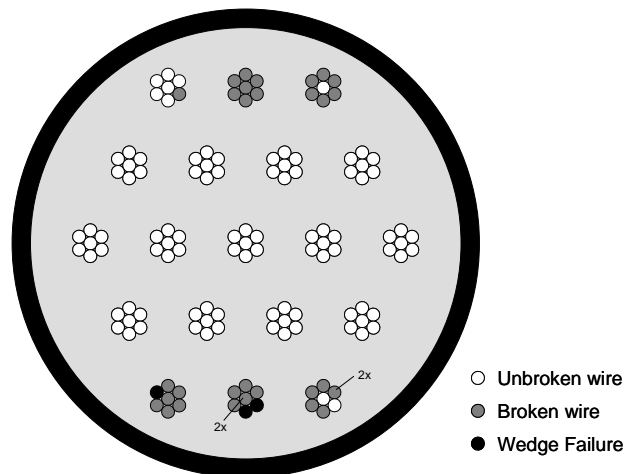
The thirty-five wire breaks at the tower end were distributed among six strands, and all breaks occurred in the top and bottom layers of strand (Figure D.153). Two wires in the bottom layer of strand experienced two wire breaks. Most of the wire breaks were within 12 in. of the inside face of the anchor head (Figure D.154); however, wire 2 in strand 19 fractured more than 15 in. from the face of the anchor head.

**Figure D.153 Distribution of Wire Breaks near Tower End – Specimen 12**

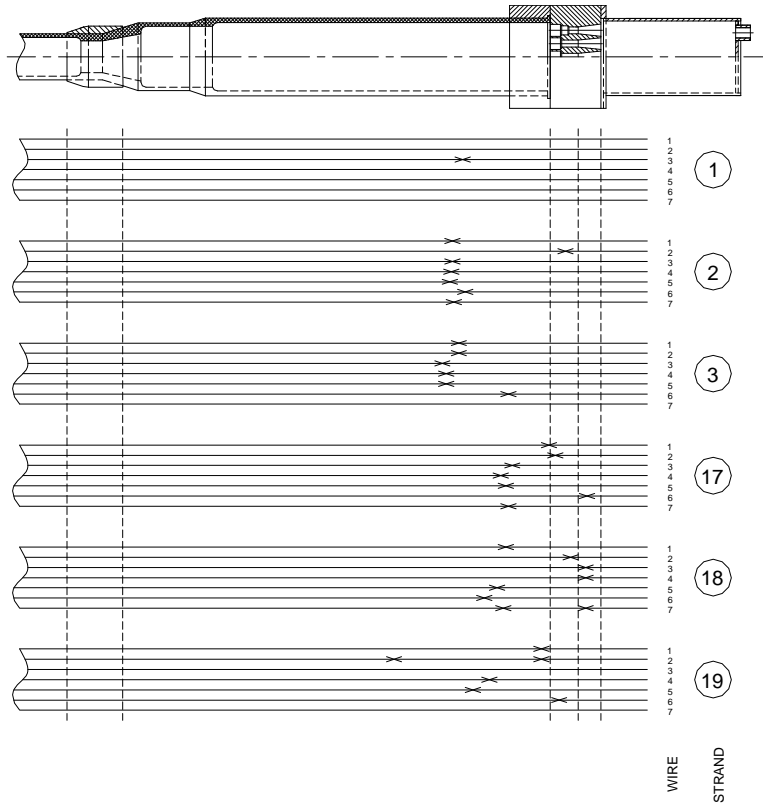
**Figure D.154 Location of Wire Breaks near Tower End – Specimen 12**

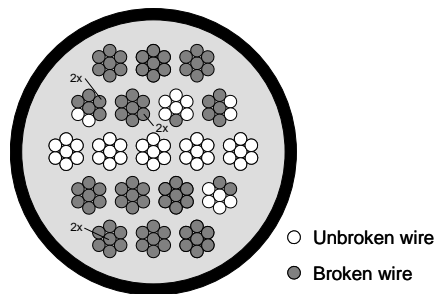
At midspan, the eighty-six wire breaks were distributed among fourteen strands (Figure D.155). Three wires experienced two wire breaks. Only the five strands in the middle row survived the fatigue test without a wire break. All wire breaks occurred within  $\pm 8$  in. of the centerline of the hydraulic actuator (Figure D.156 and Figure D.157).

**Figure D.155 Distribution of Wire Breaks near Midspan – Specimen 12**

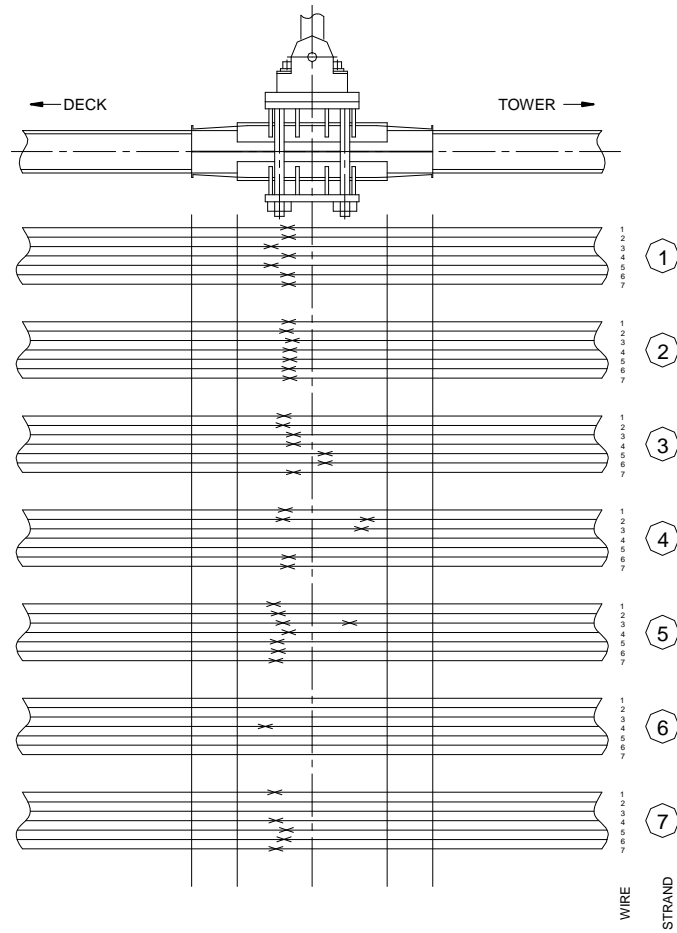
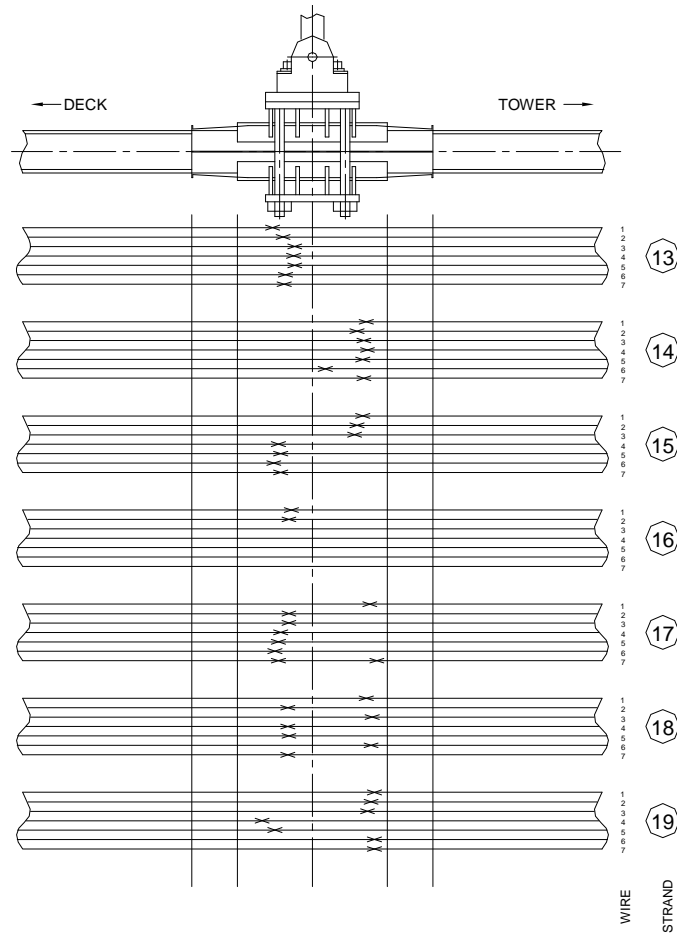
**Figure D.156 Location of Wire Breaks near Midspan – Specimen 12 (Part 1)**

**Figure D.157 Location of Wire Breaks near Midspan – Specimen 12 (Part 1)**

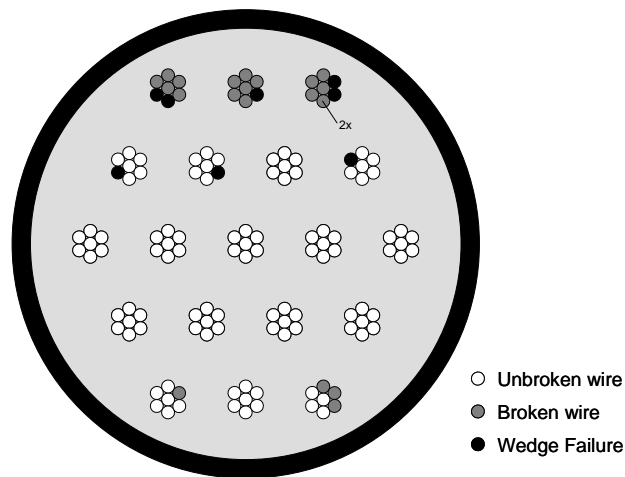
The twenty-nine wire breaks near the deck end were distributed among eight strands (Figure D.158). The damage was concentrated near the top of the cross section. All wires fractured in the three strands along the top row and one wire experienced two wire breaks. All wires in strands 1 and 2 fractured within the anchor head (Figure D.159).

**Figure D.158 Distribution of Wire Breaks near Deck End – Specimen 12**

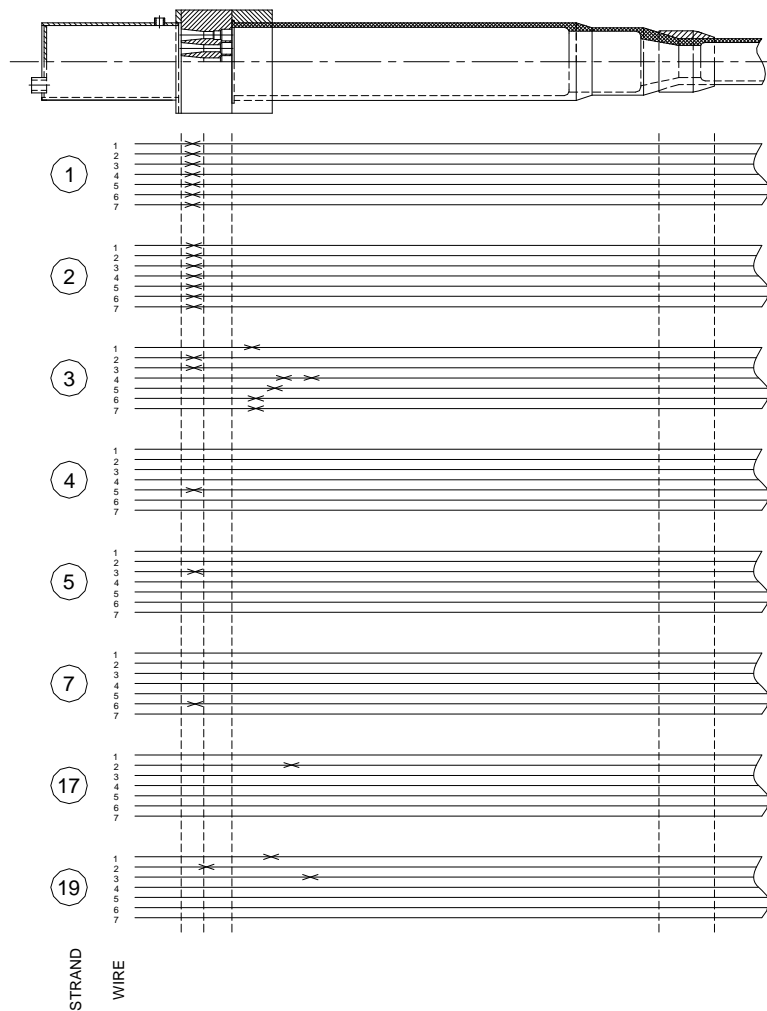
**Figure D.159 Location of Wire Breaks near Deck End – Specimen 12**

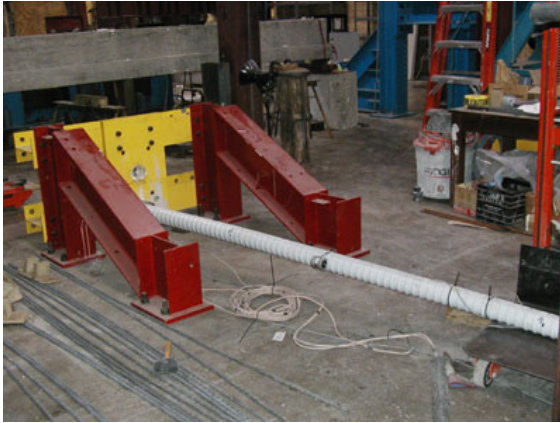
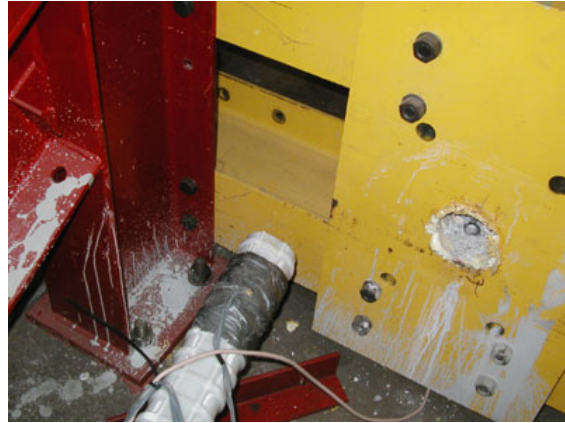
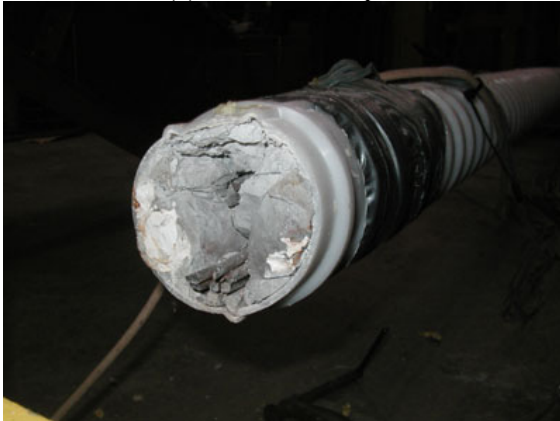
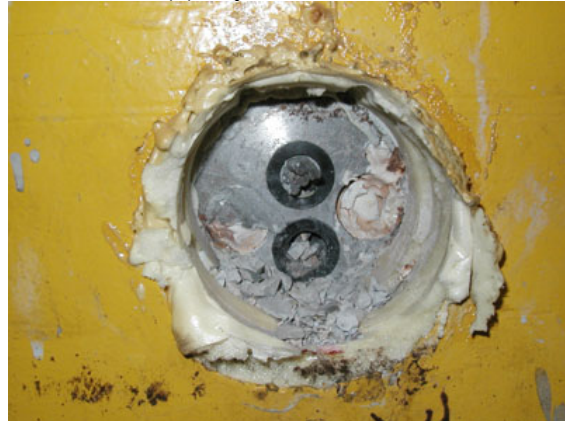
The fatigue test was terminated after all fourteen wires fractured at the north end of the specimen and the specimen collapsed (Figure E.6). All wires in the top strand failed within 2-in. of the inside face of the anchor head and all wires in the bottom strand failed inside the anchor head (Figure E.7). Sixteen wire breaks were identified during the autopsy. In addition to the fourteen wire breaks near the north anchor head, two adjacent wires fractured near midspan (Figure E.7).

(a) Overall Collapse

(b) Separated Section

(c) Looking South

(d) Looking North

**Figure E.6 Collapse of Specimen 1**

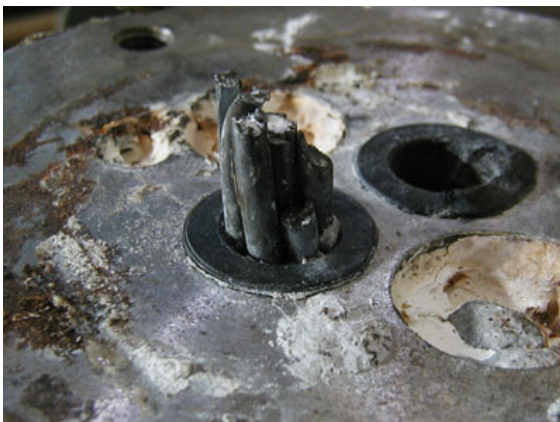
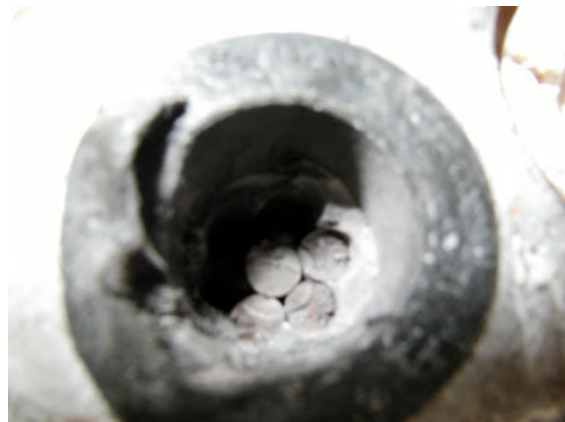
(a) Top Strand

(b) Bottom Strand

**Figure E.7 Wire Breaks at North Anchor Head – Specimen 1**

The acoustic data indicated that the two wire breaks at midspan were 2 ft apart. As shown in Figure E.8, the wire breaks were adjacent. The acoustic data indicated that the wire breaks at the north end ranged from 2.5 to 14.5 in. from the inside face of the anchor head, with an average distance of 8.5 in. As shown in Figure E.7, all wire breaks were within 2 in. of the inside face of the anchor head.

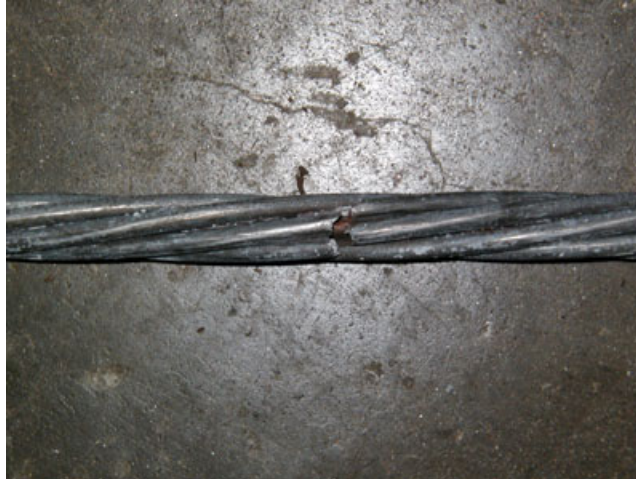
**Figure E.8 Wire Breaks near Midspan – Specimen 1**

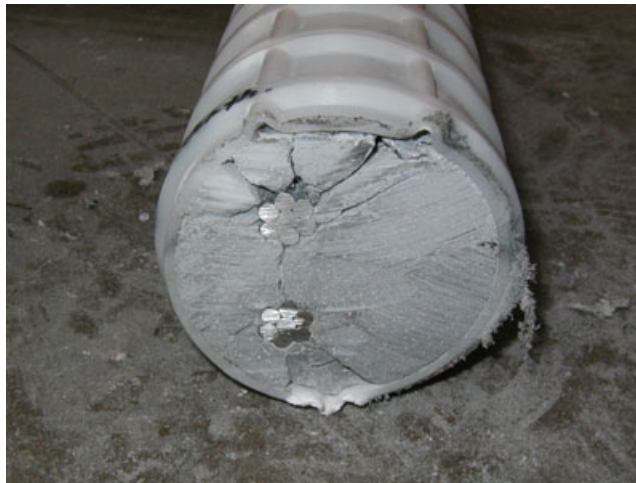
Grout at the north end of the specimen was severely cracked. Grout also cracked vertically at many sections. The crack developed from the top and bottom of the sections and continued through both of strands (Figure E.9).

**Figure E.9 Typical Vertical Crack in Grout – Specimen 1**

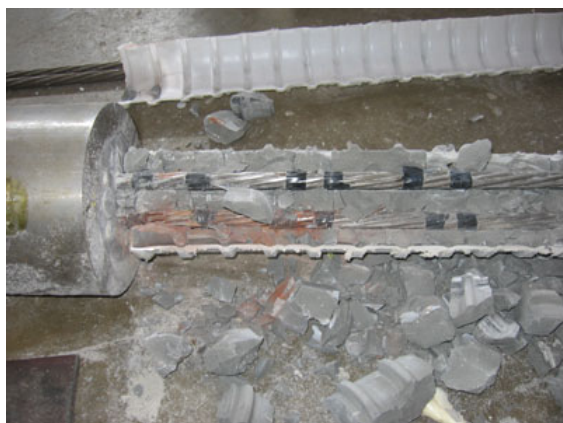
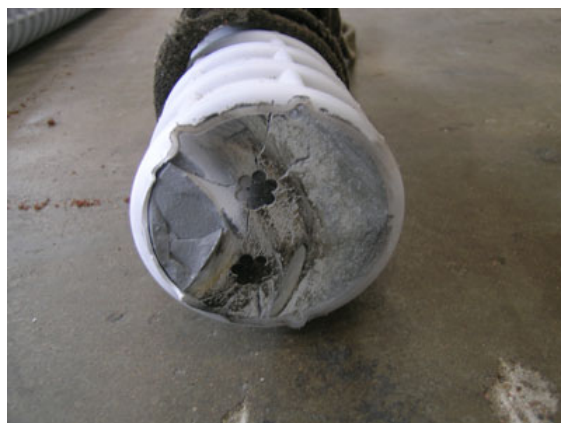
**Figure E.16 Condition of Grout – Specimen 2**

Grout near the north end was severely cracked. Vertical cracks were also identified along the entire length as shown in Figure E.16.

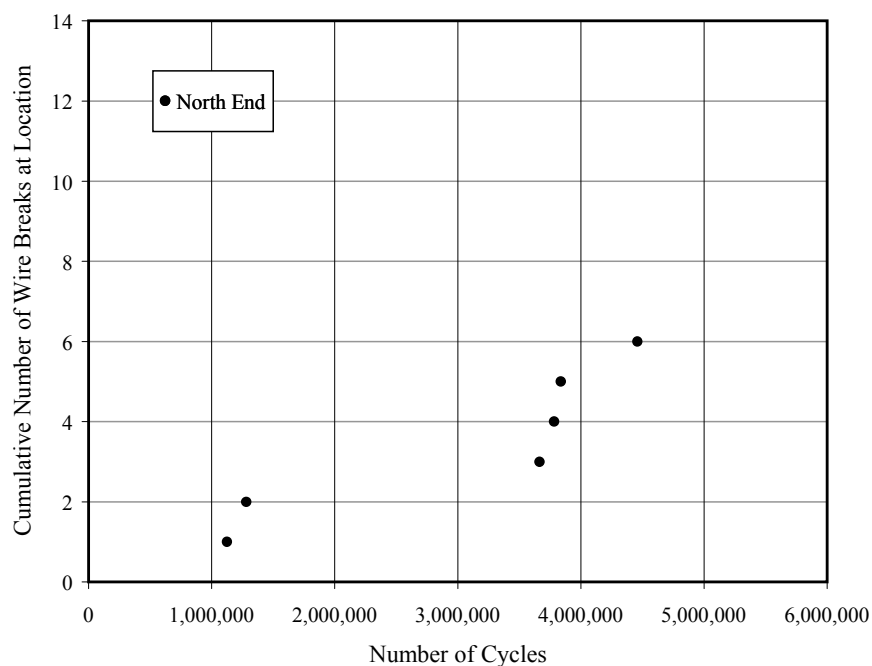
**Figure E.17 Wire Breaks Detected from Acoustic Data – Specimen 2**

The acoustic data indicated that the wire breaks at the north end ranged from 10 to 26 in. from the inside face of the anchor head, with an average distance of 18.5 in. As shown in Figure E.15, all wire breaks were within 8 in. of the inside face of the anchor head.

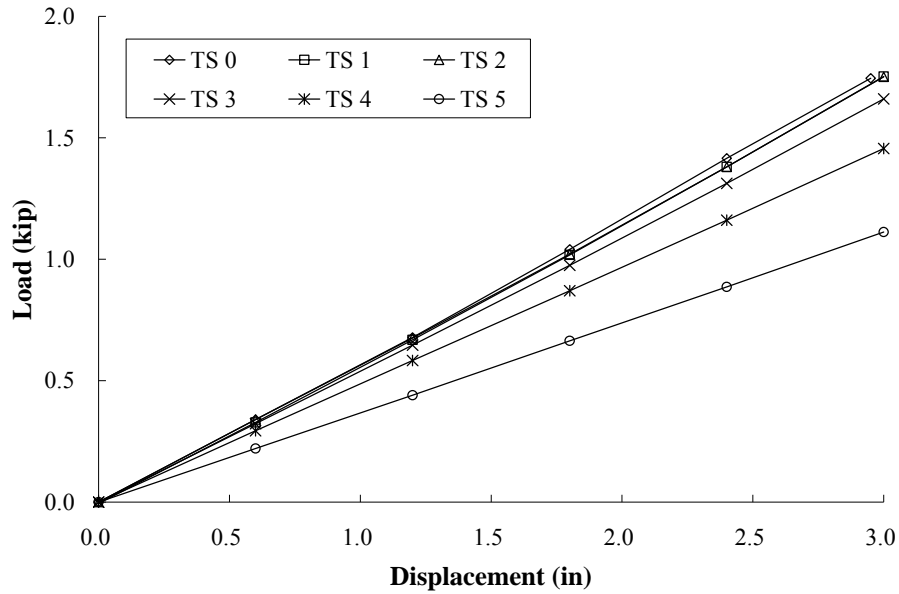
**Figure E.18 Measured Transverse Stiffness for Specimen 3**

Measurement	Date	Stiffness (kip/in.)	Wire Breaks Reported
TS 0	4/25/06	0.59	0
TS 1	4/26/06	0.58	0
TS 2	4/28/06	0.58	0
TS 3	5/01/06	0.54	4
TS 4	5/04/06	0.48	6
TS 5	5/11/06	0.37	8

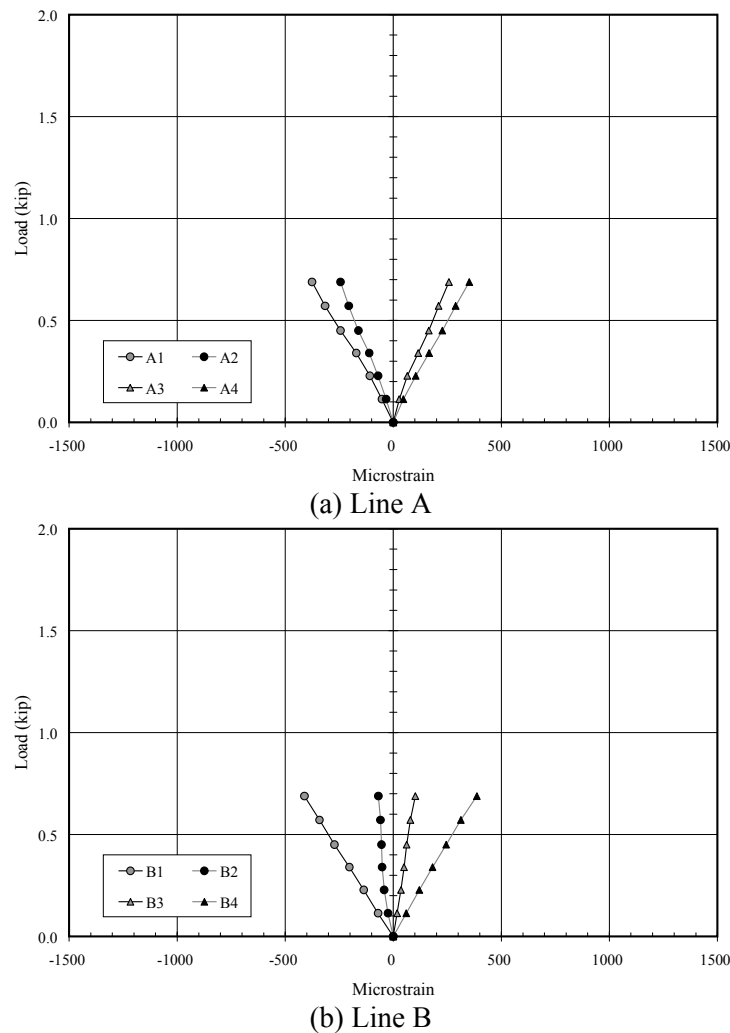
**Figure E.19 Measured Strains – Test S 0-2 – Specimen 3**

The measured strains from the two lines of gages nearest the north anchor head (Lines A and B) are plotted in Figure E.19 for Test S 0-2, in Figure E.20 for Test S 0-4, and in Figure E.21 for Test S 0-6. The strain increased linearly with increasing load in Test S 0-2; however, the maximum strains recorded along Line B exceeded the maximum strains recorded along Line A.

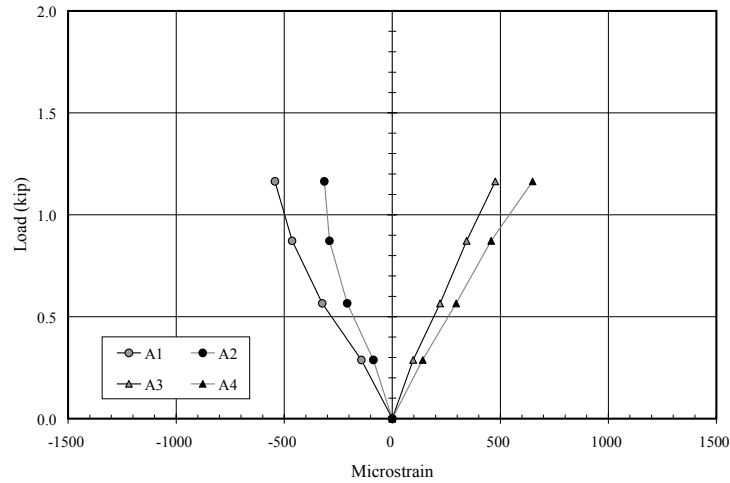
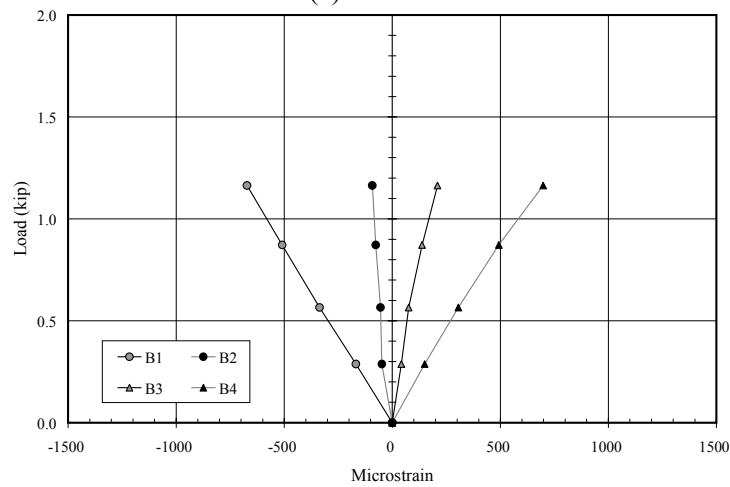
**Figure E.20 Measured Strains – Test S 0-4 – Specimen 3**

Nonlinear response was observed along Line A during Test S 0-4 (Figure E.20). The strains along Line B increased linearly with increasing load. Again, the maximum strains recorded along Line B exceeded the maximum strains recorded along Line A.

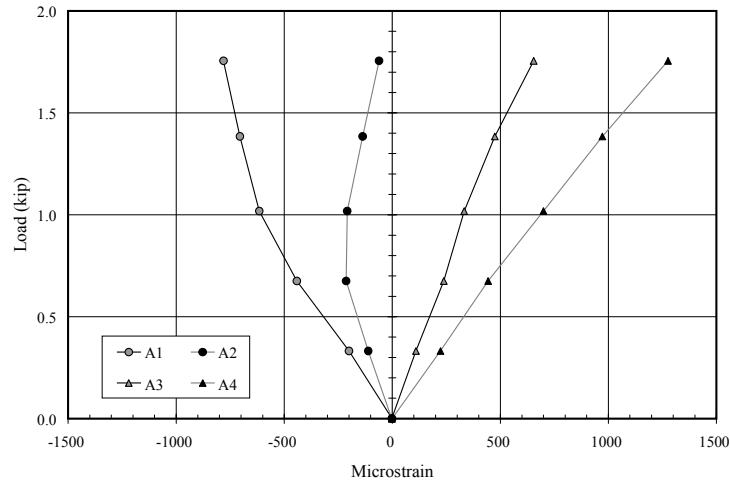
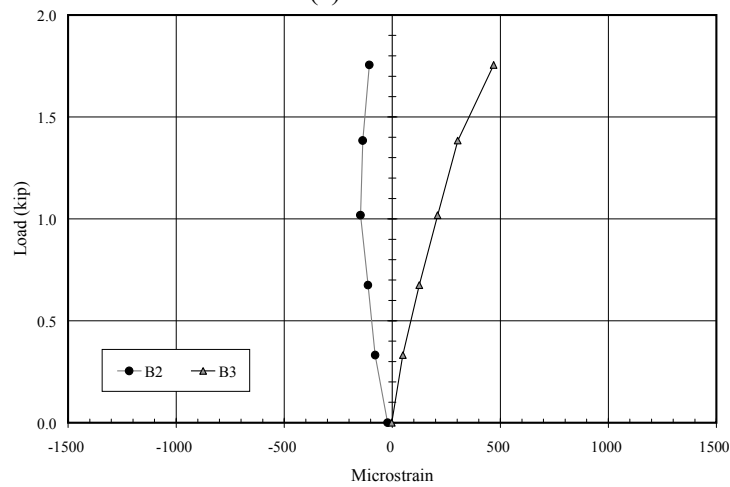
**Figure E.21 Measured Strains – Test S 0-6 – Specimen 3**

By Test S 0-6 (Figure E.21), two of the strain gages along Line B had malfunctioned, and all working gages along Lines A and B exhibited nonlinear response. A maximum strain variation of  $1280 \mu\epsilon$  was recorded in gage A4 during Test S 0-6, which corresponds to a stress of 40 ksi in the wire.

The strain data suggest that cracking of the grout, which would be expected to increase during the initial set of measurements, influences the strains in the strand. By Test S 1, five of the eight strain gages along Lines A and B had malfunctioned.

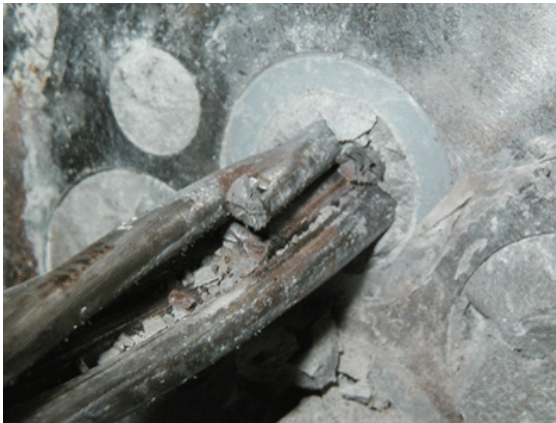
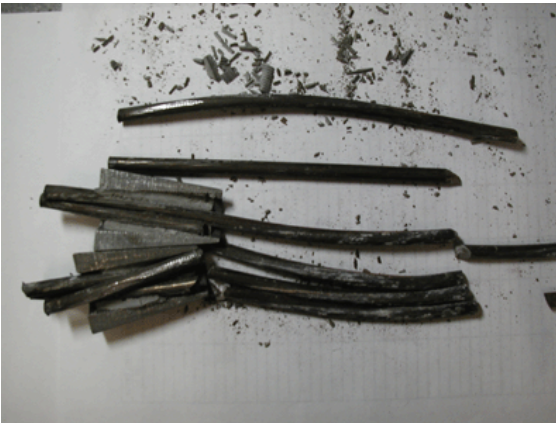
**Figure E.22 Observed Wire Fractures for Specimen 3**

At the conclusion of the fatigue test, the specimen was disassembled to determine the extent of damage. Twelve wire breaks were identified at the north end of the specimen: nine wire breaks in the bottom strand and three wire breaks in the top strand (Figure E.22).

In the bottom strand, six wires fractured inside the anchor head. Three of the outer wires in the bottom strand fractured outside the anchor head. Two of these outer wires sustained two wire breaks – one inside the anchor head and one outside. In the top strand, all three wire breaks occurred within 1 in. of the inside face of the anchor head.

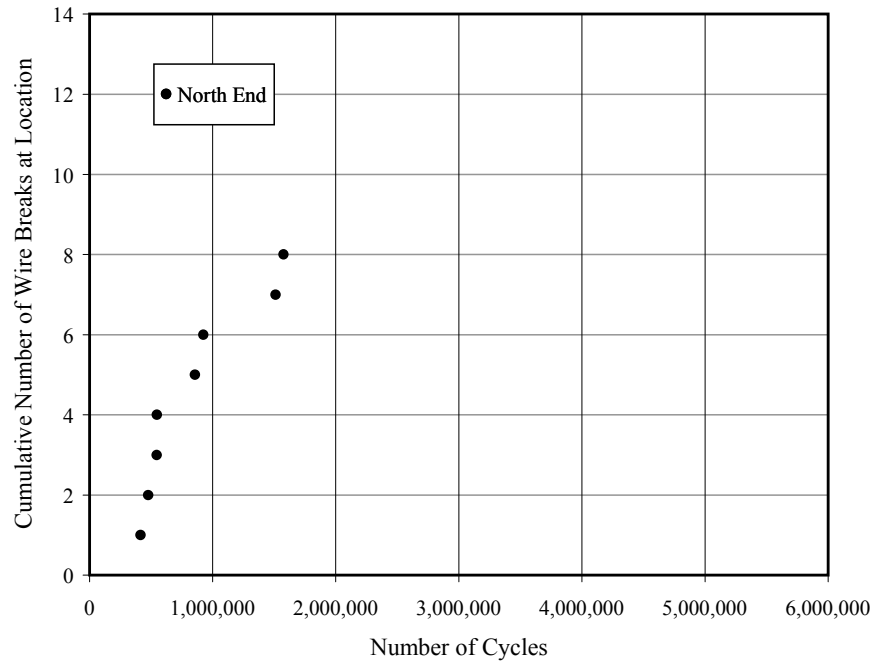
**Figure E.24 Wire Breaks Detected from Acoustic Data – Specimen 3**

The acoustic data indicated that the wire breaks at the north end ranged from 15 to 37 in. from the inside face of the anchor head, with an average distance of 17.5 in. As shown in Figure E.22, all wire breaks were within 1 in. of the inside face of the anchor head, and half of the breaks occurred within the anchor head.
