1. Report No. FHWA/TX-03/0-1857-4		2. Government Accession No.		3. Recipient's Catalog No.	
4. Title and Subtitle Bridges with Premature Concrete Deterioration: Damage Indices, Strand-Pullout Tests, and Field Observations				5. Report Date December 2002

Bridges with Premature Concrete Deterioration: Damage Indices, Strand-Pullout Tests, and Field Observations

Research Report 0-1857-4

*STRUCTURAL ASSESSMENT OF IN-SERVICE BRIDGES
WITH PREMATURE CONCRETE DETERIORATION*

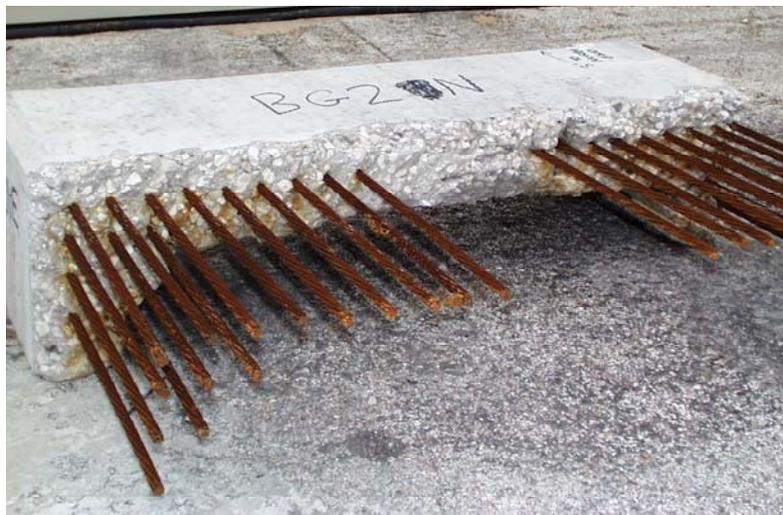
Figure 3.5: Front view of slice cut from Girder BG2N

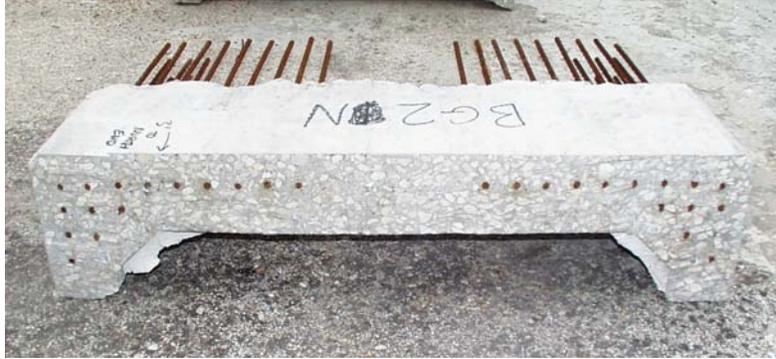
Figure 3.6: Back view of slice cut from Girder BG2N

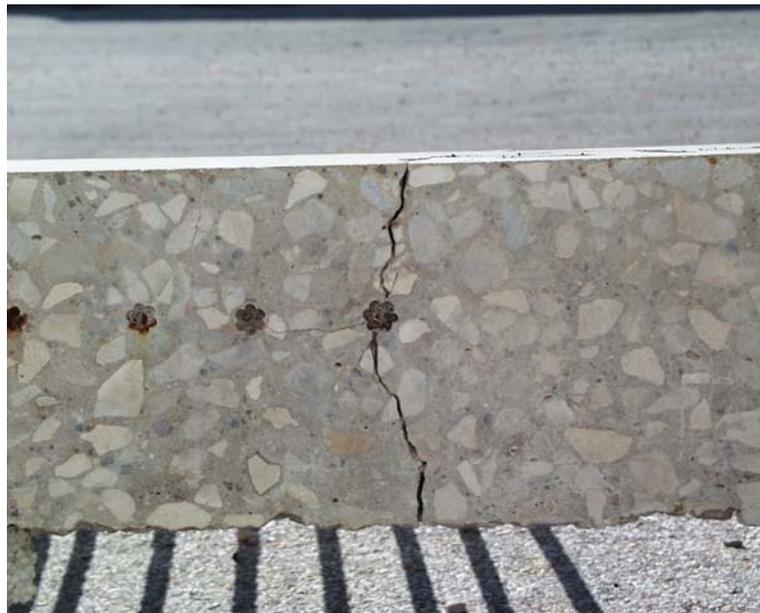
The most significant crack on Slice BG1S was a medium-wide crack (about 0.5 mm) on the bottom face corresponding with the longitudinal direction of the box girders. That crack extended into the cross-section to the void and propagated through Strand 9L in the back face (Figure 3.11).

Figure 3.11: Crack through Strand 9L in back face of Slice BG1S

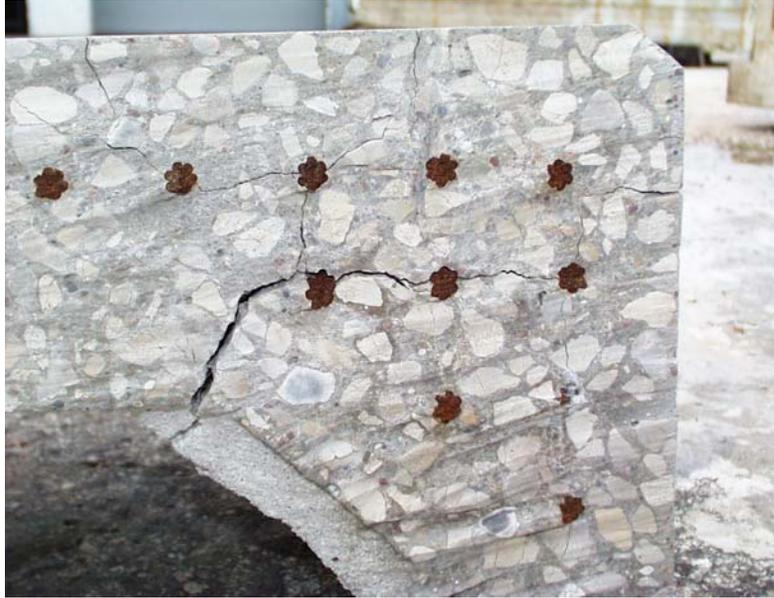
Large cracks were apparent in the back face of the slice, as shown in Figure 3.15. Very wide cracks propagated from the inner corners of the void to the corner strands (Strand 15L and Strand 15R). These cracks continued in the plane of the cross section to the adjacent strands. As shown in Figure 3.15, concrete was no longer in contact with a portion of Strand 15R. The photo also shows that the crack extended through the remaining Styrofoam void filler.

Figure 3.15: Large cracks in back face of Slice BG2N

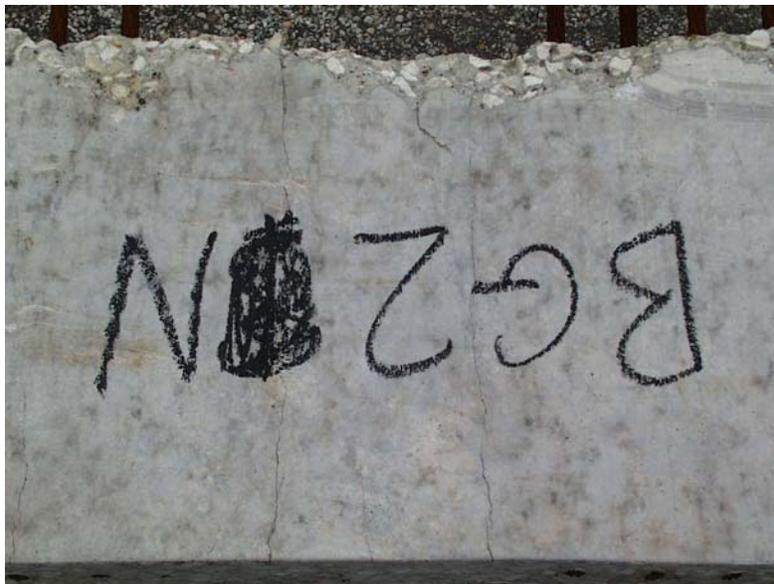
Narrow longitudinal cracks were present on the bottom face (Figure 3.16).

Figure 3.16: Cracking on middle of bottom face of Slice BG2N

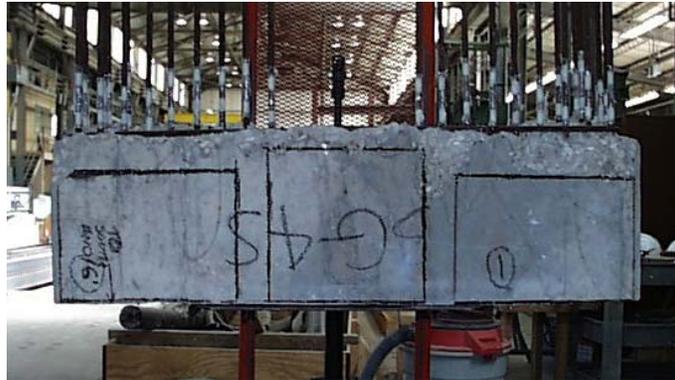
This damage index is based on cracks measured in a 12 in. (0.31 m) by 12 in. (0.31 m) square. Squares were drawn on the exterior faces of each specimen as shown in Figure 3.36 through Figure 3.39. Where possible, 12 in. (0.31 m) by 12 in. (0.31 m) squares were drawn, but in several cases, there was not sufficient surface area on the face of the slice to draw a large enough square for crack measurement. To correct for this, the computed damage index was multiplied by the appropriate scale factor required to match 144 in.² (0.093 m²) of area. For example, the damage index for a 10 in. (0.25 m) by 10 in. (0.25 m) square was multiplied by 1.44. In some cases, rectangles with an equivalent area of 144 in.² (0.093 m²) were drawn (Figure 3.36).

Figure 3.36: Representative areas for bottom face damage indices

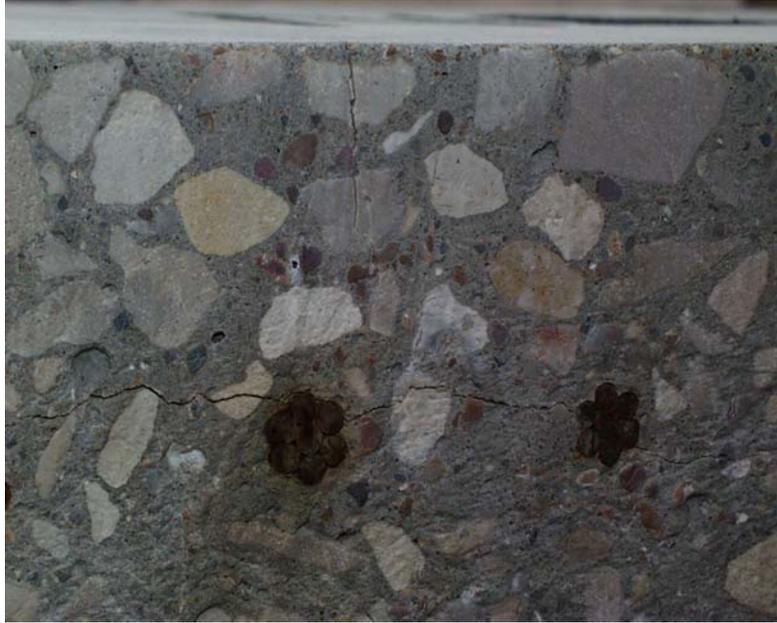
Figure 4.5: Back view of Strand BG2N_8L (right) and Strand BG2N_9L (left)

Strand BG2N_8L was tested on October 25, 2001. The concrete was cracked around the strand in the back face. Cracks propagated from the strand to adjacent strands and through the surrounding aggregates (Figure 4.5). The length of BG1S_13R embedded in concrete in the specimen prior to testing was measured to be approximately 13 in. (0.33 m).

First slip occurred during the first stage of the test, when N was 25 kips (111 kN). The load required to cause first slip was 1.98 kips (8.81 kN). Average bond strength was computed to be 97 psi (670 kPa).

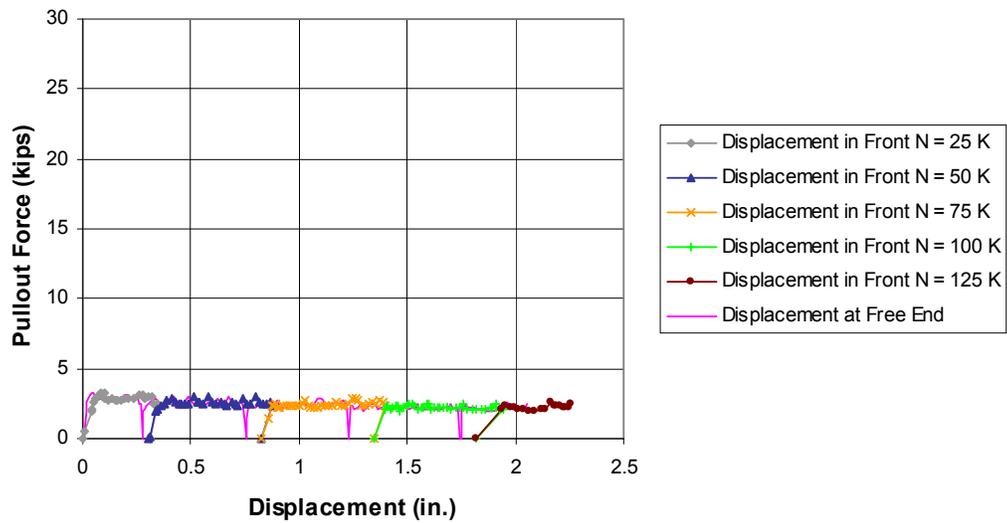
Figure 4.6: Load-displacement Relationship for Strand BG2N_8L

Figure 4.6 shows the load-displacement relationship recorded during the test. The pullout force in the strand is plotted on the vertical axis and is simply taken as the pressure in the ram multiplied by the area of the ram. Displacement is plotted along the horizontal axis.

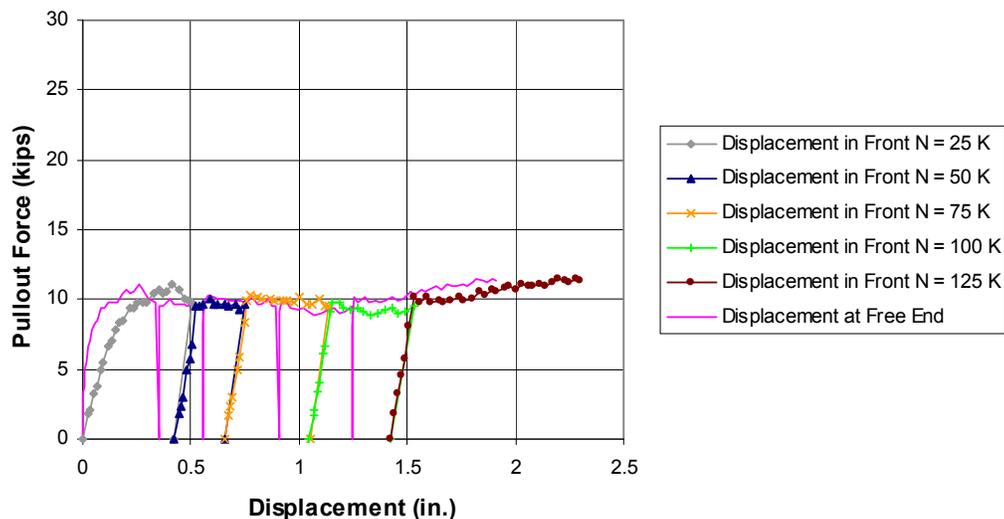
Figure 4.8: Load-displacement Relationship for Strand BG4S1_17R

Figure 4.8 shows the load-displacement relationship recorded during the test. During the last stage, when the transverse clamping load was 125 kips (556 kN), the pullout force increased slightly as displacement increased.

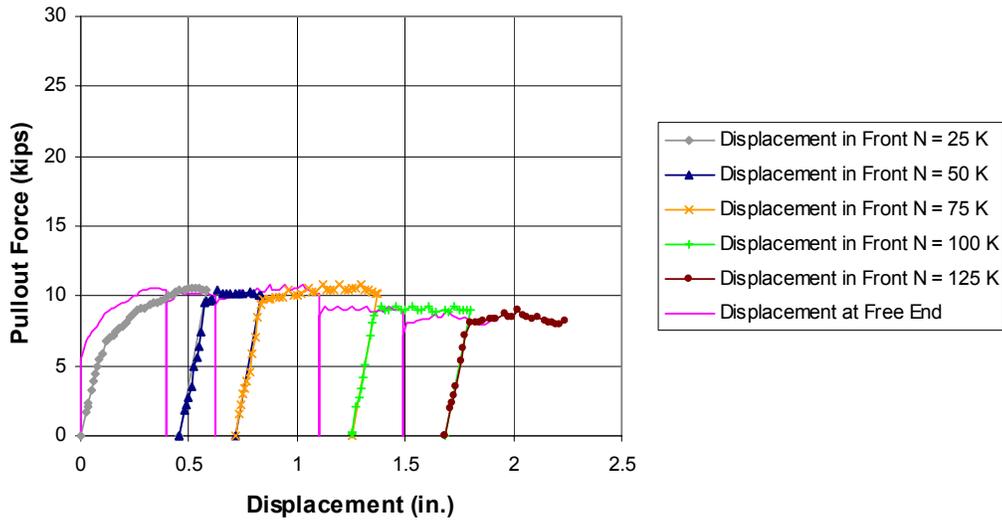
Figure 4.9: Load-displacement Relationship for Strand BG4S2_1L

Strand BG4S2_1L was tested on January 13, 2002. The concrete surrounding the back of the strand seemed to be in good condition; there was a crack near the strand in the back face, however. The length of Strand BG4S2_1L embedded in concrete prior to testing was measured to be approximately 13.2 in. (0.34 m).

Figure 4.9 shows the load-displacement relationship recorded during the test. The load required to cause first slip at the free end of the strand was 5.81 kips (25.8 kN). Average bond strength was computed to be 280 psi (1,930 kPa).

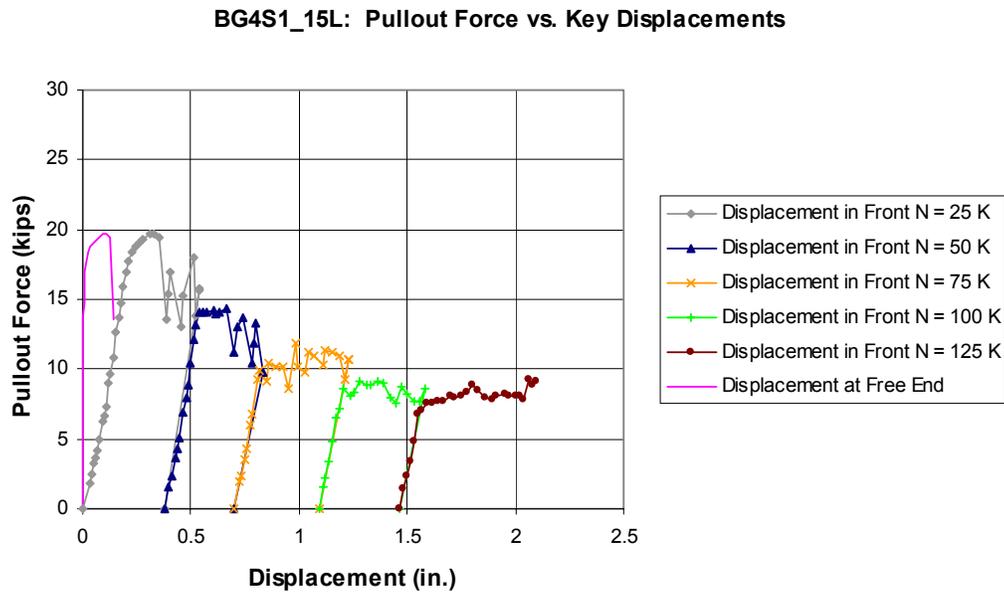
Figure 4.10: Load-displacement Relationship for Strand BG4S1_15L

Strand BG4S1_15L was tested on February 8, 2002. No cracks were apparent in the back face around the free end of the strand. The length of strand BG4S1_15L embedded in concrete prior to testing was measured to be approximately 14 in. (0.36 m).

Figure 4.10 shows the load-displacement relationship recorded during the test. The load required to cause first slip at the free end of the strand was 14.77 kips (65.7 kN). Average bond strength was computed to be 672 psi (4,630 kPa).

The linear potentiometer attached to the back of the strand became disconnected at approximately 0.3 in. (7 mm) of displacement at the front end. During the test, the strand surged forward and apparently pulled the strand off of the potentiometer shaft. This explains why the curve “Displacement at Free End” does not continue throughout the remainder of the test.

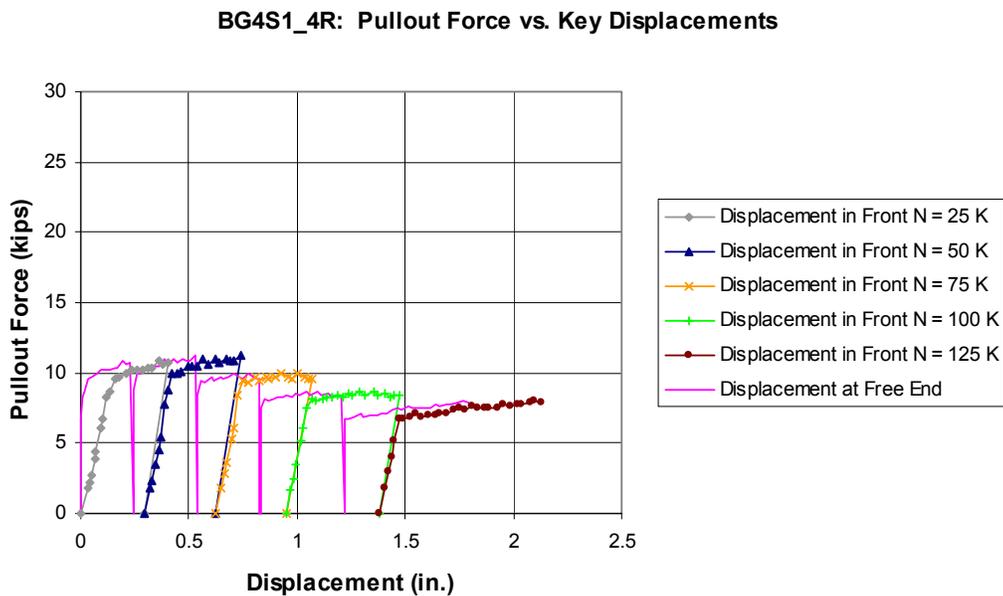
Figure 4.12: Load-displacement Relationship for Strand BG4S1_4R

Strand BG4S1_4R was tested on February 15, 2002. The concrete around the strand in the back face had some cracking through the concrete paste and aggregates (Figure 4.11). The length of Strand BG4S1_4R embedded in concrete prior to testing was measured to be approximately 13.8 in. (0.35 m).

Figure 4.12 shows the load-displacement relationship recorded during the test. The load required to cause first slip at the free end of the strand was 8.3 kips (36.9 kN). Average bond strength was computed to be 384 psi (2,650 kPa).

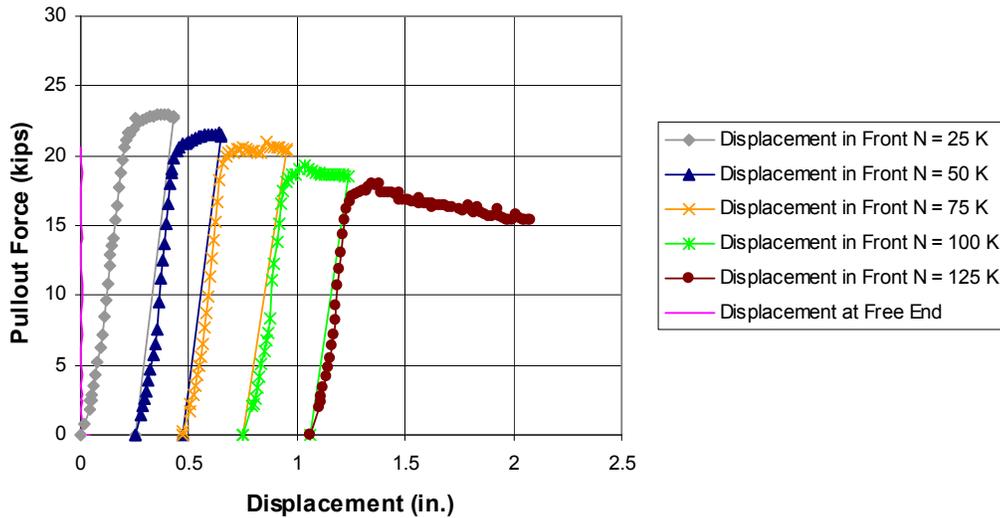
Figure 4.13: Load-displacement Relationship for Strand BG2N_9R

Strand BG2N_9R was tested on November 5, 2001. The concrete around the strand was in good condition; no cracks were apparent at the back of the strand. The length of Strand BG2N_9R embedded in concrete prior to testing was measured to be approximately 14.3 in. (0.36 m).

Figure 4.13 shows the load-displacement relationship recorded during the test. The load required to cause first slip was 18.84 kips (83.8 kN). Average bond strength was computed to be 842 psi (5,800 kPa).

The linear potentiometer attached to the back of the strand was inadvertently glued to the back of the specimen, and did not move with the free end of the strand. This explains why the curve “Displacement at Free End” does not show any displacement of the free end during the test.

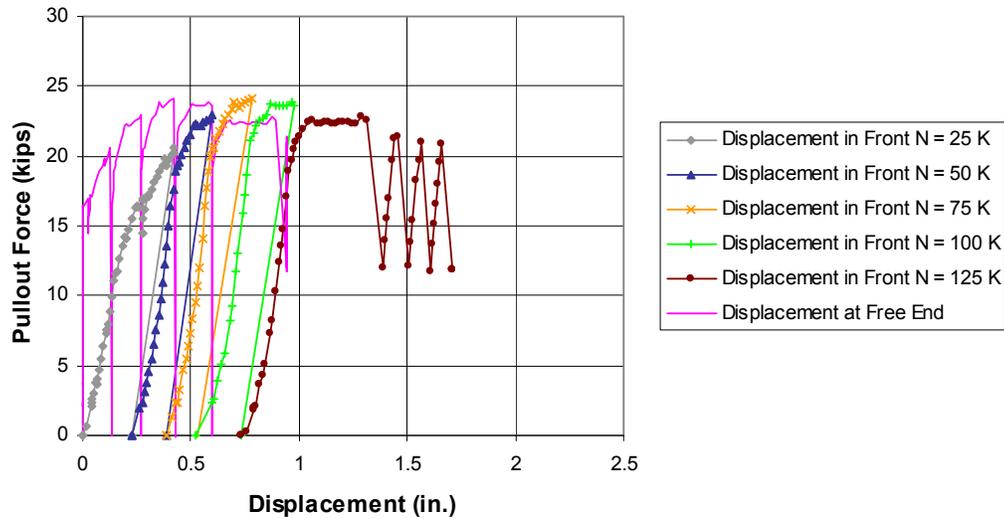
Figure 4.14: Load-displacement Relationship for Strand BG1S_13R

Strand BG1S_13R was tested on August 9, 2001. Concrete around the strand was fairly sound and did not have many cracks. The length of Strand BG1S_13R embedded in concrete prior to testing was measured to be approximately 12.6 in. (0.32 m).

Figure 4.14 shows the load-displacement relationship recorded during the test. The load required to cause first slip was 16.97 kips (75.5 kN). Average bond strength was computed to be 856 psi (5,900 kPa).

The large decreases in pressure and increases in displacement during the stage when the clamping load was 125 kips (556 kN) indicate moments when the strand jumped and surged forward during the test. These jumps were accompanied by a loud popping noise. The linear potentiometer shaft at the free end was pulled from the strand by the first surge, so subsequent potentiometer data were disregarded.

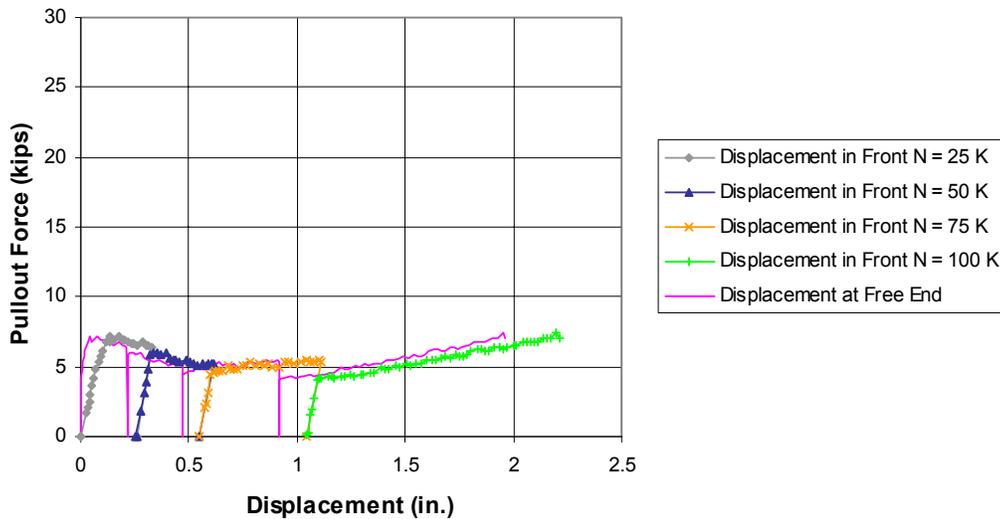
Figure 4.15: Load-displacement Relationship for Strand BG2N_2R

Strand BG2N_2R was tested on November 9, 2001. The concrete around the strand was not nearly as damaged as the concrete surrounding the adjacent strands. Figure 3.14 shows the pre-test condition for the back face of the right cluster strands of Slice BG2N. The length of Strand BG2N_2R embedded in concrete prior to testing was measured to be approximately 14 in. (0.36 m).

Figure 4.15 shows the load-displacement relationship recorded during the test. The load required to cause first slip was 4.81 kips (21.4 kN). Average bond strength was computed to be 219 psi (1,510 kPa).

During the stage when N was 100 kips (445 kN), the pullout force increased as displacement increased. This test did not show a stepped increase of P with increasing N ; it was one of the few tests that showed an increase in resistance, however. Because the pressure in the ram continued to increase, the test was continued until the ram extended fully; this occurred before a transverse clamping load of 125 kips (556 kN) could be reached.

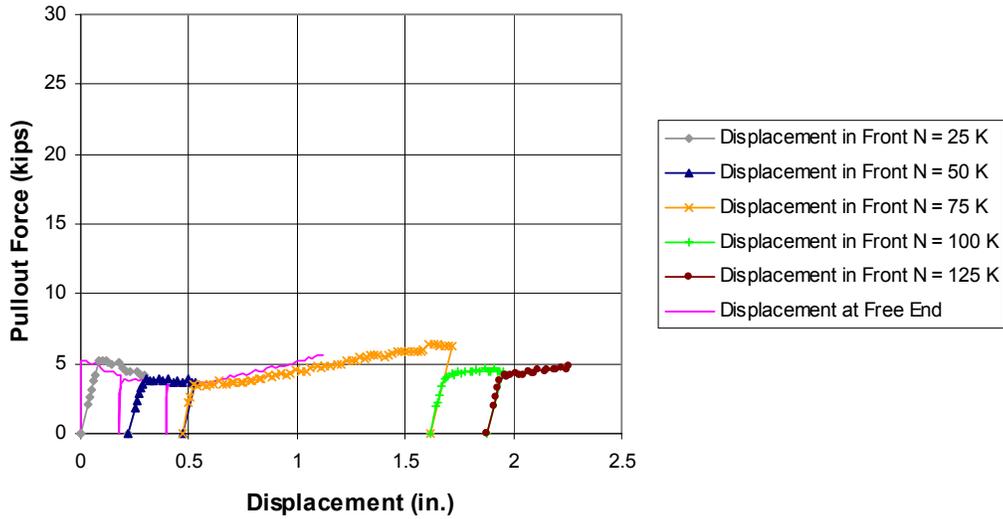
Figure 4.17: Load-displacement Relationship for Strand BG4S2_5R

Strand BG4S2_5R was tested on January 18, 2002. Cracking was significant around the back of the strand and the adjacent strands (Figure 4.16). The length of Strand BG4S2_5R embedded in concrete prior to testing was measured to be approximately 12.4 in. (0.31 m).

Figure 4.17 shows the load-displacement relationship recorded during the test. The load required to cause first slip at the free end of the strand was 5.28 kips (23.5 kN). Average bond strength was computed to be 272 psi (1,870 kPa).

The resistance increased significantly as displacement increased during the stage when N was 75 kips (334 kN), and it also increased slightly during the last two stages of the test. Even though the pullout force increased during the stages, the load required to cause slip stayed about the same.

The potentiometer shaft attached to the free end of the strand became disconnected during the stage when N was 75 kips (334 kN). Data collected by that potentiometer past this point were disregarded.

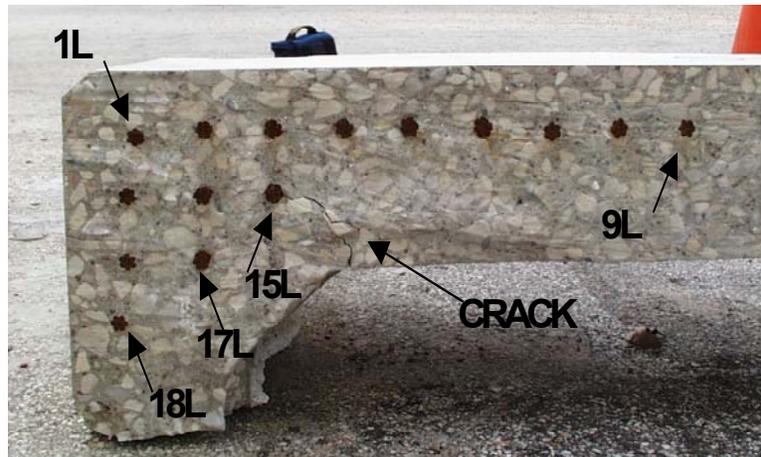
Figure 5.12: Cracking in back face of Slice BG4S2

Increases in damage index are associated with decreases in average bond strength. It is not possible to determine with external damage indices whether internal cracks involve individual strands in the cross section, however. For example, Figure 5.12 shows the left-hand strands of Slice BG4S2, as visible from the back face. The crack propagating from the left corner of the interior void in Slice BG4S2 affects Strand BG4S2_15L but not other nearby strands.

The left side damage index for Slice BG4S2 was computed to be 2,525 (Table 4.13). As discussed above, this damage index was considered nearest to Strands 1L, 15L, 17L, and 18L. Table 5.2 lists the average bond strengths estimated from pullout tests for those strands.

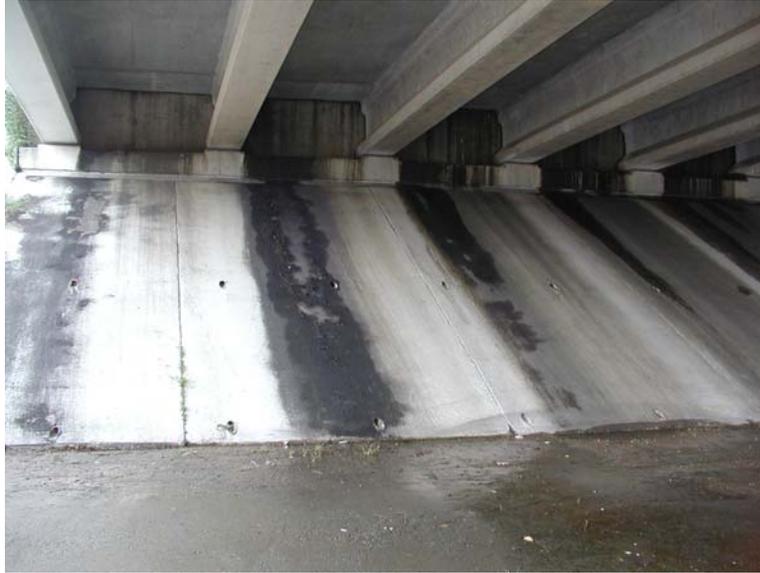
Figure 6.2: Overview of West Abutment of I-10 structure in Beaumont, Texas

The bridge girders shown in Figure 6.2 are standard AASHTO Type C prestressed girders and were fabricated in 1987. Premature deterioration existed in the ends of these girders. Other examples of damage were evident but were not reachable without lifting equipment.

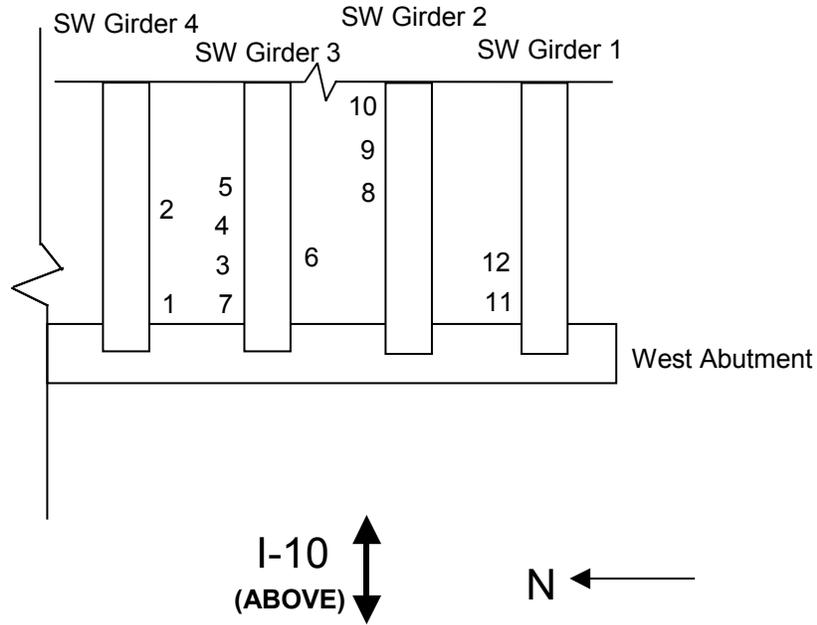
Figure 7.2: Schematic of crack-measurement locations on I-10 structure (plan view)

Figure 7.2 is a schematic drawing of crack-measurement locations on the I-10 structure. In the figure, numbers indicate relative locations of points along the girders.

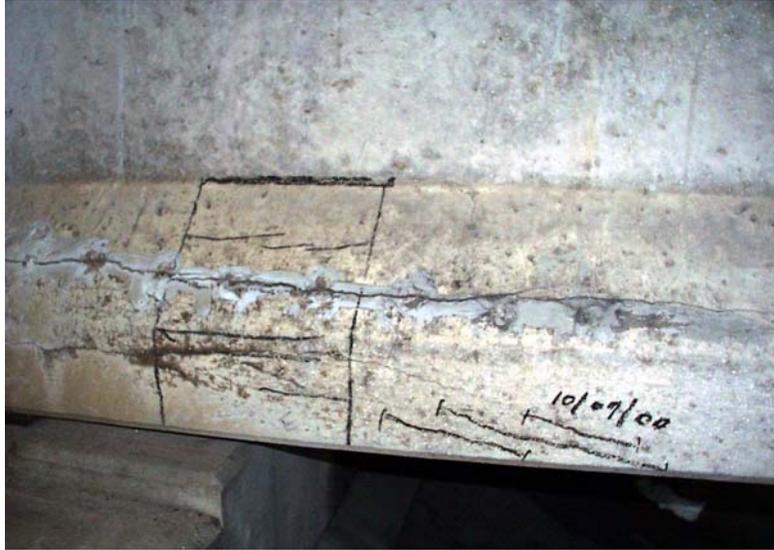
Figure 7.4: Representative areas on I-10 SW Girder 2, south face (10/7/00)

On October 7, 2000, cracks in the representative areas were observed to be significantly wider than the previous visit. Figure 7.4 shows the representative areas defined on SW Girder 2 near the west abutment.

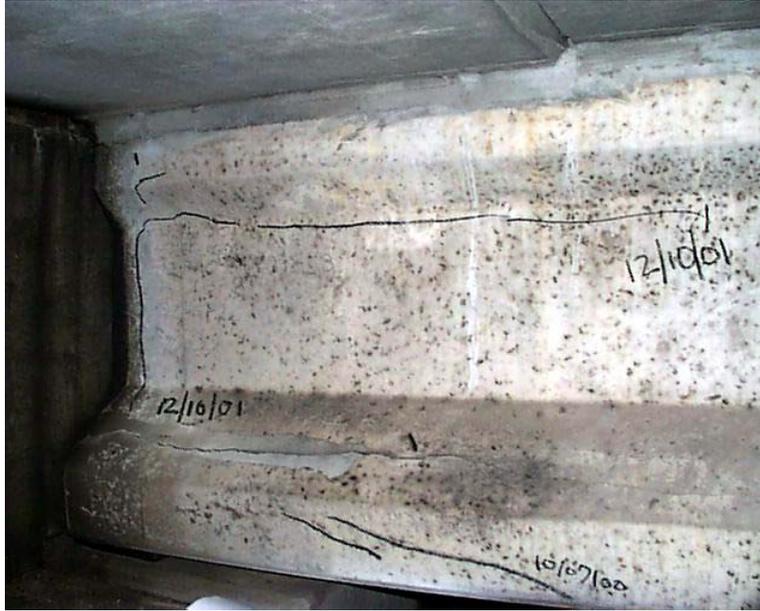
Figure 7.7: New cracks on south face of SW Girder 3 at west abutment, I-10 (12/10/01)

New cracks had become apparent on SW Girders 2 and 3. Vertical cracks had formed in the web (Face 3) close to the end of the girders; and horizontal cracks had formed at the intersection of the web and top flange (intersection of Face 3 and Face 2), and had extended towards the middle of the span. A schematic diagram of the location of these new cracks is shown in Figure 7.6. Figure 7.7 shows an example of the newly visible cracking on the south face of SW Girder 3. New, small cracks were also noted on the underside (Face 6) of SW Girder 2.

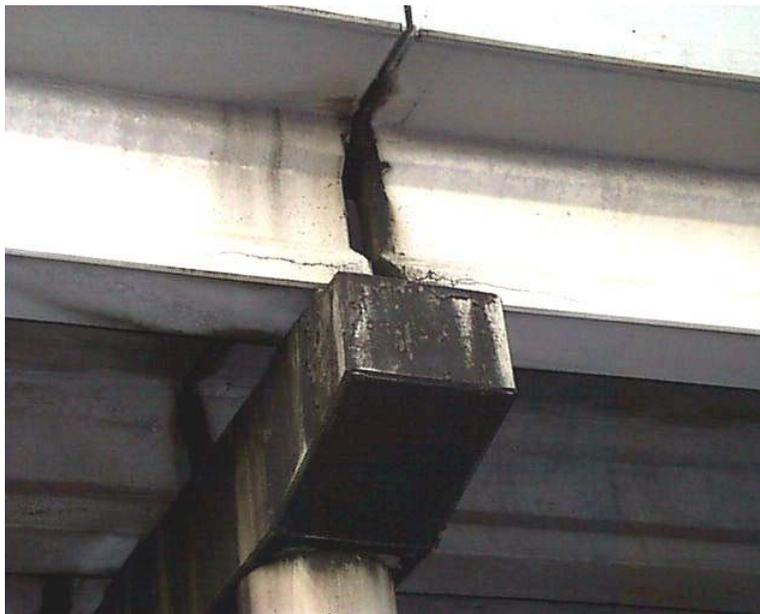
Figure 7.8: Cracks at first bent east of west abutment, I-10 (12/10/01)

Figure 7.8 shows more staining on the bent cap, indicating extensive exposure to rainwater since October 7, 2000 (Figure 7.5).

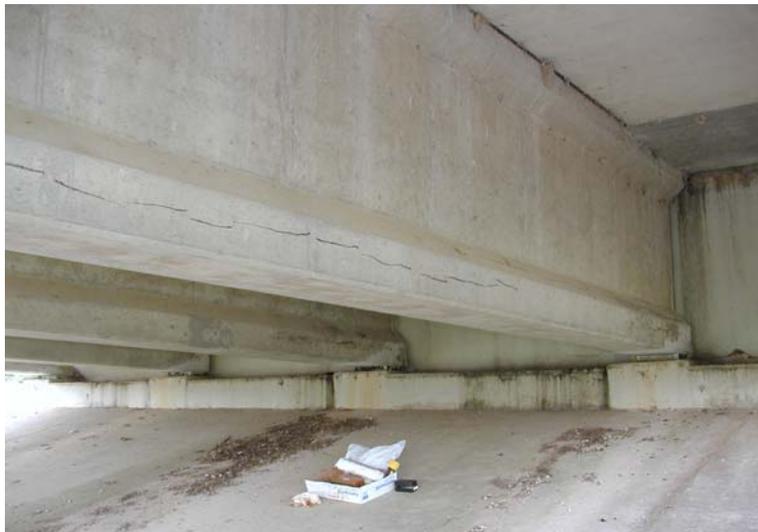
Figure 7.11: Extension of existing cracking on north surface (Face 5) of NW Girder 2, US-90 (6/22/01)

On June 22, 2001, cracking generally seemed worse than before. Previously noted cracks had extended towards midspan along Face 5 on the interior girders (Figure 7.11). In addition, many new hairline cracks were noted on the bottom flanges of most girders. Cracks over the representative areas had not changed significantly, however.

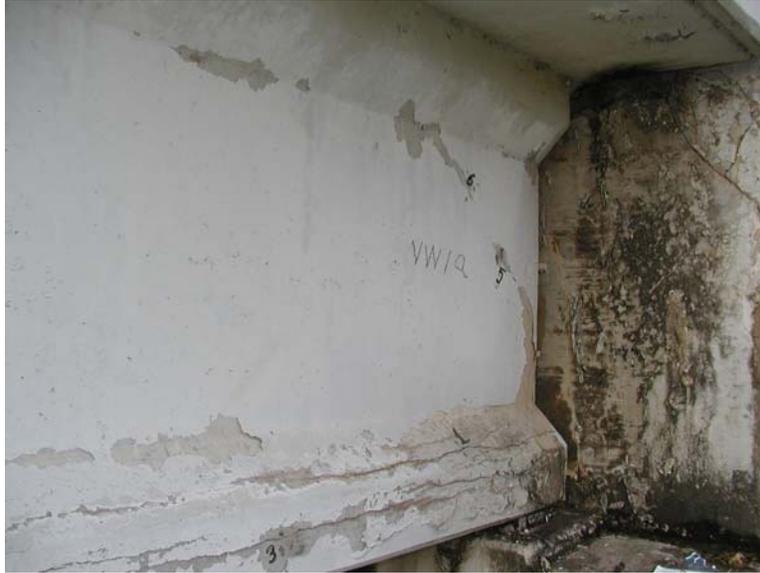
Figure 7.12: Cracks at end of NW Girder 1, US-90 (6/22/01)

Figure 7.12 shows the status of Points 1, 3, 5, and 6 and cracking at the end of NW Girder 1 at the west abutment. Several cracks were visible in the bottom flange on Face 4 and Face 5, and paint was peeling in the deteriorated regions.

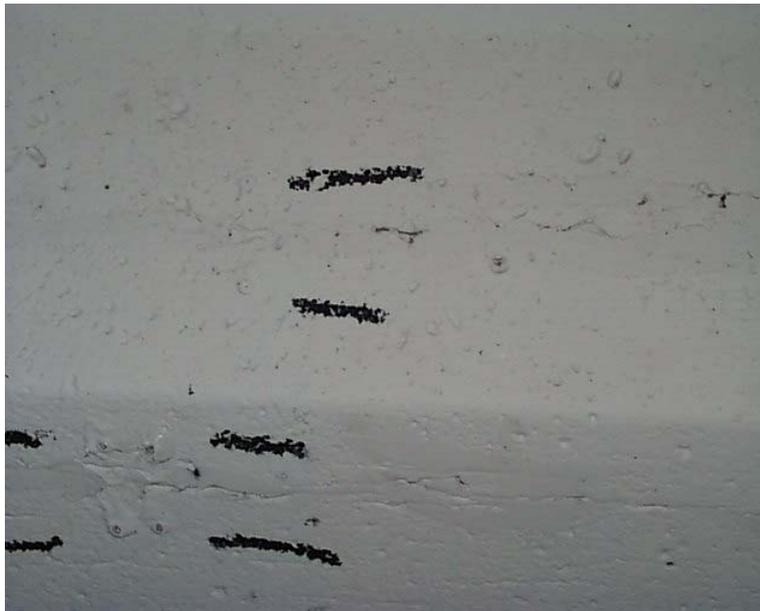
Figure 7.13: Close-up view of Point 10 (bottom, left pair of Demec discs) and Point 8 (top), US-90 (12/11/01)

Most Demec discs were still attached to the girders. The grease pencil markings and labeling of crack measurement points had been painted over, however. Sixteen of the 19 Demec points were found, and it was possible to take Demec readings at 15 of these points. The specific point numbers and locations were deduced later from previous photos and records. Figure 7.13 shows Point 10 and Point 8, located on the south surface of NW Girder 1.

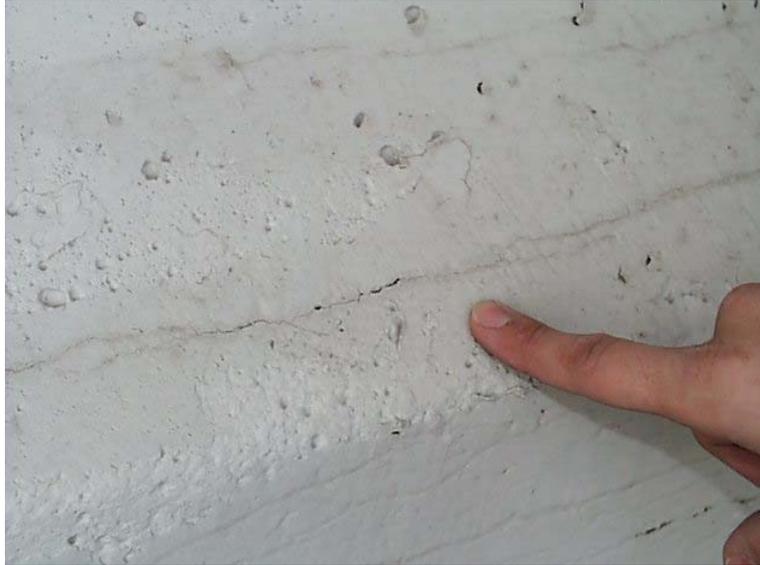
Figure 7.14: Apparent cracking through sealant, US-90 (12/11/01)

Figure 7.14 shows an example of cracks that have apparently occurred in the sealant on Face 4 of the north surface of NW Girder 1. These cracks were located approximately 3 ft (0.91 m) from the end of the girder, and ranged from 0.002 in. (0.05 mm) to 0.02 in. (0.51 mm) wide.

Evidence of cracking in the sealant indicated that the girders at the US-90 structure are continuing to deteriorate. If the girders had not been primed and sealed, the cracks may have looked worse.

Field observations also showed that crack sealants were unable to stop cracks from propagating further (Figure 7.14 and Figure 7.20). Cracks were sealed at the four structures in southeast Texas: selected cracks were treated at the I-10 and Robinson Road structures; and all surfaces were primed and painted at the US-90 and Beltway 8 structures. Surface sealants and sealants injected into cracks did not stop deterioration; protecting the damaged concrete from further exposure to water appeared to hinder crack growth, however. It is unknown how effective the sealants were because rates of deterioration for cracks before and after treatment were not available.

Examples of the existing TxDOT treatment procedure were observed on December 11, 2001 at the US-90 structure (Section 7.2.2) and the Beltway 8 structure (Section 7.2.4). Surface treatment and flexible crack sealant did not stop deterioration in those structures: cracks were apparent through sealant at US-90 (Figure 7.14).

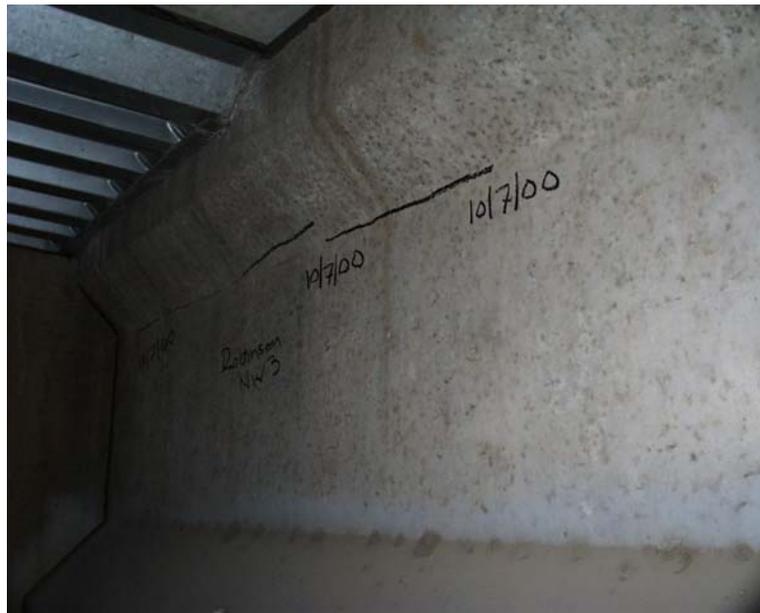
On October 7, 2000, narrow cracks had propagated on the girders along the intersection between the top flange and web (intersection between Face 2 and Face 3). This type of cracking was typical of NW Girder 1, NW Girder 2, and NW Girder 3. Figure 7.16 shows an example of this cracking on NW Girder 3, and also illustrates the armor joint seal specific to the Robinson Road structure.

Figure 7.16: Extension of new cracking on south face of NW Girder 3, Robinson Road (10/7/00)

Of the five structures studied, the Robinson Road structure had the narrowest cracks and the slowest rate of deterioration. Much of this can be attributed to the armor joint seal that kept rainwater from flowing onto the abutment and girder ends (Figure 7.16). That evidence supports the hypothesis that keeping rainwater out of existing cracks on a structure greatly reduces the rate of deterioration and is a very effective strategy for damage mitigation.

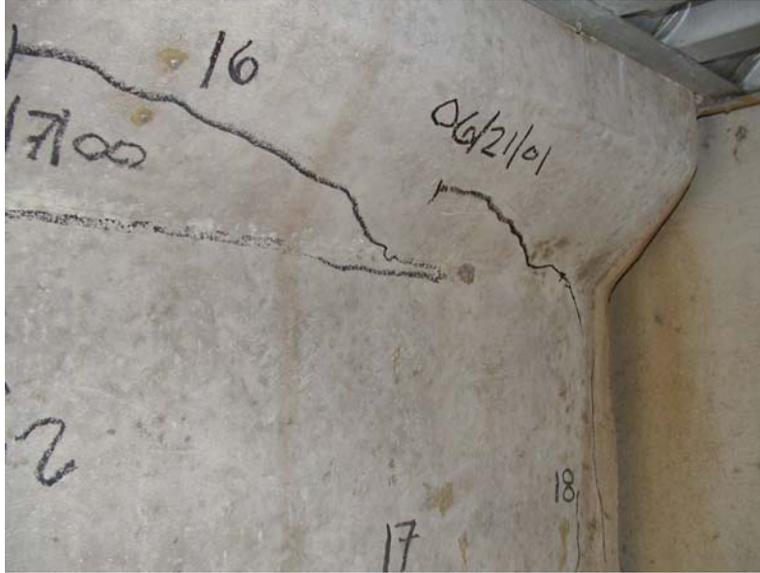
On June 21, 2001, it was observed that narrow cracks had continued to propagate. Figure 7.17 shows an extension of cracking near the end of NW Girder 2 at the west abutment. The status and locations of Points 16, 17, and 18 are also shown.

Figure 7.17: Extension of cracking on NW Girder 2, Robinson Road (6/21/01)

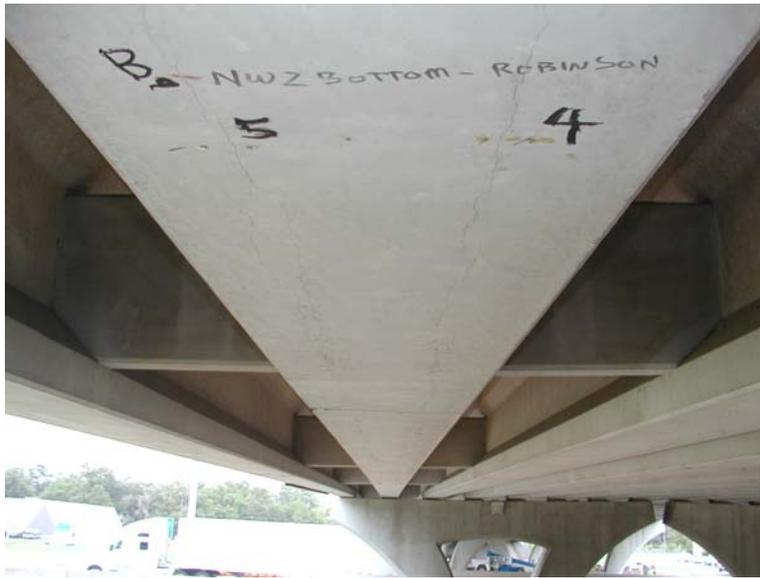
Longitudinal cracking was also apparent on the underside (Face 6) of NW Girder 2. Cracks extended from the west abutment to the middle of the span, as shown in Figure 7.18. Points 4, 5, and 6 were originally placed at this location to monitor the widths of the longitudinal cracks.

Figure 7.18: Extension of cracking on underside of NW Girder 2, Robinson Road (6/21/01)

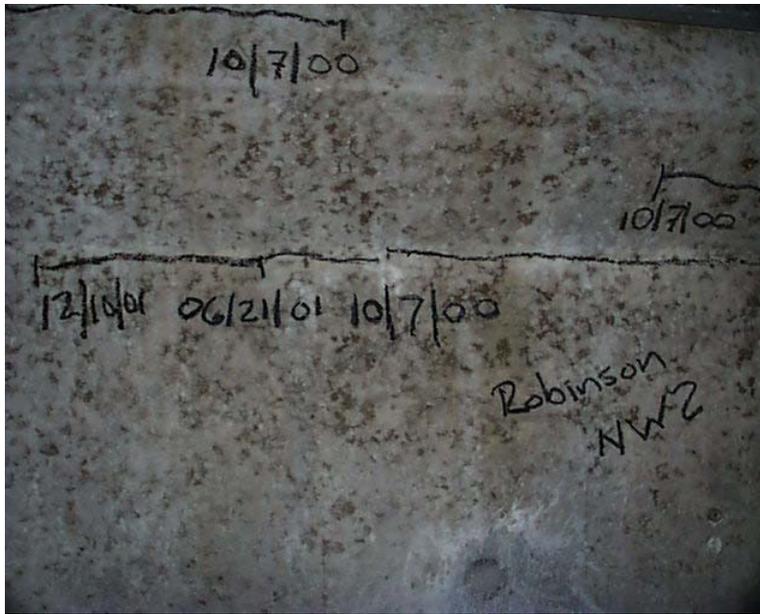
On December 10, 2001, Demec readings were lower than those taken on June 21, 2001 at all points; it was noted, however, that narrow cracks had continued to propagate. Figure 7.19 provides an example of the extension of cracking on NW Girder 2 throughout the course of the field study. Figure 7.20 shows a crack propagating past the point where it had been previously sealed.

Figure 7.19: Extension of cracking on north surface of NW Girder 2, Robinson Road, at west abutment (12/10/01)

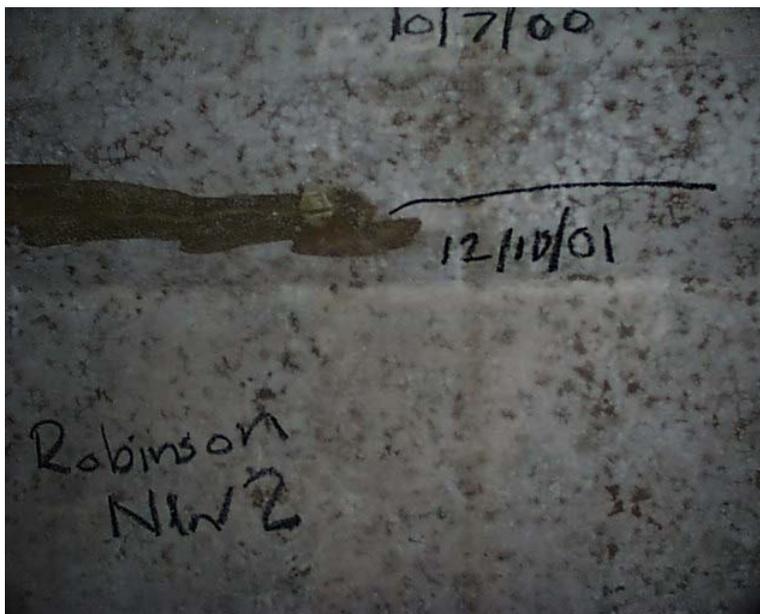
Figure 7.20: Extension of cracking past sealant on south surface of NW Girder 2, Robinson Road, at west abutment (12/10/01)

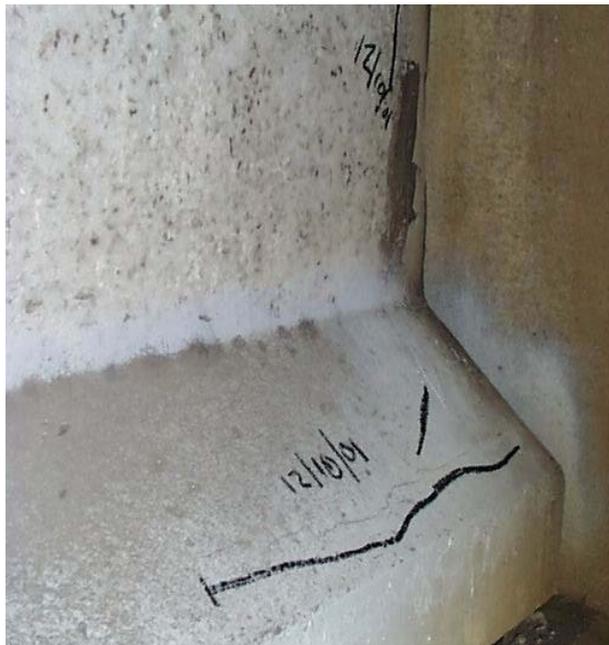
New cracks had become apparent on NW Girder 2 and NW Girder 3 at the site. A schematic diagram of the location of new cracks is shown in Figure 7.21. Figure 7.22 shows an example of new cracks on NW Girder 3.

Figure 7.22: New cracks on north surface of NW Girder 3, Robinson Road, at west abutment (12/10/01)

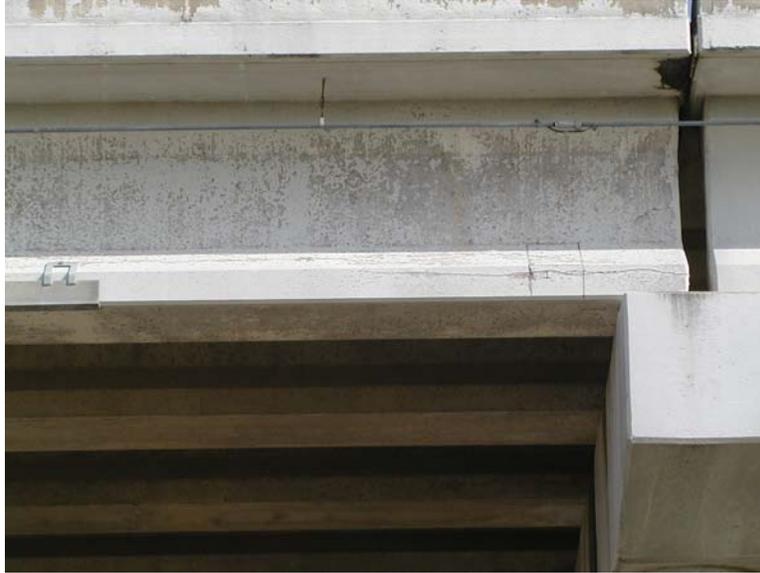
On June 22, 2001, the previously marked crack-measurement points were located. Demec discs were reinstalled at Points 1-5 with 30-minute epoxy (Figure 7.23). An overall view of Point 1 is shown in Figure 7.26. The contrast between damaged and undamaged girders is visible in the figure.

Figure 7.26: Overall view of Point 1, Beltway 8 structure (facing north) (6/22/01)

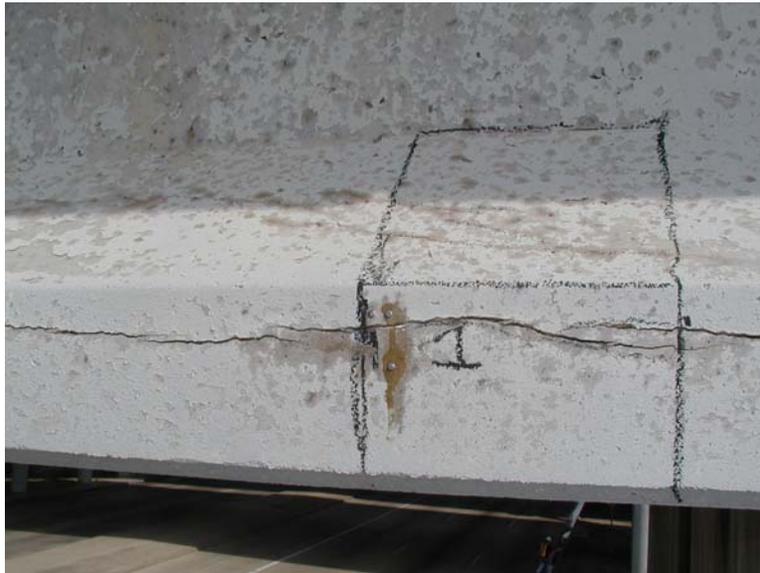
Figure 7.27 shows a close-up view of Point 1 and the representative areas previously defined on Face 4 and Face 5 for crack-ratio calculations.

Figure 7.27: Close-up view of Point 1, Beltway 8 structure (6/22/01)

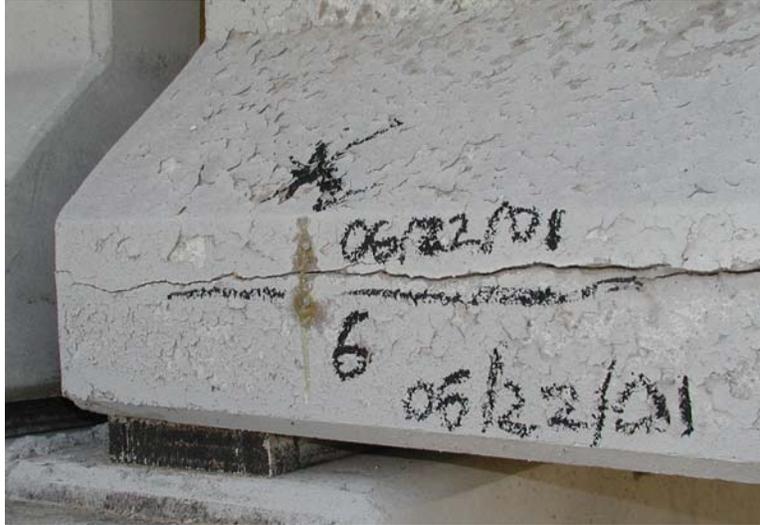
Two new sets of Demec discs were added to the structure at Point 6 and Point 7 (Figure 7.24). A wide crack existed at Point 6 on Face 5 of the girder, as shown in Figure 7.28.

Figure 7.28: Close-up view of Point 6, Beltway 8 structure (6/22/01)

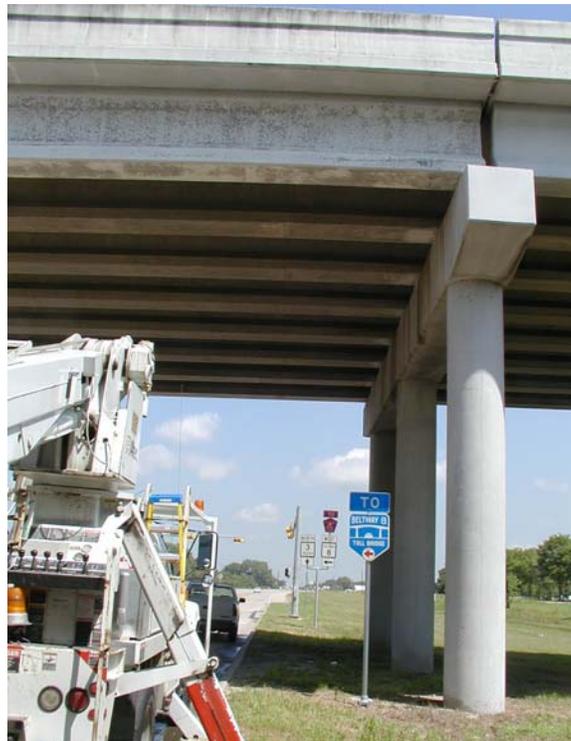
Similar cracking was observed at Point 7 on Face 5 of the south girder of the westbound frontage road bridge. Figure 7.29 shows an overall view of Point 7.

Figure 7.29: Overall view of Point 7, Beltway 8 structure (facing north) (6/22/01)

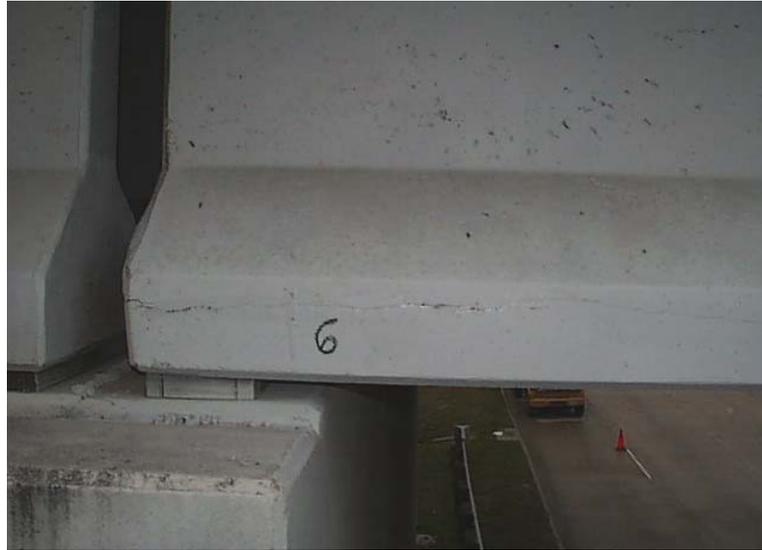
Paint was removed from the discs, and readings were taken with the Demec gauge at Points 3-6. Because of the paint, it was not possible to measure crack widths with the crack comparator card or optical scope. Some remaining exposed cracks to the left of Point 6 (Figure 7.30) were measured to be 0.03 in. (0.76 mm) to 0.05 in. (1.27 mm) wide, however. It was not clear whether these cracks had not been filled and sealed completely, or whether continued expansion of the concrete had reopened them.

Figure 7.30: Cracking near Point 6, Beltway 8 structure (12/11/01)

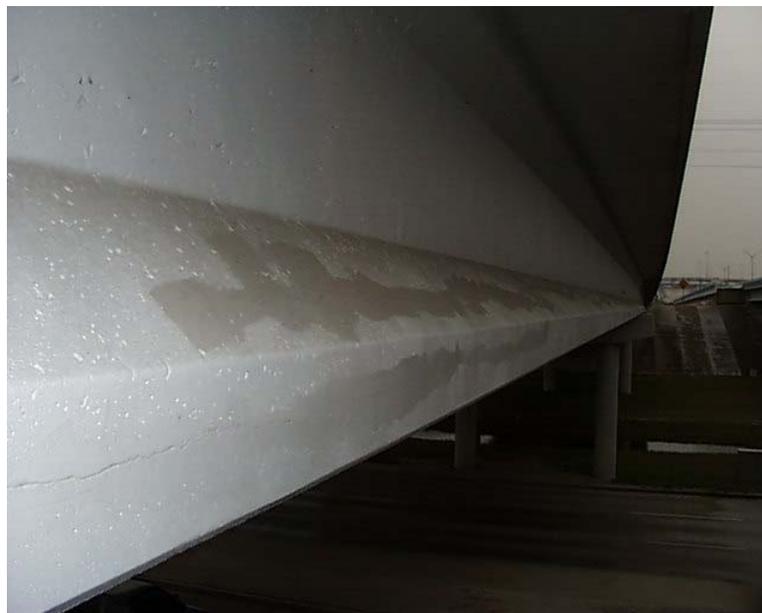
Figure 7.31 shows a typical example of sealed cracks along the bottom flanges (Face 4 and Face 5) of several girders.

Figure 7.31: Sealed cracks along girder flange near Point 6, Beltway 8 structure (12/11/01)
