1. Report No. FHWA/TX-03/0-1857-4		2. Government Accession No.		3. Recipient's Catalog No.	
4. Title and Subtitle Bridges with Premature Concrete Deterioration: Damage Indices, Strand-Pullout Tests, and Field Observations				5. Report Date December 2002

Bridges with Premature Concrete Deterioration: Damage Indices, Strand-Pullout Tests, and Field Observations

Research Report 0-1857-4

*STRUCTURAL ASSESSMENT OF IN-SERVICE BRIDGES
WITH PREMATURE CONCRETE DETERIORATION*

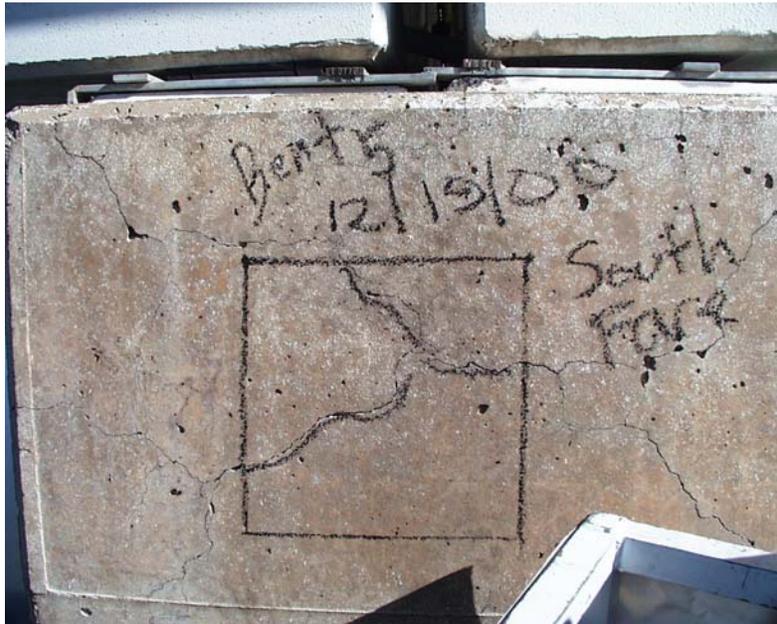
Representative squares were drawn on the south end of the bent cap at Bent 5 (Figure 7.42) and Bent 9. Cracks were plotted in the 12 in. (0.31 m) squares throughout the field study.

Figure 7.42: 12 in. (0.31 m) square on south end of bent cap, Bent 5 (12/19/00)

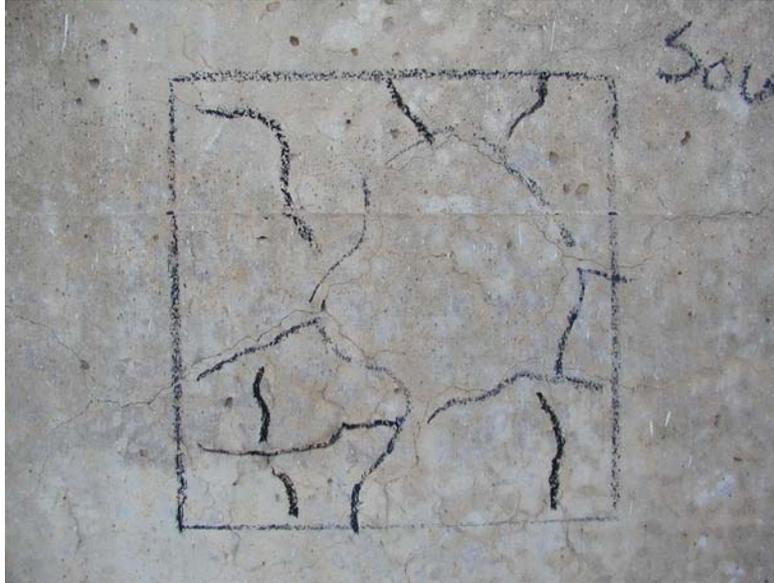
On April 24, 2001, damage to the structure was overall slightly worse than the previous visit. Cracks were wider on the south ends of the bent caps at Bent 5 and Bent 9, but the increase in width was minimal. New cracks had formed in these locations as well. Figure 7.43 shows cracking in the 12 in. (0.31 m) square on the south face of the bent cap at Bent 9.

Figure 7.43: 12 in. (0.31 m) square on south end of bent cap, Bent 9 (4/24/01)

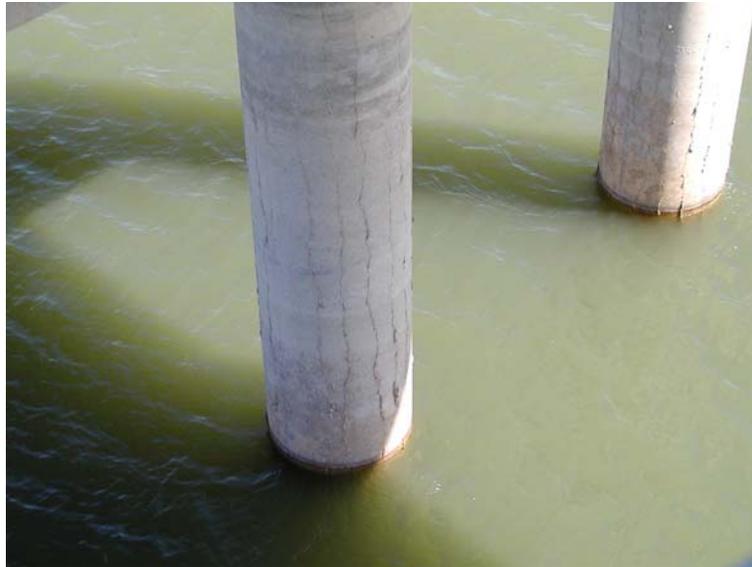
Cracking in the columns near the waterline had become more pronounced in several bents. Figure 7.44 shows vertical cracking in Bent 5. Point 10 was marked on the north column of Bent 11 (Figure 7.45). A new horizontal crack, 0.002 in. (0.05 mm) wide, was apparent at Point 10.

Figure 7.44: Example of column cracking near waterline of Bent 5 (4/24/01)

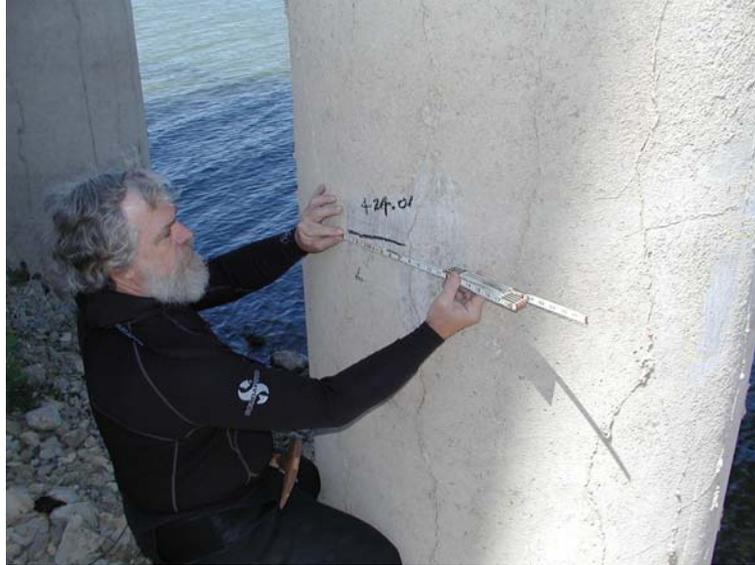
Figure 7.45: Example of column cracking near waterline of Bent 11 (Point 10) (4/24/01)

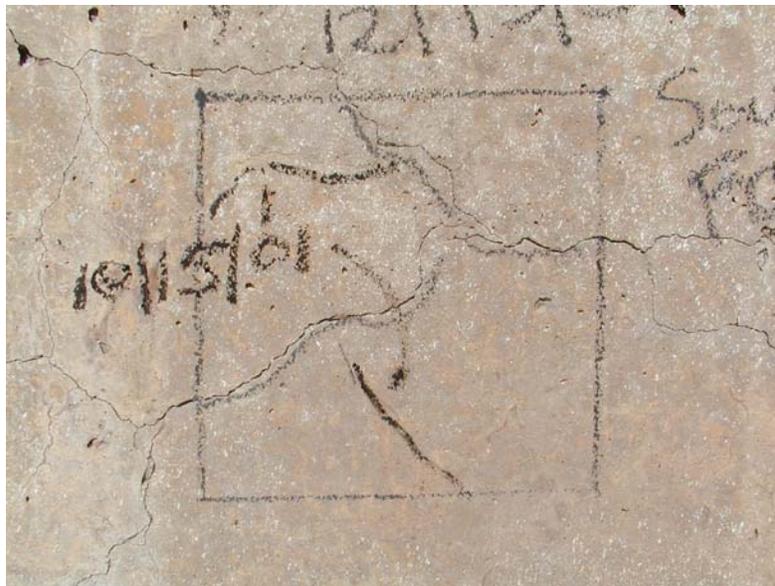
On October 15, 2001, deterioration was slightly worse than the previous visit; in some areas, cracks were not noticeably different, however. Some new cracks had formed on the south ends of the bent caps at Bent 5 and Bent 9. Figure 7.46 shows map cracking on the south end of the bent cap at Bent 5. New cracks are labeled with the date 10/15/01.

Figure 7.46: New cracks on 12 in. (0.31 mm) square on south end of bent cap, Bent 5 (10/15/01)

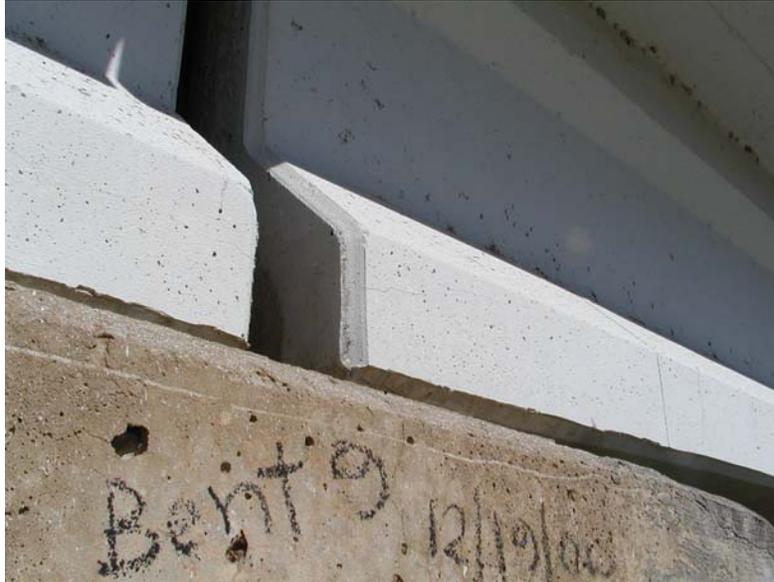
Point 11 was placed on October 15, 2001, on the exterior face of one of the south girders at Bent 9. New cracks had formed at that location since the previous visit to the bridge on April 24, 2001 (Figure 7.47 and Figure 7.48). Similar cracks became apparent on the exterior faces of the south girders at Bent 5.

Figure 7.47: New cracks on exterior faces of south girders at Bent 9 (10/15/01)

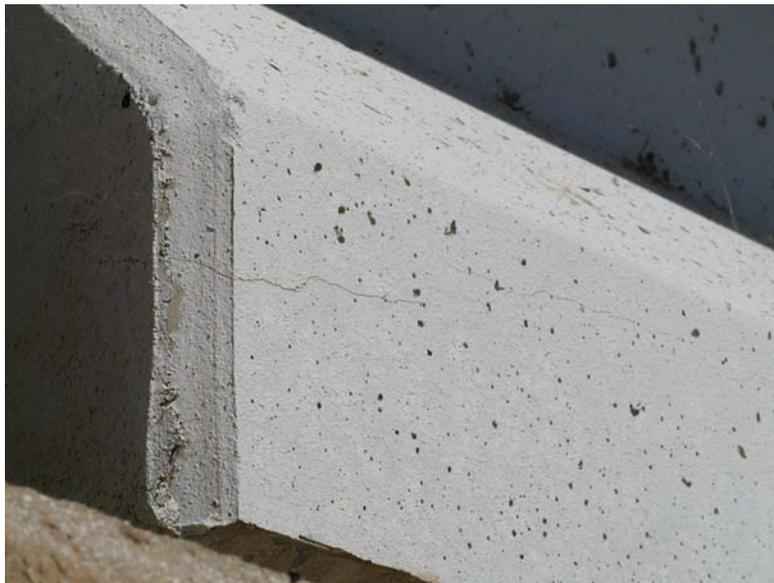
Figure 7.48: Close-up of new cracks on south girder at Bent 9 (10/15/01)

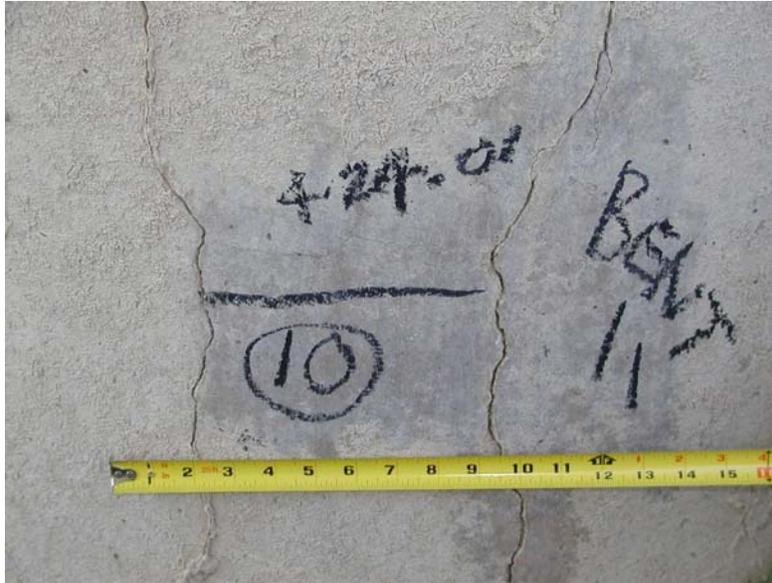
Vertical cracks at Point 10 on Bent 11 had widened to 1/8 in. (3.2 mm). These long, wide cracks extended upwards to the bottom of the tie beam. Figure 7.49 and Figure 7.50 show the status of cracks near the waterline on Bent 11 on October 15, 2001. The horizontal crack visible at Point 10 had widened to approximately 0.013 in. (0.25 mm) (Figure 7.51).

Figure 7.49: Column cracking at Point 10 near waterline, Bent 11 (10/15/01)

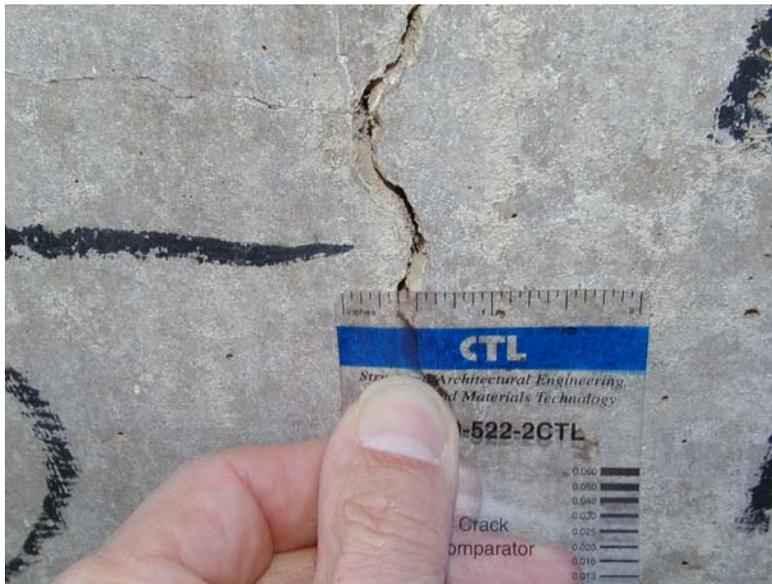
Figure 7.50: Close-up of vertical cracking at Point 10 near waterline, Bent 11 (10/15/01)

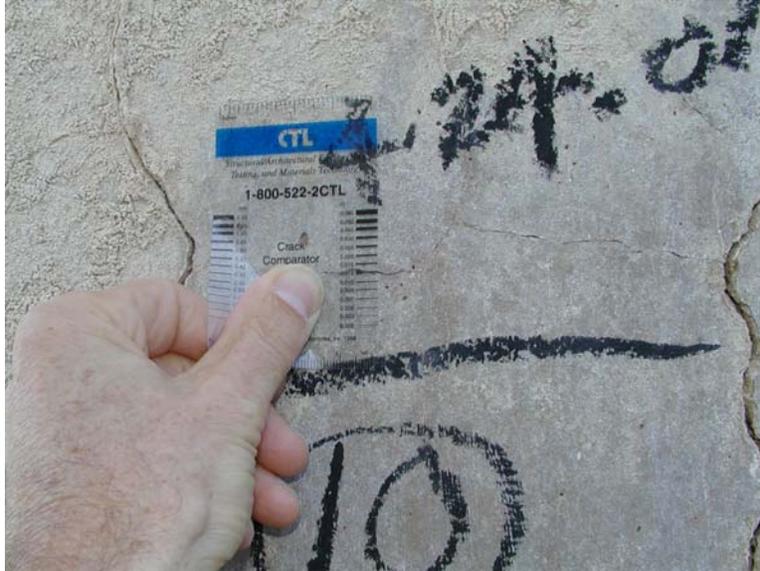
Figure 7.51: Close-up of horizontal crack at Point 10 near waterline, Bent 11 (10/15/01)

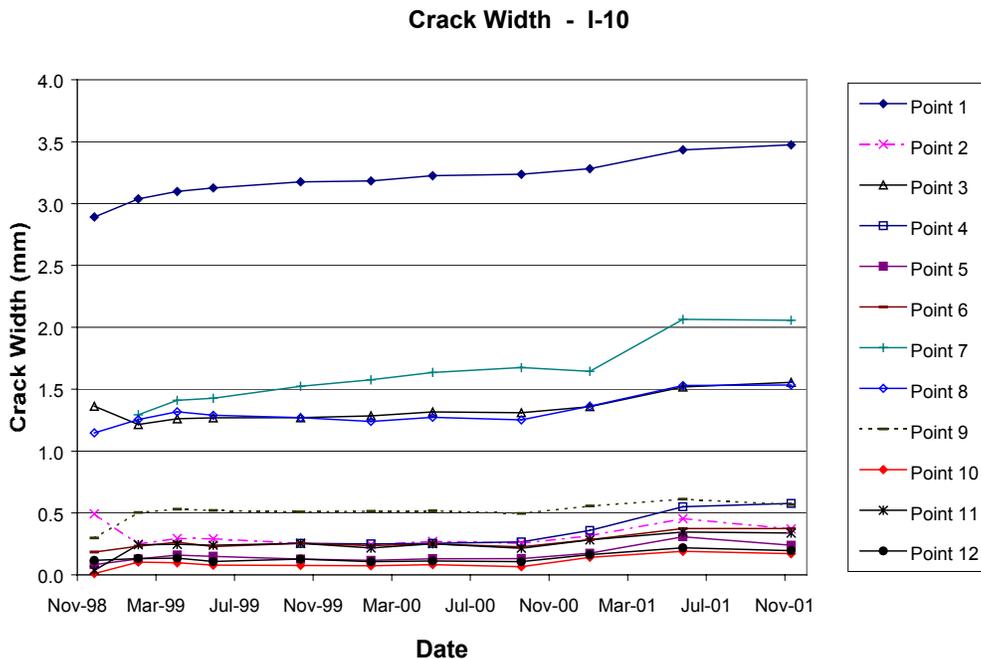
Figure 7.52: Crack width over time for I-10 structure

Cracks gradually widened over the course of the field study; they widened more rapidly between October 7, 2000 and June 21, 2001.

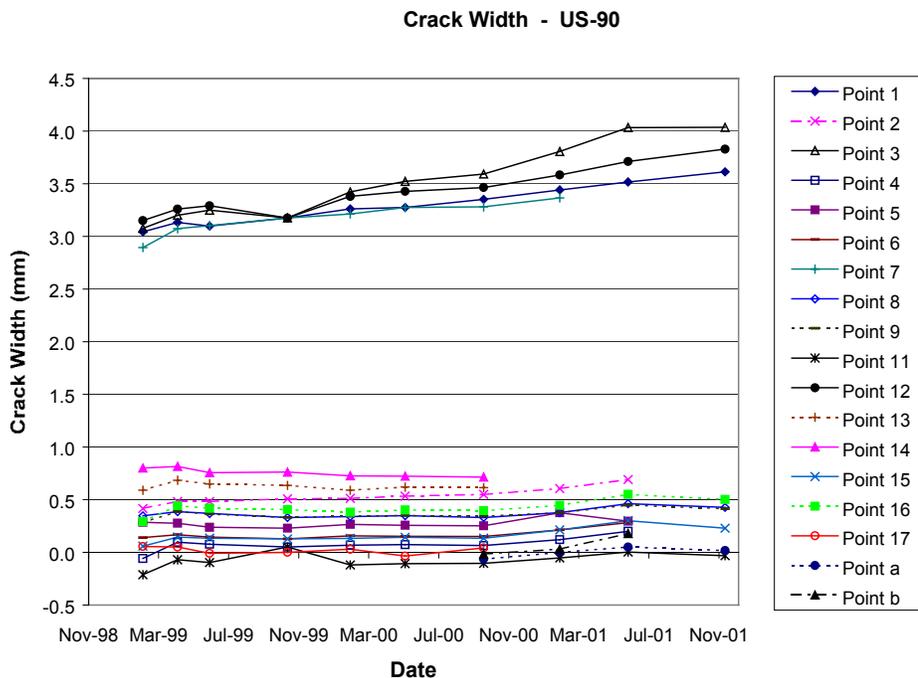
Cracks at Points 1, 3, 7, and 12 were significantly wider than at all other monitored points, and experienced dramatic increases in width compared to the majority of measurement points on the US-90 structure. Crack widths at other points remained below 1 mm and displayed gradual increases and decreases.

Figure 7.53: Crack width over time for US-90 structure

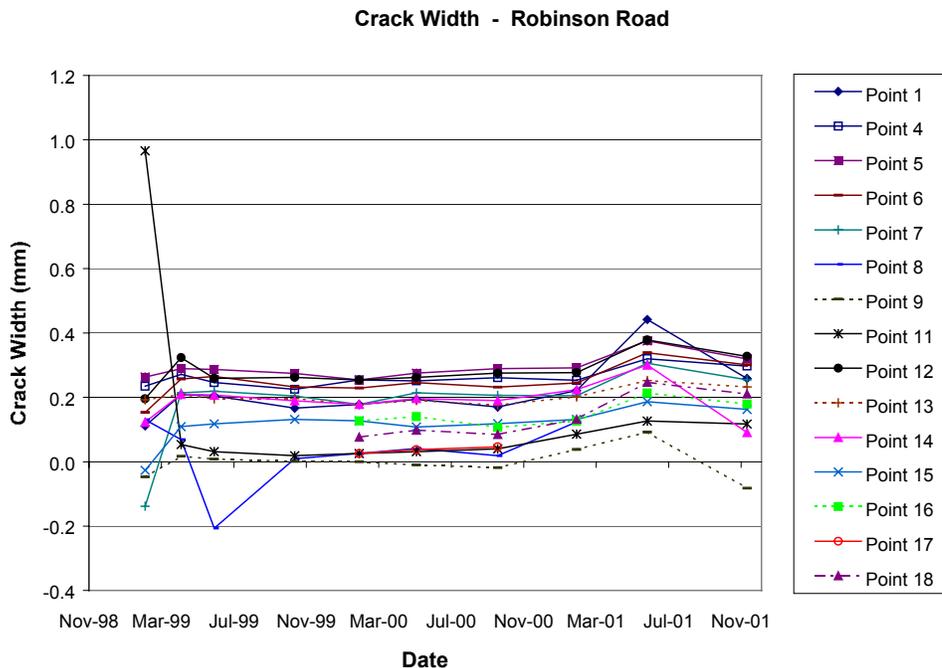
Cracks at the Robinson Road structure behaved like those of the other bridges monitored in this study. Most crack widths were about 0.3 mm throughout the field-observation program. Between February 19, 2001 and June 21, 2001, cracks generally widened at all points; between June 21, 2001 and December 10, 2001, they generally narrowed.

Figure 7.54: Crack width over time for Robinson Road structure

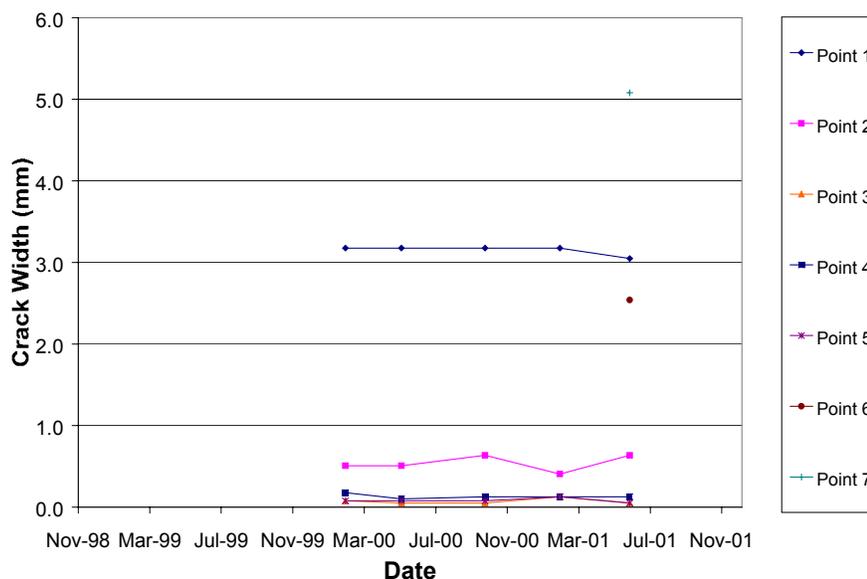
Cracks did not generally widen or narrow significantly; Demec readings, however, may have shown greater changes between visits to the structure. It is very difficult to evaluate gradual changes with a crack comparator card.

Figure 7.55: Crack width over time for Beltway 8 structure

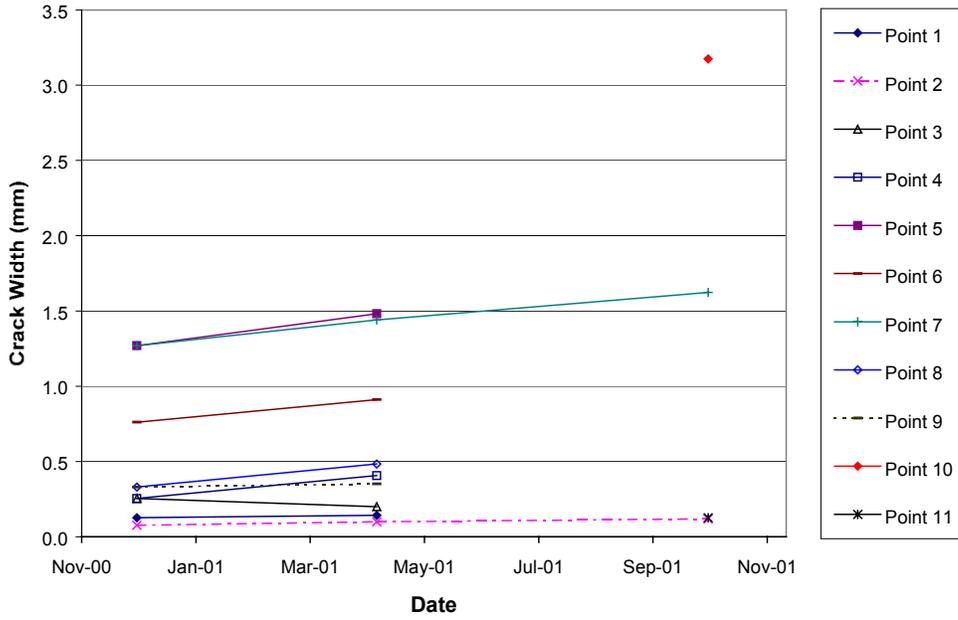
Cracks on the Lake Ivie structure are gradually widening or unchanging. Crack comparator measurements at Point 5 and Point 9 on October 15, 2001, however, indicate that these cracks narrowed following the April 24, 2001 visit.

Figure 7.56: Crack width over time for FM 1929 at Lake Ivie

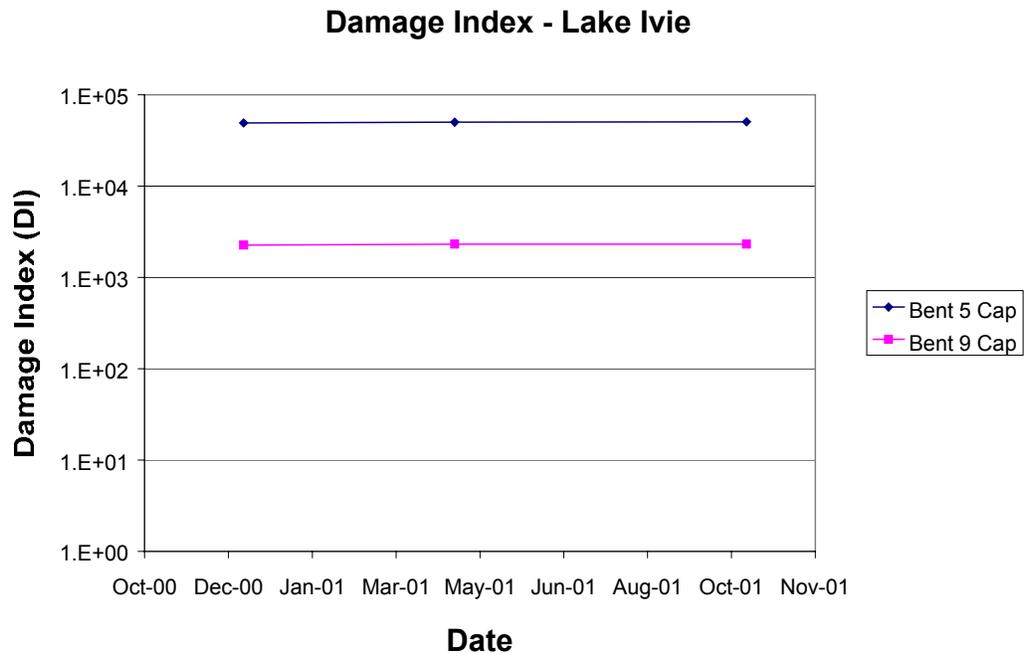
Figure 7.58: Damage Index over time for FM 1929 at Lake Ivie

The damage index for representative area on the south end of the Bent 5 cap is increasing at an average rate of 1729 units/year (3.5% per year), and the damage index for the representative area on the south end of the Bent 9 cap is increasing at an average rate of 59 units/year (2.5% per year).

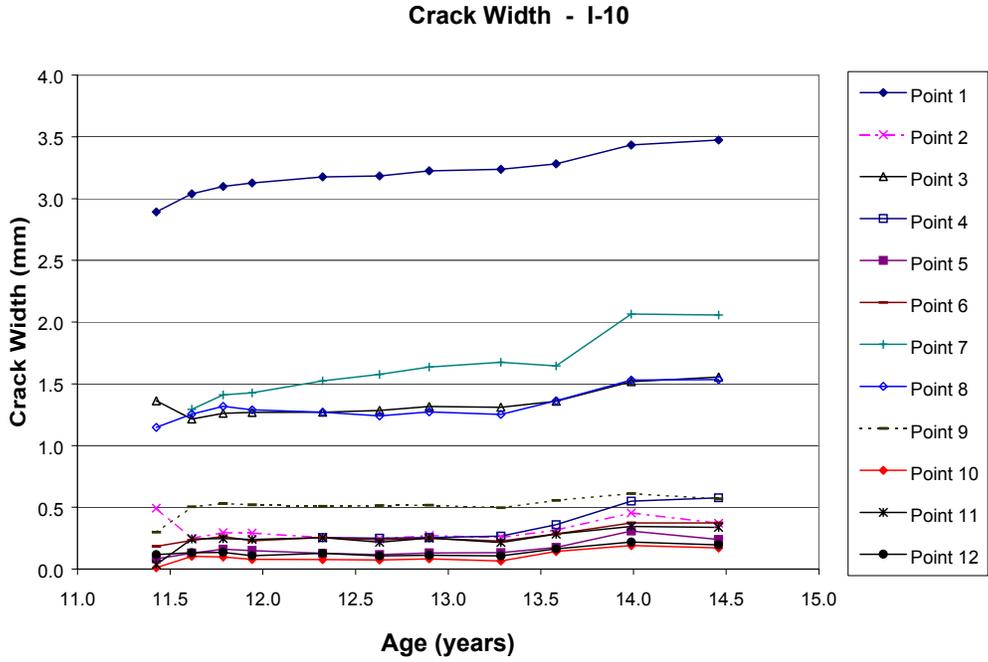
The behavior of cracks at those eight points on the I-10 and US-90 structures shows that severe exposure to water can be directly linked to accelerated crack growth. These observations match those of Boenig (2000) in earlier stages of the field observation program.

Figure 8.1: Crack width versus age of girder for the I-10 structure

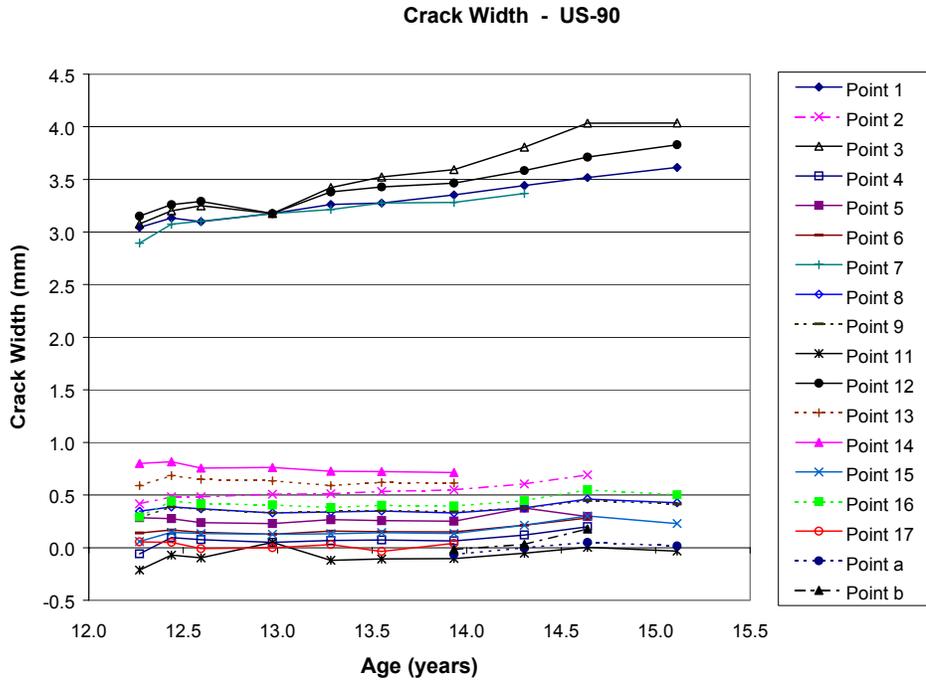
At the US-90 structure, cracks at Points 1, 3, 7, and 12 were significantly wider than at other measurement points. Those four cracks were the only ones to widen substantially; other cracks experienced only slight widening. Points 1, 3, 7, and 12 were on Face 4 or Face 5 and were all within 53 in. (1.35 m) of the ends of their respective girders at the west abutment.

Figure 8.3: Crack width versus age of girder for the US-90 structure

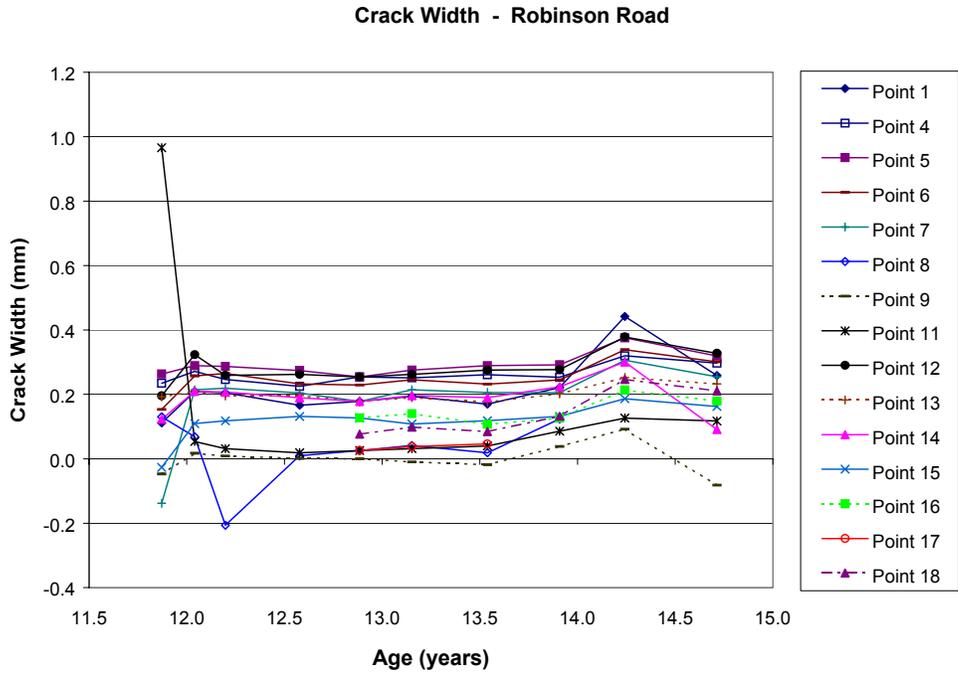
Figure 8.5: Crack width versus age of girder for the Robinson Road structure

Of the five structures studied, the Robinson Road structure had the narrowest cracks and the slowest rate of deterioration. Much of this can be attributed to the armor joint seal that kept rainwater from flowing onto the abutment and girder ends (Figure 7.16). That evidence supports the hypothesis that keeping rainwater out of existing cracks on a structure greatly reduces the rate of deterioration and is a very effective strategy for damage mitigation.

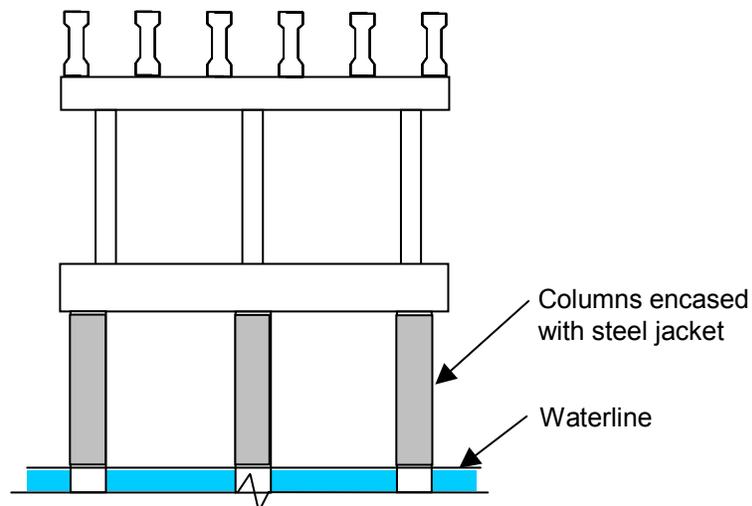
Figure 9.1: Steel jacket around bent columns

The steel may add some confinement to the damaged columns; its effectiveness is unknown, however, because the confinement for the column cores is already provided by spiral reinforcement.

The benefits of wrapping a steel jacket around damaged columns include easy technology and ease of installation. Steel is impermeable, however, and it can trap water in columns, which only perpetuates the deterioration-causing reactions. Damage would be hidden by the steel jacket; therefore, it would no longer be possible to continue crack monitoring. Additionally, the steel would rust and likely result in an unattractive and ineffective solution.

Encase the bent columns with steel jackets, as shown in Figure 9.1.

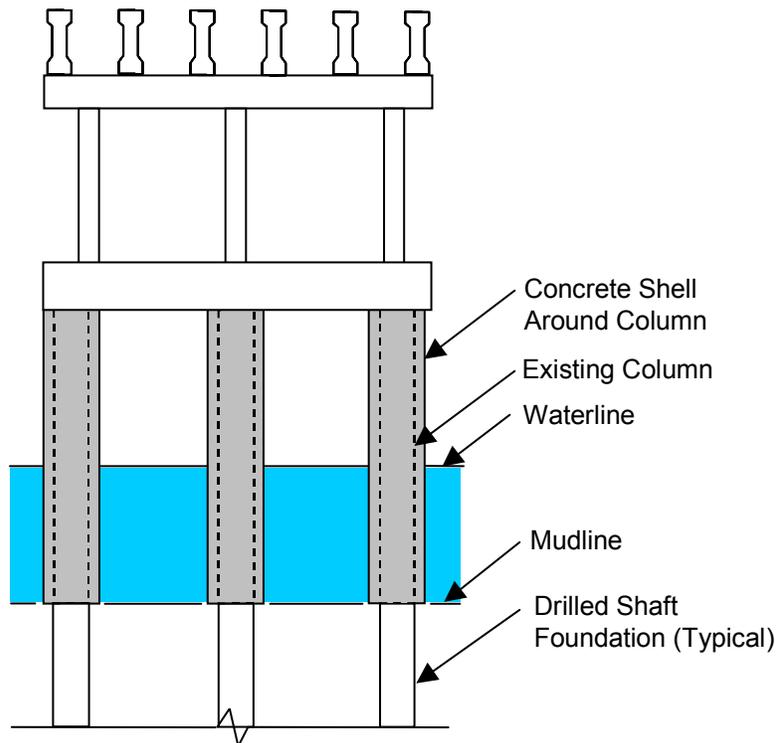
Figure 9.2: Concrete shells poured around bent columns

Pouring concrete shells around the bent columns would strengthen the damaged columns somewhat by increasing their diameter. Underwater construction would be difficult, however, and crack monitoring would no longer be possible.

Pour concrete shell around bent columns, as shown in Figure 9.2.

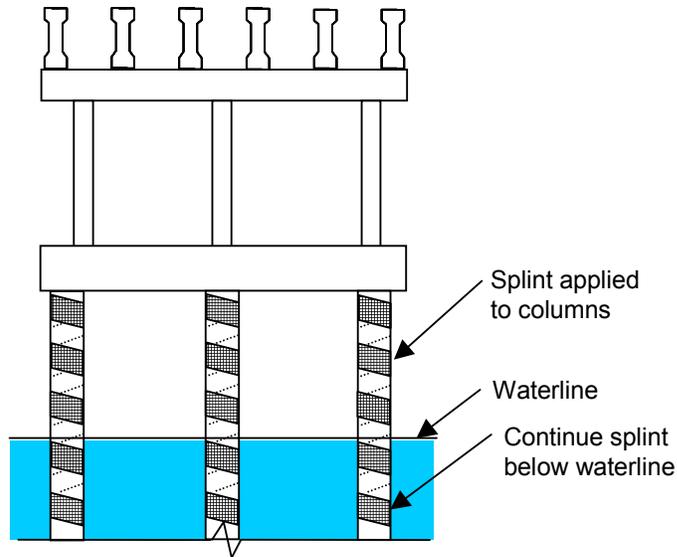
Figure 9.3: Splints installed on bent columns

A splint is a partial wrap for strength. It would be designed to strengthen the column by adding confinement. The core is already confined, however, by spiral reinforcement. Existing cracks would still be visible; inspectors could continue to monitor the progression of deterioration. Splints could be installed as an intermediate step; additional strengthening techniques could be applied at a later time if needed.

Install “splints” on the bent columns, as shown in Figure 9.3.

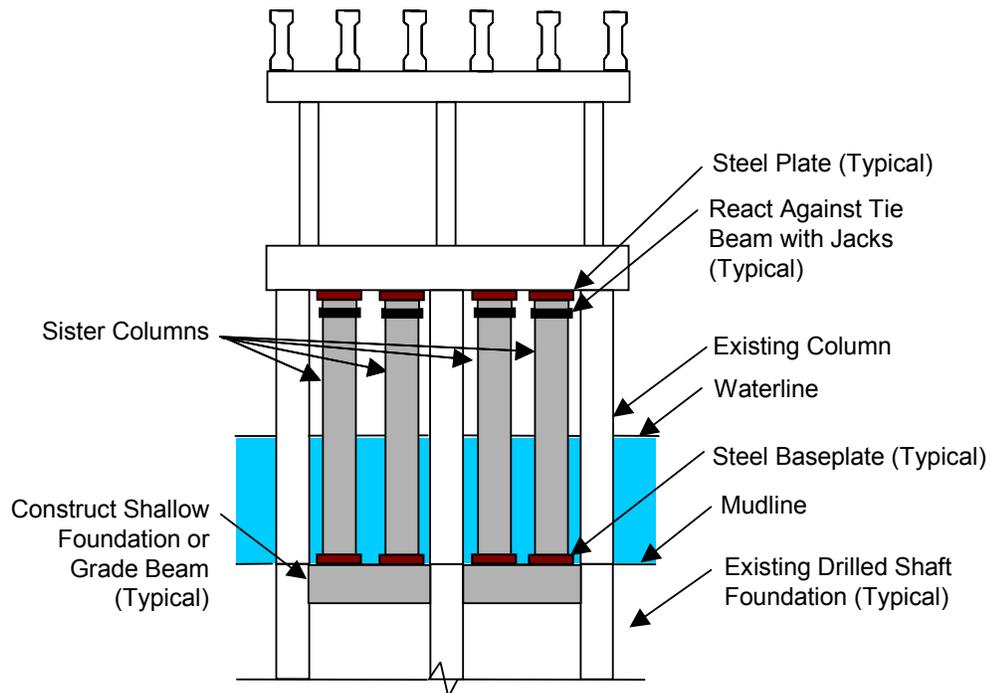
Figure 9.4: Sister columns installed at bent

Sister columns would strengthen the bents by taking some of the loads intended to be carried by the existing lower columns. Because each column is supported by a drilled shaft of the same diameter, shallow foundations or grade beams would have to be constructed to provide bearing surfaces for the sister columns. Because the existing columns are rigidly connected to the tie beam, the sister columns would have to react against the tie beam to transfer the load path away from the existing damaged columns.

Install sister columns, as shown in Figure 9.4.

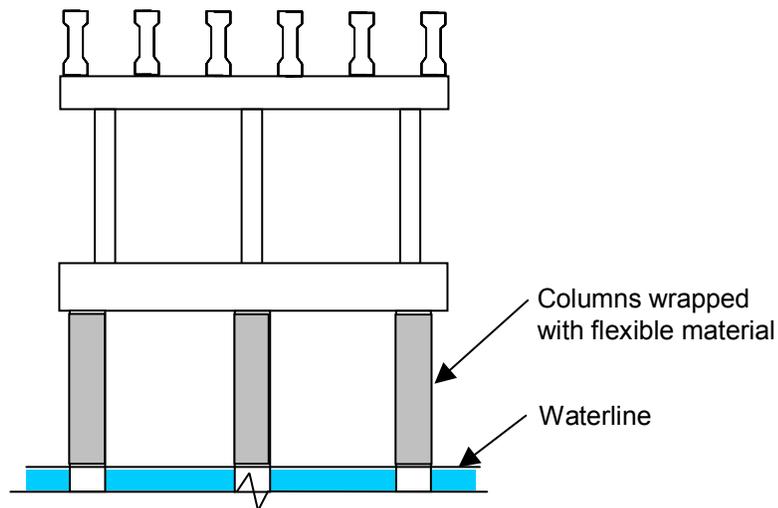
Figure 9.5: Flexible wrap around bent columns

A partially permeable wrap would keep water out of cracks above the waterline. It should be breathable for vapor to allow moisture inside the concrete to escape, but impermeable for liquid so that further exposure to rainwater is eliminated. This option will prevent large amounts of water from entering the cracks; however, it will prevent inspectors from determining the status of deterioration above the waterline. Because the lower columns are under water, it is not possible to eliminate exposure to water completely.

Wrap bent columns with flexible, partially permeable material, as shown in Figure 9.5.

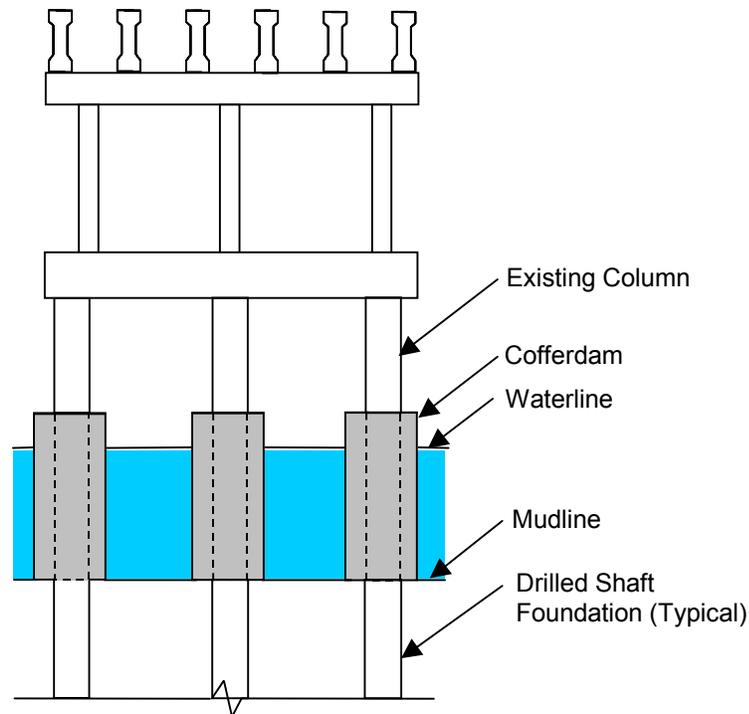
Figure 9.6: Cofferdams constructed around bent columns

The purpose of cofferdams would be to keep the columns dry below the waterline. This method is problematic, however, because of the expense and difficulty of construction and installation.

Construct cofferdams around the bent columns, as shown in Figure 9.6.

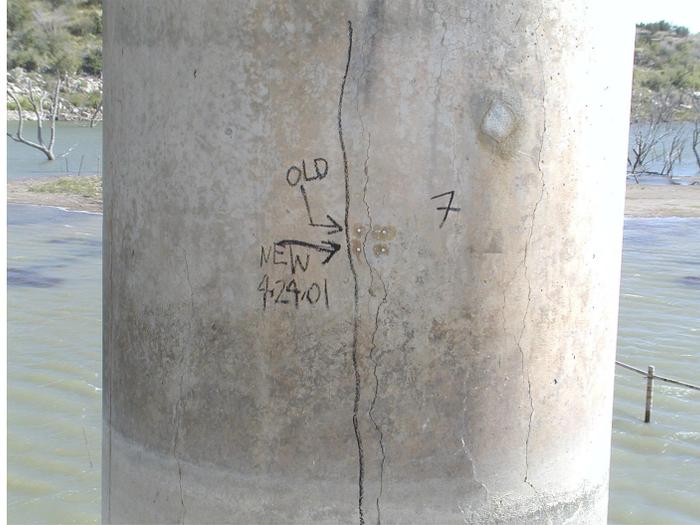
Figure 9.11: Typical vertical cracking on south lower column of Bent 5 (10/15/01)

Figure 9.11 shows typical damage (observed on October 15, 2001) near Point 7 on the south lower column of Bent 5. Based on these field observations, a damage index can be estimated for this column. On October 15, 2001, the vertical crack at Point 7 (Figure 9.9) was 0.064 in. (1.63 mm) wide, as determined from Demec measurements. If a representative 12 in. (0.31 m) square is drawn on the column, at most two or three vertical cracks can be expected to extend through that square. Using Equation 3-1 and assuming three vertical cracks of the same width in the representative square, the damage index for the column as of October 15, 2001 can be estimated:

From Figure 9.9, a damage index of 147,000 corresponds to a f_c / f_c' ratio of 0.51, and to almost the same ratio of probable to specified compressive capacity.
