Corrosion Resistance Recommendations from Long-Term Exposure Testing of Post-Tensioning Systems

CTR Technical Report:	0-4562-5F
Report Date:	May 2013
Project:	0-4562
Project Title:	Corrosion Resistance of Grouted Post-Tensioning Systems
Sponsoring Agency:	Texas Department of Transportation
Performing Agency:	Center for Transportation Research at The University of Texas at Austin

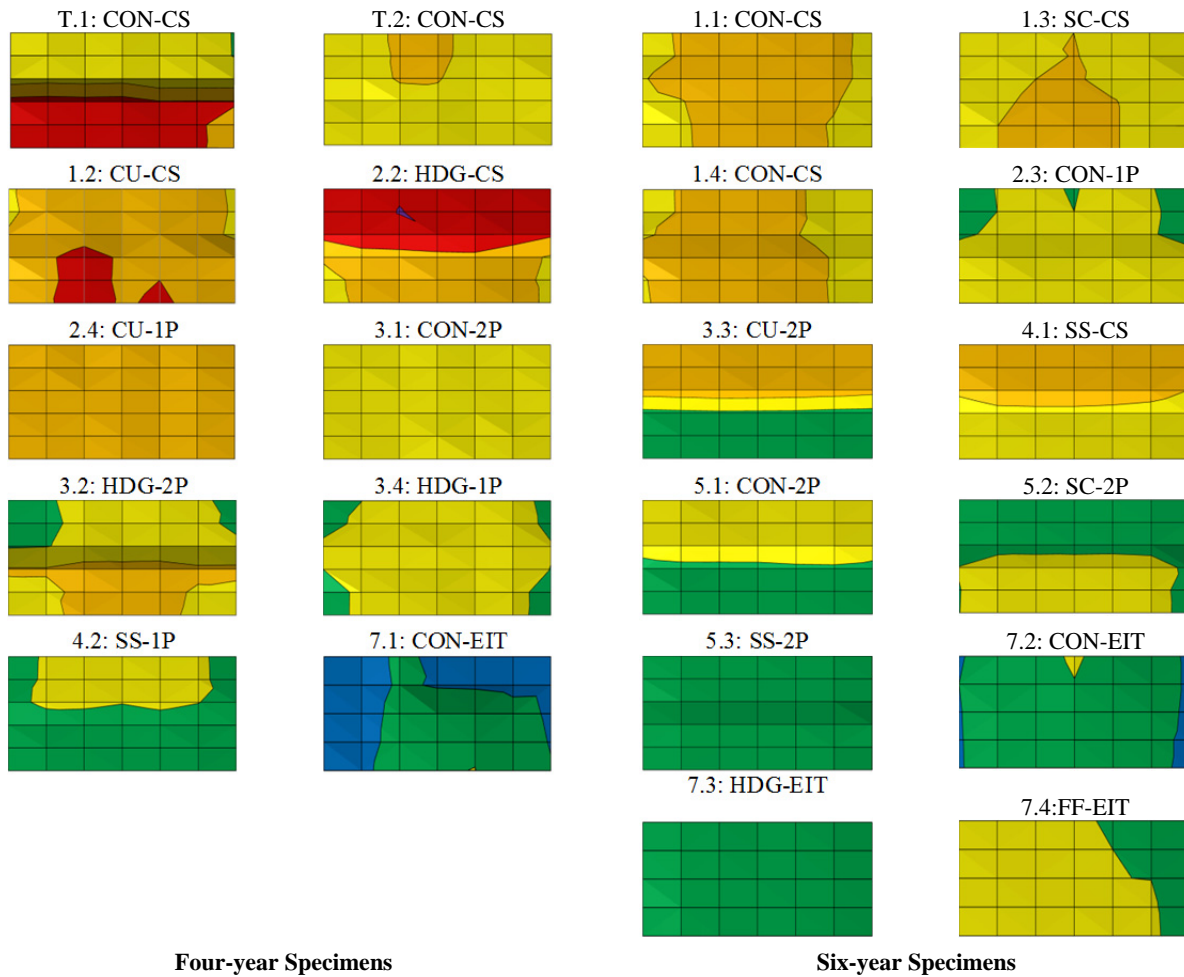
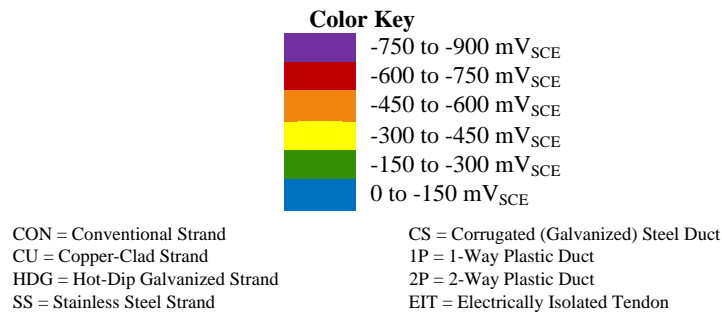
Figure 5.4 – Final Half-Cell Potential Contour Plots

Half-cell contour plots are presented in Figure 5.4 for both four- and six-year specimens. These plots represent the final potential readings taken at every point on each specimen just prior to autopsy. Specimens 4.4 and 4.3 did not contain any duct or prestressing tendons and are therefore not included. Note that the contour maps represent an overhead view of the ponding region of the specimens with the live end to the left and the north coupled duct on the top and south uncoupled duct on the bottom. The least negative potentials are shown in blue and green and represent the lowest corrosion potential. The red and purple regions have the most negative potential and are accordingly the most susceptible to corrosion. North and south duct differences were seen in specimens across both exposure durations. However, some specimens such as T.1, 1.2, and 5.2 showed the uncoupled tendons with a more negative potential while others such as 2.2, 3.3, and 5.1 showed coupled tendons with a more negative potential. Both sets of specimens did show some variation between the ends of the ponding region and midspan. Specimens 3.2 and 3.4 from the four-year exposure and specimens 1.4 and 2.3 from the six-year exposure both show a higher corrosion potential towards midspan.

Differences in north and south cannot be attributed to the differences in couplers between the tendons. The differences in the ends of the ponding area versus midspan can be seen in some instances, indicating a greater probability of corrosion at midspan. This is not, however, attributed to greater cover, as the tendon is at a uniform depth across the ponding region. More likely the potential is associated with likelihood of cracks to form near midspan and around the grout vents to promote chloride ingress. As with the half-cell measurements over time, the final contour plots do not show a significant difference between coupled and uncoupled ducts. The stainless steel, two-way plastic duct, and electrically isolated tendons (EIT) tend to have the

lowest corrosion potential while the specimens with galvanized duct show the worst behavior and highest corrosion potential.

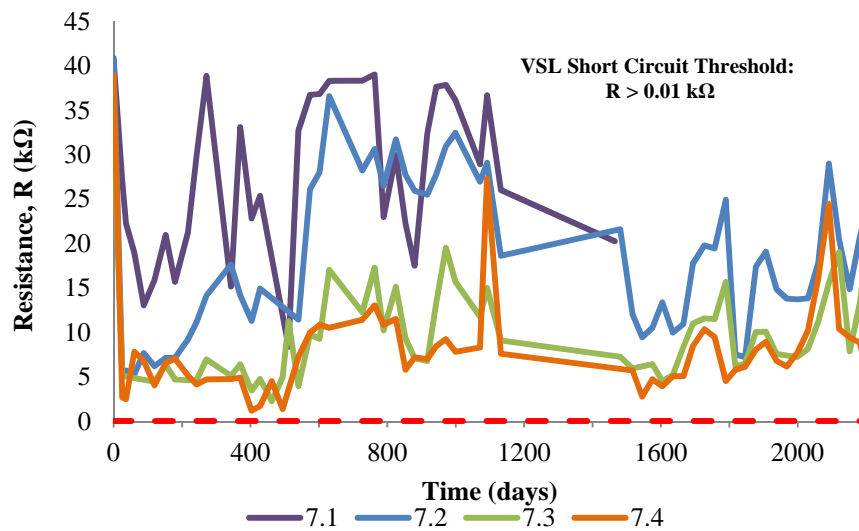
Figure 5.5 – Resistance of EIT Specimens throughout Exposure

Resistance, capacitance, and loss factor were measured each month on specimens 7.1, 7.2, 7.3, and 7.4. Outliers were omitted from the analysis at 462 and 494 days for specimen 7.1 by McCool. Measured values at these times were several orders of magnitude larger or smaller than the rest of the data. VSL defines the minimum resistance required to assure the absence of a short circuit to be 10Ω ⁸. All resistance measurements easily exceed this value as shown in Figure 5.5. Thus, it is reasonable to assume that no short circuit occurred between the tendon and reinforcing steel.

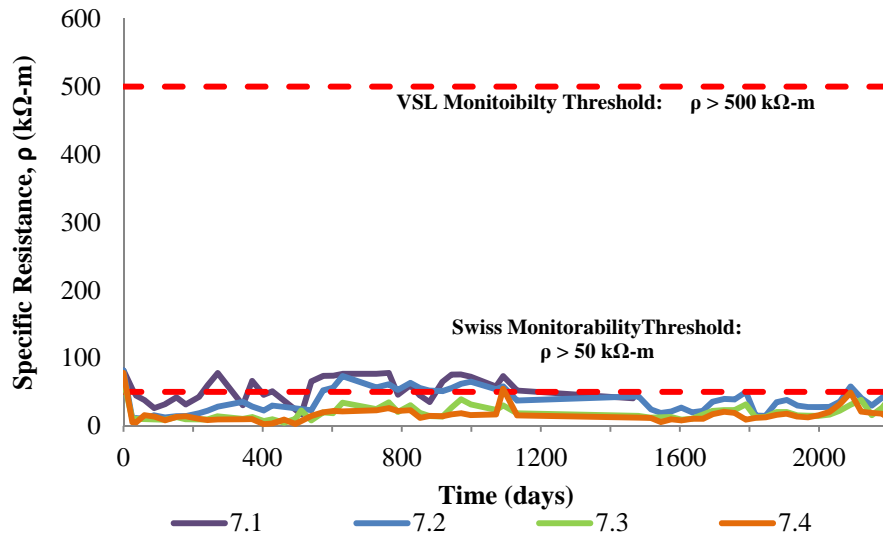
Figure 5.6 – Specific Resistance of EIT Specimens throughout Exposure

VSL also defines a threshold specific resistance of $500 \text{ k}\Omega\text{-m}$ ⁸, below which a post-tensioning tendon is not considered monitorable in the long term. All of the specific resistance values were well below this value, suggesting that the tendon is not suitable for accurate long-term monitoring. However, ASTRA (Swiss Federal Road Office) gives a much lower threshold⁹ for monitorability of $50 \text{ k}\Omega\text{-m}$. As Figure 5.6 indicates, approximately 60% of the specific resistance values for Specimen 7.1 were above this threshold, with specimens 7.2, 7.3, and 7.4 registering less than that throughout their respective exposures.

The ASTRA standard is several years newer than that which was published in fib Bulletin 33. The specific resistance threshold was reduced after field experience showed that 500 k Ω -m was nearly unattainable. Regardless of which standard is used, the monitorability of the EIT specimens is in question. While Figure 5.5 shows no short circuits, the data shown in Figure 5.6 effectively nullifies whatever conclusions may be drawn from this. The procedure seemed suspect and even called for McCool to contact the distributor and initiate different testing methods.

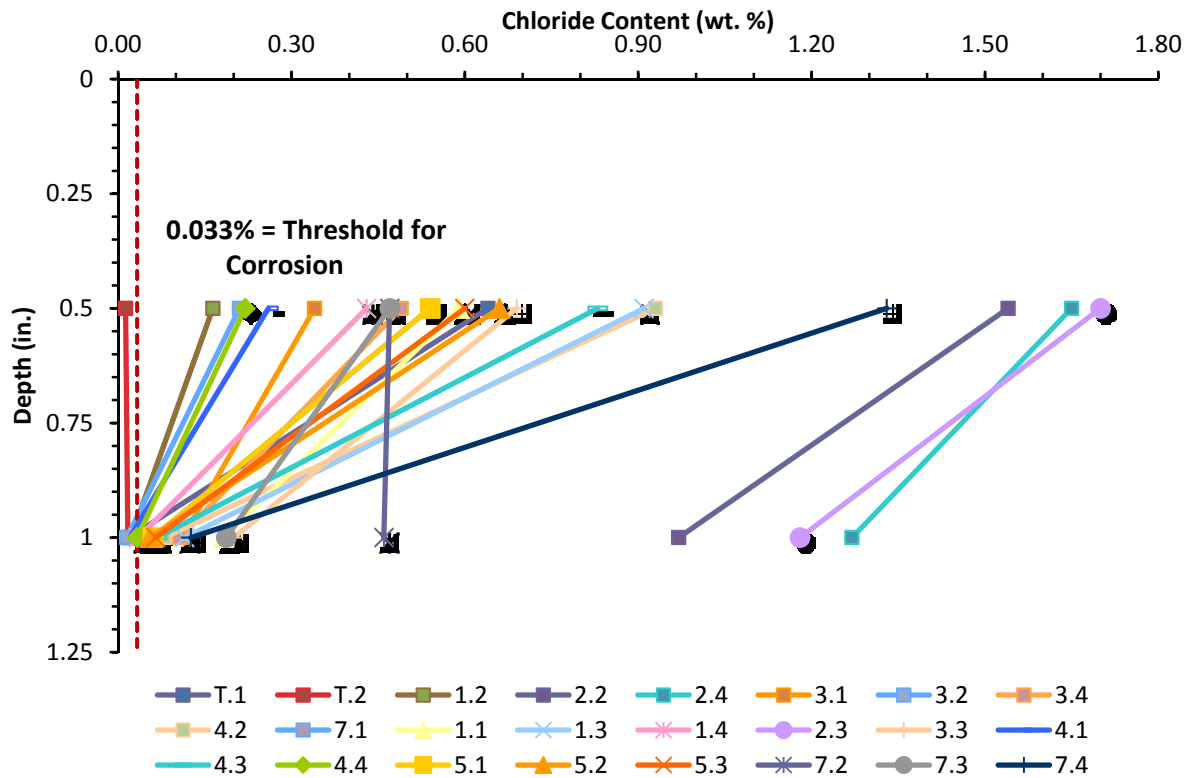
Figure 5.7 – Chloride Penetration from Top of Specimen

Penetration of chlorides into the top of the specimen occurred in both the 0.5 in. and 1 in. samples taken at four and six years. The maximum chloride content occurred in specimens 2.2 and 2.4 from the four-year exposure and 2.3 from the six-year exposure. While these three specimens are consecutive in the naming process, they represent three different types of strand and two types of duct. Therefore there does not appear to be a direct connection between them. From the data presented in Figure 5.7, only specimen 7.1 does not show a decrease in chloride content as with an increase in depth. Finally, only specimen T.2 is below the corrosion threshold.

The figure shows only six specimens had content below the threshold at 1 inch depth. They are, however, grouped well below 0.30% with outliers for specimens 7.1, 2.2, 2.4, 7.2, and 2.3. The high level of chlorides within the top surface of the specimens may indicate one of two things. Either several samples were extracted from a small crack or the concrete was relatively porous and allowed chlorides to permeate to a depth of at least one inch. The procedures McCool and Moyer adhered to deliberately attempted to avoid the former. The latter is more realistic and plausible. The surface of the specimens' saltwater trays generally appeared to be in poor condition upon autopsy at both four and six years, and the subsurface concrete condition could have been affected as well. Had control blocks been cast alongside the post-tensioned specimens at the start of the project with inert dye to display penetration effectively, there would be a better understanding of the transport of chlorides through the concrete.

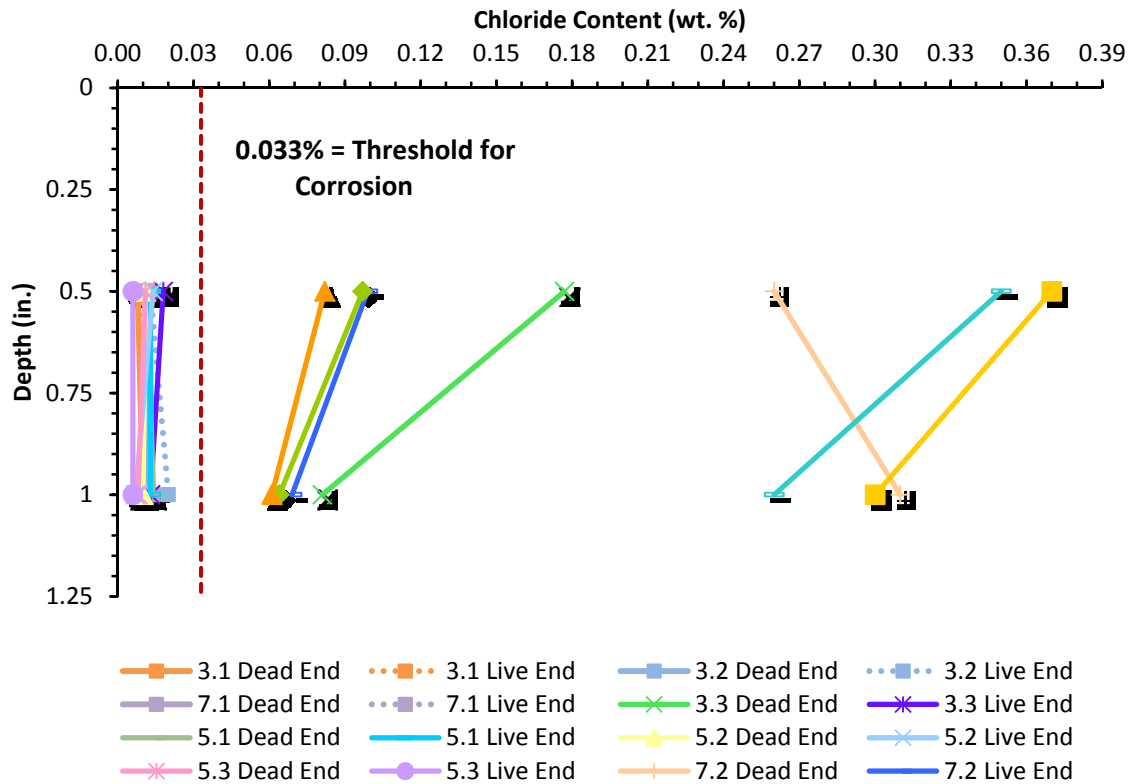
Figure 5.8 – Chloride Penetration at Anchorage Region with Salt Solution Spray

Anomalies in both sets of specimens were noticeable around the anchorages. Samples were taken for specimens that were subject to exposure from drippers as well as unexposed specimens. Chloride contents for the anchorage regions of the dripper as well as non-dripper specimens are shown in Figure 5.8 and Figure 5.9. Note that on the dead end of the specimens, samples were extracted 5 inches from the top surface. On the live end, samples were extracted 6 inches from the top surface. For 7-series specimens, samples were extracted 6 inches from the top surface at both ends. At all extraction sites, samples were taken at depths 0.5 and 1 inch.

Surprisingly, samples from the dead end anchorage regions of Specimens 5.1, 5.2, and 5.3, which were the ends that received salt solution spray, did not have chloride contents above the corrosion limit. This might be due to the concrete of the pour backs being well consolidated, causing the concrete to have lower permeability than the other dead end pour backs. Another interesting observation is the chloride contents of the live end anchorage regions of the 7-series had chloride contents above the corrosion limit. Moyer noted cracking over the vent spout in the anchorage during the visual inspection before autopsy and this may contribute to the elevated

chloride content. Another anomaly is the chloride content of the concrete sample taken from the dead end anchorage region of Specimen 7.2 increased with depth. Again this might be due to the cracking over the dead end anchorage region.

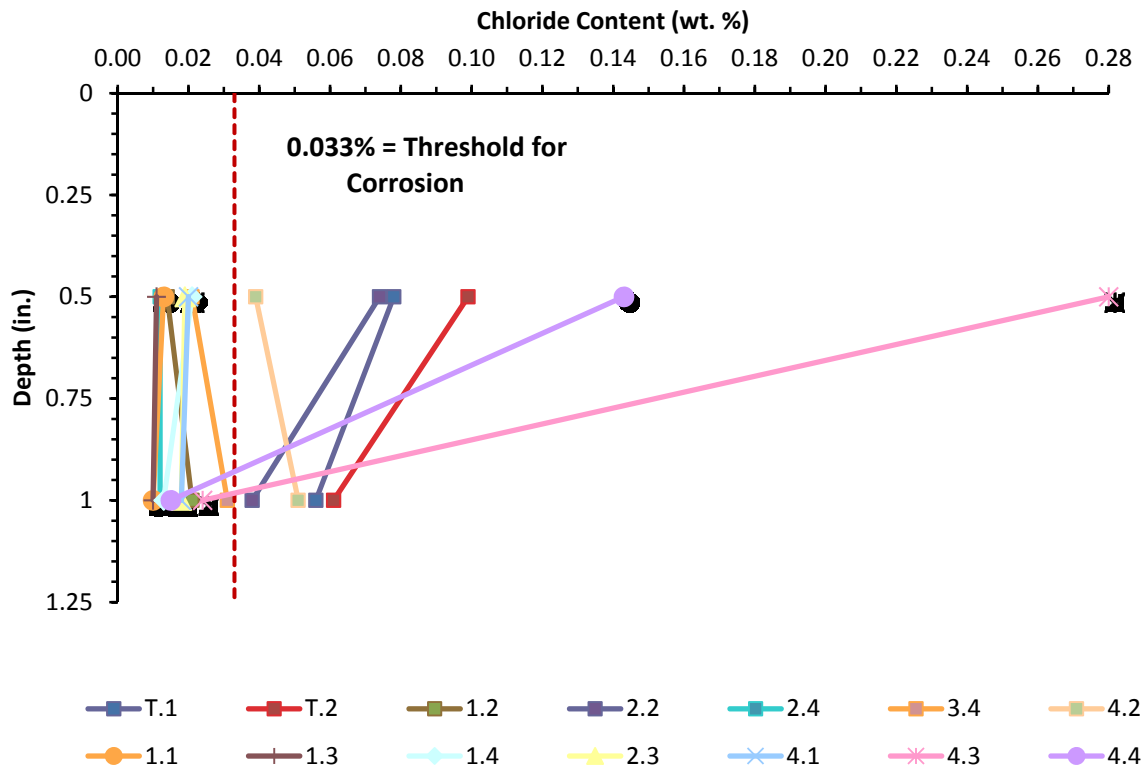
Figure 5.9 – Chloride Penetration at Anchorage Regions without Salt Solution Spray

As expected, many of the concrete samples from both depths had chloride contents below the corrosion limit. Interestingly, the four-year specimens had a greater number of specimens over the corrosion threshold. The two samples in the six-year exposure that were above the corrosion limit were both from a depth of 0.5 inch and were from Specimens 4.3 and 4.4, the non-prestressed specimens. These outliers might be because these specimens did not have pourbacks because they were only reinforced with conventional epoxy-coated and uncoated steel reinforcement and the concrete surface were scaled. However, for McCool the pourbacks were visually in better condition so cracking promoting chloride ingress is not considered a factor. For all four-year specimens, the pourbacks were visually in much better condition upon autopsy than the saltwater trays. Therefore, concrete permeability should not have played a role in the unusual chloride distributions. This is coupled with the factor that samples were not taken from cracks. The strange distributions in Figure 5.9 could be partially caused by inaccuracies of the testing equipment at lower chloride contents.

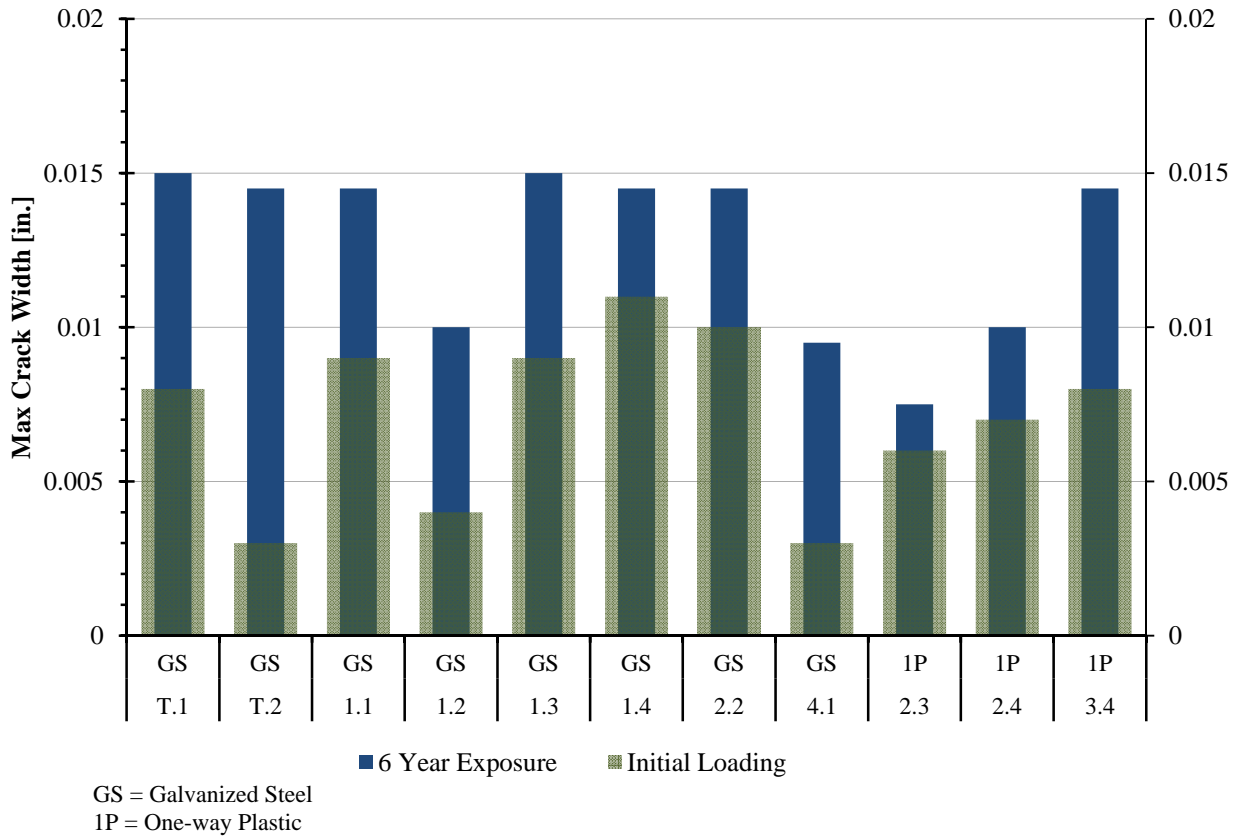
Figure 5.12 – Propagation of Absolute Maximum Crack Width over Exposure

With these considerations, a comparison between crack widths reported by Ahern²⁰ at the time of live loading and Moyer⁴ after six years of aggressive exposure show some increase. Both the absolute maximum crack width on each specimen and the average maximum crack width of the cracks on each specimen are shown in Figure 5.12 and Figure 5.13. The absolute maximum crack widths show that some cracks did expand over the course of the exposure as was expected. Considering the minimal visible staining, expansive forces from corrosion products can only be considered minimal. This is in agreement with the data as the crack widths do not expand significantly. Only Specimen T.2 showed a major increase in the crack width.

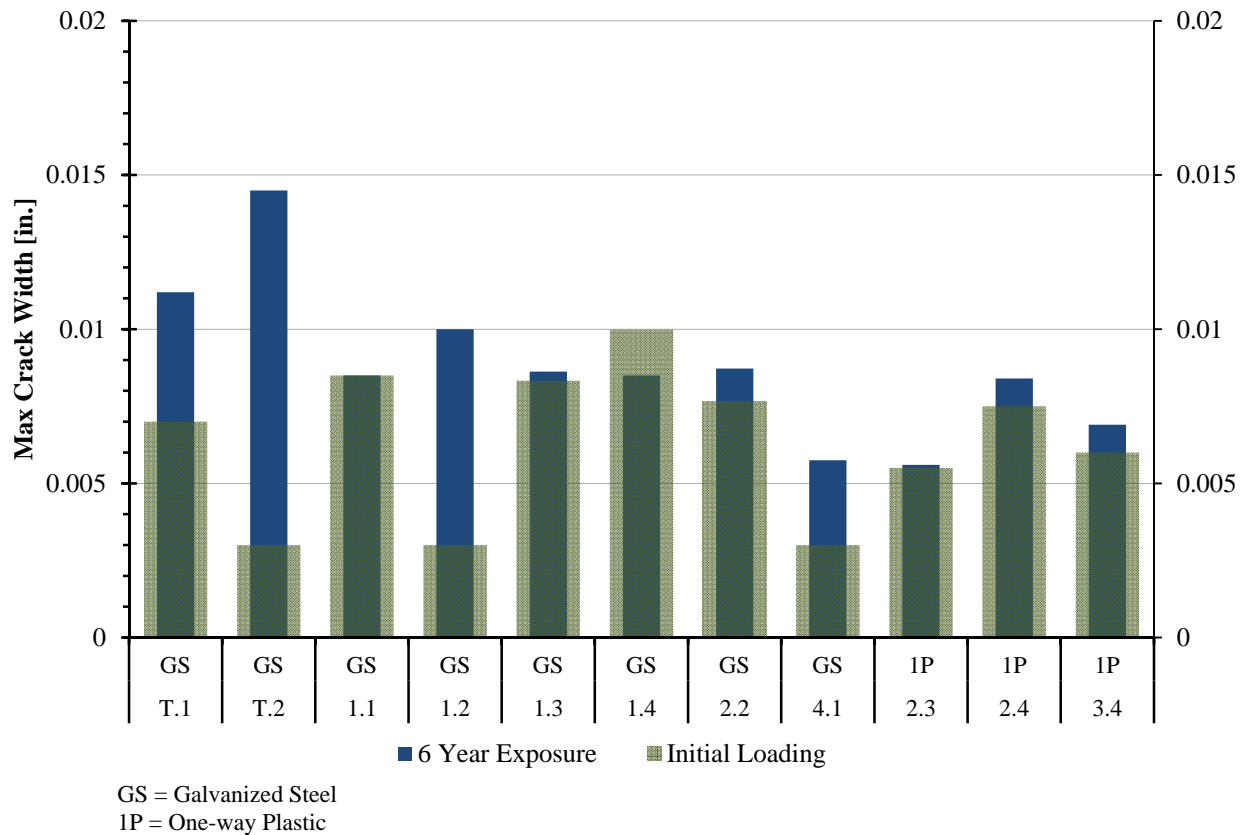
Figure 5.13 – Average Maximum Crack Width over Exposure

The average maximum crack widths in Figure 5.13 show only small increases. Specimen 1.4 shows a decrease in crack widths; however, this can be attributed to a number of smaller cracks being included in the calculation of the average. Specimen T.2 and 1.2 provide the major increase in crack data.

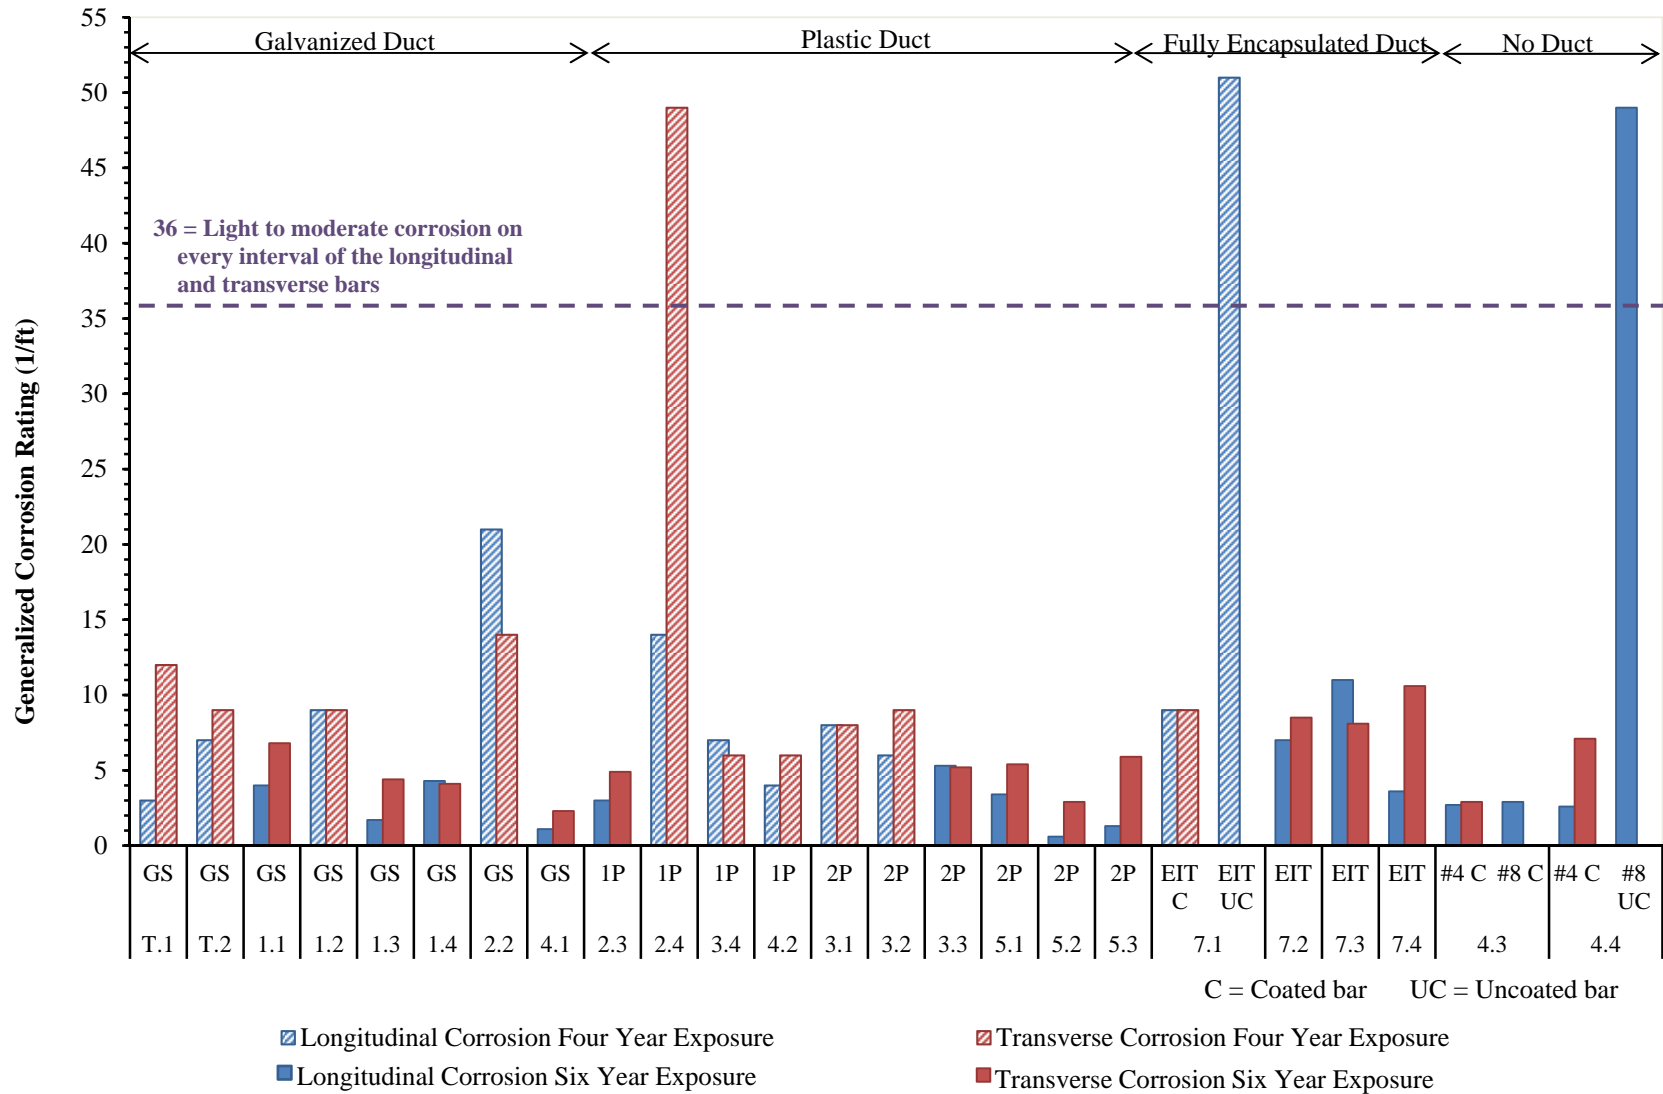
Figure 5.15 – Longitudinal and Transverse Corrosion Rating of Four- and Six-Year Specimens

Both McCool and Moyer plotted generalized longitudinal bar and stirrup corrosion ratings with crack ratings for each. However, due to the discrepancy between the four- and six-year crack rating, this comparison is not given herein. Figure 5.15 compares only the corrosion ratings from the transverse mild reinforcement (the stirrups) and the longitudinal mild reinforcement. As expected, the epoxy coating proved to be a significant factor. The uncoated bars used in specimens 4.4 and 7.1 have the two highest ratings out of any of the reinforcement. The transverse reinforcement in Specimen 2.4 had an unusually high corrosion rating even though it was epoxy-coated. This is attributed to one stirrup that lost over 20% of its cross section over a small length at midspan of its horizontal portion. This damage did not correspond directly to a surface crack location. Of the total corrosion rating given as 590, this single stirrup accounted for 530 of the total, indicating it is a major outlier.

A generalized corrosion rating with a value of 36 is used in Figure 5.15 to indicate when transverse or longitudinal bar was found to have light to moderate corrosion throughout on both the top and bottom of the bar as indicated by the rating system originally developed for Project 0-1405¹¹.

The EIT series specimens had the highest corrosion ratings for coated longitudinal and transverse bars in the six-year study. This might be because the specimens were larger and therefore the reinforcement cages were larger. More likely, the difficulty in fabricating the isolated tendon system resulted in a less well constructed specimen. When comparing the EIT specimens with the rest of the specimens, the results are not significantly different. Specimen 2.2 had a much larger corrosion rating for the longitudinal bars due to a particularly bad north bar. Specimen 2.4 had particularly poor results for the stirrup damage. The specimen contained one heavily damaged stirrup, while the others were not nearly as bad. Excluding these two outliers, the data is consistent across both exposure periods. One would expect behavior that indicates initiation and propagation. This would show itself with a higher six-year corrosion rating. The data does not support this, however, showing both sets of results as roughly equal. It's more probable that corrosion propagated on all areas of corrosion and formed a complete layer of corrosion product. To further reinforce this, the uncoated reinforcement had similar ratings in both four and six years, demonstrating how that particular reinforcing bar had already been corroded and formed a layer of corrosion product. This meant the propagation phase had been fully finished at four years.

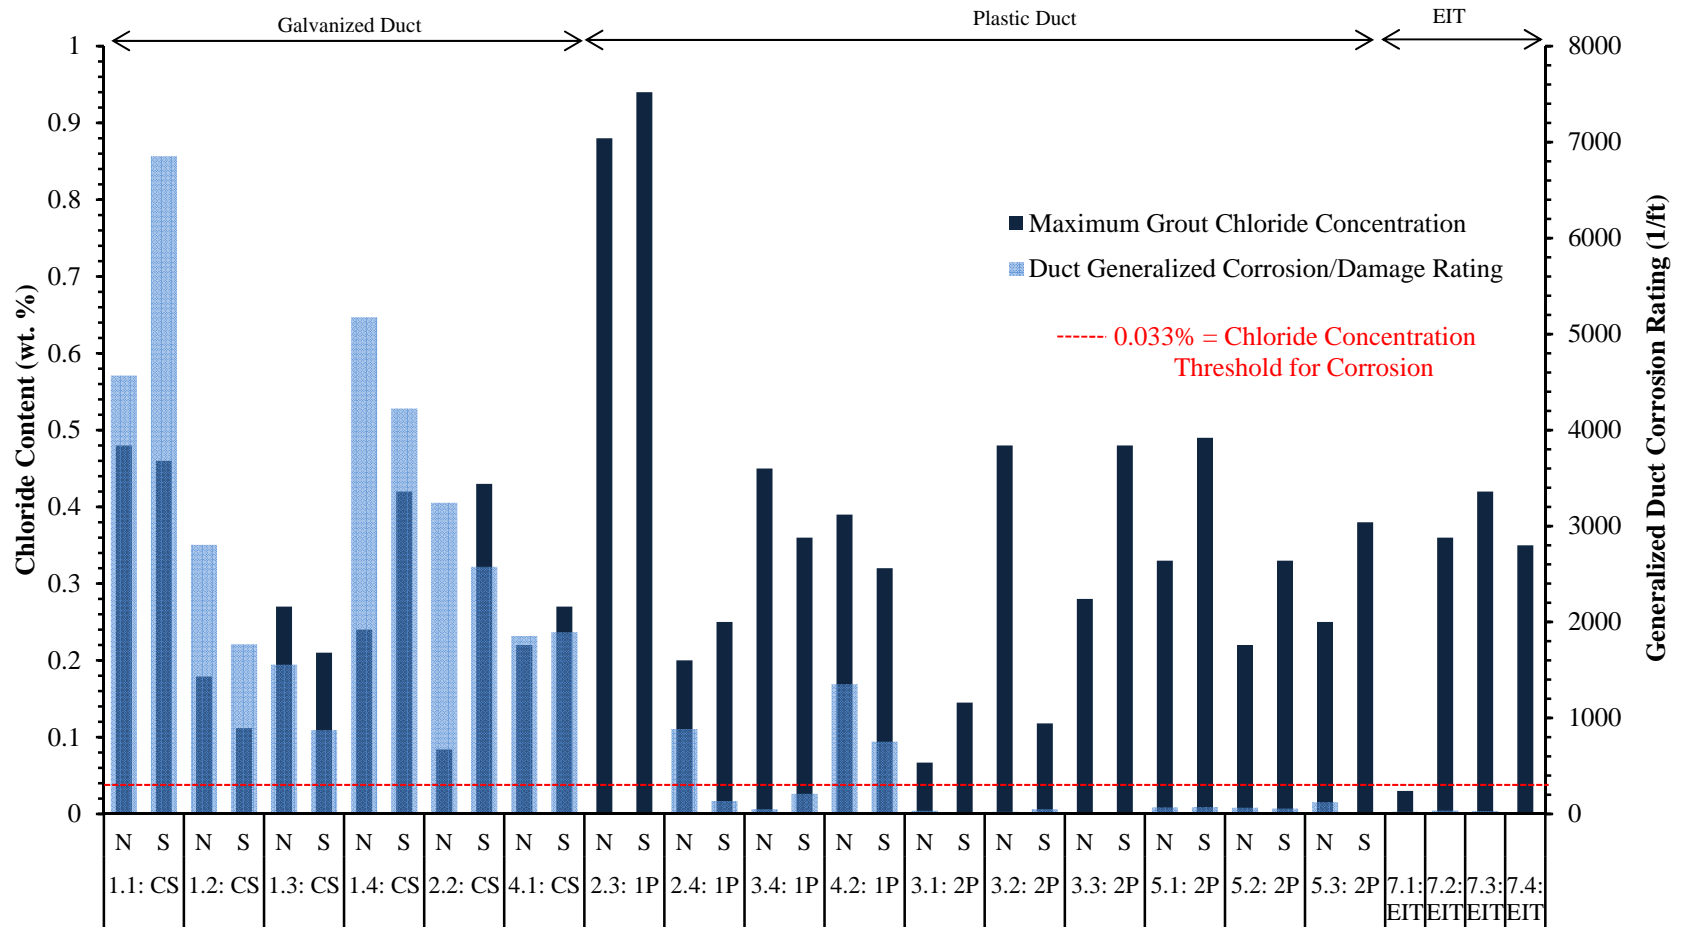
Figure 5.20 – Grout Chloride Content and Generalized Duct Corrosion Rating

As seen in Figure 5.20, chloride content was not an indicator of duct corrosion. Significant chloride penetration into the grout occurred within all specimens, showing that impermeability was not achieved with any system. Only Specimen 7.1 had chloride content below the corrosion threshold. The other EIT specimens had chloride content on the order of the other specimens, including the highly corroded galvanized duct. While the purpose of the experimental procedure is not to compare galvanized duct to plastic duct, the values comparing the two do demonstrate that while the plastic duct does not corrode nearly as much, the value of it as a barrier to corrosion penetration is greatly reduced if duct couplers or grout attachments are not perfectly sealed.

The ducts themselves were not permeable; instead, the location of the couplers and the grout vents proved to be the means of ingress. Except for Specimen 7.2, none of the plastic ducts had observed holes or cracks in either the four- or six-year intervals. This indicates that the high chloride levels found in the grout of the plastic ducts did not come from a defect in the duct. This is further reinforced by Figure 5.20. The seal of the heat shrink-wrap to the duct and the mechanical couplers were observed to be inadequate to keep out contaminants in the north ducts and the 7-series specimen's duct. Also, the couplers used to connect the two halves of the north ducts and to connect the sections of the 7-series specimen's duct did not provide an adequate seal to keep out contaminants. McCool and Moyer both noted the silicone or epoxy used to attach the grout vents to the south ducts was found to be loose on all specimens. All of these factors would have provided a path for chlorides to enter the ducts and explain the elevated chloride concentrations that had been observed in the grout from the specimens with plastic duct.

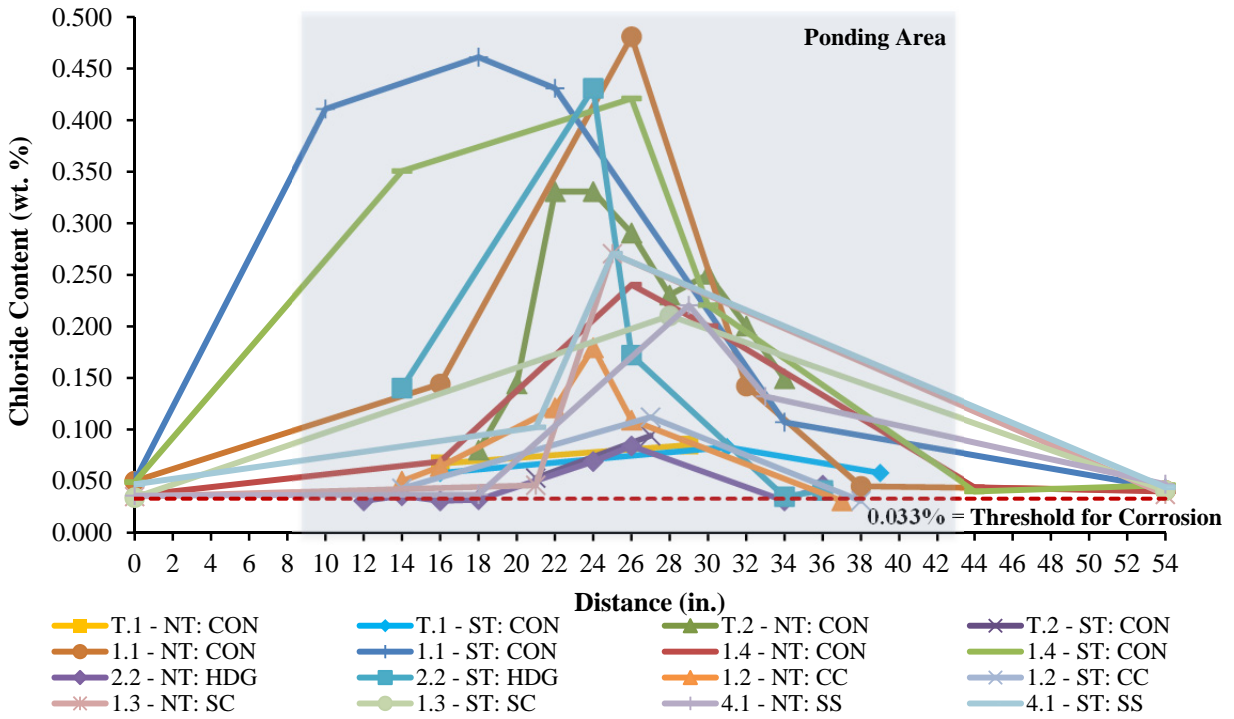
Figure 5.21 – Grout Chlorides for Galvanized Duct Specimens

Figure 5.21, Figure 5.22, Figure 5.23, and Figure 5.24 show the chloride concentrations of tendons that contained galvanized duct, one-way plastic duct, two-way plastic duct, and EIT systems, respectively. All tendons had chloride concentrations along the whole length of tendon above the corrosion limit of 0.033% by weight of grout. This is consistent with the average half-cell potential readings at the end of exposure testing being more negative or close to the greater than 90% probability of corrosion half-cell potential readings that these tendons had. As expected, the chloride concentrations were greater at midspan than in the anchorages except for the EIT specimens. Because the couplers failed to prevent ingress and there was no major difference between coupled and uncoupled ducts, this is not unexpected. This might be because the chlorides would take longer to get to the anchorages because the chloride ions would have to travel through the interstitial space between the grout and the duct and/or interstitial space between the grout and the strand. The chloride concentrations at the anchorages were all somewhat equivalent. The stainless steel and clad specimens did have higher live end concentrations, but the magnitude is not considerably different.

The live end side of the south tendons in Specimens 1.1 and 1.4 had chloride concentrations that were far greater than the chloride concentrations of the dead end side of the tendons. Specimens 1.1 and 1.4 had tendons with galvanized duct. This difference in chloride concentrations between the live and dead ends of the south tendons of Specimens 1.1 and 1.4 might be from the cracks on the live end over the south tendons of the ponding area in the concrete allowing more chlorides to reach the live end of the tendons than the dead ends. On the other hand, the chloride concentrations of the north tendons of Specimens 1.1 and 1.4 dropped significantly away from the midspan of the tendon. The elevated chloride concentrations of the tendons would make the average final half-cell potentials more negative but the average final half-cell potentials for the tendons with galvanized duct, Specimens 1.1 and 1.4, were more negative than the potentials from the tendons with plastic duct. This would suggest that the corrosion of the zinc in the galvanized duct as well as the chlorides were contributing to the average final half-cell potential of the tendons in Specimens 1.1 and 1.4. The level of chlorides in the tendons is consistent with the corrosion observed during autopsies.

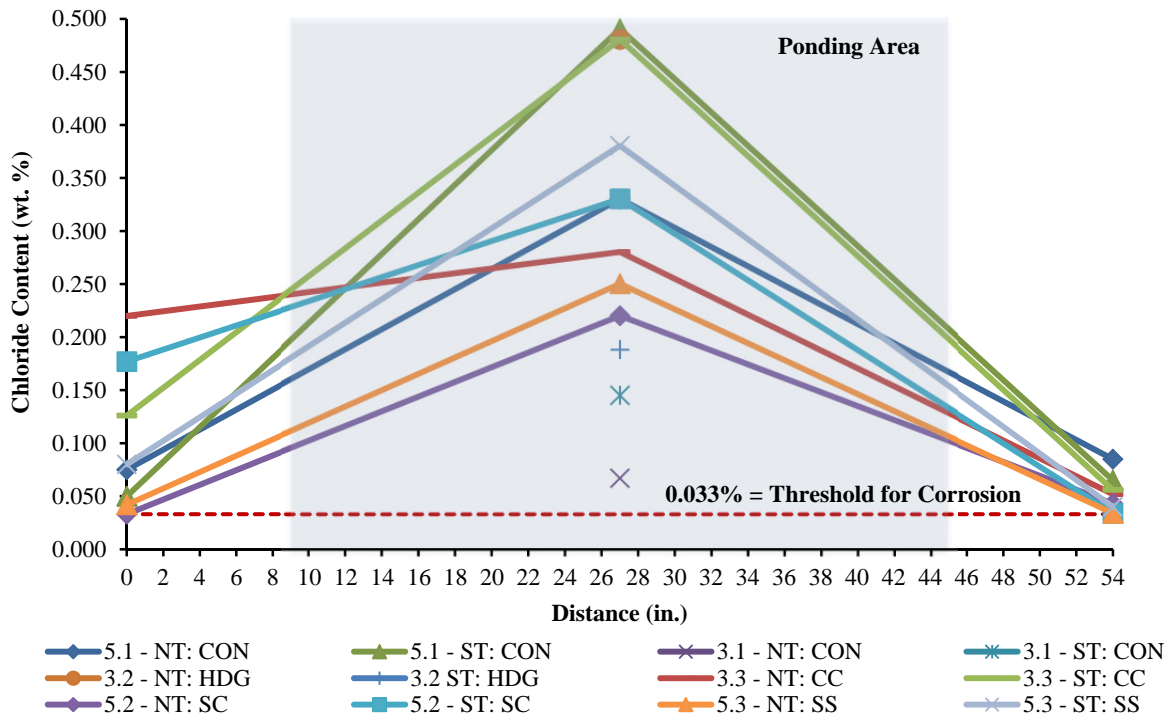
Figure 5.23 – Grout Chlorides for Two-Way Plastic Duct

Surprisingly, the tendons from Specimen 2.3 had the highest chloride contents despite being two-way plastic ducts. This might indicate that the ducts are not watertight and allowed chlorides to enter the tendon earlier than the other ducts. Another interesting observation is the tendons from Specimen 5.1 had chloride concentrations comparable to the chloride concentrations from the tendons in galvanized duct. The ducts that encased the tendon in Specimen 5.1 were two-way plastic duct, as well. Again, the watertightness of the couplers and grout vents of the plastic ducts are in question. The north tendon of Specimen 1.4 had the lowest chloride concentration at midspan. The disparity in the average final half-cell potentials between the north and south tendons of Specimen 5.1 do not correspond to the difference in chloride concentrations at midspan of the same tendons. The south tendon had chloride concentrations greater than the north tendon and midspan, whereas the average final half-cell-potentials suggest that the north tendon should have had the higher chloride concentrations. Therefore, the disparity in the average final half-cell potentials might be from corrosion of the epoxy-coated steel reinforcement located closer to the north duct elevating the half-cell potentials.

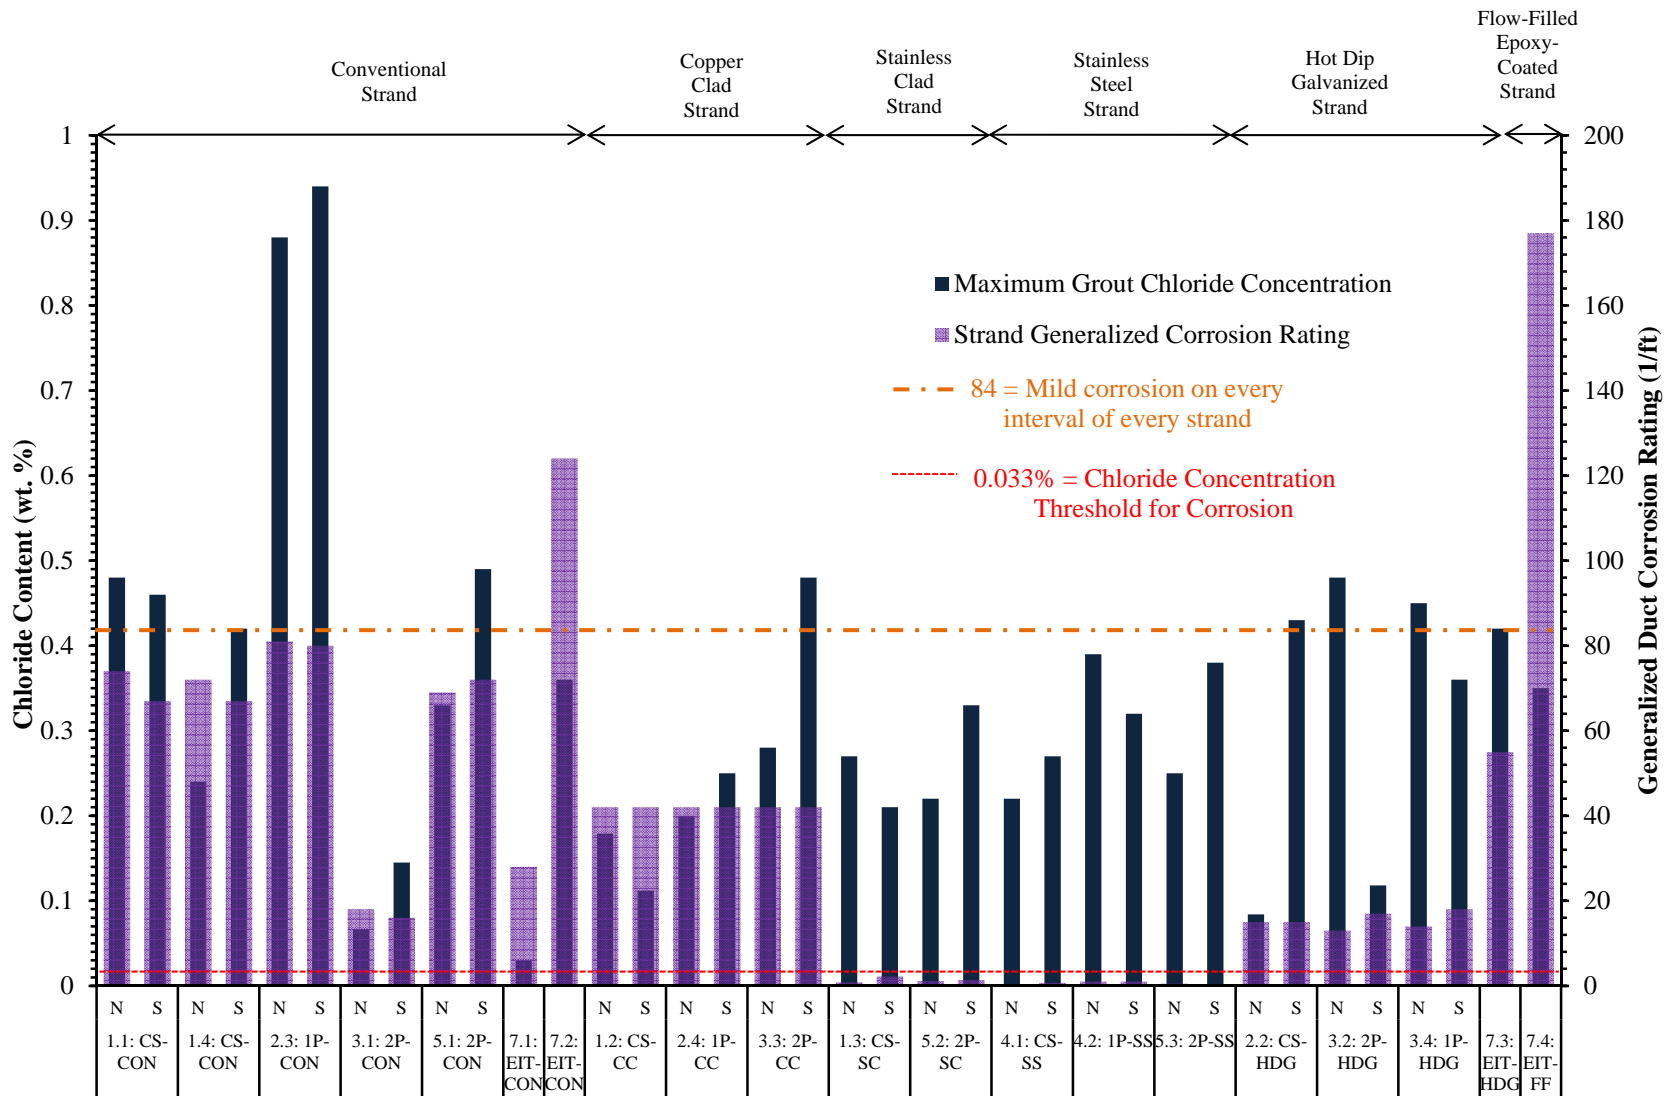
Figure 5.25 – Strand Corrosion with Grout Chlorides

Because the different strand types corroded in different ways, direct comparison among them is difficult. Generalized strand corrosion ratings are plotted with maximum chloride content for both tendons in each autopsy specimen in Figure 5.25. Maximum chloride concentrations for all the tendons were above the threshold for all the four-year specimens except for Specimen 7.1 and were well above the threshold for six-year specimens.

All corrosion was very light. There was only mild pitting in the six-year strands. Corrosion was noticeable where there had been direct contact with the duct. The four-year strands were mainly lightly discolored with some corrosion, mostly on the non-coated inner wires. Stainless steel in the four-year group performed well, as the chloride content was high but the corrosion rating was low. This was reiterated in the six-year autopsy as the chloride content is elevated but the corrosion rating is basically non-registered. Flow-filled epoxy-coated strand did not perform as well in the six-year exposure as anticipated, as the extreme right side of Figure 5.25 shows. Half-cell results suggest the damage may have been present underneath the coating prior to their use and Figure 5.26 shows some corrosion within the bundle of wires once the epoxy is stripped off and the wires are separated. Note the intermittent discoloration that indicates minor corrosion.

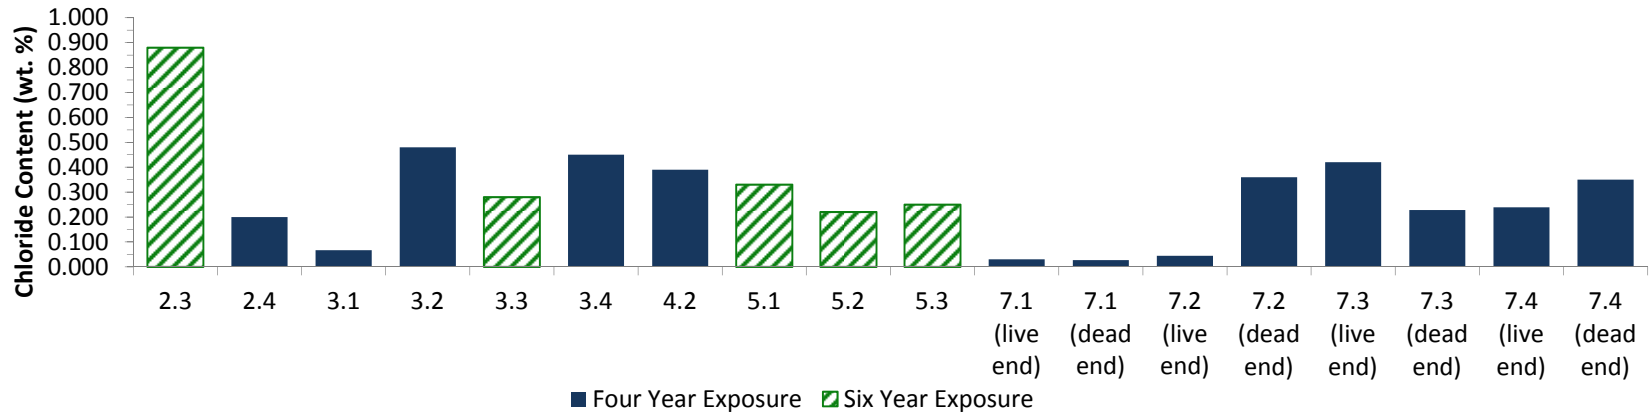
Figure 5.30 – Grout Chloride Content at Coupler Location

The specimens with galvanized steel ducts did not contain couplers. In each specimen with plastic ducts, the two halves of the north duct were connected at midspan with one of two couplers for conventional specimens: GTI slip-on or GTI snap-on. The south ducts were continuous within these specimens. The fully encapsulated specimens had VSL snap-on couplers, although the coupler was not located at midspan but at the connection between the anchorage and the duct. Chloride content at all coupler locations is shown in Figure 5.30 while content at midspan of one-way and two-way plastic duct is shown in Figure 5.31.

The highest grout chloride concentration was found inside the GTI snap-on coupler within Specimen 2.3. The lowest concentrations were found in both VSL snap-on couplers inside Specimen 7.1, although these couplers had the benefit of being covered with an additional plastic sheath. Both chloride concentrations in Specimen 7.1 were below the corrosion threshold—the only two values that fell below the threshold. The presence of chlorides within the couplers confirms that breaches had occurred, as observed during autopsies. For each coupler installed in multiple specimens, chloride concentrations vary significantly. This suggests that the integrity of the couplers depends more on workmanship during construction than on coupler type and manufacturer. The inexperience of the project team at the time of construction may have resulted in improper installation of the couplers, which allowed chloride ingress during exposure.

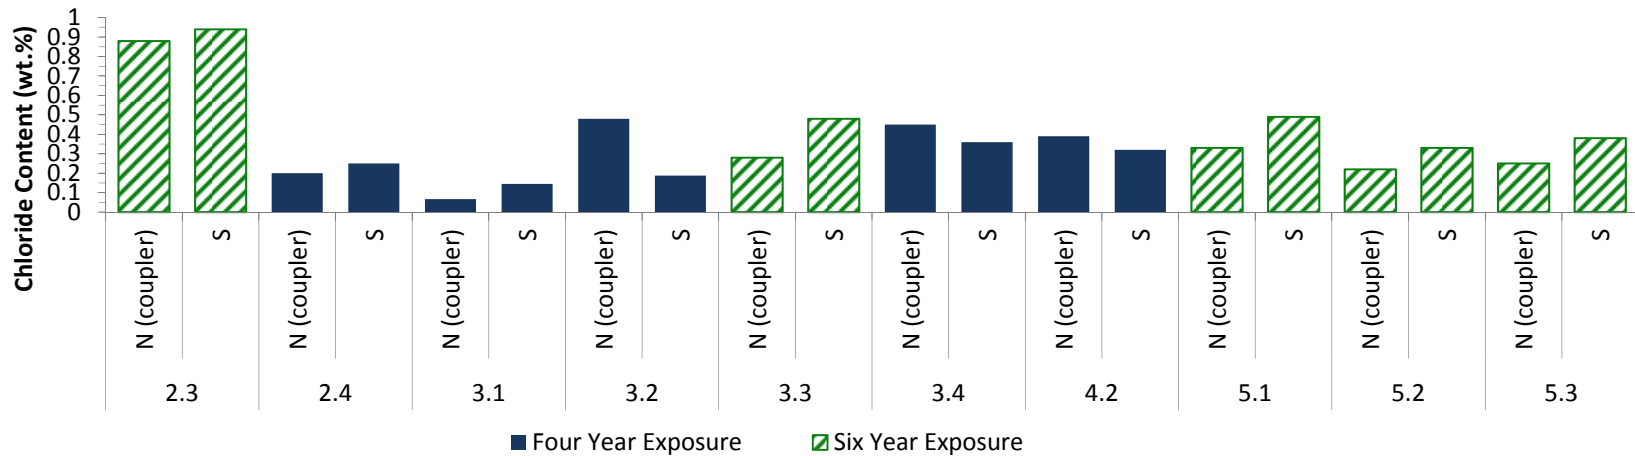
Figure 5.31 – Grout Chloride Content at Midspan of Coupled and Uncoupled Non-EIT Specimens

For all specimens with one coupled and one uncoupled plastic duct, grout chloride concentrations at midspan are plotted in Figure 5.31. This figure makes clear that chloride levels at midspan were well above the corrosion threshold in both tendons of each specimen. For the four-year specimens chloride levels were generally higher in the north tendons. Interestingly, it switched for the six-year specimens. Regardless, concentrations were of similar magnitude in the corresponding tendons across both sets of specimens. This is most clear for Specimens 2.3, 2.4, 3.4, and 4.2, for which both chloride concentrations were nearly equal. This trend confirms that the grout vents at midspan of the south ducts were indeed breached by chlorides during the exposure period.
