Corrosion Resistance Recommendations from Long-Term Exposure Testing of Post-Tensioning Systems

CTR Technical Report:	0-4562-5F
Report Date:	May 2013
Project:	0-4562
Project Title:	Corrosion Resistance of Grouted Post-Tensioning Systems
Sponsoring Agency:	Texas Department of Transportation
Performing Agency:	Center for Transportation Research at The University of Texas at Austin

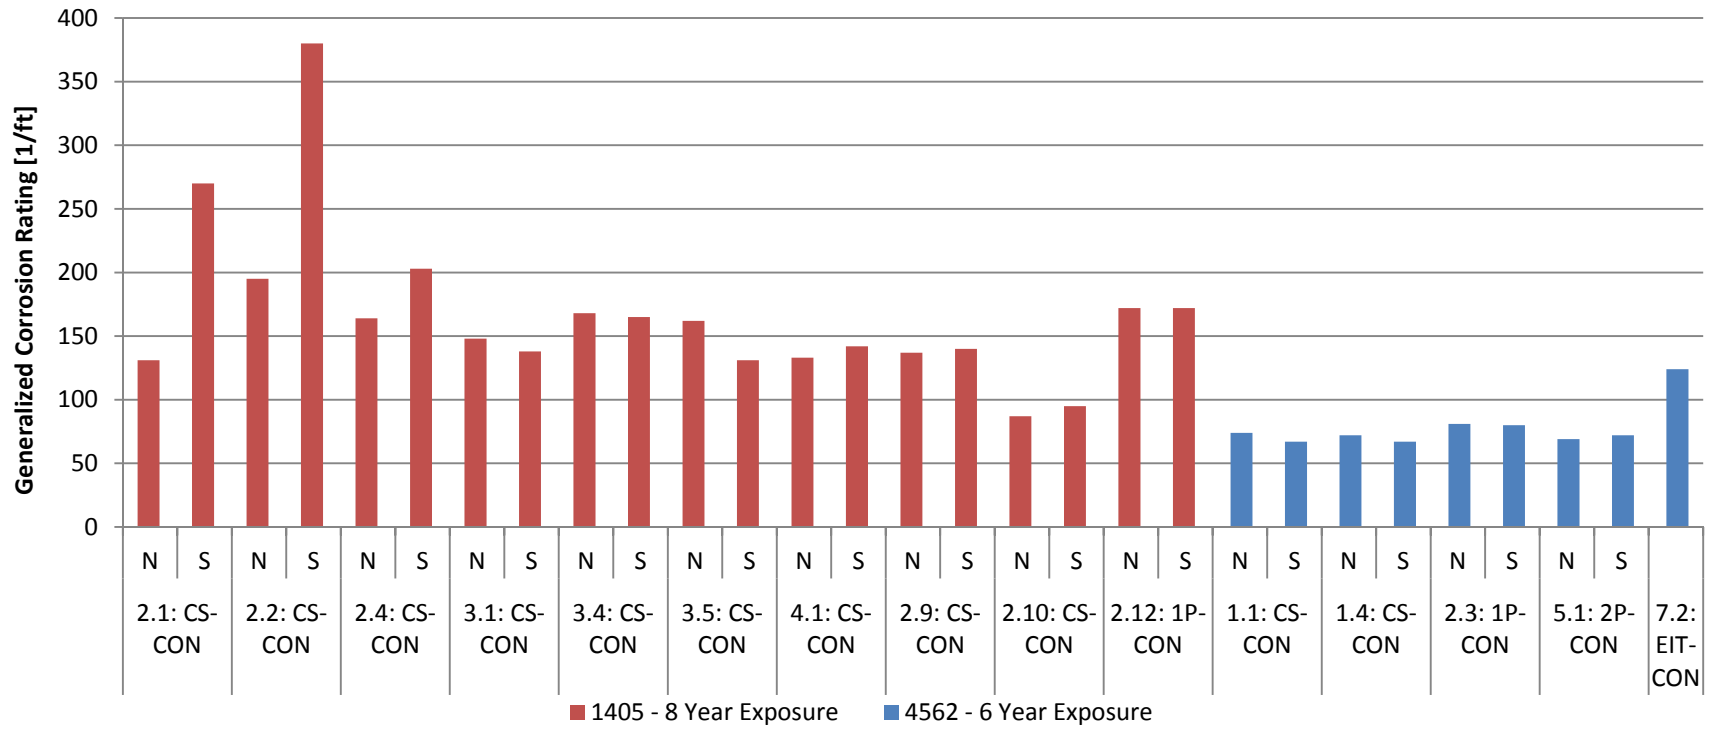
Figure 7.1 – Comparison of Conventional Strand Corrosion at Final Autopsy for Project 1405 and 4562

The new specimens also show the better corrosion protection that was implemented. Figure 7.1 shows that while the strand corrosion was better isolated as a variable, the overall value of the corrosion rating was lower. This can be attributed to multiple different factors. With the new specimens, cracking was controlled and secondary expansive corrosion from the mild reinforcement was limited. More significantly, the grouts and grouting procedure was improved in the time between the specimens were cast. While there are concerns regarding the chloride in the prepackaged grout used in the smaller specimens, the overall placement and coverage of the grout was likely much better. PTI recommendations for grouting were followed, which limited grout voids and segregation that contribute to strand corrosion.
