1. Report No. FHWA/TX-09/0-4893-2		2. Government Accession No.		3. Recipient's Catalog No.	
4. Title and Subtitle Concrete Pavement Overlays and Failure Mechanisms			5. Report Date February 2007; Revised July 2008

Concrete Pavement Overlays and Failure Mechanisms

CTR Technical Report:	0-4893-2
Report Date:	February 2007; Revised July 2008
Project:	0-4893
Project Title:	Performance of Old Concrete Under Thin Overlays
Sponsoring Agency:	Texas Department of Transportation
Performing Agency:	Center for Transportation Research at The University of Texas at Austin

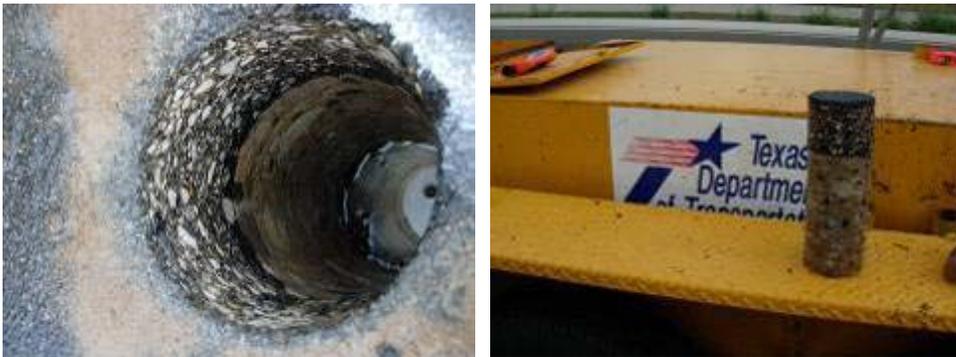
Figure 2.2 Core obtained from inside lane

Figure 2.2 shows one of the cores obtained for testing along the inside lane of SH 6. The coring equipment used during testing worked well without any delays. However, only three cores were obtained for testing because of rain that prevented further work.

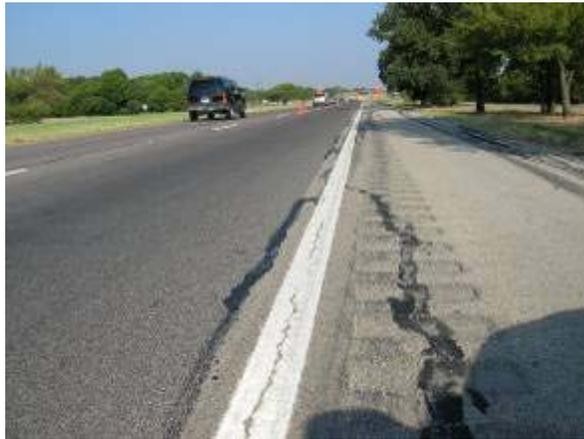
Figure 2.5 Panoramic view of AC section located on IH-35 W

In general, the AC overlay was in good condition with mild transverse cracking and some longitudinal cracking. Likewise, low-severity raveling was found in isolated areas. Figure 2.6 displays a raveled area.

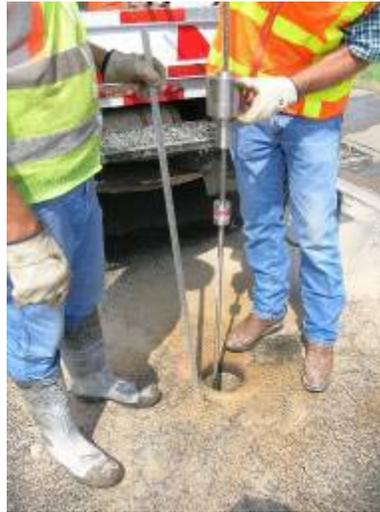
Figure 2.10 TxDOT staff conducting DCP test

After taking out the core samples a dynamic cone penetration (DCP) test was run in most of the cores drilled in the main lanes and also the outside shoulder. The DCP was basically used to evaluate the conditions of the subbase and subgrade layers. Figure 2.10 shows the DCP apparatus being used in the perforation left by Core 6. The estimated modulus of elasticity of the layers underneath the pavement is plotted in Figure 2.11.

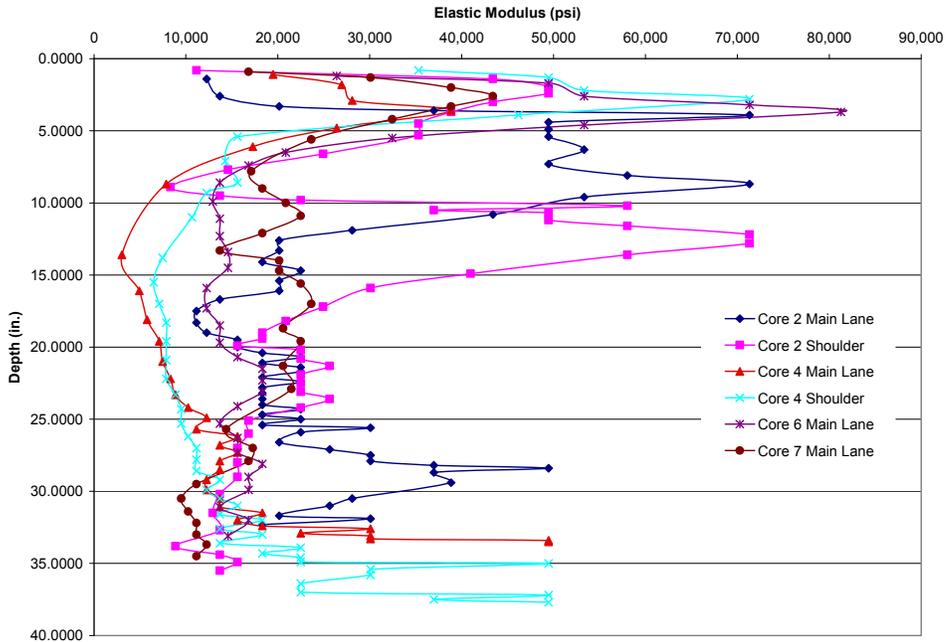
Figure 2.11 Results of DCP testing on IH-35 W

Figure 2.11 shows that the modulus of elasticity (E) values for the lime-treated subbase, up to 6 in. in depth, lie between 20,000 and 80,000 psi. In the depth between 6 in. and 35 in., the bulk of the modulus of elasticity values fall between 5,000 psi and 25,000 psi. These values correspond to the subgrade layer. As expected, the E values are somehow higher as they approach to the surface, mainly owing to the effect of capillary reaction in the materials, which tend to consolidate.

DCP testing was conducted for Cores 2, 4, 6, and 7, also shown in Figure 2.11. For Cores 2 and 4, both the main lane and shoulder were tested as can be seen in the graph. Cores 6 and 7 only had their main lanes tested. In Core 2, the DCP shows the highest modulus closer to the surface, more so for the main lane than the shoulder. The opposite holds true for Core 4, where the shoulder has the largest modulus in comparison to the main lane. Cores 6 and 7 keep with the overall trend, as their highest modulus values are closer to ground level, and decrease as depth increases. These values are generally smaller than those of Core 2 and 4, despite the fact that Core 6's main lane has the highest batch modulus values for all the cores.

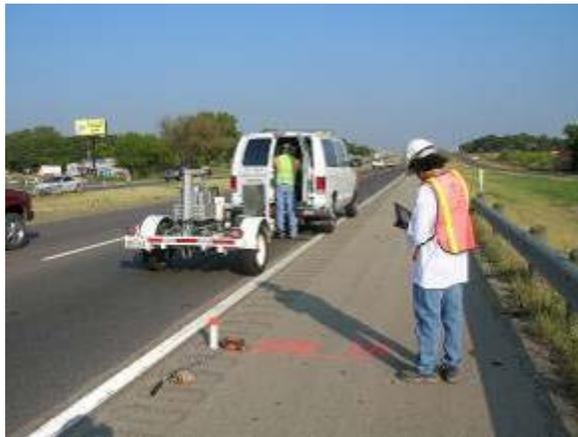
Figure 2.12 Deflection measurement at test section

Figure 2.12 shows the beginning of test section, where FWD testing started. The FWD testing was conducted only used in the outside lane only.

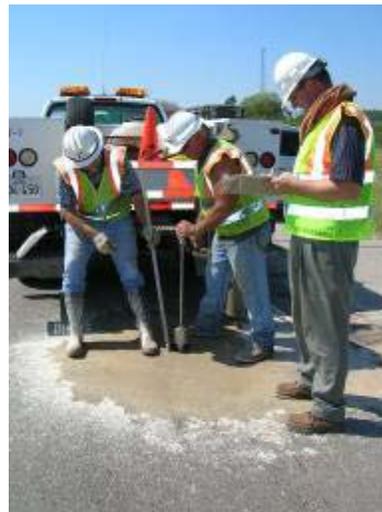
Figure 2.19 DCP testing on IH-20

Figure 2.19 shows TxDOT staff performing the DCP test. The DCP testing performed in this section provided similar results to those obtained from the section located on IH-35W, previously described. In general, it was observed that the capillary effect of the water in the subgrade layer has caused some higher than usual calculated values of E for that layer.

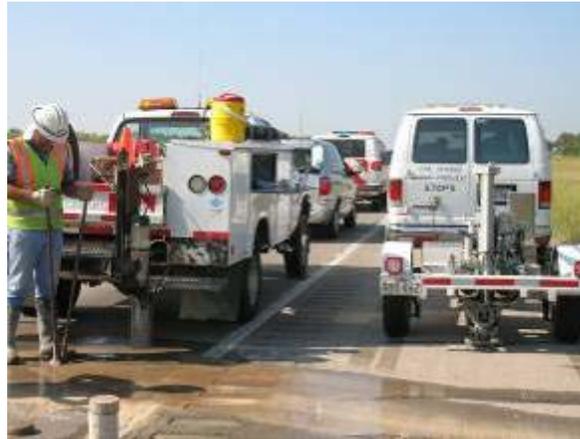
Figure 2.20 Coring and FWD testing on pavement

Deflection testing tasks were conducted on time, with no delays. The outside lane and shoulder testing was also completed. LTE calculations at specific locations along this section showed that the transfer efficiency was good with values between 85 and 95 percent. Figure 2.20 shows coring tasks in the mainline while FWD is being conducted on the outside shoulder.

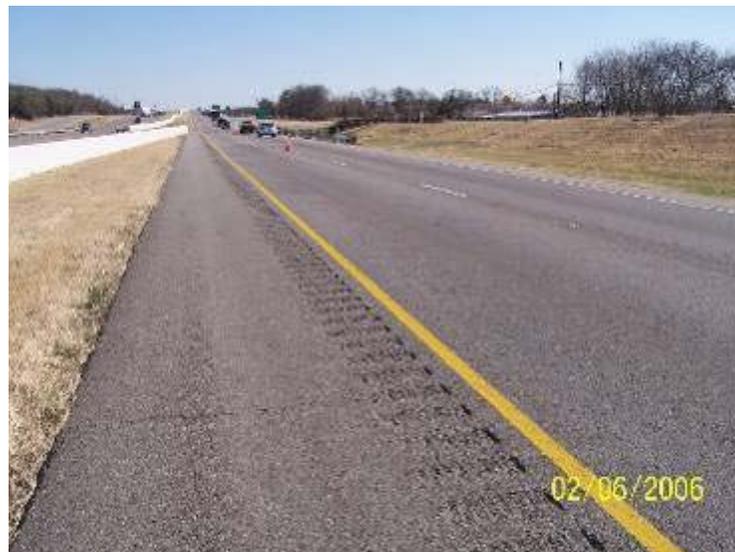
Figure 2.22 Panoramic view of AC overlay, EB lanes

Figure 2.22 depicts a panoramic view of the section being studied. As can be seen in this image, the AC overlay has almost no transverse cracking and no longitudinal cracking. Figure 2.23 shows location C1, where the first core on the westbound lanes was extracted.

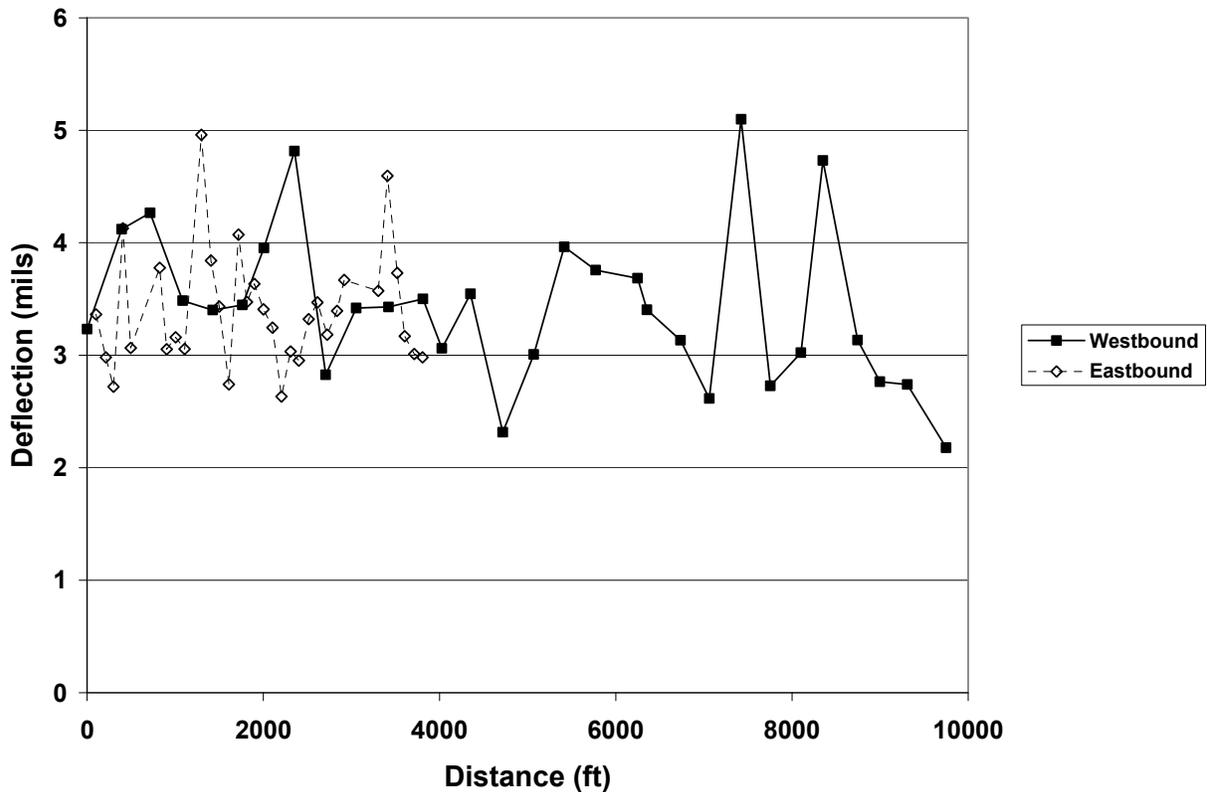
Figure 2.26 Deflection profile obtained for US 175

The deflection testing process was conducted without delays. Figure 2.26 shows deflections along both EB and WB lanes. The graph illustrates that the overall deflections in both directions are comparable to each other. The average deflections were 3.43 mils for WB and 3.40 mils for EB, with the difference less than 1 percent. As stated above, glass-grid fiberglass mesh was used in WB while strata reflective crack relief system interlayer was used in EB. It appears that the performance difference between the two interlayer systems was not detected by FWD deflections.

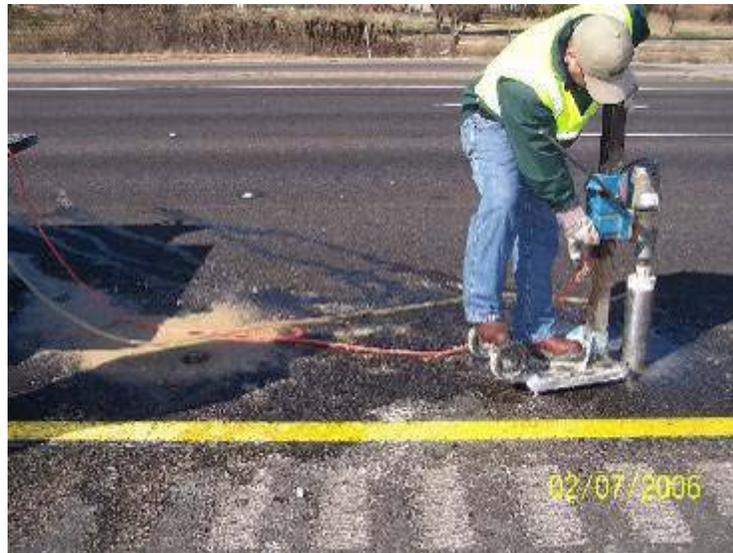
Figure 2.27 Problems during coring on I-635

During field work, problems were experienced with the coring rig, as can be seen below in Figure 2.27. The coring bit was defective and the coring crew had to try coring at different locations. Other testing was performed efficiently with no delays. Figure 2.28 shows a panoramic

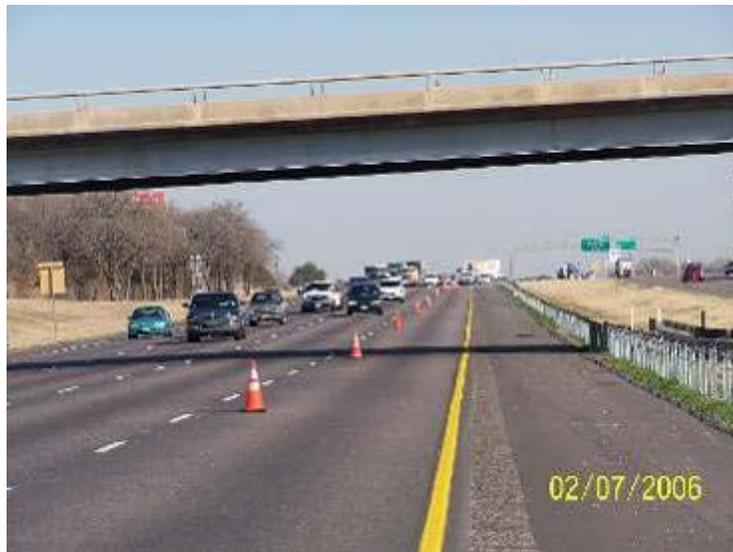
Figure 2.28 Panoramic view of section on I-635

view of the section being studied. As can be seen in this image, the AC overlay is in very good condition.

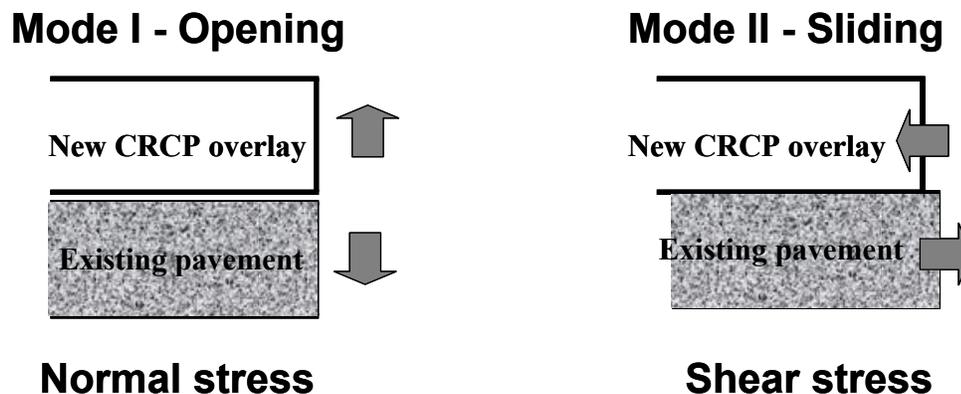
Figure 3.1 Debonding failure model at interface between old concrete and new concrete

Figure 3.1 shows two different debonding failures that can occur depending on the state of strain or stress at the interface between old concrete pavement and new CRCP overlay. If normal stress at the interface exceeds normal bond strength, Mode-I debonding failure (opening) will occur. On the contrary, Mode-II debonding failure (sliding) will happen when shear stress is more than shear bond strength. To identify debonding failure mode, it is necessary to investigate stress or strain at the interface. Field testing was conducted on a section of pavement in Houston to investigate these failure modes.

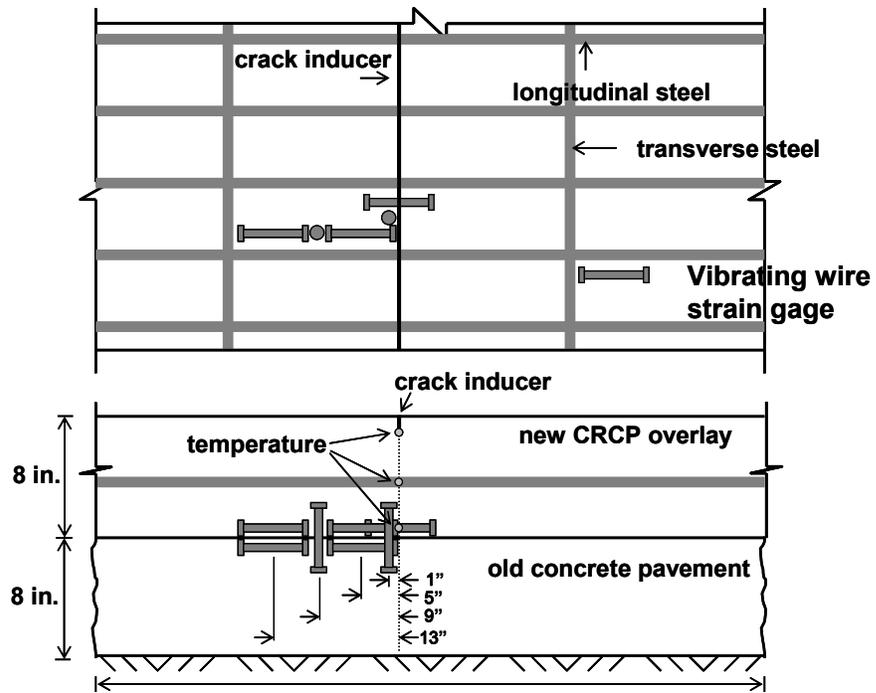
Figure 3.3 Layout of VWSG installation for identification of CRCP overlay delamination

To investigate the microscopic behavior of new CRCP overlay at early ages, seven vibrating wire strain gages (VWSG) were installed, as shown in Figure 3.3. Six of VWSGs were installed near the crack and one VWSG across the induced transverse crack. Additionally, temperature was measured at top, middle, and bottom of new CRCP overlay to examine the effect of environmental condition on the occurrence of transverse crack and debonding failure. (“Top” is 1 in below the surface, “middle” is at the mid-depth of the slab, and “bottom” is 1 in above the bottom surface of the slab.) A transverse crack was induced at the intended location by reducing the thickness of new CRCP overlay. Figure 3.4 shows the 1 in. deep saw cut that was done 8 hours after concrete placement.

To identify the dominant debonding mode of interface between old concrete pavement and new CRCP overlay, six VWSGs were installed in the vertical and horizontal directions near the interface (Figure 3.3). Two vertical VWSGs, placed at 1 in. and 9 in. from the induced crack, were installed through the interface to detect Mode-I debonding failure. In other words, a half of the VWSG length was embedded in old concrete and the other half in new concrete. Two horizontal VWSGs were installed into old concrete pavement and two in new CRCP overlay at the distance of 5 in. and 13 in. from the induced crack. It was expected that measured differences of horizontal strain at the same location between old and new concrete would provide information on Mode-II debonding failure.

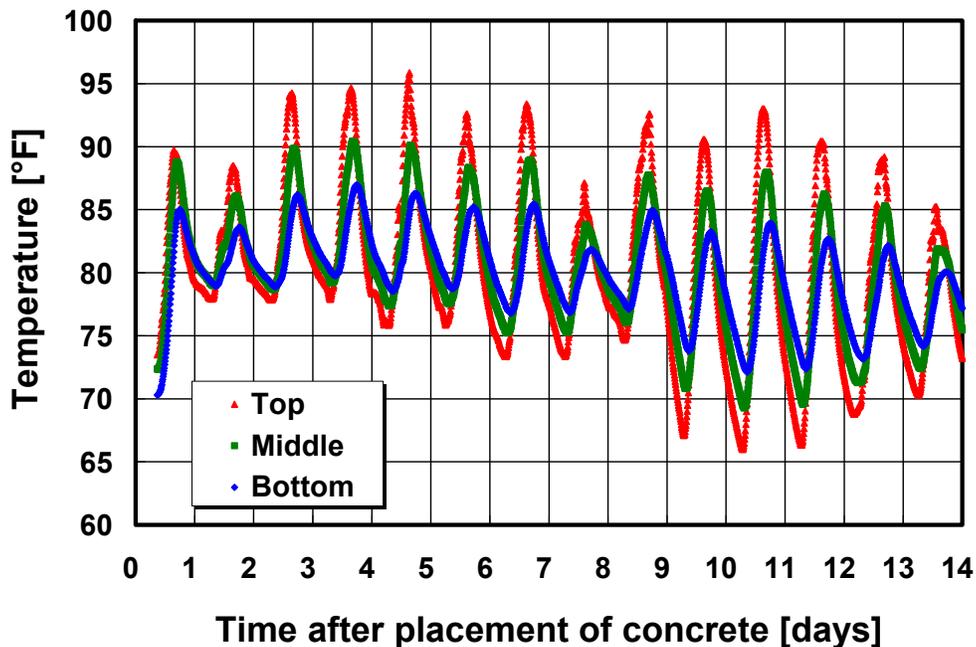
Figure 3.5 Temperature history at top, middle, and bottom depths of new CRCP overlay

Figure 3.5 shows the variation of temperature between top, middle, and bottom of new CRCP overlay after placement of concrete. In the figures in this report, time zero in x-axis indicates midnight before the concrete placement. Therefore, day 1 in x-axis represents the first midnight after concrete placement, and the mid-point between day 1 and day 2 indicates noon next day after concrete placement. As expected, the variation of temperature at top was larger than that observed at middle and bottom of the slab. It can be seen that the temperature at day 9 decreased significantly compared to previous days.

It is noted that the strains increased in the morning of day 9. It is explained by the decrease in minimum concrete temperature in the morning of day 9, as shown in Figure 3.5.

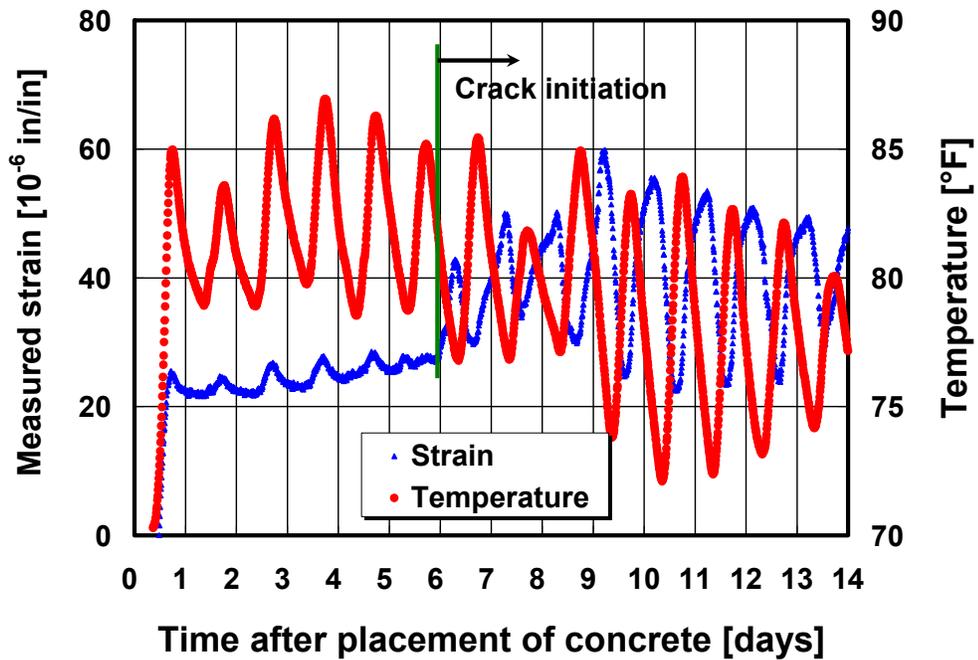
Figure 3.6 Longitudinal strain and temperature at the bottom of new CRCP overlay

Figure 3.6 shows the measured longitudinal strain of new CRCP overlay evaluated at the induced transverse crack and concrete temperature at the bottom of the overlay. The variations of longitudinal strain are not significant from the beginning of placement until day 5. However, there was a substantial increase in concrete strain at day 6 and it is considered that this change was caused by the development of a transverse crack at the induced crack location. Note that there was a drop of about 2.5 °F in minimum temperature from day 5 to day 6. It is shown that this drop of minimum temperature caused initial transverse crack. It is also noted that there was little difference in concrete temperature for days 6, 7, and 8, and corresponding concrete strains. In the morning of 9th day, there was additional 3.8 °F drop in minimum concrete temperature

from the previous morning and concrete strain increased substantially. This finding exemplifies the importance or significant effect of temperatures on cracking behavior of concrete pavement.

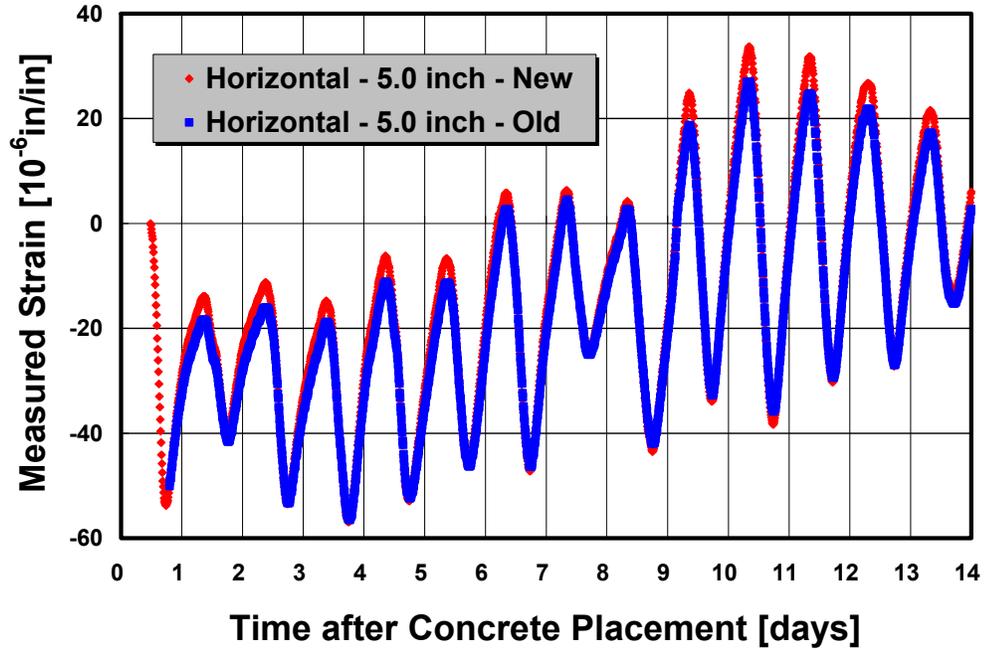
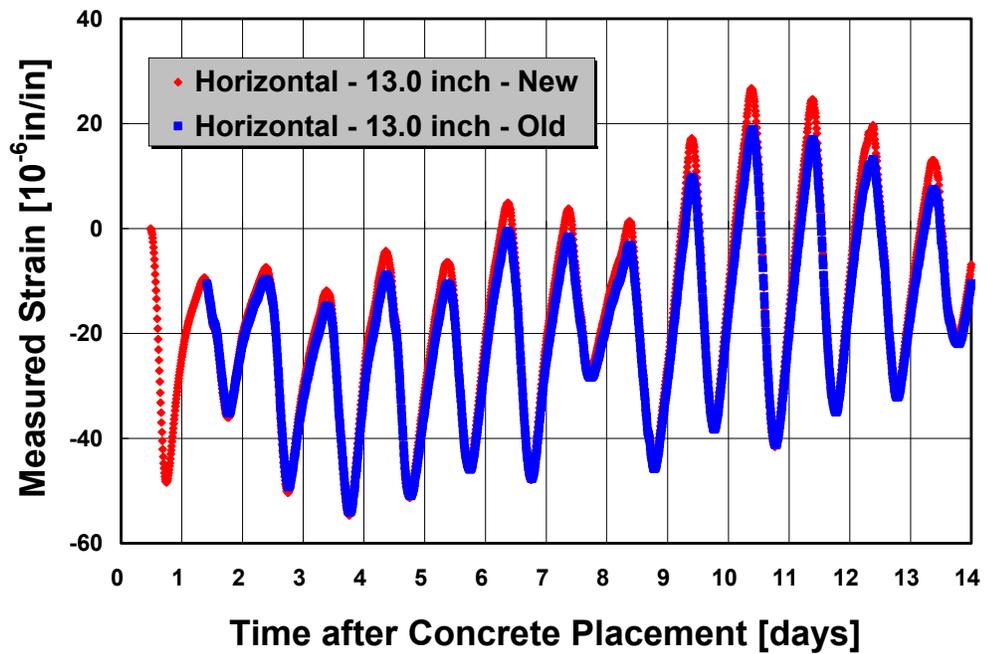
Figures 3.7 and 3.8 show the measured horizontal strains in old pavement and new CRCP overlay at 5 in. and 13 in. away from the induced transverse crack, respectively. There was little difference in concrete strains between old pavement and new pavement at these two locations. This indicates that there was little debonding or shear failure taking place, if any, at these locations. Therefore, Mode-II debonding failure is not considered to be the primary debonding mode at the interface.

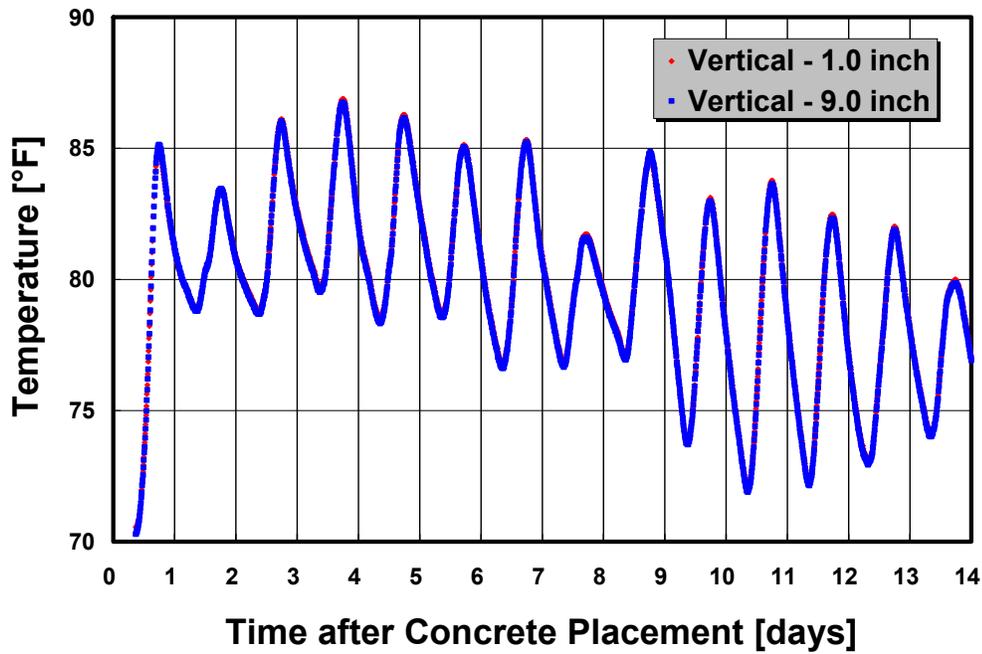
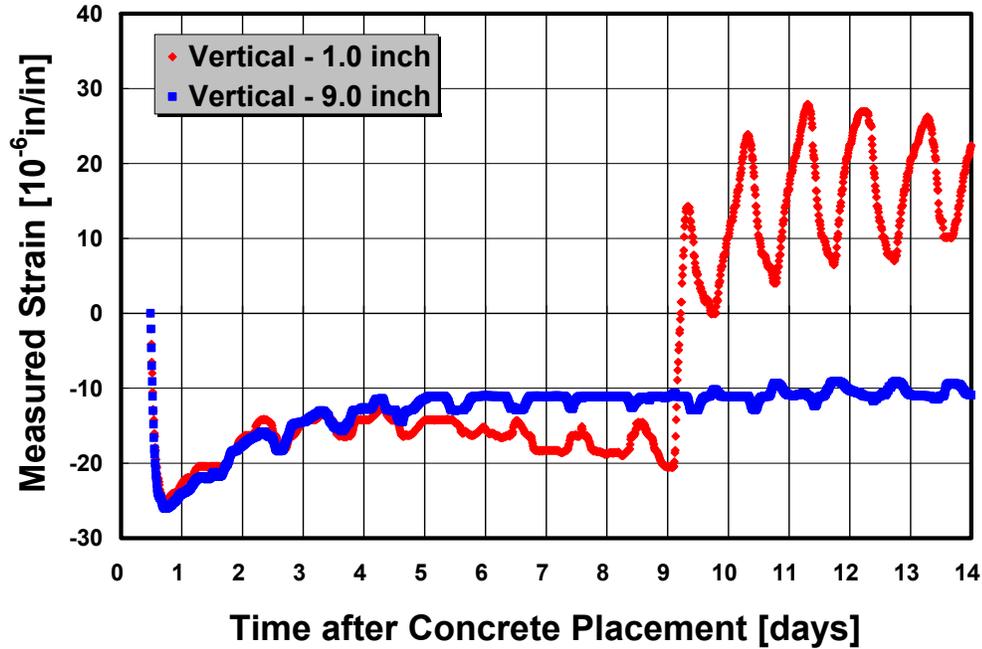
Figures 3.9 and 3.10 illustrate measured temperature and strain from VWSGs installed vertically through the interface between old pavement and new CRCP overlay, respectively. The measured temperatures from the two gages are almost identical as expected, since they are at the same depth. Figure 3.10 shows measured strains at the two locations are quite similar until the afternoon of day 4. The strains start diverging from that point, but still maintain the same trend until the morning of day 6. From the morning of day 6, the strains at 1-in location are getting larger than those at 9-in location and the strains have opposite directions – in other words, when the strains are decreasing at 1-in location, they are increasing at 9-in location. This is explained by the fact that a transverse crack started developing in the morning of day 6 (see Figure 3.6). Once the crack occurred, there was curling of the overlaid slab, resulting in larger strains at 1-in location than in 9-in location. Also, curling explains the opposite directions of the strains at the two locations. Figure 3.10 also shows a sudden increase in strains at 1-in location in the morning of day 9. It was shown in Figure 3.6 that there was a larger drop in minimum concrete temperature the morning of day 9 and resulting increase in crack widths. There is a good compatibility between the strains in horizontal and vertical directions. The concrete slab behavior shown in Figures 3.6 and 3.10 indicates that Mode-I failure is the primary debonding mechanism at early ages.
