Evaluation of Bonded Concrete Overlay on IH 610 in Houston, Texas

CTR Technical Report:	0-4893-3
Report Date:	February 2008
Project:	0-4893
Project Title:	Performance of Old Concrete Under Thin Overlays
Sponsoring Agency:	Texas Department of Transportation
Performing Agency:	Center for Transportation Research at The University of Texas at Austin

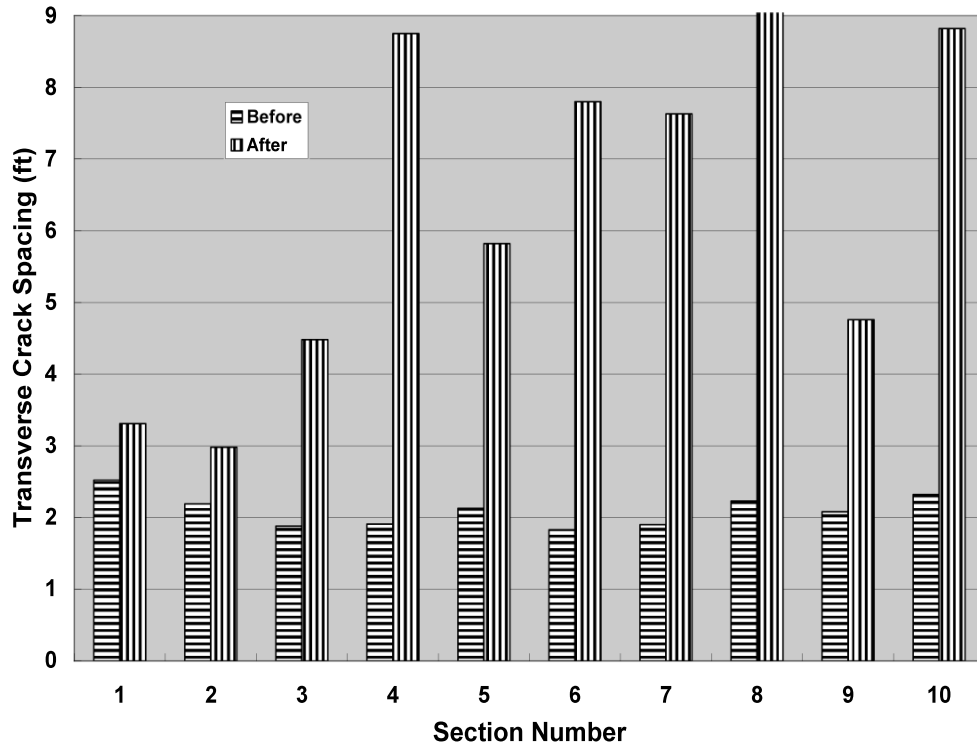
Figure 2.3: Transverse crack spacing before and after the overlay

One year after the overlay, average spacing for transverse cracks increased from 2.1 ft to 7.2 ft. The examination of the crack spacing before and after BCO for each test section shows poor correlation, as depicted in Figure 2.3. This implies that some of the existing cracks did not reflect through the new overlay at the time of the survey. Alternately, the cracks in the overlay might not have been caused by reflection. Table 2.1 indicates that crack spacing surveyed almost 20 years after overlay is larger than the spacing before overlay. This implies that reflection might not be the primary cause of transverse cracking in BCO.

The condition survey conducted in June 2006 indicates that transverse crack spacing has been stabilized at between 2 ft and 4.5 ft. For example, Sections 7 and 8 had unusually large crack spacing one year after overlay (7.6 ft and 17.4 ft, respectively). After 20 years of service, they were reduced to 2.6 ft and 3.2 ft, respectively. Compared with the after-overlay condition survey (year 1987), in 2006, the total number of cracks actually decreased in Sections 3, 4, and 5. Possible explanation is that some length of Section 3 was not surveyed due to the exit ramp in that section. There were a number of patches in Sections 4 and 5 and it is possible that there were transverse cracks in those patch areas. Also, transverse crack information was not collected on Sections 6 and 9 in the 2006 survey. There was extensive map cracking in those sections, and it was determined that the information on transverse cracking will not provide valid information for comparison.

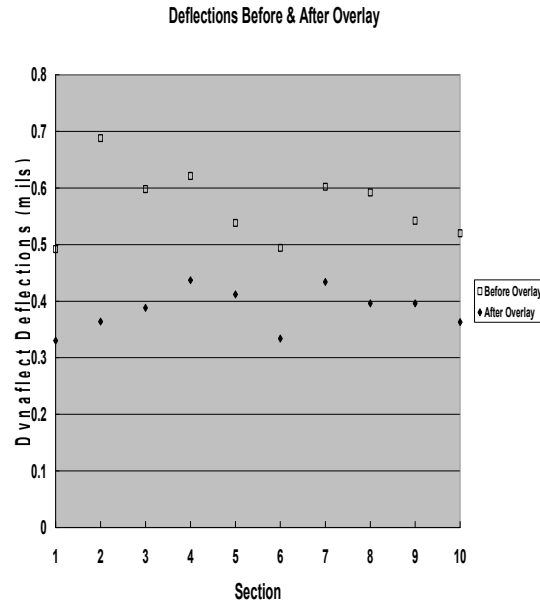
*Figure 2.4: Dynaflect deflections before and after BCO*

In order to estimate the effect of 4-in. overlay on the increase in structural capacity of the overlaid system, deflections measured before and after overlay (February 1986 and January 1987 measurements) were compared. Figure 2.4 shows the results, illustrating the effect of 4-in. overlay on the reduction in Dynaflect deflections. On average, deflections were reduced by one-third, indicating that 4-in. overlay over 8-in. CRCP increased the structural capacity of the pavement system in proportion to the thicknesses. This is expected from Westergaard's analysis of deflections. Figure 2.4 illustrates a strong correlation between deflections before overlay and after overlay in each section.

Sections with larger deflections prior to overlay, such as Sections 4 and 7, also experienced larger deflections after overlay. At the same time, sections with lower deflections prior to the overlay, as in Sections 1, 6, and 10, also had lower deflections after overlay. Because large deflections due to wheel load applications and resulting pumping are the primary causes of distresses in CRCP, the benefits of BCO are clearly shown. Dynaflect is no longer in use at TxDOT; the falling weight deflectometer (FWD) has replaced Dynaflect as a non-destructive pavement evaluation tool. FWD is a powerful tool for structural evaluation of pavement systems, and several data analysis programs have been developed and are in use. However, it requires a stop-and-go operation and would require substantial time for the testing of all the sections for this project. Due to the heavy traffic in this project, it was not feasible to close the sections for an extended period time for FWD testing. As an alternative, RDD testing was conducted. The Rolling Dynamic Deflectometer is a semi-continuous deflection measuring device developed at The University of Texas at Austin. It runs at about one mile per hour and it took only one night of lane closures to complete the testing. The testing was conducted on the night of May 8, 2006. Static force of 13 kips and dynamic p-p force of 5 kips were applied with a loading frequency of 30 Hz. The average deflections from RDD varied between 3.2 and 4.2 mils, indicating excellent structural condition of the pavement. It was noted earlier that there were a number of patches in Sections 4 and 5, but none in the other sections. RDD data indicates that even though the deflections in Sections 4 and 5 are larger than the other sections, except for Section 1, they are still quite low. The patches, therefore, appear to have been to repair distresses due to delaminations.
