Aggregate Distribution Investigation in Box Beams Fabricated With Self Consolidating Concrete

CTR Technical Report:	0-5197-01-1
Report Date:	October 2009
Project:	0-5197-01
Project Title:	Continuing Research on Allowable Design Release Stresses for Prestressed Concrete Beams
Sponsoring Agency:	Texas Department of Transportation
Performing Agency:	Center for Transportation Research at The University of Texas at Austin

This technical report summarizes the observations and findings obtained after placing transverse cuts in four box beams specimens tested in TxDOT Project 0-5197 and visually examining the exposed surface.

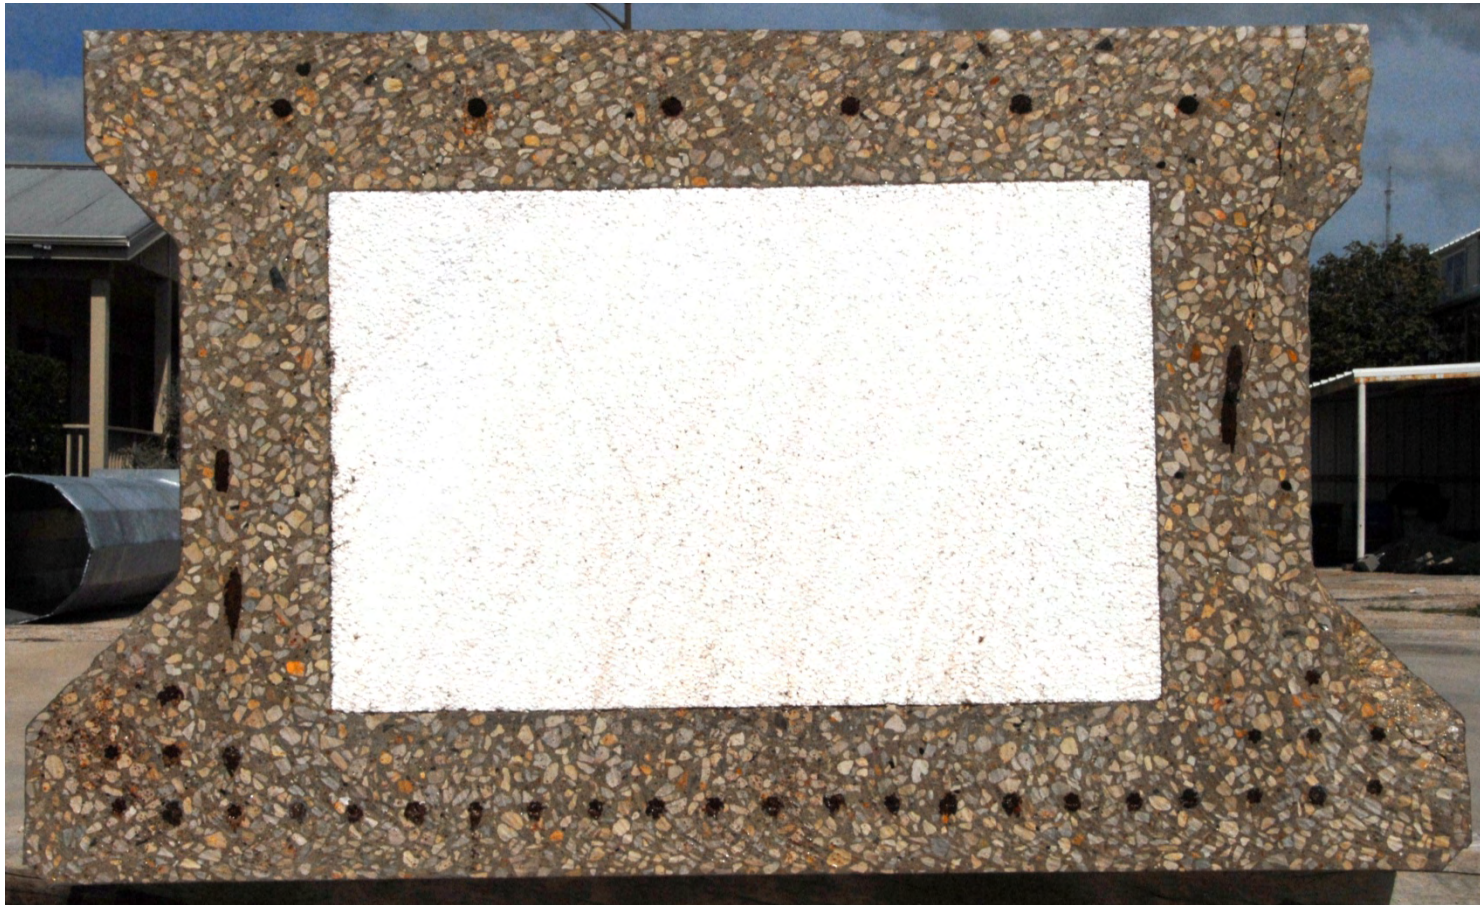
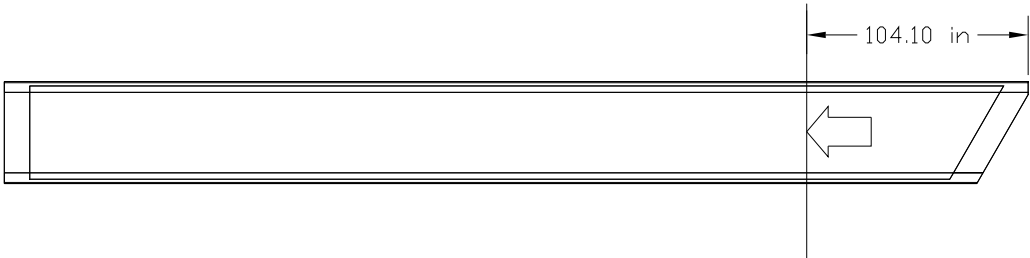
Figure A. 1: Picture BB02C1A

Beam Mark:	BB02	<p>Cut Location and View:</p>

Concrete Type:	Conventional Concrete	
Aggregate:	Limestone	
Cut ID:	BB02C1A

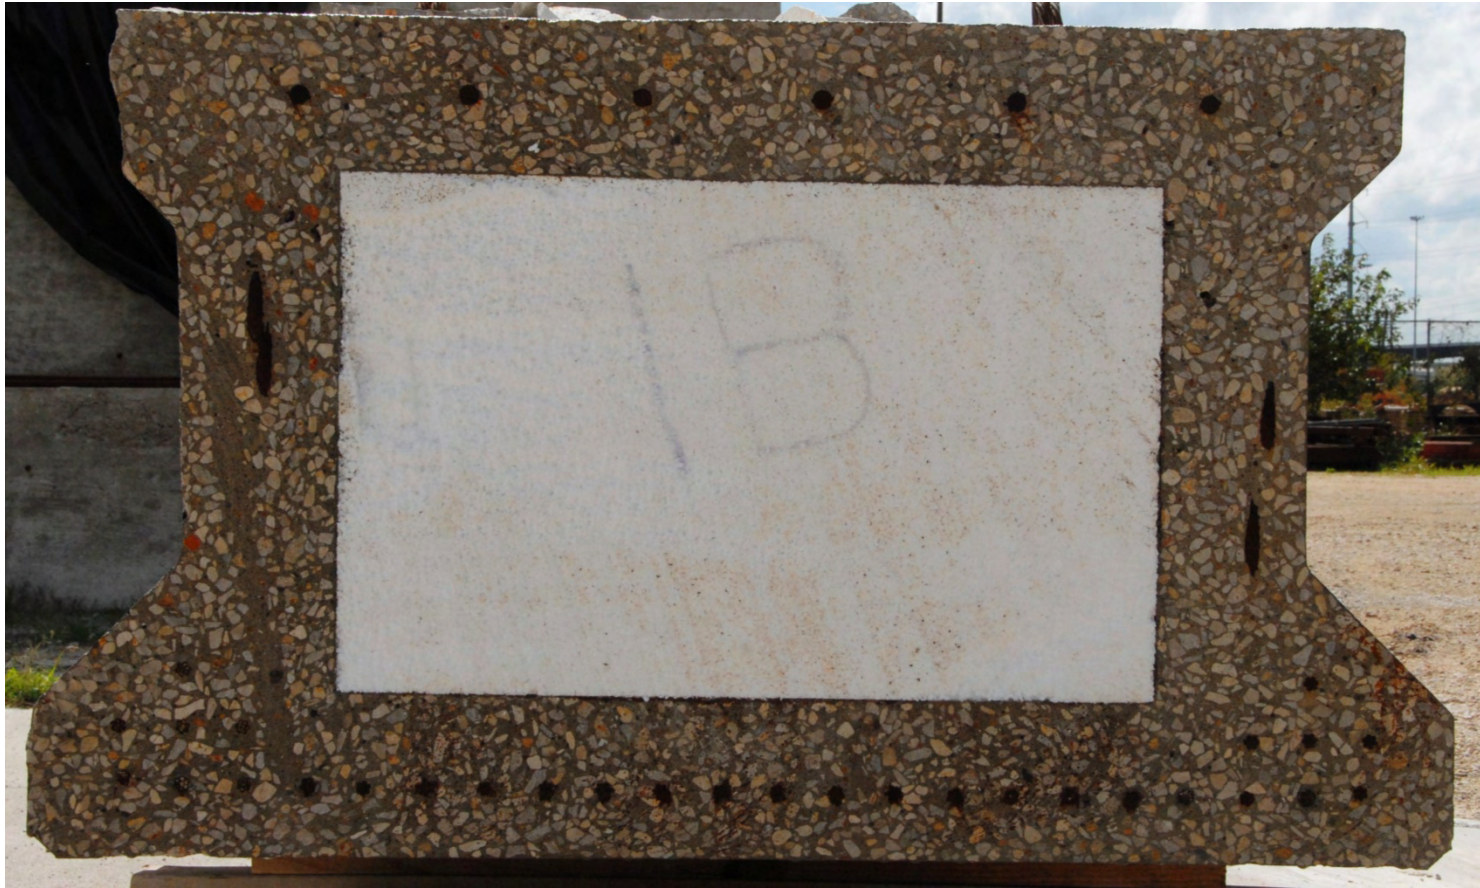
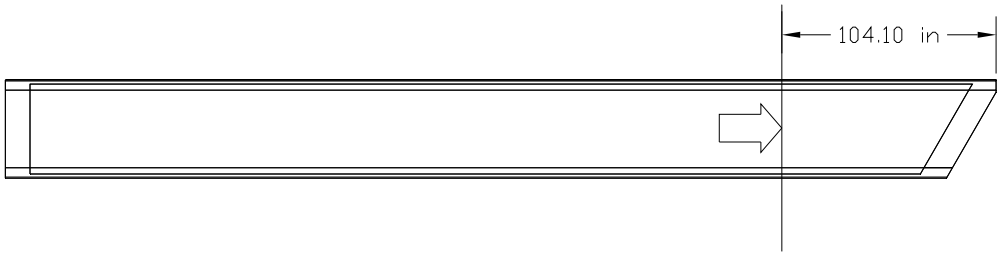
Figure A. 2: Picture BB02C1B

Beam Mark:	BB02	Cut Location and View:

Concrete Type:	Conventional Concrete	
Aggregate:	Limestone	
Cut ID:	BB02C1B

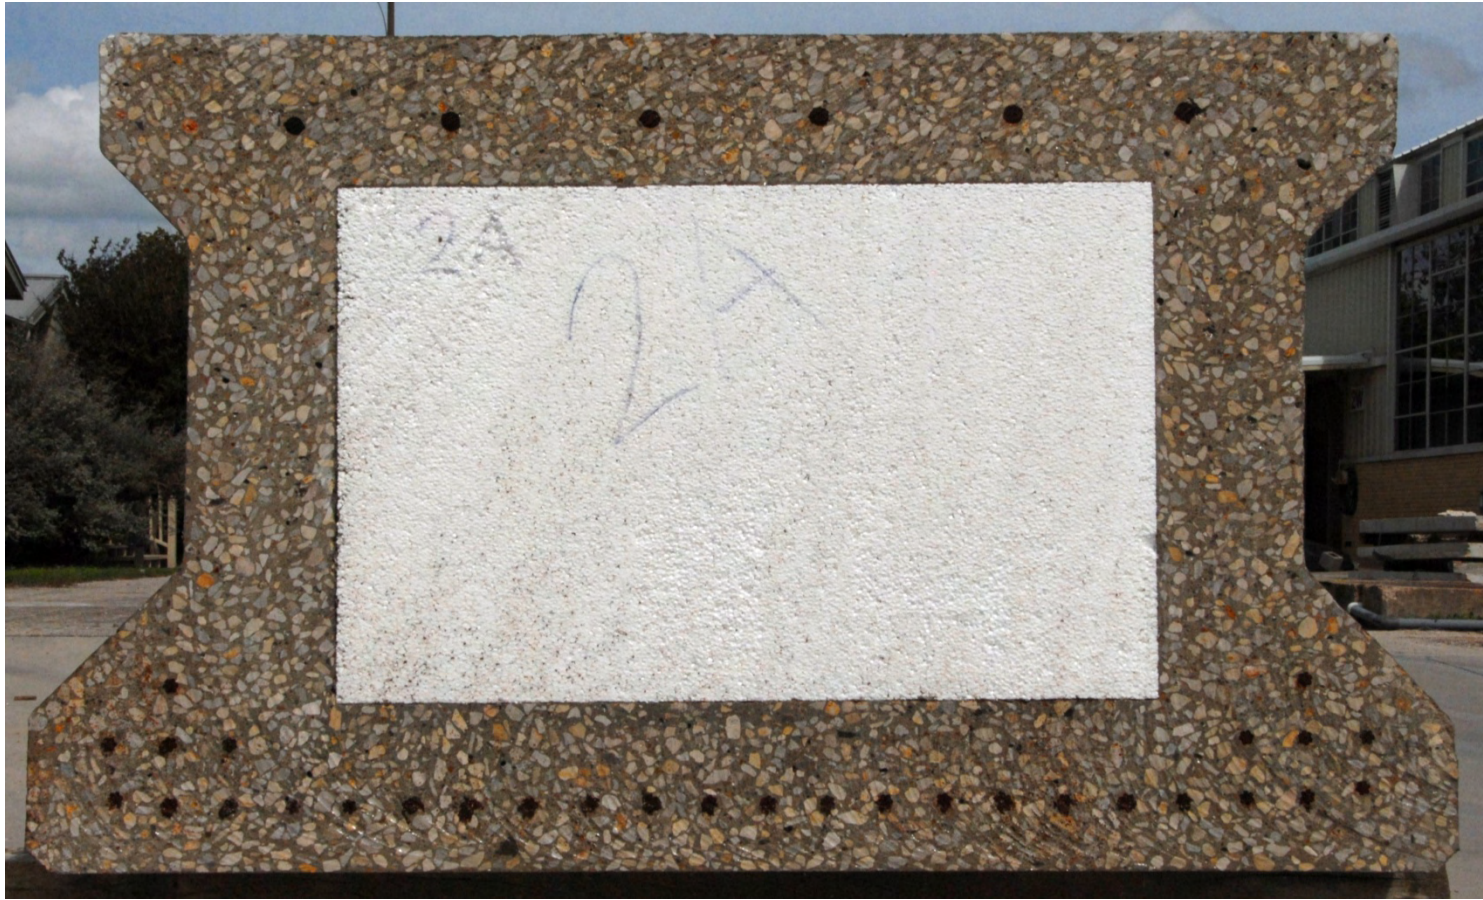
Figure A. 3: Picture BB02C2A

Beam Mark:	BB02	Cut Location and View:
Concrete Type:	Conventional Concrete	
Aggregate:	Limestone	
Cut ID:	BB02C2A

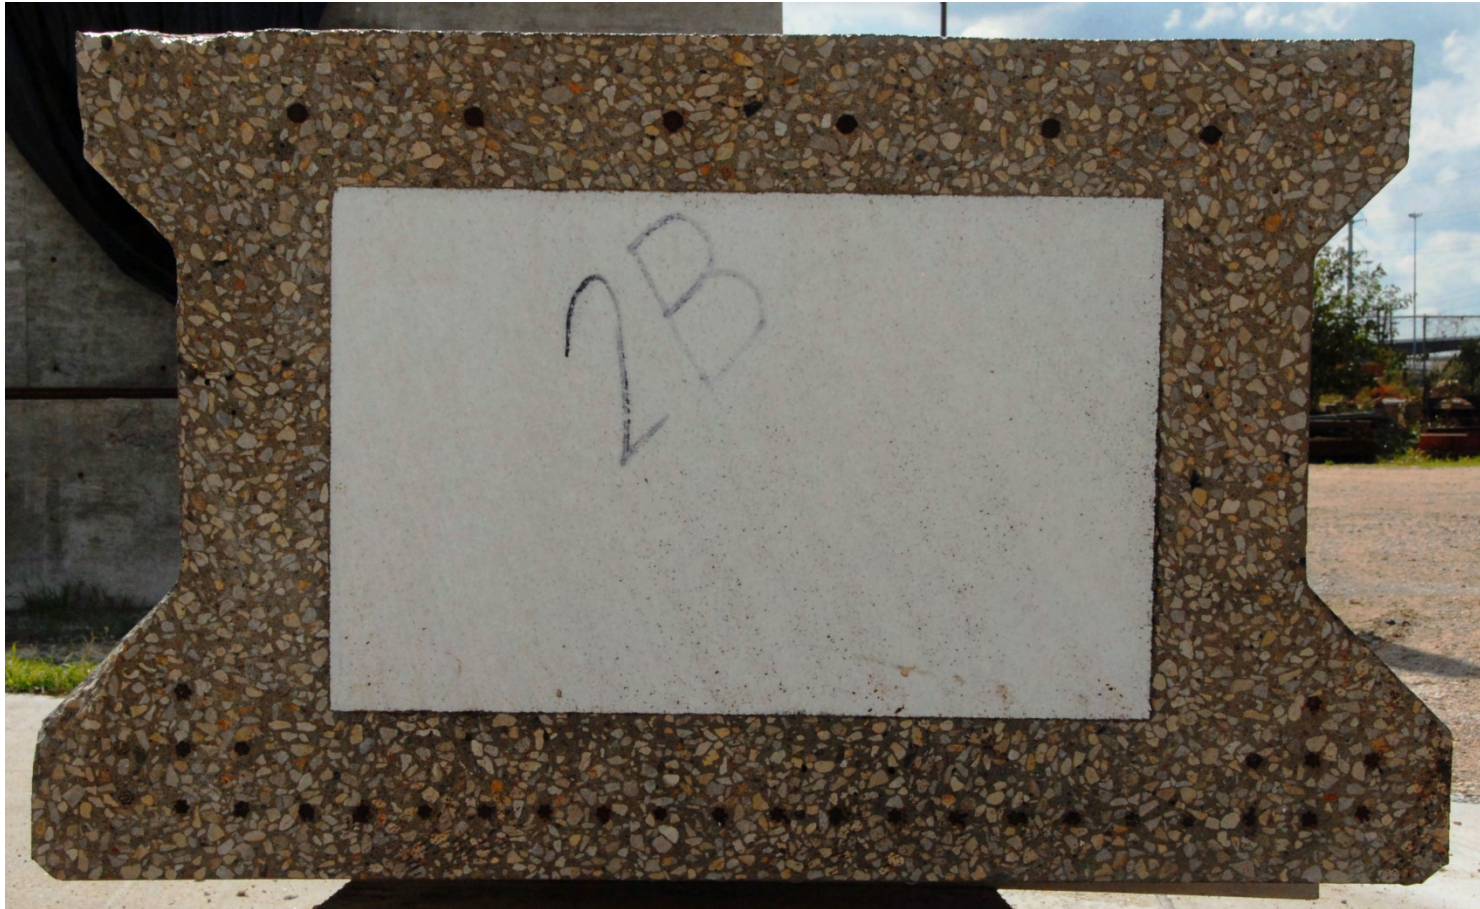
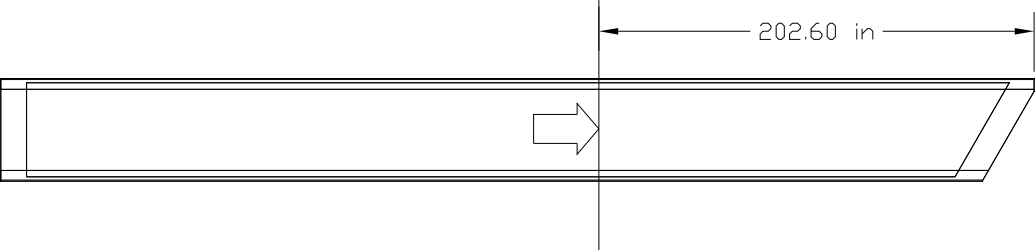
Figure A. 4: Picture BB02C2B

Beam Mark:	BB02	Cut Location and View:

Concrete Type:	Conventional Concrete	
Aggregate:	Limestone	
Cut ID:	BB02C2B

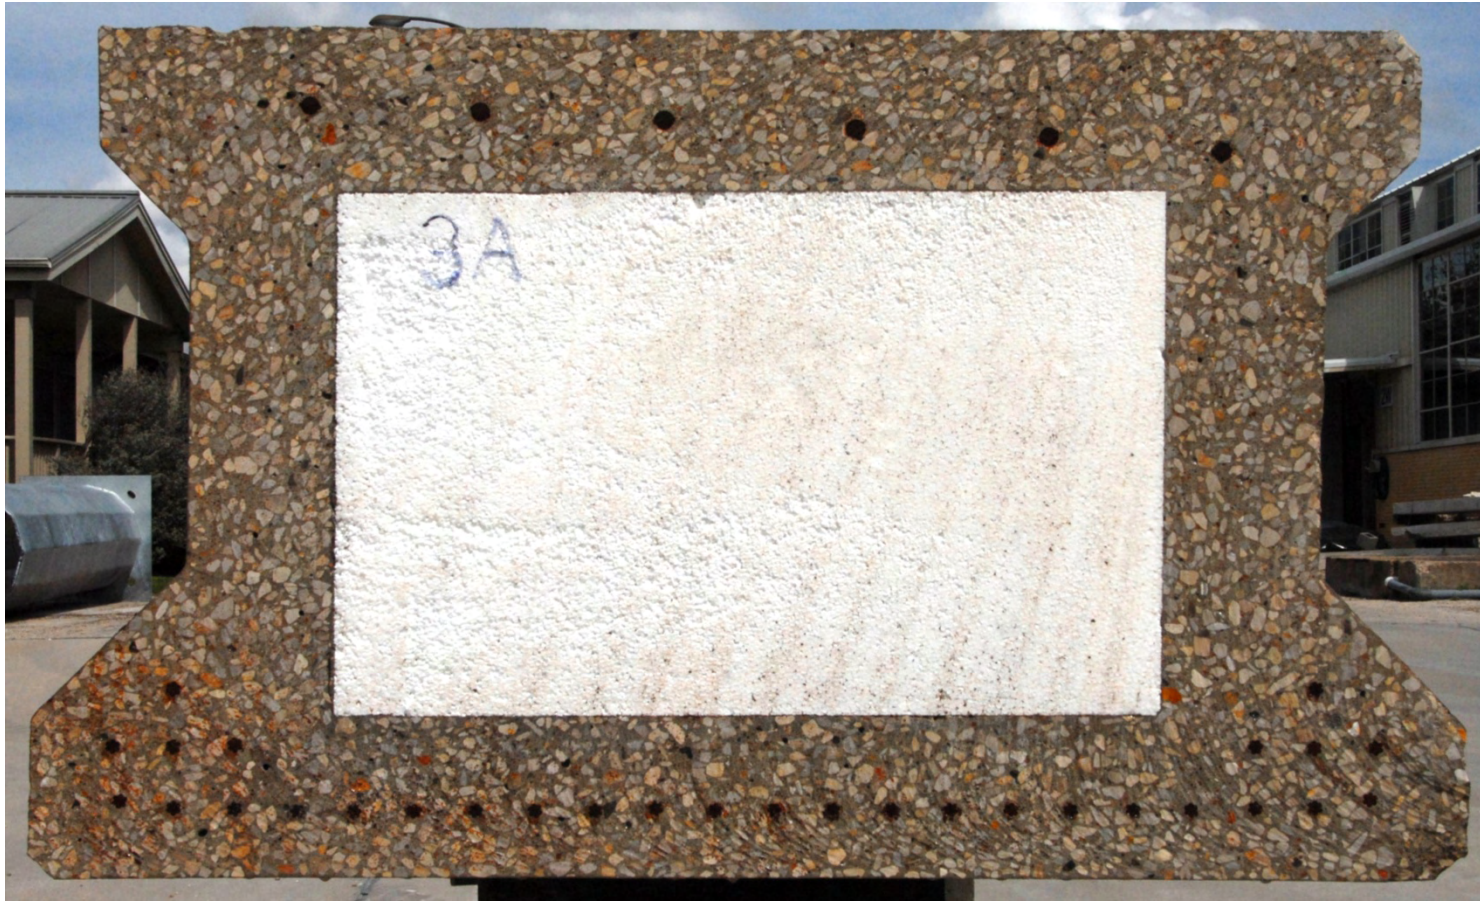
Figure A. 5: Picture BB02C3A

Beam Mark:	BB02	Cut Location and View:
Concrete Type:	Conventional Concrete	
Aggregate:	Limestone	
Cut ID:	BB02C3A

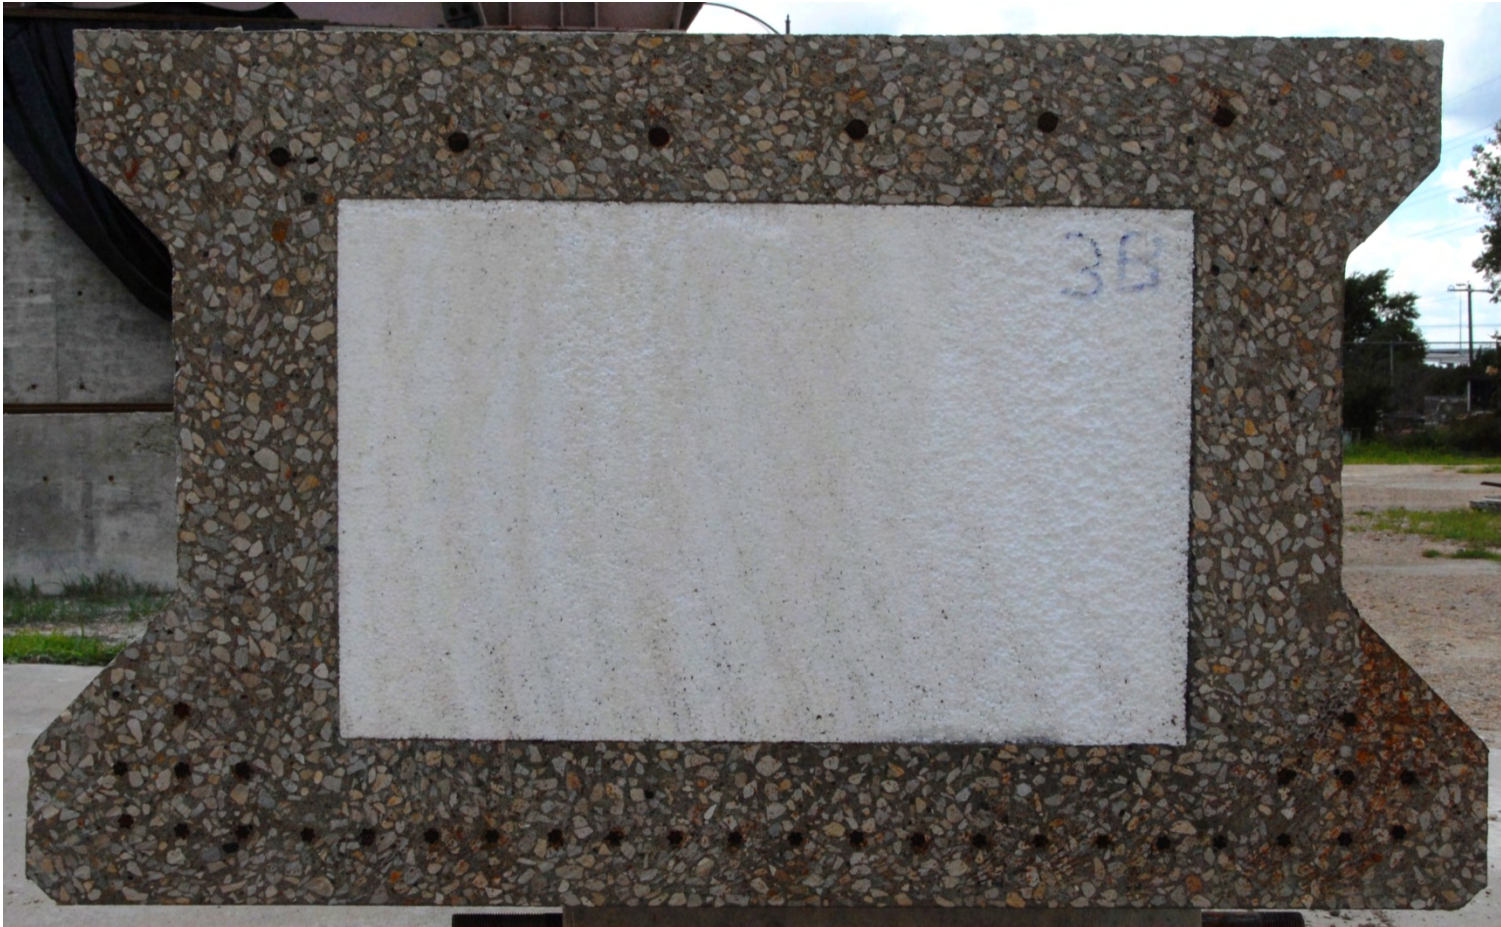
Figure A. 6: Picture BB02C3B

Beam Mark:	BB02	<p>Cut Location and View:</p>
Concrete Type:	Conventional Concrete	
Aggregate:	Limestone	
Cut ID:	BB02C3B

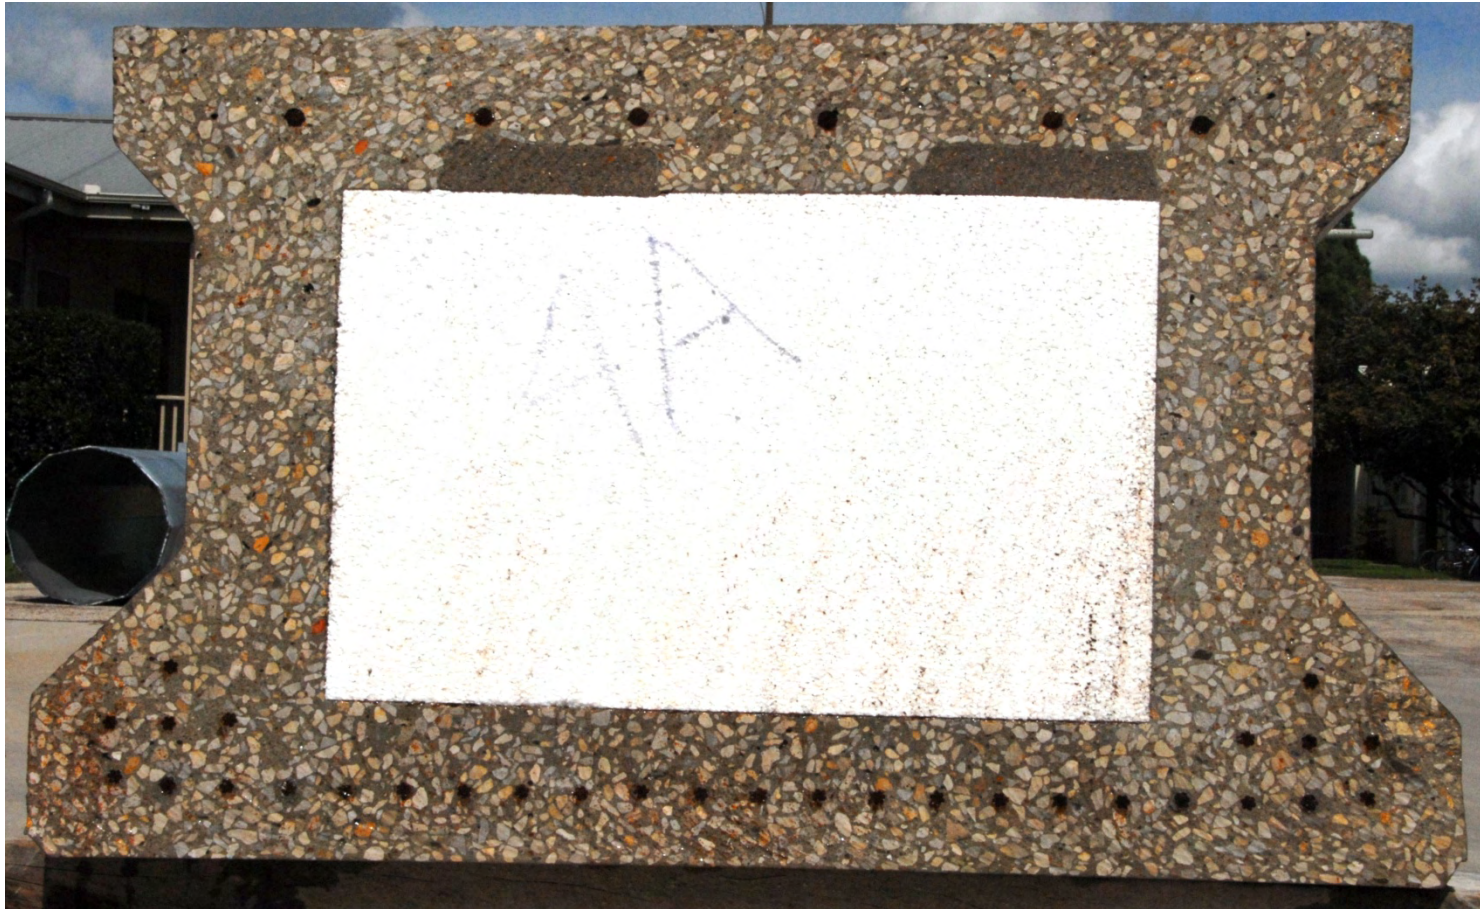
Figure A. 7: Picture BB02C4A

Beam Mark:	BB02	<p>Cut Location and View:</p>
Concrete Type:	Conventional Concrete	
Aggregate:	Limestone	
Cut ID:	BB02C4A

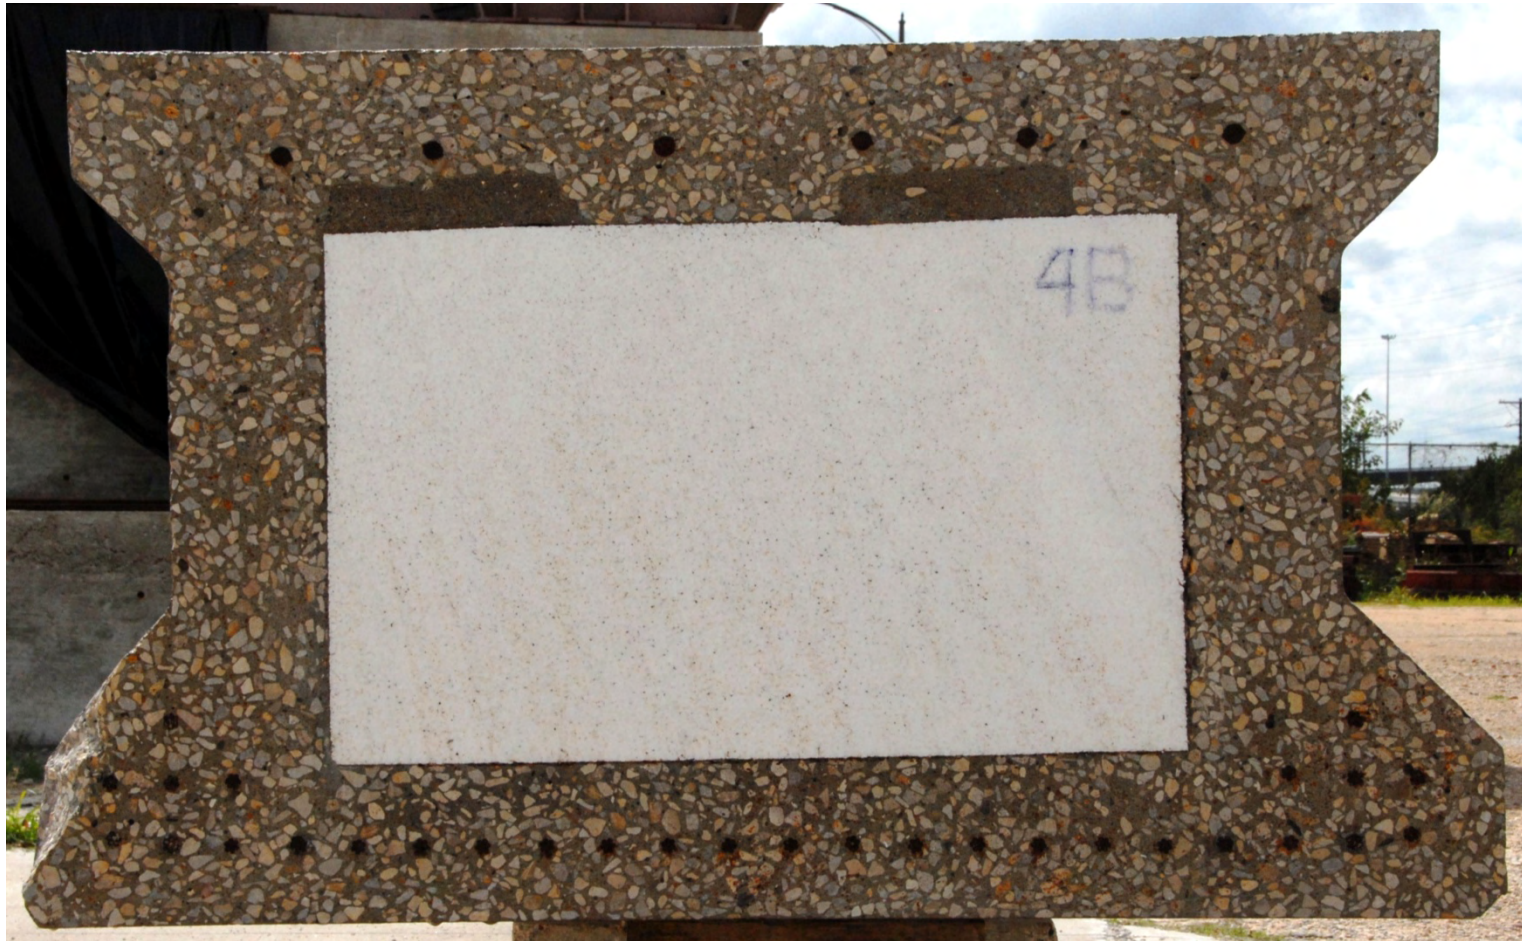
Figure A. 8: Picture BB02C4B

Beam Mark:	BB02	<p>Cut Location and View:</p>
Concrete Type:	Conventional Concrete	
Aggregate:	Limestone	
Cut ID:	BB02C4B

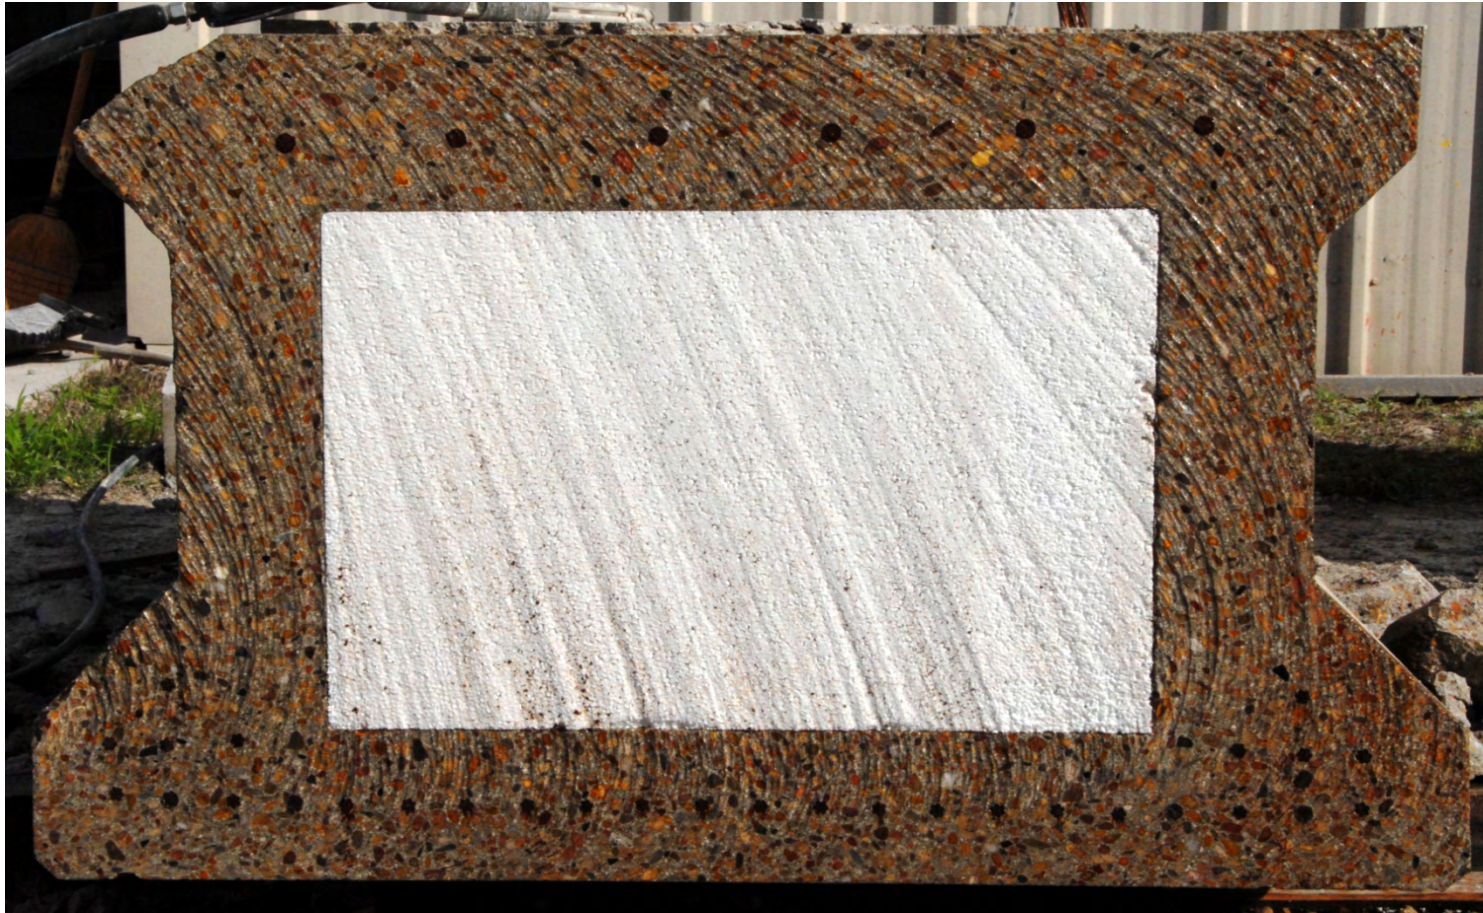
Figure A. 9: Picture BB07C1A

Beam Mark:	BB07	<p>Cut Location and View:</p>
Concrete Type:	Self consolidating	
Aggregate:	River Rock	
Cut ID:	BB07C1A

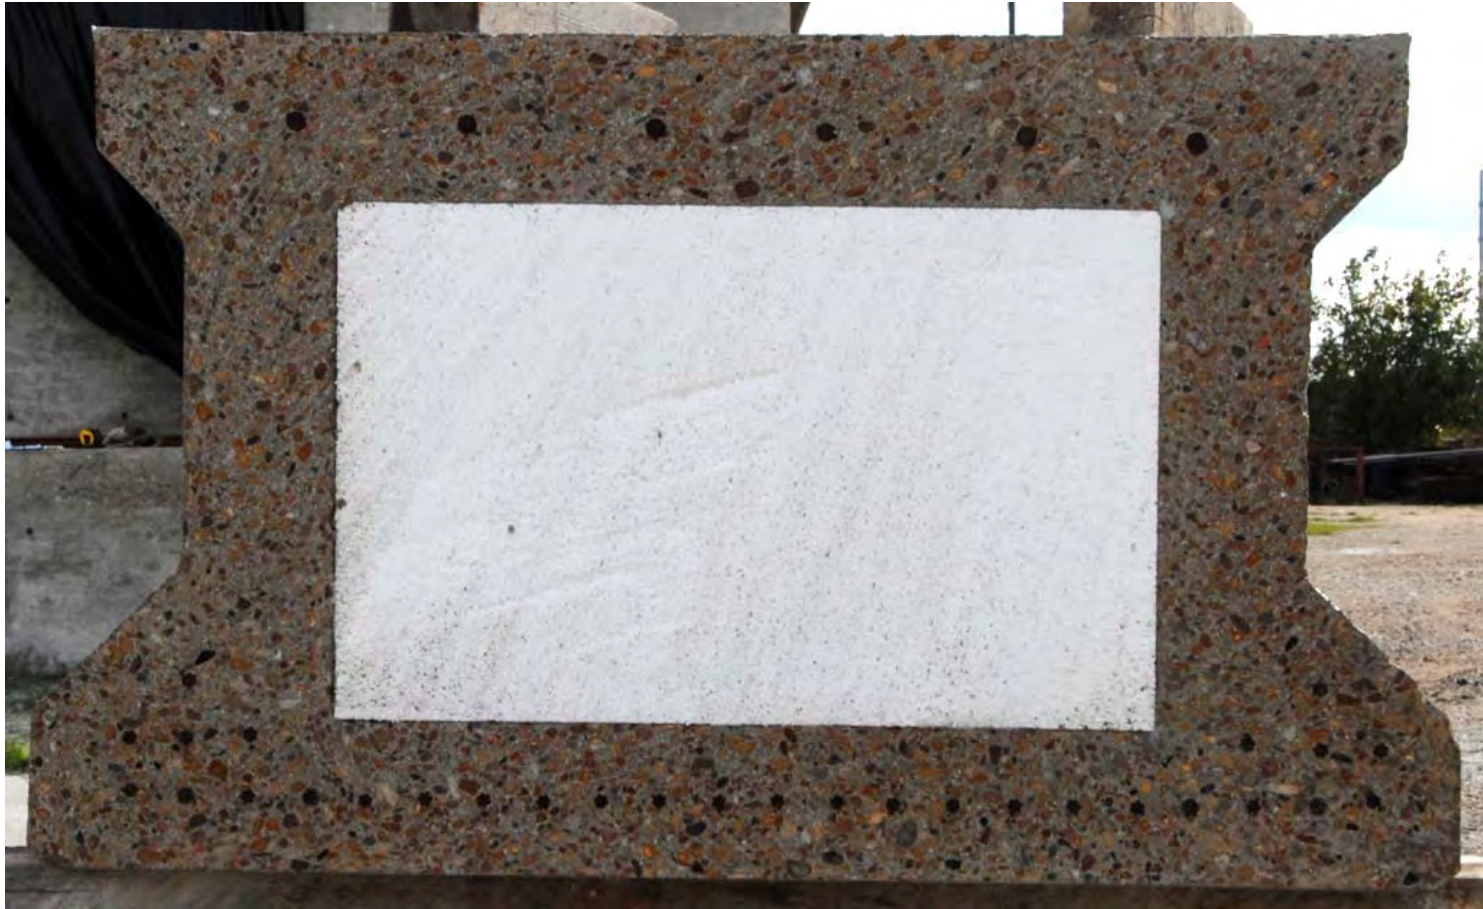
Figure A. 10: Picture BB07C1B

Beam Mark:	BB07	<p>Cut Location and View:</p>
Concrete Type:	Self consolidating	
Aggregate:	River Rock	
Cut ID:	BB07C1B

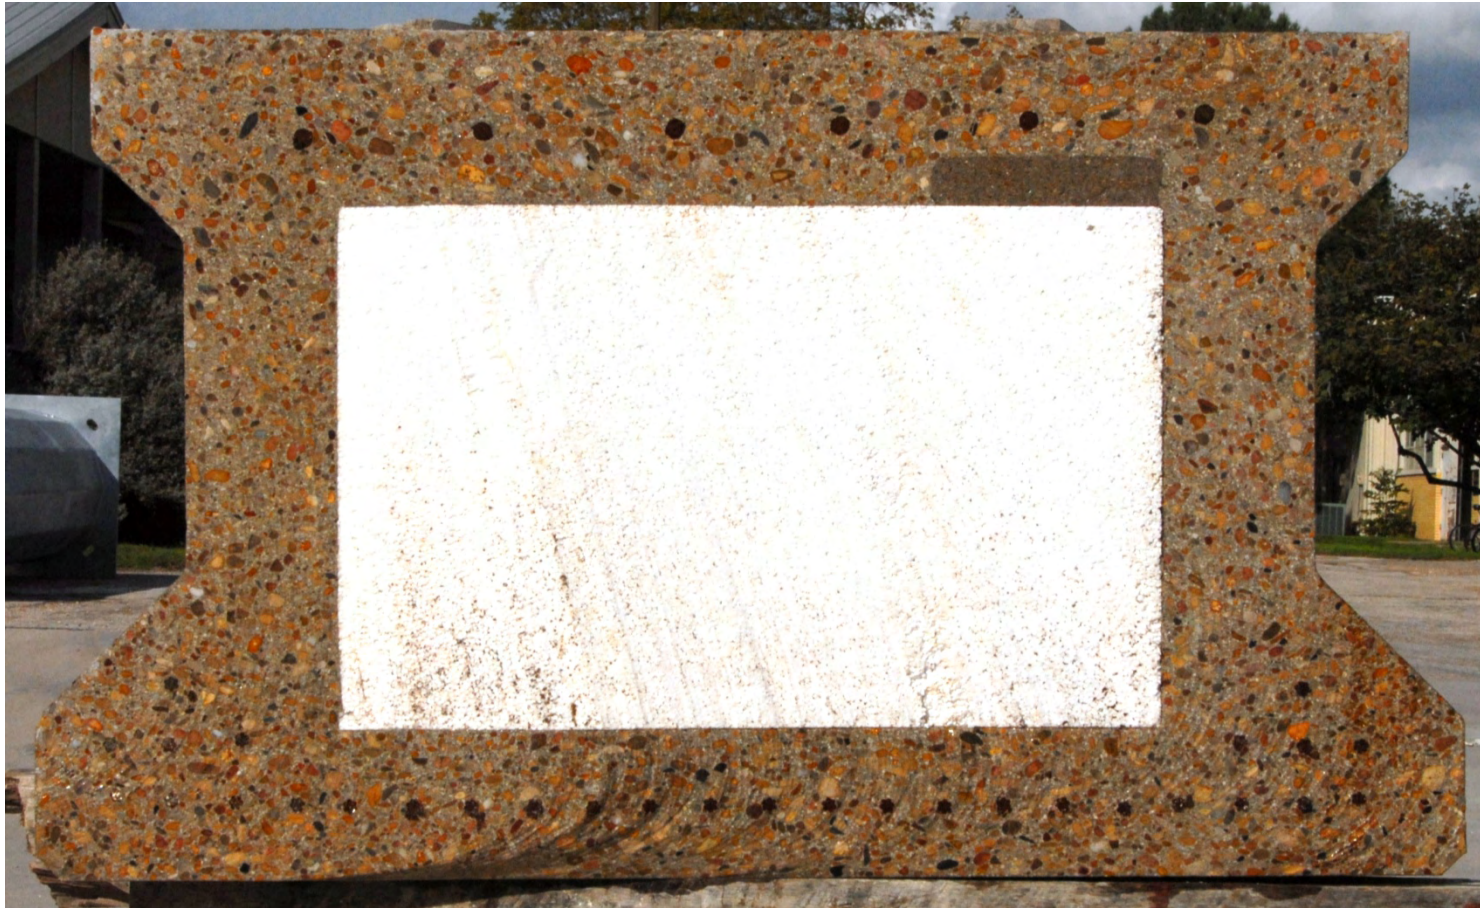
Figure A. 11: Picture BB07C2A

Beam Mark:	BB07	<p>Cut Location and View:</p>
Concrete Type:	Self consolidating	
Aggregate:	River Rock	
Cut ID:	BB07C2A

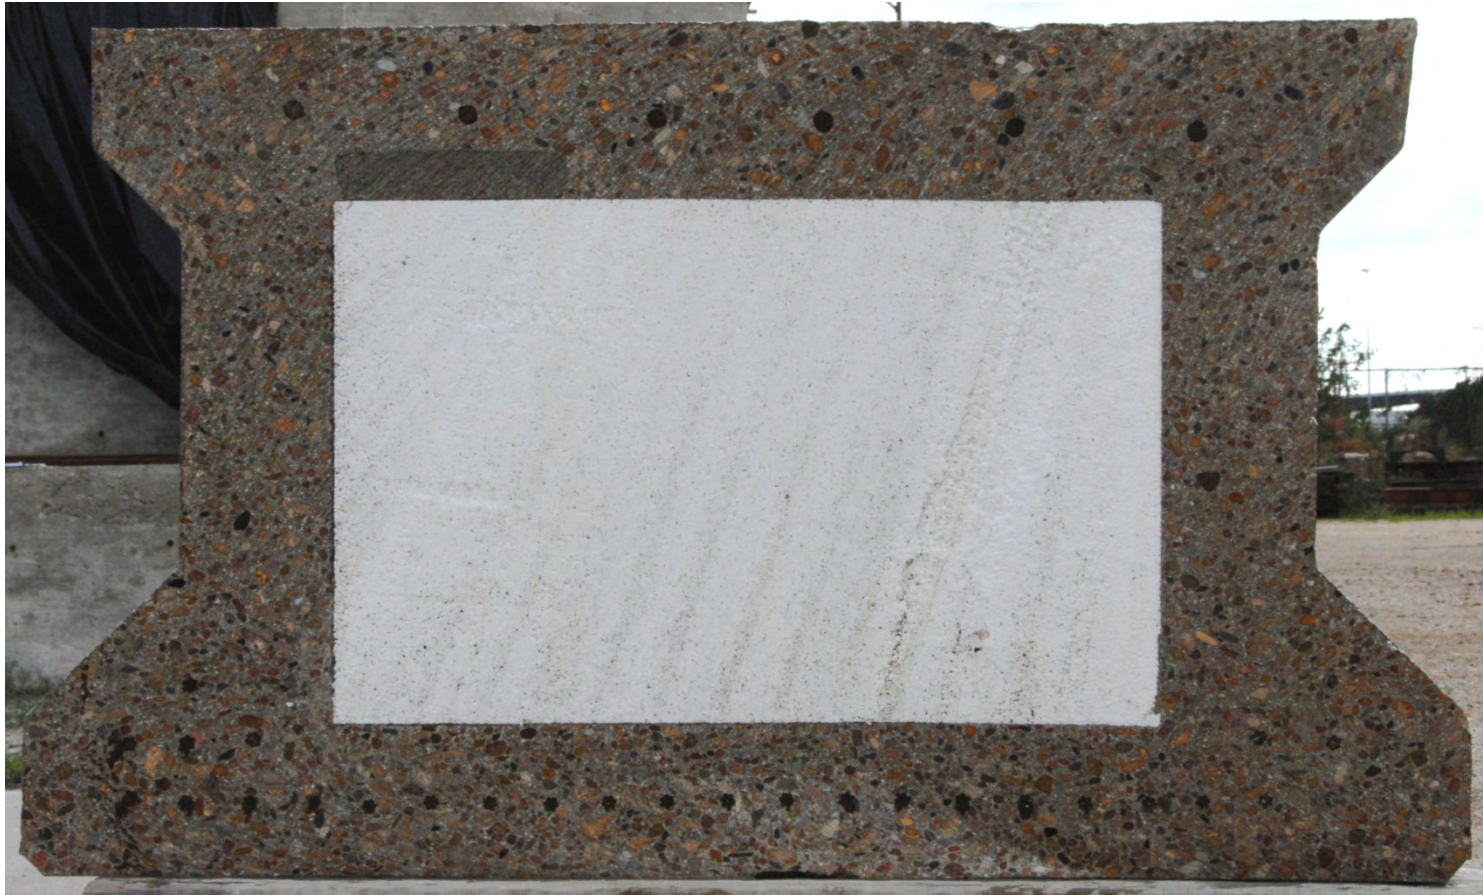
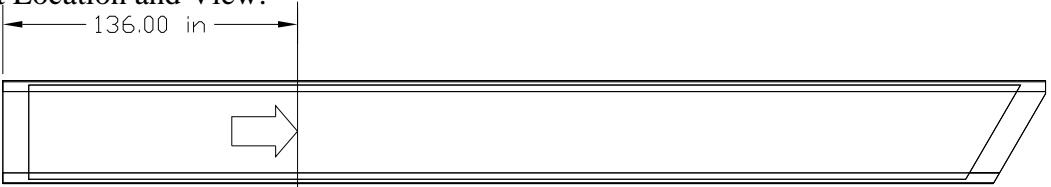
Figure A. 12: Picture BB07C2B

Beam Mark:	BB07	<p>Cut Location and View:</p>

Concrete Type:	Self consolidating	
Aggregate:	River Rock	
Cut ID:	BB07C2B

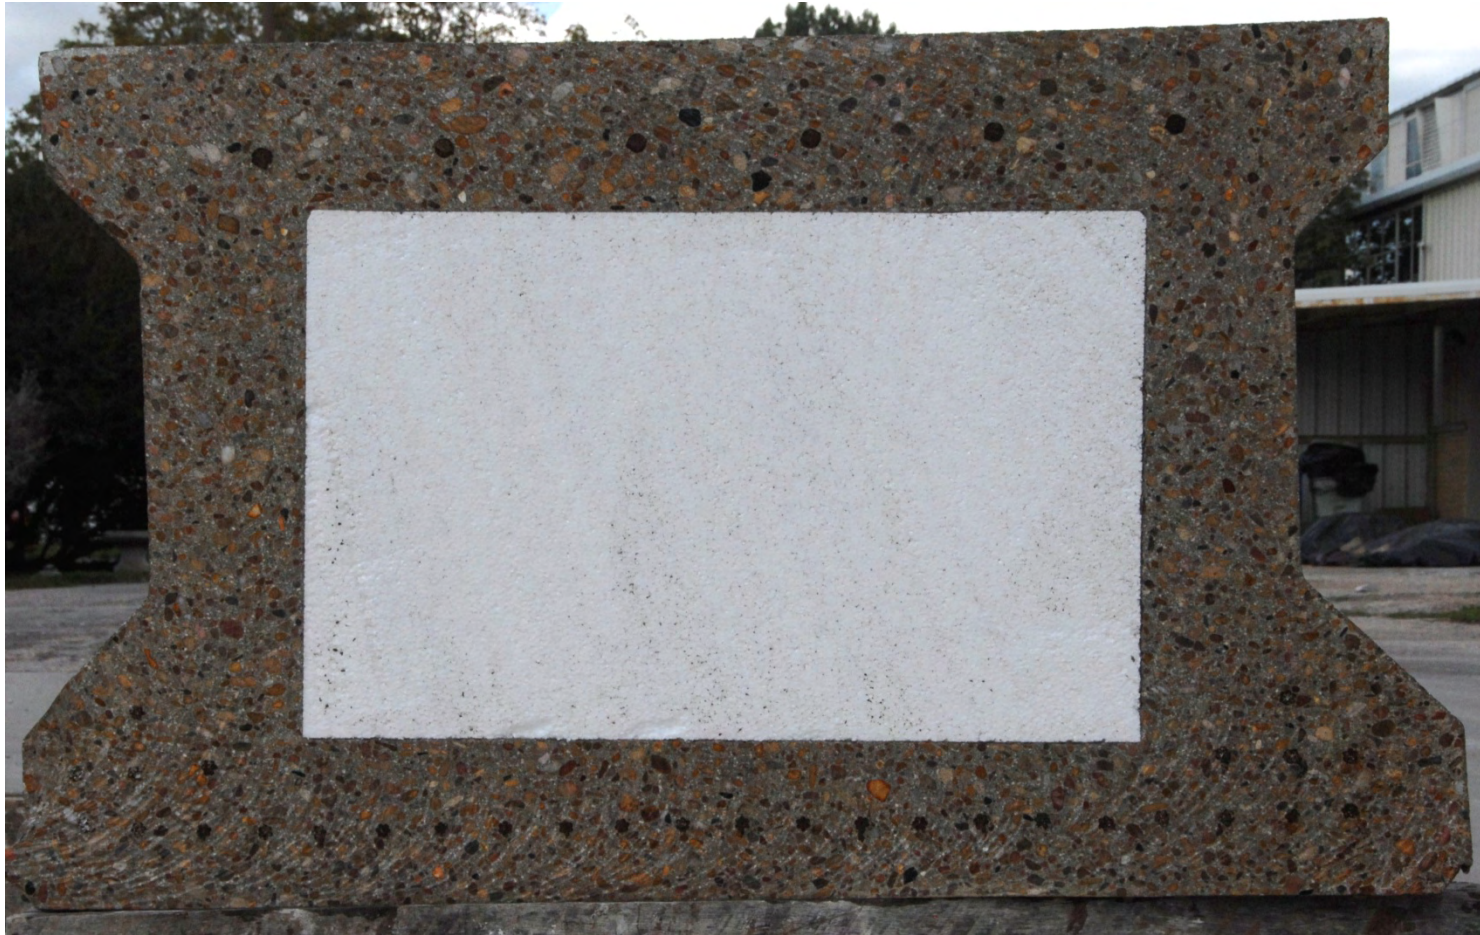
Figure A. 13: Picture BB07C3A

Beam Mark:	BB07	<p>Cut Location and View:</p>
Concrete Type:	Self consolidating	
Aggregate:	River Rock	
Cut ID:	BB07C3A

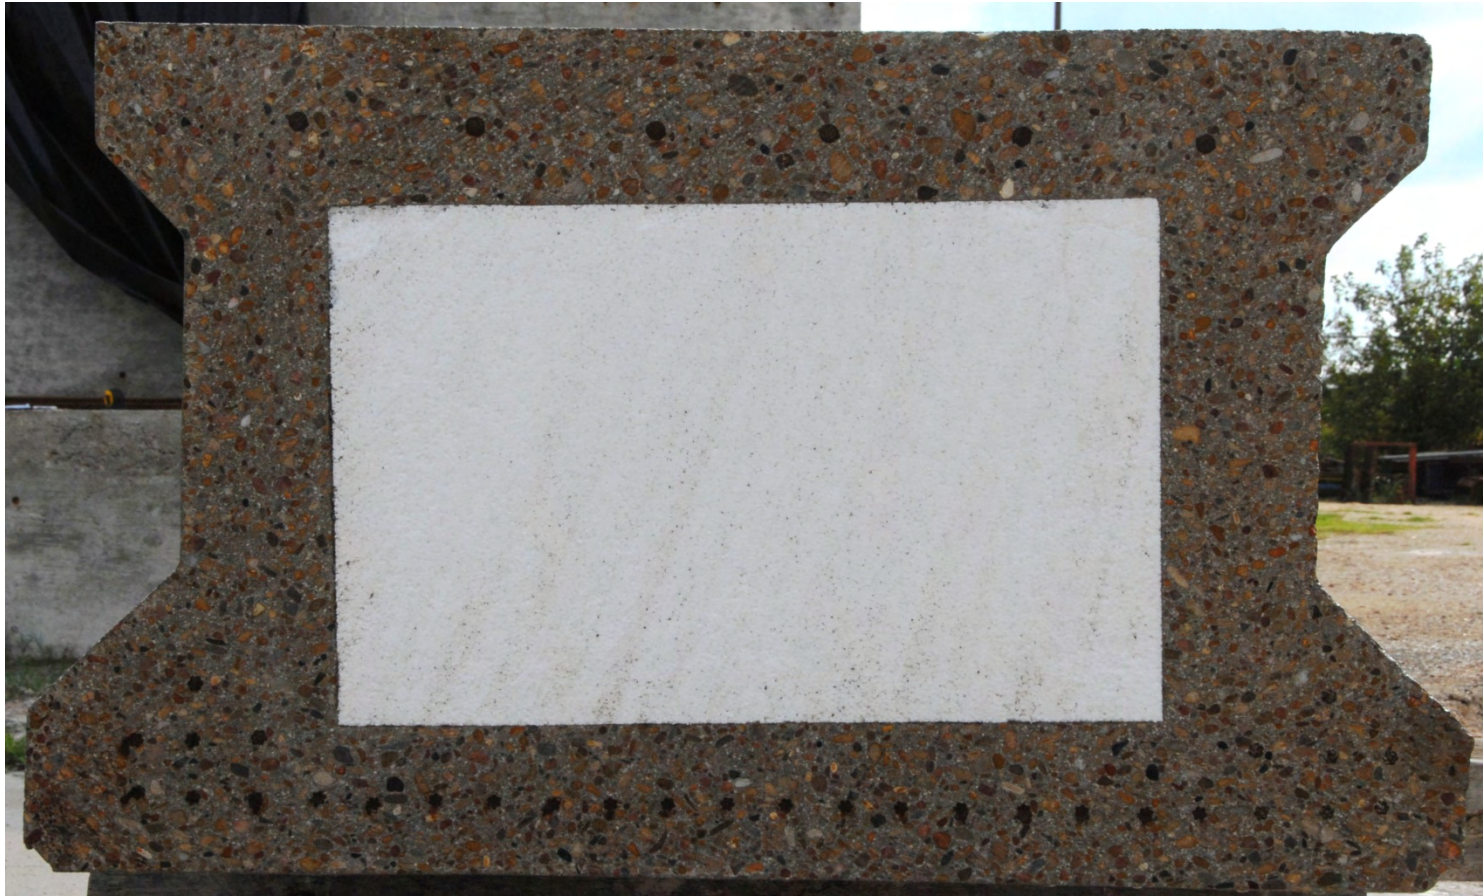
Figure A. 14: Picture BB07C3B

Beam Mark:	BB07	<p>Cut Location and View:</p>
Concrete Type:	Self consolidating	
Aggregate:	River Rock	
Cut ID:	BB07C3B

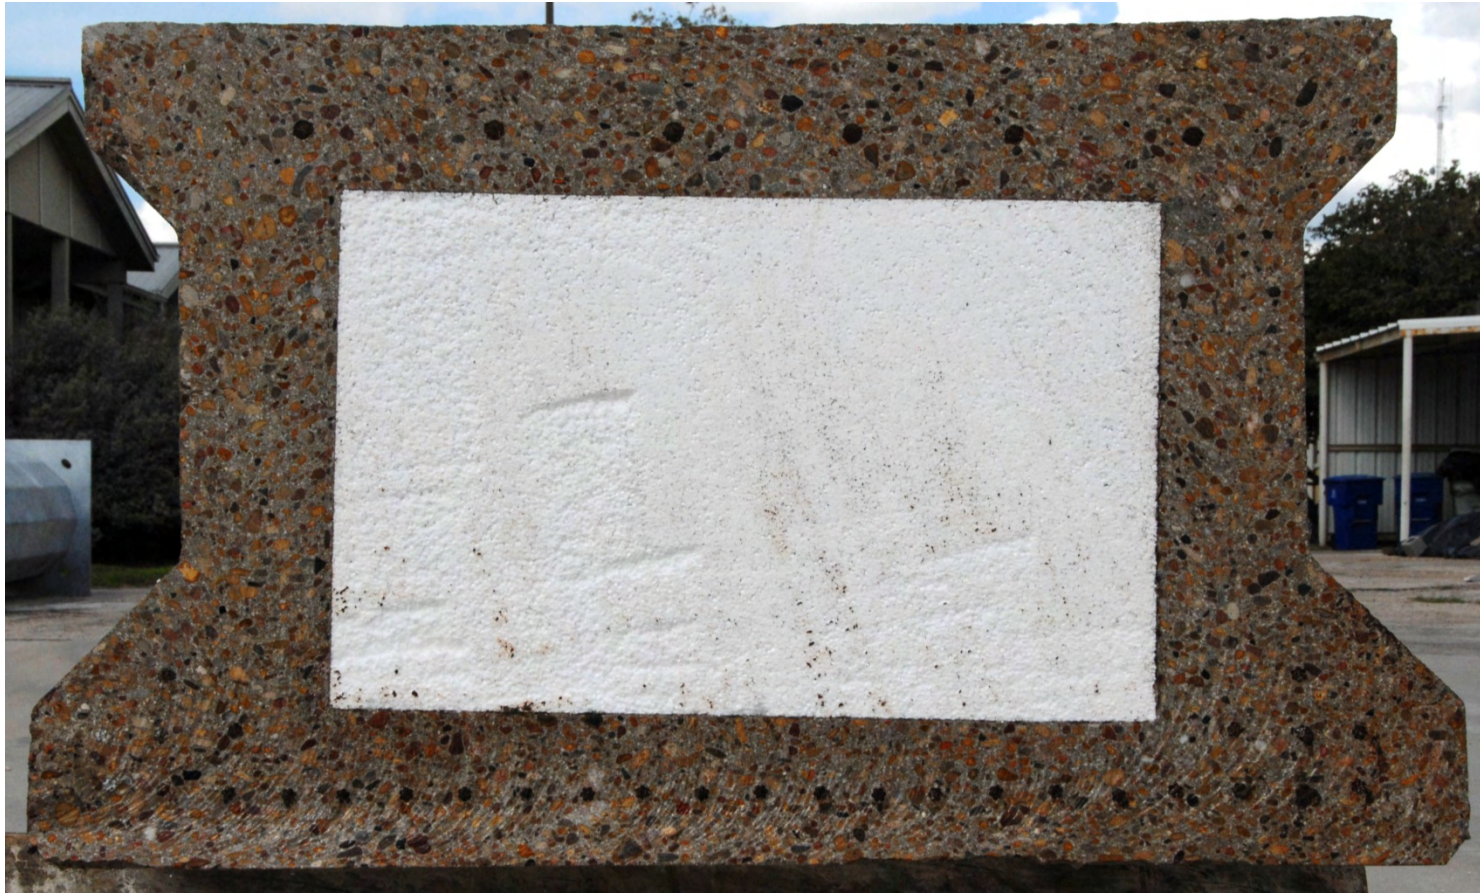
Figure A. 15: Picture BB07C4A

Beam Mark:	BB07	<p>Cut Location and View:</p>
Concrete Type:	Self consolidating	
Aggregate:	River Rock	
Cut ID:	BB07C4A

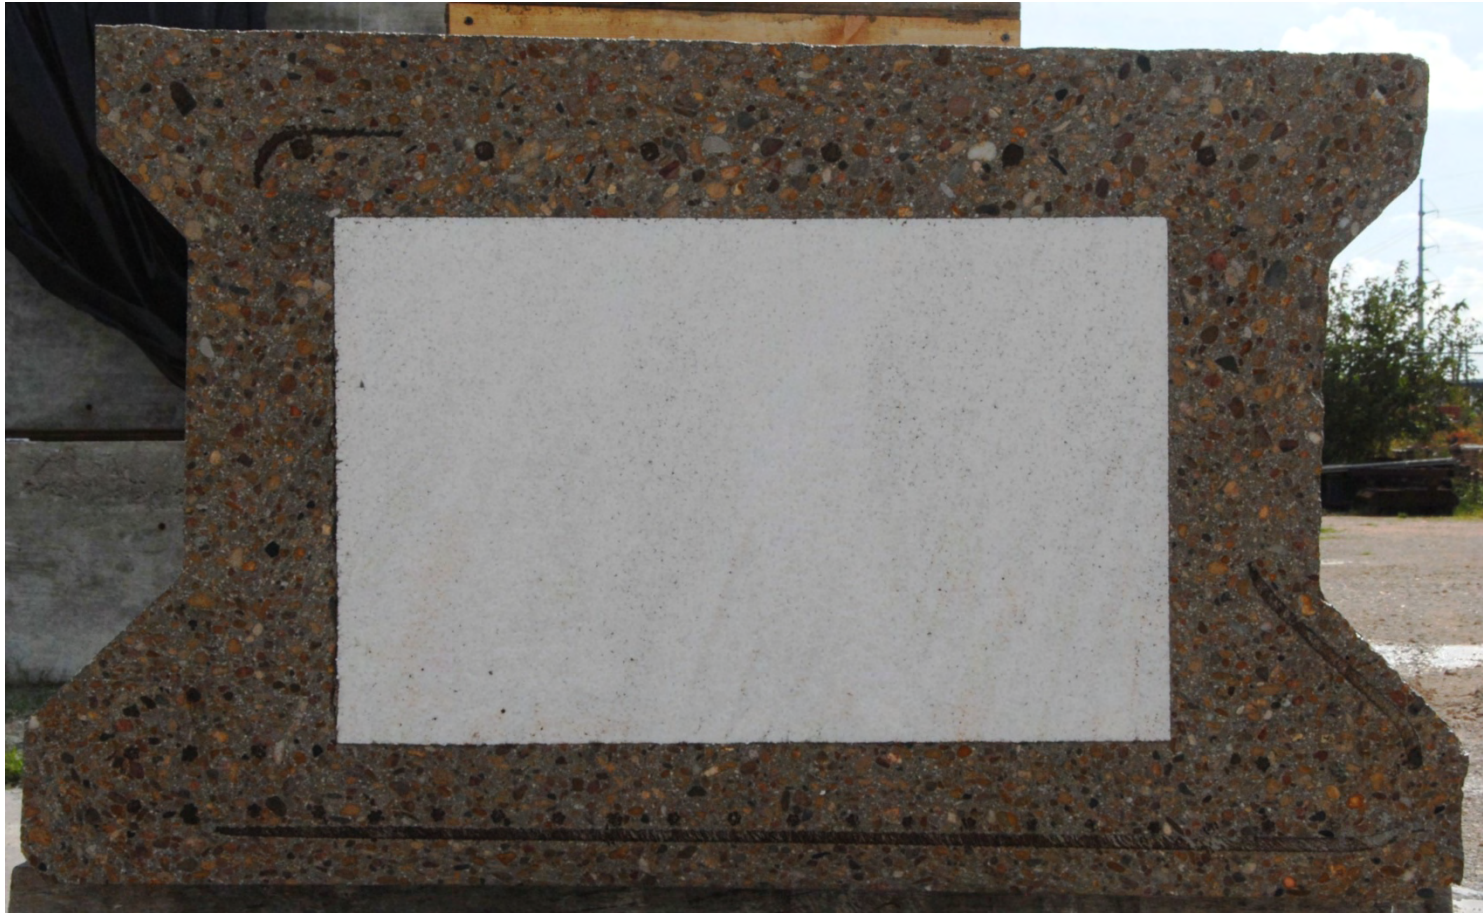
Figure A. 16: Picture BB07C4B

Beam Mark:	BB07	<p>Cut Location and View:</p>
Concrete Type:	Self consolidating	
Aggregate:	River Rock	
Cut ID:	BB07C4B
