Aggregate Distribution Investigation in Box Beams Fabricated With Self Consolidating Concrete

CTR Technical Report:	0-5197-01-1
Report Date:	October 2009
Project:	0-5197-01
Project Title:	Continuing Research on Allowable Design Release Stresses for Prestressed Concrete Beams
Sponsoring Agency:	Texas Department of Transportation
Performing Agency:	Center for Transportation Research at The University of Texas at Austin

This technical report summarizes the observations and findings obtained after placing transverse cuts in four box beams specimens tested in TxDOT Project 0-5197 and visually examining the exposed surface.

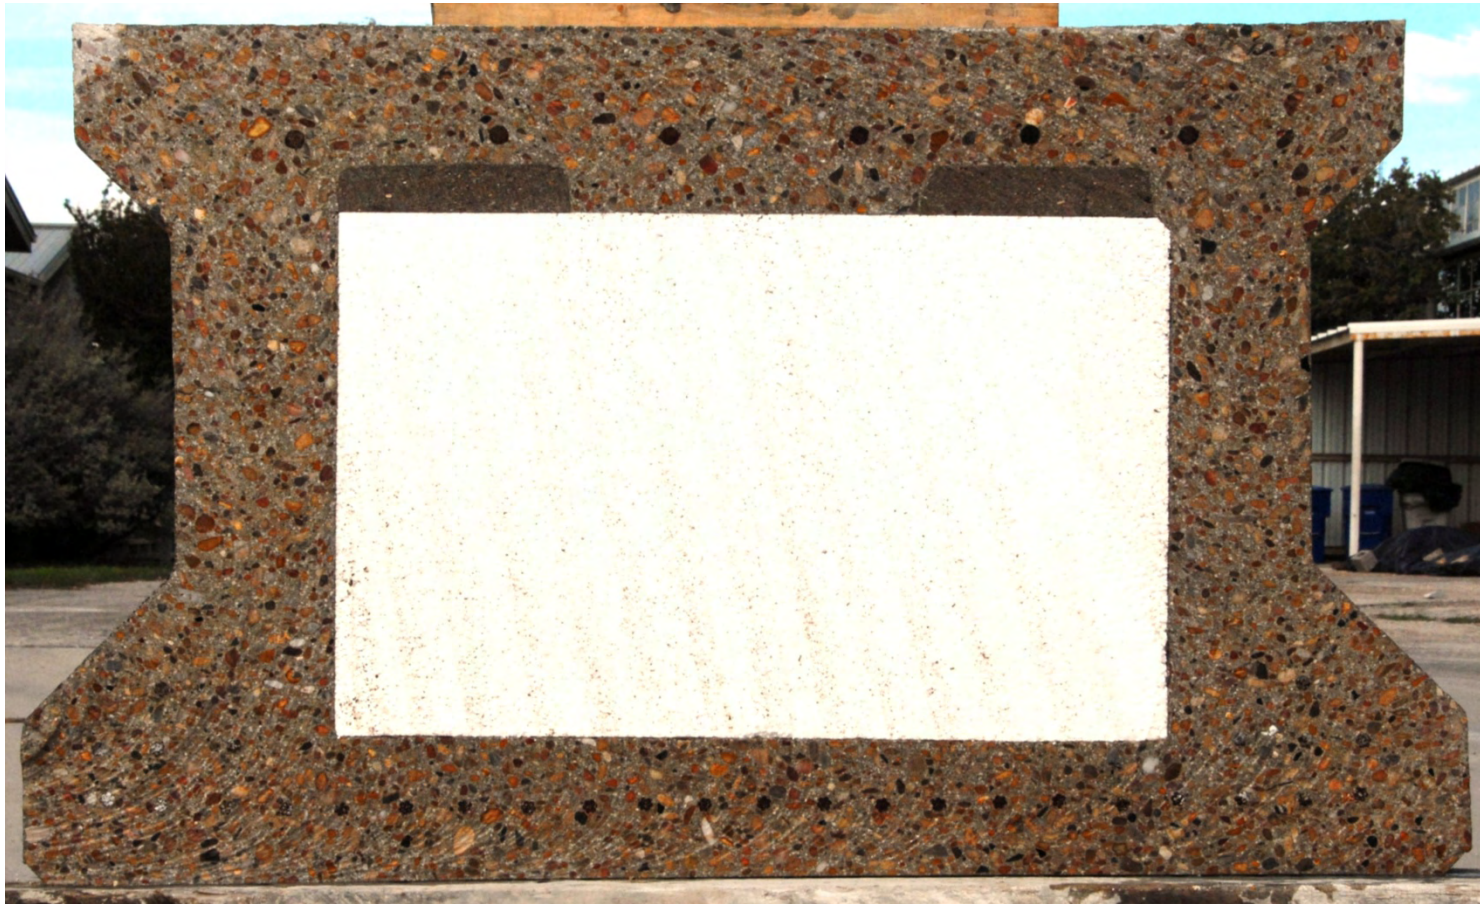
Figure A. 17: Picture BB07C5A

Beam Mark:	BB07	<p>Cut Location and View:</p>
Concrete Type:	Self consolidating	
Aggregate:	River Rock	
Cut ID:	BB07C5A

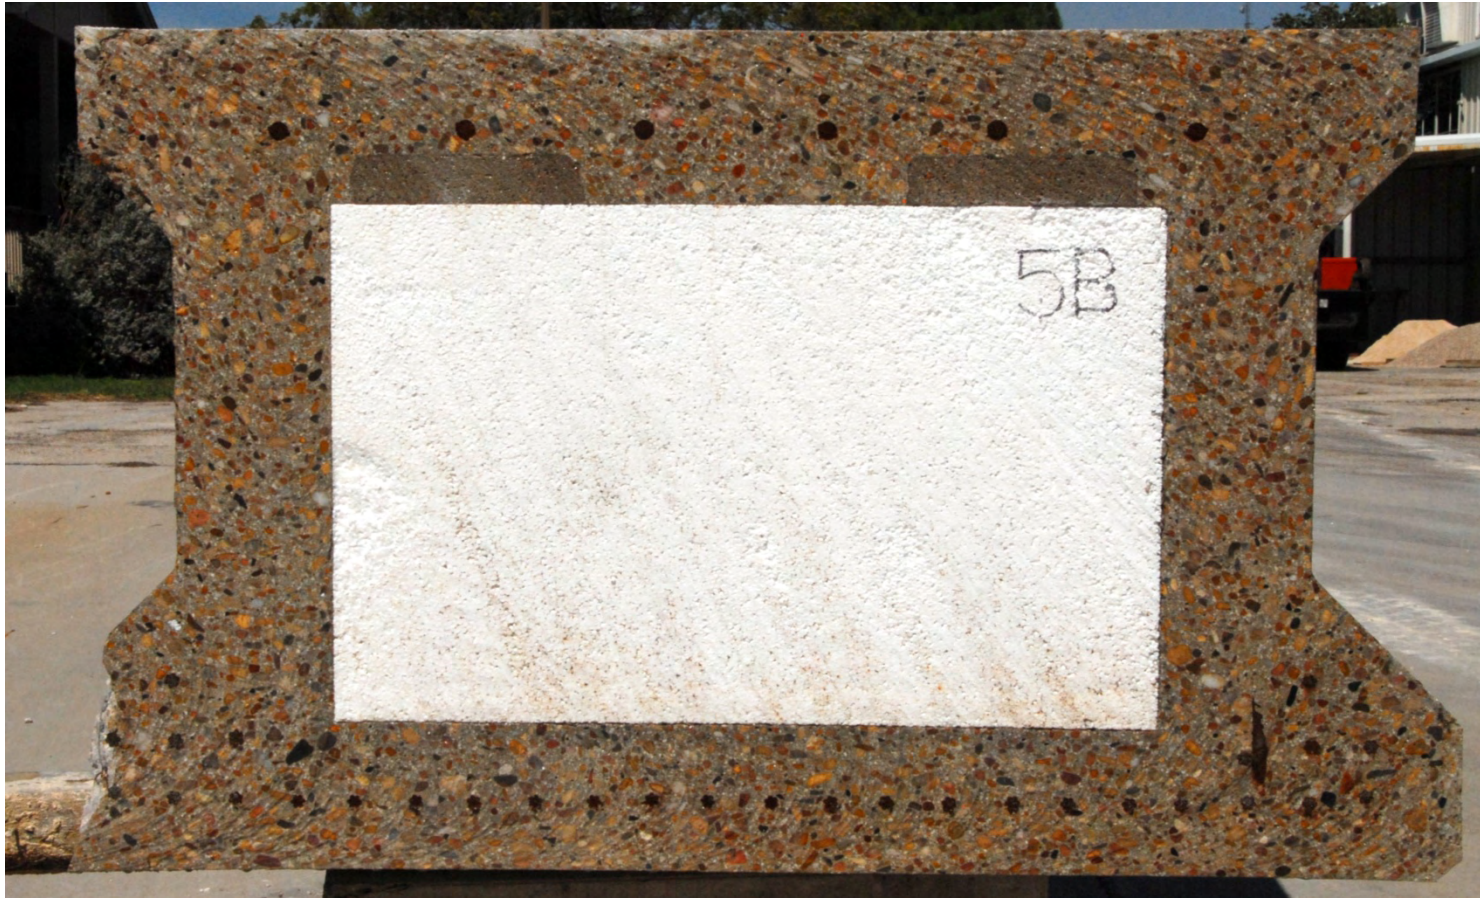
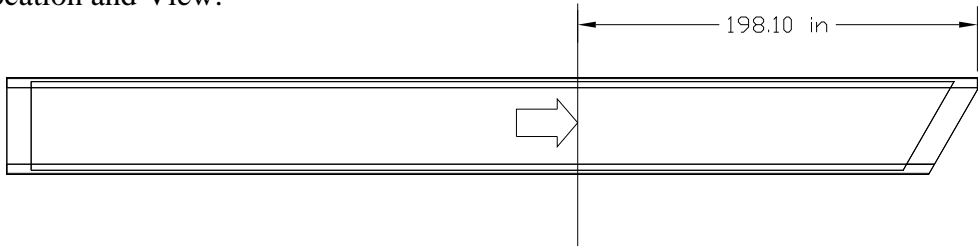
Figure A. 18: Picture BB07C5B

Beam Mark:	BB07	Cut Location and View:

Concrete Type:	Self consolidating	
Aggregate:	River Rock	
Cut ID:	BB07C5B

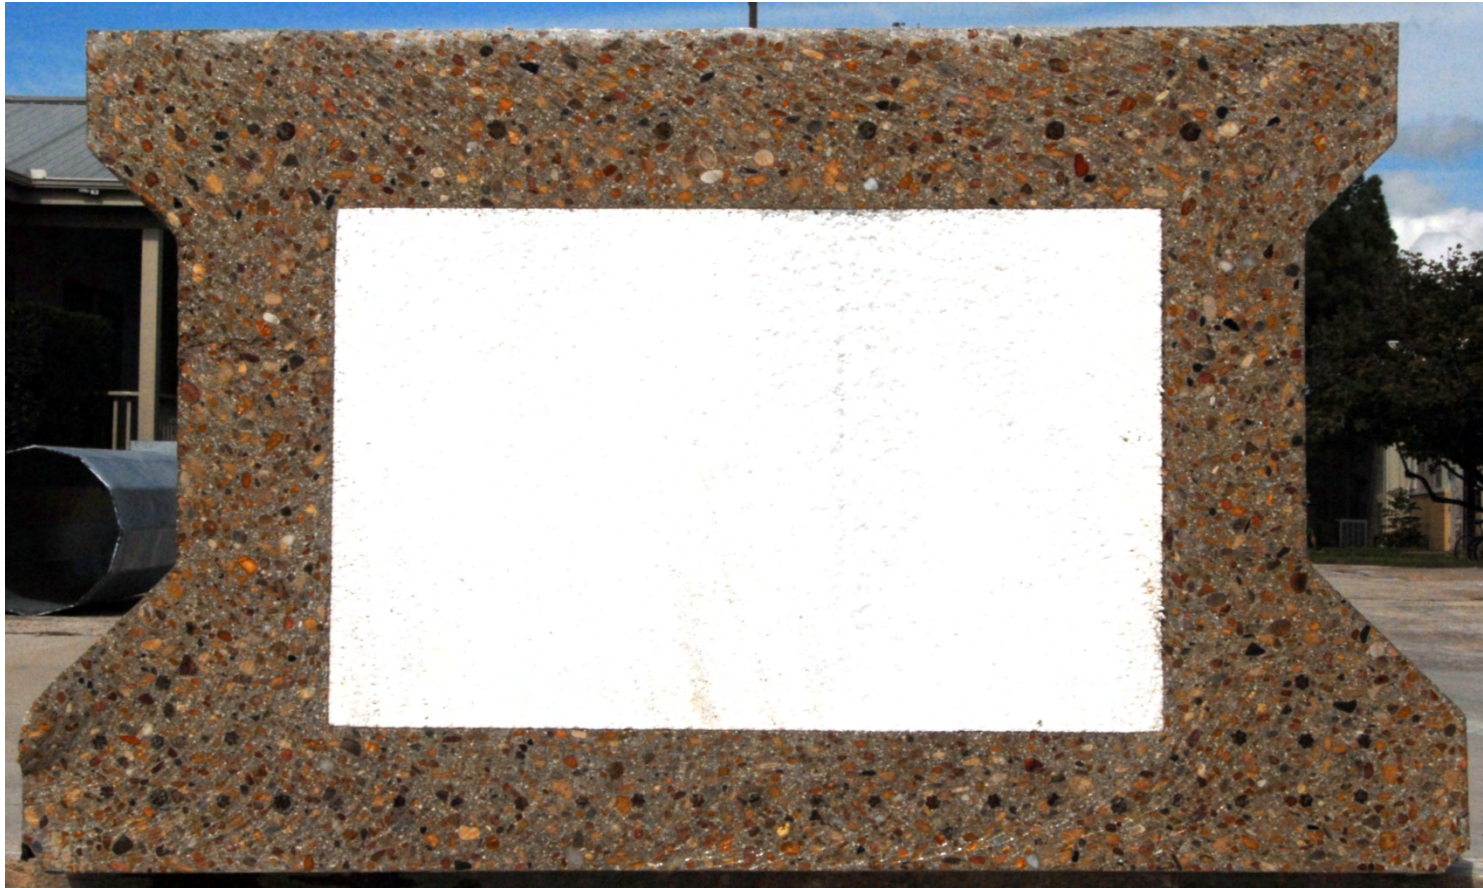
Figure A. 19: Picture BB07C6A

Beam Mark:	BB07	<p>Cut Location and View:</p>
Concrete Type:	Self consolidating	
Aggregate:	River Rock	
Cut ID:	BB07C6A

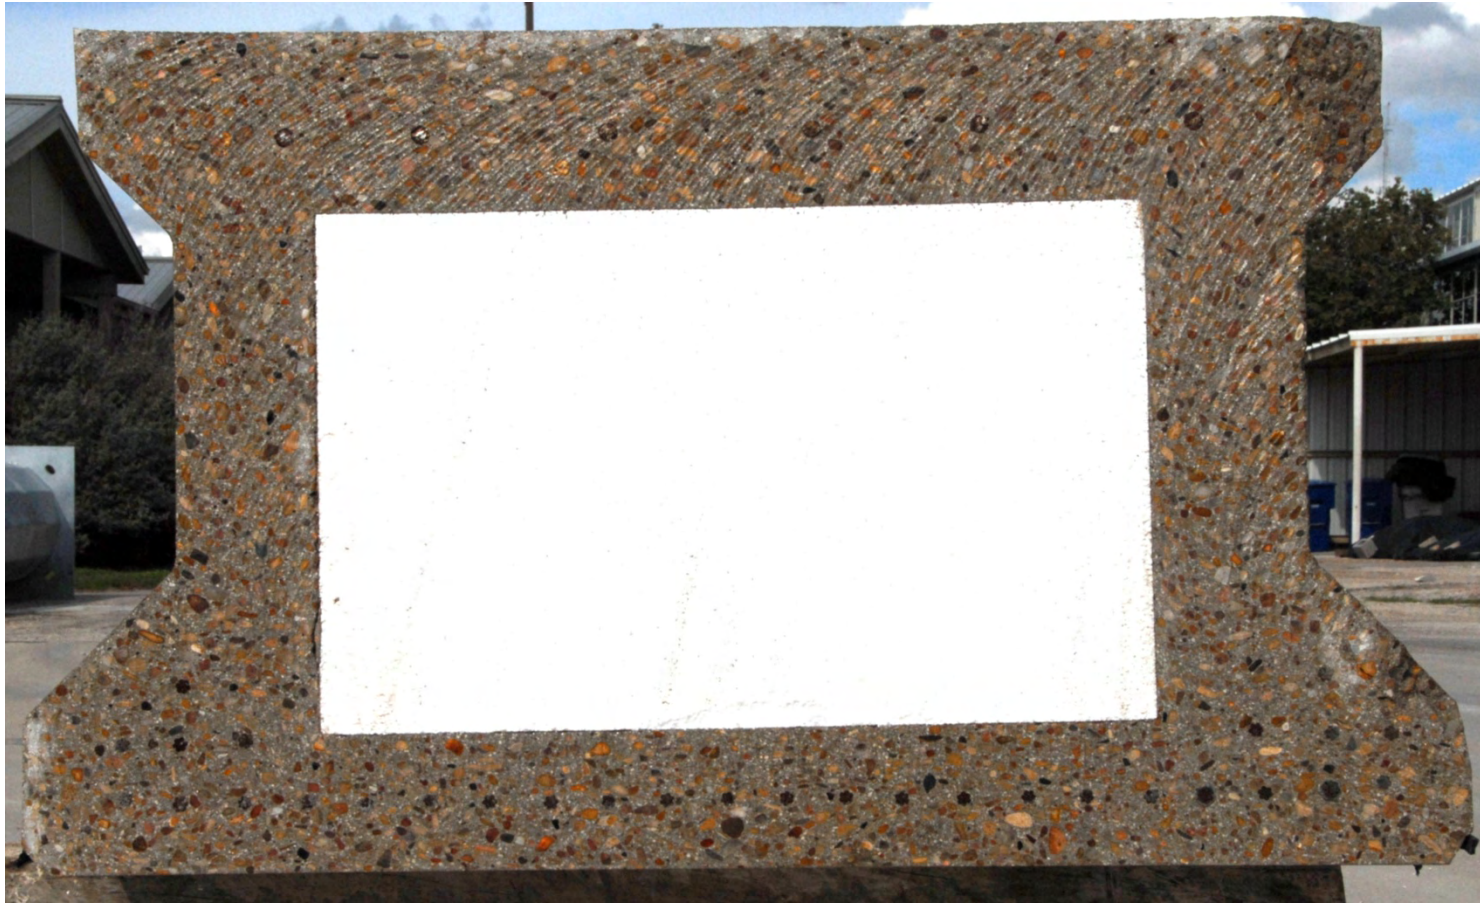
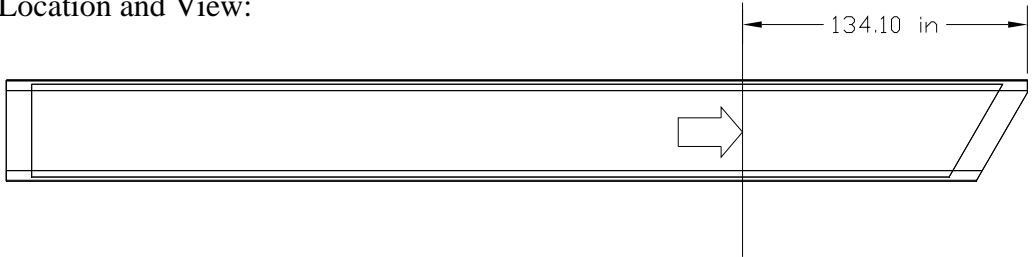
Figure A. 20: Picture BB07C6B

Beam Mark:	BB07	Cut Location and View:

Concrete Type:	Self consolidating	
Aggregate:	River Rock	
Cut ID:	BB07C6B

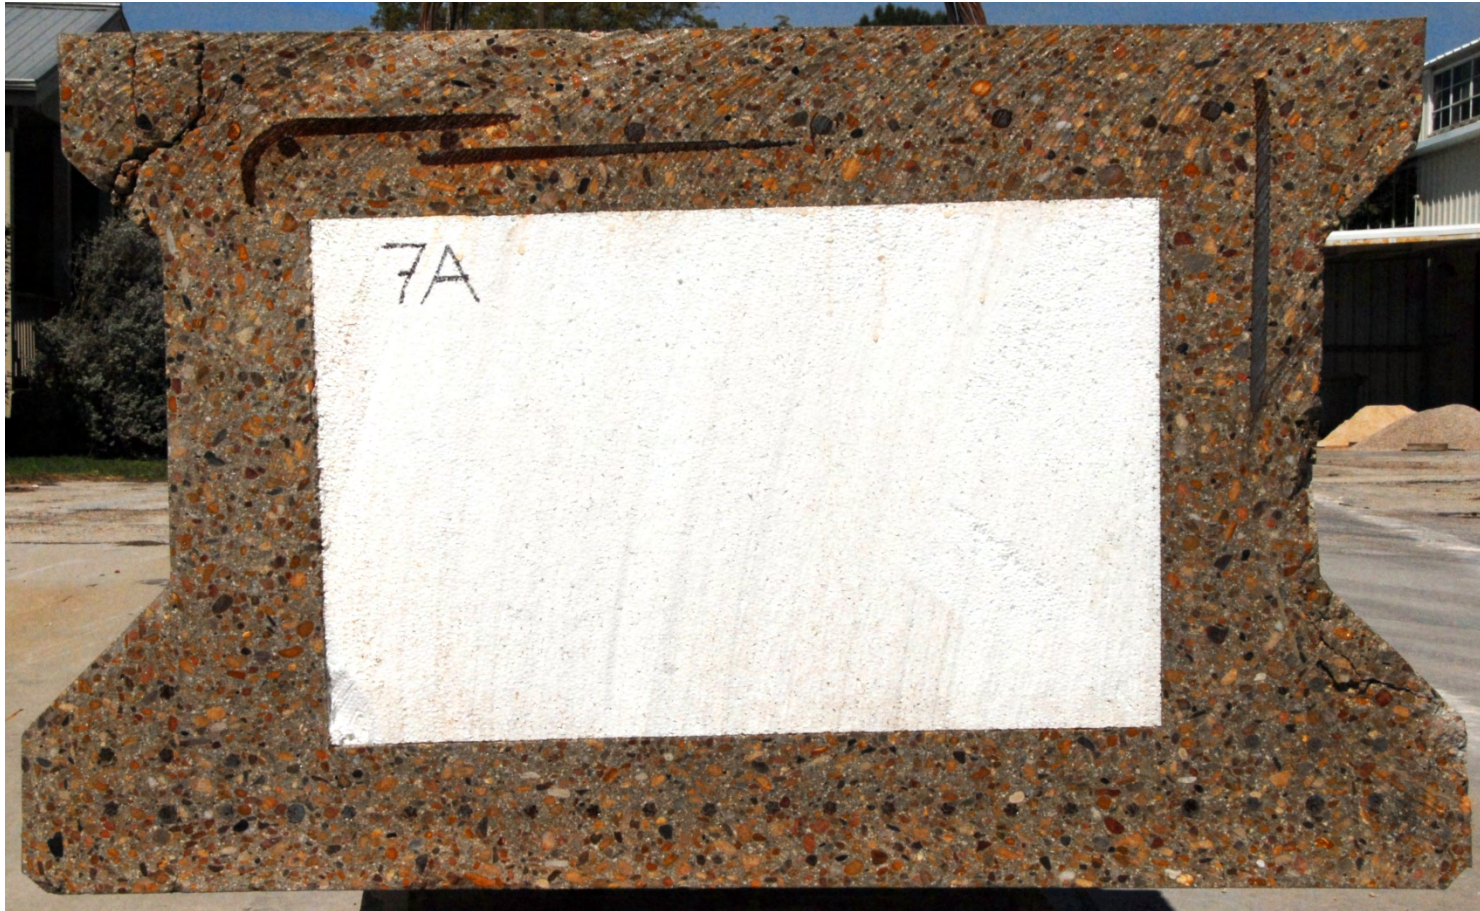
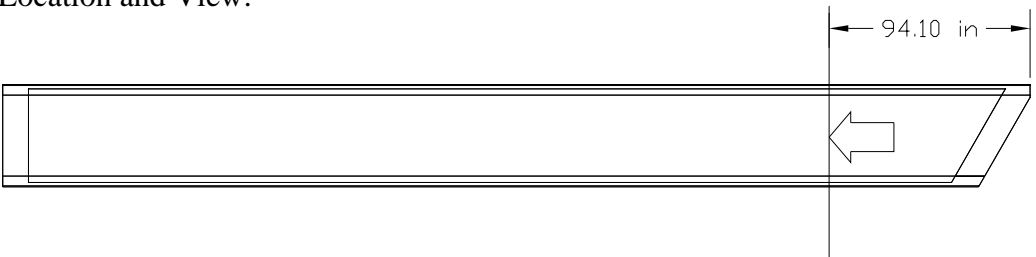
Figure A. 21: Picture BB07C7A

Beam Mark:	BB07	Cut Location and View:

Concrete Type:	Self consolidating	
Aggregate:	River Rock	
Cut ID:	BB07C7A

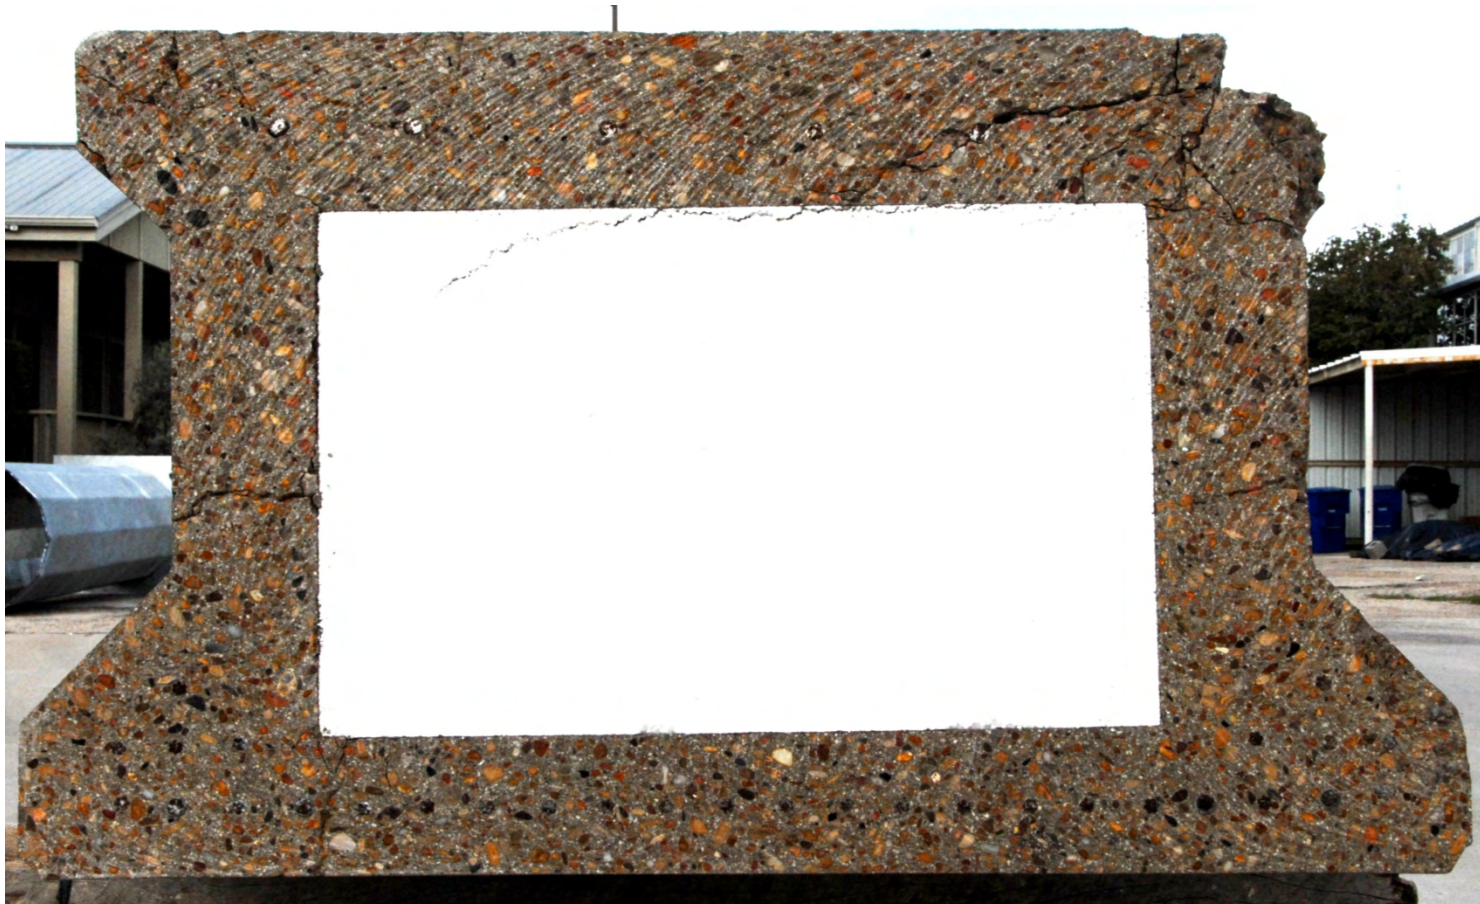
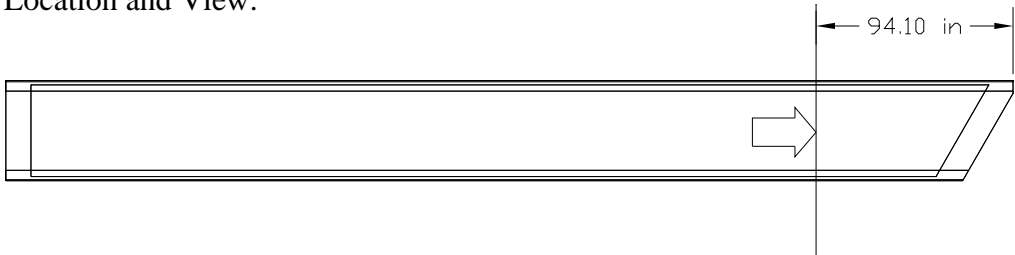
Figure A. 22: Picture BB07C7B

Beam Mark:	BB07	Cut Location and View:

Concrete Type:	Self consolidating	
Aggregate:	River Rock	
Cut ID:	BB07C7B

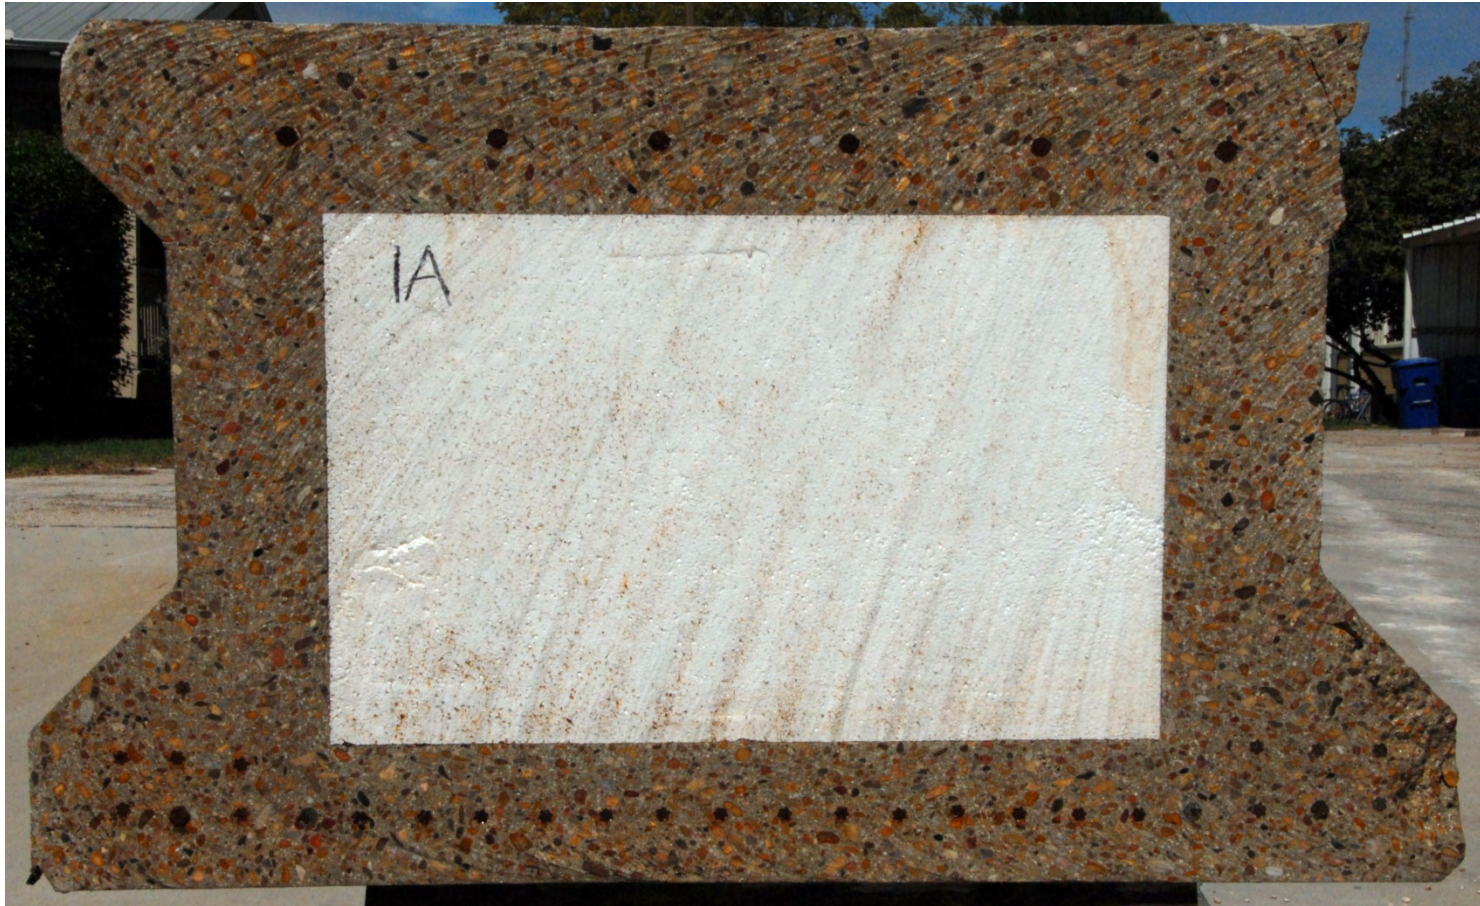
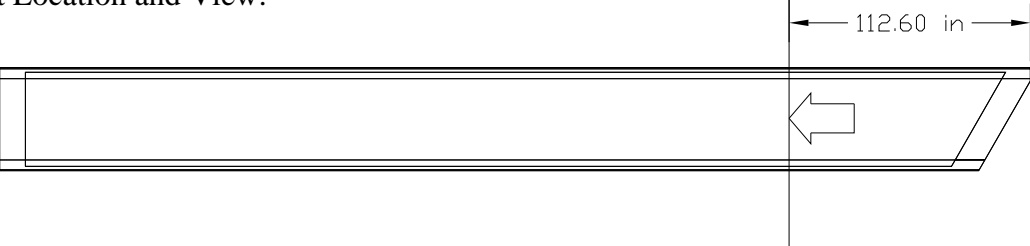
Figure A. 23: Picture BB08C1A

Beam Mark:	BB08	<p>Cut Location and View:</p>

Concrete Type:	Self consolidating	
Aggregate:	River Rock	
Cut ID:	BB08C1A

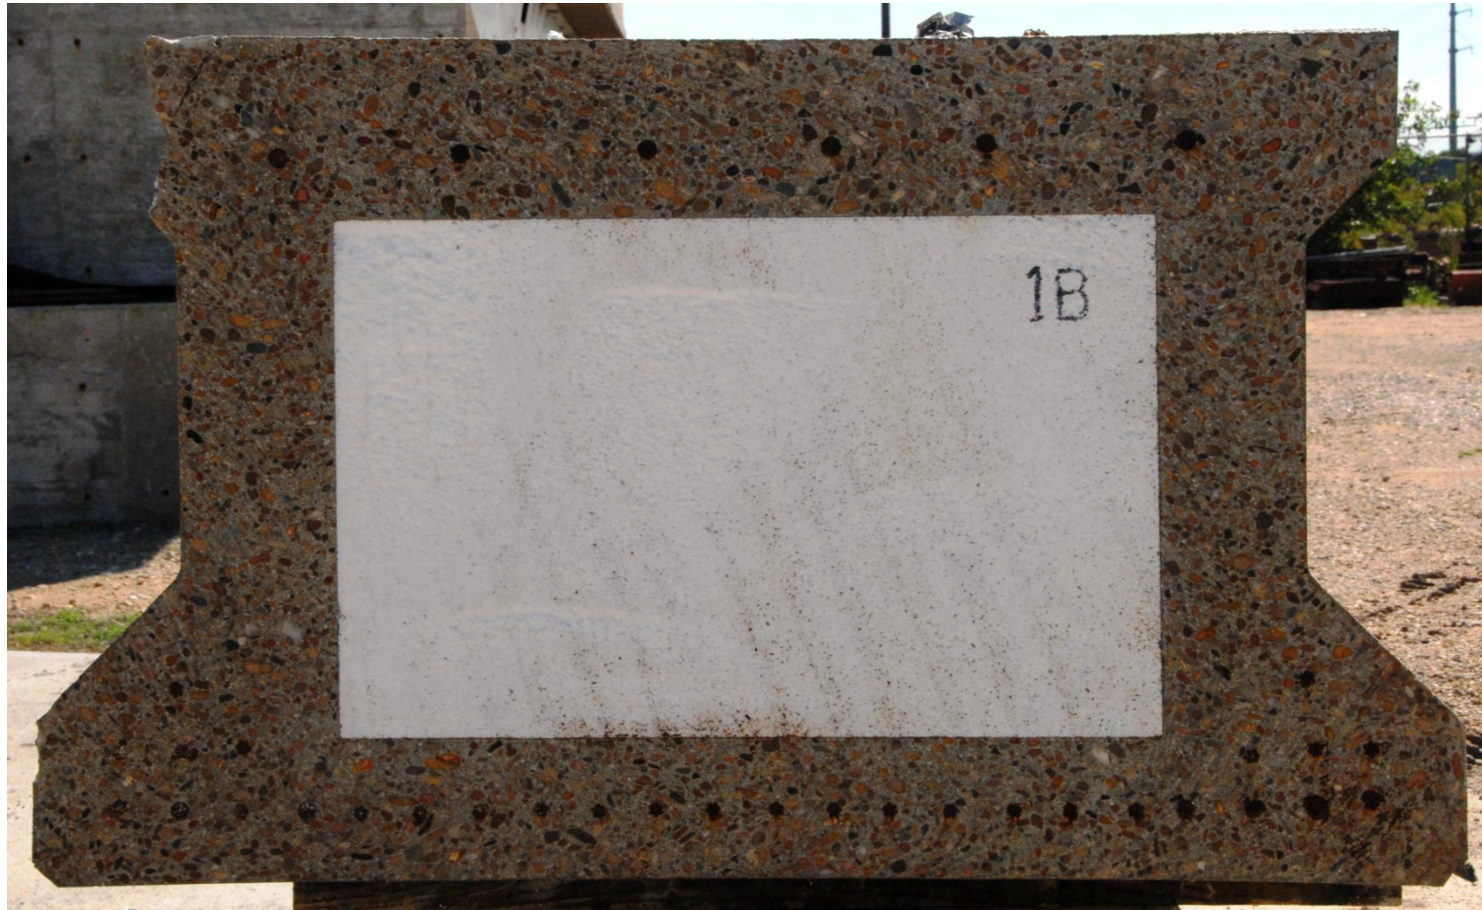
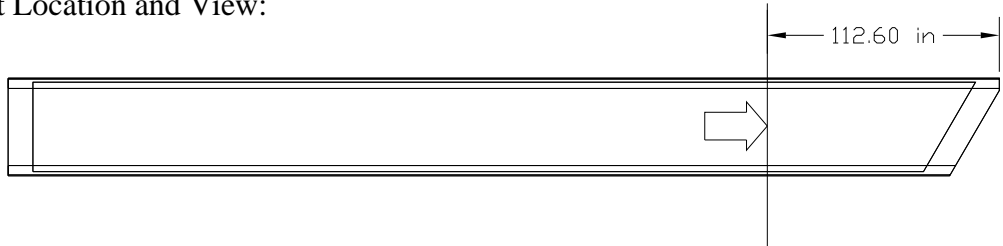
Figure A. 24: Picture BB08C1B

Beam Mark:	BB08	Cut Location and View:

Concrete Type:	Self consolidating	
Aggregate:	River Rock	
Cut ID:	BB08C1B

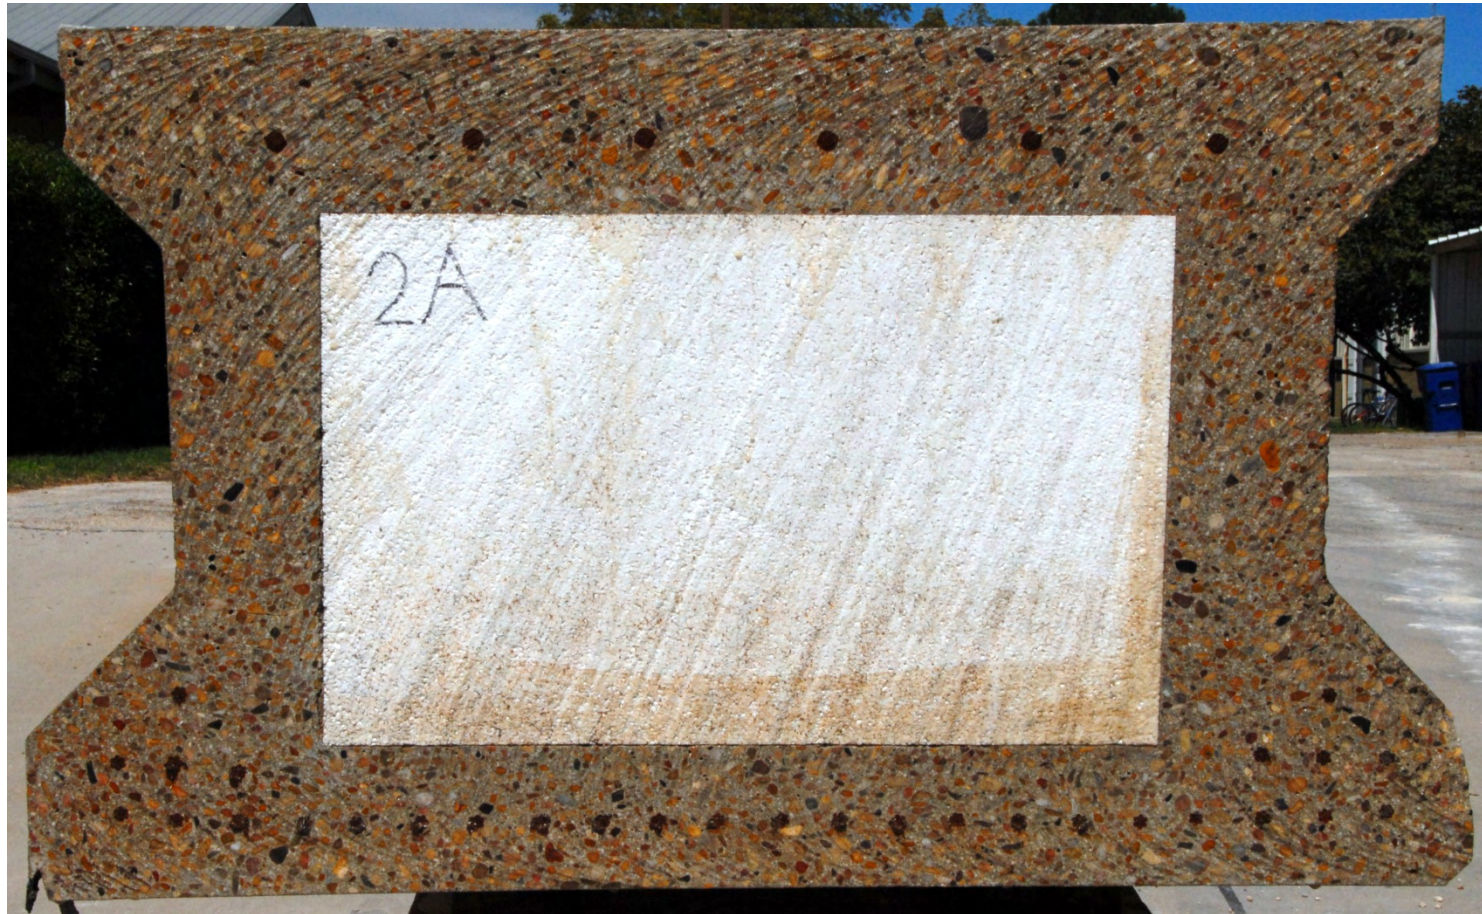
Figure A. 25: Picture BB08C2A

Beam Mark:	BB08	<p>Cut Location and View:</p>
Concrete Type:	Self consolidating	
Aggregate:	River Rock	
Cut ID:	BB08C2A

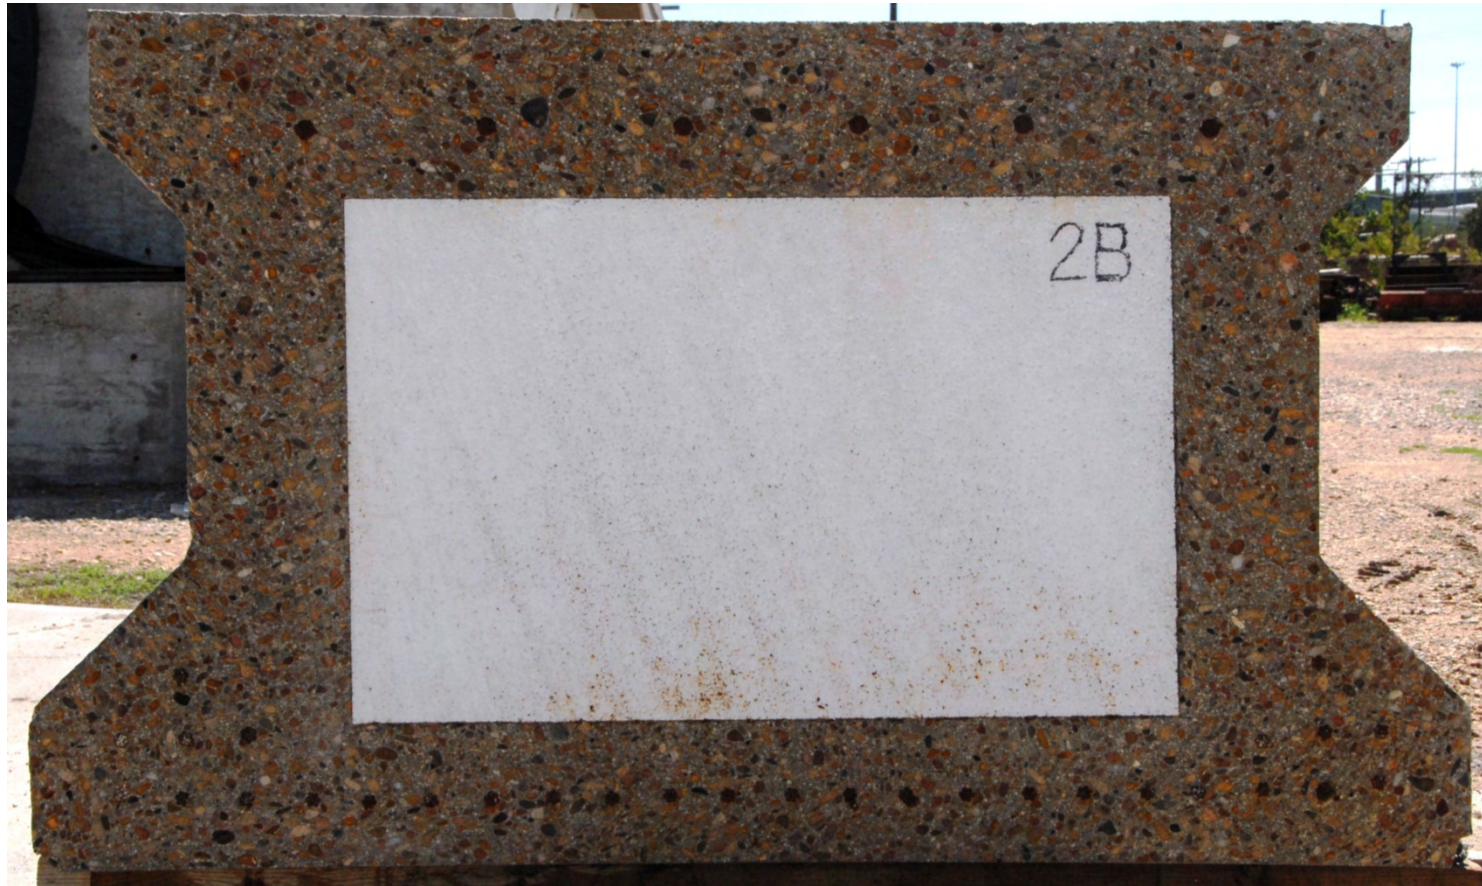
Figure A. 26: Picture BB08C2B

Beam Mark:	BB08	<p>Cut Location and View:</p>
Concrete Type:	Self consolidating	
Aggregate:	River Rock	
Cut ID:	BB08C2B

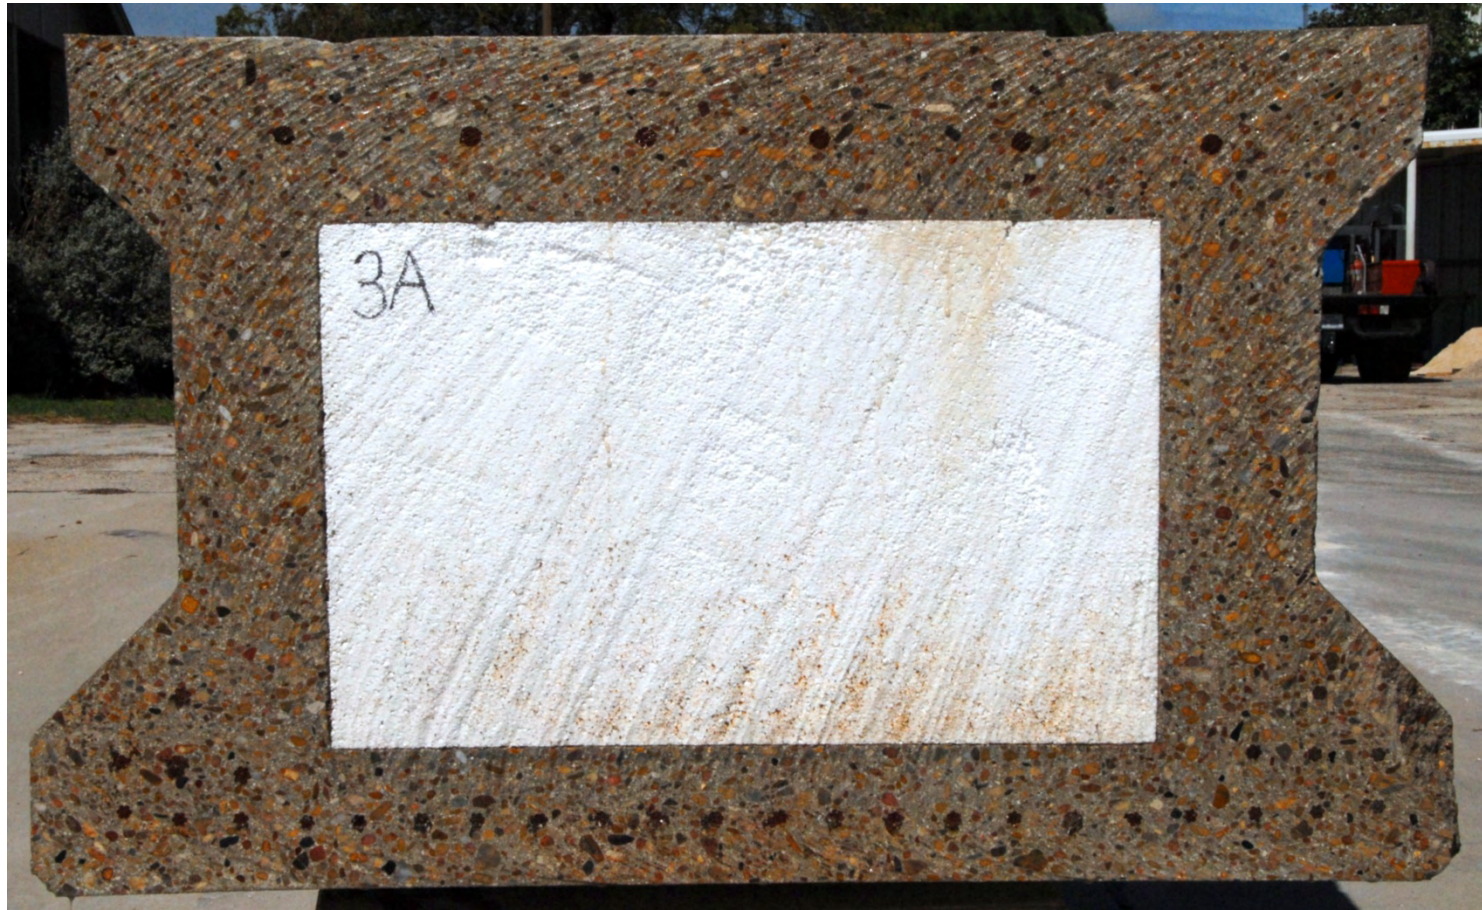
Figure A. 27: Picture BB08C3A

Beam Mark:	BB08	<p>Cut Location and View:</p>
Concrete Type:	Self consolidating	
Aggregate:	River Rock	
Cut ID:	BB08C3A

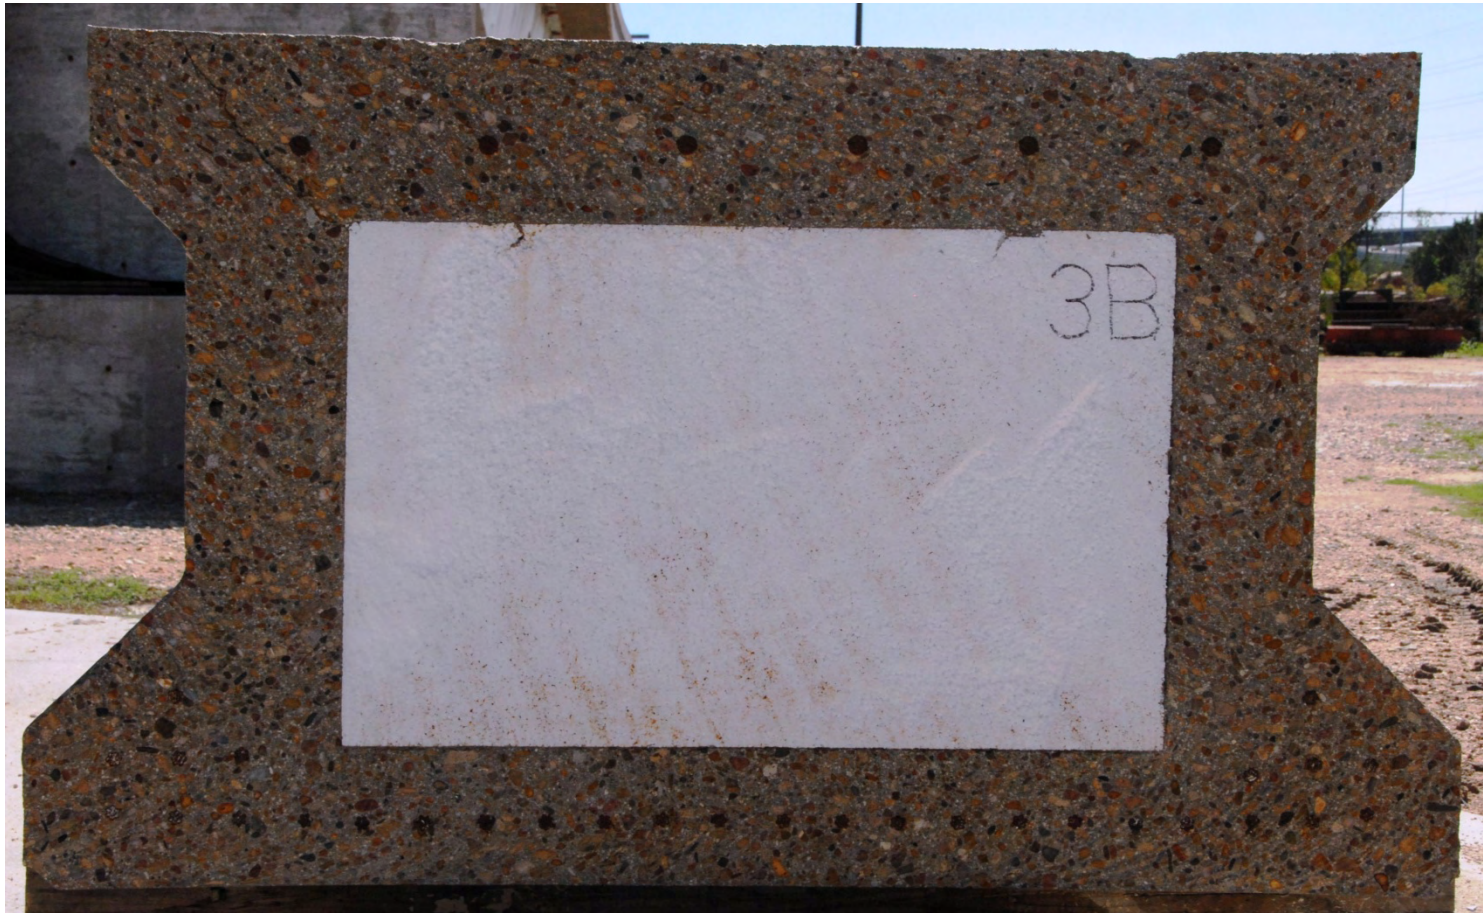
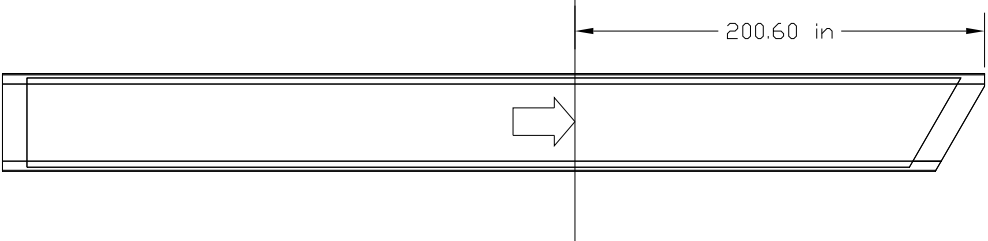
Figure A. 28: Picture BB08C3B

Beam Mark:	BB08	<p>Cut Location and View:</p>

Concrete Type:	Self consolidating	
Aggregate:	River Rock	
Cut ID:	BB08C3B

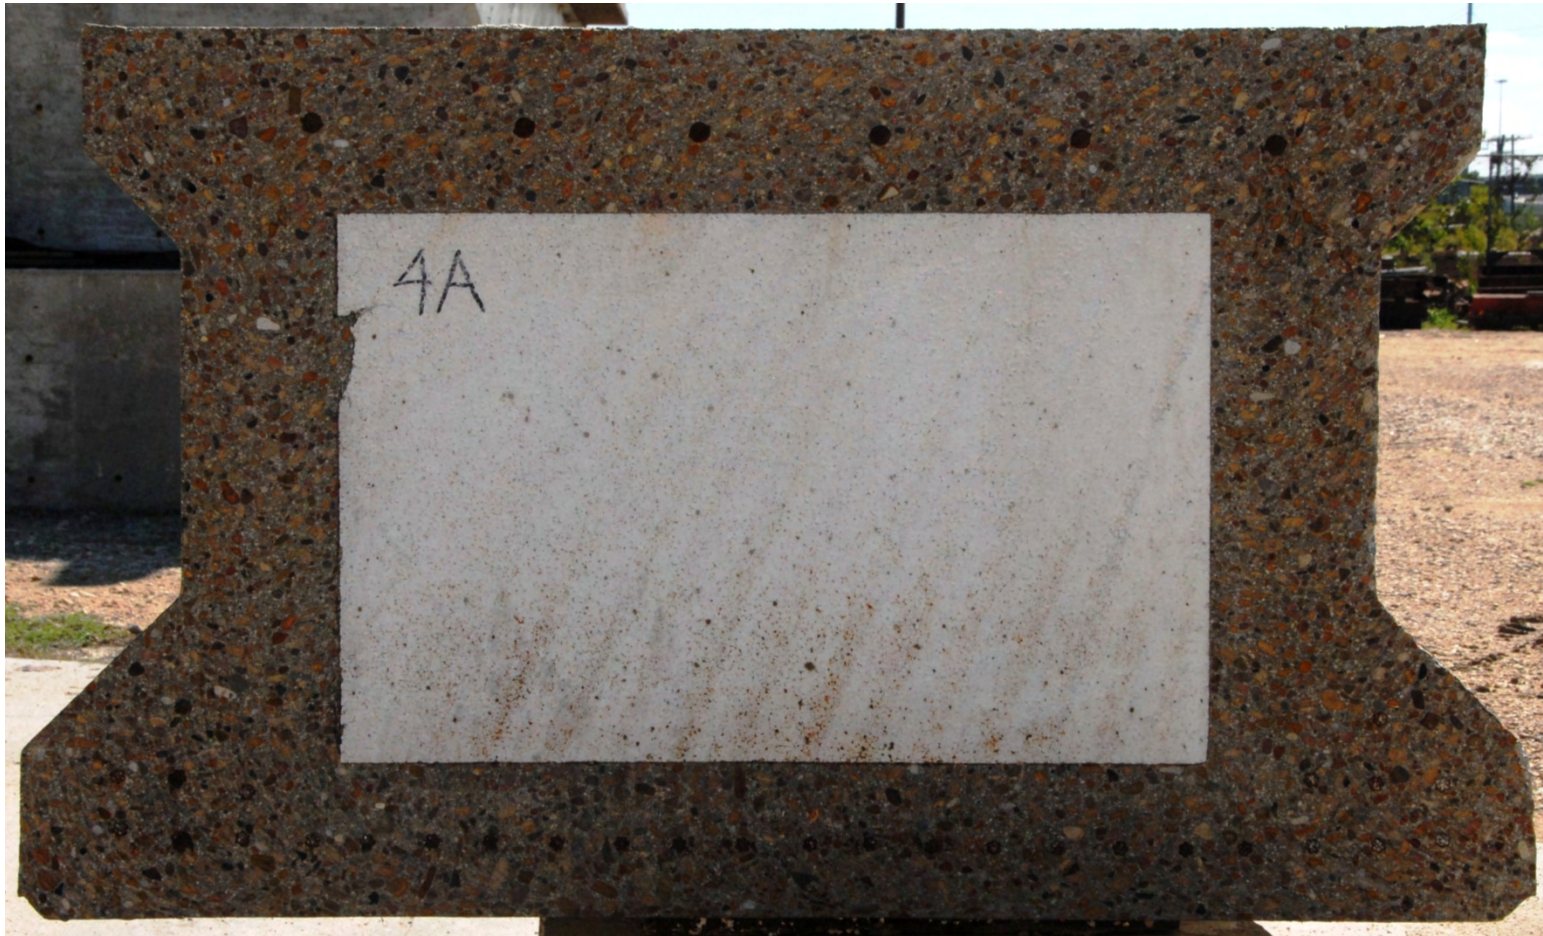
Figure A. 29: Picture BB08C4A

Beam Mark:	BB08	<p>Cut Location and View:</p>
Concrete Type:	Self consolidating	
Aggregate:	River Rock	
Cut ID:	BB08C4A

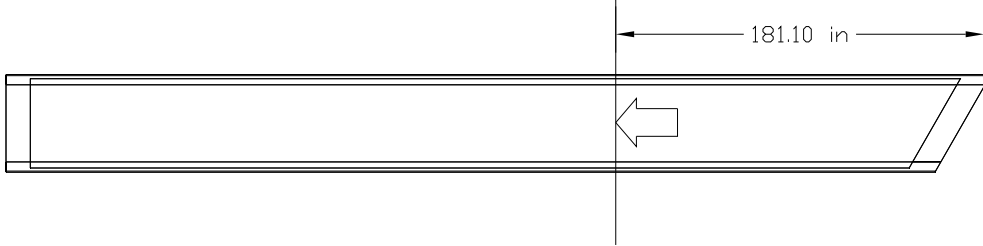
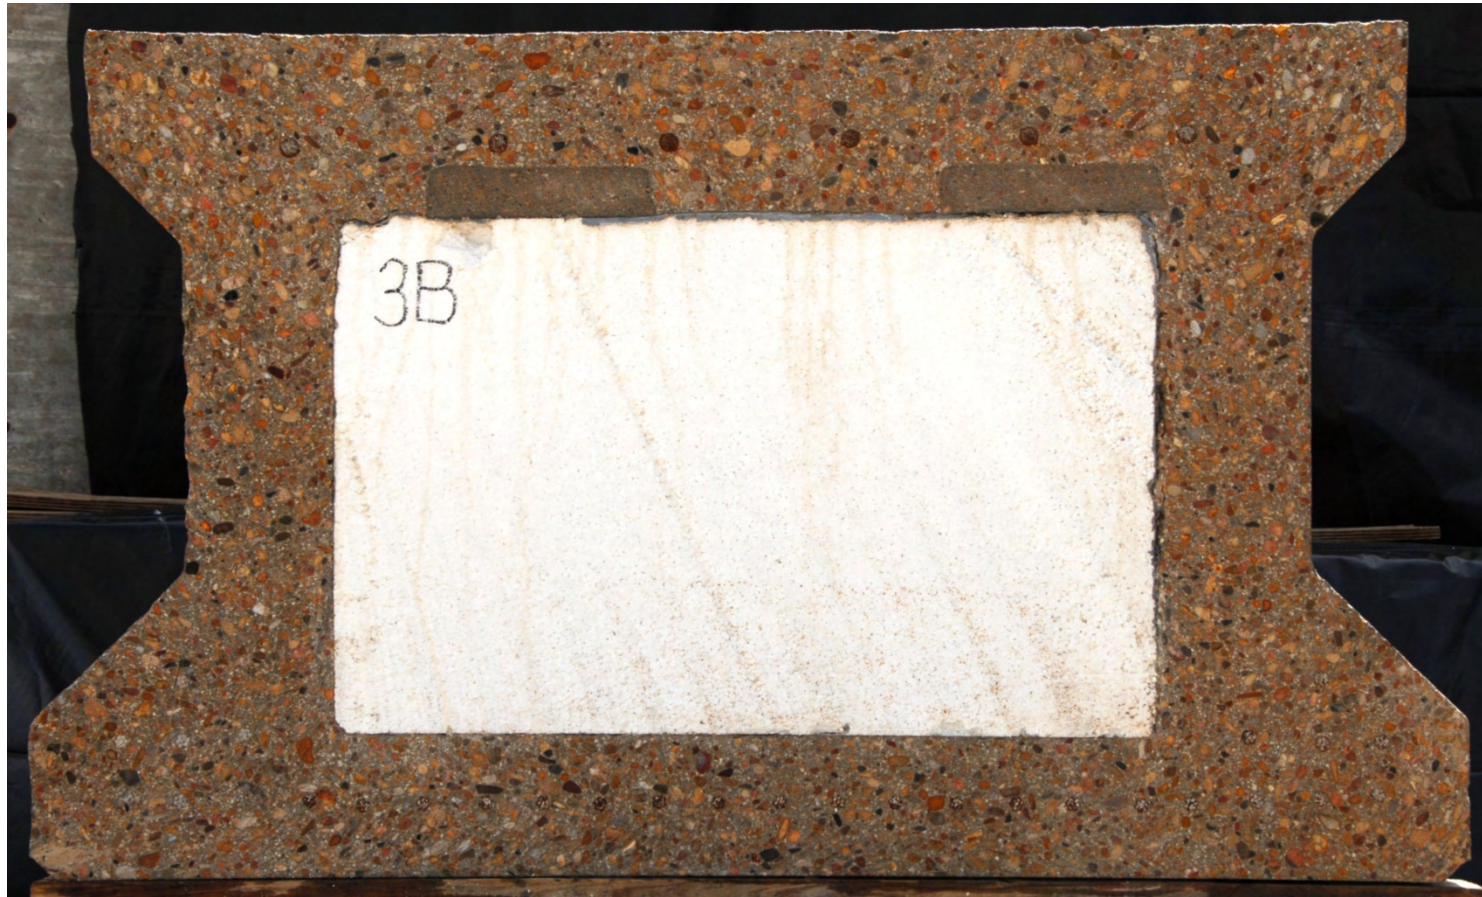
Figure A. 41: Picture BB09C3A

Concrete Type:	Self consolidating	
Aggregate:	River Rock	
Cut ID:	BB09C3A	
<div>Observations: This cut coincided with the joint between two Styrofoam blocks. The fabricator tapes together the top and sides of the blocks but since nothing is done to keep the bottom of the blocks together, concrete is able to flow up into the space between the blocks. This creates a thin layer of concrete (about ¼ inch) as it is observed in this picture.</div>
