1. Report No. FHWA/TX-11/0-6590-1		2. Government Accession No.		3. Recipient's Catalog No.	
4. Title and Subtitle Materials Selection for Concrete Overlays: Information Survey Review and Evaluation of Existing Concrete Overlays in Texas				5. Report Date October 2010; Revision April 2011

Materials Selection for Concrete Overlays: Information Survey Review and Evaluation of Existing Concrete Overlays in Texas

This technical report is divided into two parts: Information Survey Review and Condition Surveys/Evaluation of the Existing Overlays in Texas. These two topics were the first two tasks performed for CTR Project 0-6590: Materials Selection for Concrete Overlays.

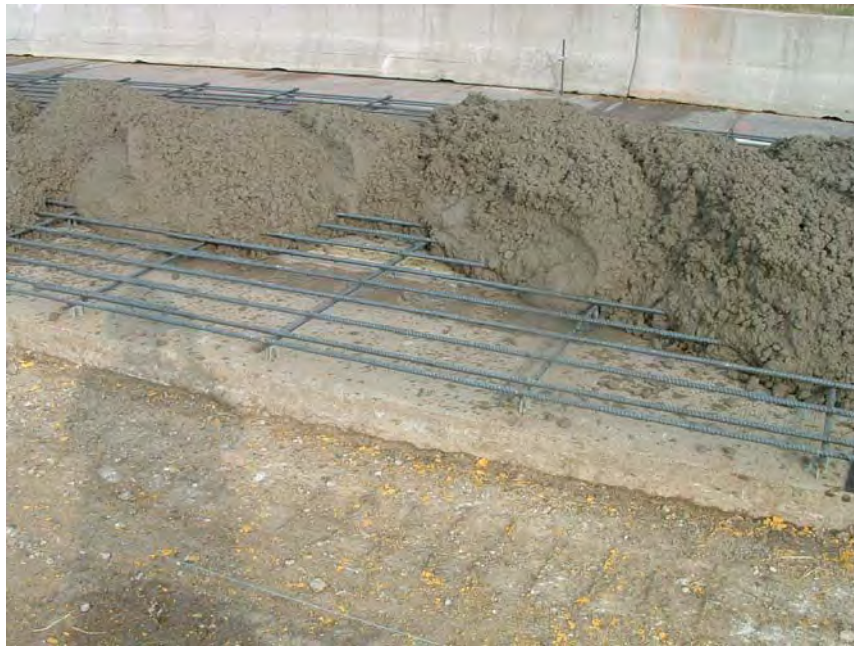
Figure 8.11: Dried surface around concrete

There were instances when concrete was placed too far ahead of the paving machine and there were possible risks of concrete setting even before the paving machine reached those areas. Also, the pavement surface around the concrete dried. Figure 8.10 shows the concrete waiting on the paving machine to catch up, and Figure 8.11 shows the dried surface around the concrete. The contractor was asked to slow the placing of concrete ahead of the paving machine.
