TECHNICAL REPORT 0-6603-1

TXDOT PROJECT NUMBER 0-6603

LONG-TERM PERFORMANCE OF DRILLED SHAFT RETAINING WALLS: ASSESSMENT OF EXISTING WALLS

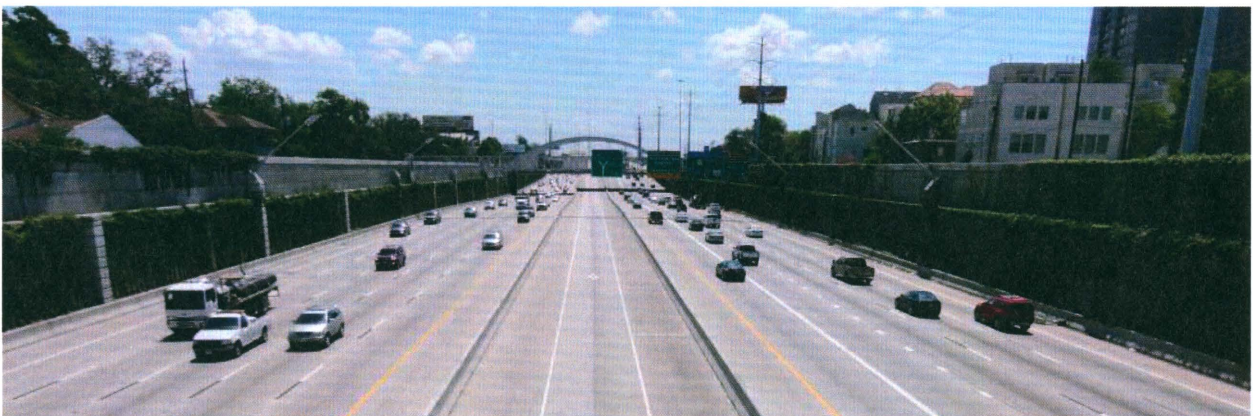
A large scale view of the project area is presented in Figure 6.6. Because the facing was installed at an angle and is currently covered with dense vegetation, very little information about the shafts can be obtained from road level (Figure 6.7).

Figure 6.6: Large-scale view of project area (facing east). Sound wall is located above the main retaining structure.

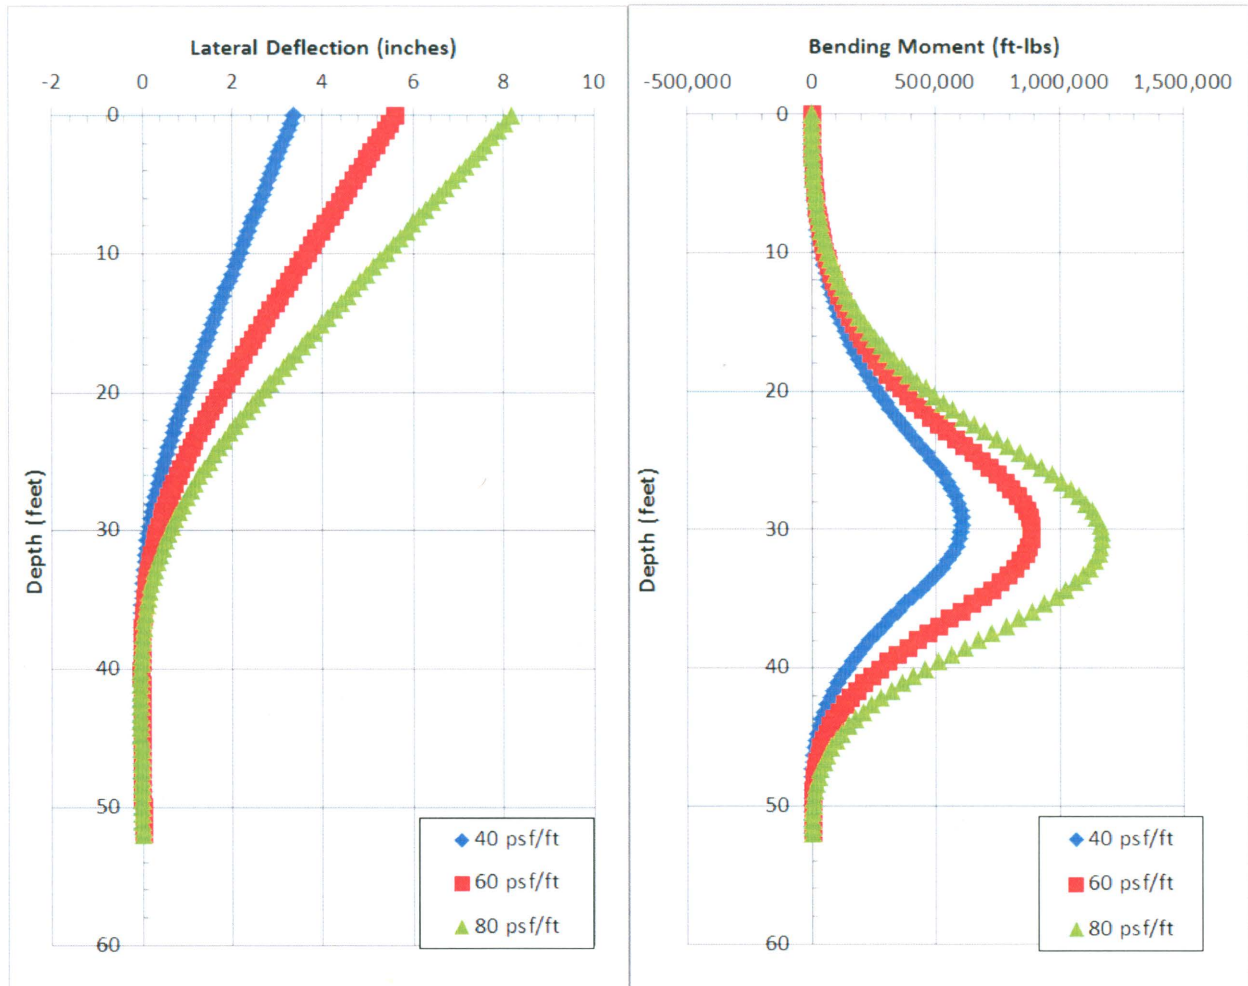
Seven different shaft layouts were used for this analysis. Soil, shaft, and loading properties used in this analysis are presented in Tables 7.1 and 7.2. Results show that the shaft layout that deflected the most relative to the height of the wall was the wall layout with shaft lengths of 52 feet and a height of 23 feet. At an equivalent fluid pressure of 40 psf/ft with two feet of soil surcharge, the top-of-wall deflection was 1.22 percent of the wall height (3.36 inches). At an equivalent fluid pressure of 80 psf/ft with two feet of surcharge, the wall deflected 2.96 percent (8.17 inches) of the wall height. The shortest shafts analyzed ($L=31$ ft, $H=12$ ft), deflected 0.16 percent of the wall height at an equivalent fluid pressure of 40 psf/ft. Results from the L-Pile analysis are summarized in Figures 7.1–7.7.

Figure 7.7: Results of L-Pile analysis for FM 1960 @ Kuykendahl; shaft length = 52 feet; wall height = 23 feet.

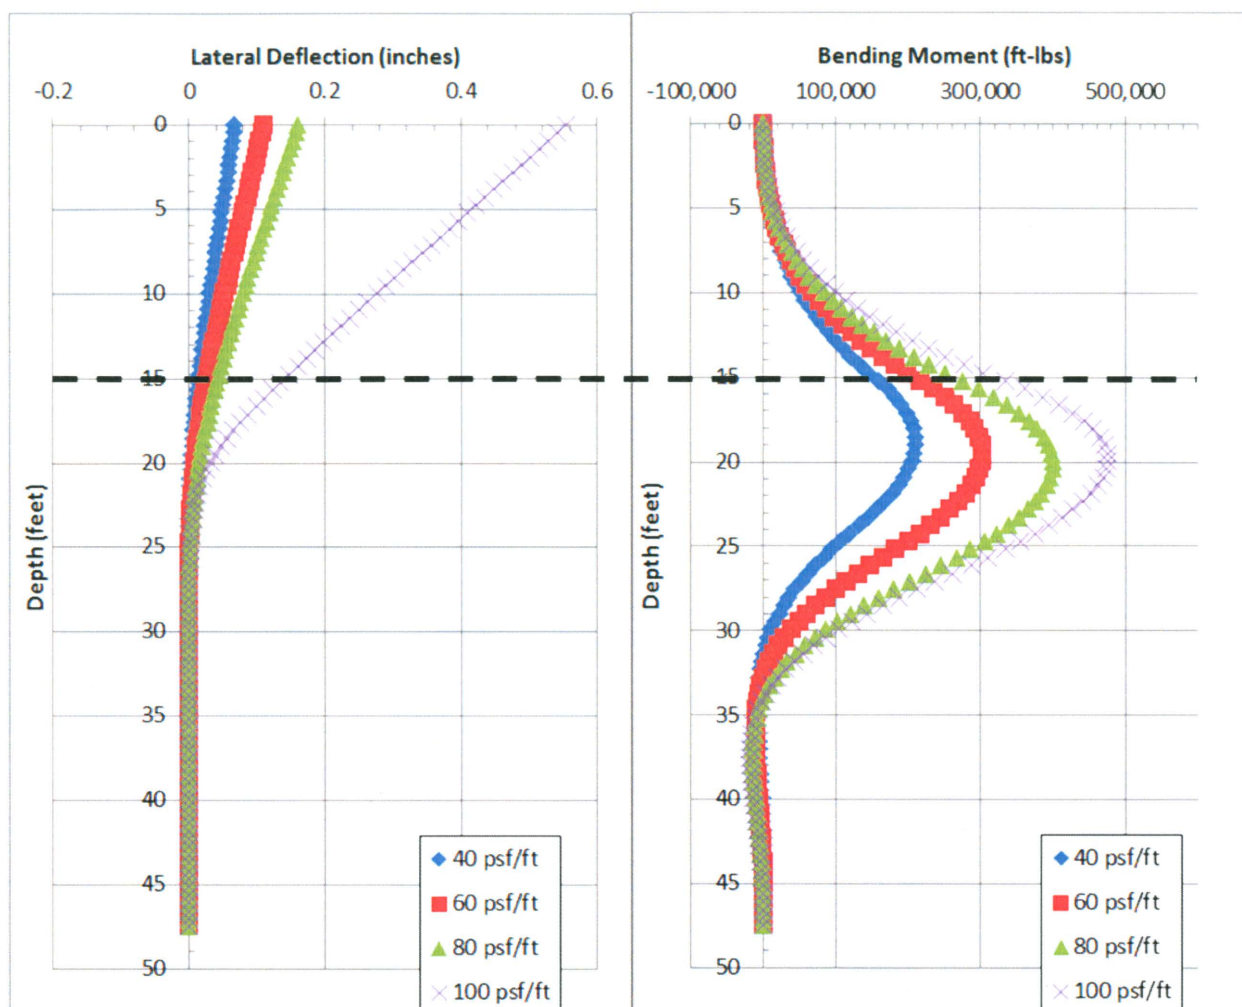
Because of the large size of the shafts and potential for moisture changes on the project site, the wall layout was analyzed using one additional loading scenario consisting of an equivalent fluid pressure of 100 psf/ft with two feet of surcharge. Soil, shaft, and loading properties used in this analysis are presented in Tables 7.3 and 7.4. Results show that the wall will not deflect more than one percent of the wall height for any of the loading conditions. Even at an equivalent fluid pressure of 100 psf/ft with two feet of surcharge, the wall deflects just 0.3 percent of the wall height (0.55 inches). Results from the L-Pile analysis are summarized in Figure 7.8.

Figure 7.8: Results of L-Pile analysis for US 59 and Hazard Street; shaft length = 47.5 feet, wall height = 15 feet. Dashed line indicates excavation depth.

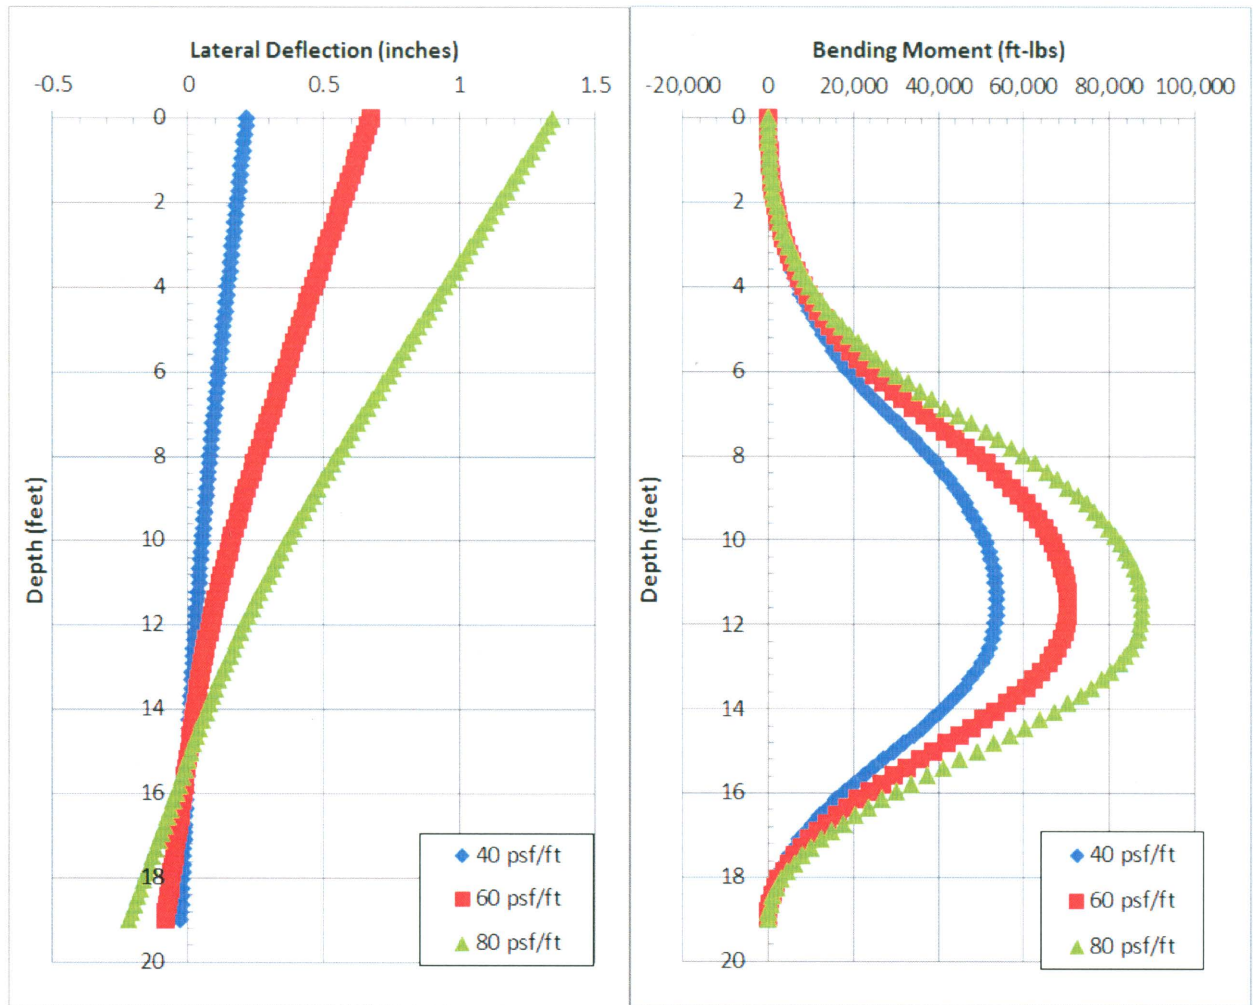
It should be noted that determining the shaft lengths and wall heights were estimated based on the design files provided by TxDOT. This estimation was due to the lack of clear documentation in the design files. The analysis of the wall with a height of 7 feet and a total shaft length of 19 feet shows that embedment depth is not sufficient to reach fixity for all the loading scenarios. It is likely that either the as-built wall height was smaller than reported, or the as-built shaft length was larger than reported, but without supporting documents that clearly indicate the layout of the shafts, this cannot be determined with certainty. Results from the L-Pile analysis are summarized in Figures 7.9–7.12.

Figure 7.10: Results of L-Pile analysis for Greens Rd @ IH 45; shaft length = 19 feet, wall height = 7 feet.
