TECHNICAL REPORT 0-6804-2
TxDOT PROJECT NUMBER 0-6804

Analysis of Lightweight Transparent Noise Barriers on IH-30 Elevated Structures in Dallas, Texas

August 2018; Published June 2019

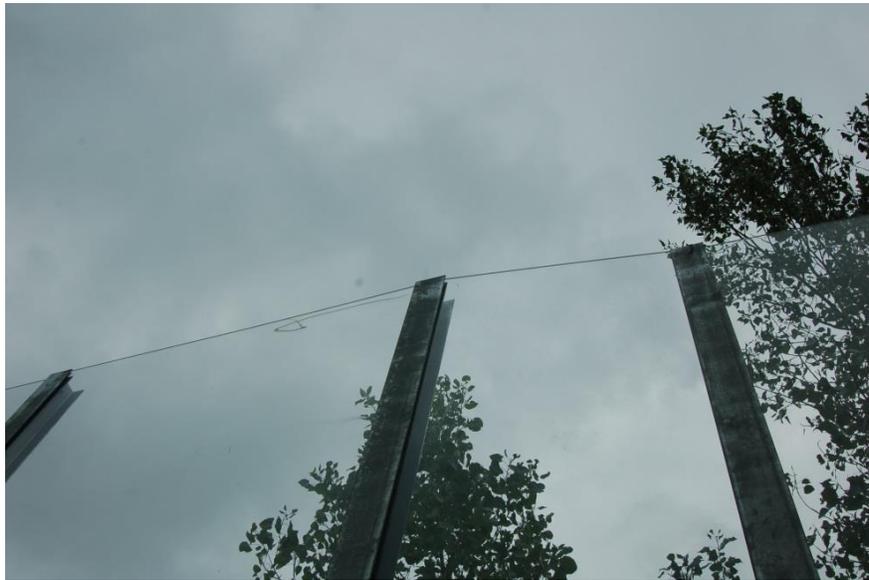
A few problems were noticed before the completion of the installation, such as some supports not being completely vertical (Figures 8.9 and 8.10), some apparently missing rubber gaskets between panels and the metal supports, some gaskets slightly out of place (Figure 8.11), as well as some gaps between gaskets and metal supports, both for vertical and horizontal gaskets (Figures 8.12 and 8.13).

Figure 8.10: Vertical support off-plumb

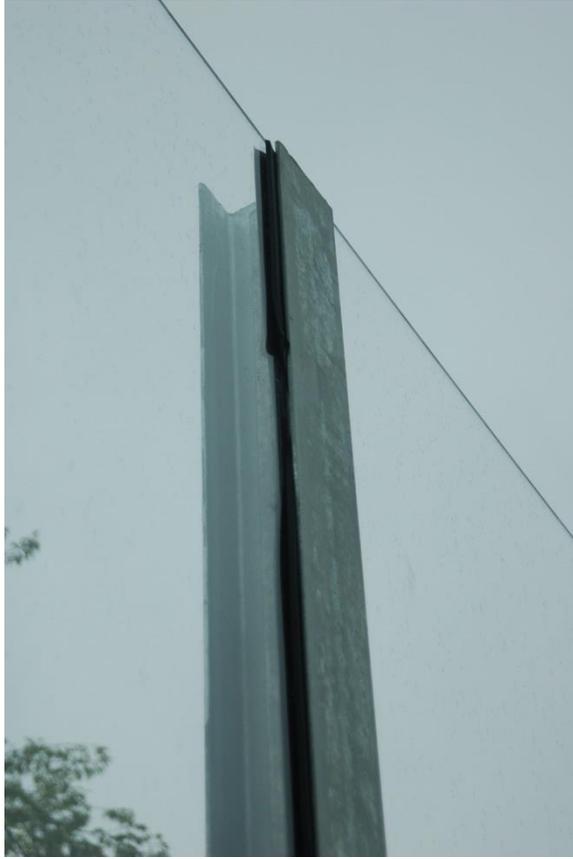
Figure 8.11: Gasket protruding from metal support

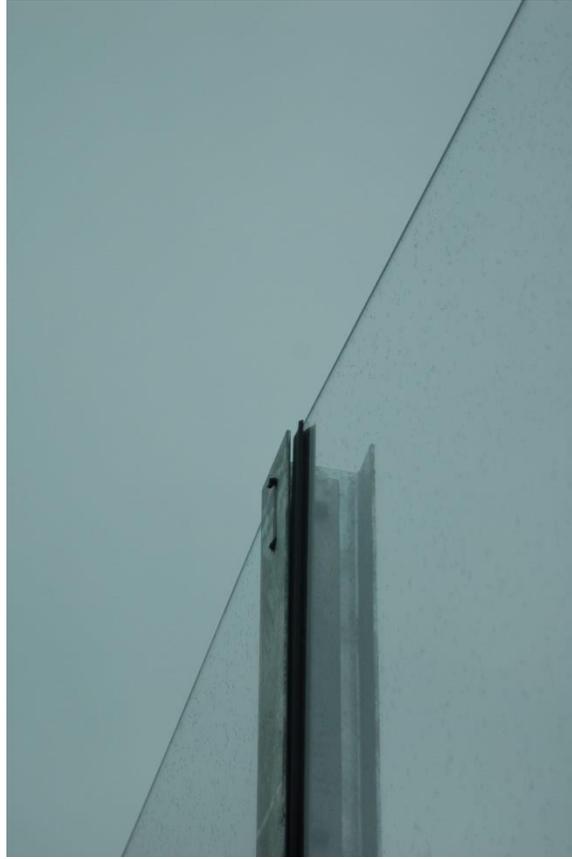
Figure 8.12: Gap between vertical gasket and metal support

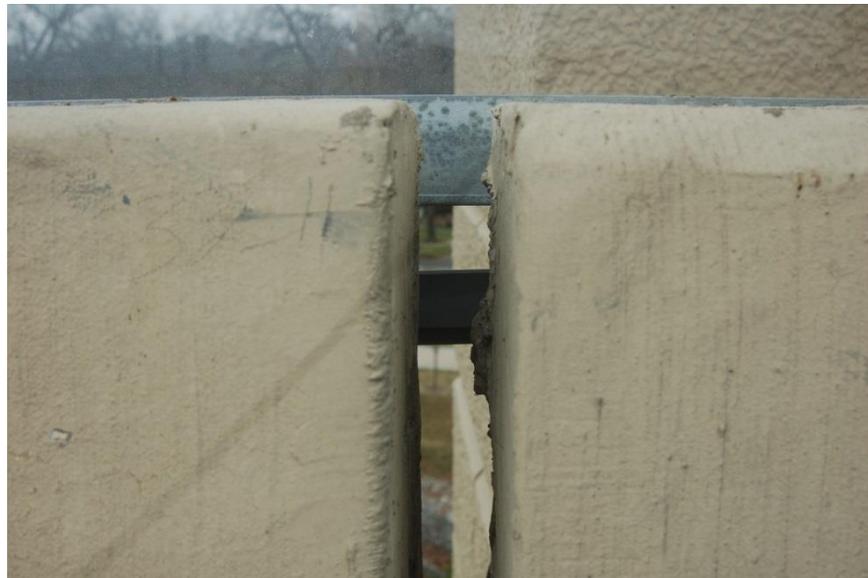
Additionally, some gaps were observed in the existing concrete wall at the expansion joints of the bridge (Figures 8.15 and 8.16), gaps that should be filled with some elastic joint sealing material allowing for the bridge’s thermal expansion and contraction. Such material should prevent the sound from traveling from the highway to the neighborhood to further attenuate the noise at the receivers’ locations and contribute to the wall’s effectiveness. This would be TxDOT’s responsibility, as it is not an issue of the transparent noise wall, but rather of the existing structure.

Figure 8.16: Gap in existing concrete wall at bridge expansion joint as seen from the highway side

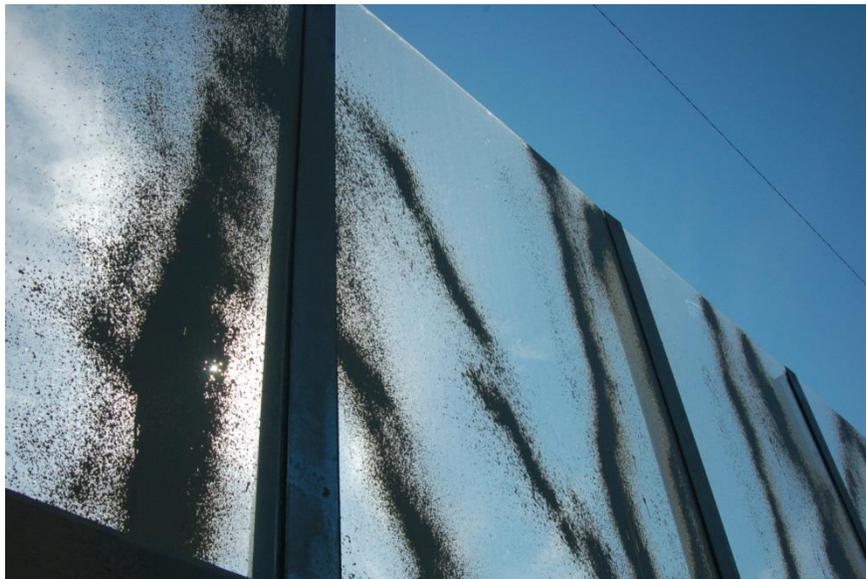
On November 11, 2013, while performing the wall inspection, it was noticed that some of the panels had been damaged by graffiti. Ten transparent panels, from spans # 135 to 144 (as marked by the contractor on the concrete wall during installation) were sprayed with paint. The concrete wall under span # 144 was also painted. From the distance, the damage was barely noticeable, and from some angles, it was not visible at all. However, when seen from the close proximity of the eastbound shoulder and at walking speed the paint was very

noticeable. The appearance of the sprayed material was that of some type of drywall mud or acoustic texture that is used in ceilings. Pictures of the graffiti are shown in Figures 8.17 to 8.23. The damage was reported immediately to TxDOT.

Figure 8.18: Graffiti as seen from the highway shoulder on November 11, 2013

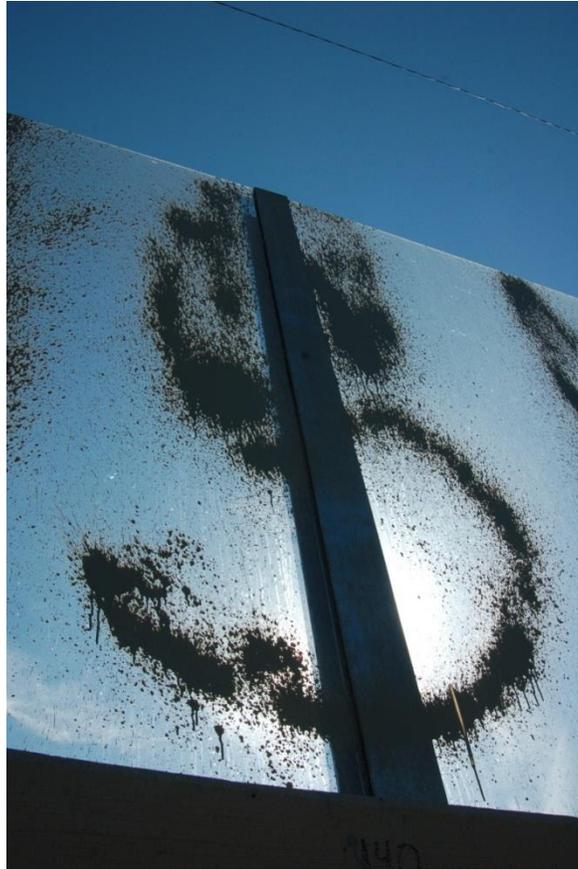
Figure 8.21: Graffiti as seen from the highway shoulder on November 11, 2013

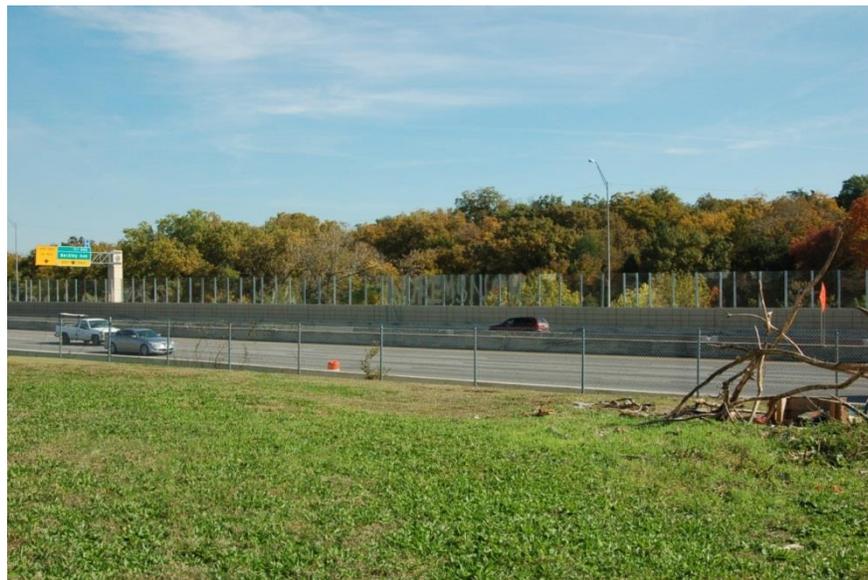
Figure 8.22: Graffiti seen from the north side of IH 30

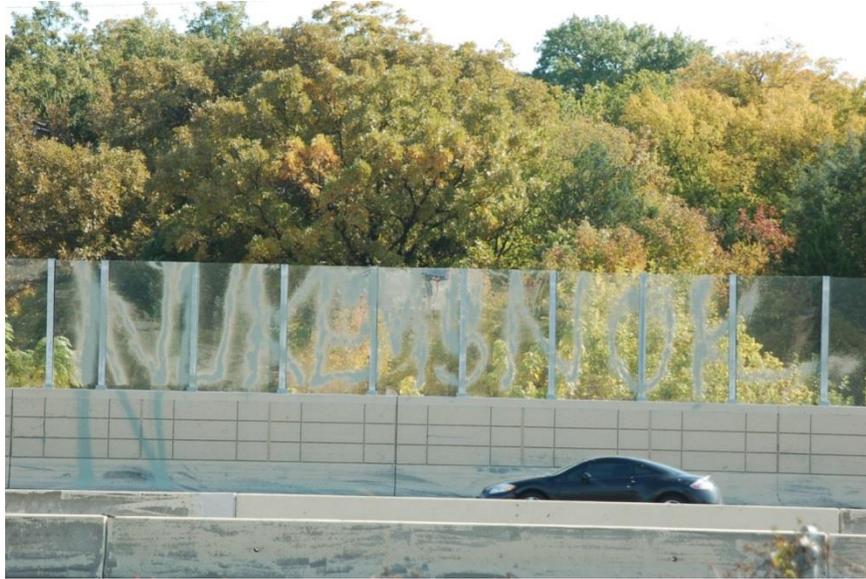
Figure 8.23: Graffiti seen from the north side of IH 30

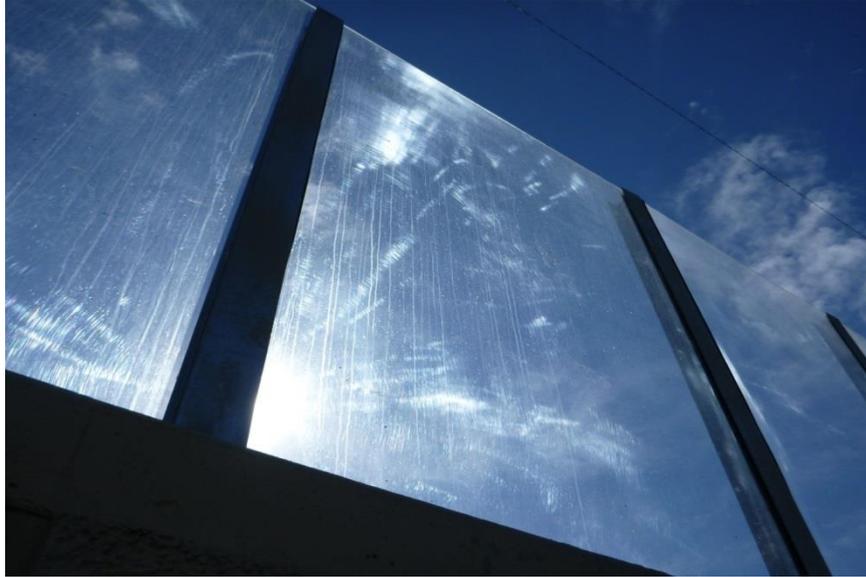
Figure 8.24: Cleaned panel showing traces of the cleaning operation

During the remaining part of November and December 2013, no work was performed to clean the sound wall. By January 28, 2014, the panels had been cleaned. The following cost information for the cleaning operations was kindly provided by Mr. Frank Jett, with the Dallas District, Heavy Equipment Maintenance:

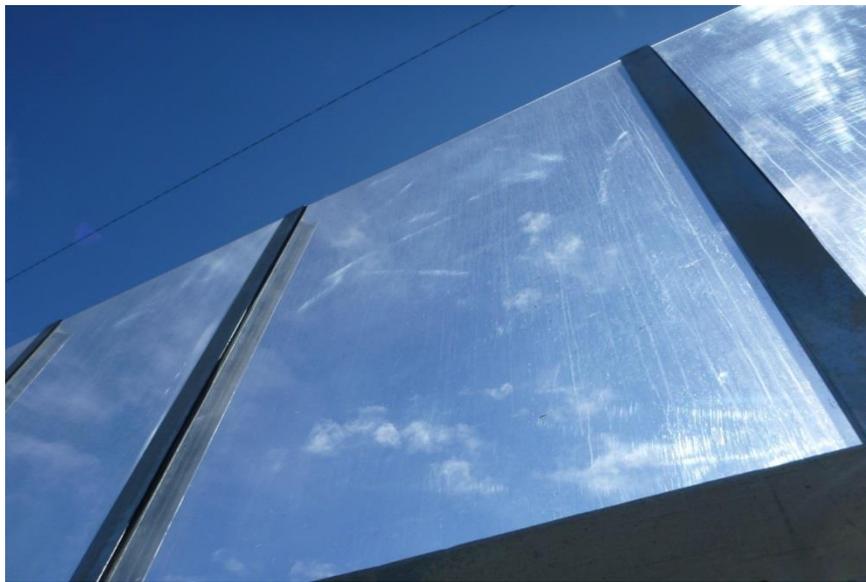
Figure 8.25: Cleaned panel showing traces of the cleaning operation

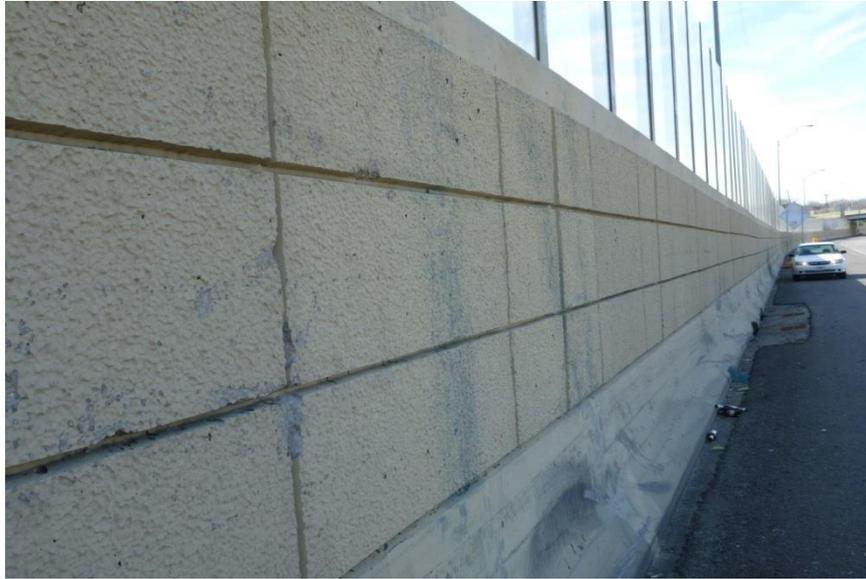
Figure 8.26 shows that the graffiti that extended to the concrete wall could not be entirely removed, and Figure 8.27 shows a photograph taken from afar after the panels had been cleaned.

Figure 8.26: Remnants of the graffiti on the concrete wall below the panels

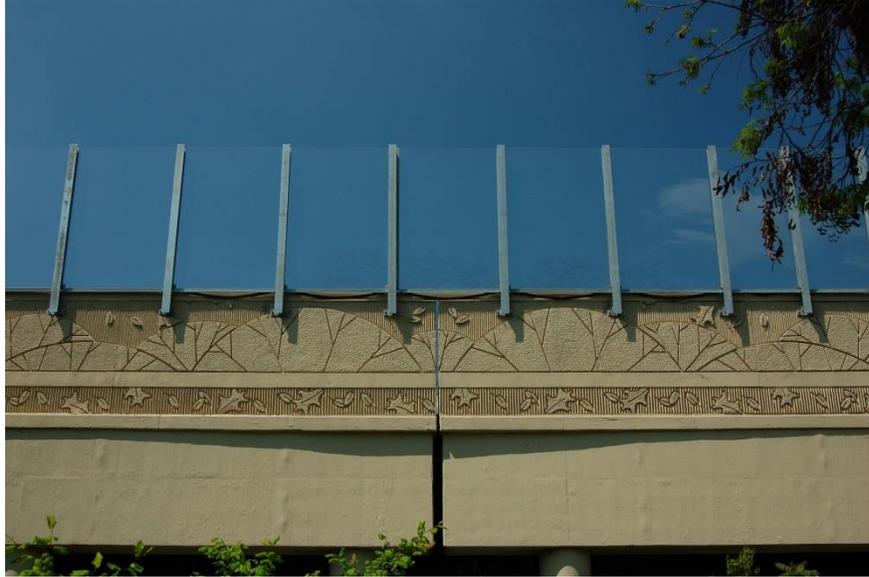
Besides the graffiti, which was successfully removed, the main problem with the wall was the deteriorating condition of the rubber gaskets that are supposed to seal the spaces between panels and the metal supports and the existing concrete walls. This problem was reported shortly after the wall was installed, as it was detected in the inspections during the installation, as mentioned before in this chapter. In the subsequent months, the condition of such gaskets appeared to worsen. Many of the gaskets were not properly placed from the time the wall was installed, and then, perhaps due to the weather, some of them fell out of

place, sagging and even breaking, leaving open gaps through which the noise travels from the highway to the neighborhood. Making an analogy with architectural acoustics, this is similar to leaving an opening (e.g., an open window or a gap under a door) in a room, in which case, the acoustic energy goes through the opening, and the transmission loss of the walls is undermined by the area of the opening, significantly reducing the wall's effectiveness. The problem with the gaskets occurred in both the vertical and horizontal gaskets, but the worst cases correspond to the horizontal gaskets that seal the bottom of the acrylic panels with the concrete wall. The sagging of the horizontal gaskets can be seen in Figures 8.28 through 8.31.

Figure 8.29: Sagging of horizontal rubber gaskets

It was estimated that about 80% of the horizontal gaskets were in poor condition (broken, sagging, or out of place), which significantly hinders the acoustic performance of the barrier. In May 2014, CTR learned that the contractor had offered to fix the problems with the gaskets at no cost to TxDOT. In the following months, it was noticed that the sagging and broken gaskets had been removed, eliminating the negative visual impression of disrepair; however, those gaskets were not replaced with new ones, leaving the openings

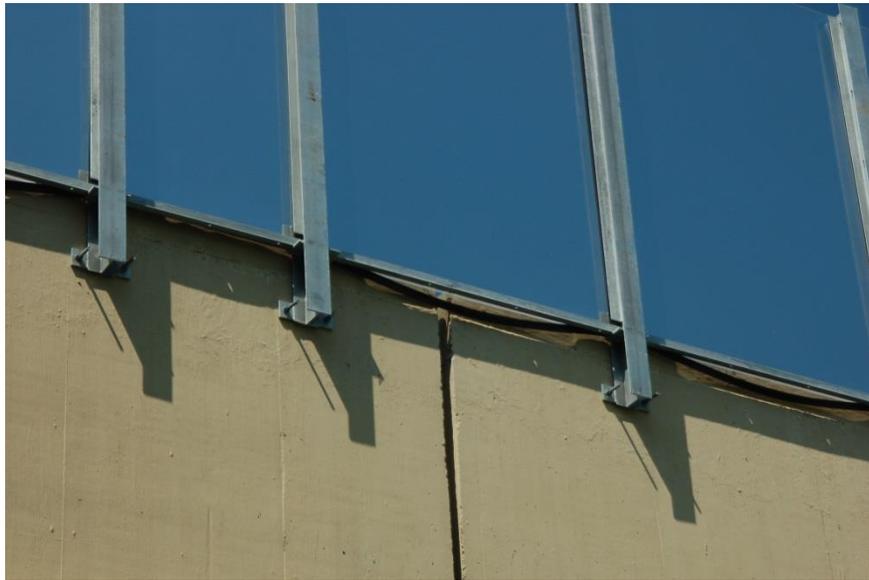
Figure 8.30: Sagging of horizontal rubber gaskets

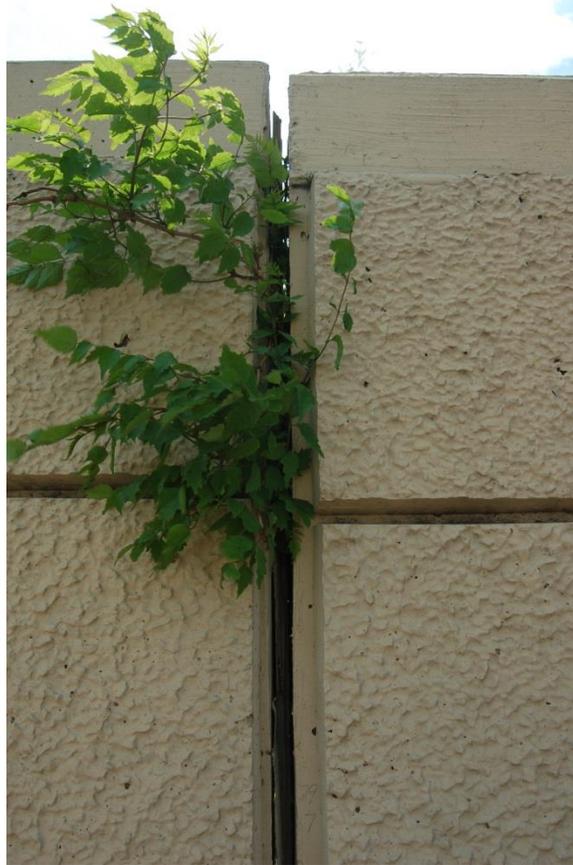
Another problem not directly related to the acrylic wall, but one that minimizes its effectiveness, is the high number of open joints in the existing concrete wall. This was mentioned before in this chapter, as it was noticed shortly after installation of the wall had been completed. These gaps are as wide as 3 or 4 in. (Figure 8.37); the joint sealants are old and have disintegrated with time and weather (Figure 8.38), and in some cases cannot be seen at all (Figure 8.39), allowing the acoustic energy to travel to the neighborhood. The vegetation is also growing through these gaps, as can be seen Figure 8.40. If these can be sealed and the gaskets can be repaired, the wall could be much more effective in mitigating the noise.

Figure 8.40: Vegetation from the creek side growing through the openings in the concrete structure

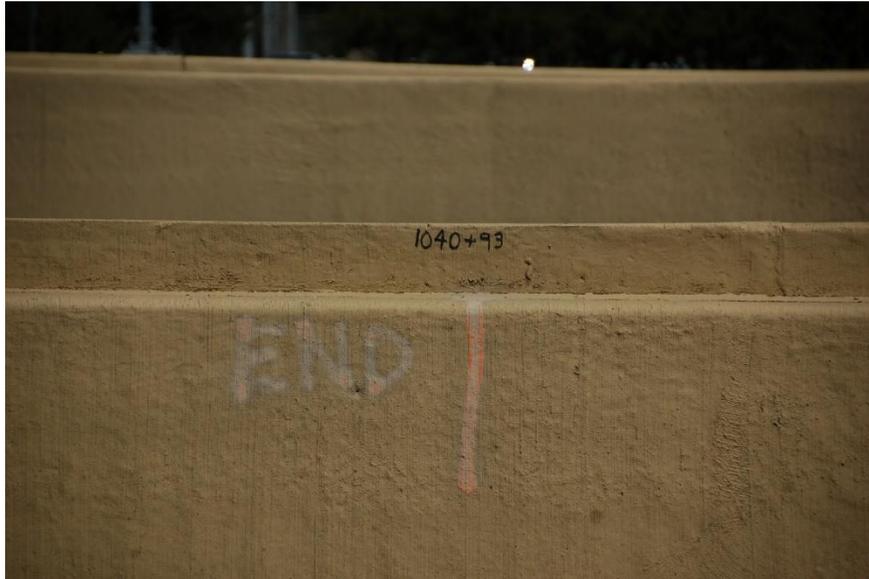
The easternmost end of the wall (Segment 3) was initially supposed to be at station 1040+93 (Figure 9.16), about 200 ft. to the east of where it actually ends, close to station 1039 (Figure 9.17). The stations are painted on the outside of the CTB, for Segment 3. There is also a paint mark at the spot where the wall is supposed to end, at station 1040 + 93. The reason for shortening the wall length was due to the difficulty of installing vertical posts beyond the actual end, as there is no more room to anchor the posts where the concrete

Figure 9.16: Supposed easternmost end of the wall at Station 1040+93 (March 2018)

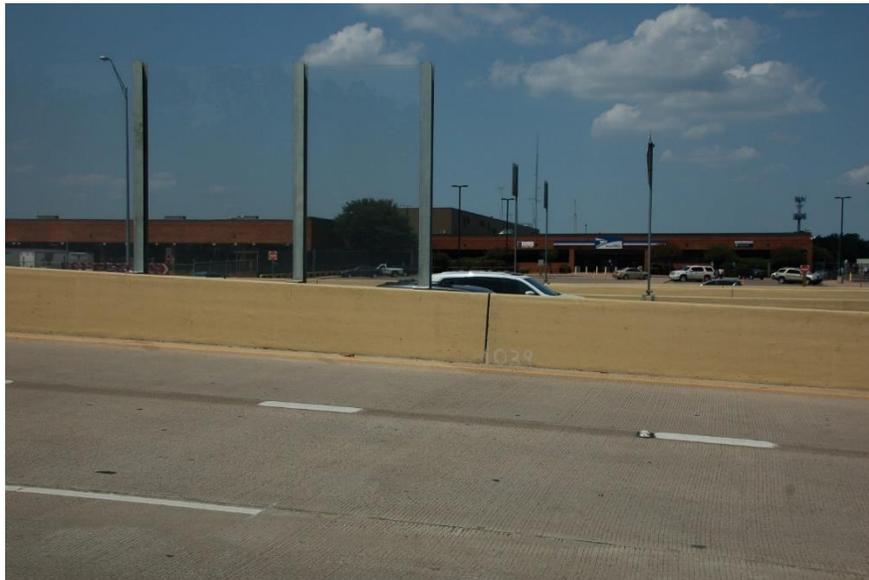
Figure 9.17: Actual easternmost end of the wall a few feet before Station 1039 (August 2018)

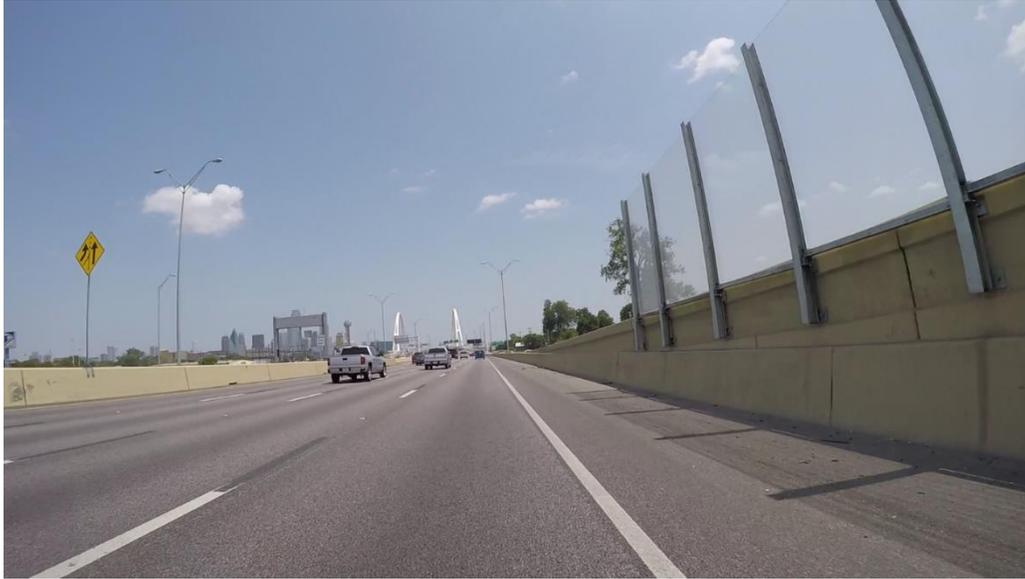
wall's height decreases. This can be seen in Figure 9.18, which shows the actual end of the wall as seen from the main lanes' side.

Figure 9.18: Actual easternmost end of the wall as seen from the main lanes (August 2018)

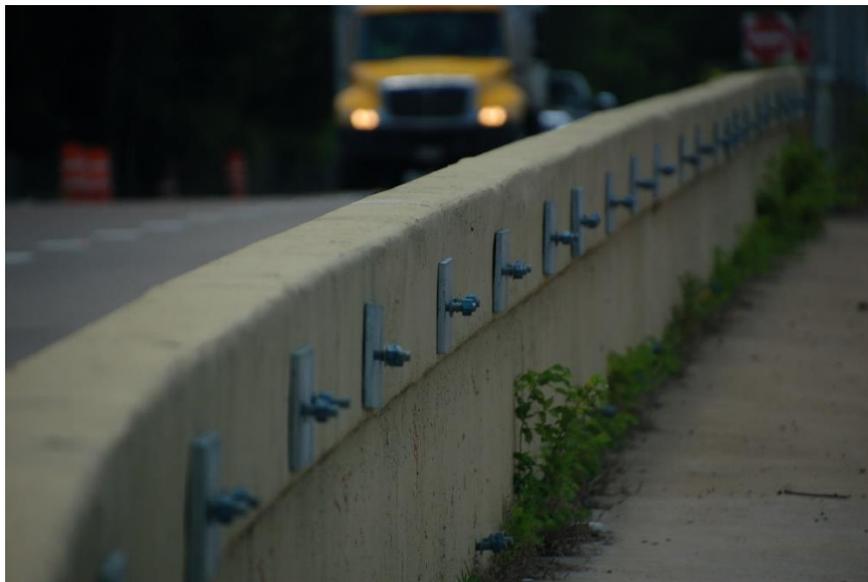
- In March, there were 85 vertical posts already installed for Segment 3, almost all the way to the end of the segment. There were panels already in place up to the 26th post. Some of the posts and panels had to be removed, as there was a design problem with the mounting of the posts to the existing concrete wall, as explained before in this chapter (Figures 9.19 and 9.20). Then the construction had to be interrupted to fix the problem. By the April 19th visit, the segment only had 15 posts and only 14 panels and only reached as far as approximately halfway between station 1033 and 1034. Once the design problem was resolved, construction resumed and the posts and panels were put back in place all the way to the end in August 2018.

Figure 9.20: Only plates and bolts remained after some posts were removed in April to fix design problem (May 2018)

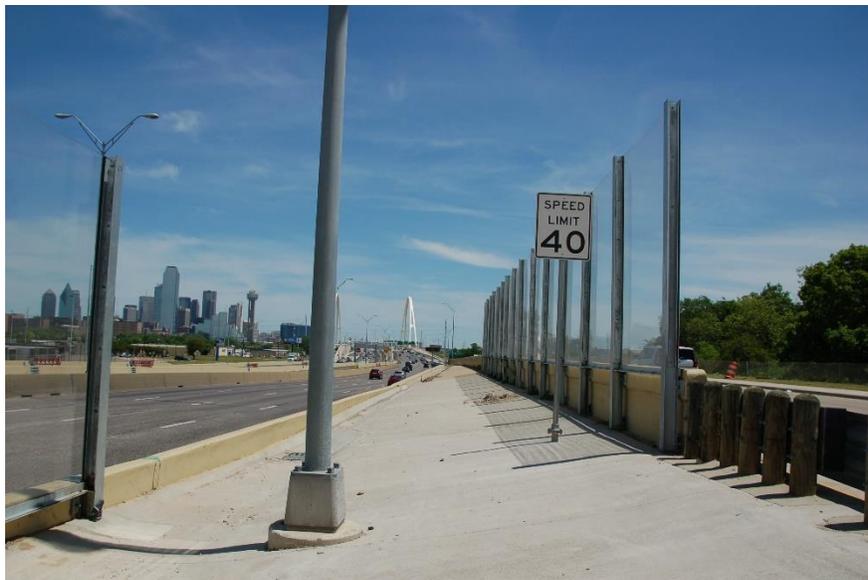
- Initially, only one of the two overlaps designed to reduce the noise traveling through the gaps between segments was installed; this was the overlap between the Segment 1 easternmost end and the Segment 2 westernmost end (Figure 9.21). Before August, there was no overlap between Segment 2 and Segment 3 (Figure 9.22). In fact, there was a small gap of about 5 ft. between segments (Figure 9.23). Once the installation work resumed in July 2018, the segment was extended to the east to include the overlap at the request of TxDOT (Figures 9.24 and 9.25). Notice the green paint marks on the CTB in Figures 9.23 (before) and 9.25 (after) that

Figure 9.22: No overlap between Segment 2 and Segment 3 (April 2018)

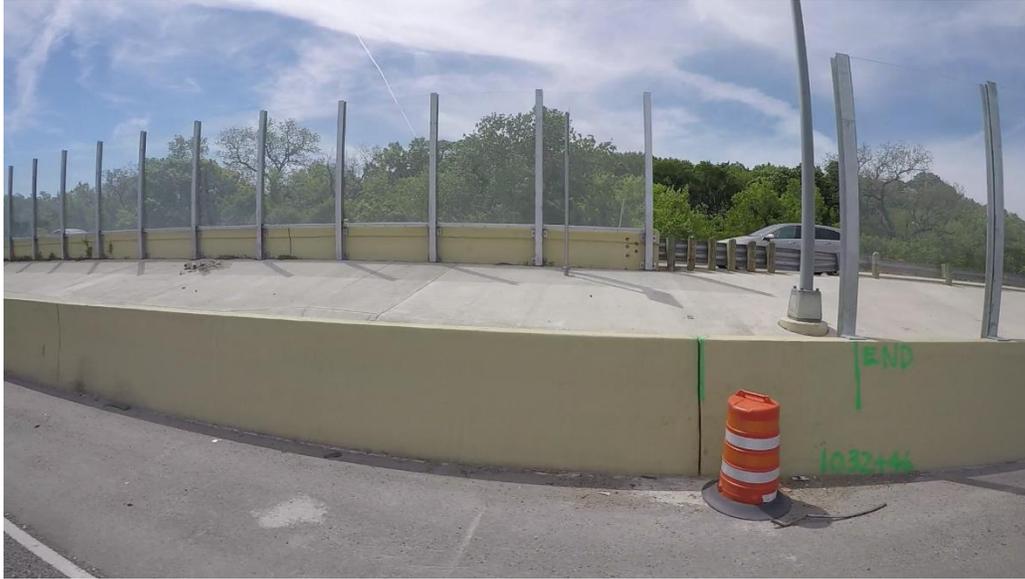
Figure 9.23: No overlap between Segment 2 and Segment 3, seen from the main lanes (April 2018)

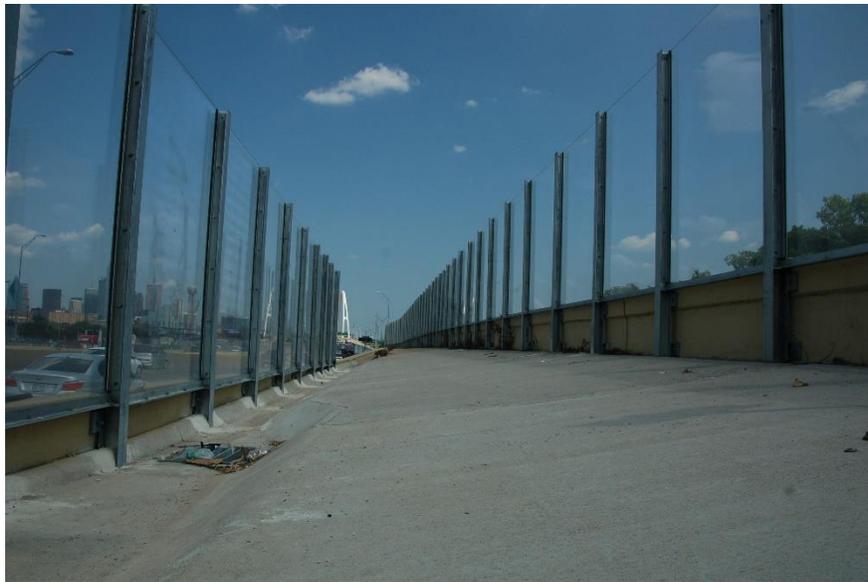
Figure 9.24: Segment 2 extended to the east to include overlap (August 2018)

indicate the initial contractor's end of Segment 2, and the length of the overlap extended to the east in Figure 9.25 beyond the paint mark (11 panels added beyond the paint).

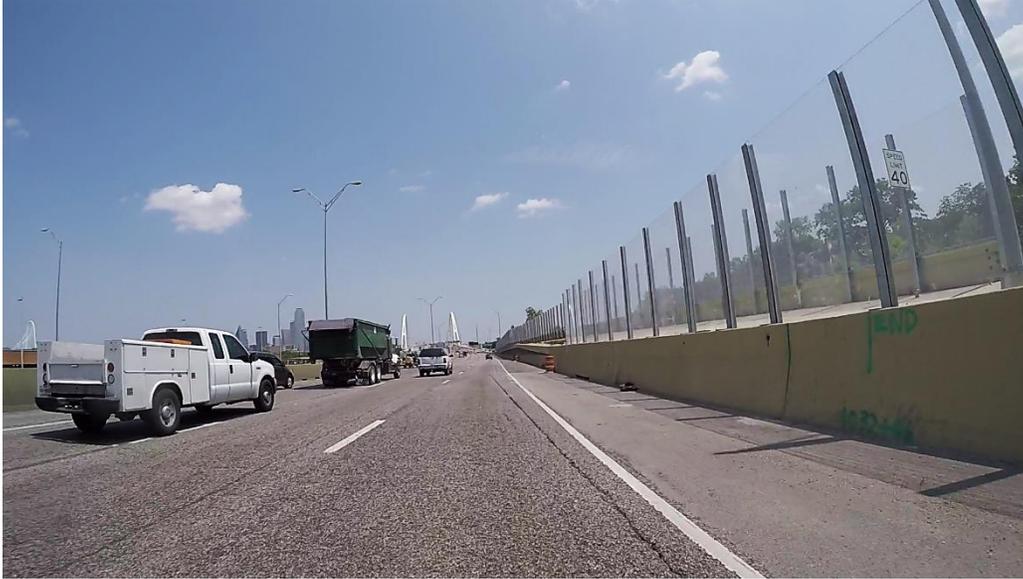
Figure 9.25: Segment 2 extended to the east to include overlap (August 2018)

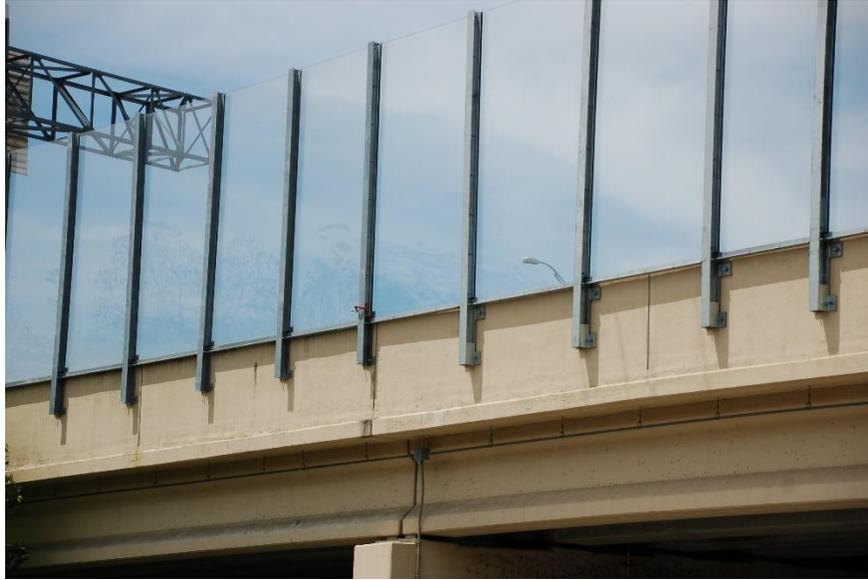
- The system that attaches the vertical supports to the concrete walls seems more robust than the one used for the Site 1 wall. There is also more length of the posts

that is bolted to the concrete (Figure 9.28). In this photograph, a red clamp is attached to the last post from the Site 1 wall.

Figure 9.28: Different anchoring for vertical posts at Site 1 wall (L) and Site 2 wall (R)

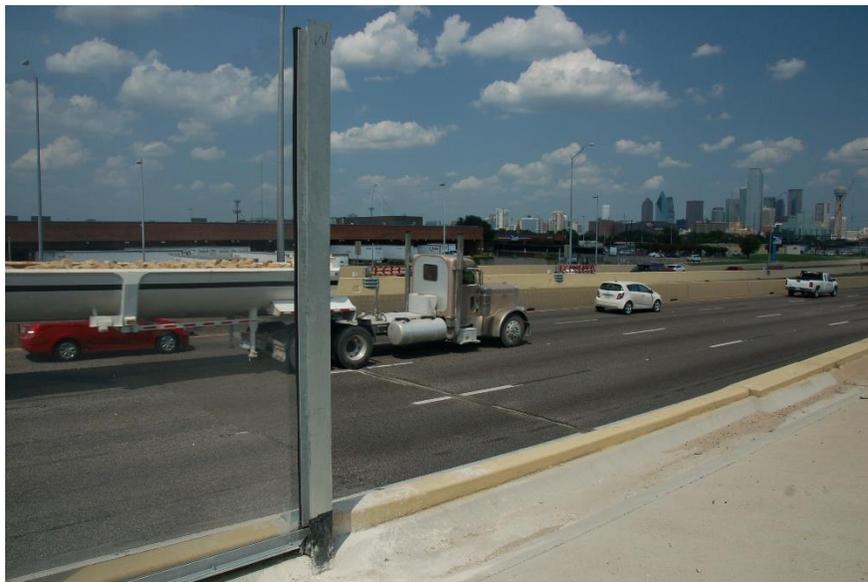
- There is a badly damaged, open expansion joint in the pavement that extends all across the right four eastbound main lanes and the shoulder. It causes a loud thumping noise every time a vehicle goes over it, which is very frequently. It is located just to the east of where Segment 2 ends, so there is no shielding from that loud and frequent noise. Hopefully, this joint can be fixed when the road is repaved (Figures 9.41 to 9.43).

Figure 9.43: Location of the open joint in relation to the end of Segment 2

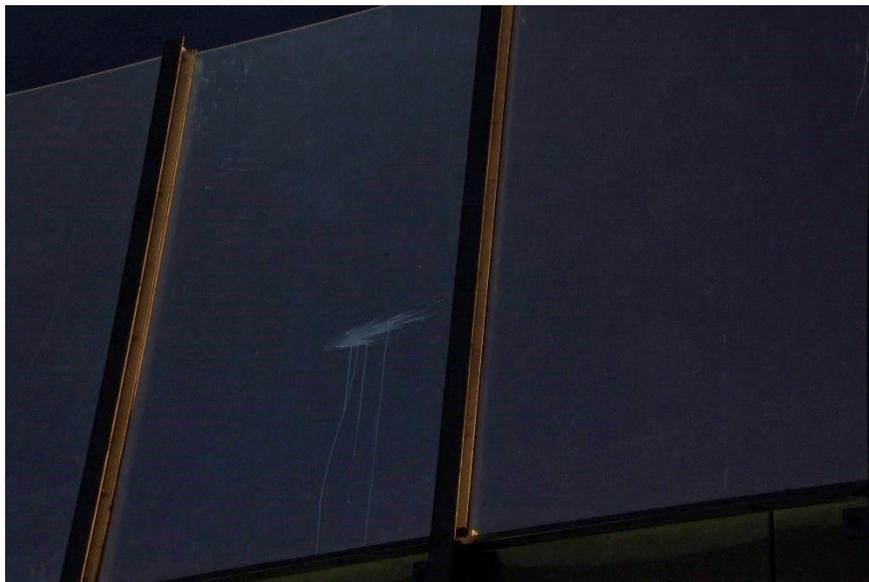
- There is already a bird-crash on one of the panels of Segment 1, east of Sylvan Ave., close to the easternmost end of the segment (Figure 9.47).

Figure 9.47: Bird-crash in one of the panels of Segment 1 (April 2018)
