TECHNICAL REPORT 0-6804-4
TxDOT PROJECT NUMBER 0-6804

Final Analysis of Lightweight Transparent Noise Barriers on I-30 Elevated Structures in Dallas, Texas

Dr. Manuel Trevino

July 2020; Published July 2021

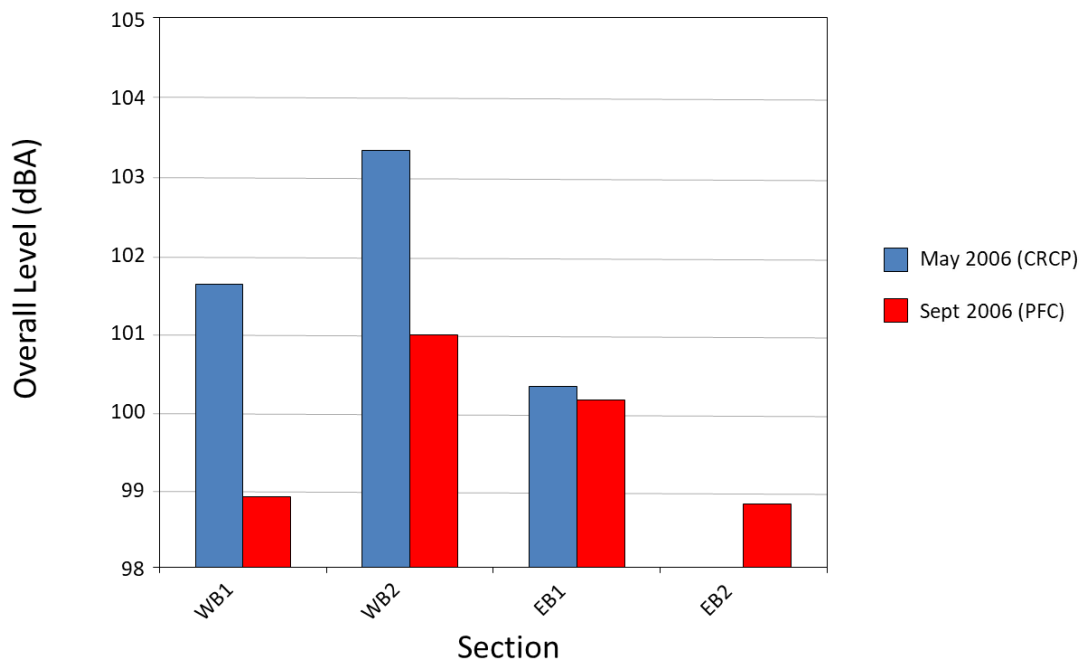
Figure 3.28 Initial noise reduction provided by 2006 PFC from OBSI tests

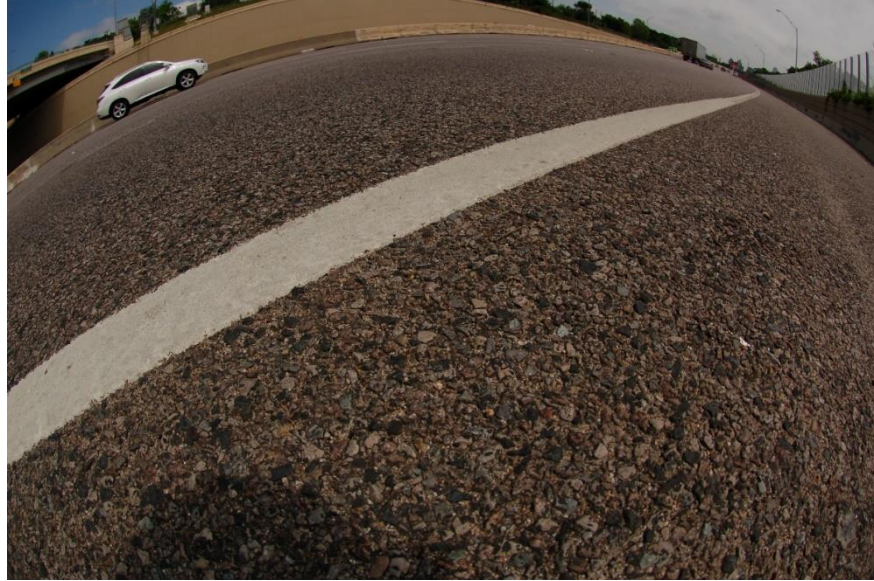
Unfortunately, this type of pavement tends to lose its acoustic benefits over time, as its void content diminishes due to clogging and compaction. Clogging occurs when debris from the road fills the original pores that make these pavements quieter, while compaction under heavy traffic loading has a similar effect of reducing the voids over time. The degradation of the acoustical properties of PFC pavement surfaces over time is documented in the literature (*Arambula 2013, Smit 2016*). Figures 3.29 to 3.31 illustrate this degradation of the PFCs, showing how the pavements resembled dense-graded asphalt surfaces after clogging and compaction had decreased their void content.

Figure 3.31 2010 PFC in May 2016

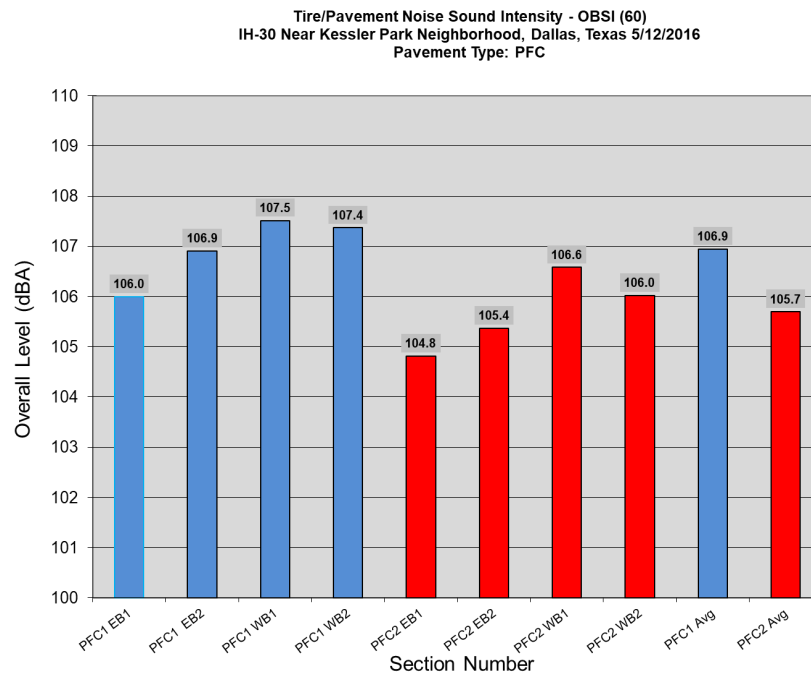
More recent OBSI results, from 2016 (Figure 3.32), confirmed that these overlays had gotten much louder, indicating that their acoustic benefits had substantially diminished over time; the 2006 PFC (PFC1 in the chart) was about 107 dBA, on average, while 2010 PFC (PFC2 in the chart) was almost 106 dBA, on average. Figure 3.33 compares two series of recent OBSI tests (the data from 2014 and 2016) indicating the trend that both PFCs were producing higher levels of noise.

Figure 3.32 Recent OBSI results confirming degradation of acoustic benefits of both PFCs

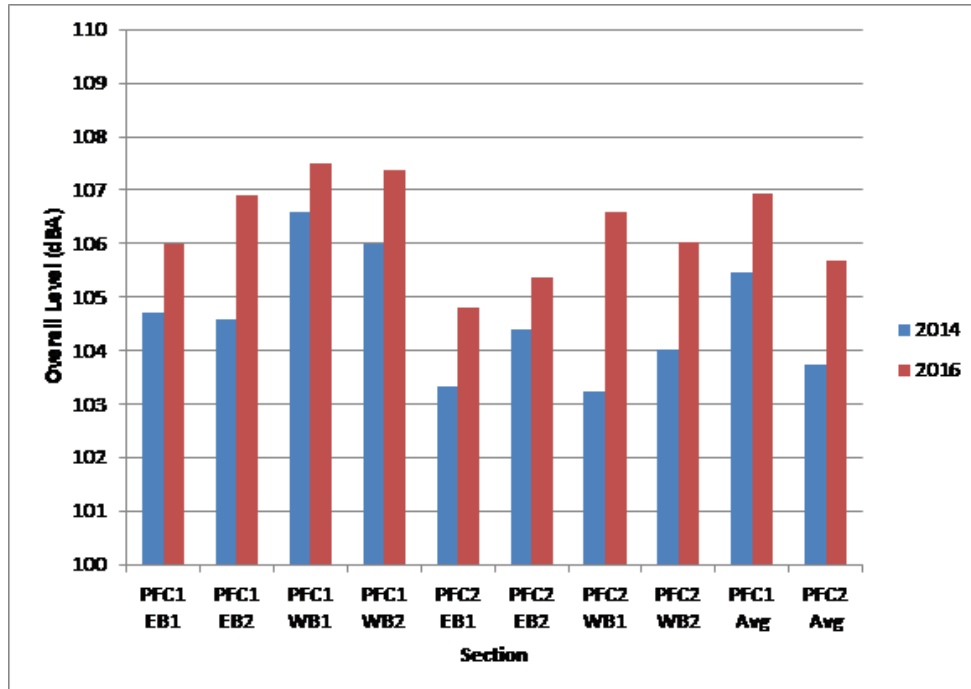
Figure 3.33 Comparison of two recent series of OBSI tests on PFCs on I-30

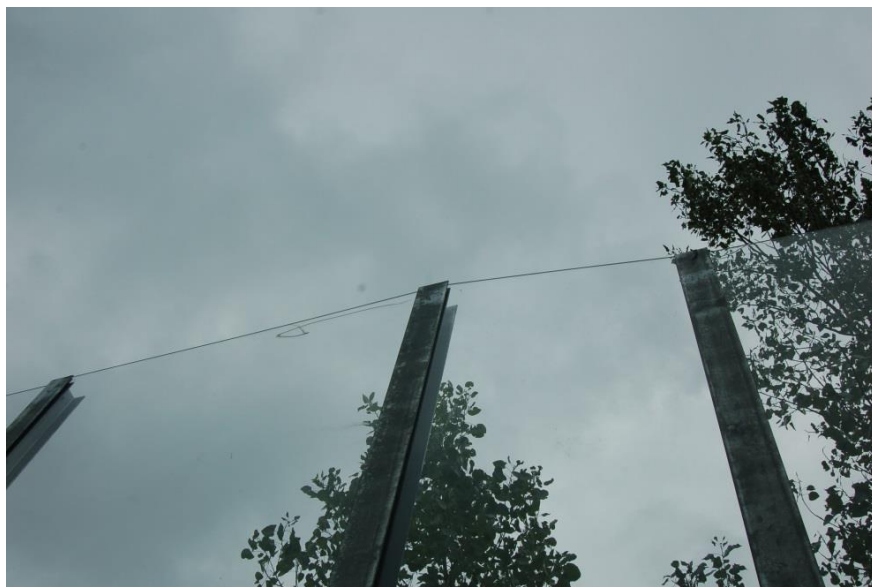
A few problems were noticed before the completion of the installation, such as some supports not being completely vertical (Figures 8.9 and 8.10), some apparently missing rubber gaskets between panels and the metal supports, some gaskets slightly out of place (Figure 8.11), as well as some gaps between gaskets and metal supports, both for vertical and horizontal gaskets (Figures 8.12 and 8.13).

Figure 8.10 Vertical support off-plumb

Attending this request, the contractor fixed some of the problems at no cost to TxDOT, such as the off-plumb posts and the missing gaskets.

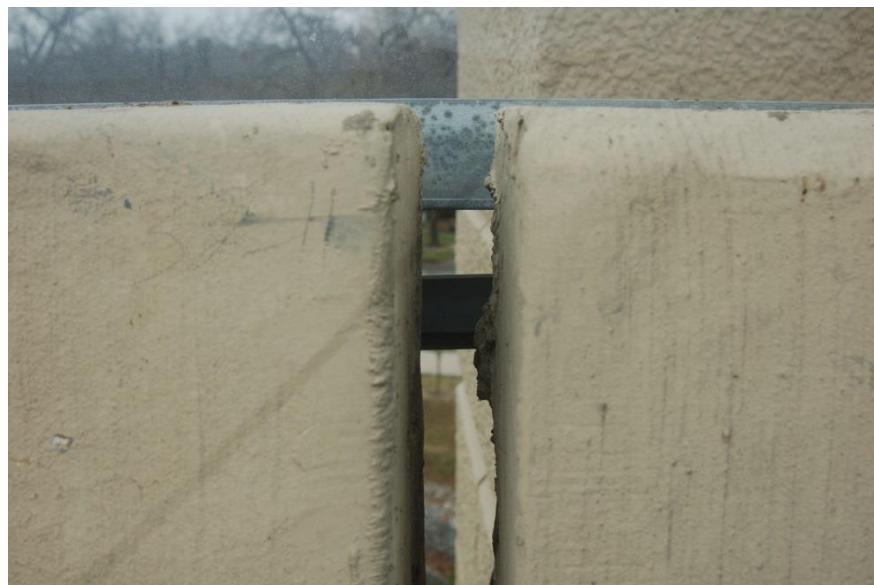
Additionally, some gaps were observed in the existing concrete wall at the expansion joints of the bridge (Figures 8.15 and 8.16), gaps that should be filled with some elastic joint sealing material allowing for the bridge's thermal expansion and contraction. Such material should prevent the sound from traveling from the highway to the neighborhood to further attenuate the noise at the receivers' locations and contribute to the wall's effectiveness. This would be TxDOT's responsibility, as it is not an issue of the transparent noise wall, but rather of the existing structure.

Figure 8.16 Gap in existing concrete wall at bridge expansion joint as seen from the highway side

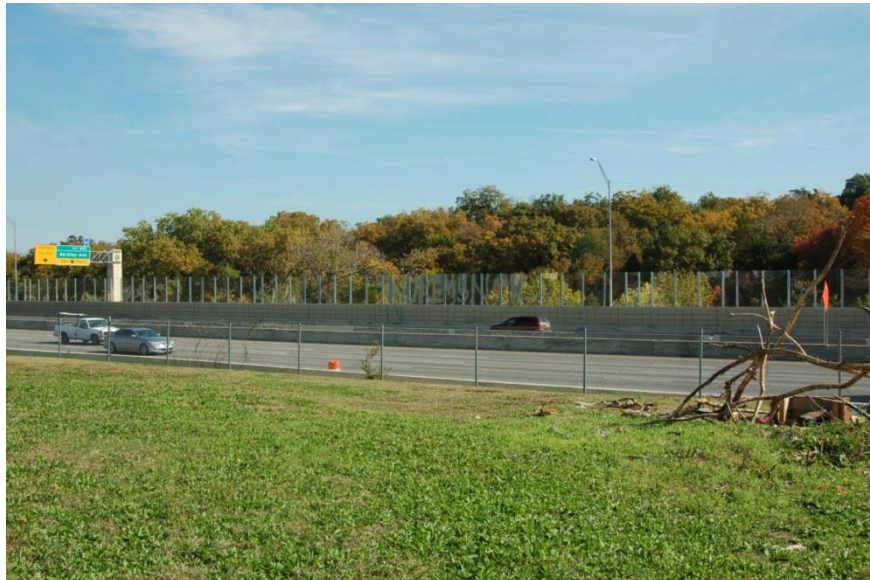
Figure 8.22 Graffiti seen from the north side of I-30

During the remaining part of November and December 2013, no work was performed to clean the sound wall. By January 28, 2014, the panels had been cleaned. The following cost information for the cleaning operations was kindly provided by Mr. Frank Jett, with the Dallas District, Heavy Equipment Maintenance:

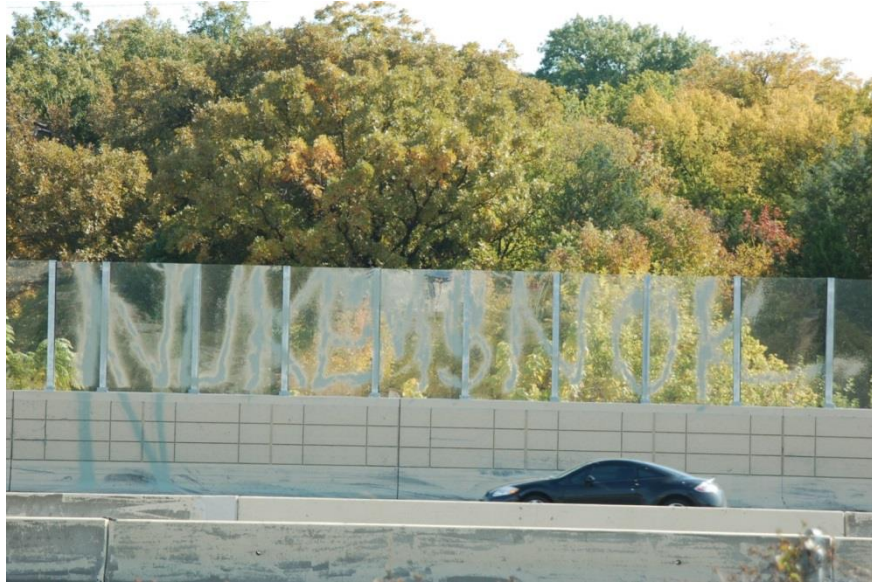
Figure 8.23 Graffiti seen from the north side of I-30

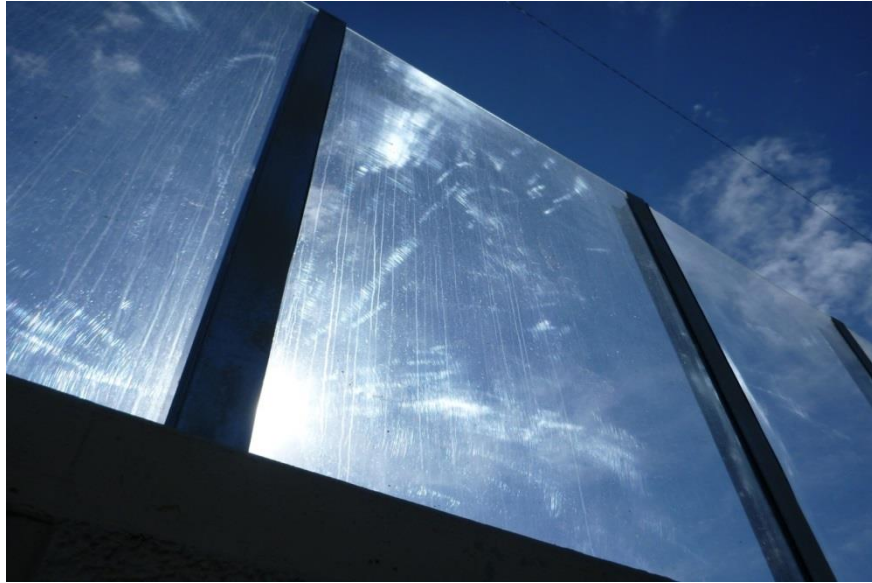
Figure 8.24 Cleaned panel showing traces of the cleaning operation

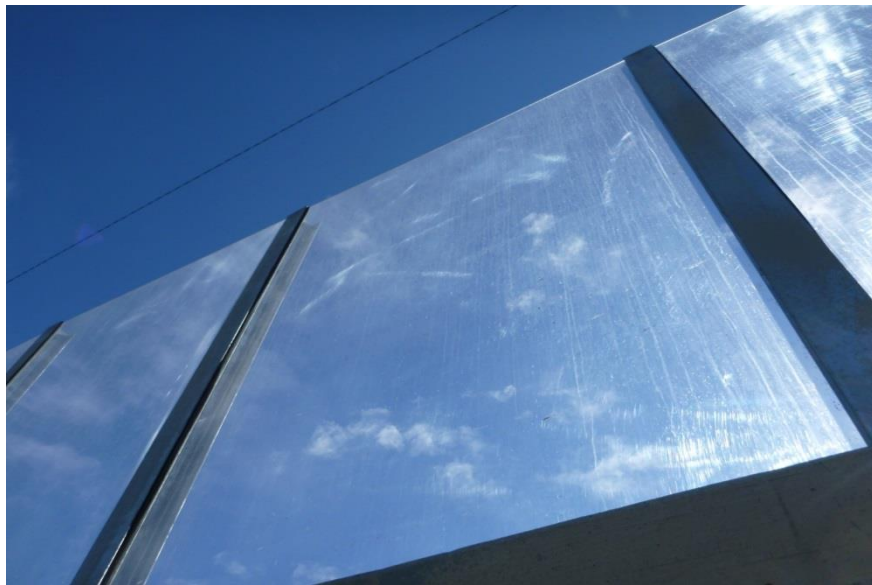
Figure 8.25 Cleaned panel showing traces of the cleaning operation

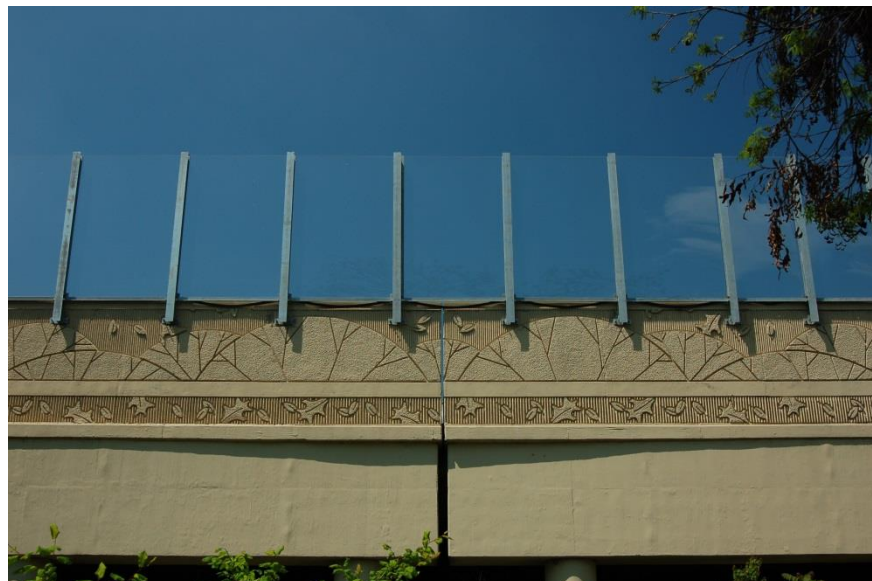
architectural acoustics, this is similar to leaving an opening (e.g., an open window or a gap under a door) in a room, in which case, the acoustic energy goes through the opening, and the transmission loss of the walls is undermined by the area of the opening, significantly reducing the wall's effectiveness. The problem with the gaskets occurred in both the vertical and horizontal gaskets, but the worst cases correspond to the horizontal gaskets that seal the bottom of the acrylic panels with the concrete wall. The sagging of the horizontal gaskets can be seen in Figures 8.28 through 8.31.

Figure 8.29 Sagging of horizontal rubber gaskets

It was estimated that about 80% of the horizontal gaskets were in poor condition (broken, sagging, or out of place), which significantly hinders the acoustic performance of the barrier. In May 2014, CTR learned that the contractor had offered to fix the problems with the gaskets at no cost to TxDOT. In the following months, it was noticed that the sagging and broken gaskets had been removed, eliminating the negative visual impression of disrepair; however, those gaskets were not replaced with new ones, leaving the openings intact. At this stage, after a few years have passed, it is very unlikely that the contractor will still replace those gaskets.

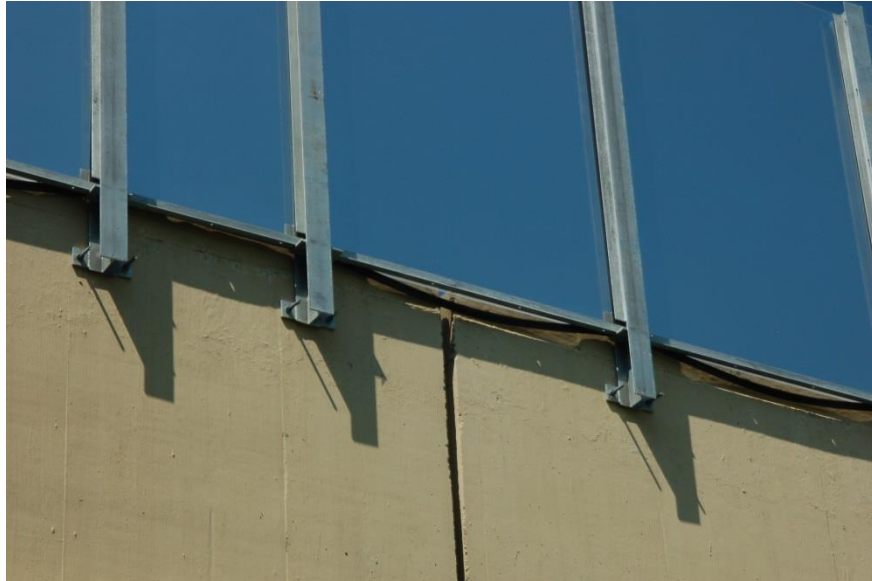
Figure 8.30 Sagging of horizontal rubber gaskets

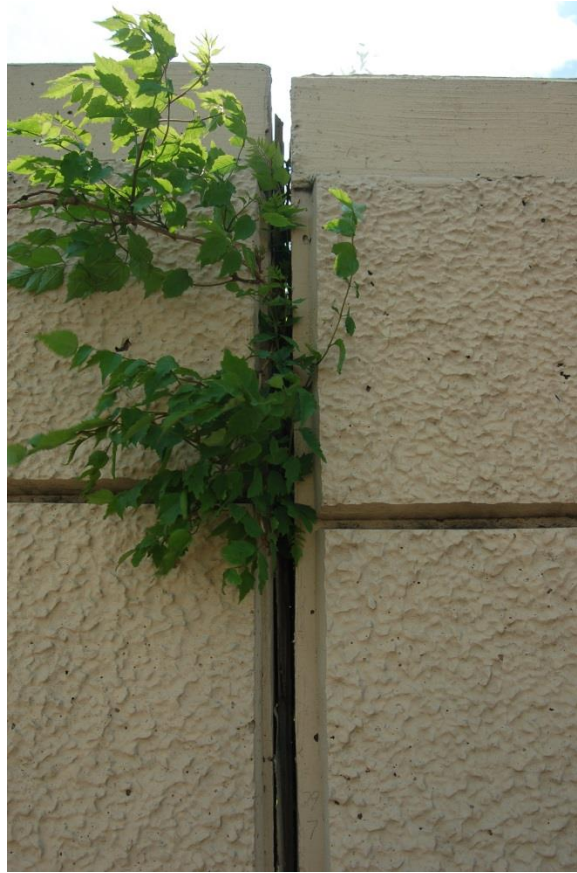
Another problem not directly related to the acrylic wall, but one that minimizes its effectiveness, is the high number of open joints in the existing concrete wall. This was mentioned before in this chapter, as it was noticed shortly after installation of the wall had been completed. These gaps are as wide as 3 or 4 in. (Figure 8.37); the joint sealants are old and have disintegrated with time and weather (Figure 8.38), and in some cases cannot be seen at all (Figure 8.39), allowing the acoustic energy to travel to the neighborhood. The vegetation is also growing through these gaps, as can be seen Figure 8.40. If these can be sealed and the gaskets can be repaired, the wall could be much more effective in mitigating the noise.

Figure 8.40 Vegetation from the creek side growing through the openings in the concrete structure

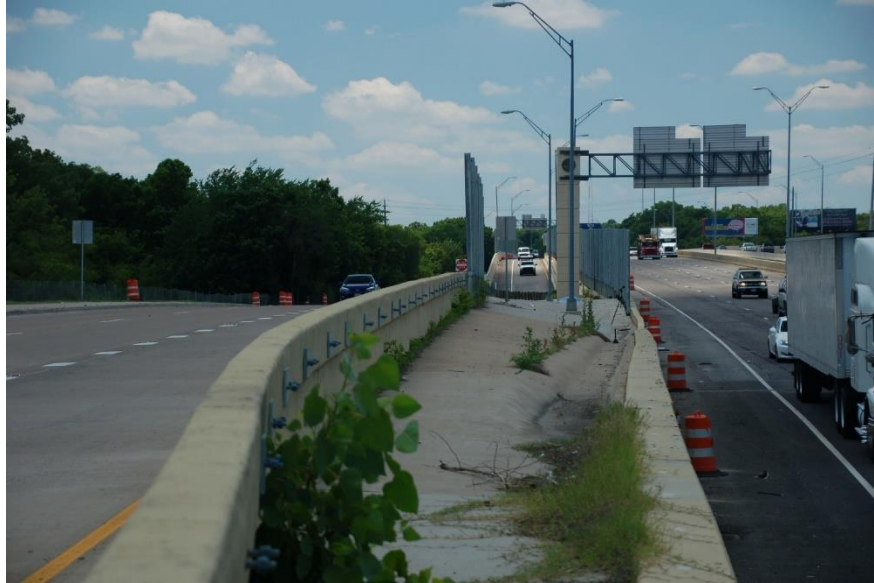
the existing concrete wall ends in a wedge-like shape, preventing installation of any more vertical supports for the noise wall (Figure 9.10). See Chapter 5, Section 5.6 for more information on the determination of the easternmost limit of the barrier, as dictated by the geometric configuration of the highway and existing CTBs.

Figure 9.10 Frontage road and main lanes CTBs converge in a wedge-like shape (May 2018)

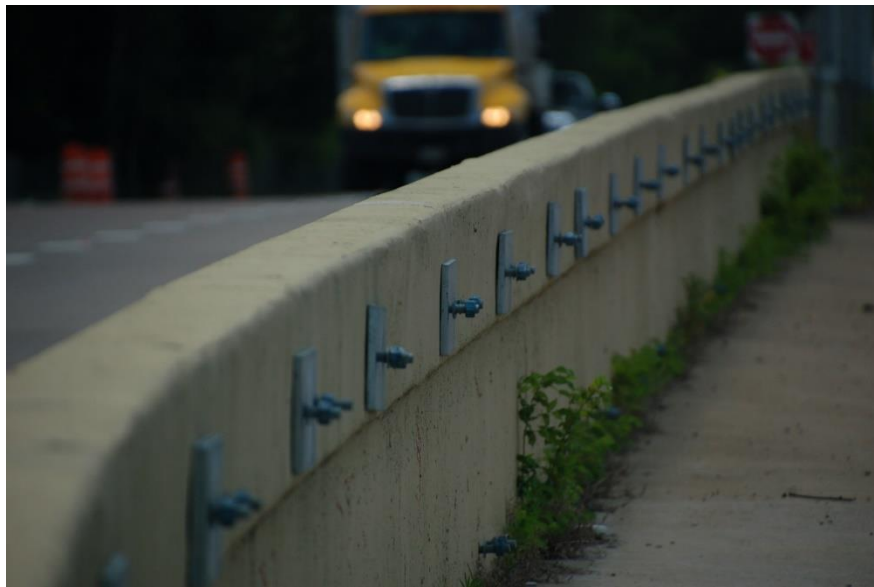
- In March, there were 85 vertical posts already installed for Segment 3, almost all the way to the end of the segment. There were panels already in place up to the twenty-sixth post. Some of the posts and panels had to be removed, as there was a design problem with the mounting of the posts to the existing concrete wall, as explained before in this chapter (Figures 9.19 and 9.20). Then the construction had to be interrupted to fix the problem. By the April 19th visit, the segment only had 15 posts and only 14 panels and reached approximately halfway between station 1033 and 1034. Once the design problem was resolved, construction resumed and the posts and panels were put back in place all the way to the end in August 2018.

Figure 9.20 Only plates and bolts remained after some posts were removed in April to fix design problem (May 2018)

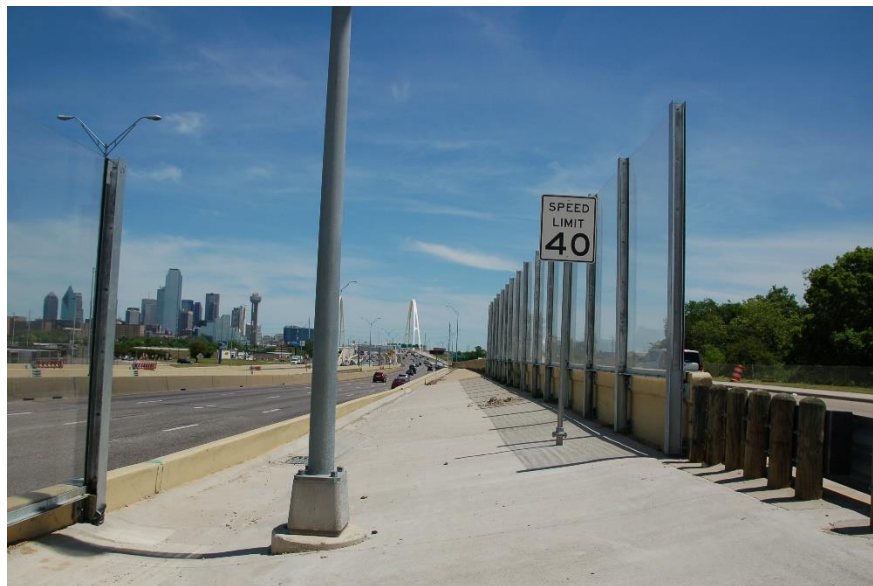
- Initially, only one of the two overlaps designed to reduce the noise traveling through the gaps between segments was installed; this was the overlap between the Segment 1 easternmost end and the Segment 2 westernmost end (Figure 9.21). Before August, there was no overlap between Segment 2 and Segment 3 (Figure 9.22). In fact, there was a small gap of about 5 ft between segments (Figure 9.23). Once the installation work resumed in July 2018, the segment was extended to the east to include the overlap at the request of TxDOT (Figures 9.24 and 9.25). Notice the green paint marks on the CTB in Figures 9.23 (before) and 9.25 (after) that indicate the initial contractor's end of Segment 2, and the

Figure 9.22 No overlap between Segment 2 and Segment 3 (April 2018)

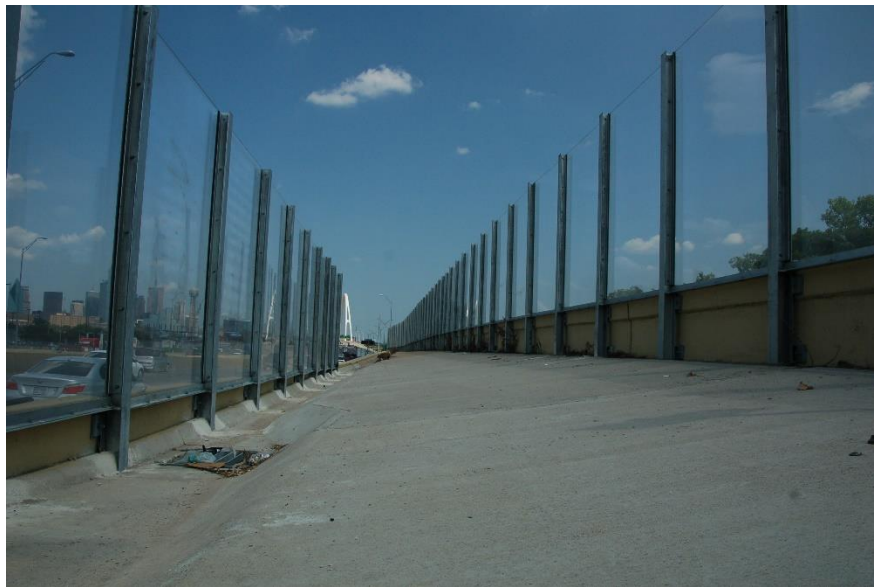
Figure 9.24 Segment 2 extended to the east to include overlap (August 2018)

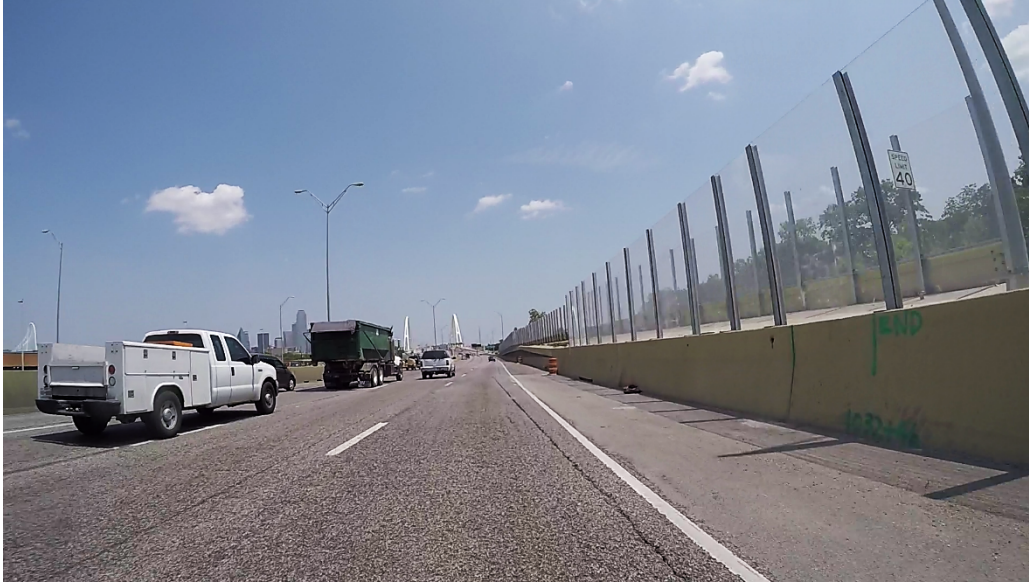
length of the overlap extended to the east in Figure 9.25 beyond the paint mark (11 panels added beyond the paint).

Figure 9.25 Segment 2 extended to the east to include overlap (August 2018)

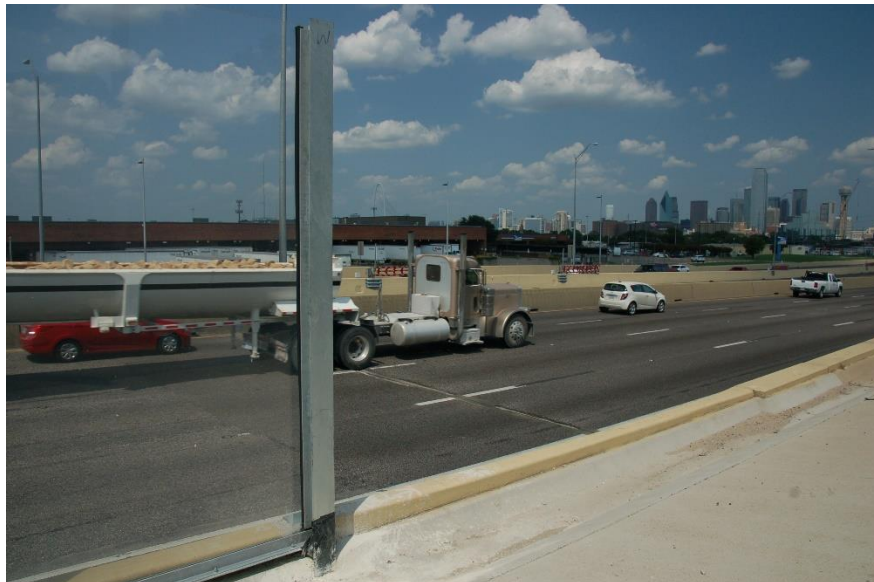
- There is a badly damaged, open expansion joint in the pavement that extends across the right four eastbound main lanes and the shoulder. It causes a loud thumping noise every time a vehicle goes over it, which is very frequently. It is located just to the east of where Segment 2 ends, so there is no noise barrier shielding from that loud and frequent noise. Hopefully, this joint can be fixed when the road is repaved (Figures 9.41 to 9.43).

Figure 9.43 Location of the open joint in relation to the end of Segment 2

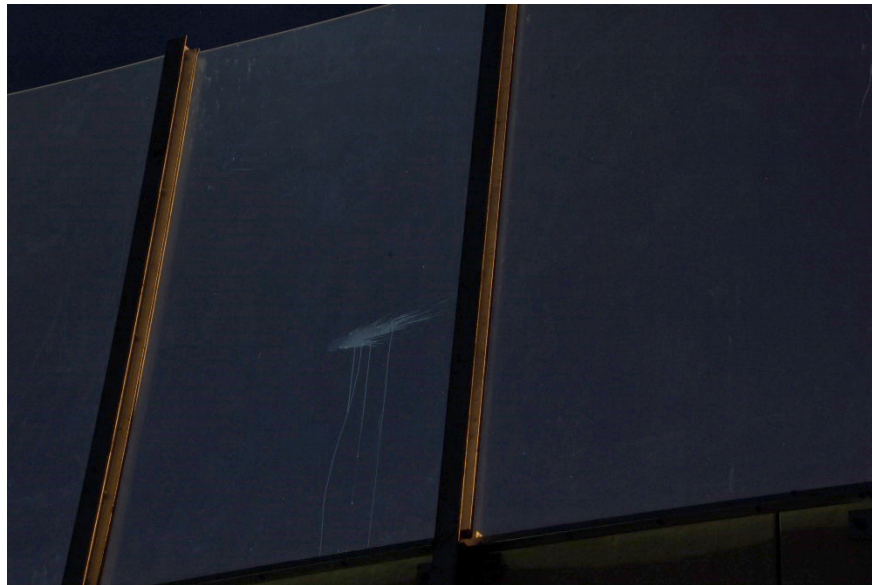
- Shortly after being finalized, there was already a bird-crash on one of the panels of Segment 1, east of Sylvan Avenue, close to the easternmost end of the segment (Figure 9.47).

Figure 9.47 Bird-crash in one of the panels of Segment 1 (April 2018)

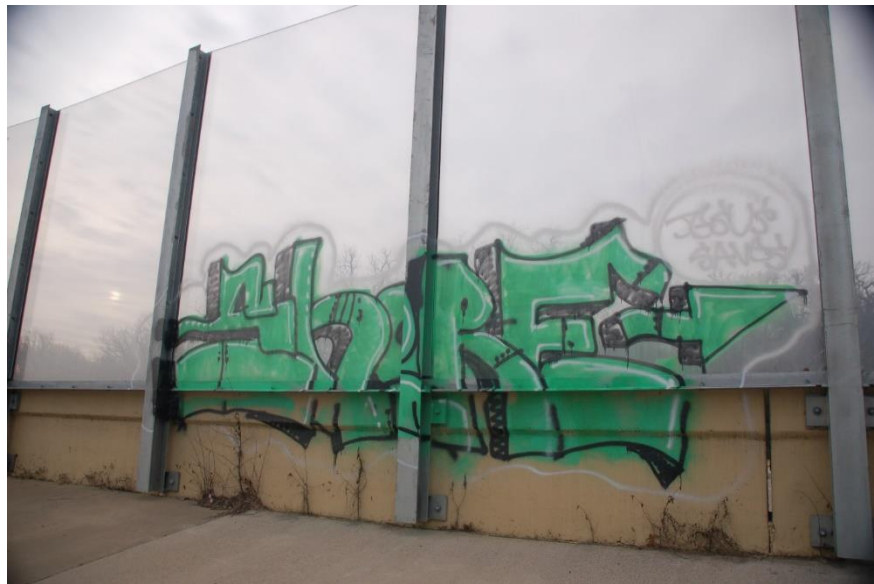
On January 30, 2019, the occurrence of vandalism in the form of graffiti was observed on the noise wall. Three panels corresponding to Segment 3 (the easternmost segment) were sprayed with green and black paint. The graffiti also included the concrete under the panels as well as the metal supports. The twelfth, thirteenth, and fourteenth panels of Segment 3, counting from the west, were the ones involved. The damage was done from the highway side. This section is easy to access as

Figure 9.49 Graffiti on Segment 3 of the Site 2 barrier, seen from the roadway side (January 30, 2019)

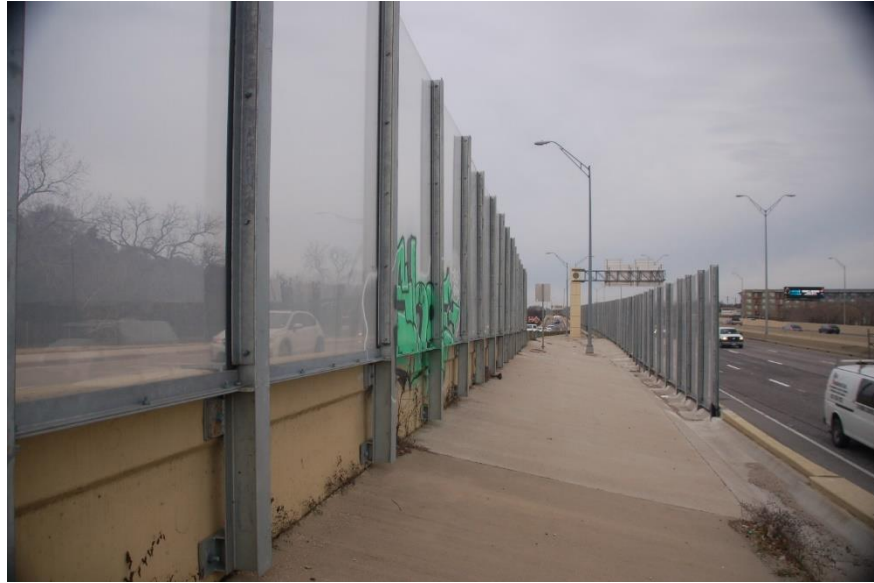
Figure 9.50 Graffiti on Segment 3 of the Site 2 barrier, seen from the roadway side (January 30, 2019)

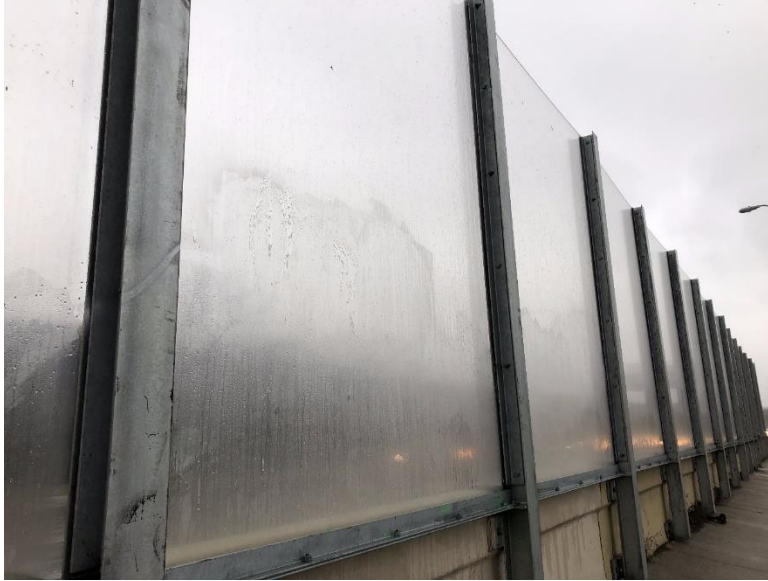
The cleaning process for the graffiti resulted in some damage to the two panels in question: on a rainy day, such as February 19, 2019, it seemed that the cleaned panels were wet with soap, as can be seen in the pictures from that day (Figures 9.51, 9.52 and 9.55). When they were touched on dry days (June 13 and August 15, 2019), they appeared wet but were in fact dry; they had been actually textured by the cleaning product (Figures 9.56 to 9.58).

Figure 9.52 Cleaned panels after graffiti removal (February 19, 2019)

By mid-February 2019, the graffiti had been cleaned from the Site 2 I-30 noise wall. Figures 9.51 to 9.58 show the cleaned wall. The paint was removed from the panels and, because it could not be removed from the concrete of the CTB, the CTB had to be painted over with a similar color as shown in some of the photographs (Figures 9.51 to 9.53). Some of the photos show remnants of the green graffiti on the ground, as well as on some of the steel supports (Figures 9.53 and 9.54).

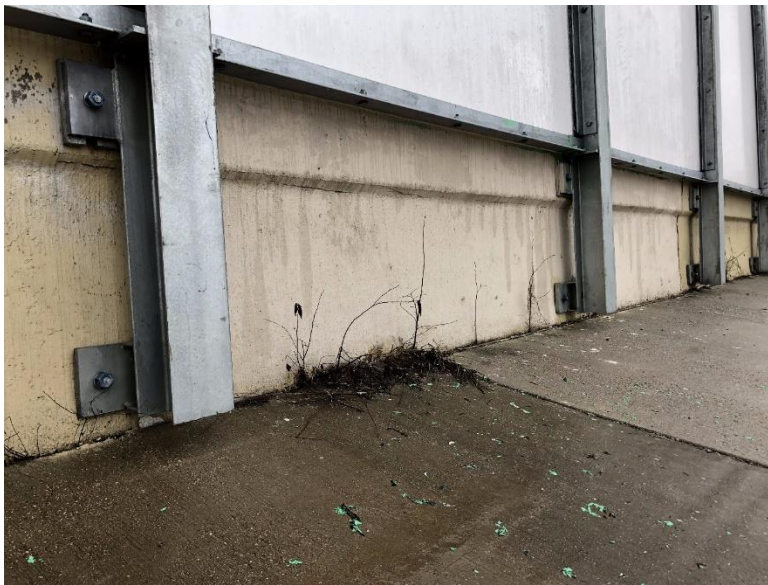
Figure 9.53 Painted CTB to cover graffiti and remnants of graffiti on the ground (February 19, 2019)

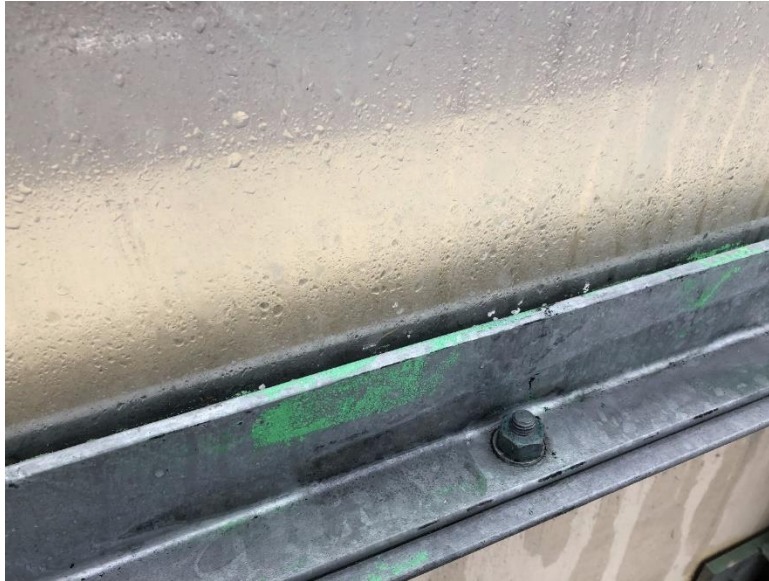
Figure 9.54 Paint remaining on metal support after graffiti removal (February 19, 2019)

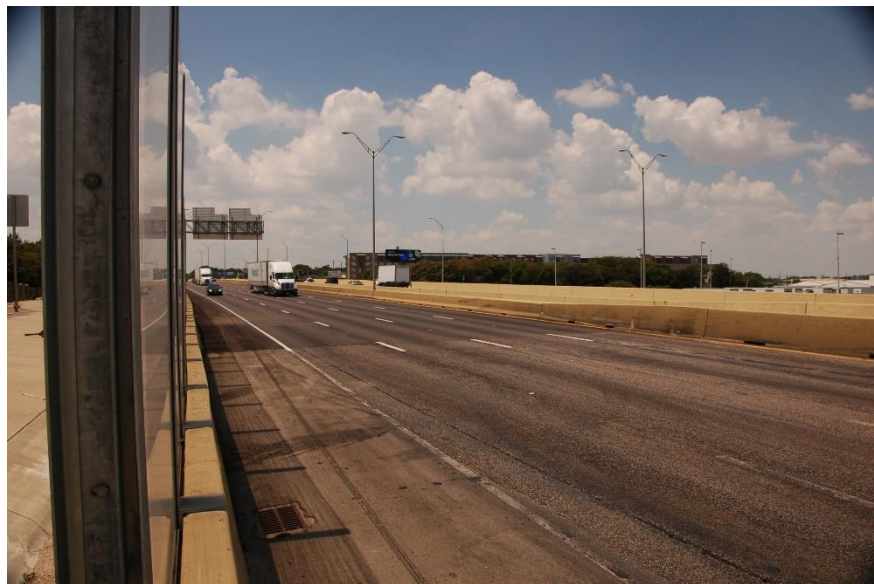
The westbound overlay ends west of Sylvan Avenue. The eastbound overlay ends close to the easternmost end of the Segment 2 of Site 2 barrier. The easternmost limit of the eastbound overlay can be seen in Figure 9.72. Also, the very loud, damaged open expansion joint that had been identified as a major noise source (see Section 9.2.4 earlier in this chapter), next to the end of Segment 2, is just beyond the limits of the new overlay, and it was not repaired (Figures 9.73 and 9.74). Therefore, it remained in poor condition, still producing loud noise as vehicles go by.

Figure 9.72 Easternmost limit of the new eastbound overlay
