TECHNICAL REPORT 0-6804-5
TxDOT PROJECT NUMBER 0-6804

Traffic Noise Barrier Study on SH 190 in Rowlett, Texas

November 2020; Published July 2021

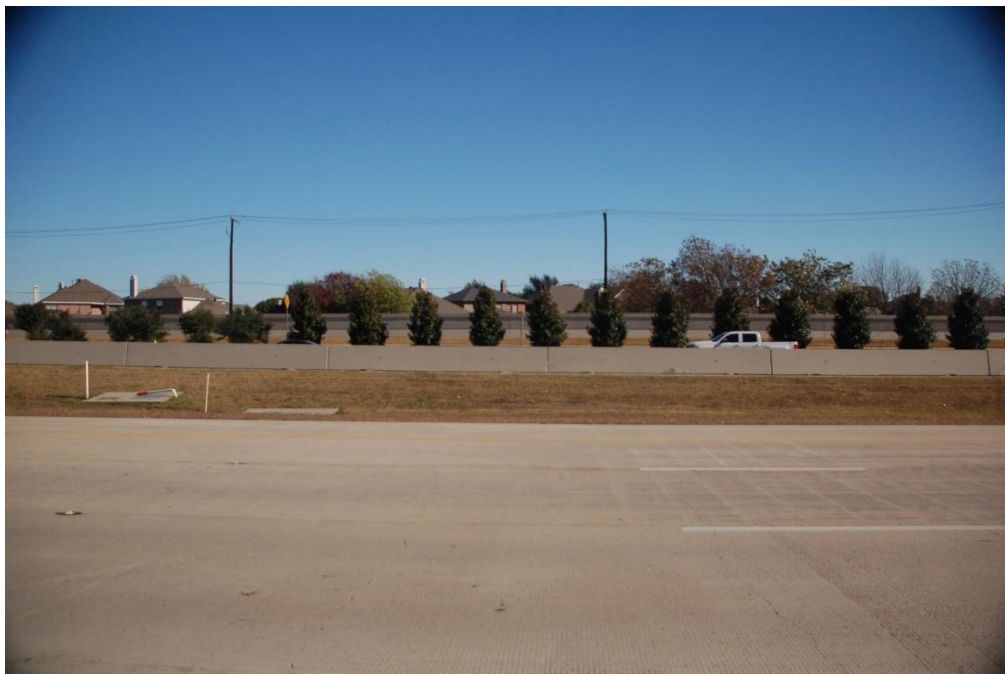
Figure 3.5 Southbound main lanes

The pavement condition for the SH 190/PGBT is excellent, with minimal distresses; no punchouts or delaminations were observed. Punchouts and delaminations are normally considered as the major distresses occurring on CRCP. Figures 3.5 through 3.21 show various views of the SH 190/PGBT pavement, including main lanes and frontage roads.

Transverse cracks are a normal occurrence on CRCP. Transverse cracking is defined as cracks that are mainly perpendicular to the pavement centerline. Crack spacing and crack widths are two parameters of importance on CRCPs. From the visual survey conducted on the pavements, the crack spacing is adequate and the crack openings do not seem wide, so the cracks appear in good condition. There is very little spalling in a few of the cracks. Few longitudinal cracks were observed, but they appear to be very minor.

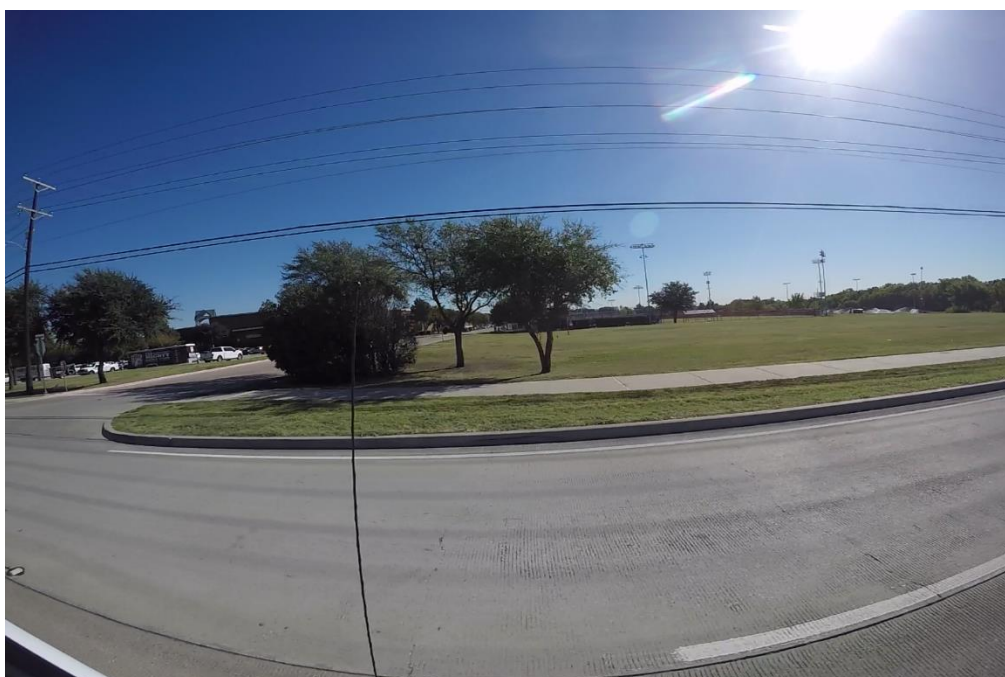
Figure 3.18 Northbound frontage road. Pavement in excellent condition as recorded by video

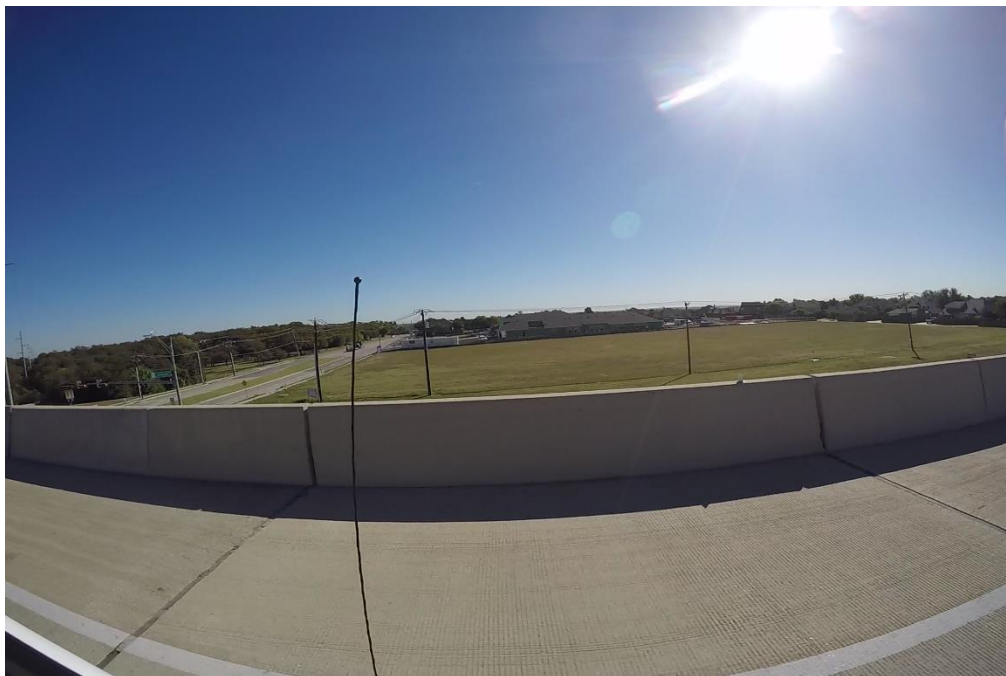
Figure 3.19 Northbound main lane. Expansion joints in the elevated section as recorded by video

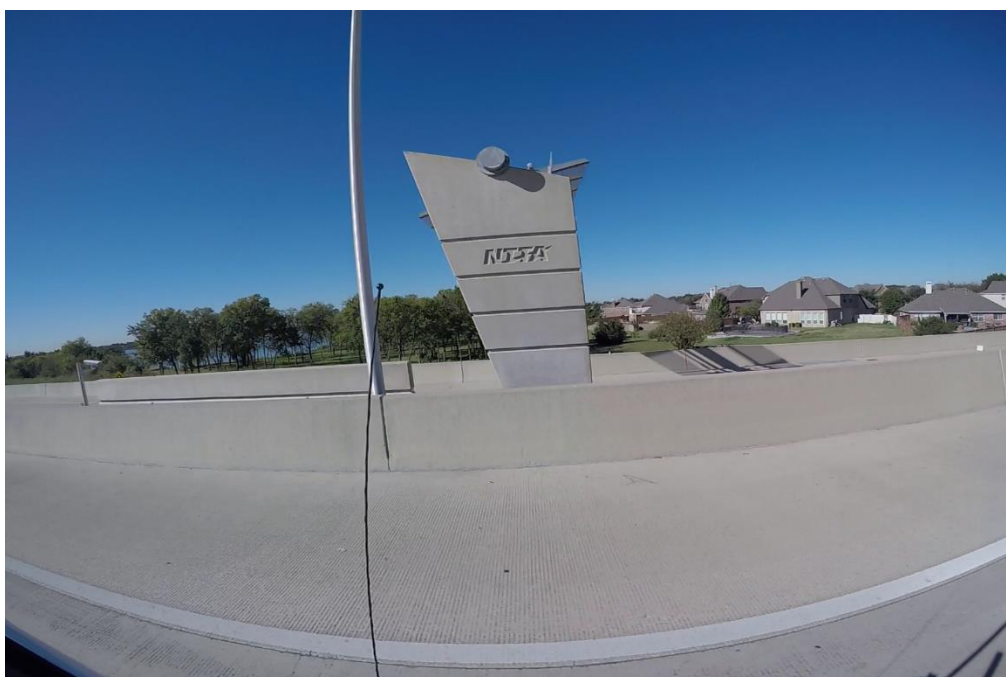
Figure 3.20 Southbound main lane. Pavement in excellent condition as recorded by video

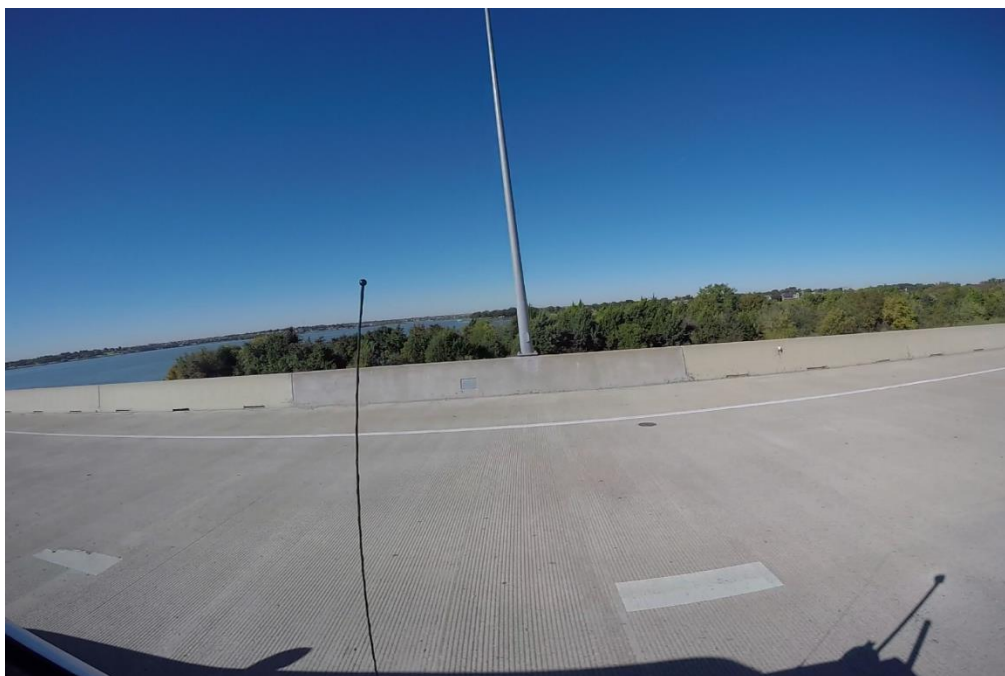
Figure 3.21 Southbound main lane. Pavement in excellent condition as recorded by video

It is estimated that the condition of the SH 190 pavements is excellent and does not contribute to the generation of additional tire-pavement noise.

It is recommended that, in order to reduce the noise at the source, a quieter pavement overlay could be considered, such as a TOM or a PFC, both of which are capable of providing substantial noise reductions over a typical transversely tined CRCP.

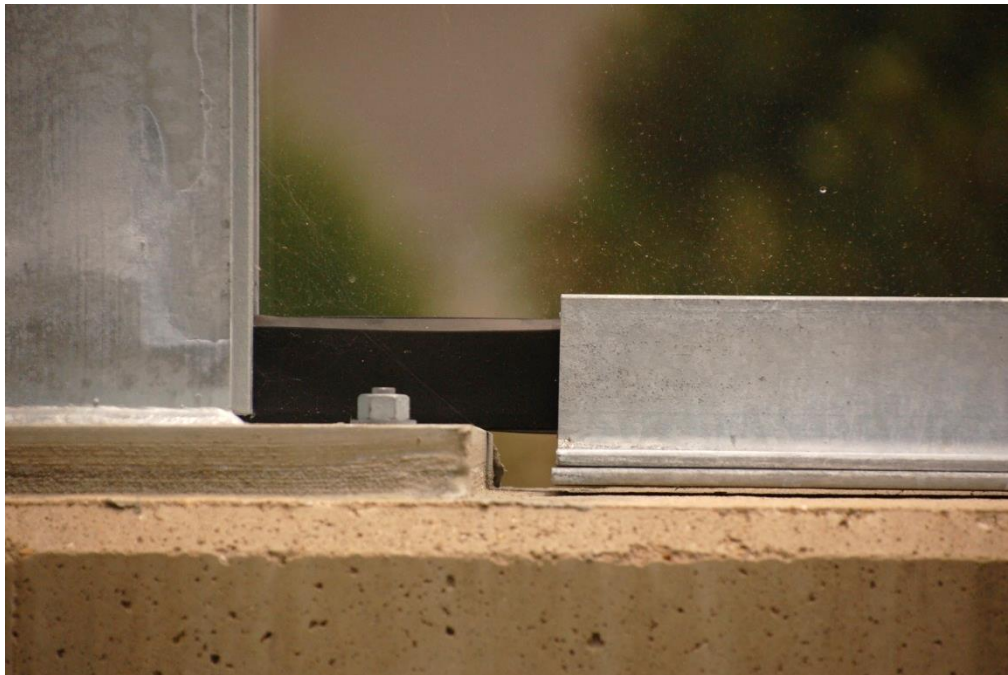
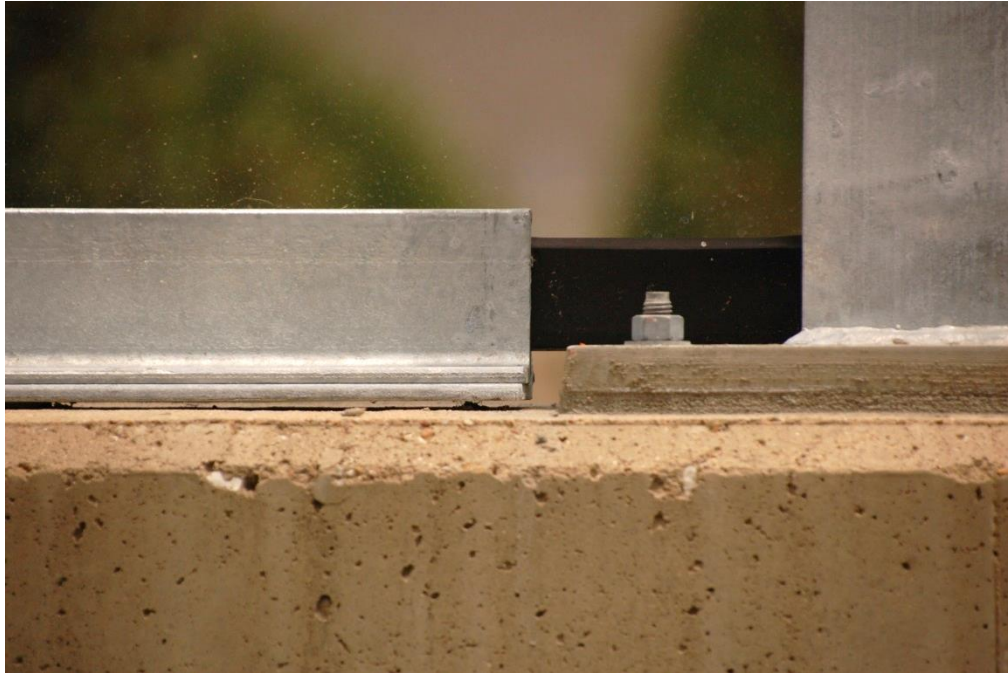
A problem detected after the noise wall installation is related to the design of the supports and their interface with the existing concrete and panels. Thus, it is a design issue rather than a construction issue. The problem is the presence of a gap (in some instances) between the bottom metal support and the top of the existing concrete wall, and an opening (in all instances) between the acrylic panel and the bottom metal support. The opening forms a square shape. The problem arises from the fact that the panels are placed on top of the existing concrete wall. For the case of the I-30 noise walls, these gaps and openings do not exist because the acrylic panels and metal supports are placed behind the existing concrete wall. Figures 7.29 to 7.31 show examples of these openings in the west side wall, as photographed from the neighborhood side. The small openings occur because the horizontal metal support does not cover the entire span of the acrylic panel due to the presence of the horizontal plates on either end that function as a base for the vertical supports. These are small openings, but the sound from the highway side travels through them and reaches the neighborhood receivers.

Figure 7.29 Gap and opening; west side noise wall finalized, as seen from the neighborhood side (August 14, 2019)

Figure 7.30 Gap and opening; west side noise wall finalized, as seen from the neighborhood side (August 14, 2019)

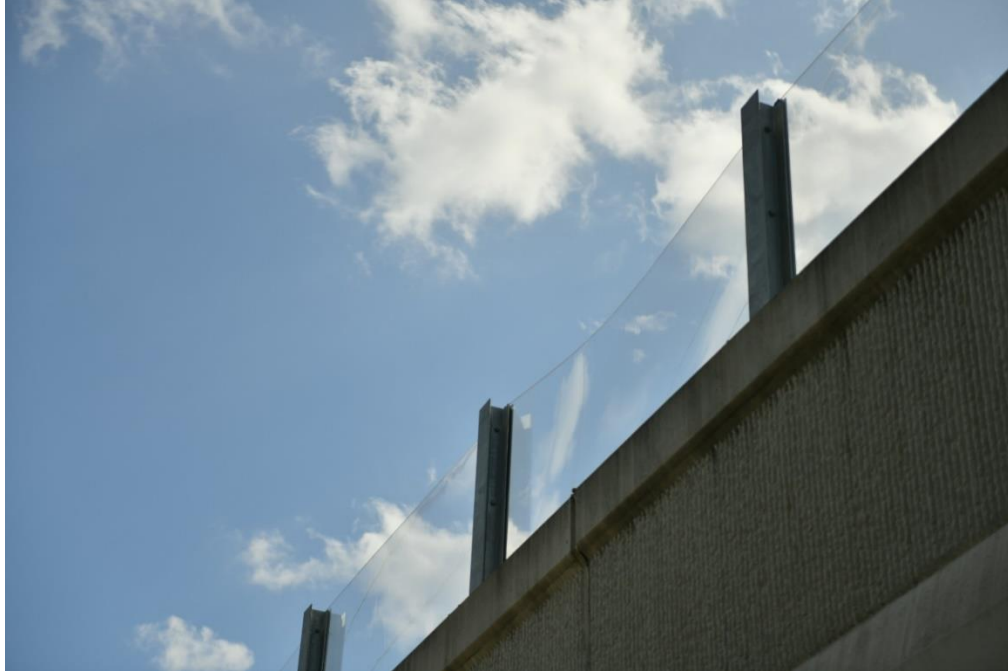
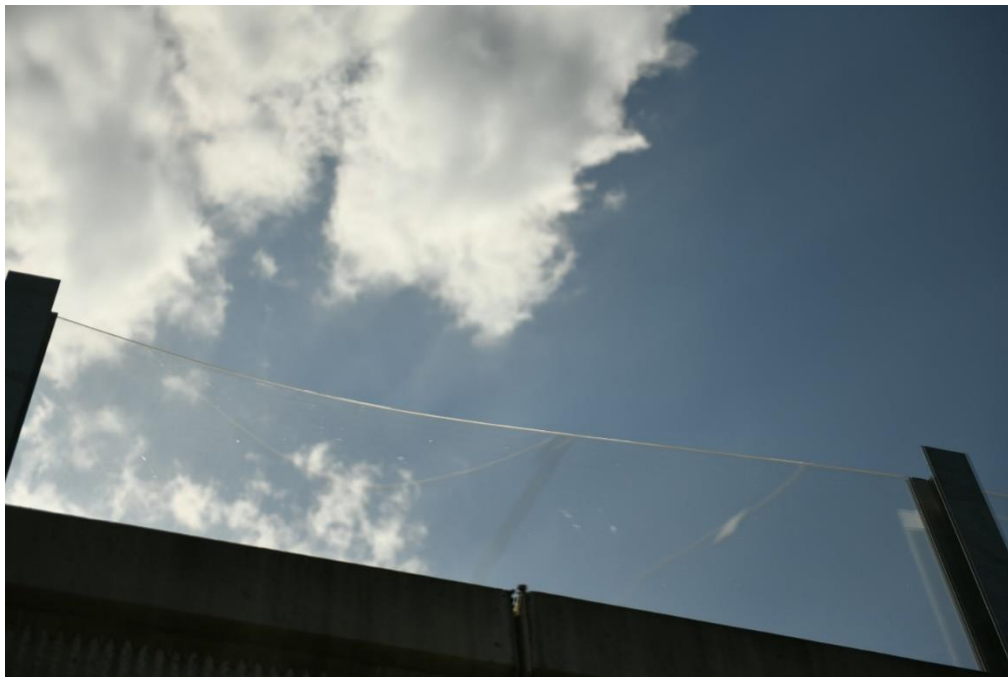
Another issue that is present in the east side wall, near its northernmost end, approaching Harborview Boulevard, is a warped acrylic panel. The reason for this problem appears to be that the panel may have been fabricated slightly wider than needed. As it was installed in between the metal supports, it had to warp in order to fit. Figures 7.32 and 7.33 show this panel.

Figure 7.32 Warped acrylic panel, east side wall

Figure 7.33 Warped acrylic panel, east side wall

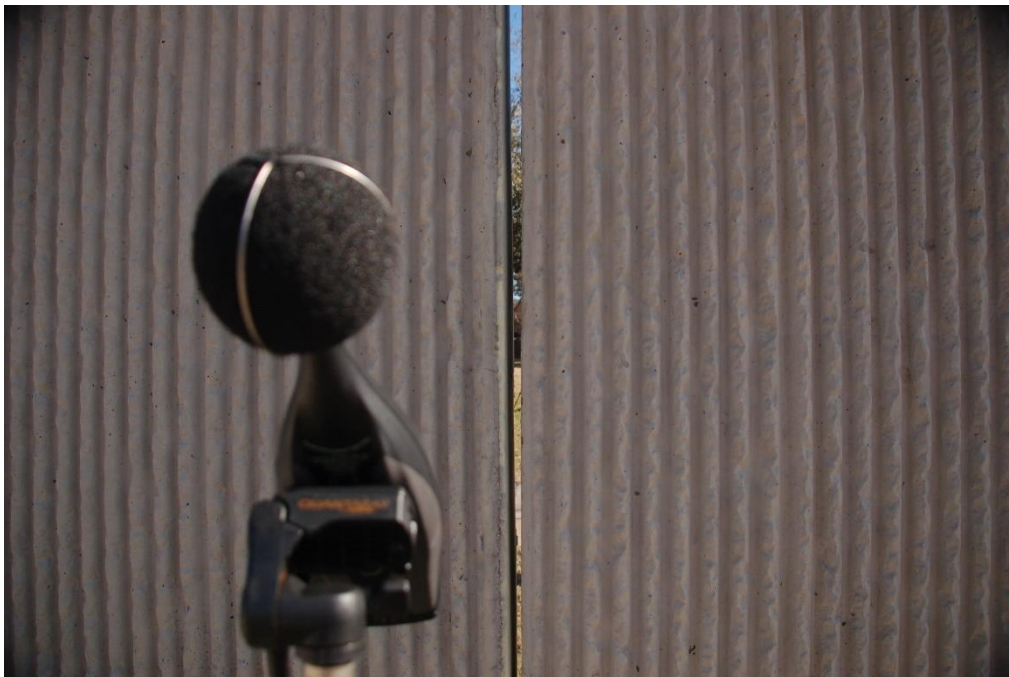
However, a separate problem was observed with the existing concrete walls that has an impact on noise perceived at the neighborhood: some of the vertical expansion joints in the concrete are open

and not sealed; this was more prevalent on the east side wall. The problem arises as a result of the degradation of the flexible joint sealant material that allows for the thermal expansion and contraction of adjacent concrete panels. When this material is in good working condition, the material prevents the highway sound from traveling through the openings and reaching the neighborhood's residences. An example of one such joint in good condition, with the sealant in proper shape, is shown in Figure 7.34. In contrast, Figures 7.35 and 7.36 provide examples of open joints with no sealant material.

Figure 7.36 Noise test conducted in front of noise wall with an open expansion joint without sealant material in the background

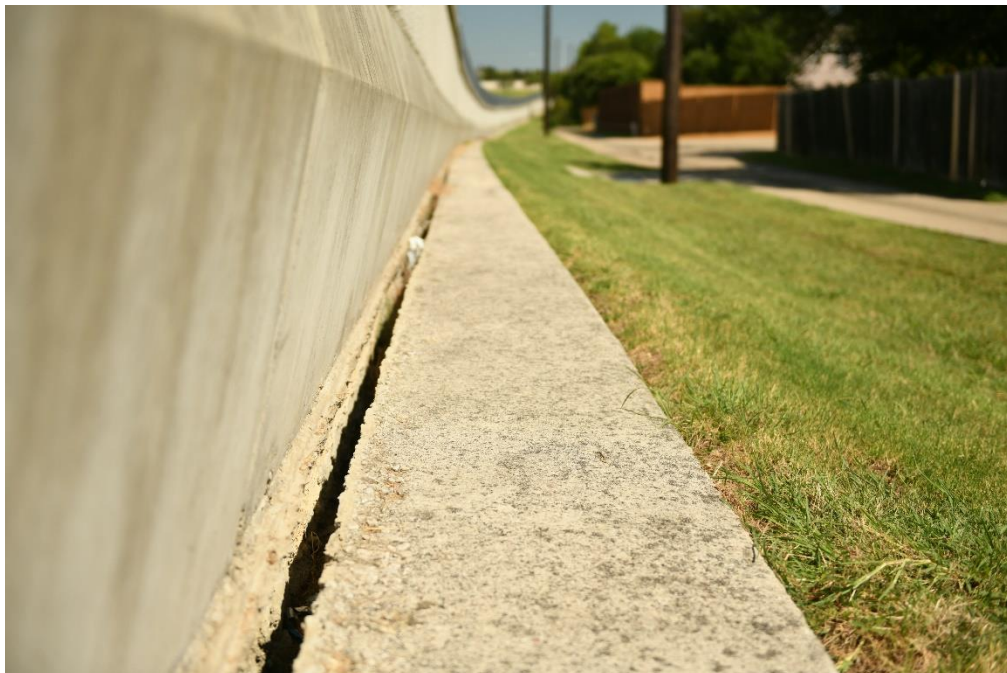
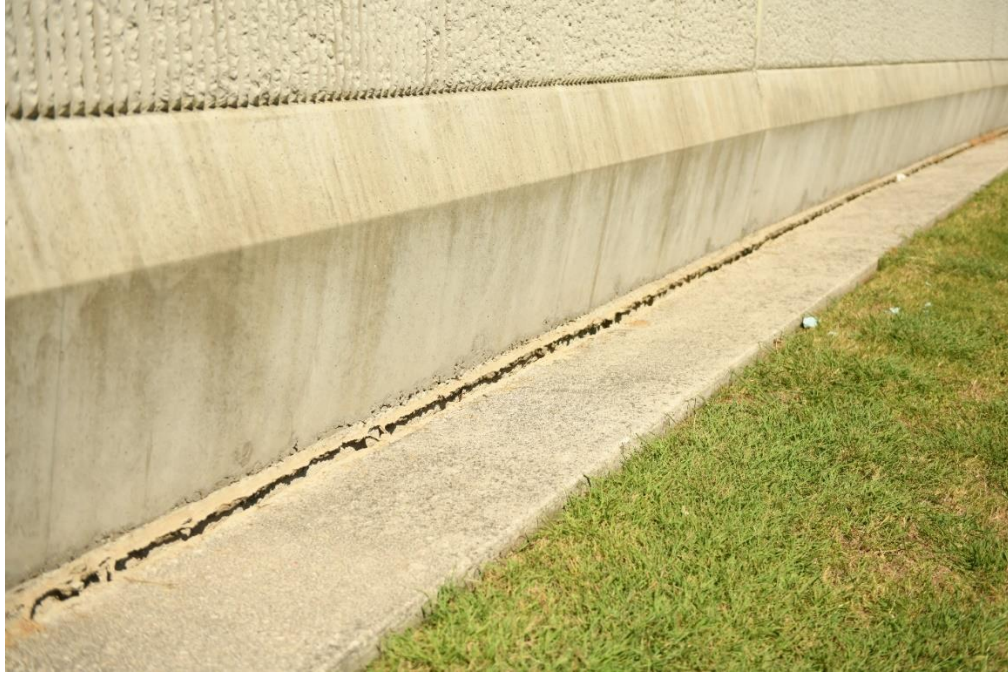
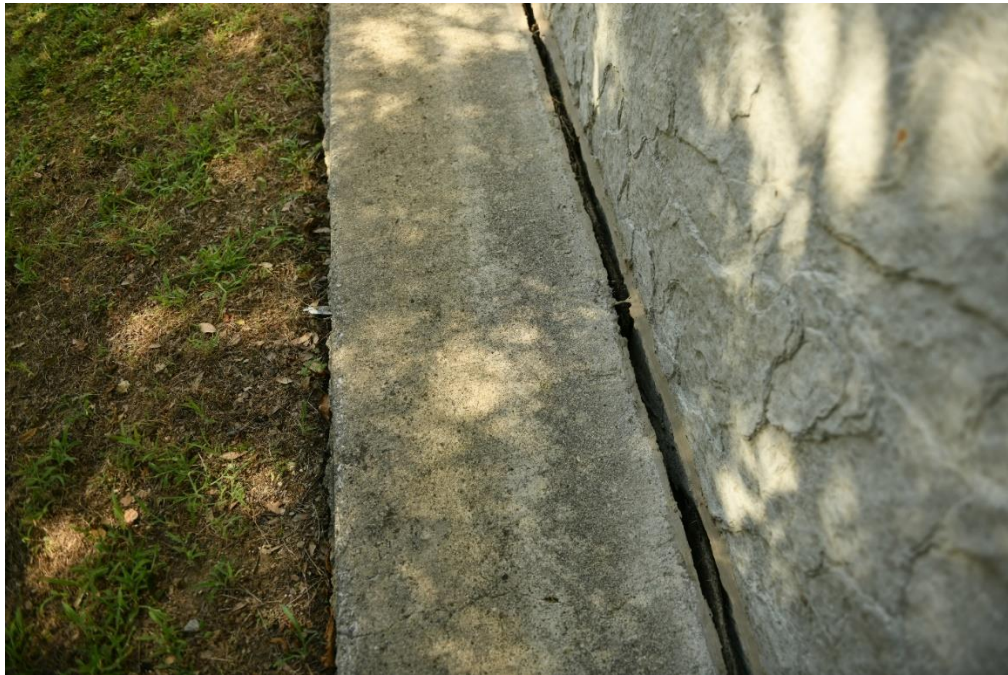
An additional problem that does not impact the noise received at the residential locations, but that could potentially affect the structural integrity of the noise walls, is the presence of some separations between the noise wall and the concrete base. This problem exists in some segments of the east side wall, next to the Harborside community, as well as in a segment next to receiver R#12, on the west side, in the Ridgecove community. These openings in the concrete at the base

of the walls appear to have developed over time as a result of settlements of the soil and the foundation of the concrete walls relative to the walls. Figures 7.37 to 7.39 illustrate these gaps for the east side wall, and Figures 7.40 and 7.41 show a similar opening for the west side wall.

Figure 7.38 Separation between noise wall and concrete base, east side wall, close to receiver R#1

Figure 7.39 Separation between noise wall and concrete base, east side wall, close to receiver R#1

Figure 7.40 Separation between noise wall and concrete base, west side wall, close to receiver R#12

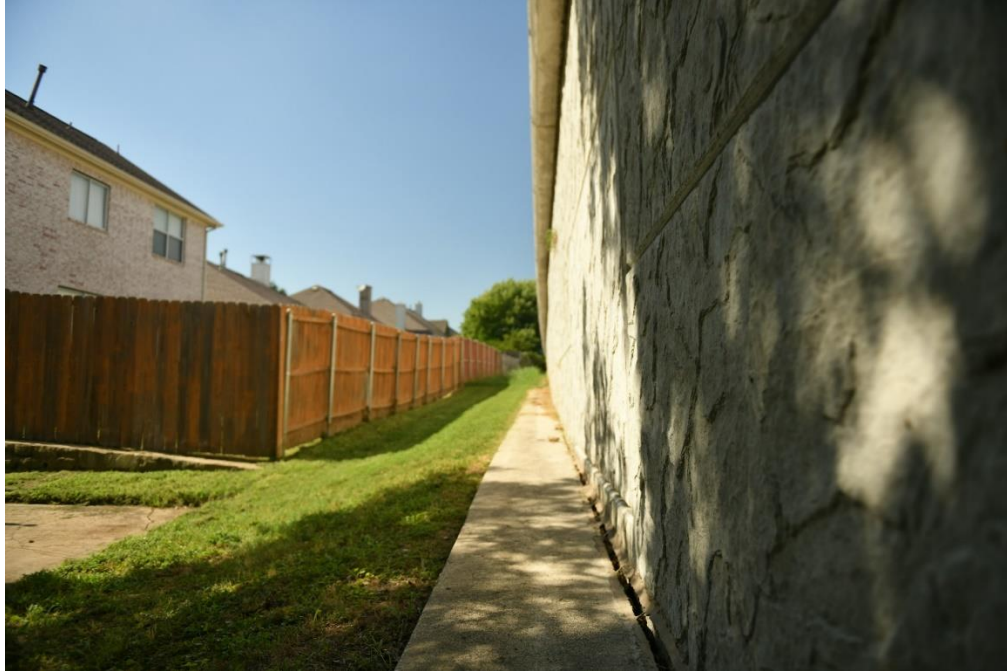
Figure 7.41 Separation between noise wall and concrete base, west side wall, close to receiver R#12
