# **CORROSION PERFORMANCE OF EPOXY-COATED REINFORCEMENT-BEAM TESTS**

**Research Report No. 1265-4**

*STRUCTURAL INTEGRITY OF EPOXY-COATED BARS*

**Texas Department of Transportation**

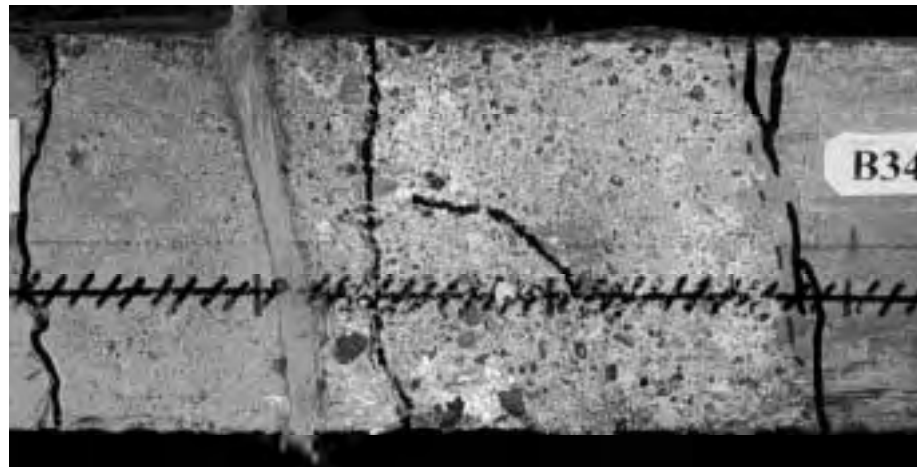
Concrete surfaces deteriorated and scaled within the wet zone and neighboring regions outside the wet zone of all beams (Figure 2.30). Salt crystals accumulated and were visible on scaled surfaces. Salt crystals could not be removed with a putty knife. Extent of concrete scaling outside the wet zone was more extensive and severe at the bottom surfaces in the exposure position. Degree of scaling ranged from light to severe. Concrete surfaces away from wet areas remained in good to excellent condition in all beams.

*Figure 2.30 Concrete scaling and deterioration outside wetted region (front surface as in exposure).*

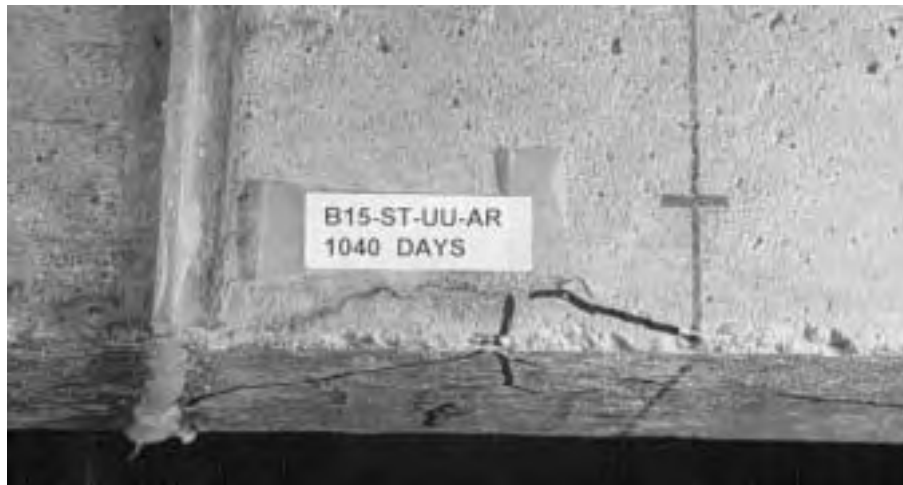
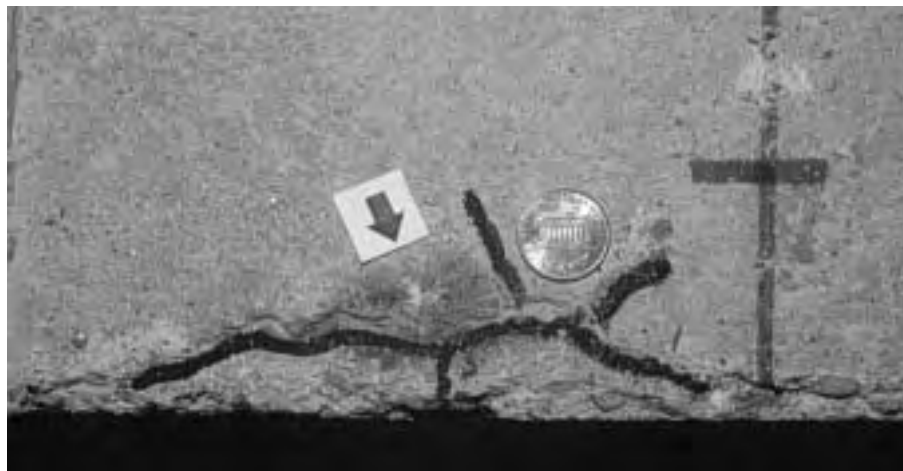
An apparent corrosion-induced crack was detected on the top surface of the beam, within the wet zone, to the left of midspan (Figure 2.34). The crack was detected at 1.5 years of exposure and ran parallel to the beam longitudinal axis and close (2cm) to the beam edge. The crack had a width of 0.15mm. Brownish staining was observed around the crack. At 1.9 years, a build-up of rust was observed along the crack. A crack perpendicular to the first one extended towards and around the edge of the beam (crack width was 0.15mm). At 2.1 years, additional rust was evident and the initial crack widened to 0.4mm. At 2.2 years, the crack extended and rust staining increased. More rust products and staining accumulated on the top surface after 2.5 years (Figure 2.34). Overall, the size of the rust spot increased from about 7cm<sup>2</sup> at 1.5 years to 11cm<sup>2</sup> at 2.8 years. Rust staining around cracking on the top surface stabilized at the end of 3 years and was less prominent at the end of 4.3 years.

**Figure 2.34 Crack with rust exudation on top surface of beam B15.**

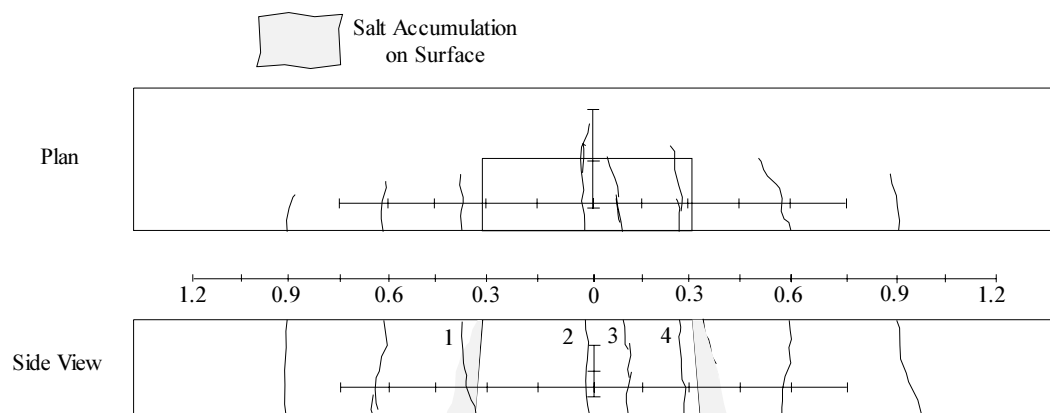
**Figure 2.41** Surface condition of beam B29 (Group III) after one year of exposure showing monitored cracks.

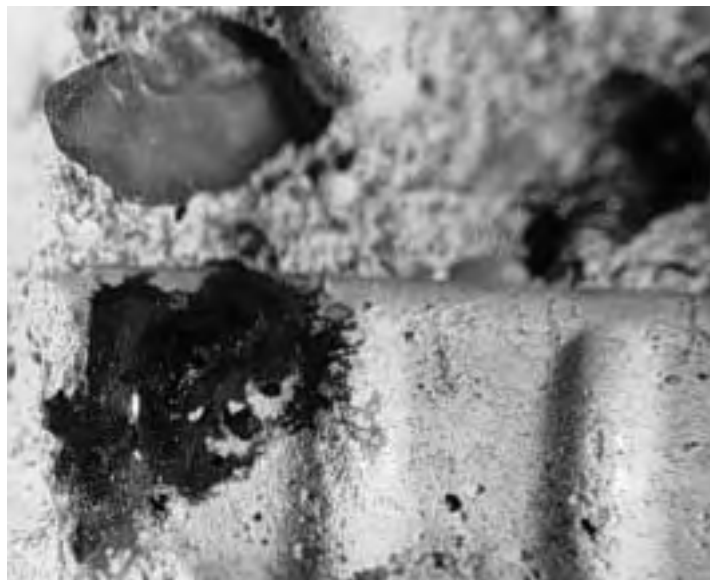
***Figure 2.44 Corrosion spots coincident with voids in concrete (specimen removed after one year).***

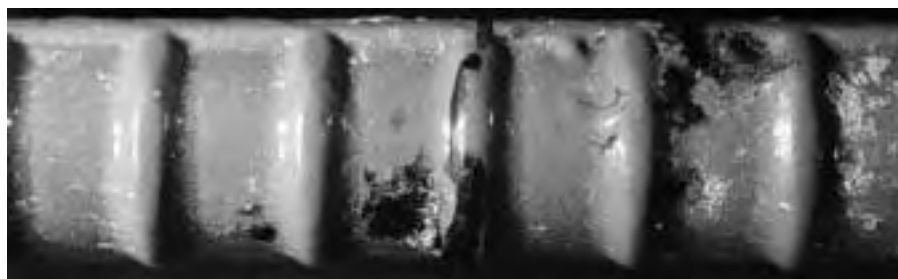
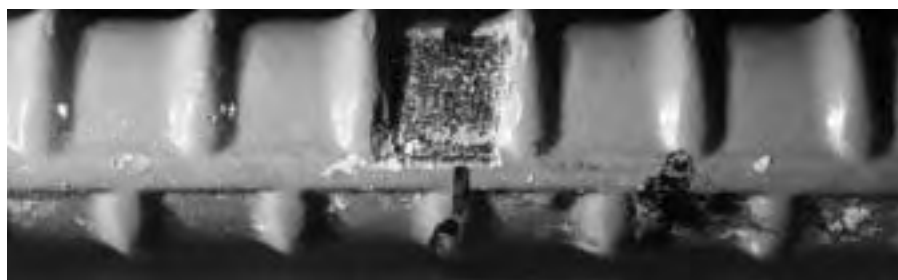
The corrosion products in all cases were black and brown. The products were mostly brown in the vicinity of cracks. In some instances, upon exposing the bars around stirrups in beams with splice bars, a greenish-black corrosion product was found in a soluble form. The dark greenish product rapidly converted to brown on contact with air. Similar to macrocell observations, steel corroded spots on the longitudinal bars almost always coincided with voids in the surrounding concrete as shown in Figure 2.44. Of particular interest was the observation that corrosion occurred at holidays and exposed steel areas mainly on the side of the bar facing concrete cover on the short side of beam, *i.e.* the lower side of the bar in casting position. Even at crack locations, where corrosion was apparent on exposed steel areas facing the cover, no corrosion occurred on exposed areas on the other side. Figure 2.45 shows the two sides of a damaged bar at the crack location with rust only on one side.

**Figure 2.45** *Difference of corrosion performance between upper and lower sides of bar at the same crack location after one year.*

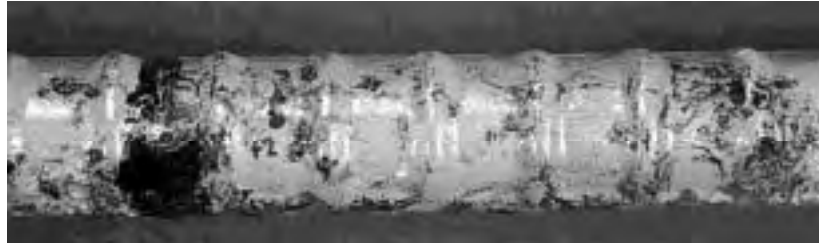
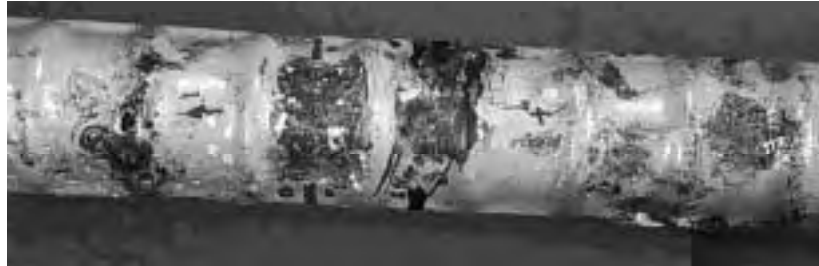
The manifestation of corrosion consisted of rust staining, coating blistering, and corrosion attack of exposed areas (Figure 2.46). The color of rust stains ranged from dark to light brown, and their appearance varied from dense to tenuous. Blisters size varied, with smaller ones being more prevalent. Corrosion did not always occur at the damaged, exposed areas. Minor corrosion was observed on patched areas. There was almost always a void in the concrete surrounding a blister. However, corrosion did not always occur at coating areas adjacent to concrete voids. Contrary to the observations from coated bars in macrocells, the appearance of brownish, liquid, acidic solution was not as pronounced in bars from beam specimens after 4.3 years of exposure. The time between autopsy and end of exposure was longer for beams and could explain the difference observed.

(a) Rust stains at lower bar of beam B10, portion within the wetted zone  
Damaged spot at crack location

(b) Bar of beam B10, portion at midspan (wetted zone)

**Figure 2.46** *Corrosion of longitudinal coated bars after 4.3 years of exposure.*

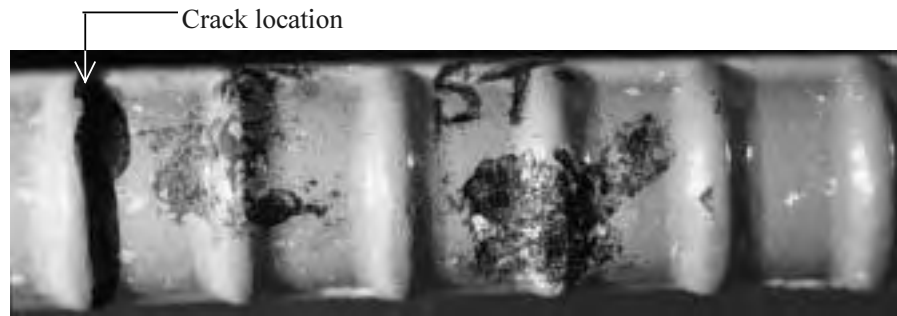
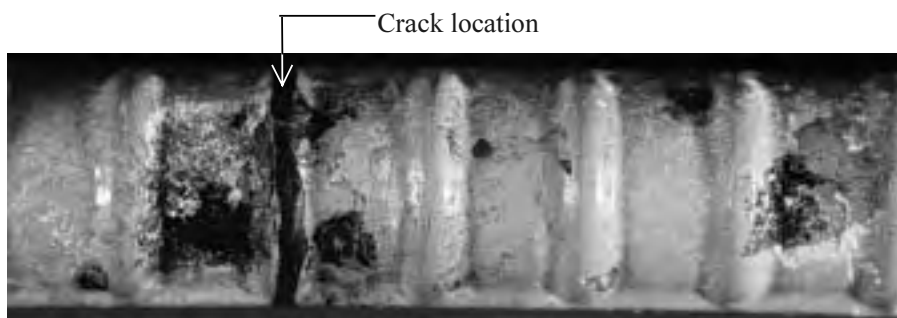
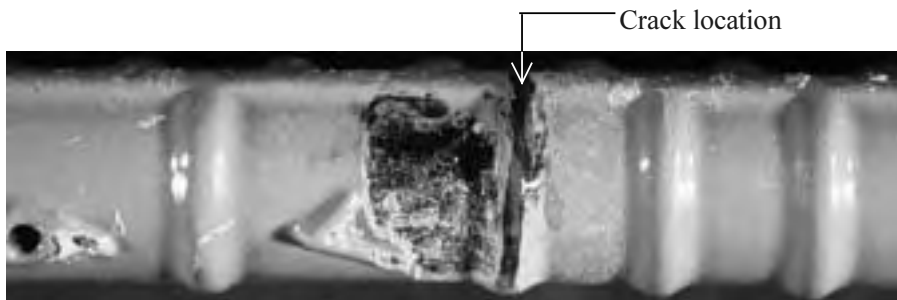
(a) Damaged upper bar from cracked unloaded beam B9

(b) Damaged upper bar from cracked loaded beam B11

(c) Damaged lower bar from cracked loaded beam B11

**Figure 2.48 Corrosion on lower side of bars removed from beams after one year of exposure.**

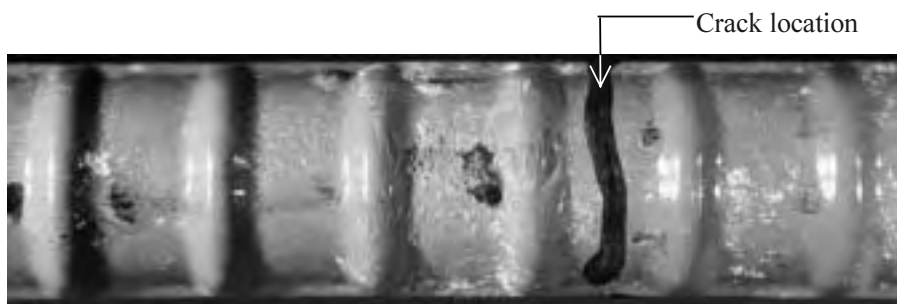
around the bar and an arrow in the figures). Bars with patched damage showed minor rust spotting on the patched areas with evidence of coating cracking and blistering as shown in Figure 2.49.

**Figure 2.49 Corrosion on lower side of patched bar removed after one year of exposure.**

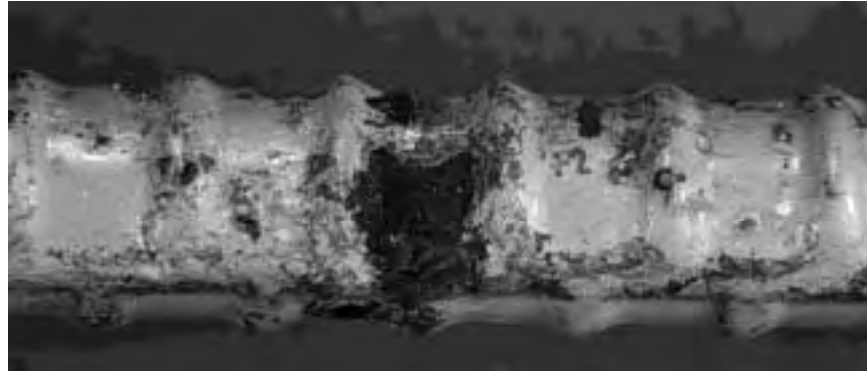
All bars with 3% damage underwent some degree of corrosion and rust staining on the coating surface, regardless of loading condition and presence of cracks. Damaged areas had uniformly dark brown rust, in some cases with buildup of rust products (Figure 2.50). No deep pits were noticed. Interestingly, not all damaged areas corroded, and there were several exposed areas with a clean metallic surface, even in proximity with cracks! (Figure 2.51). There was no specific pattern regarding location of corroded areas. Frequently, concrete adjacent to uncorroded exposed sites had only a few small voids.

***Figure 2.50 Build up of rust products at damaged spot on bar from beam B10 after 4.3 years.***

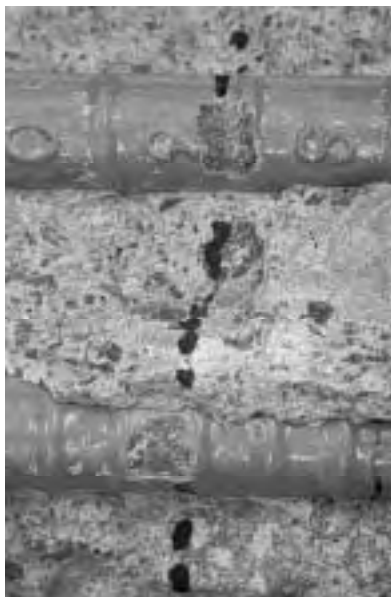
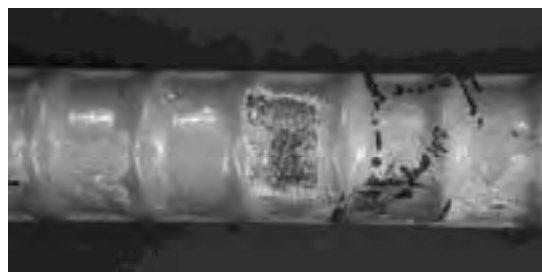
***(a) Outside the wet zone of beam B10, about 43cm to the left of midspan***

***(b) Damaged spot located near stirrup and crack inside wetted region (Beam B10)***

***Figure 2.51 Uncorroded damaged areas near crack locations after 4.3 years.***

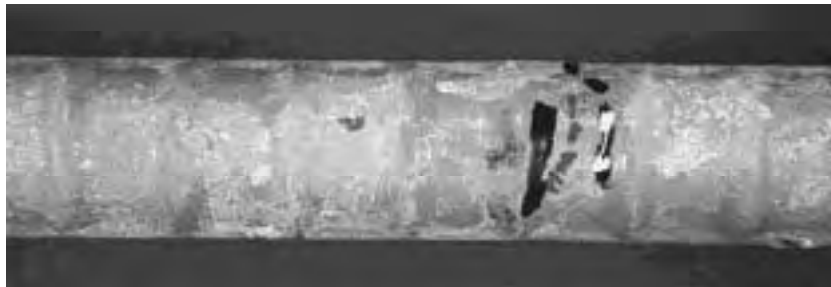
Bars with 3% patched damage (beam B14, cracked, unloaded) showed less extensive corrosion than bars with unrepaired damage. Several patched areas showed brown rust staining, from tiny freckles to larger stains. Several other patched spots had no rust spotting (Figure 2.52).

*Figure 2.52 Aspect of uncorroded patched area on upper bar in beam B14, near crack location within the wetted zone after 4.3 years.*

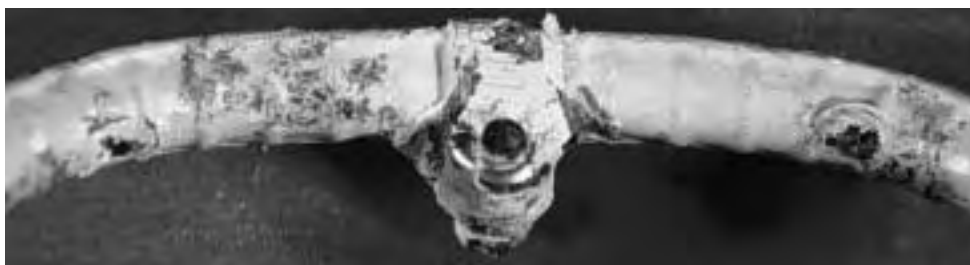
Stirrups in uncracked beams showed corrosion spots, blisters and coating cracking at the hook end closest to the lower concrete surface. In addition to blistering, stirrups in beams with unopened cracks exhibited corrosion spots at areas of contact with uncoated bars as shown in Figure 2.53. Similar but worse corrosion appeared along the continuous ribs, hook end, and bends of stirrups in beams with opened cracks as shown in Figure 2.54.

*Figure 2.53 Corrosion at areas of contact between stirrup and uncoated bars at one year.*

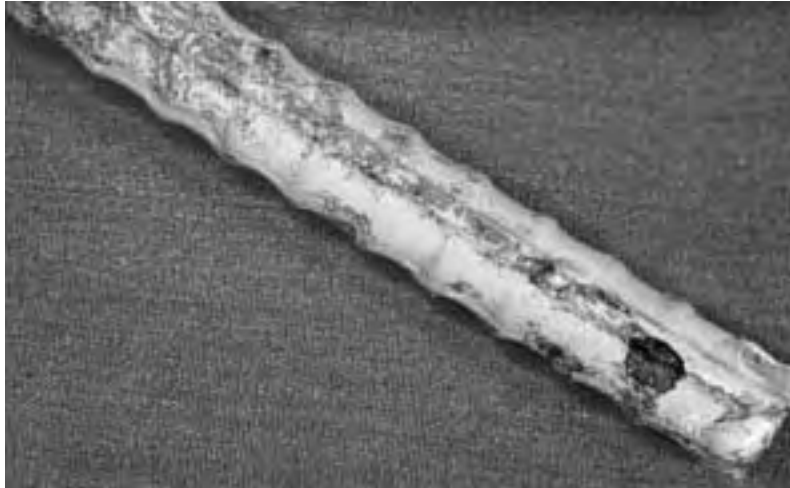
*Figure 2.54 Corrosion on hook end of stirrup removed from cracked loaded beam after one year of exposure.*

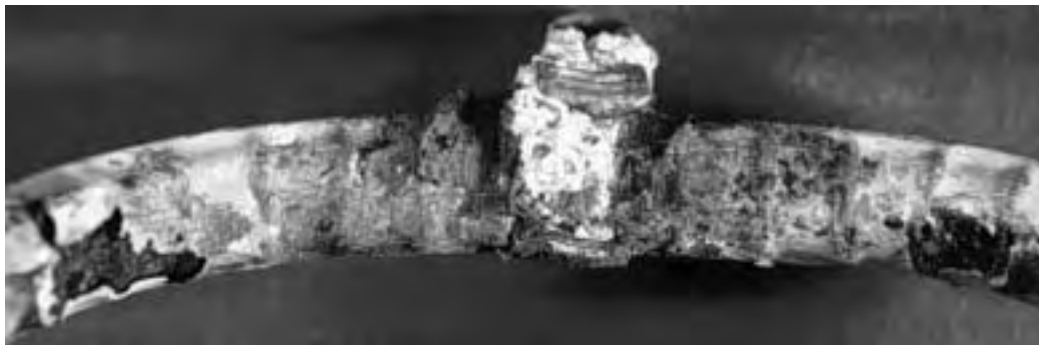
Stirrups with patched bends in uncracked beams were free of visible corrosion. Other patched stirrups in cracked beams had a similar condition to that described above for stirrups without patching. Figure 2.55 shows corrosion spots on the inside surface of patched bends in contact with uncoated bars.

*Figure 2.55 Corrosion at areas of contact between patched stirrup and uncoated bars at one year.*

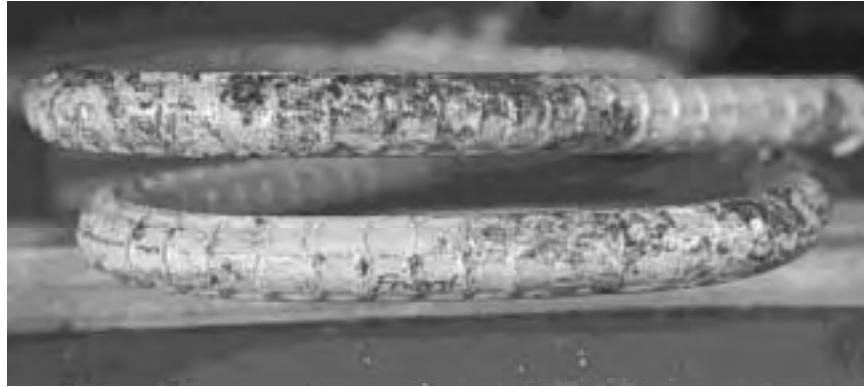
The stirrup from an uncracked, unloaded beam (B15) underwent extensive staining on two legs and on two bends. One leg was practically stain free. At the time of autopsy, there were four greenish or dark-greenish rust spots on one leg; after one or two days, their appearance changed to reddish-brown or orange-brown. The stirrup from a cracked, unloaded beam (B17) had rust staining that was denser on the portion of the stirrup within the wetted zone (Figure 2.56).

*Figure 2.56 Rust staining of stirrup from beam B17 (portion within the wet zone) after 4.3 years.*

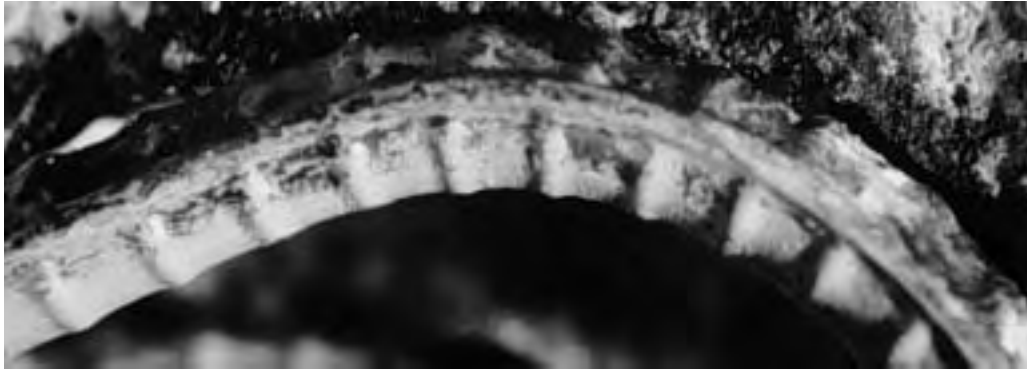
These stirrups had similar, but more visible, signs of corrosion as the stirrups in an as-received condition. Stirrups used in splice regions at midspan, in particular, showed the worst rust spotting (breakdown of coating) along hook ends, continuous ribs, and bends, and longitudinal cracks in the coating. The patched damaged areas were severely corroded as shown in Figure 2.58.

*Figure 2.58 Corrosion on patched damaged areas of stirrup after one year of exposure.*

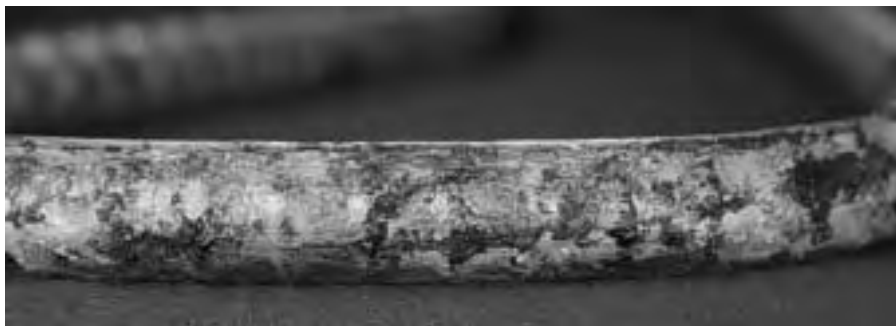
The stirrup from cracked, unloaded beam B27 experienced extensive rust staining at three legs and one bend. Several blisters and coating breaks were observed on one leg. The stirrup in cracked, unloaded beam B32 (with splice bars) developed widespread rust staining at two legs and two bends (Figure 2.59). The coating was in good condition at two legs. Patched areas at one bend and on one cut end did not develop corrosion and showed a clean steel surface. Remaining patched areas experienced tearing of the patch with visible dark corrosion of the exposed steel areas.

*Figure 2.59 Rust staining on a stirrup leg near the front beam surface (beam B32) after 4.3 years.*

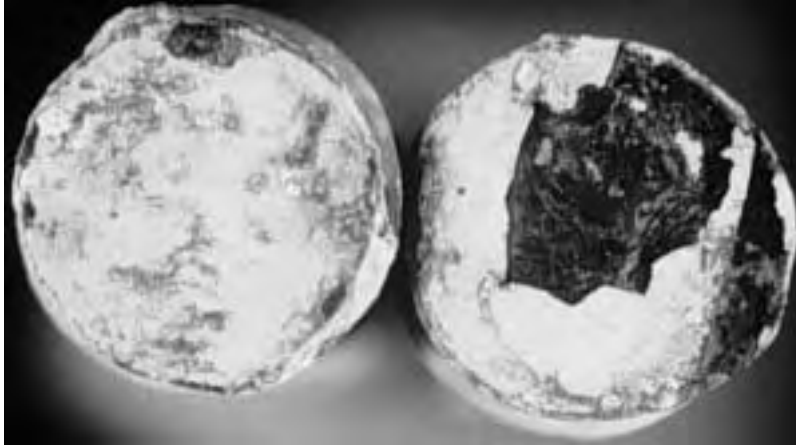
As shown in Figure 2.60, rust covered about 10 to 60% of the patched cut ends of bars. Additionally, coating cracking and blistering were visible up to about 140mm (5.5in.) from the bar end.

*Figure 2.60 Corrosion on patched cut ends of splice bars after one year of exposure.*

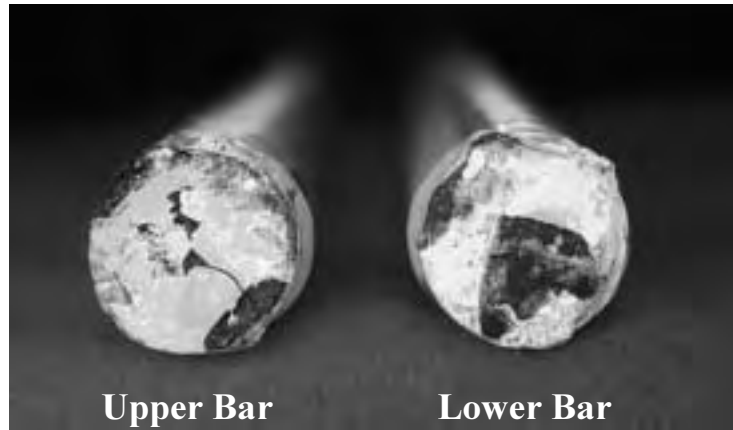
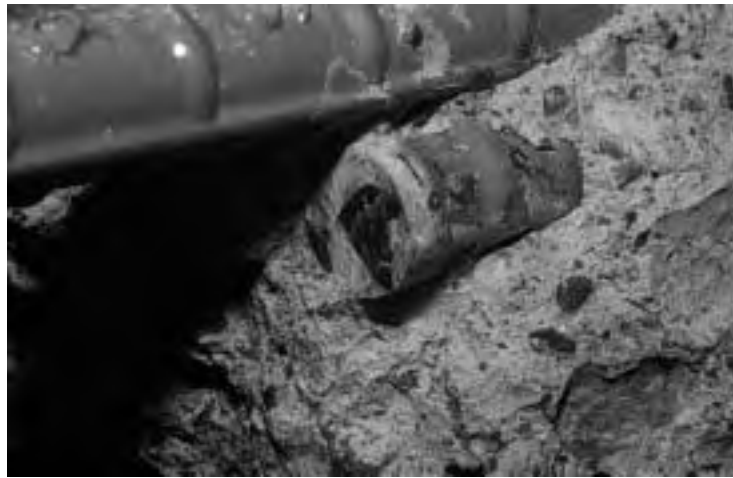
The patch at the cut end of the bar cracked and left some portions of steel uncovered. The steel surface of unprotected areas was black or dark rust (Figure 2.61). Several dispersed rust stains, ranging from dark to light, formed on the epoxy surface, mainly towards the top and front side of the bar (closer to the exterior beam surfaces). Rust staining extended about 23cm from the bar cut end.

At the lower bar, the patch at the bar cut end broke and left a large exposed steel area. The exposed steel surface color was black rust (Figure 2.61). Concrete paste residues stuck to remaining patched areas. Several dark, brown rust stains developed on the coating surface on the bottom side of the cast position of the bar, that is, towards the exterior front surface of the beam. No staining was observed on the opposite side of the bar. Rust staining extended up to 17cm from the bar cut end.

(a) Patch at bar ends of splice bars broke during autopsy, showing a dark corroded surface underneath

(b) Lower splice bar, appearance of bar end at time of autopsy

**Figure 2.61 Patched ends of splice bars from beam B32 after 4.3 years of exposure.**

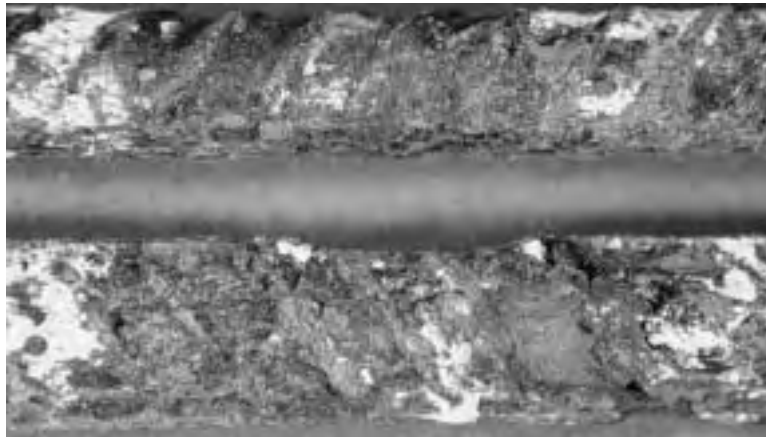
During removal of stirrups, short lengths of the uncoated bars in the compression zone were uncovered. In many cases, the uncoated bars were severely corroded with extensive surface degradation and loss of metal around contact points with the stirrup. Corrosion spread along the bar about 75mm (3in.) and was associated with chloride solution transport through the wide transverse cracks near beam midspan as shown in Figure 2.62.

***Figure 2.62 Corrosion of uncoated compression bars at crack location after one year.***

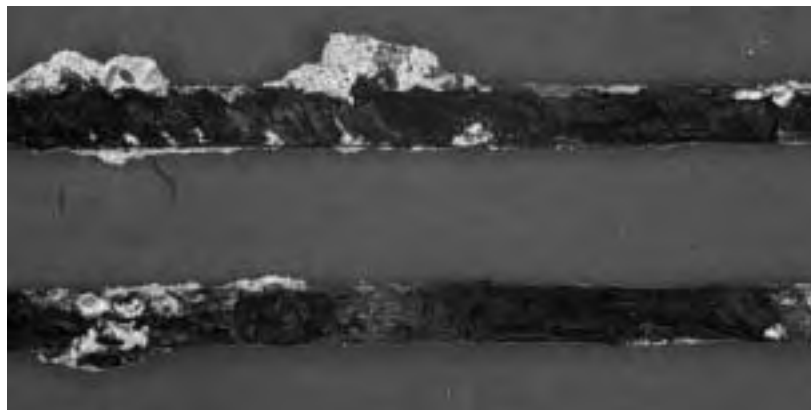
Black bars were moderately to extensively corroded and several moderate to severe pits were observed. Corrosion typically consisted of uniform black or dark rust with widespread shallow pitting (Figure 2.63). Several moderate to severe pits were observed in more corroded bars, as shown in Figure 2.64. Dark-green rust was frequently observed at severe pits at the time of autopsy (Figure 2.65). Severe pitting with

***Figure 2.63 Dark corrosion with widespread pitting on uncoated bars from beam B14 after 4.3 years.***

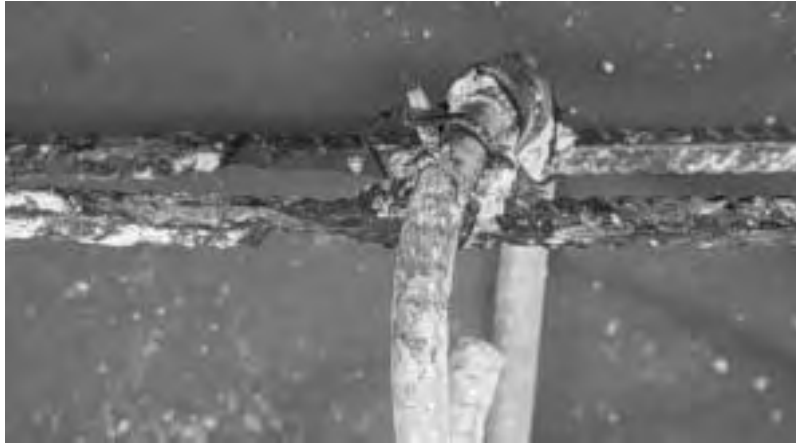
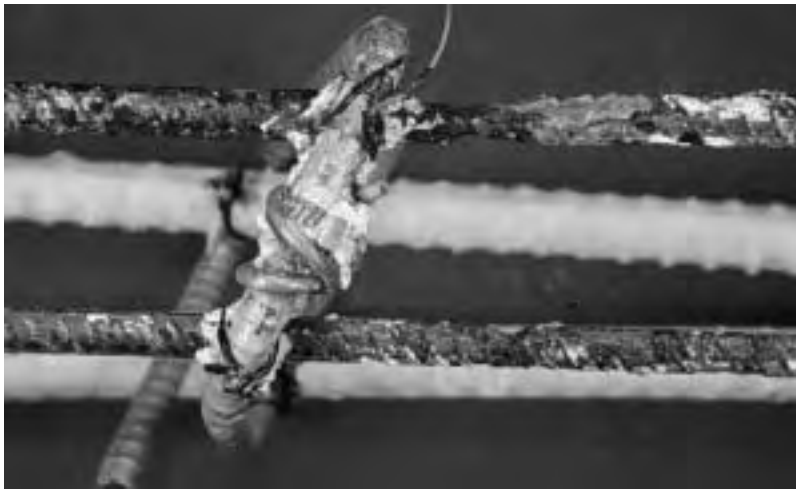
(a) Severe pitting on lower black bar near coated stirrup (beam B23).

(b) Severe pitting on black bars near coated stirrup (beam B23)

***Figure 2.64 Severe pitting and loss of cross section on uncoated bars near crack locations after 4.3 years.***

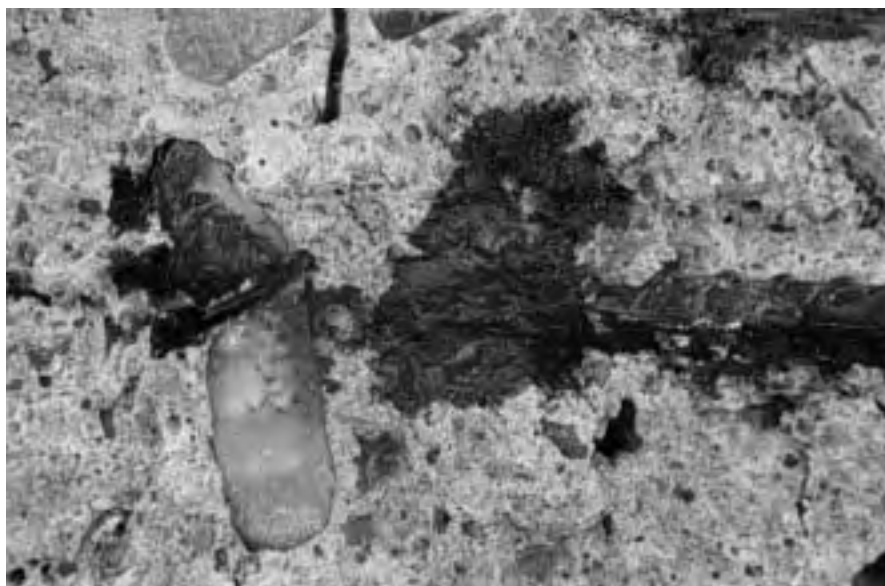
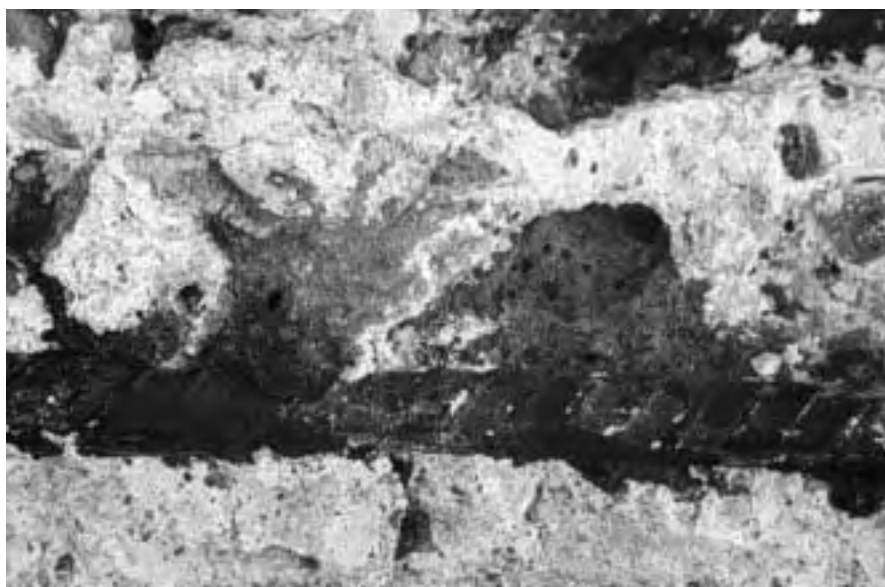
***Figure 2.65 Dark-greenish rust staining around black bars at pitted areas after 4.3 years.***

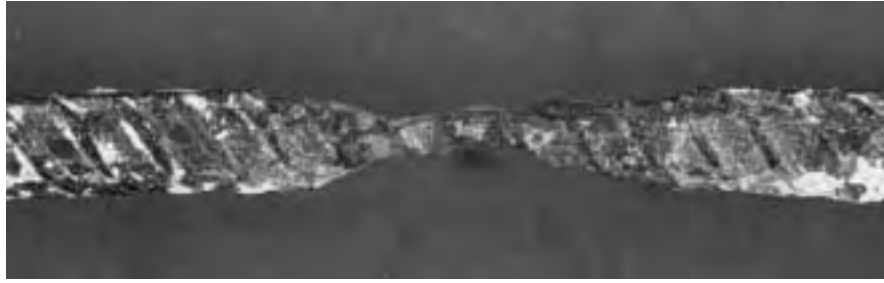
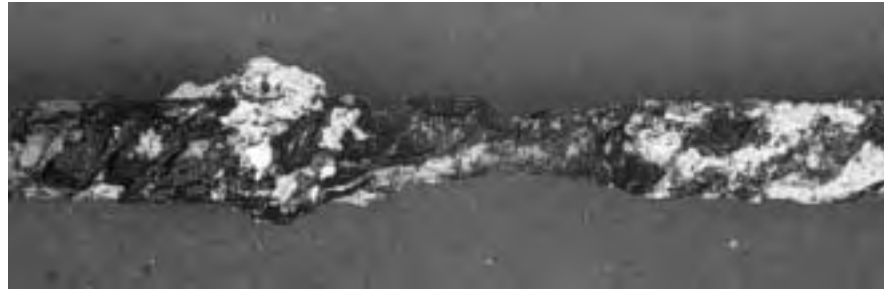
loss of cross-sectional area was evident at crack locations. Maximum loss of cross-sectional area was 78% at the lower bar of beam B27 (group II), as shown in Figure 2.66. One bar in beam B25 (group II) was so weakened at the severely pitted cross section, that the bar accidentally fractured while being examined (Figure 2.67). After being exposed to oxygen, dark-green areas changed to reddish-brown or dark color. Numerous, scattered reddish-brown rust spots appeared above the black corroded surface of the bars after being exposed to air for several hours and days. Similar to uncoated bars in macrocells, drops of brown, acidic solution, formed on the bar surfaces a day after removal from the concrete. Corrosion was generally confined to the wet zone in bars from group I but extended beyond the smaller wet zone in bars from groups II and III. Unquestionably, black bars suffered more severe corrosion than longitudinal and transverse coated bars. Fragments of concrete of different size remained stuck to several portions of bar surfaces, evidence of good adherence between concrete and uncoated steel. A more detailed description of examined black bars is included in Appendix A.

**Figure 2.66** *Very severe pitting and loss of cross section on uncoated bars at crack locations (beam group II) after 4.3 years.*

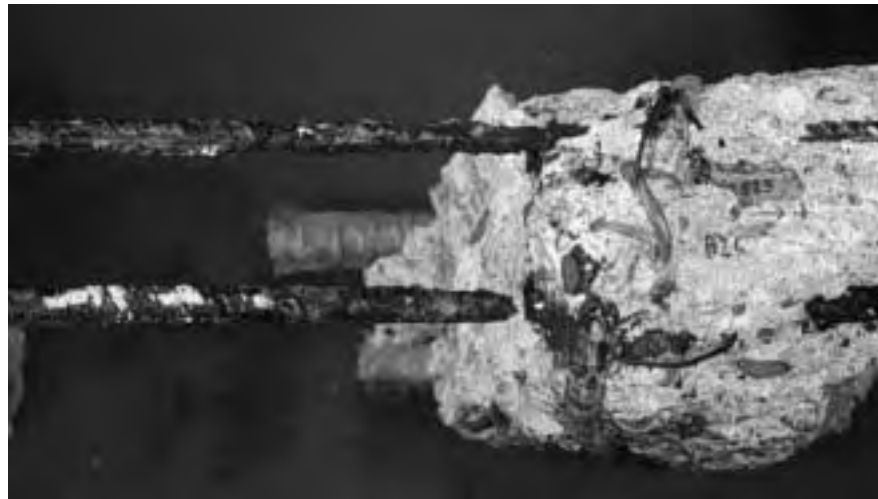
**Figure 2.67** *Upper black bar in beam B25 fractured during autopsy at severely pitted location after 4.3 years.*

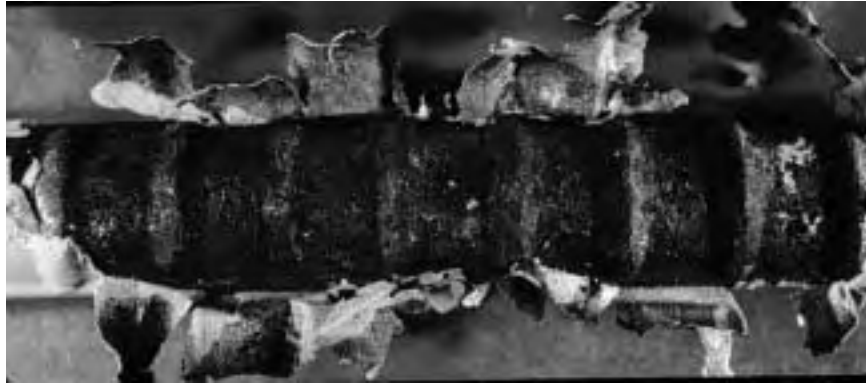
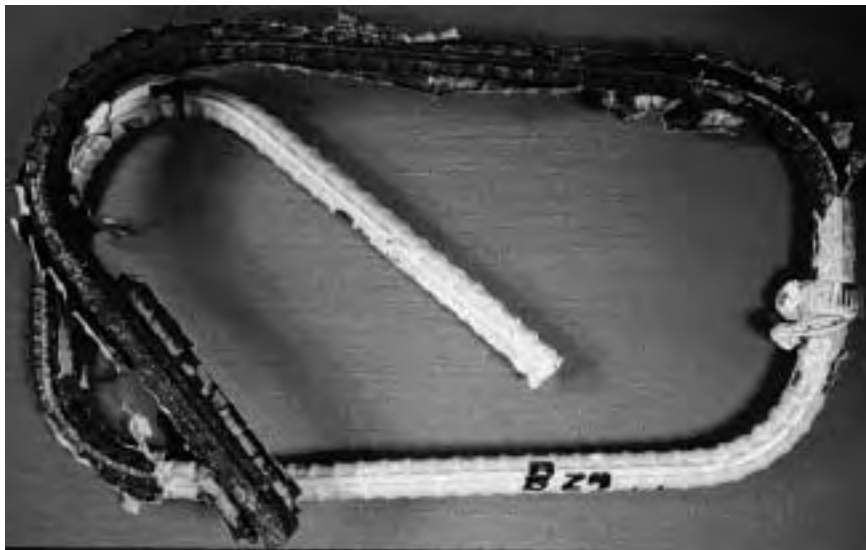
For stirrups, coating debonding was much more prevalent on stirrups in cracked beams than in uncracked beams. The areas of stirrup most vulnerable to coating debonding were the bent portions and the patched ends. In addition, the coating was debonded to some extent along the rust areas. Debonding was particularly extensive (over 60% of stirrup surface) in those specimens where stirrups were used with longitudinal or splice bars. For cut bar ends, debonding took place along the cracked coating extending from the cut end. Figure 2.68 illustrates the extent of debonding of the epoxy coating on a longitudinal bar and a stirrup.

**Figure 2.68** Coating debonding after one year of beam exposure.

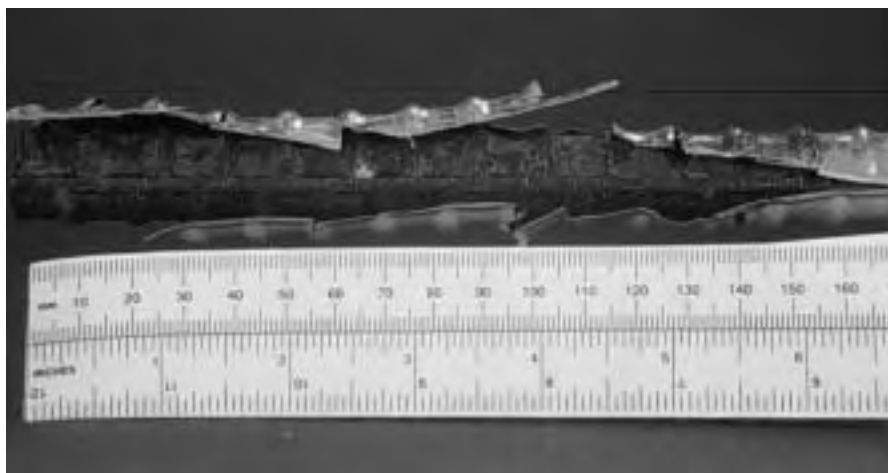
Coating debonded more extensively after 4.3 years of exposure. The coating was usually easy to peel on the portion of the bars within the exposure (wet) zone of the beams and gave an indication of nearly complete loss of coating adhesion (Figure 2.69). Coating debonding progressed from the wet areas at midspan towards the outer, dryer zones and was more extensive in cracked beams than in uncracked beams. Coating adhesion was preserved outside the wet zones of the beams, usually about 0.50 m beyond midspan in beams with larger exposed areas (Group I). At splices (cracked, unloaded beam B32), coating debonded from the cut ends up to a distance of about 20 to 24cm. In the uncracked beams, bars with 3% damage to coating showed much more adhesion loss than bars in an as-received condition. It was observed that adhesion was always lost around damaged, exposed areas, and the regions with good adhesion were located away from the damaged spots. The as-received bars in uncracked beam B1 had good adhesion within the wet zone, with only limited, isolated areas losing adhesion. The coating could be removed only in small chips (Figure 2.70).

**Figure 2.69** Coating debonding of splice bar within the wetted region (beam B32) after 4.3 years.

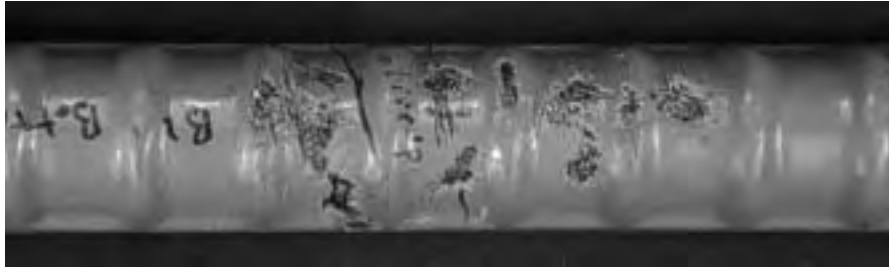
**Figure 2.70** *Coating adhered well throughout most portions of bars from beam B1 after 4.3 years of exposure.*

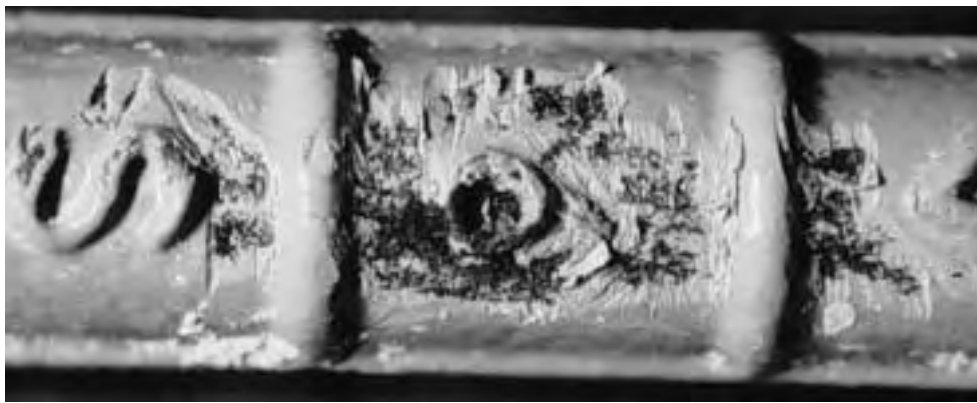
Generally, bars and stirrups in uncracked beams suffered the least substrate corrosion. The metal either remained bright with no visible corrosion activity, or was slightly discolored with minor surface disruption at sporadic locations as shown in Figure 2.72.

***Figure 2.72 Minor surface corrosion of undamaged bar removed from uncracked beam after one year of exposure.***

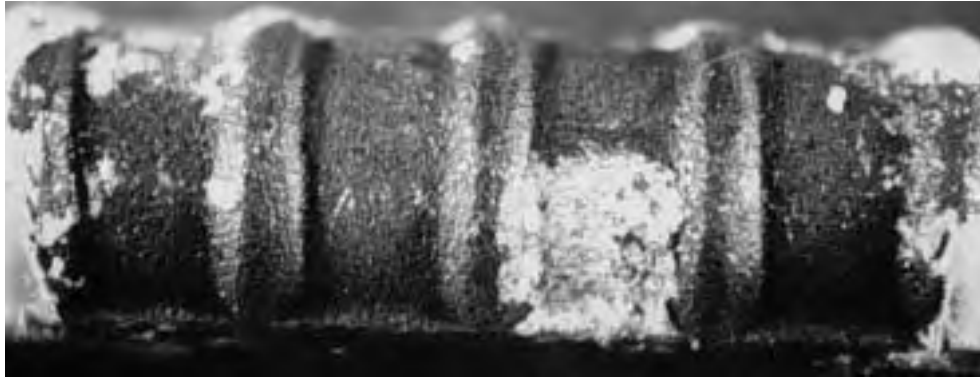
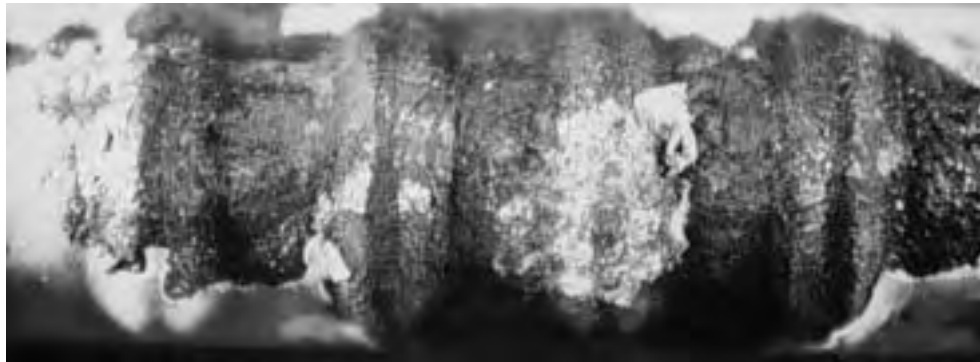
Metal corrosion on the longitudinal bars in cracked beams was mainly concentrated on the bar side facing concrete cover. Thin black -sometimes brown- corrosion products covered the metal surface around the affected sites. Underfilm corrosion spread to about 75mm from crack location, and up to about 45mm from the edge of the damaged areas. There was not any appreciable difference in the extent or severity of substrate corrosion between as-received bars in cracked loaded and unloaded beams. However, bars with intentionally introduced damage showed more substrate corrosion in cracked loaded beams than in cracked unloaded beams as illustrated in Figure 2.73.

(a) Corrosion on bar from uncracked beam B7

(b) Corrosion on bar from cracked unloaded beam B9

***Figure 2.73 Substrate corrosion on bars with introduced damage and variable beam loading condition after one year.***

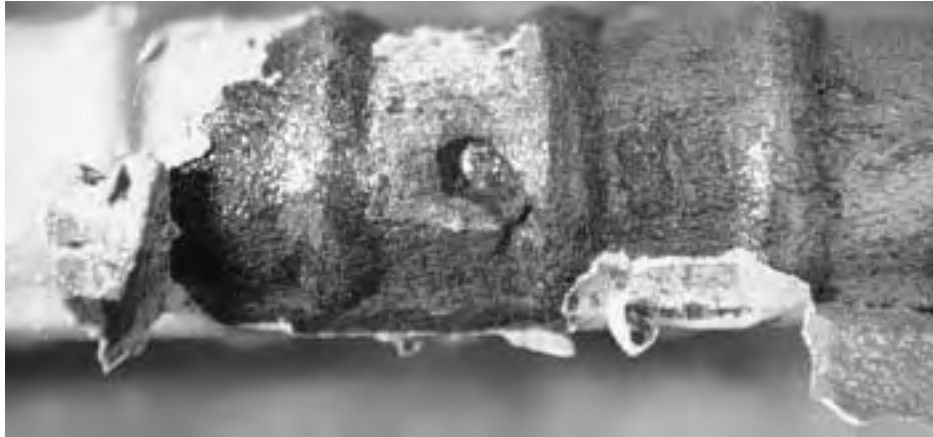
These pits were elliptical measuring about 6 x 9mm (1/4 x 3/8in.) in perpendicular directions and up to 1.25mm (0.05in.) in depth as shown in Figure 2.74. Several smaller pits existed beneath the coating in adjacent areas. The pits were covered with dark brown corrosion products.

(a) Pitting on upper longitudinal bar

***Figure 2.74 Pitting on exposed steel areas of bars removed from cracked loaded beam B11 after one year of exposure.***

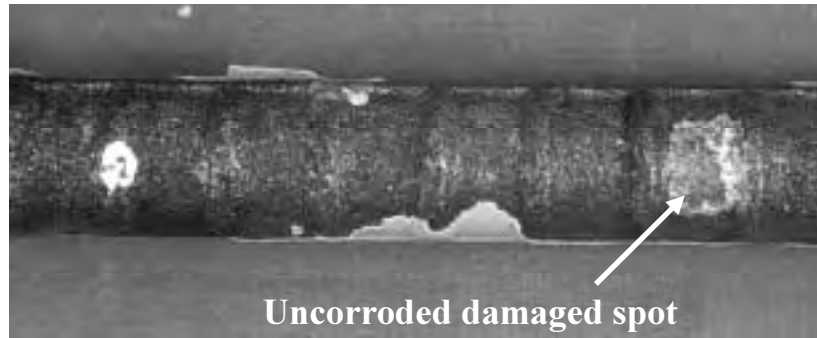
As in the macrocell study (Report 1265-3<sup>23</sup>), two types of surface appearance were found beneath areas with debonded coating: 1) Surfaces with a mottled, glittery golden-brown or bronze appearance, with no corrosion products, as shown in Figure 2.78; and 2) Dark or black corroded surfaces with accumulation of rust products (Figure 2.79). Mottled surfaces were thought to be areas where cathodic disbondment took place, as was discussed in Research Report 1265-3.<sup>23</sup> There was not a specific pattern for location and distribution of mottled surfaces: At some bars mottled surfaces predominated in the middle 30-cm portion of the beams, while at other bars, most mottled surfaces were closer to outer portions of wet areas. Mottled surfaces were found more frequently on longitudinal bars than at stirrups.

**Figure 2.78** *Mottled surface at lower bar of beam B8 within the wetted region.*

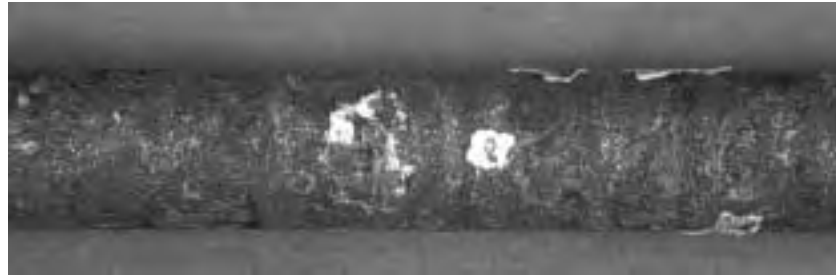
**Figure 2.79** *Dark corroded surface on longitudinal upper bar of beam B8 within the wetted region (zone at midspan).*

A uniformly black or dark rusted surface developed at corroded portions of the bar. Depending on the severity of corrosion, shallow pitting and metal depletion, rust volume increase, and blistering developed to varying degrees (Figure 2.79). No severe, localized, deep pits were found in longitudinal bars. Moderate pits were observed in some stirrups. The largest pits were less than 0.5mm deep in longitudinal bars and 1.0mm in stirrups. Figure 2.80 shows the worst pit observed in a stirrup. No drastic reduction of cross-sectional area was found in any longitudinal coated bar. Moderate reductions in cross-sectional area were observed in worst corroded stirrups. Variable amounts of dark rust powder came off during removal of the coating. Blisters were of different sizes and smaller blisters were more abundant than larger blisters. Blistered areas had a very hard, solid consistency.

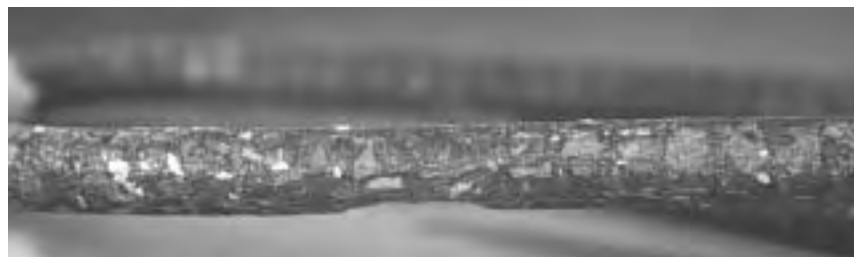
**Figure 2.80** *Pitting on stirrup leg near the bottom beam surface (beam B17).*

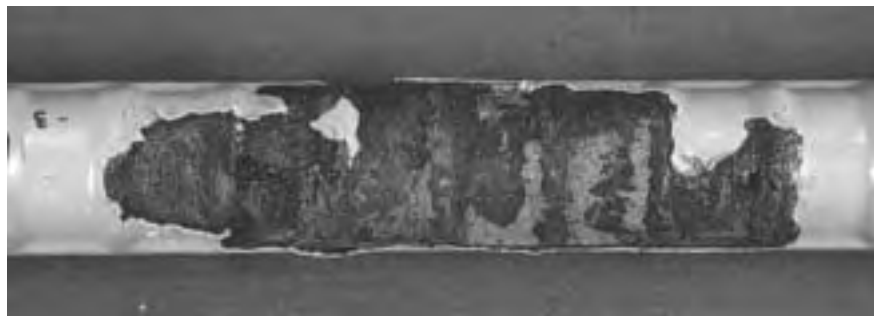
Areas with mostly reddish-brown rust deposits or pockets of varying size, shape, appearance, and amount were usually present above the dark corroded surface (Figure 2.81). The size of such rust spots ranged from very large to small flecks. Appearance of rust spots was dependent on rust concentration, varying from a light film of rust to thicker layers of rust deposits. In a few instances, spots with whitish, pasty

***Figure 2.81 Reddish-brown rust products on lower bar of beam B8 (Zone just outside of wetted region).***

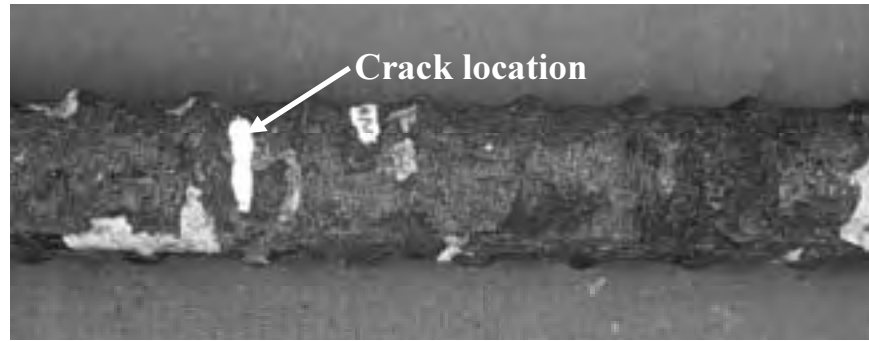
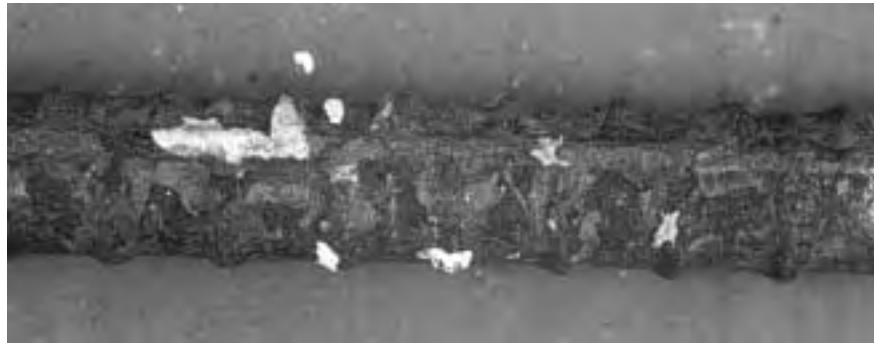
(a) Zone around crack location near the edge of wetted region

(b) Another view of zone around crack location near the edge of wetted region

**Figure 2.82 Corroded portion on lower bar of beam B10.**

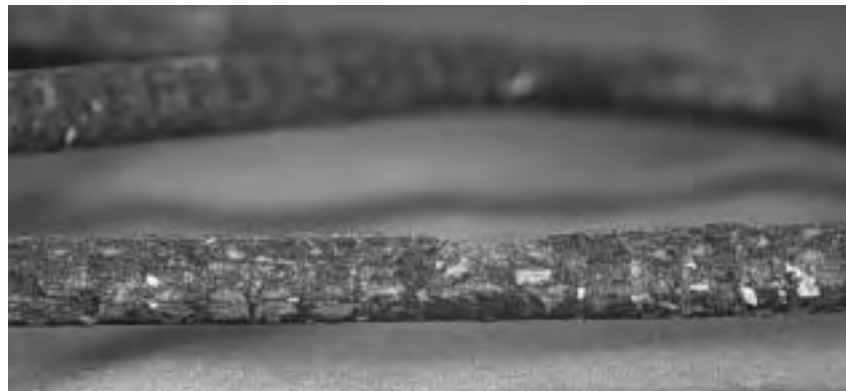
The as-received stirrup from cracked unloaded beam B17 experienced more widespread and severe corrosion than the as-received stirrup from uncracked, unloaded beam B15. The stirrup from beam B17 had several pits (0.3mm to 0.7mm deep) at the most critically corroded portions. Figure 2.83 shows one such pitted area. The rusted metal was cracked and came off in flat pieces. As-received and patched stirrups had less severe corrosion than as-received stirrups. Patched stirrups exhibited uniformly dark corrosion with shallow pitting. In one case (cracked, unloaded beam B23), metal beneath a patch on the hook end was clean and bright (Figure 2.57). Stirrups with 3% repaired damage exhibited widespread dark corrosion and relatively deep pitting, up to 1mm deep, as shown in Figures 2.84 and 2.85.

**Figure 2.83 Pitting on stirrup leg near the bottom beam surface (beam B17).**
