# **CORROSION PERFORMANCE OF EPOXY-COATED REINFORCEMENT-BEAM TESTS**

**Research Report No. 1265-4**

*STRUCTURAL INTEGRITY OF EPOXY-COATED BARS*

**Texas Department of Transportation**

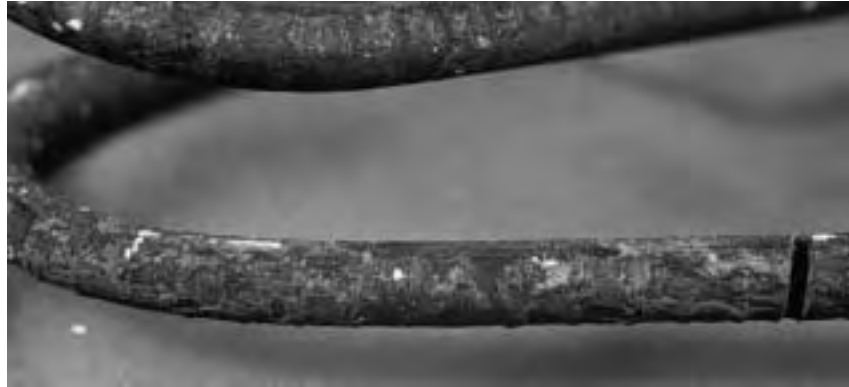
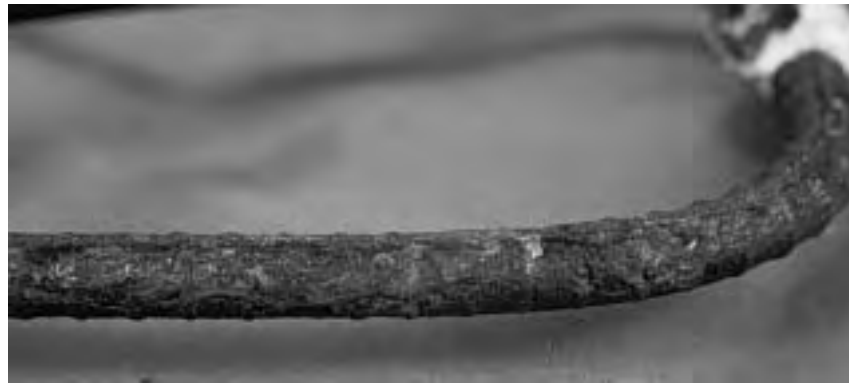
**Figure 2.84 Pitting along stirrup leg near the bottom beam surface (beam B27).**

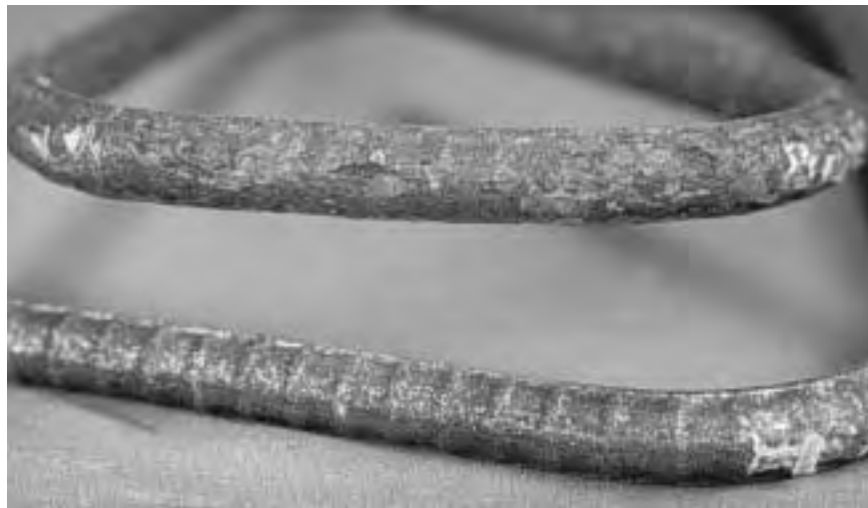
**Figure 2.85 Corrosion on stirrup leg (top in photo) and mottled surface on stirrup hook (bottom in photo). Portion near the front beam surface (beam B32).**

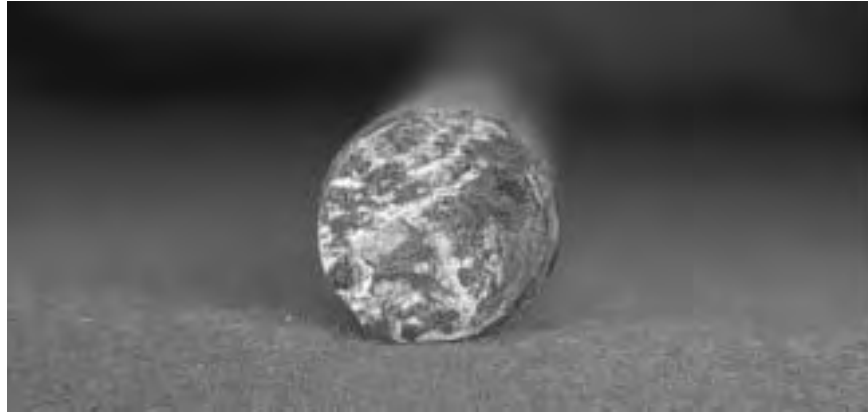
Cut ends of spliced bars showed a uniformly dark or black corroded metal surface with shallow pitting (Figure 2.86). A dark corroded surface with shallow pitting extended from the patched ends of the bars on one side of the bars. The steel exhibited a mostly mottled surface on the side opposite to the corroded surface (Figure 2.87). Undercutting extended 20cm to 24cm from patched bar ends.

**Figure 2.86** *Dark corrosion on steel surface beneath the patch at lower splice bar end of beam B32.*

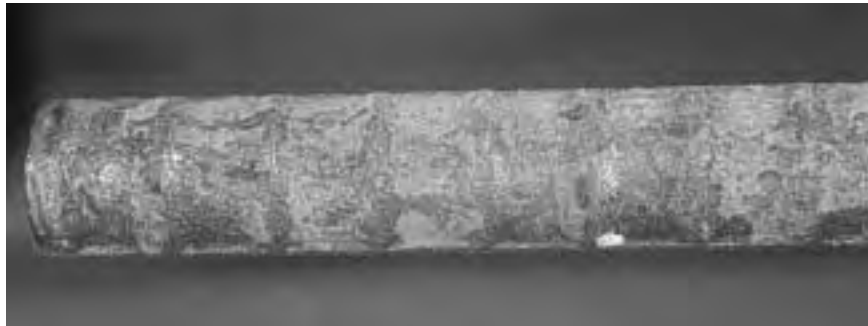
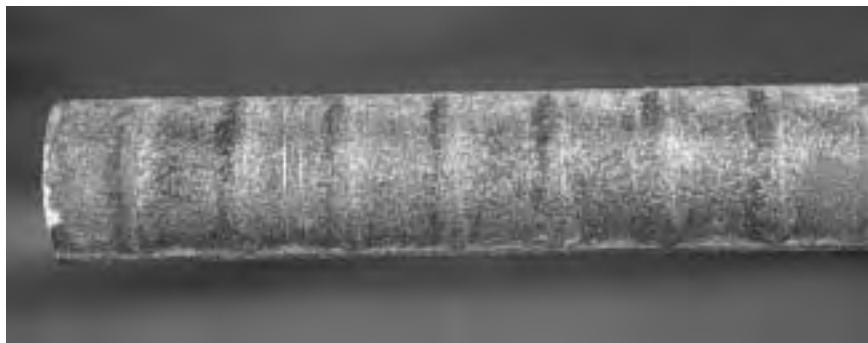
(a) Accumulation of reddish-brown rust products on side near the concrete surface

(b) Mottled surface on opposite side facing the beam core

**Figure 2.87** *Appearance of steel surface of lower splice bar after 4.3 years of exposure (beam B32).*

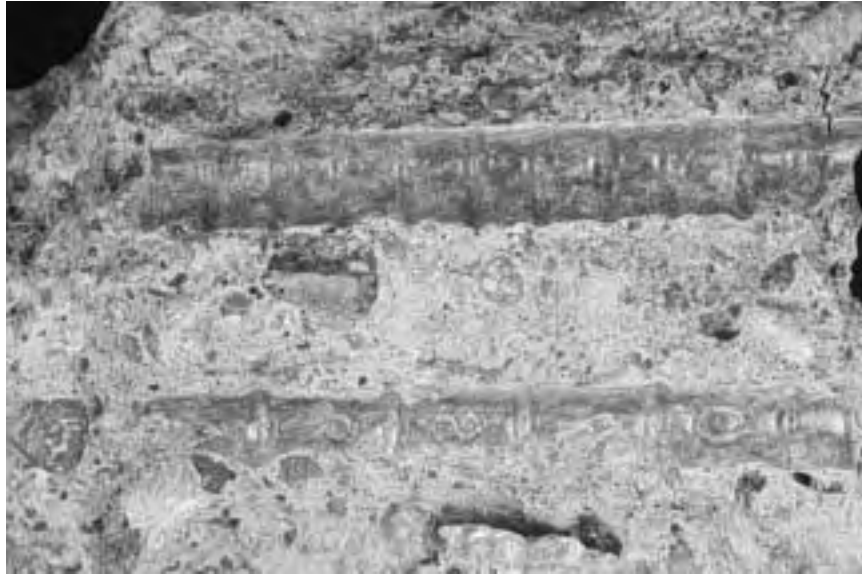
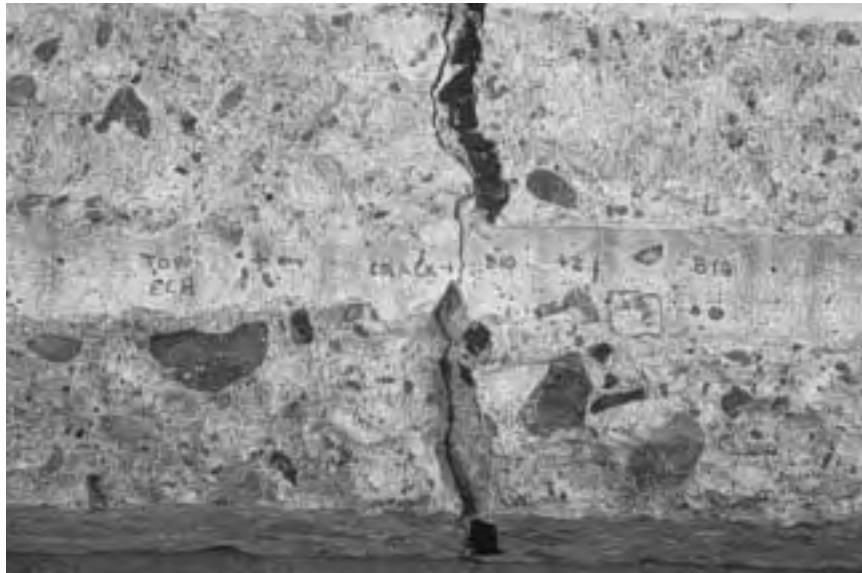
Bar traces of coated steel confirmed the previously mentioned findings from the macrocell study.<sup>23</sup> Concrete on top of the coated steel (in casting position) appeared glossy, smooth with a grayish-like appearance, the rib imprints were clearly defined, and was generally free of voids [Figure 2.88(a)]. Concrete on the underside of the coated steel appeared whitish, dusty, and porous with laitence and had many voids of different sizes [Figure 2.88(b)]. In general, more rust products were visible in and around the voids at the bottom trace than at the top. Chemical adhesion to concrete was lost, as evidenced by the ease in removing the bar from the concrete and lack of concrete adhering to the bar. Only a film of white dust from the concrete paste adhered to the bottom of the bars.

***Figure 2.88 Bar trace in concrete above and below epoxy-coated bars (as in casting position).***

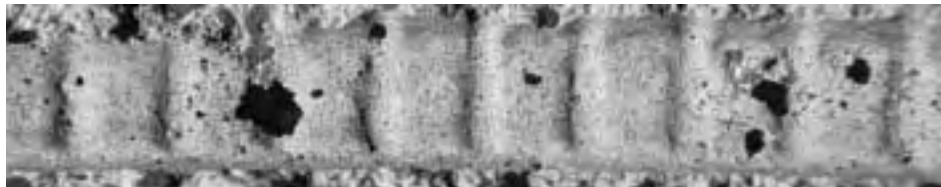
The stirrup trace did not have a similar distinct pattern. There were some voids distributed along the stirrup legs and concrete was not as glossy as it appeared on top of the longitudinal bars. Figure 2.89 shows an example of a stirrup trace in concrete. An interesting observation was that the patching material used at the coating plant to repair stirrup ends remained on the stirrup imprint in concrete as shown in Figure 2.90.

***Figure 2.89 Stirrup trace in concrete.***

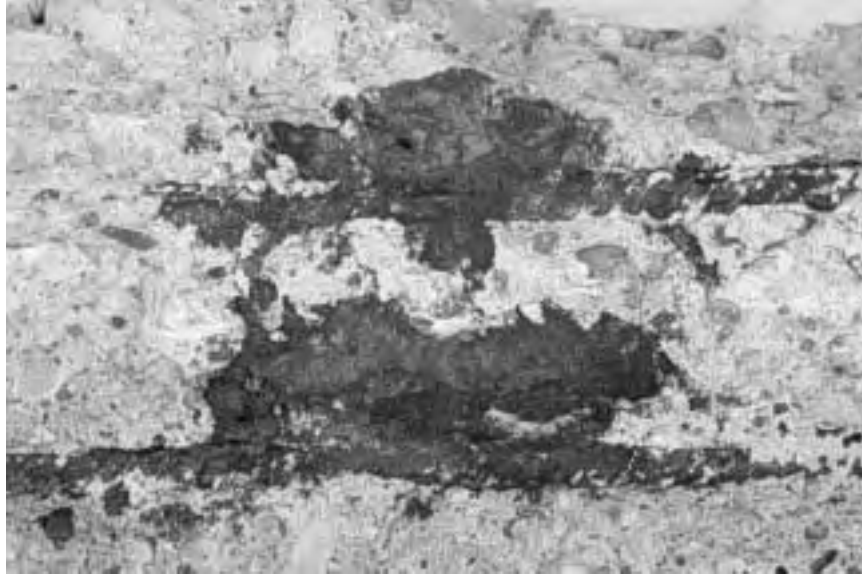
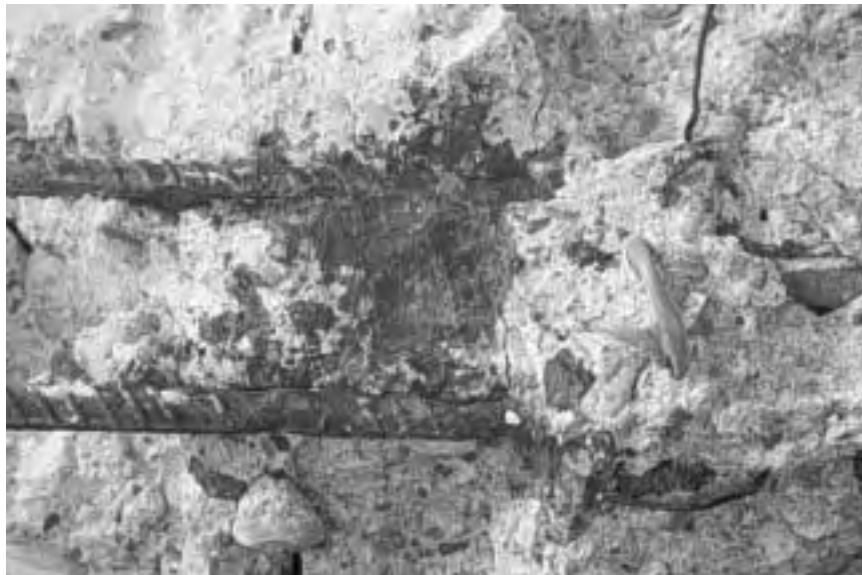
Concrete surrounding heavily corroded uncoated bars was extensively rust stained after 4.3 years of exposure (Figure 2.91). Rust stains were very large, mostly black or dark and reddish-brown colored. Other observed stains were dark-green, bright orange, brownish, and yellowish-brown. Typically, dark-greenish stains would turn orange-brown, reddish-brown, or dark a few hours after exposure to the atmosphere. In general, rust stains penetrated the concrete far beyond the bar location at most areas where the bar was pitted. Stains penetrated cracks and expanded towards the exterior surface. Rust staining was mostly reddish-brown and orange-brown at areas closer to the exterior surface while it tended to be dark or black at the rebar level. Reddish-brown and dark rust was also observed inside large concrete voids above and below the bar.

***Figure 2.91 Extensive dark or dark-greenish rust staining was observed on concrete around uncoated bars at severely pitted locations.***

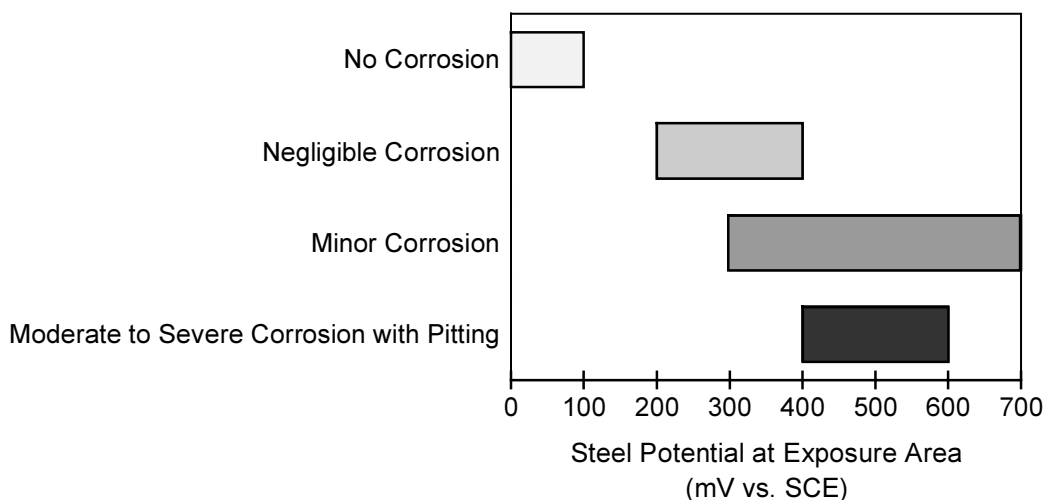
Based on the discussion above and observations of actual bar condition, corrosion potential values correlated well with the state of corrosion of coated steel after one year of exposure. Figure 3.1 summarizes the relation between the ranges of measured potentials and corrosion state. Although the extent of corrosion spreading on the bar surface did not correlate with steel potential, the corroded area tended to increase as corrosion severity increased. This relationship became less clear after 4.3 years of exposure. Figure 3.2 illustrates the relation between corrosion activity and steel potential for epoxy-coated and black bars from beams autopsied after one and 4.3 years. Although there was a tendency for readings to become more negative as corrosion activity of epoxy-coated bars increased, there was a wide overlap of corrosion performance in the potential range of -300 to -550 mV SCE. Corrosion potentials less negative than -300 mV SCE indicated negligible or no corrosion. Likewise, corrosion potentials more negative than -550 mV SCE indicated moderate to severe corrosion with some cases showing only minor corrosion.

**Figure 3.1** Relation between corrosion activity and steel potential after one year of exposure.

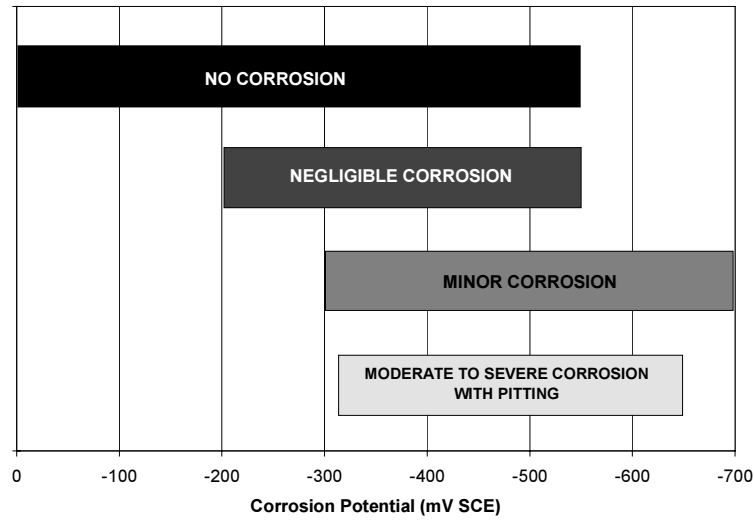
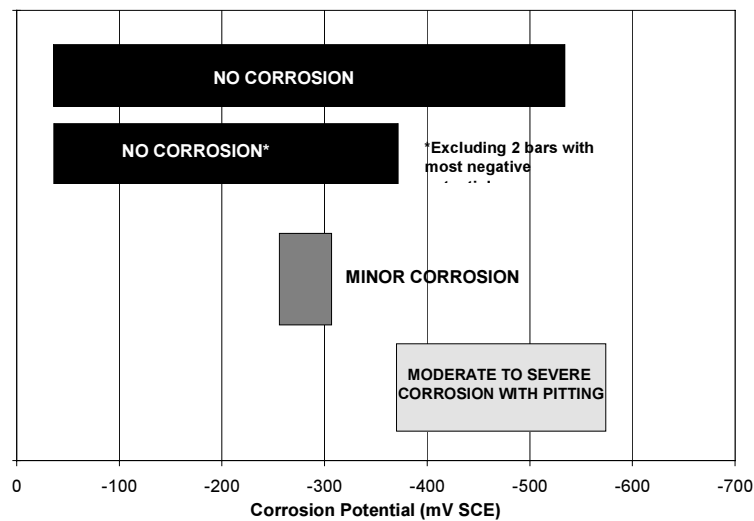
**Figure 3.2 Relation between corrosion activity and steel potential from tests in this study (beams autopsied after one and 4.3 years of exposure).**

For black bars, the overlap of bars with varying corrosion performance was in the potential range of -255 to -535 mV SCE. However, if the two bars showing the most negative potentials in uncorroded zones are excluded, the overlap drastically reduces [see Figure 3.2(b)]. In this case, corrosion potentials less negative than -300 mV SCE correlated with either minor or no corrosion. Corrosion potentials in the range of -370 to -575 mV SCE were associated with moderate to severe corrosion.

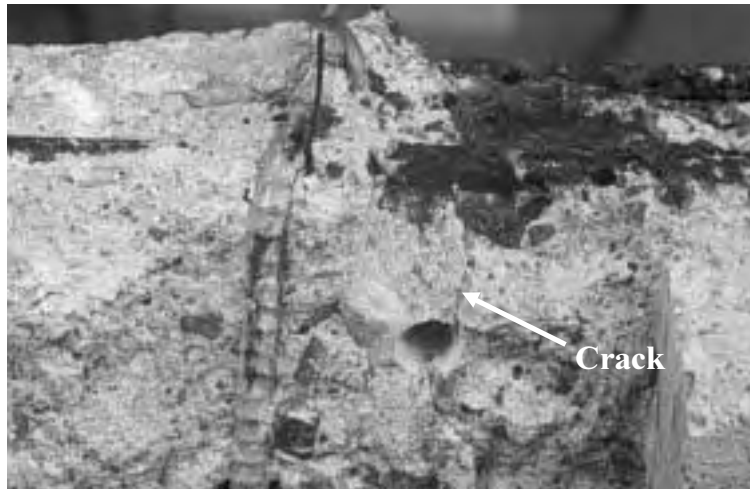
(a) Pitting corrosion of uncoated bars at crack location (beam B25)

**Figure 3.4 Uncoated bars exhibited severe corrosion at crack locations.**

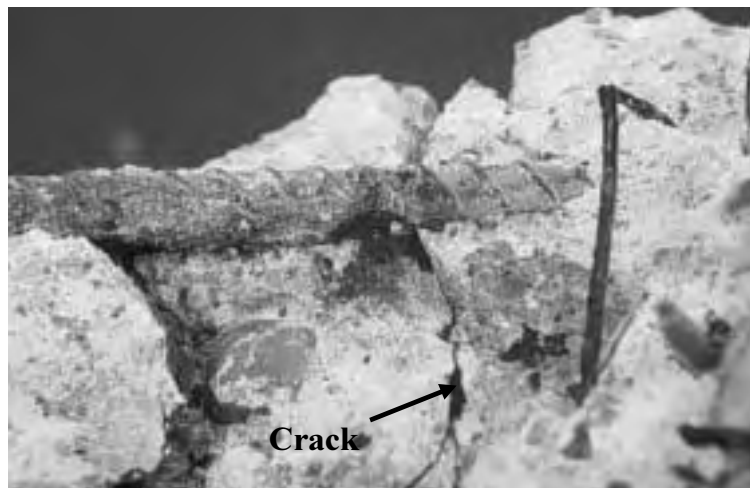
(b) Pitting corrosion of black bar at crack location (beam B23)

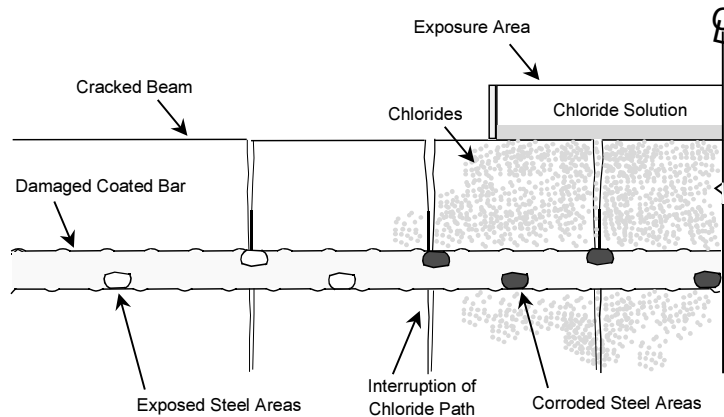
**Figure 3.5 Anode-cathode development on longitudinal bar with variable chloride contamination in cracked beam.**

Concrete cracking also affected the corrosion process on coated bars by creating different environments along the beam member at different times of exposure. During the first year of exposure, cracks on the outside but close to the exposure area interrupted chloride paths as shown in Figure 3.5. Chloride concentrations were considerably different on both sides of the crack as confirmed by the chloride analysis presented in Section 2.4.3. As a result, any exposed steel area located away from the crack and the exposure zone would be predominantly cathodic with respect to those steel areas at the cracks or within the exposure zone. However, this condition changed gradually with increasing time of exposure. After 4.3 years, flexural cracks adjacent to wet zones did not stop passage of chlorides to outer regions as they did in specimens examined after one year. Instead, chloride amounts gradually decreased as a function of distance from the wet zone.

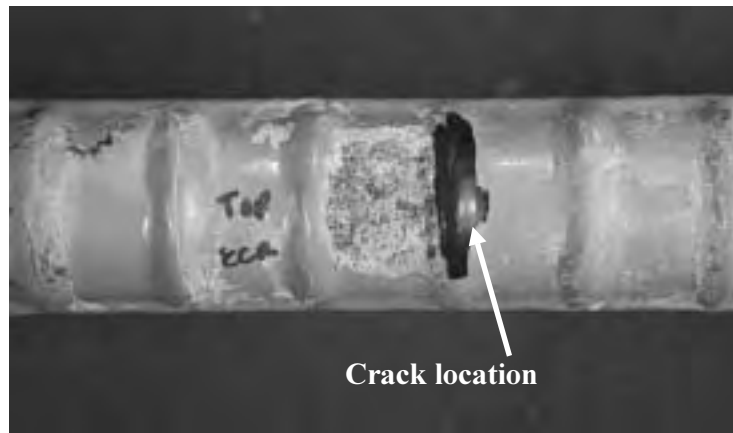
Several longitudinal coated bars did not experience corrosion on some damaged sites (patched or unpatched), even when located near crack locations within the wetted zone (Figure 3.6). The steel surface beneath the coating around such locations was mottled. It seemed that some damage sites near crack locations remained passive while other damaged sites tended to become anodically polarized. Cathodic polarization may have protected damaged sites near cracks from active corrosion. Strangely enough, surrounding concrete at such spots was often porous and with many voids (Figure 3.7).

(a) Uncorroded damaged spot near a crack within the wetted region (Upper bar)

**Figure 3.6** *Uncorroded damaged spots on longitudinal bars of beam B10.*

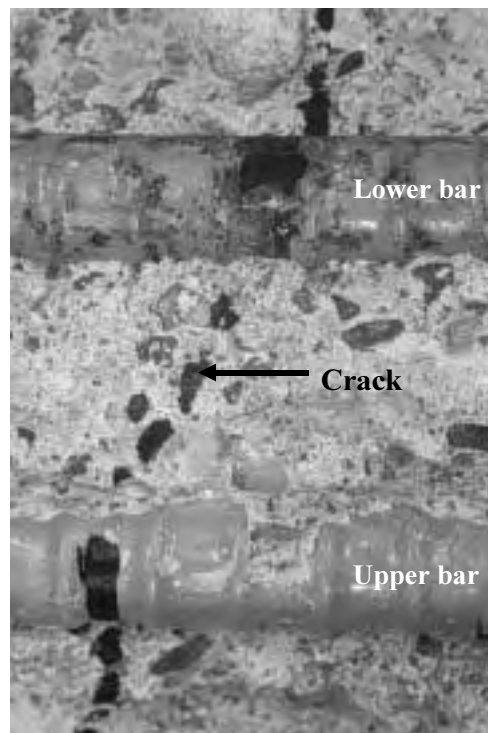
(b) Uncorroded damaged spot near a crack on upper bar. Damaged spot at crack location experienced extensive corrosion on lower bar

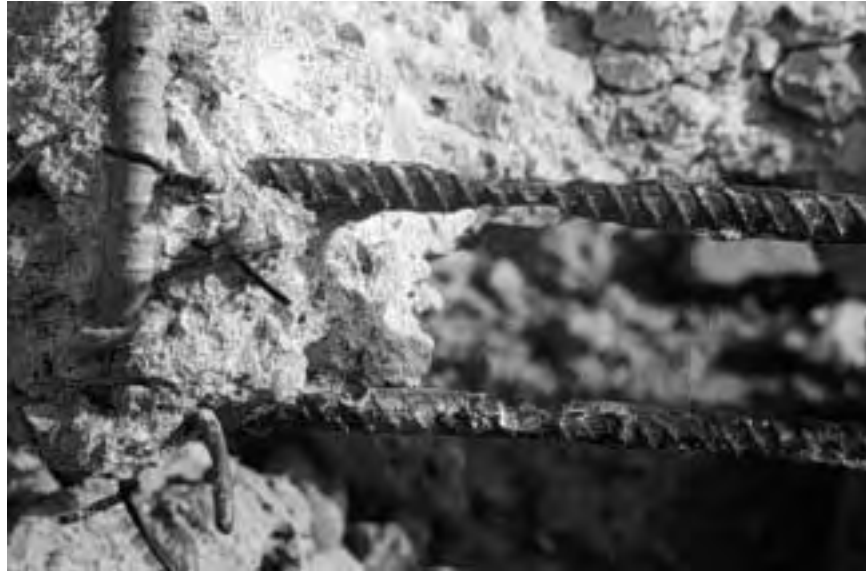
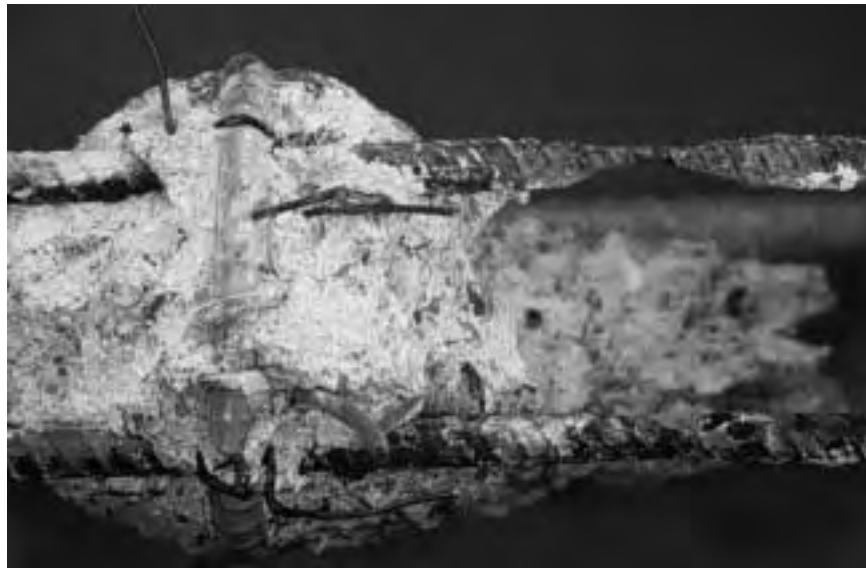
Interestingly, uncoated bars in beams from group I (longitudinal bars) underwent less severe pitting than uncoated bars in beams from groups II and III (stirrups and splice bars) after 4.3 years. Pits in uncoated bars from groups II and III were very deep and produced significant loss of cross-sectional area (Figures 3.8 and 3.9). Several factors may have contributed to this phenomenon. First, a larger area on the beam surface (twice as large) was exposed to chloride solution in beams from group I. Second, several cracks (from two to four) were enclosed within the wetted, exposed surface of beams in group I, while one crack only (sometimes two) was enclosed within the exposed areas of beams in groups II and III. In addition, cracks in group II beams were wider (0.15 to 0.35mm) than those in group I beams (0.08 to 0.20mm). Therefore, uncoated bars from beams in group I were exposed to chlorides and moisture over a larger portion compared to uncoated bars from groups II and III. A smaller surface area of bar tended to

be polarized and to become anodic in black bars from beam in groups II and III. Portions of the bar adjacent to anodic areas became cathodic. In consequence, uncoated bars from beam groups II and III tended to have a smaller anode and larger cathode, that is, a more unfavorable (smaller) anode/cathode ratio compared with bars from beam group I. The resulting driving force for corrosion was larger for uncoated bars from beam groups II and III.

***Figure 3.8 Severe pitting corrosion of uncoated bars at crack location (beam B27).***

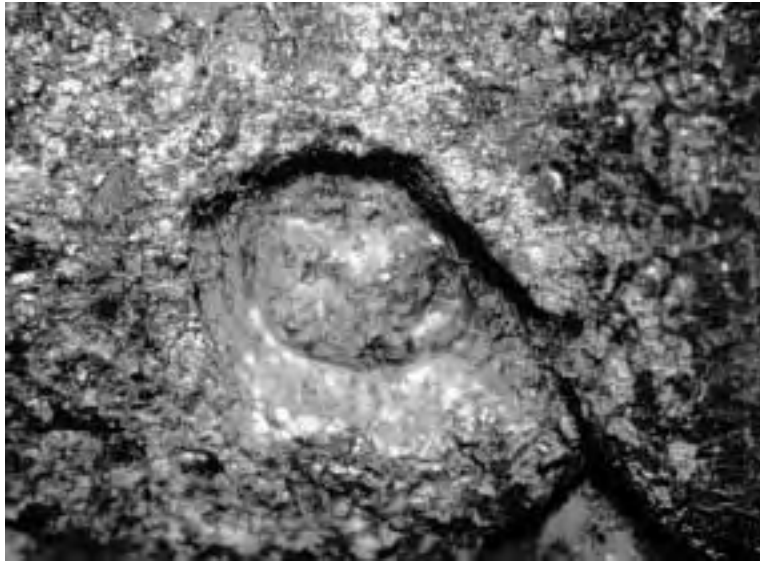
Significant pitting was only observed on damaged longitudinal bars in beams with opened cracks. However, corrosion severity on these coated bars was still less than that observed on uncoated bars recovered from cracked beams. Figure 3.11 shows a close up of one pit that formed on an exposed area of a coated bar at a crack location, and an example of surface degradation of an uncoated bar at another crack location. Hence, coated bars, even with heavy damage, had improved performance relative to uncoated bars.

(a) Pitting on damaged longitudinal bar (B11-upper)

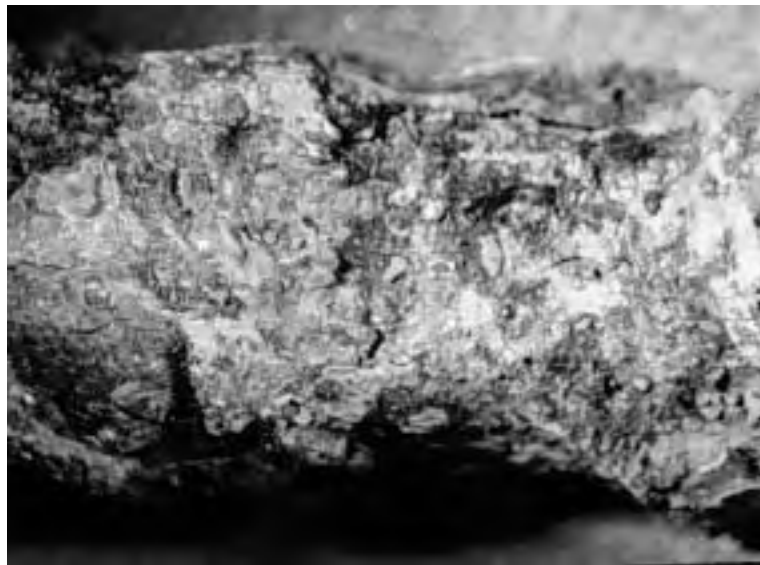
(b) Pitting on uncoated bar (B26)

***Figure 3.11 Pitting corrosion on coated and uncoated bars in beams with opened cracks (at one year).***

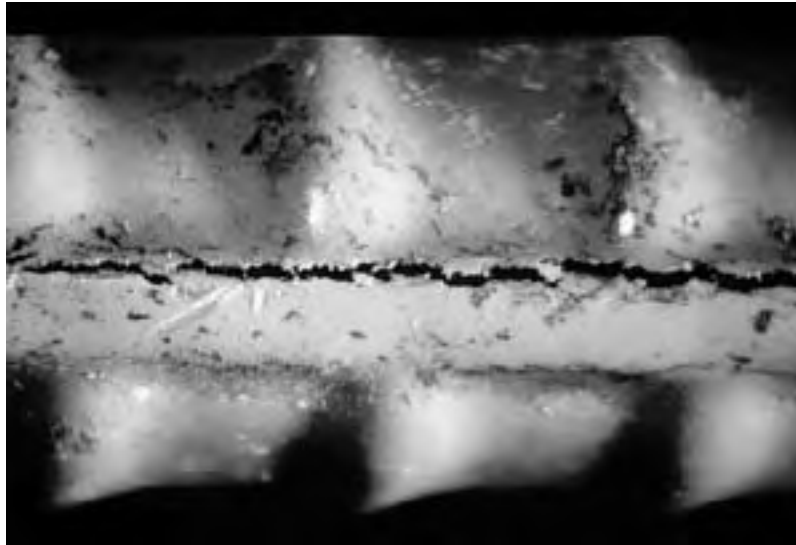
Generally, the coating of stirrups tended to break down along the longitudinal rib as observed on a number of corroded stirrups. A typical crack in the coating extending along a stirrup leg is shown in Figure 3.12. The coating on the bar rib is particularly weak.

*Figure 3.12 Cracking of coating along stirrup leg.*

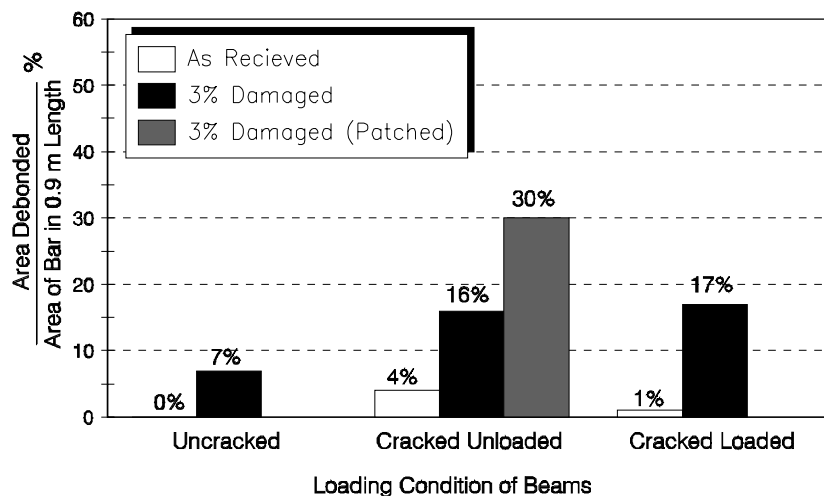
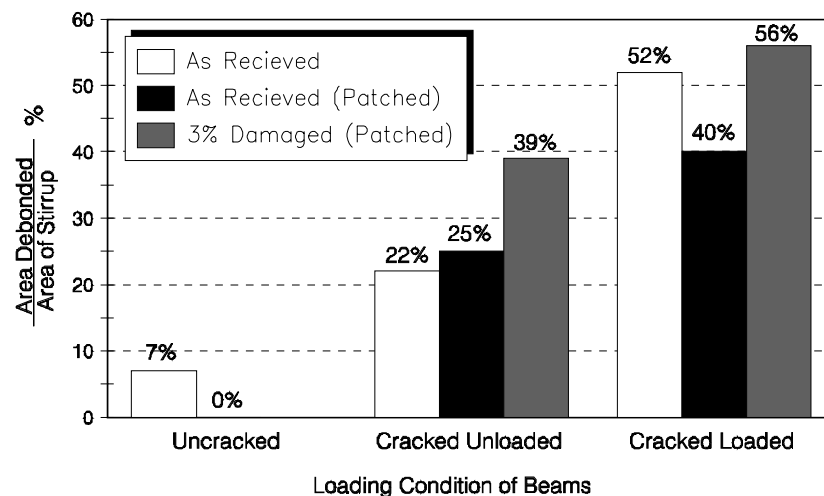
**Figure 3.13 Variation of debonded area with bar damage level and loading condition after one year.**

Figure 3.13 shows the average amounts of debonding on longitudinal bars and stirrups with different damage levels and under various loading conditions. Coating debonding on longitudinal bars increased when beams were cracked and coating was significantly damaged prior to testing. The results were not much different between cracked unloaded and cracked loaded beams. Coating debonding on stirrups,

however, increased significantly when beams were cracked, and more so when the beams were loaded. Stirrups with as-received and as-received-patched conditions had almost the same amount of debonding indicating that patching was ineffective. Interestingly, there was no substantial difference between debonding on the as-received stirrup and that with 3% patched damage in cracked loaded beams. The results indicated the vulnerability of stirrups to significant debonding under service conditions similar to those incorporated in the beam test.

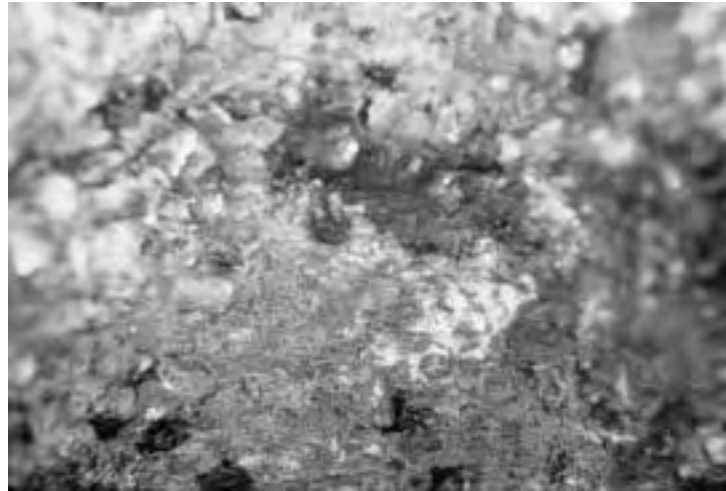
***Figure 3.14 Roughness on contact surface of coating after one year.***

Among the major factors affecting the effectiveness of patching are the thickness of patching material and surface anchor pattern. The thickness of a chipped piece of patch material from a bar cut end was measured and found to be only 75-100  $\mu\text{m}$  (3-4 mils) thick which is approximately one-third of the required fusion-bonded coating thickness. Cut ends of bars are usually not prepared for patching; the steel

surface is not roughened to provide an anchor profile. As a result, coating adhesion at cut areas remains weaker than that at the bar surface. Figure 3.14 demonstrates the difference in appearance of the backsides of two chipped pieces of coating: one from electrostatically sprayed coating; and the other from brushed patching compound.

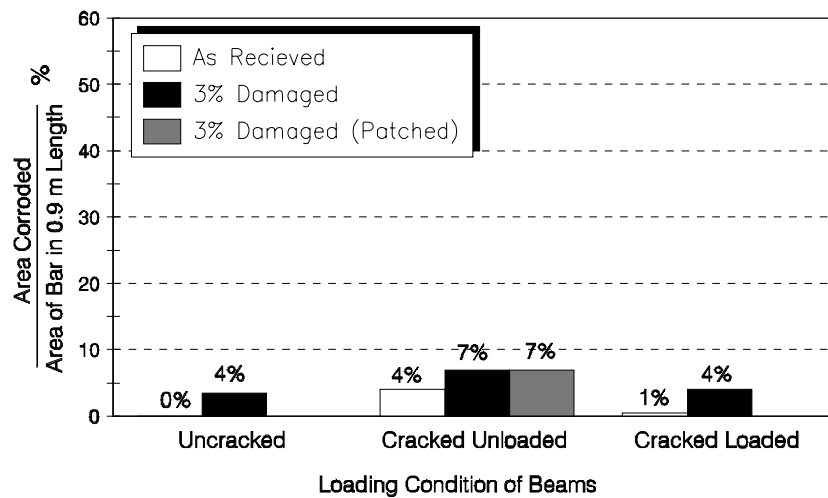
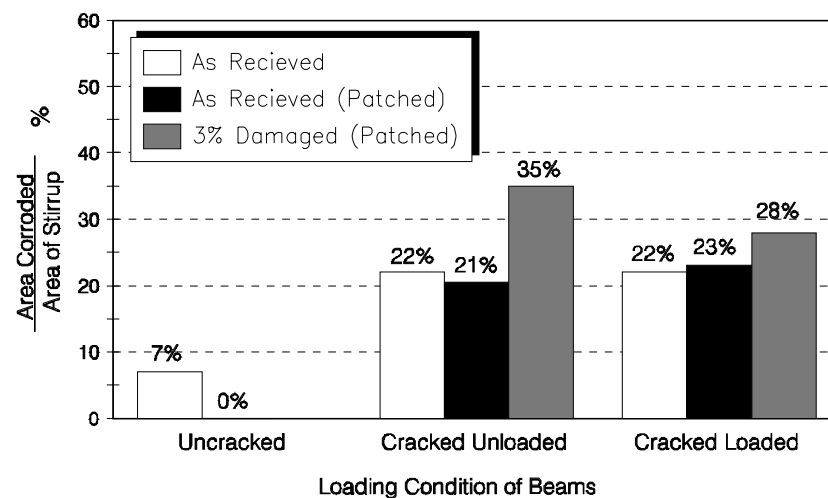
**Figure 3.15 Variation of corroded area (undercutting) with bar damage level and loading condition.**

Figure 3.15 shows the variation of undercutting with bar damage level and loading condition for both longitudinal bars and stirrups. Comparing the results in this figure with those in Figure 3.13, it was clear that larger crack widths lead to larger debonded areas as a result of greater cathodic activity and not

necessarily greater corroded surfaces. In other words, cracks permitted excessive amounts of oxygen to reach the steel surface and to support the cathodic reactions thus resulting in larger debonded areas. Cycling the imposed loads, particularly during drying periods, may then be viewed as an oxygen *pump* that promoted corrosion activity. This observation explains why severe pitting occurred on bars with a relatively high proportion of debonded area to corroded area.

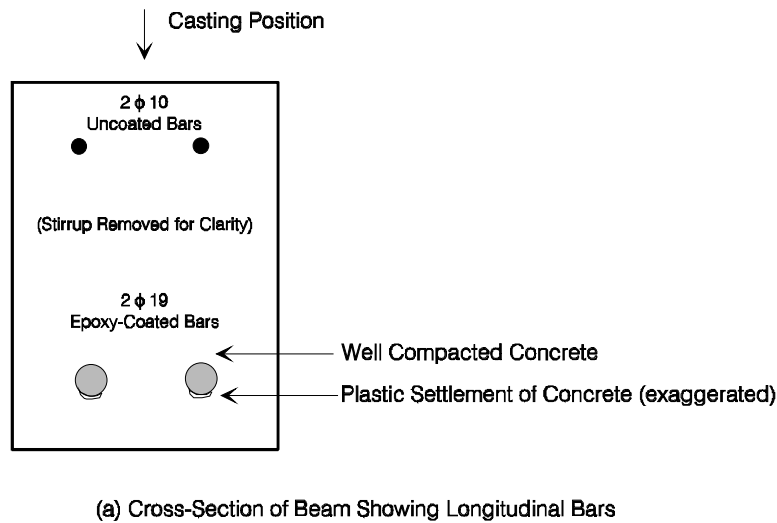
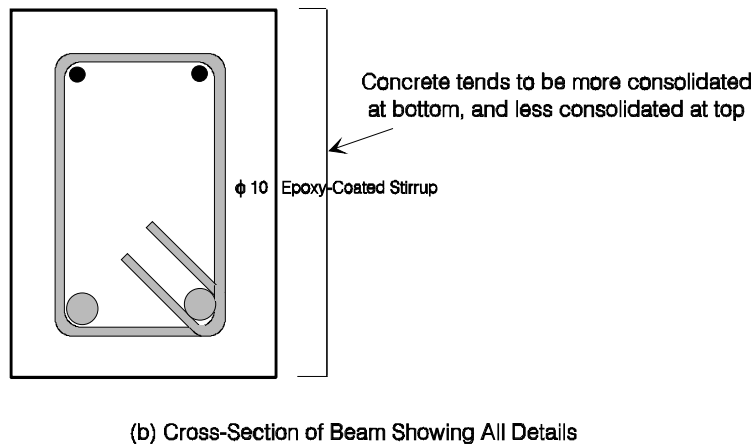
Small gaps and air pockets may form under the coated bar during concrete consolidation. By contrast, a smooth and continuous interface layer may form on top of the bar. Such variation in the concrete density was more noticeable for longitudinal bars than for stirrups. Figure 3.16 shows two cross sections of a beam specimen in the casting position to demonstrate the variation in concrete quality at different regions.

**Figure 3.16 Variation of concrete quality in beam cross section.**

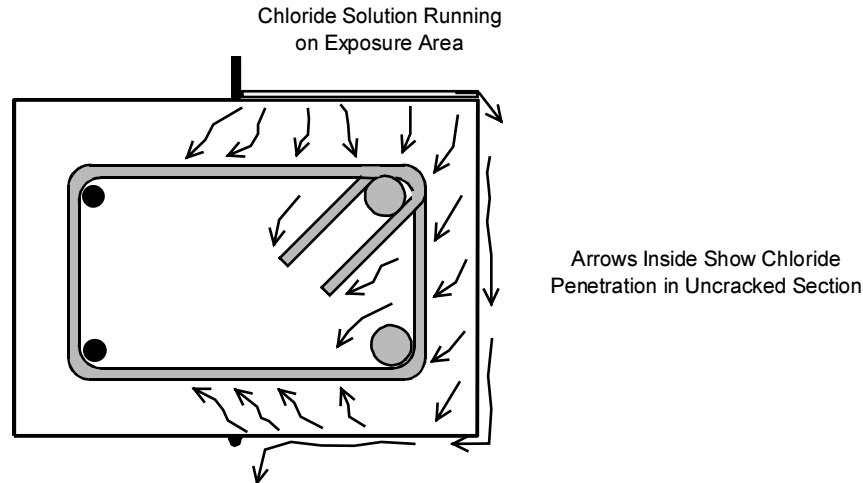
Variation in the concrete density surrounding the reinforcing bar creates concentration cells which, in turn, produce differences in potential and lead to macrocell action. Non-uniform chloride concentrations around the bar were probably the most significant contributor to corrosion initiation and acceleration in the beam test. Differences in chloride concentration at the top and bottom of the bar result from variations in chloride penetration as illustrated in Figure 3.17. In addition, the amount of chloride ions that can accumulate in the zone immediately above the bar may be limited by concrete density. However, the less dense zone beneath the bar can retain more chlorides. Moreover, the surface below the coated bars (in the cast position) was closer to the exterior, irrigated surfaces. Consequently, slightly more corrosion and blistering were observed on the lower half of the longitudinal bars than on the top half. Concrete surfaces below the bars had more extensive rust staining than concrete surfaces above the bars. Nevertheless, corrosion was observed on the upper half of the bars and was more extensive after 4.3 years than after one year.

**Figure 3.17 Chloride penetration in uncracked beam cross section.**

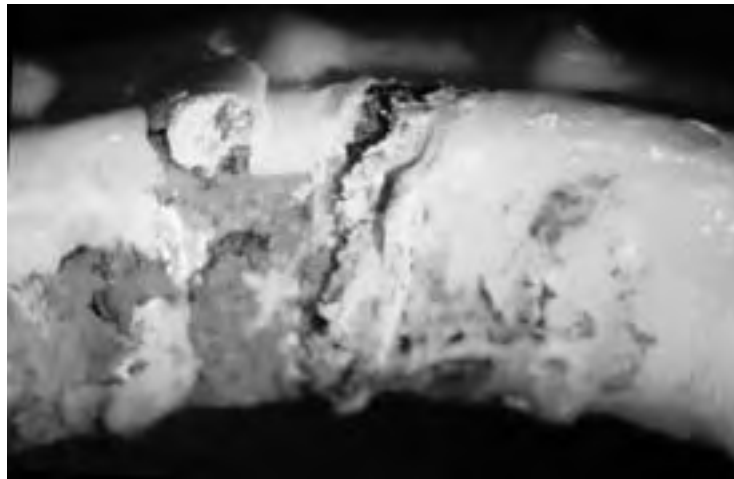
Electrical continuity between the stirrup and uncoated bars was possibly present through damage at contact points and may have affected corrosion performance. Damage on the inside of the bend of stirrup was introduced either during fabrication (in the form of mashed spots) or by cutting through the coating during cage assembly. An example of the later is shown in Figure 3.25. Sometimes, the protected tie wire was stripped under the action of twisting causing the metal to be uncovered. Another possible source of continuity could be semiconducting corrosion products that accumulated around the contact points, bridging the gap between uncoated bars and exposed areas in stirrups, as shown in Figure 3.26.

*Figure 3.25 Damage of coating of stirrup at contact with uncoated bar.*

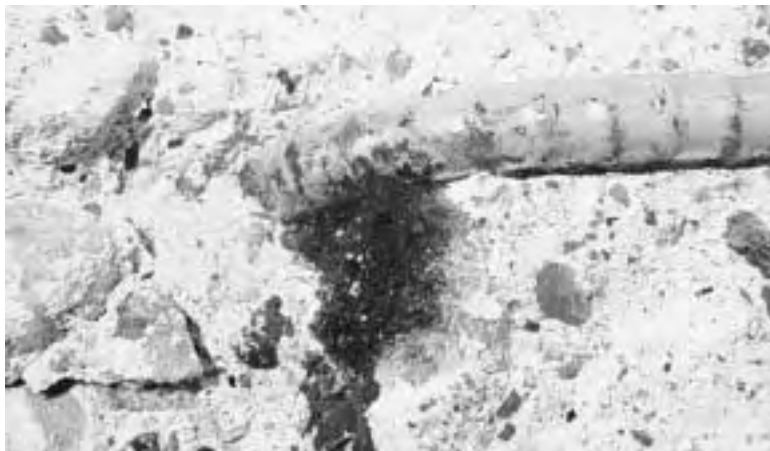
*Figure 3.26 Corrosion at location of contact of coated stirrup and uncoated bar.*

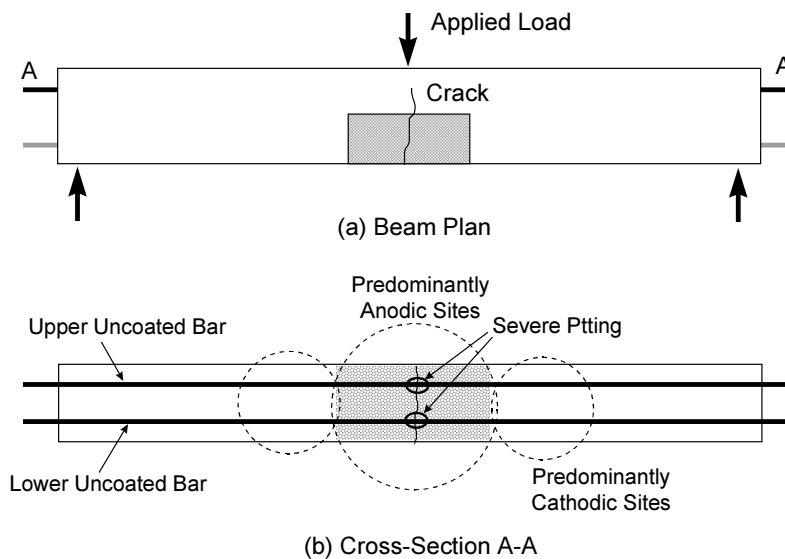
Uncoated bars in the compression zone of the beams exhibited severe macrocell corrosion. The lack of a protective coating allowed the steel surface to be continuously exposed through wetted and dry regions, and through regions with variable moisture content and chloride contamination (Figure 3.28). Bars became anodic within wetted regions, at crack locations or other locations where chlorides accumulated in high concentrations. Anodic regions were characterized by moderate or severe pits with dark-greenish corrosion products. Cathodic portions generally developed at wet-dry transition regions, where chloride content was slightly lower than that at wetted regions near midspan, but some moisture (and a highly alkaline environment) was available. Sometimes, cathodic regions were within the wetted zone, to the left or right of midspan, while the rest of the bar within the wetted region was anodic. The differential alkaline and salt concentrations generated a potential difference between contaminated parts and adjacent areas. As a result, galvanic corrosion currents flowed between the small anodes and large cathodes. Unrestricted availability of oxygen maintained corrosion under anodic control.

**Figure 3.28 Macrocell corrosion of uncoated bars.**

Uncoated bars in beams groups II and III underwent very severe pitting, with significant reduction of cross-sectional area and metallurgical degradation of sound steel. The macrocell effect was more intense than in beam group I, possibly because of a smaller wetted region typically enclosing one wide crack. Group I beams had a larger wetted region enclosing more narrow cracks. Consequently, a smaller

anode/cathode ratio developed in bars from groups II and III, resulting in severe pitting at the crack location. Although corrosion spread from the active area at the crack, intensive macrocell action was sufficient to cause severe localized metal consumption in a very small portion.

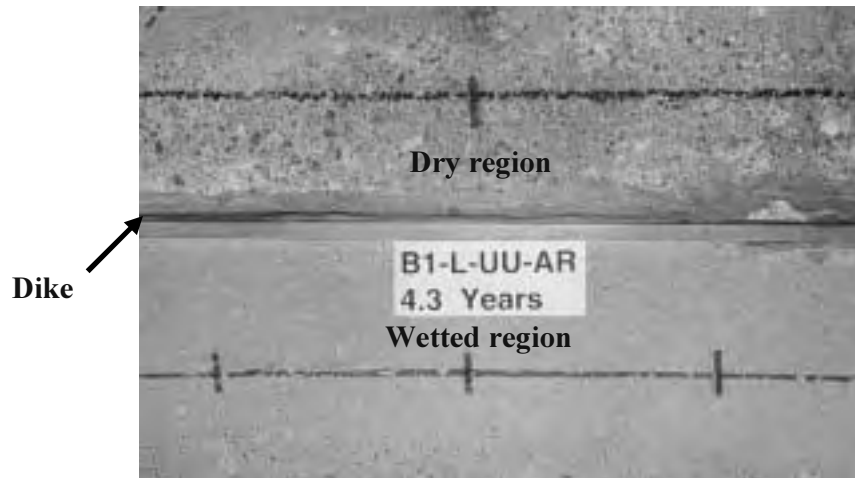
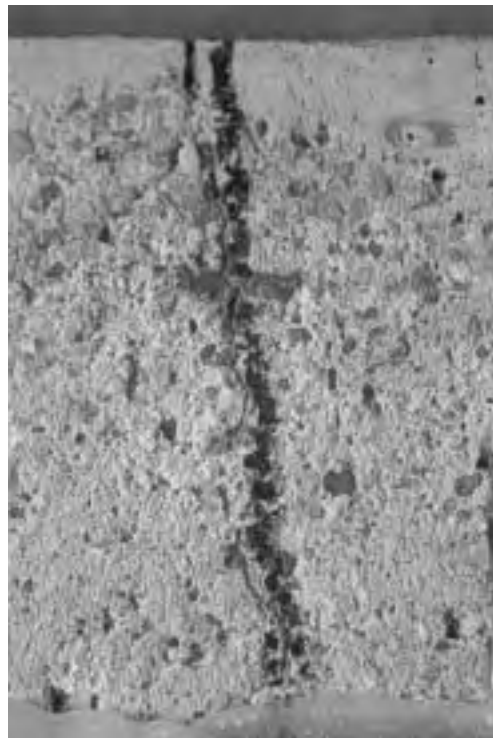
A mechanism of concrete deterioration, similar to that of macrocell specimens with uncoated bars, took place in all beams. As was mentioned in Chapter 2, the concrete surface deteriorated and scaled within the wet zone and in regions outside the wet zone (Figure 3.29). Concrete scaling outside the wet zone was more extensive and severe at the bottom surfaces, and the degree of scaling ranged from light to severe. Scaling was usually worse outside the wetted regions. Scaling extended up to 76cm to each side of midspan in beams group I and up to 51cm to each side of midspan in beam groups II and III.

Concrete scaling and non-structural cracks were caused by forces from expansive hydrated salt crystals that were driven through concrete pores after periodic cycles of wetting and drying. When water evaporated during dry cycles, salts in the form of crystals were left in the capillary pores. Upon subsequent wetting, the crystals re-hydrated and grew, exerting an expanding force on the surrounding cement paste. The crystallization of salt in a zone having a free evaporation surface or one that the solution reaches by capillary forces, such as the regions adjacent to the wetted zone in the beams, results in destructive internal pressures that may crack and deteriorate the concrete.<sup>1, 45, 46</sup> Such surfaces are vulnerable because free evaporation results in an increase of salt concentration. At scaled areas, the hardened cement paste and embedded fine aggregate particles were removed, leaving behind protruding coarse aggregate particles (Figure 3.29). Large deposits of salt crystals were visible at scaled surfaces.

(a) Beam B1, top surface (plan view)

(b) Bottom surface of beam B1, close up of crack at midspan

***Figure 3.29 Concrete scaling inside and outside wetted regions. Scaling was more severe outside (but near) wetted regions.***

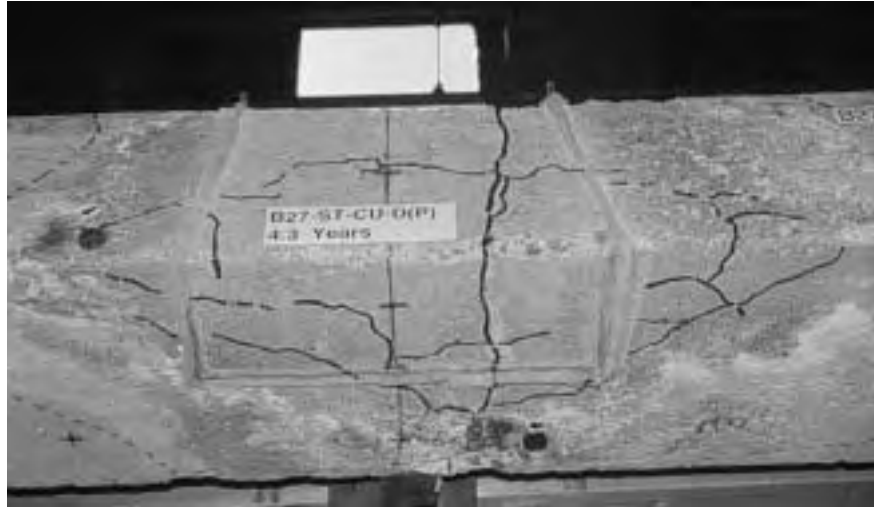
In addition to concrete scaling, loaded and unloaded beams experienced cracking with random orientation, mainly longitudinal, at and around the wet zone (Figure 3.30). Such cracks appeared between 2.5 and 3.6 years, and had a maximum width of 0.20mm, with most between 0.08 and 0.10mm. No signs of rust were found inside or around such cracks.

***Figure 3.30 Random cracking at and around wetted region of beam B27.***

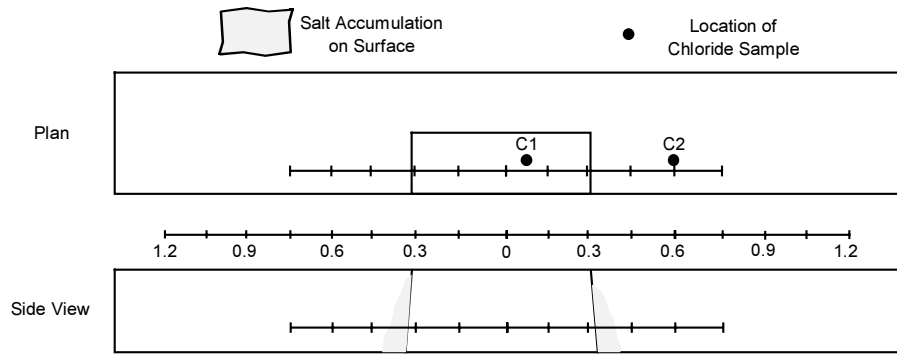
**Figure A.23** Surface condition of beam B2-L-UU-AR after one year of exposure.

| Beam No. | Bar Surface Condition | Coating Adhesion | Undercutting |
|---|---|---|---|
| B2-Upper | No apparent corrosion. | Very good adhesion. | Bright steel, as new. |
| B2-Lower | No apparent corrosion except at one mill mark. | Very good adhesion except at rust spot. | Bright steel, one 3 x 6mm black rust spot. |

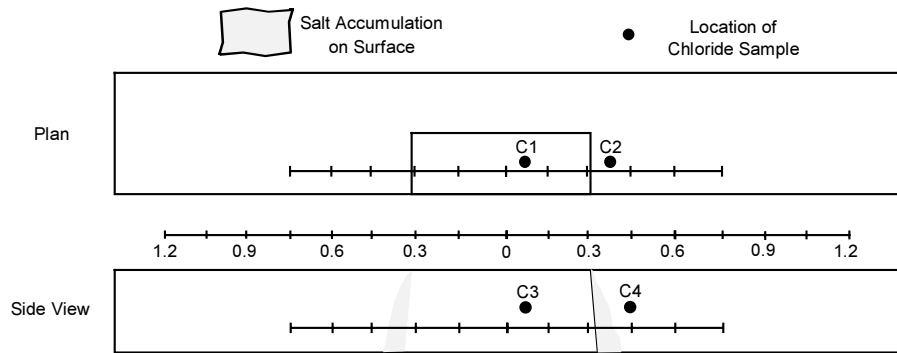
**Figure A.24** Surface condition of beam B7-L-UU-D after one year of exposure.

| Beam No. | Bar Surface Condition | Coating Adhesion | Undercutting |
|---|---|---|---|
| B7-Upper | Rust spotting only on steel areas facing cover. | Debonding up to 25mm around rust areas. | Dark (or black) around damaged (or rust) spots |

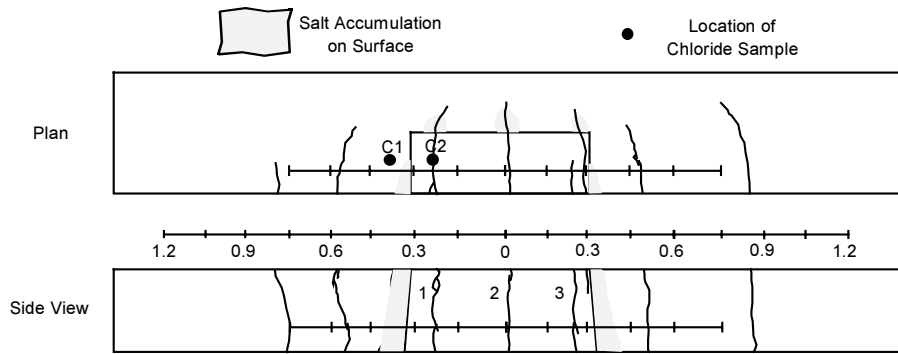
**Table A.6** Average crack width measurement for beam B4-L-CU-AR.

**Figure A.25** Surface condition of beam B4-L-CU-AR after one year of exposure.

| Beam No. | Bar Surface Condition | Coating Adhesion | Undercutting |
|---|---|---|---|
| B4-Upper | As B2-Lower, rust 13mm from crack near stirrup. | Very good adhesion except at rust spot. | Black over 25mm from crack -side facing cover. |
| B4-Lower | Rust spots at mill marks within 25mm from cracks. | Debonding along 130mm around rust spots. | As B4-Upper, but about 50-75mm from crack. |

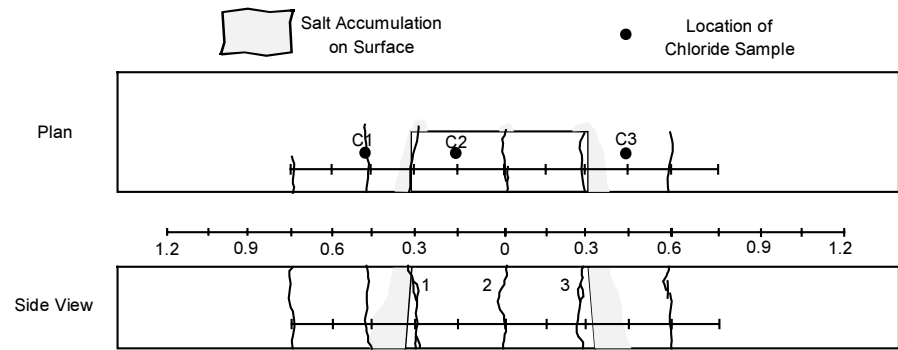
**Figure A.26** Surface condition of beam B5-L-CL-AR after one year of exposure.

| Beam No. | Bar Surface Condition | Coating Adhesion | Undercutting |
|---|---|---|---|
| B5-Upper | No apparent corrosion. | Very good adhesion except at a mill mark. | Bright steel, one 13 x 13mm black rust spot. |
| B5-Lower | Rust at one damaged spot 37mm from crack. | Very good adhesion except at rust spot. | Bright steel, one 22 x 13mm black rust spot. |

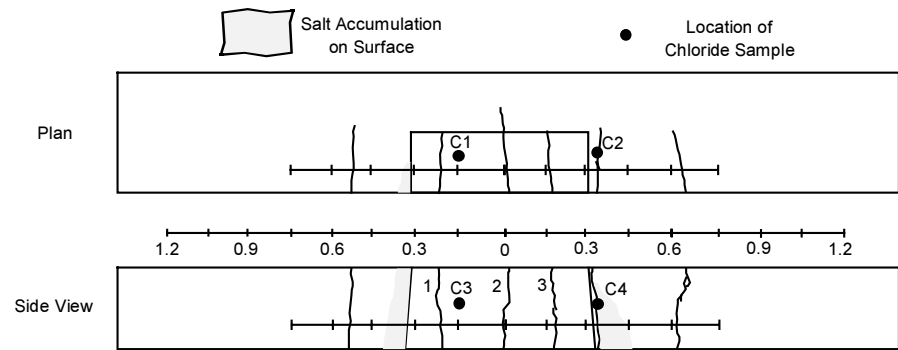
**Figure A.27** Surface condition of beam B11-L-CL-D after one year of exposure.

| Beam No. | Bar Surface Condition | Coating Adhesion | Undercutting |
|---|---|---|---|
| B11-Lower | Rust on areas up to 60mm from cracks, 5 blisters | As B9-Lower. | As B9-Upper, one pit 6 x 9 x 1.15 (deep)mm. |
