# **CORROSION PERFORMANCE OF EPOXY-COATED REINFORCEMENT-BEAM TESTS**

**Research Report No. 1265-4**

*STRUCTURAL INTEGRITY OF EPOXY-COATED BARS*

**Texas Department of Transportation**

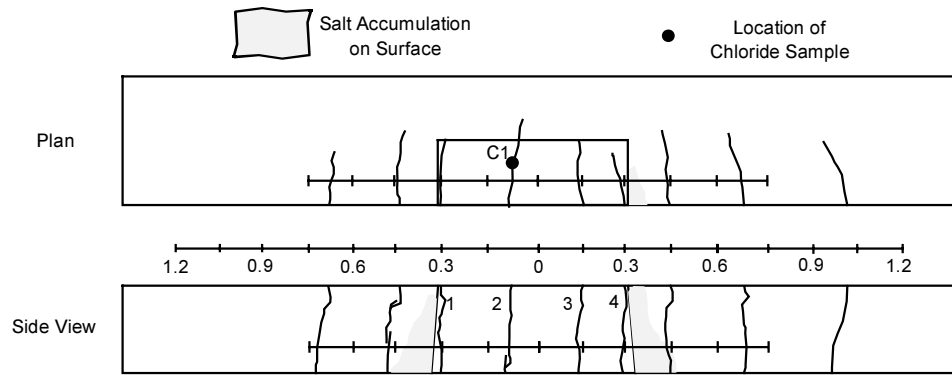
**Table A.8 Average crack width measurement for beam B13-L-CU-D(P).**

**Figure A.29** Surface condition of beam B13-L-CU-D(P) after one year of exposure.

| Beam No. | Bar Surface Condition | Coating Adhesion | Undercutting |
|---|---|---|---|
| B13-Upper | As B11-Lower but patched areas, cracking and blistering of coating. | Extensive debonding mostly on side facing cover. | Darker around than under patches, rust up to 50mm from crack. |

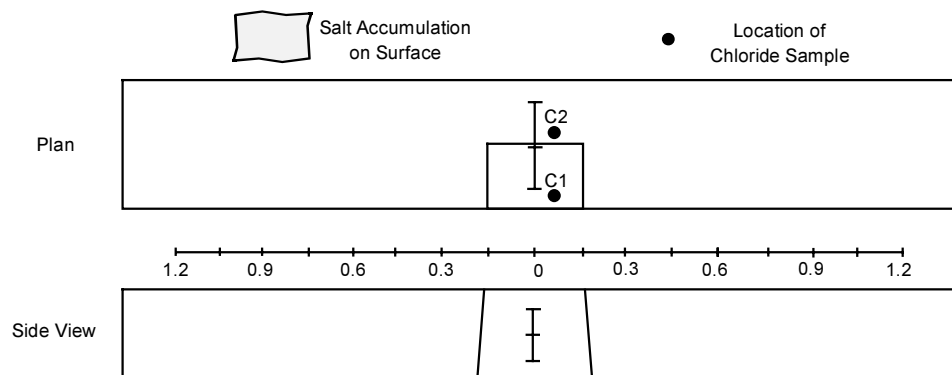
**Figure A.30** Surface condition of beam B16-ST-UU-AR after one year of exposure.

| Beam No. | Bar Surface Condition | Coating Adhesion | Undercutting |
|---|---|---|---|
| B16 | Corrosion spots, blisters and coating cracking of hook end near bottom concrete surface. | Poor bond at bent portions (more on outside) and some straight portions. | Mostly bright steel inside and dark outside of stirrup, rust along 90mm of hook end. |

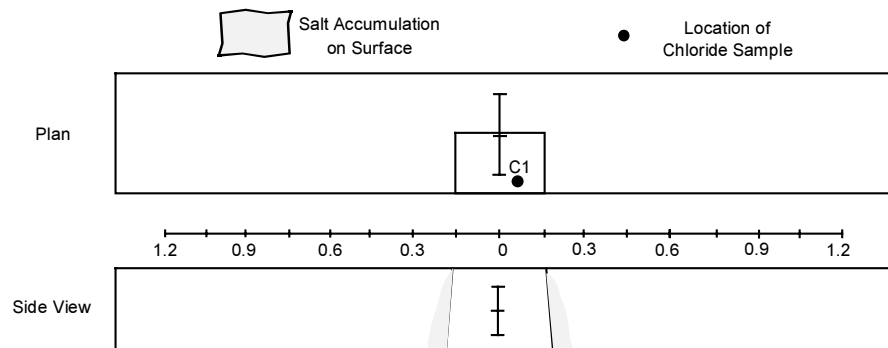
**Figure A.31** Surface condition of beam B21-ST-UU-AR(P) after one year of exposure.

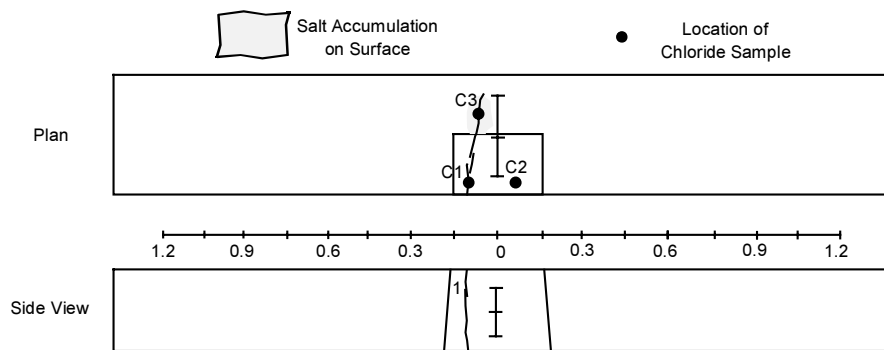
**Table A.9 Average crack width measurement for beam B18-ST-CU-AR.**

**Figure A.32 Surface condition of beam B18-ST-CU-AR after one year of exposure.**

| Beam No. | Bar Surface Condition | Coating Adhesion | Undercutting |
|---|---|---|---|
| B18 | Corrosion spots at areas of contact with uncoated bars, 10 small blisters. | Poor bond as B16 and to about 13mm from patched ends and along rust areas. | Rust along 0.22m near contact points with black bars, mostly dark steel elsewhere. |

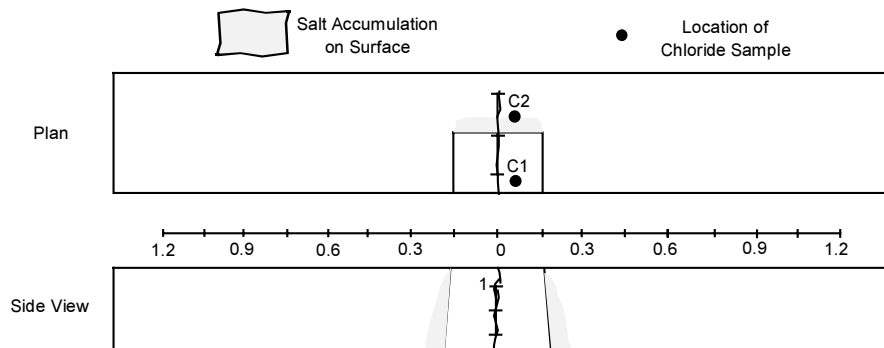
**Figure A.33 Surface condition of beam B20-ST-CL-AR after one year of exposure.**

| Beam No. | Bar Surface Condition | Coating Adhesion | Undercutting |
|---|---|---|---|
| B20 | Corrosion along continuous ribs at bend, longitudinal cracking of coating along hook end and inside bends. | As B16 and along rust areas, almost half length of stirrup. | As B16, corrosion concentrated along hook and leg closest to crack. |

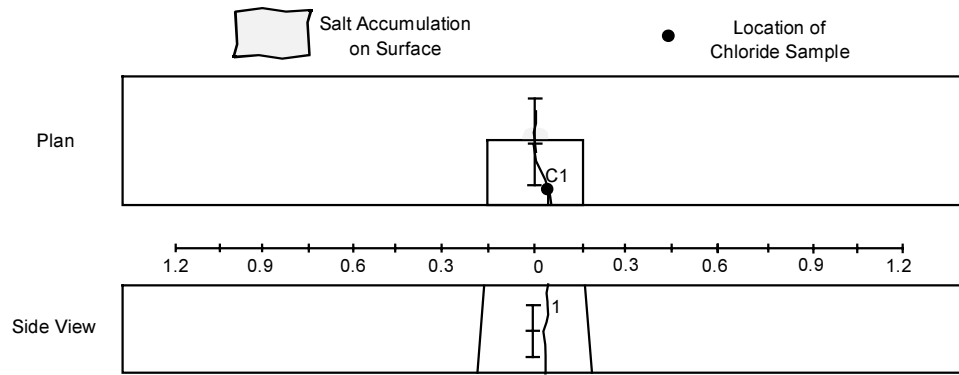
**Figure A.34** Surface condition of beam B26-ST-CL-AR(P) after one year of exposure.

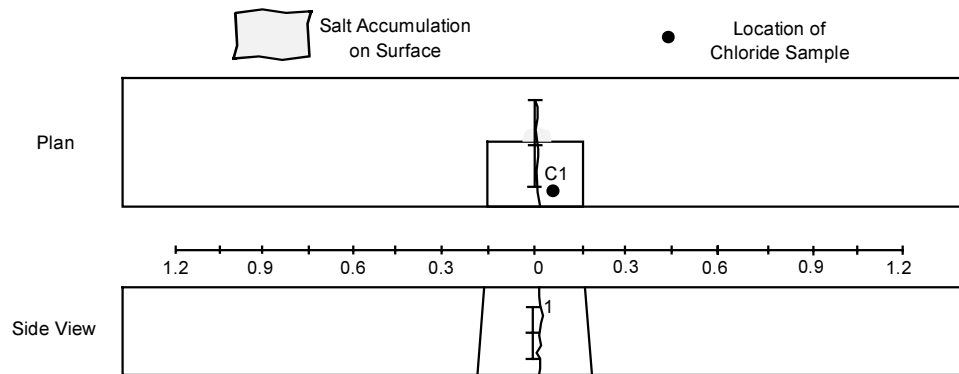
**Table A.10** Average crack width measurement for beam B24-ST-CU-AR(P).

**Figure A.35** Surface condition of beam B24-ST-CU-AR(P) after one year of exposure.

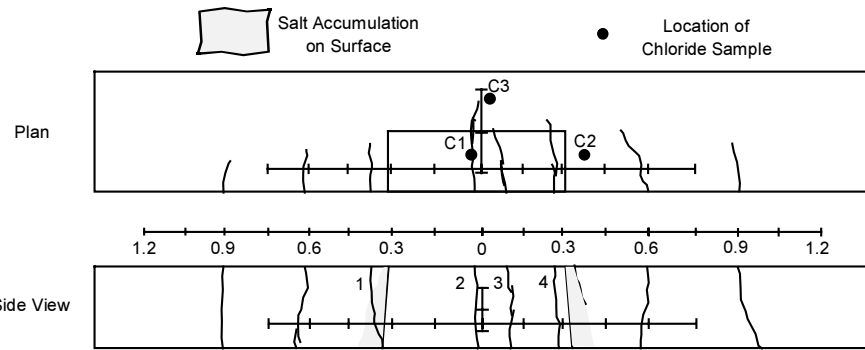
**Table A.12 Average crack width measurement for beam B29-L/ST-CU-D(P).**

**Figure A.37** Surface condition of beam B29-L/ST-CU-D(P) after one year of exposure.

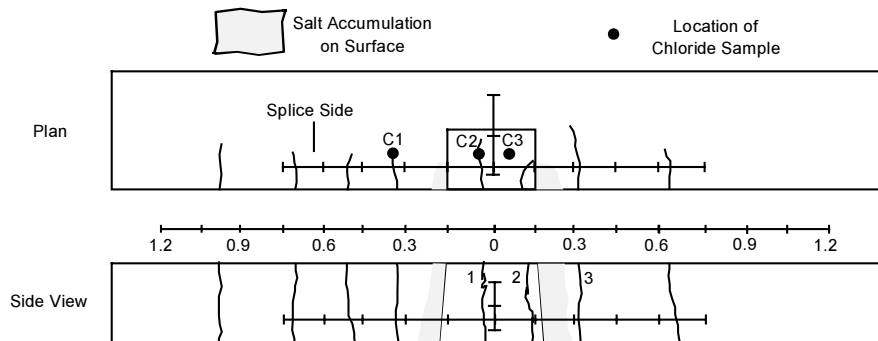
**Table A.13** Average crack width measurement for beam B31-SP-CU-D(P).

**Figure A.38** Surface condition of beam B31-SP-CU-D(P) after one year of exposure.

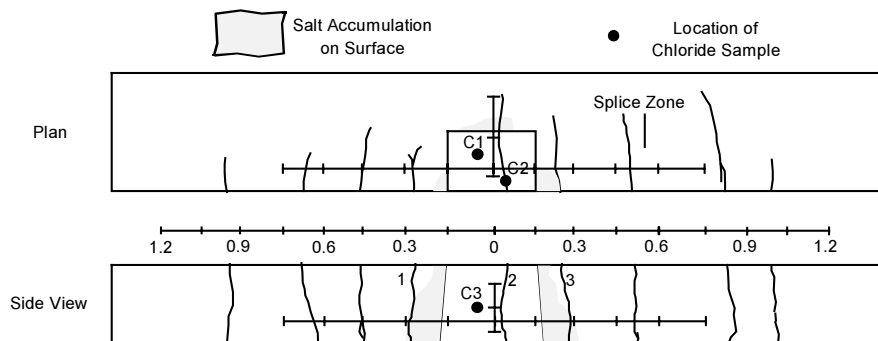
**Figure A.39** Surface condition of beam B33-SP-CU-D(P) after one year of exposure.

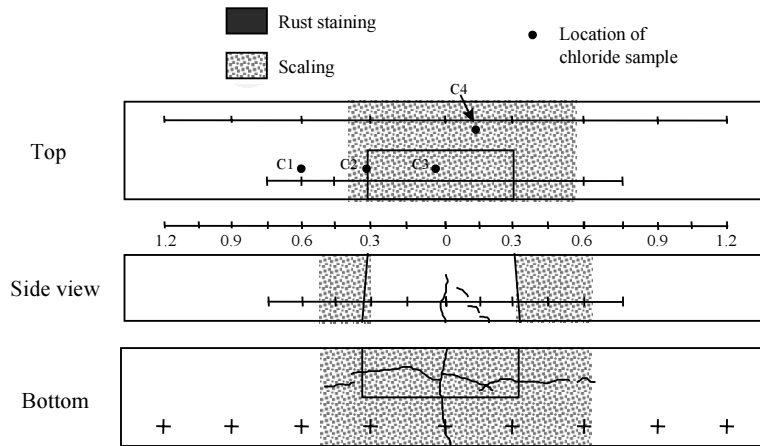
**Figure A.40** Surface condition of beam B1-L-UU-AR after 4.3 years of exposure.

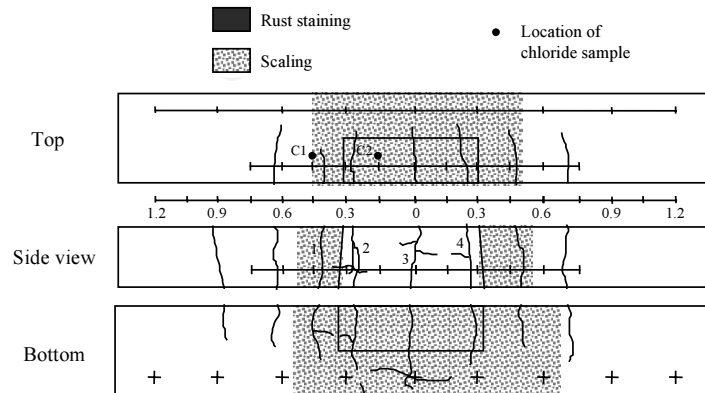
**Figure A.41** Surface condition of beam B3-L-CU-AR after 4.3 years of exposure.

**Table A.14 Average crack width measurement for beam B3-L-CU-AR.**

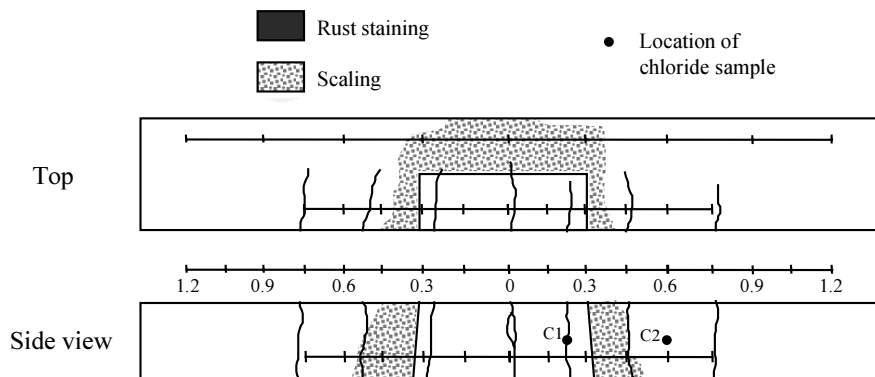
**Figure A.42 Surface condition of beam B6-L-CL-AR after 4.3 years of exposure.**

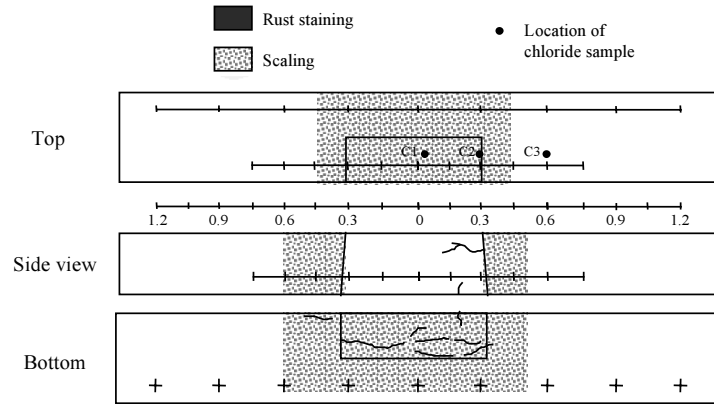
**Figure A.43** Surface condition of beam B8-L-UU-D after 4.3 years of exposure.

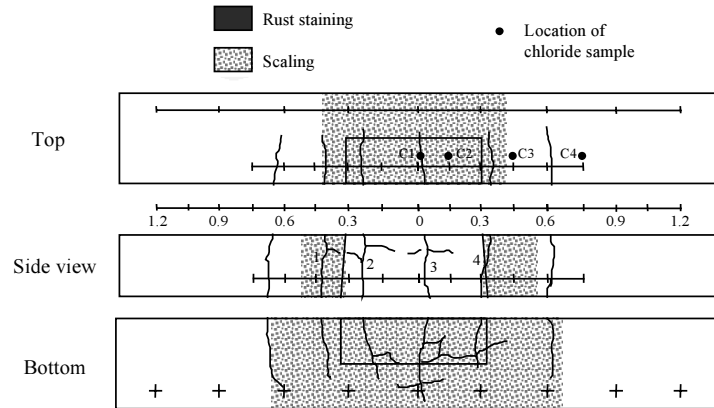
**Figure A.44** Surface condition of beam B10-L-CU-D after 4.3 years of exposure.

**Table A.15 Average crack width measurement for beam B10-L-CU-D.**

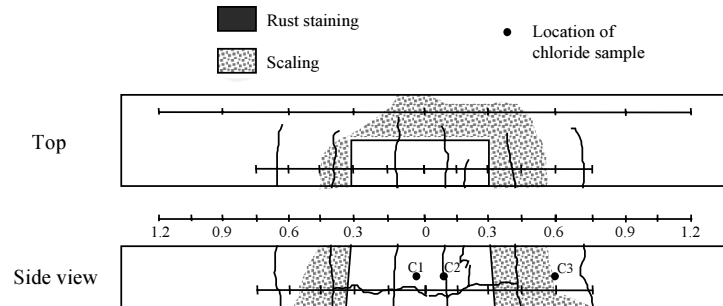
**Figure A.45 Surface condition of beam B12-L-CL-D after 4.3 years of exposure.**

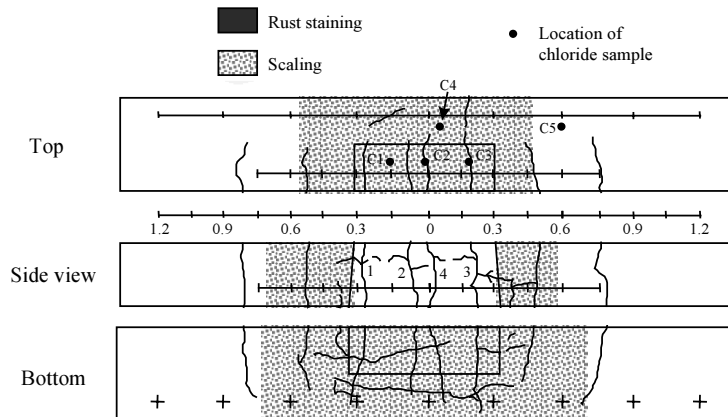
**Figure A.46 Surface condition of beam B14-L-CU-D(P) after 4.3 years of exposure.**

**Table A.16 Average crack width measurement for beam B14-L-CU-D(P).**

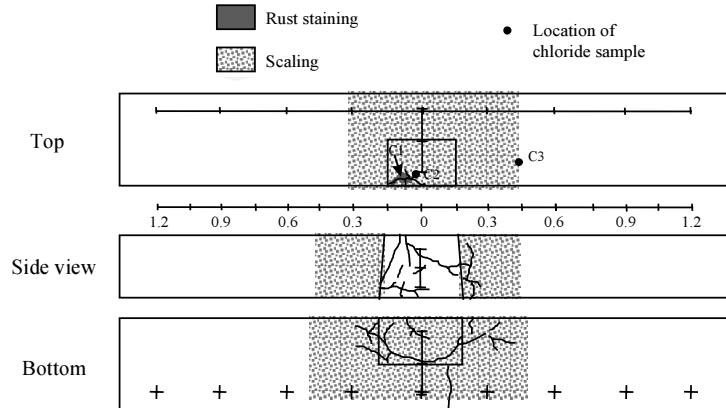
**Figure A.47 Surface condition of beam B15-ST-UU-AR after 4.3 years of exposure.**

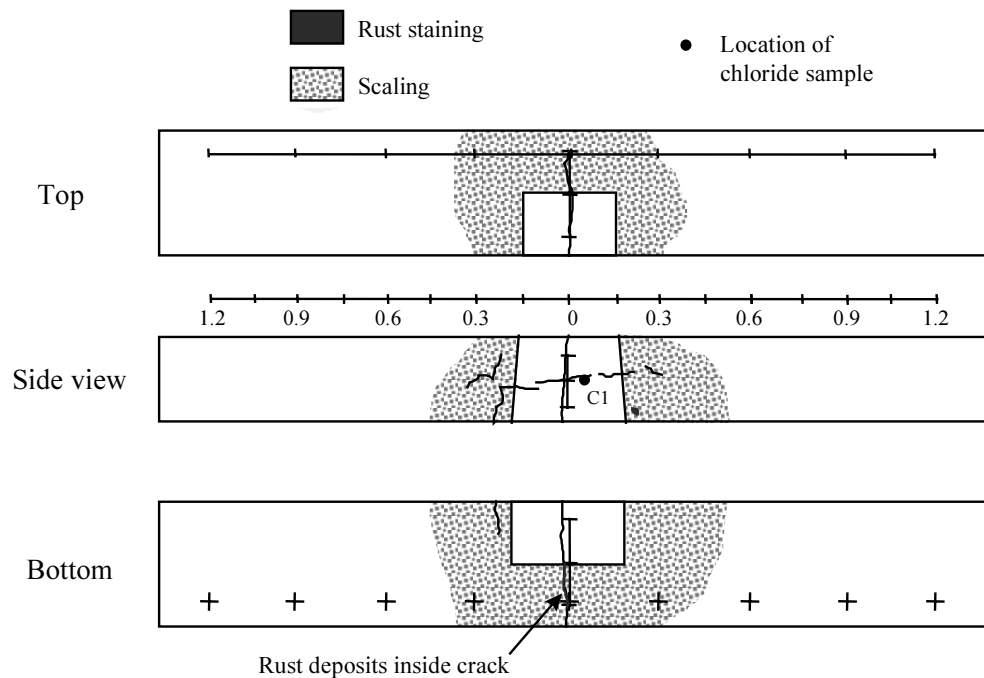
**Figure A.49** Surface condition of beam B19-ST-CL-AR after 4.3 years of exposure.

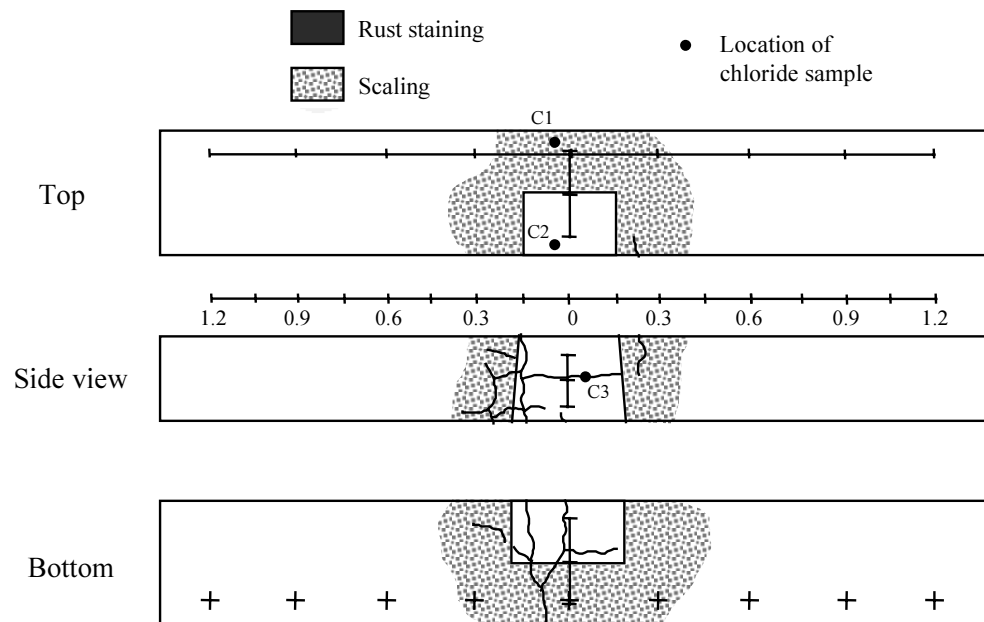
**Figure A.50** Surface condition of beam B22-ST-UU-AR(P) after 4.3 years of exposure.

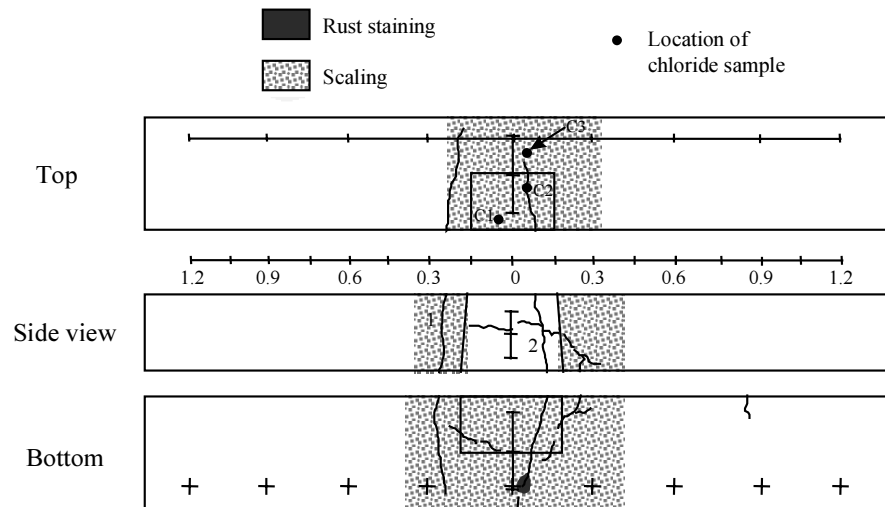
**Figure A.51** Surface condition of beam B23-ST-CU-AR(P) after 4.3 years of exposure.

**Table A.18** Average crack width measurement for beam B23-ST-CU-AR(P).

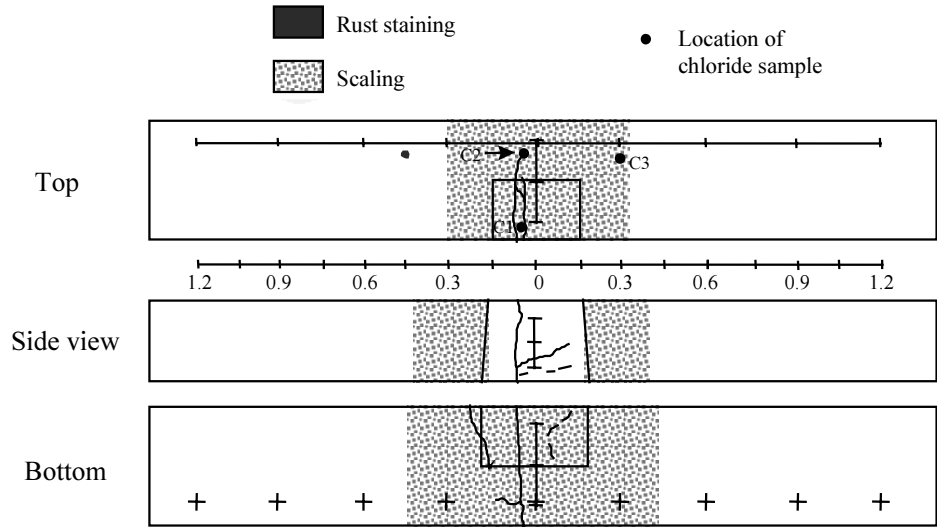
**Figure A.52** Surface condition of beam B25-ST-CL-AR(P) after 4.3 years of exposure.

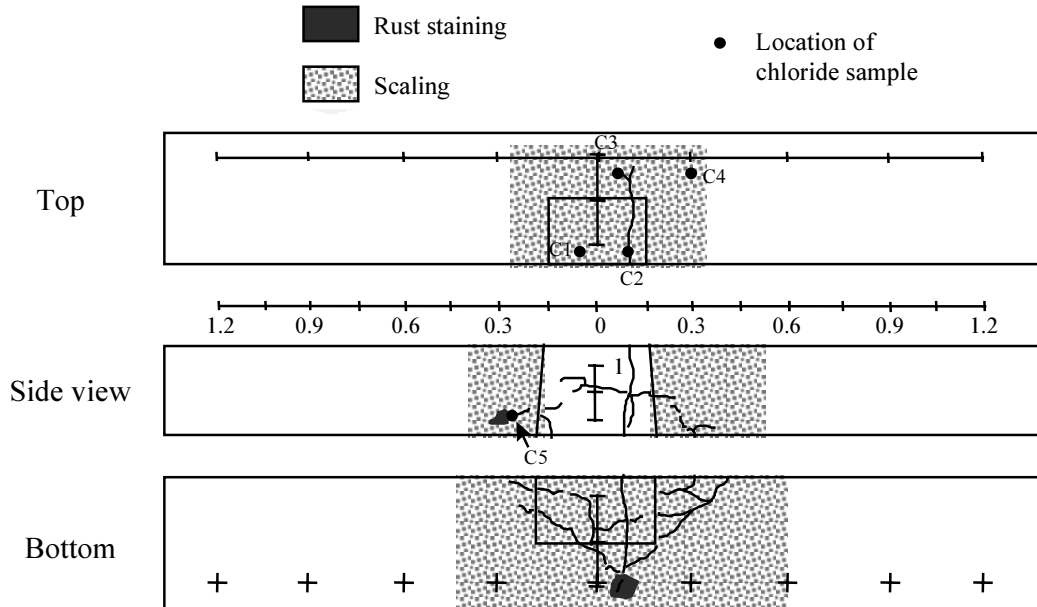
**Figure A.53** Surface condition of beam B27-ST-CU-D(P) after 4.3 years of exposure.

**Table A.19 Average crack width measurement for beam B27-ST-CU-D(P).**

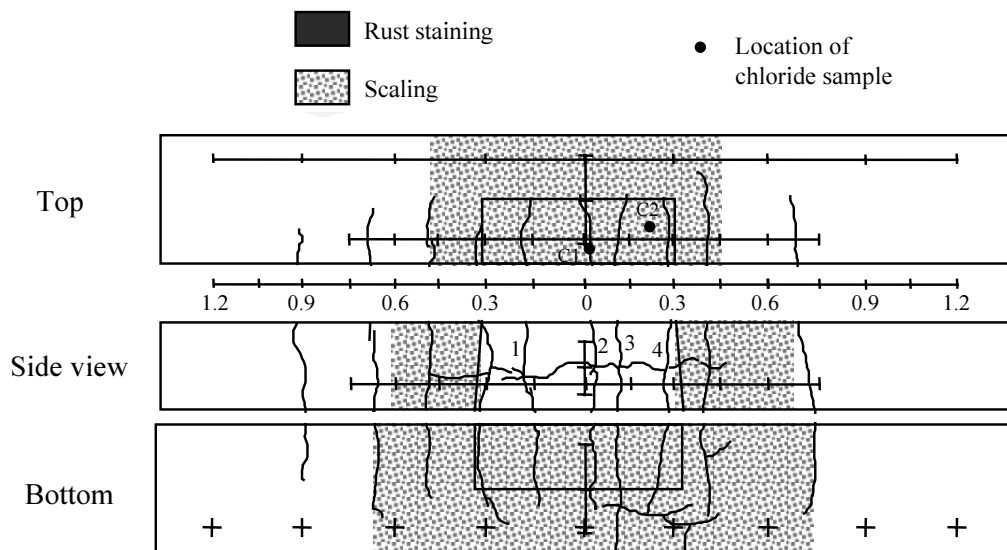
**Figure A.54 Surface condition of beam B30-L/ST-CU-D(P) after 4.3 years of exposure.**

**Table A.20 Average crack width measurement for beam B30-L/ST-CU-D(P).**

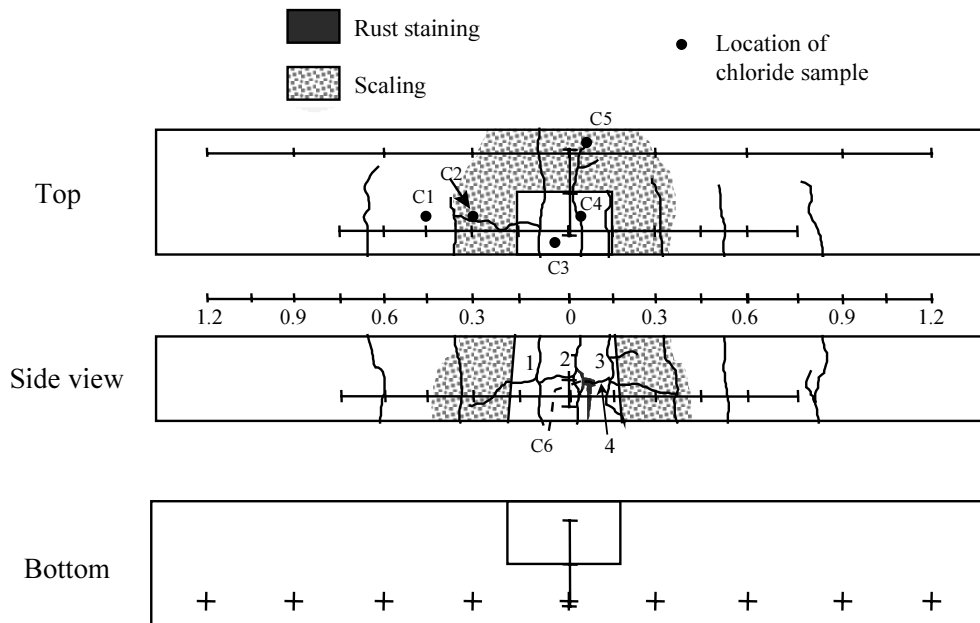
**Figure A.55 Surface condition of beam B32-SP-CU-D(P) after 4.3 years of exposure.**

**Table A.21 Average crack width measurement for beam B32-SP-CU-D(P).**

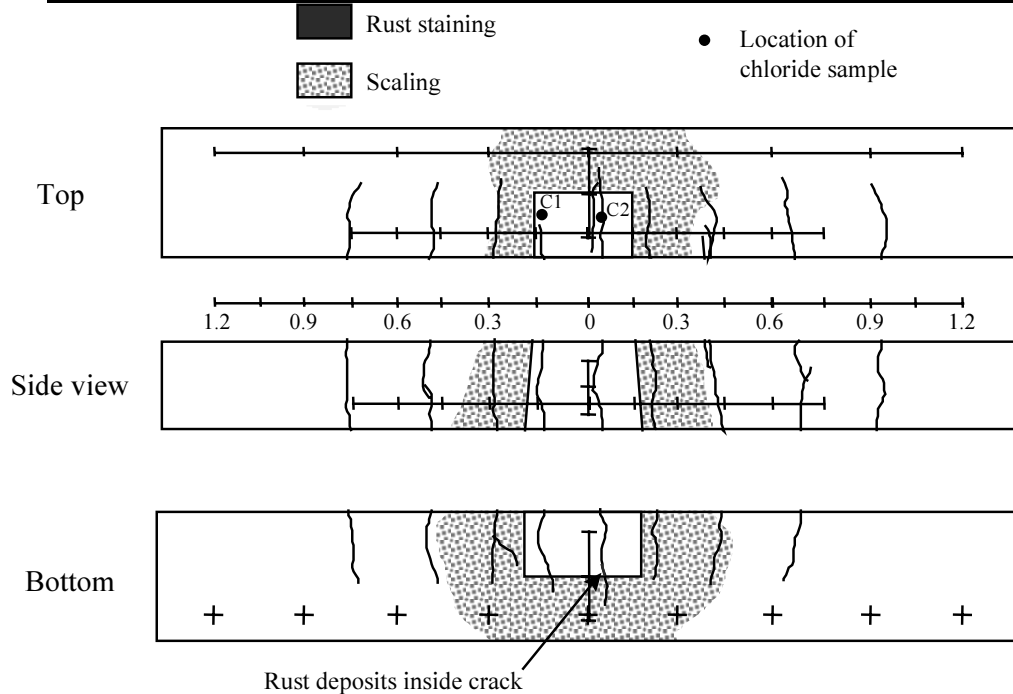
**Figure A.56 Surface condition of beam B34-SP-CL-D(P) after 4.3 years of exposure.**
