# Field Performance of Selected High-Performance Concrete Bridge Decks

Report 2941-3

Research Project 7-2941  
*Long-term Behavior of High-Performance Concrete Bridges*

**Annual Inspection**  
**Lubbock - July 10, 2002**  
**US HW 82/62 & FM 179**

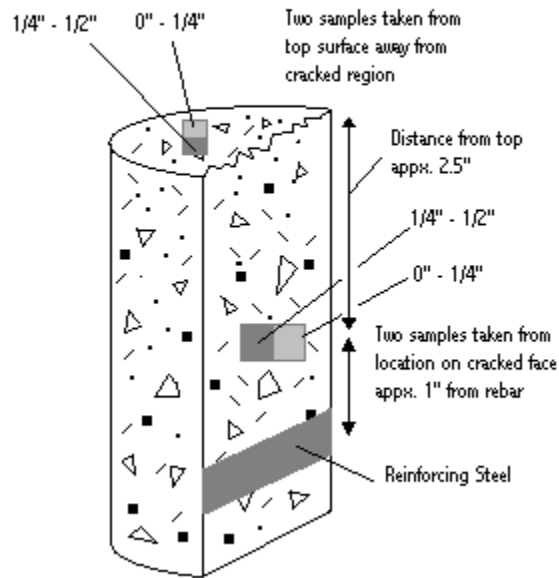
*Figure 11. Drill Locations for Sampling Procedure 1*

The percent Cl values were determined using the CL-500 test calibration graphs and graphed in Figure 11. For clarification, the prefix for each group indicates the core from which the sample was retrieved, and the suffix lettering indicates the two samples collected at each core.

It should be mentioned that the first sampling process with our limited number of specimens left the cores from the RM 1061 bridge too badly damaged to drill material with the required confidence of location and contamination to conduct the ASTM C 1152 chloride evaluation test procedure. The impact rotary drill disintegrated portions of these cores and made it impossible to say with certainty which locations were 1/2 in. above the rebar and 1/2 in. from the surface.

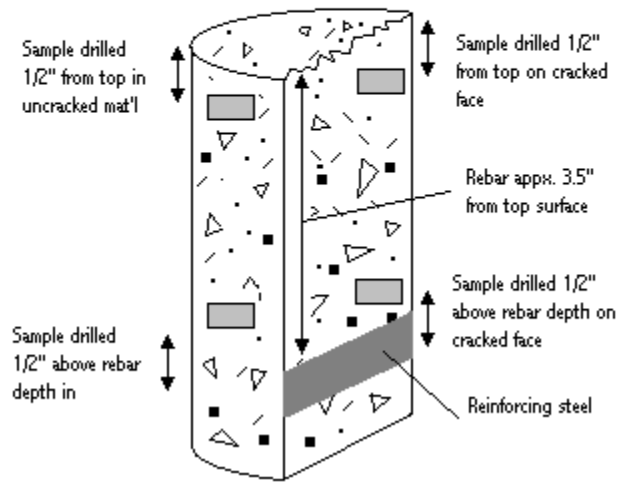
*Figure 13. Drill Locations for Sampling Procedure 2*

Later, it was determined that chloride content readings should also be recorded at depths closer to the rebar at the cracked section face, and compared with the equivalent depth in an uncracked portion of the deck. In this second procedure, samples were collected 1/2 in. above the rebar depth both inside the cracked surface and the exterior circumference of the core. Furthermore, samples were collected 1/2 in. from the top surface inside the crack face as well as the exterior. A diagram showing the location of these tests is presented in Figure 13 and the results can be found in Figure 14.
