SPECIAL RESEARCH REPORT

ANALYSIS OF VEHICLES USING THE
ENTRANCE RAMP FROM PEARL STREET
TO SOUTHBOUND IH 45

CENTER FOR TRANSPORTATION RESEARCH
BUREAU OF ENGINEERING RESEARCH
THE UNIVERSITY OF TEXAS AT AUSTIN

SEPTEMBER 1999

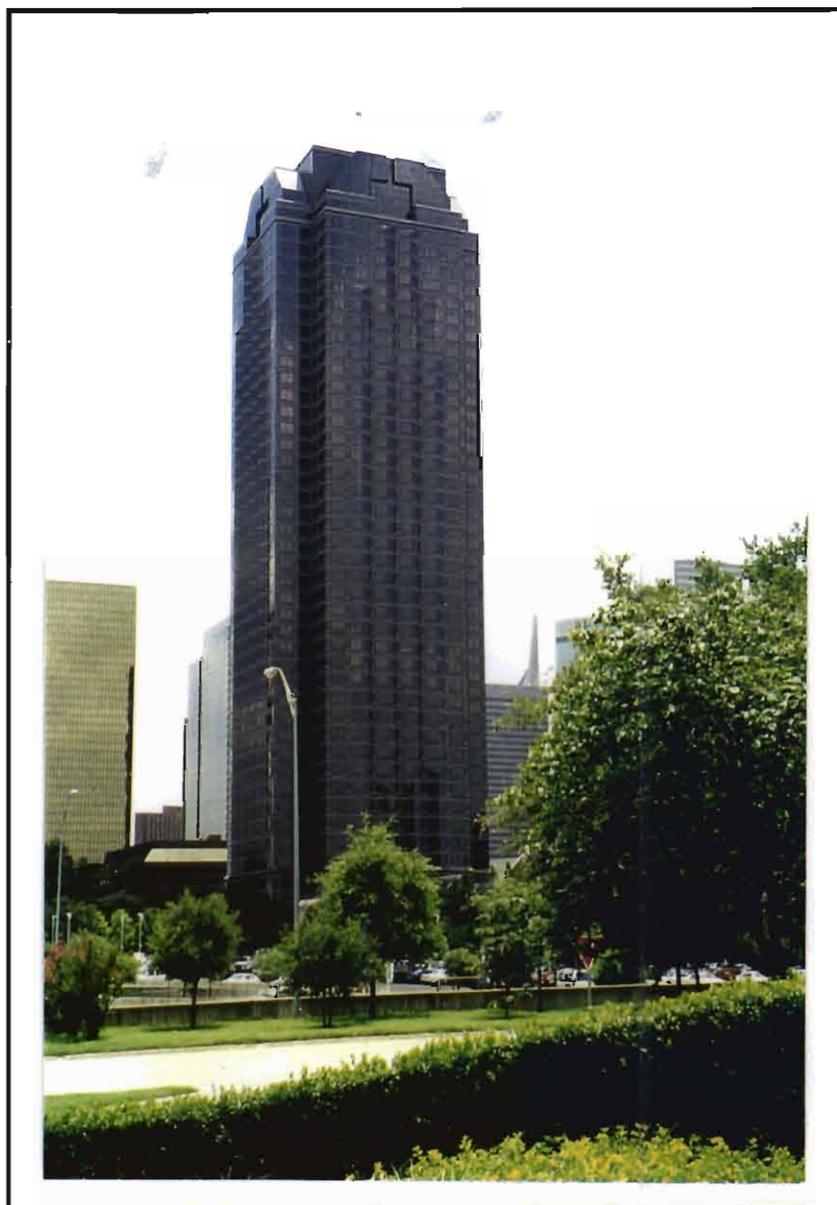
Photo 2. Trammell Crow Center. Video camera was located on the balcony of the 47th floor.

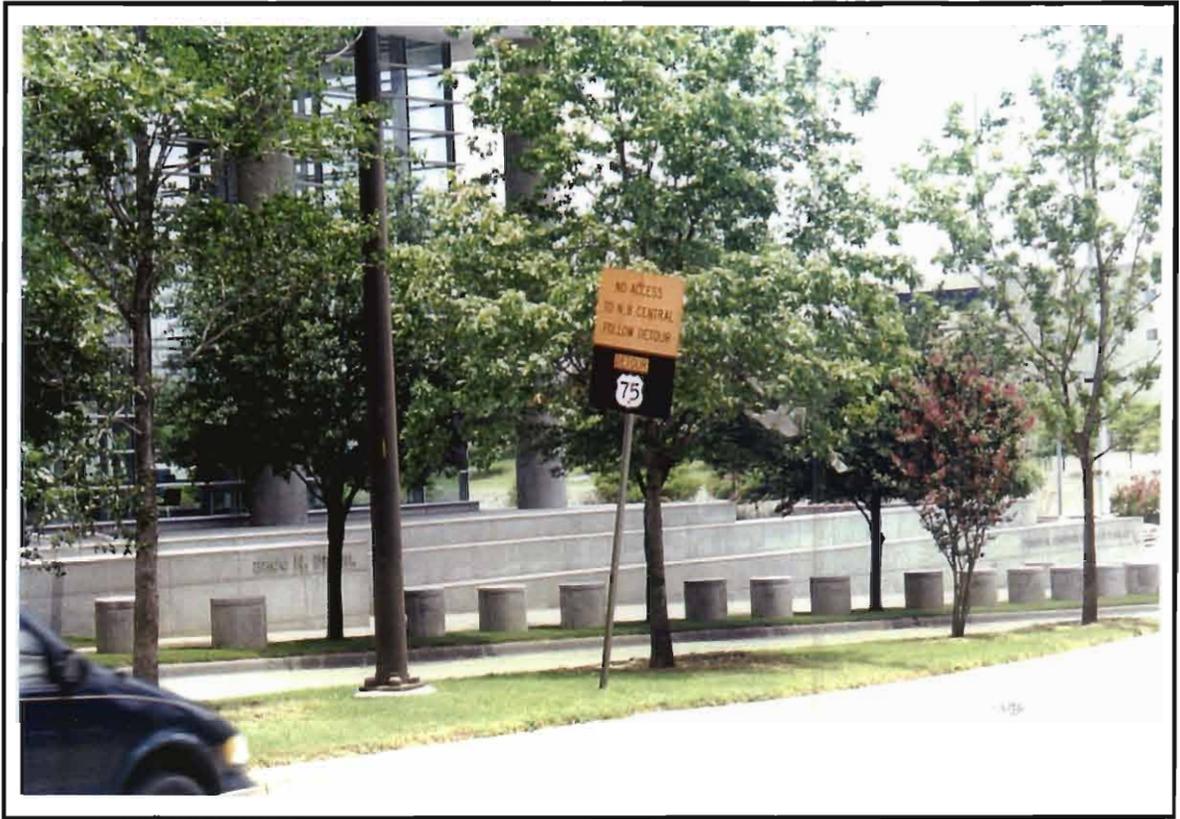
Photo 9. Detour notice on Pearl Street (directed to traffic coming from Howland Street and heading towards Woodall Rodgers Freeway).

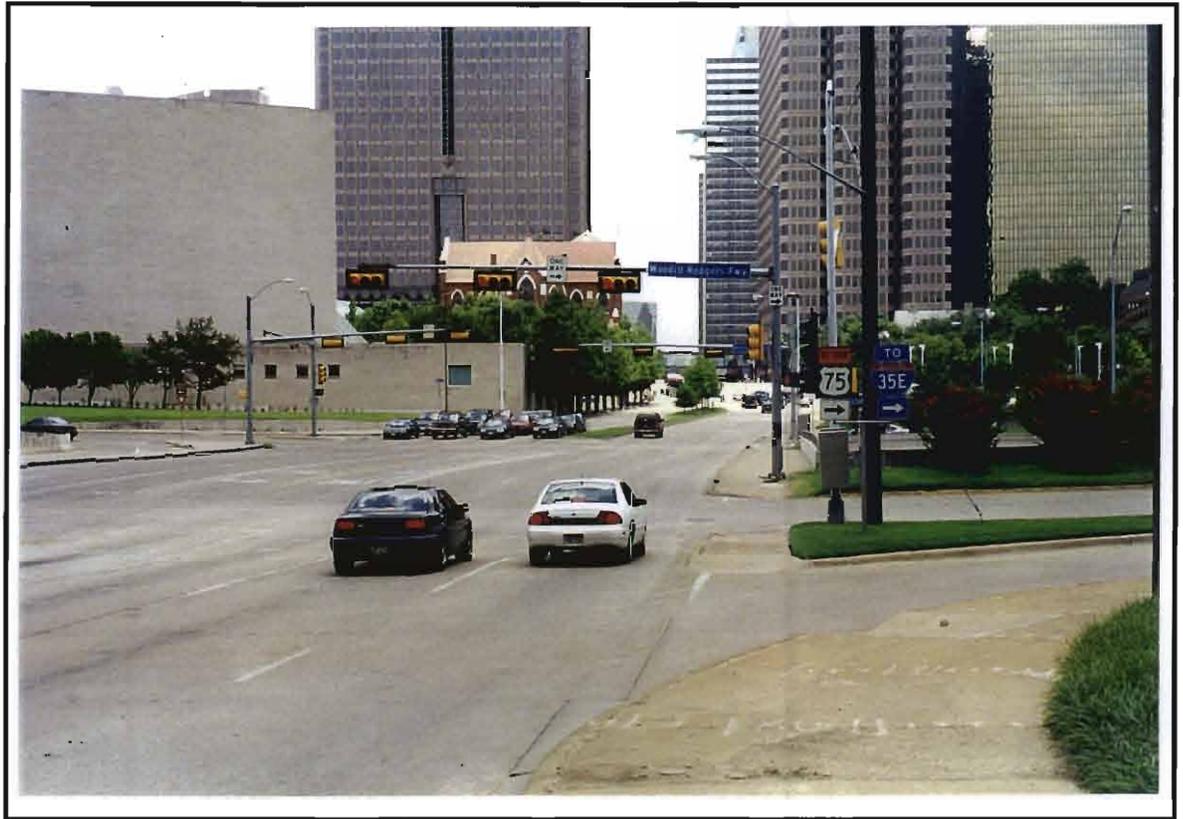
Photo 10. Existing road signs at the intersection of Pearl Street and frontage road of Woodall Rodgers Freeway (directed to traffic coming from Howland Street).
