RAPID SETTING CEMENT MORTARS FOR
CONCRETE REPAIR - FIELD TRIALS

Final Report

Materials and Tests Division
Texas Highway Department

3-09-71-020
January 1974

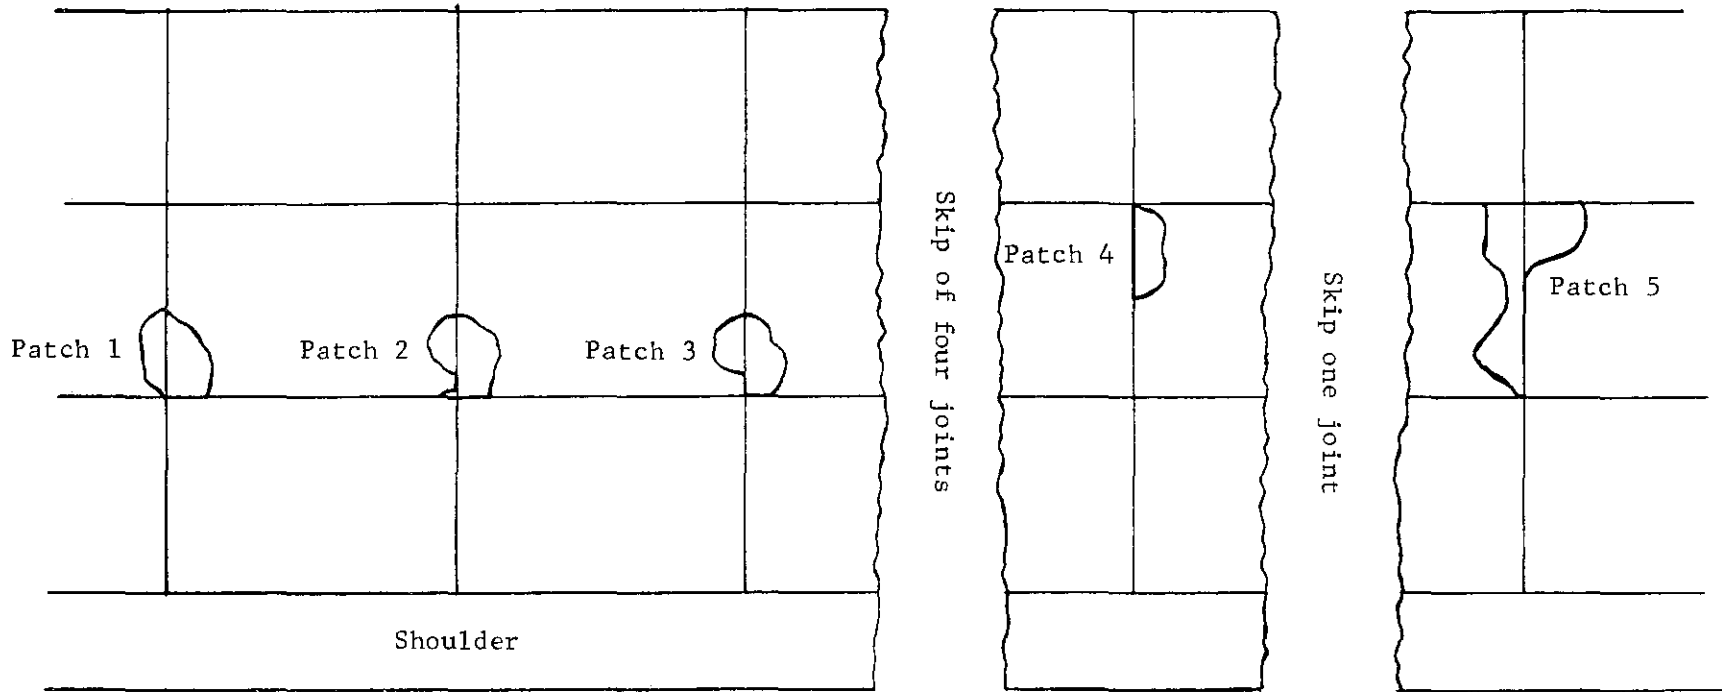
Location of Patches 1 through 5

Patch 1 is on 20th joint
West of Wirt Rd. Overpass

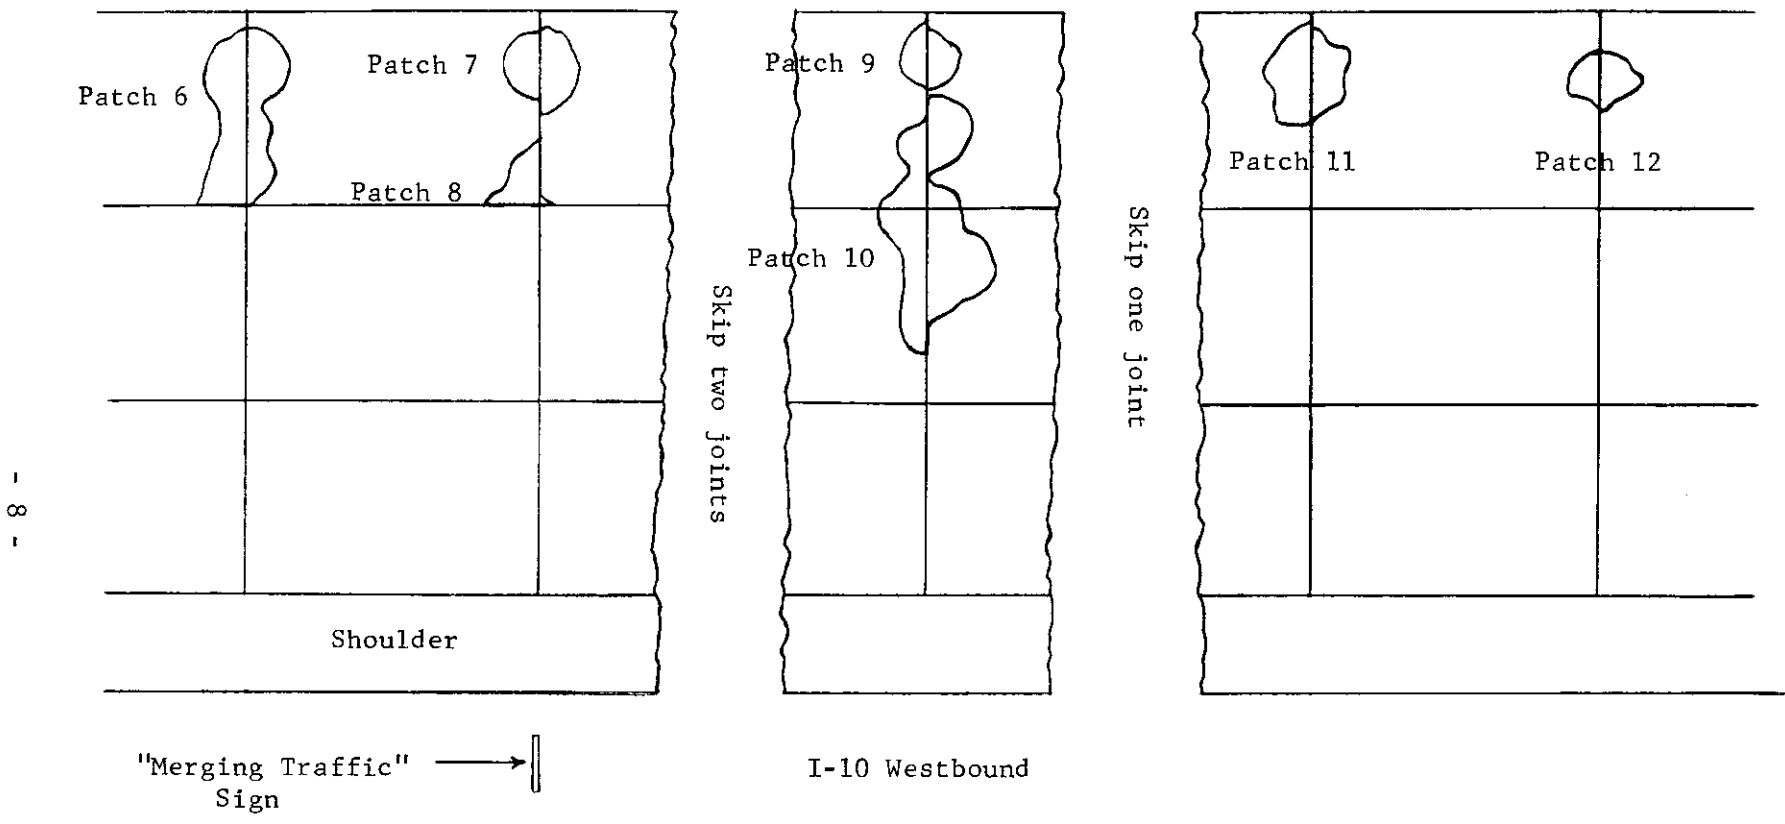
Figure 2
Location of Patches 6 through 12

Patch 6 is located just West of Campbell Road Overpass one joint East of "Merging Traffic" sign.
