EMBANKMENT SLOPE FAILURE PROBLEMS
IN DISTRICT 12

State Department of Highways and Public Transportation

May 1984

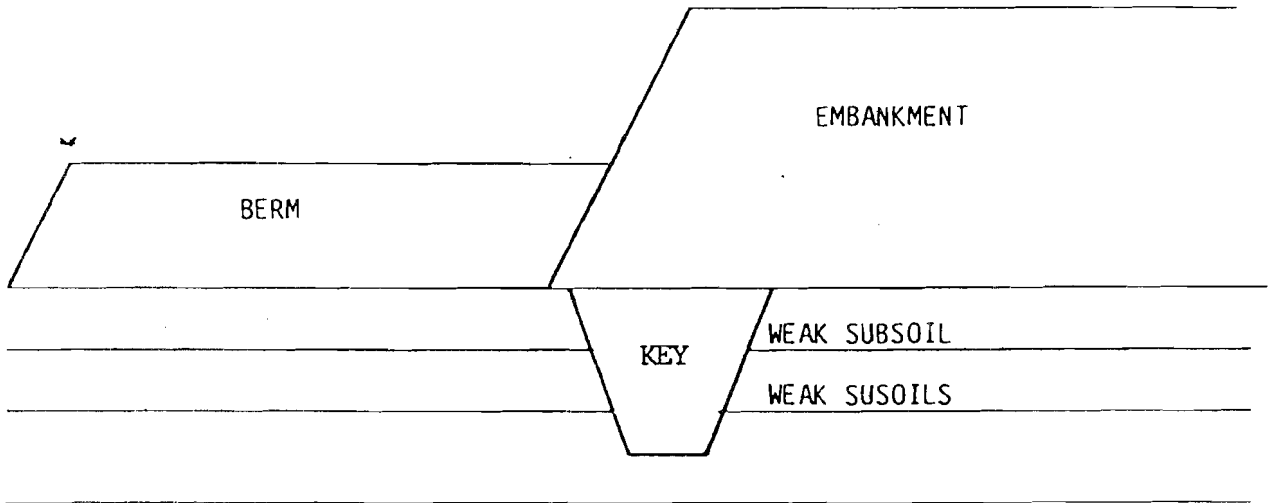
FIGURE 3

Another type of failure Andy mentioned pertained to the stability and strength of the sub-soil. As in the previous cases, an increase in the moisture content of the sub-soil will cause the shear strength to decline. The weight of the overburden will become too great for the weakened sub-soil to support that it will actually start "flowing" outward. This causes the embankment to settle or slip (Figure 2). Also, low cohesive soil strength will cause the sub-soil to fail.

1. Providing adequate drainage of surface and subsurface water to prevent an influx of water into the sub-soil.
2. Putting in some type of berm to increase the resistance for lateral movement (See Figure 3).
3. Placement of a "key" into the sub-soil that will act as a sort of "dam" to prevent the material from flowing (Figure 3).
