1. Report No.		2. Government Accession No.		3. Recipient's Catalog No.	
4. Title and Subtitle Crash Tests of Rural Mailbox Installations				5. Report Date Revised February November 1978 1979

7. Author(s) Ross, Hayes E., Jr., and Walker, Kenneth C.				6. Performing Organization Code	
9. Performing Organization Name and Address Texas A&M Research Foundation Texas Transportation Institute Texas A&M University College Station, Tx 77843				8. Performing Organization Report No. 3254-6

16. Abstract Five full-scale crash tests were conducted to evaluate the impact behavior of rural mailbox installations. Three of the five tests involved commonly used wood post supports, two of which were single box installations and the third was a four-box installation. The other two tests involved two promising new support concepts which utilized standard steel pipe. Both tests involved single box installations. Results showed that installations with multiple boxes mounted on boards pose a serious hazard to motorists since the board can easily penetrate the windshield. The results also showed that a pipe support post performs in a more desirable manner than does a wood post. Careful attention must be g

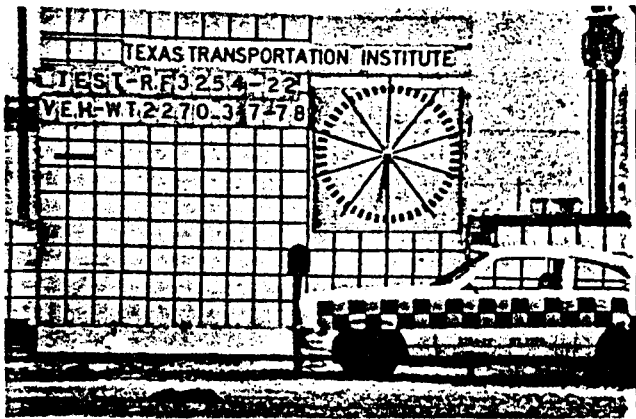
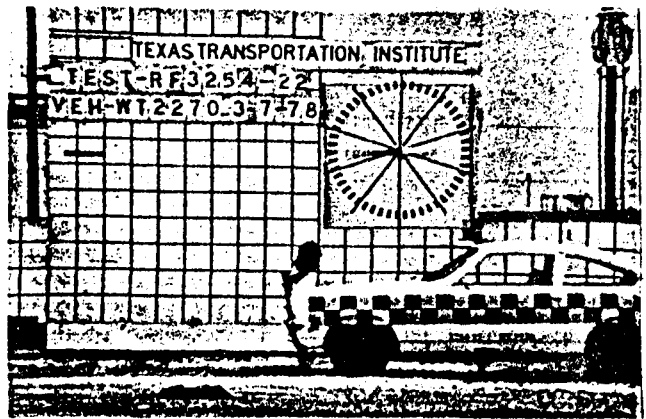
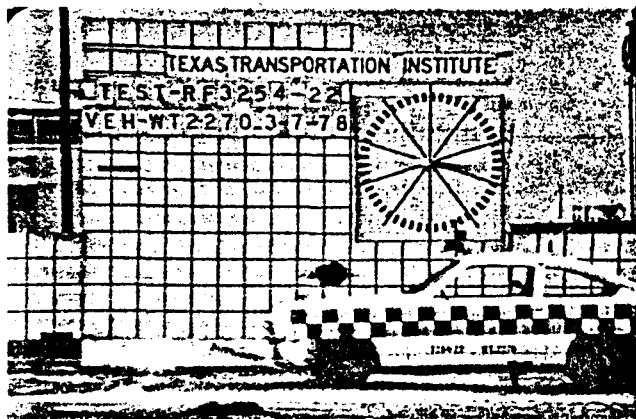
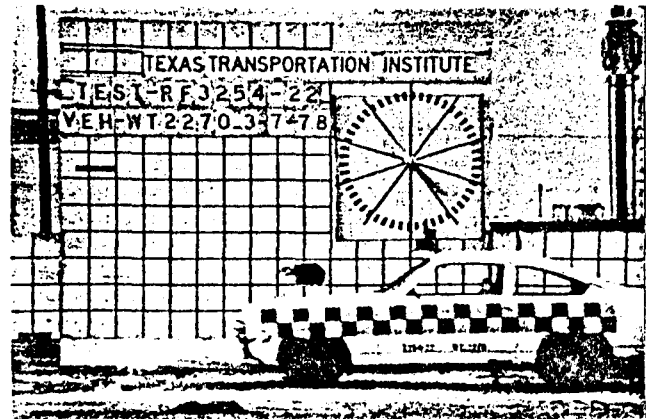
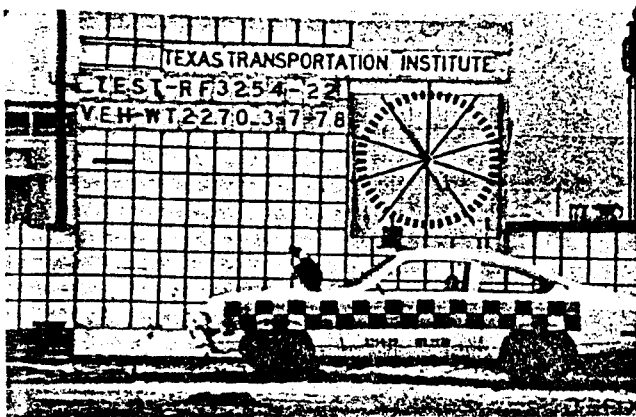
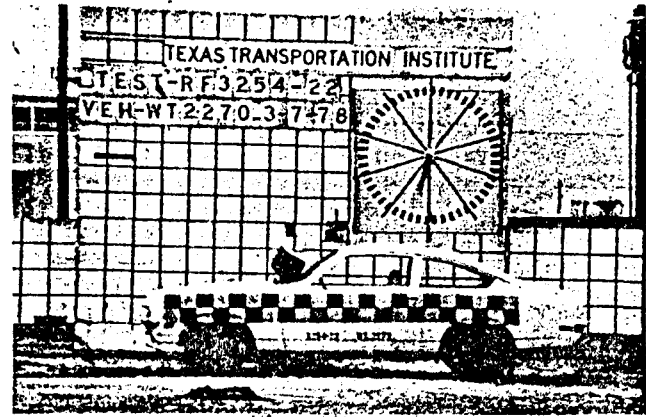
Figure 18. Sequential photos, test 22.

Almost immediately after impact the mailbox, mailbox base, and base braces separated from the post. Shortly thereafter the post broke away at ground level. Because of its inertia, the mailbox and timber cap remained almost stationary as the post broke away, until striking the top of the hood and rolling into the windshield. The box broke and dished the windshield and bent the moulding above the windshield. However, the box did not penetrate through into the passenger compartment. Figures 22 and 23 show the damage to the post, base, and mailbox. Other than a broken windshield, the vehicle sustained only minor damage as can be seen in Figure 24.

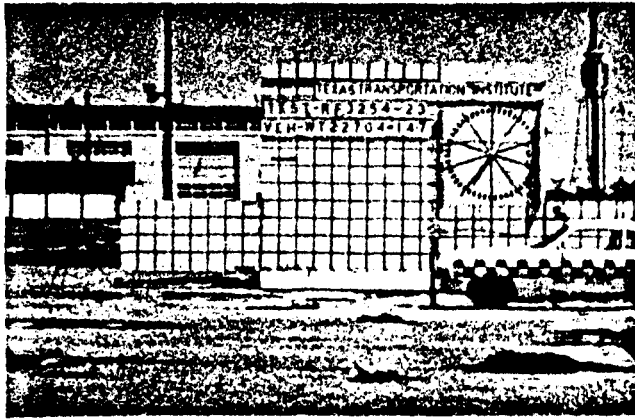
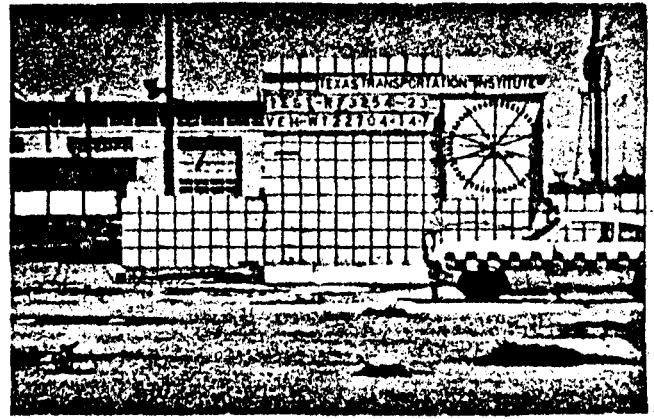
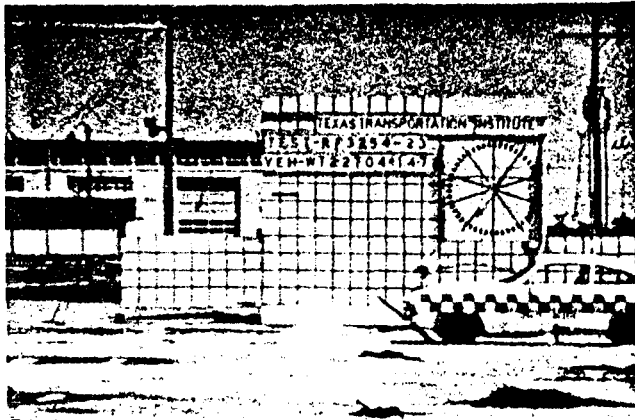
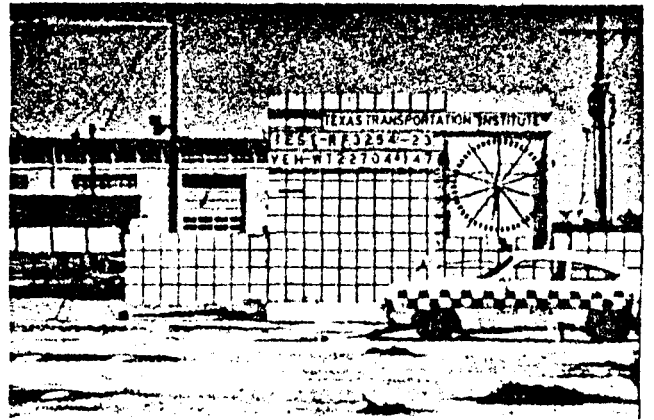
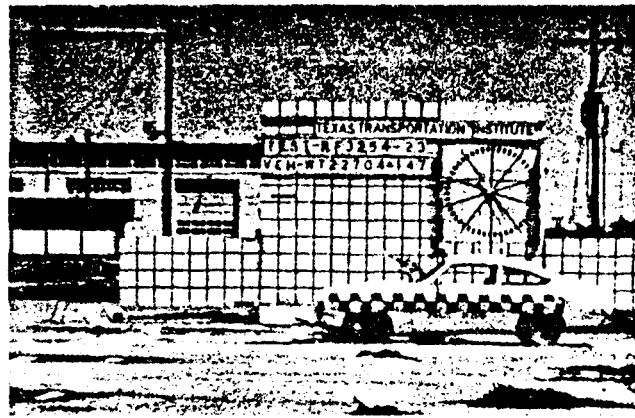
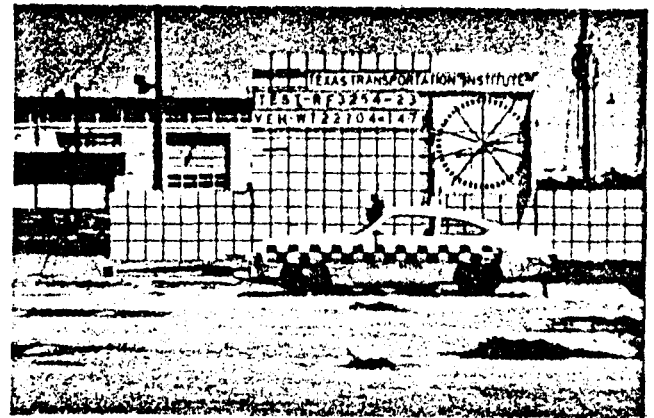
Figure 25. Sequential photos, test 23.

Upon impact the post split at the top where the connecting straps were attached to the post, then broke on the side away from impact. The mailbox and timber cap gained little velocity during the initial impact. After the support broke at ground level, the vehicle continued moving forward, and the mailbox impacted and broke the windshield. However, the box did not penetrate through to the passenger compartment. Damage to the support and mailbox is shown in Figures 29 and 30, and Figure 31 shows vehicle damage after test 23.

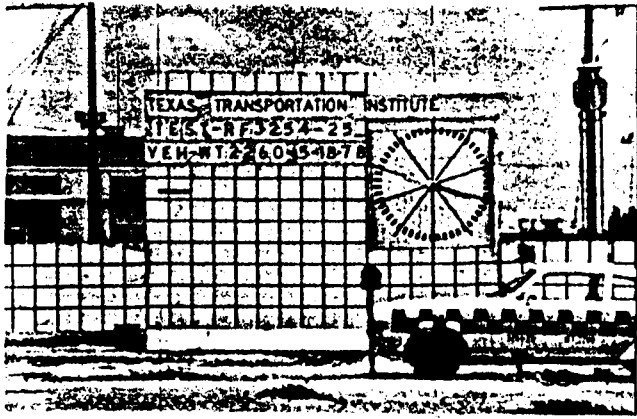
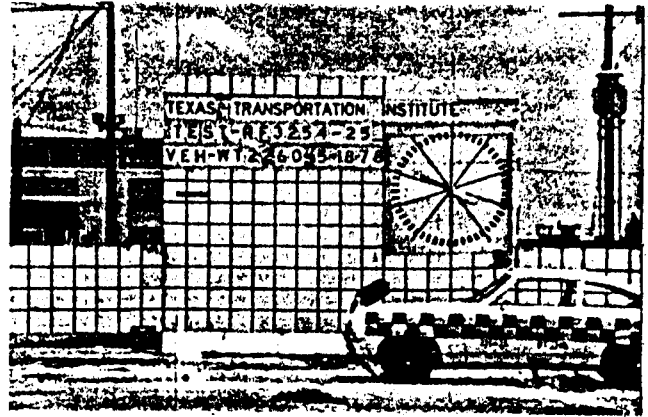
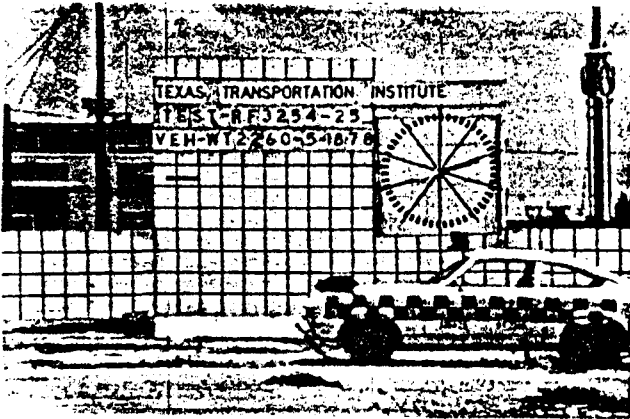
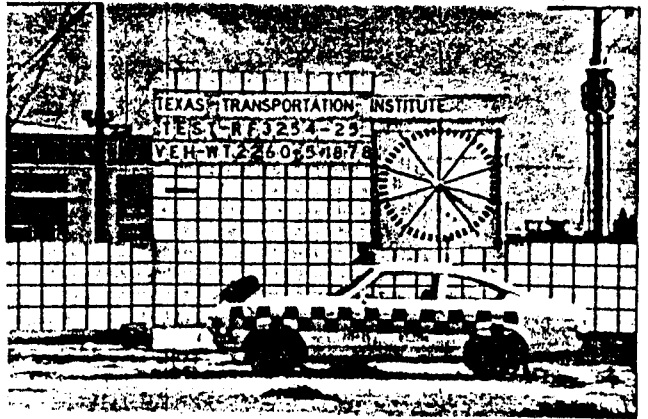
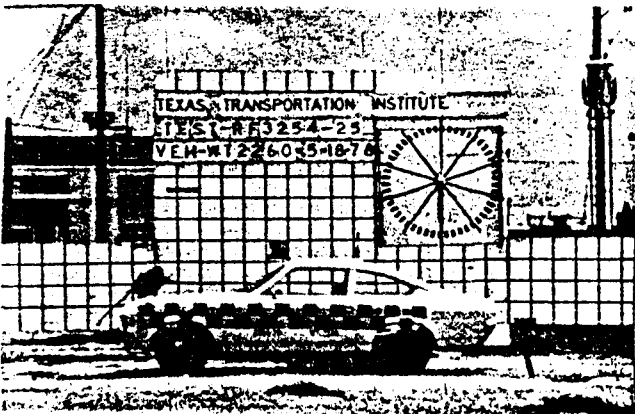
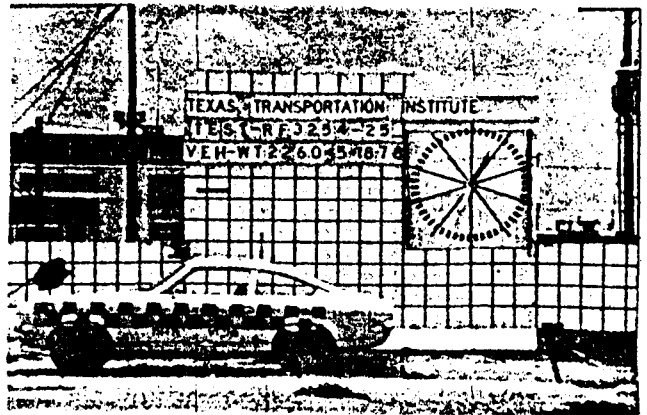
Figure 39. Sequential photos, test 25.

This was the first test in which the windshield was not struck by some part of the mailbox or its support. Although the mailbox broke free of the support, it remained intact long enough to attain a velocity approximately equal that of the vehicle. As a result, the mailbox rode along on the hood and harmlessly fell away. Investigation of the bracket-to-post connection showed that the lock nut threads stripped, allowing the box to separate from the post. Two lock nuts on the top of the bracket would have likely prevented this separation (see test 26 description). The support and mailbox were too badly damaged to be reused. However the anchor post was not damaged and could be reused. Damage to this system is pictured in Figure 43. Note that the shear bolt fractured as designed, retaining the post but allowing it to rotate downward. Vehicle damage was minimal as can be seen in Figure 44.
