SECOND ANNUAL REPORT
ON
EXPERIMENTAL NOISE BARRIER WALL
US-59 SOUTHWEST FREEWAY
RICE AVENUE TO CHIMNEY ROCK ROAD
LARCHMONT SUBDIVISION

EXPERIMENTAL PROJECT NUMBER TX-89-06
CONSTRUCTION PROJECT NUMBER MA-F514 (90)

AUGUST 1992

SECOND ANNUAL REPORT

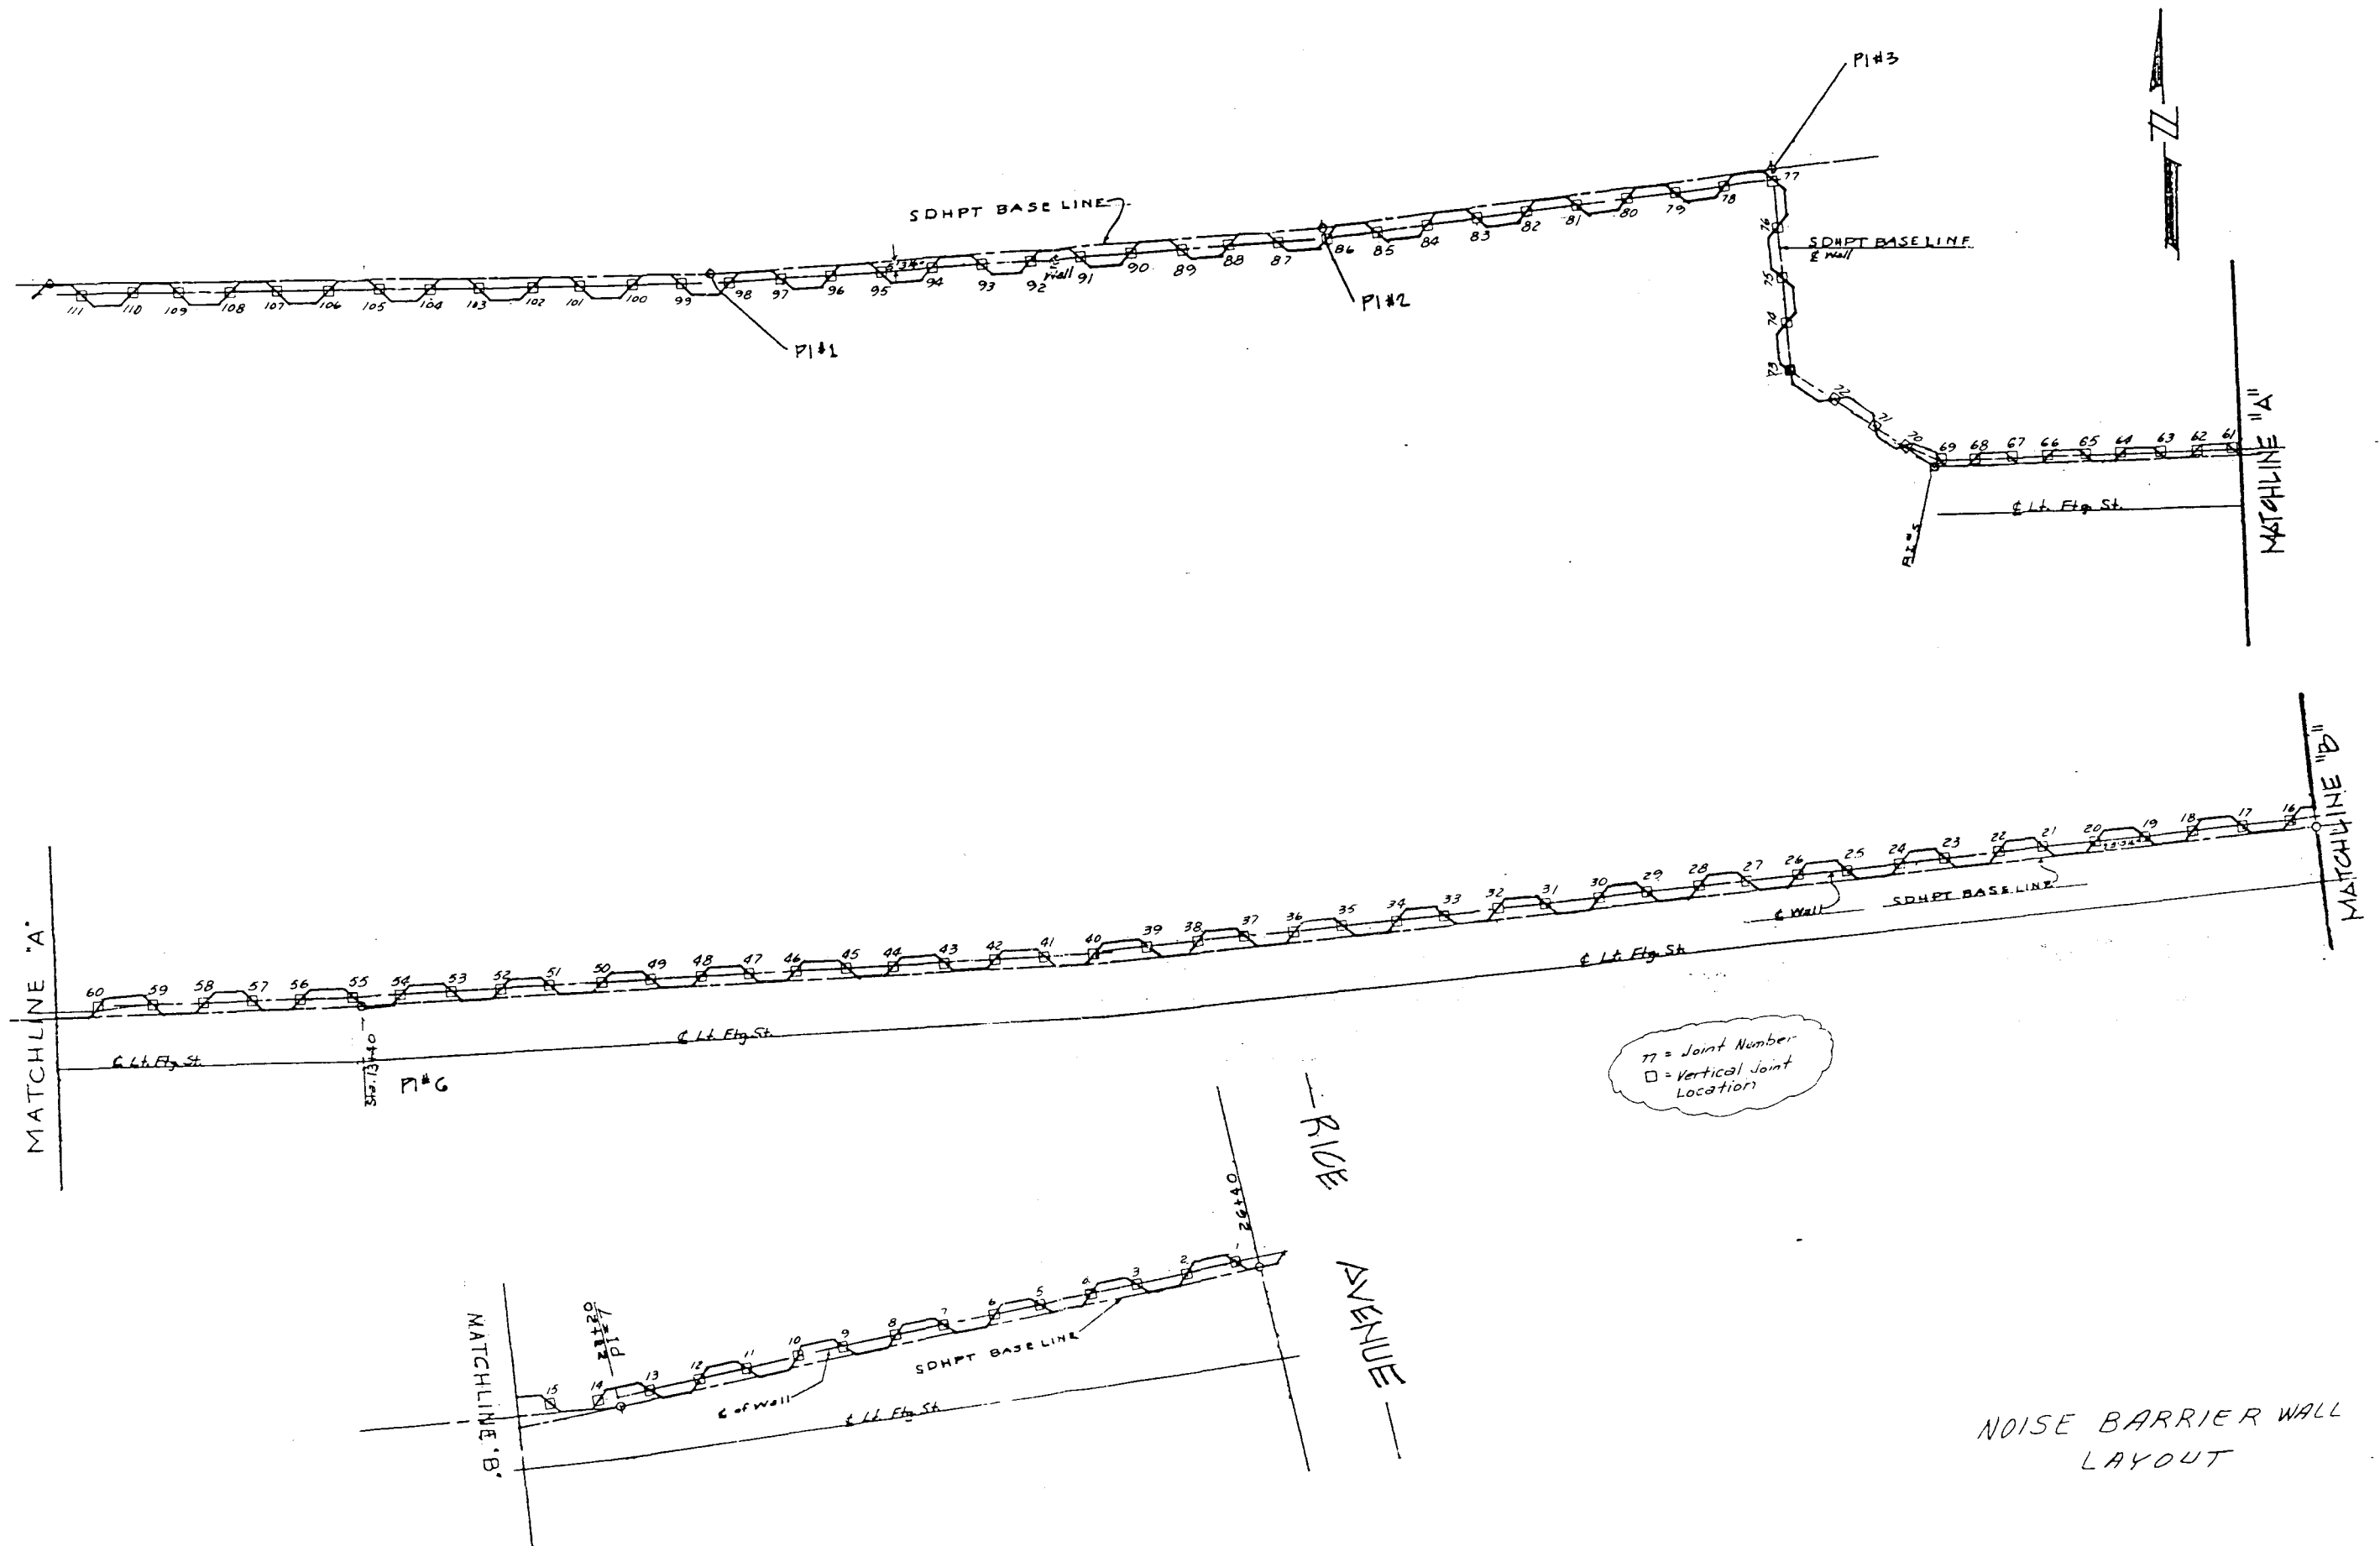
NOISE BARRIER WALL LAYOUT

No cracks were observed at the interior prestressing cables which are located at the 45° bends in each panel. Refer to Noise Barrier Wall Layout, and Plan and elevation sheets.
