**FREWAY OPERATIONS STUDIES
WORK ORDER # 14
CONTRACT No. (86) 06-03-A3-AG
(58545P5007)**

**IH-820 AT RUFÉ SNOW DRIVE
IH-820 AT WHITE SETTLEMENT ROAD
IH-35W AT NORTHSIDE DRIVE**

**SUBMITTED BY
TRAFFIC ENGINEERS, INC.
FORT WORTH, TEXAS
AUGUST 1986**

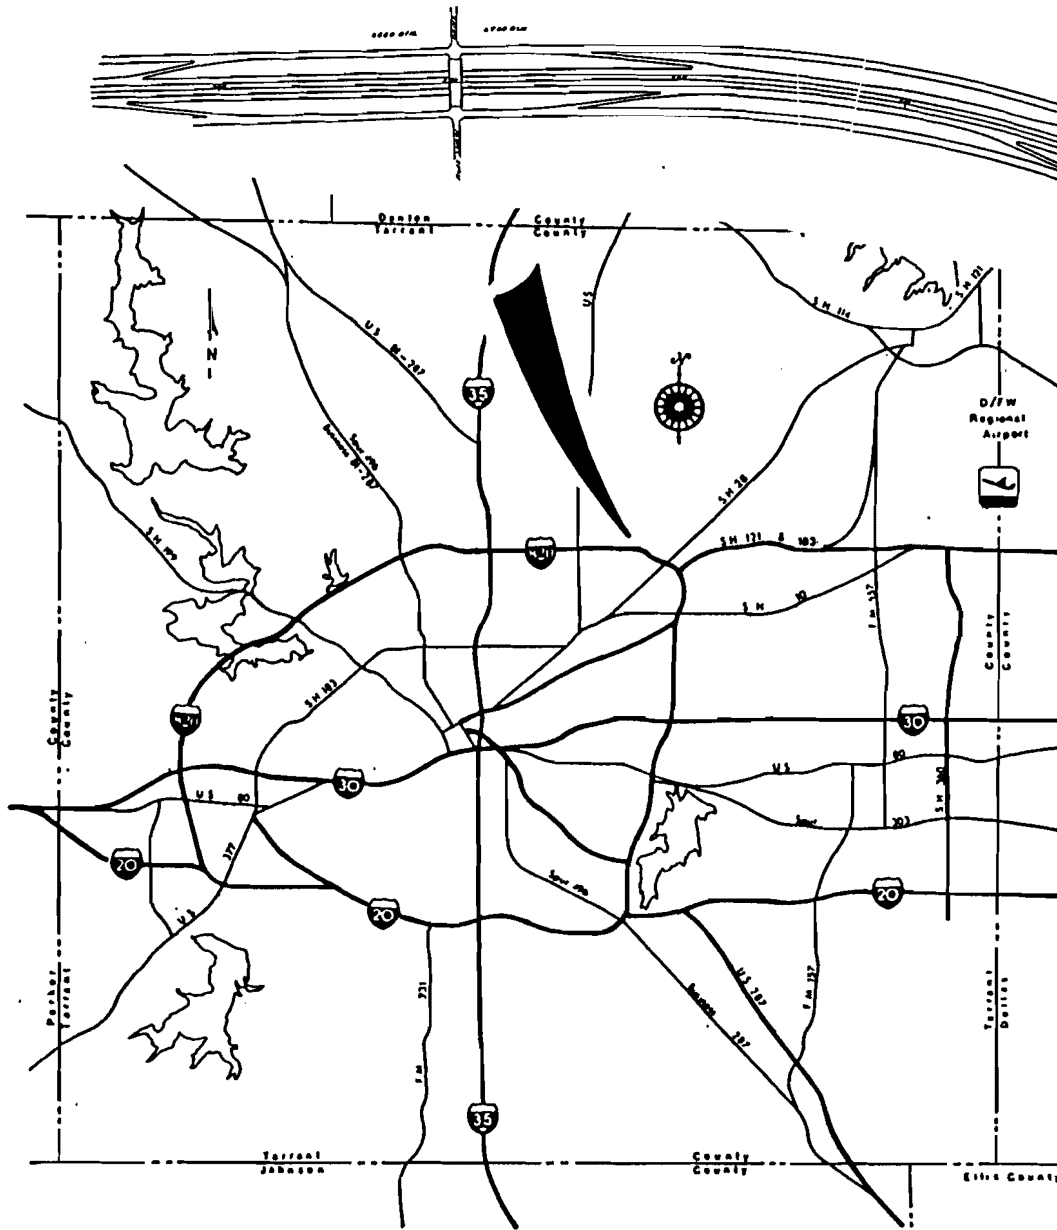
FIGURE 1

The subject problem location is at the diamond interchange of IH-820 and Rufe Snow. It serves as a major north-south arterial for North Richland Hills with major retail development immediately north of the interchange and residential areas to the south and the north. Figure 1 schematically shows the geometrics of the study area.

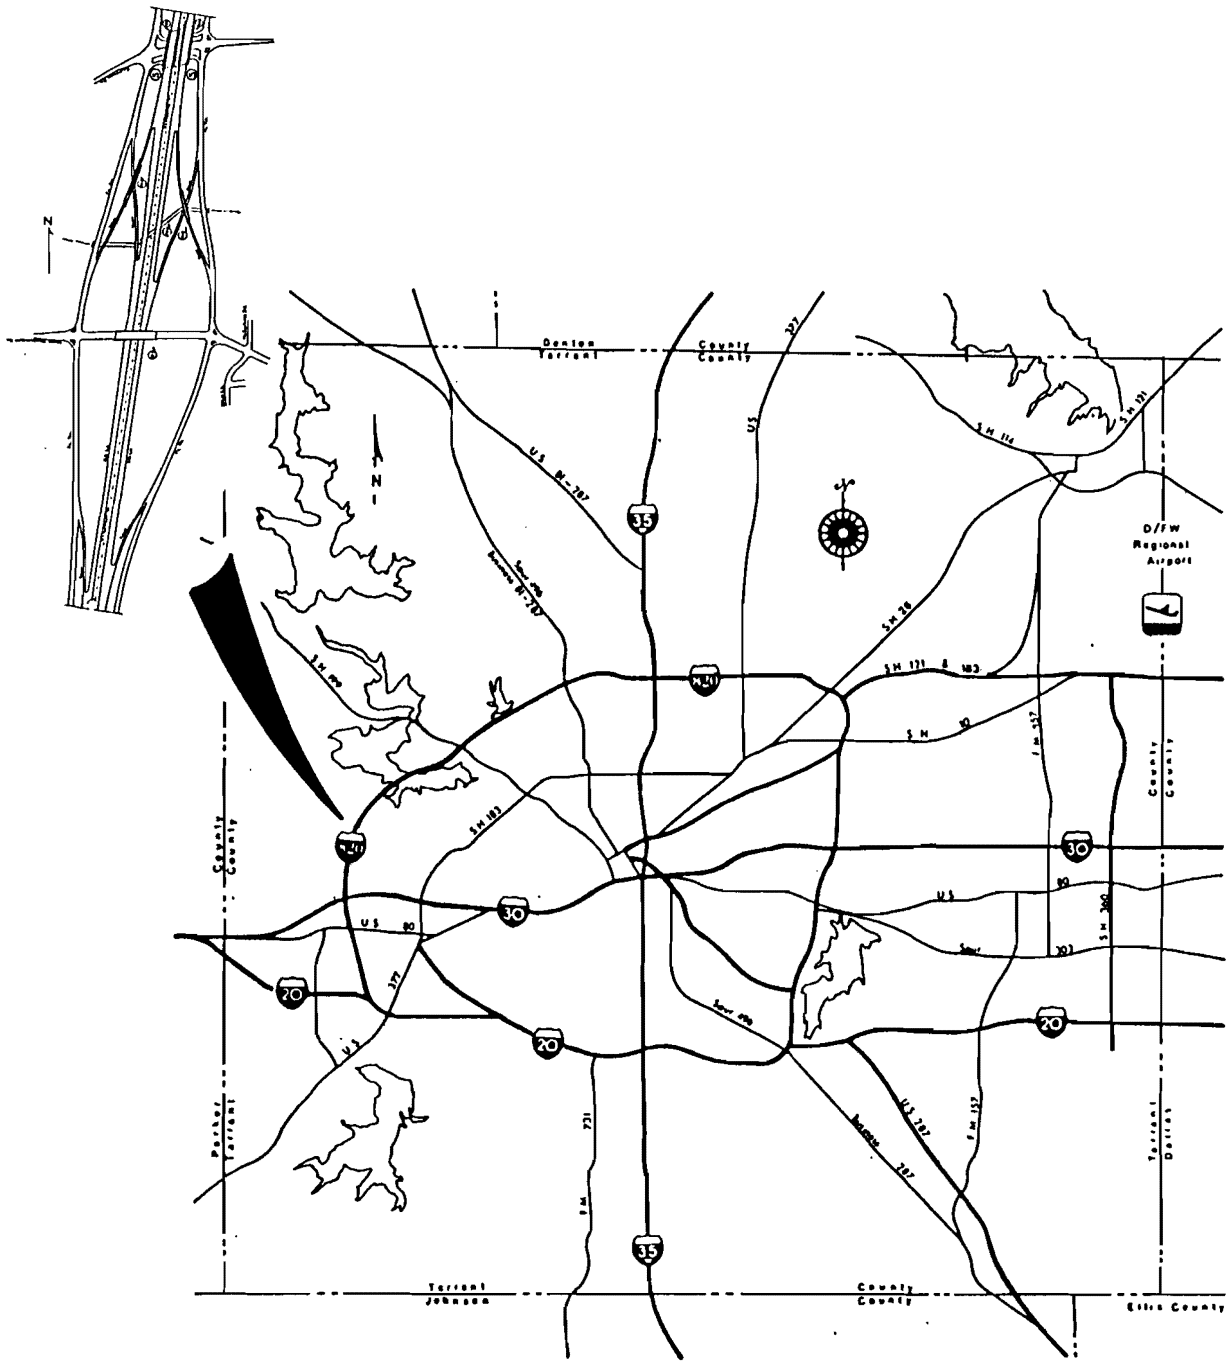
FIGURE 8

The subject problem location is at the diamond interchange of IH-820 and White Settlement Rd, which serves to connect the City of White Settlement with a residential area west of IH-820. Presently, the interchange is controlled by utilizing stop signs on the frontage roads with all approaches marked as one lane. A layout of the intersection is shown in Figure 8.

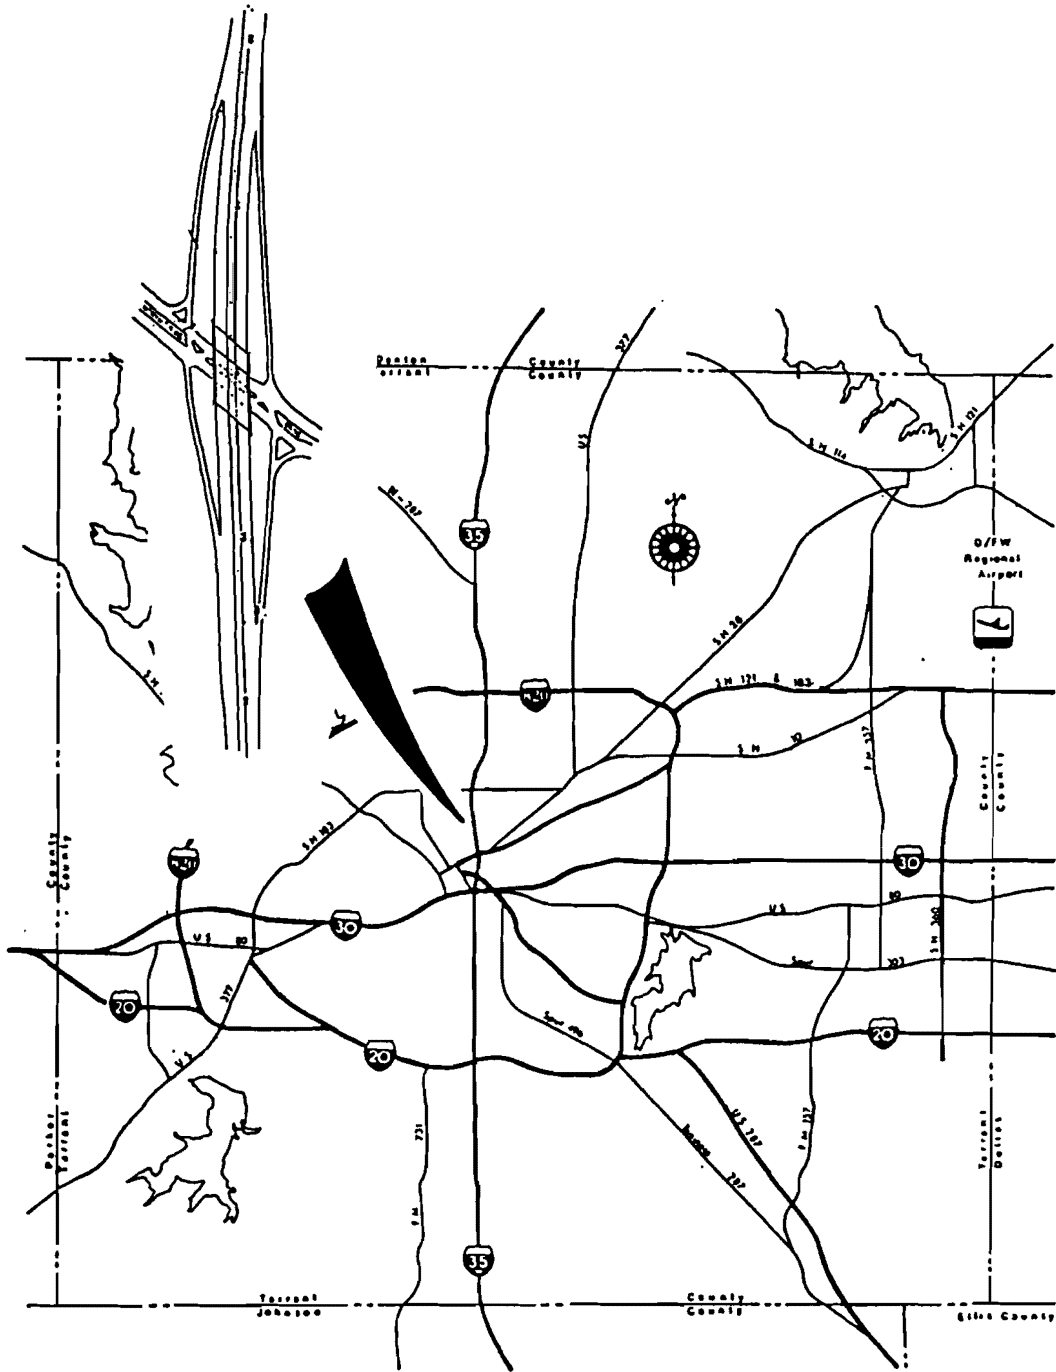
FIGURE 14

The subject problem location is at the diamond interchange of IH-35W and Northside Dr. The interchange serves an established residential area to the east and as a pass through facility to commercial, industrial, and residential areas to the west. Figure 14 shows the existing geometrics of the study location.
