EVALUATION OF FAILURE IN BRIDGE EXPANSION JOINT RAILS

Research Report Number 1309-1F

This report summarizes the investigation into the cause of failures of strip seal expansion joints at the US 83 and US 281 interchange at McAllen, Texas. The investigation was made at the request of the Texas Department of Transportation. The interchange of US 83 and US 281 at McAllen, Texas, opened in December of 1993, is composed of four unidirectional ramps (1, 2, 3, 4). Each of the ramps uses a mix of simple span AASHTO girders and continuous steel girders. The supporting substructure includes both concrete and steel bent cap systems with concrete piers. Concrete systems are inverted tee bents, hammerhead or tee piers and concrete beam straddle bents. Decking for all of these structures is 8-inch reinforced concrete with a design strength of 24.8 MPa (3600 psi). Concrete mixes for the deck were standard TxDOT S class mixes with a maximum aggregate size of 38 mm (1-1/2 inches). All ramps have vertical grade and most are in horizontal curves with super elevation.

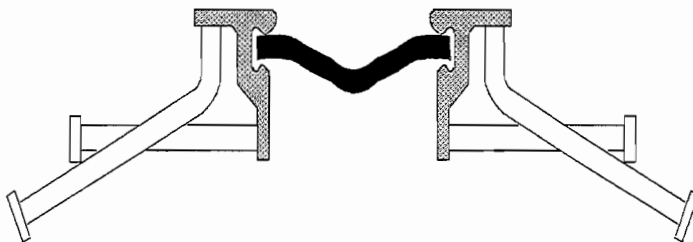
Figure 1 Typical strip seal expansion joint with seal and anchorages

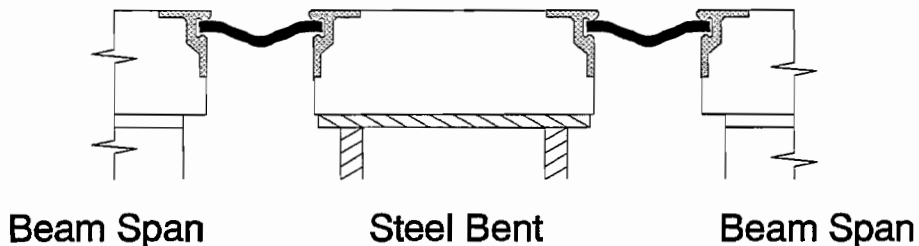
Figure 2 Arrangement of expansion joints at steel bent caps

Pier 20 on Ramp 3 was a box steel bent with expansion joints (See Figure 2). The downstream joint of the two present at this bent was examined in place. The examination showed small cracks in the concrete deck along the lip of the downstream side rail. Using a screwdriver and pry bar to lift the rail small pieces of loose concrete were removed. Surface concrete near the rail edge was not very strong and could be described as "Punky." After removal of this concrete a tape measure was inserted into the resulting hole as shown in Figure 10 to a depth of 41 mm ($1\text{-}5/8\text{-in.}$) The downstream rail was easily moved using a pry indicating that it was very loose.

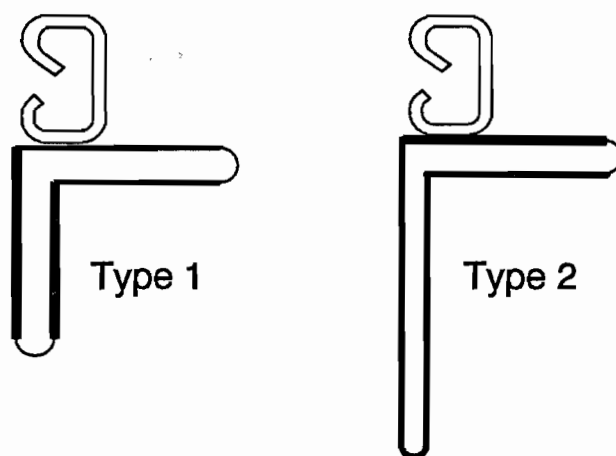
Even with the oxidation of the rail surfaces, several observations were made. Joints on the Round Rock bridges were used in conjunction with asphaltic overlays. The rails used were made of studs attached to an angle section with a grooved channel section for the seal welded to the angle section (Figure 15). Even with

Figure 15 Rail cross-section

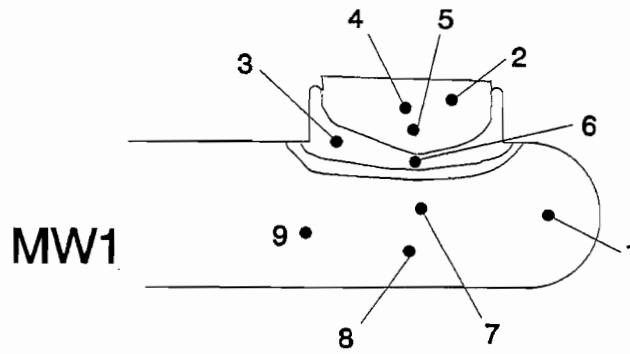
1	2	3	4	5	6	7	8	9
R _c	9.0	14.9	32.5	9.8	11.2	29.0	14.1	10.8	10.1
Area	BM	ST	WM	ST	ST	WM	BM	BM	BM

Figure 25 Sample McAllen Weld #1

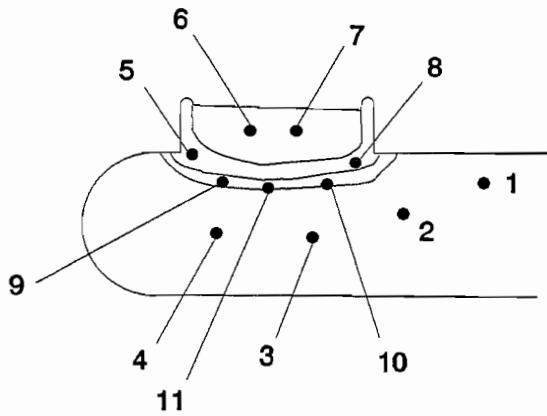
1	2	3	4	5	6	7	8	9	10	11
R _c	-0.8	8.1	10.2	8.8	21.0	1.8	6.9	30.0	26.1	26.2	27.1
Area	BM	BM	BM	BM	WM	ST	ST	WM	HAZ	HAZ	HAZ

Figure 26 Sample McAllen Weld #2

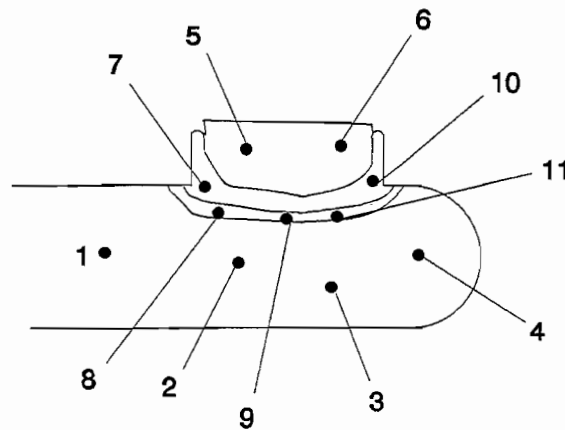
1	2	3	4	5	6	7	8	9	10	11
R _c	4.4	8.6	7.9	7.5	9.8	11.8	16.0	21.1	25.1	29.5	30.8
Area	BM	BM	BM	BM	ST	ST	WM	HAZ	HAZ	WM	HAZ

Figure 28 Sample McAllen Weld #4

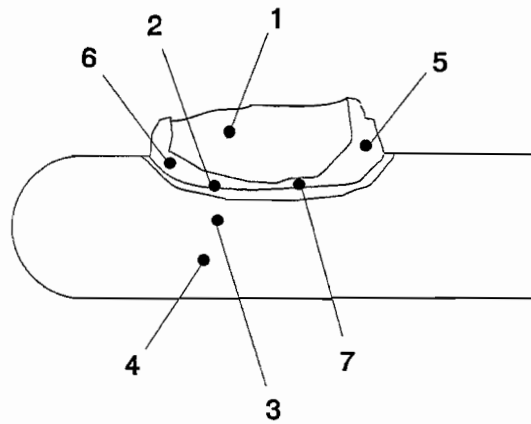
1	2	3	4	5	6	7
R _c	12.0	12.9	4.1	3.0	30.1	28.0	10.4
Area	ST	HAZ	BM	BM	WM	WM	HAZ

Figure 32 Sample Georgetown Weld #4

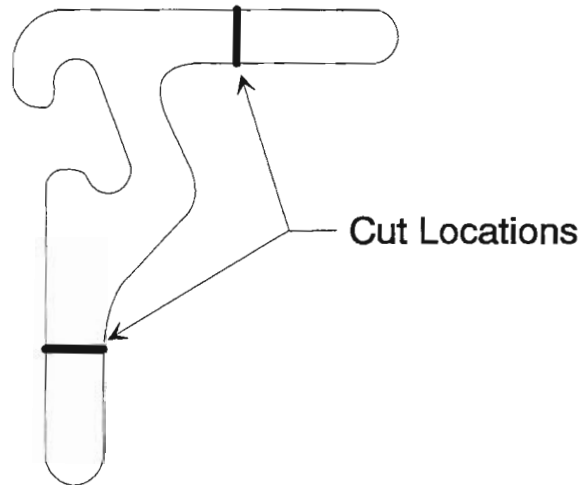
Figure 38 Locations of cuts to be made in rail

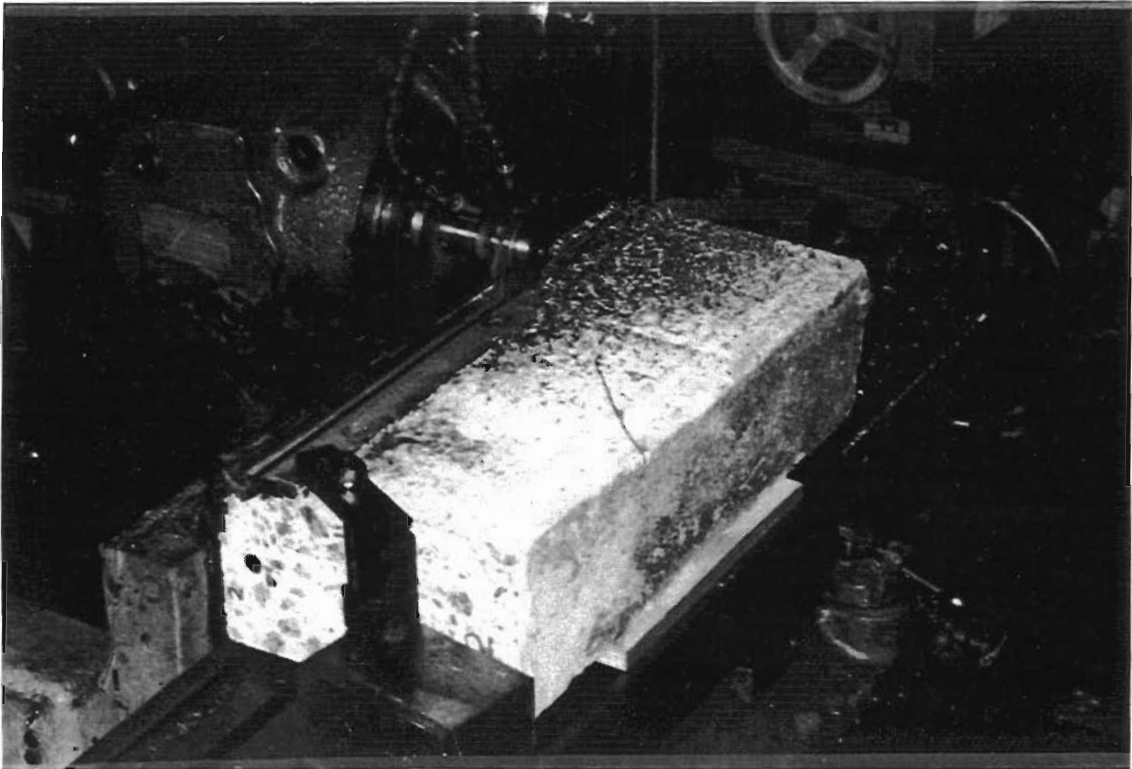
Figure 39 Roadway section in milling machine

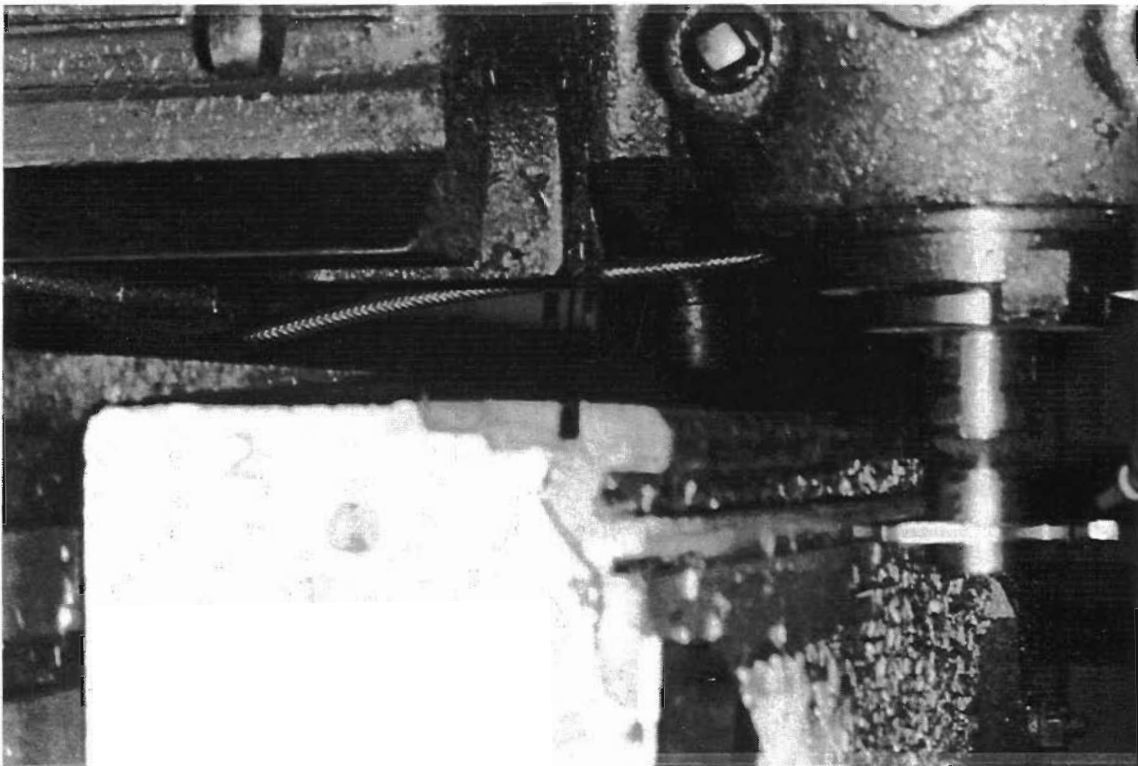
Figure 40 Roadway section in milling machine

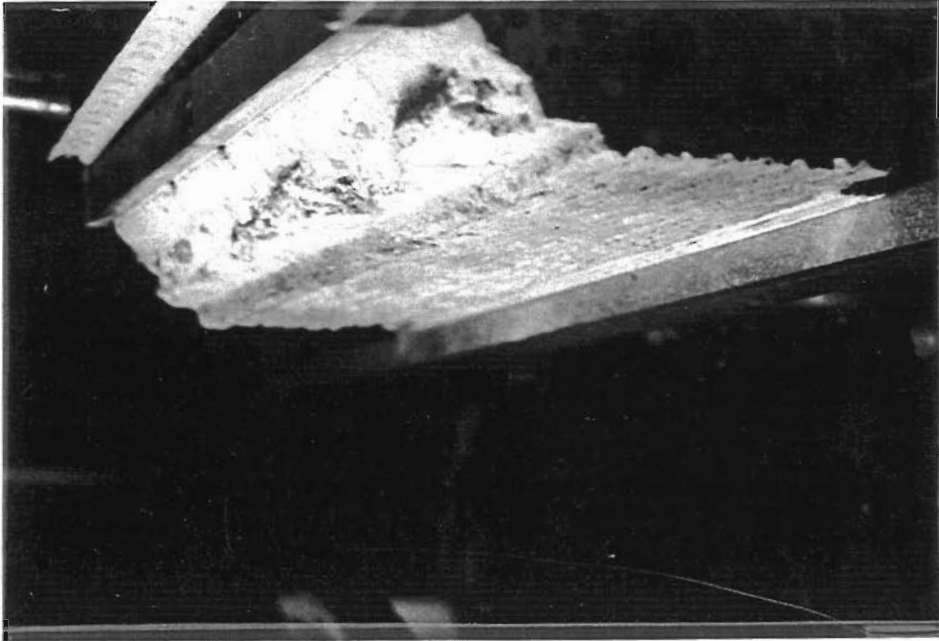
With removal of the rail complete, it was readily apparent that complete consolidation of the concrete along the corner of the rail had not occurred. Figures 42 and 43 show views of the section looking down the corner of the block section. It is apparent in the figures (42 & 43) that in areas, the concrete did flow into the corner of rail as indicated by the highest or hump areas. The now exposed concrete section also exhibited a pasty or crusty white coating on the exposed surface shown in Figure 44. This pasty coating indicated the presence of bleed water in this area during curing. By allowing bleed water to collect, the strength of the concrete was further reduced in this critical area. The section also showed the presence of voids along the underside of the rail. Figure 45 shows the presence of one such void.

Figure 42 Edge view of roadway section after rail is removed

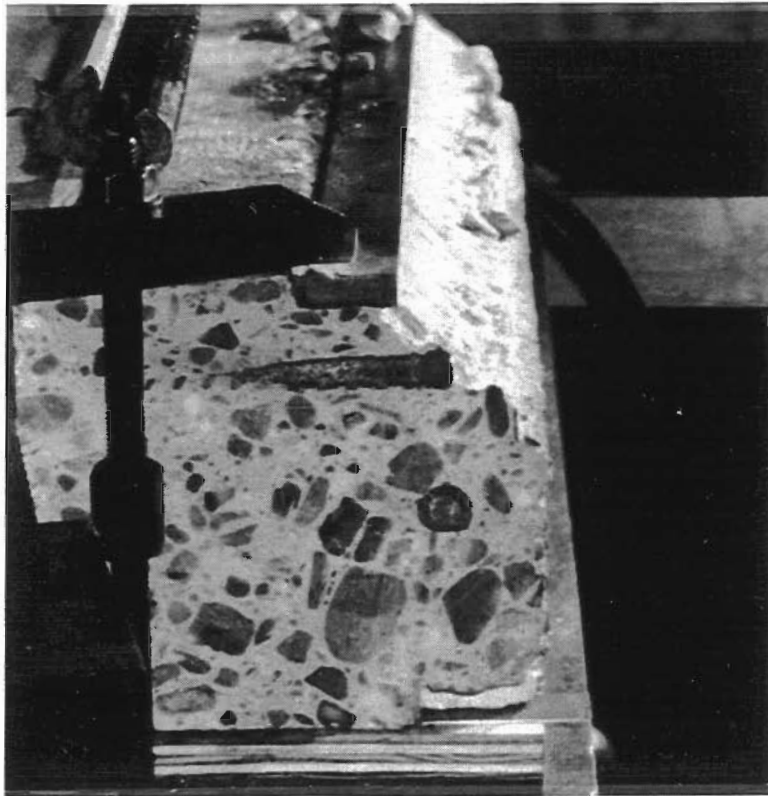
Figure 43 Edge view of roadway section after rail is removed

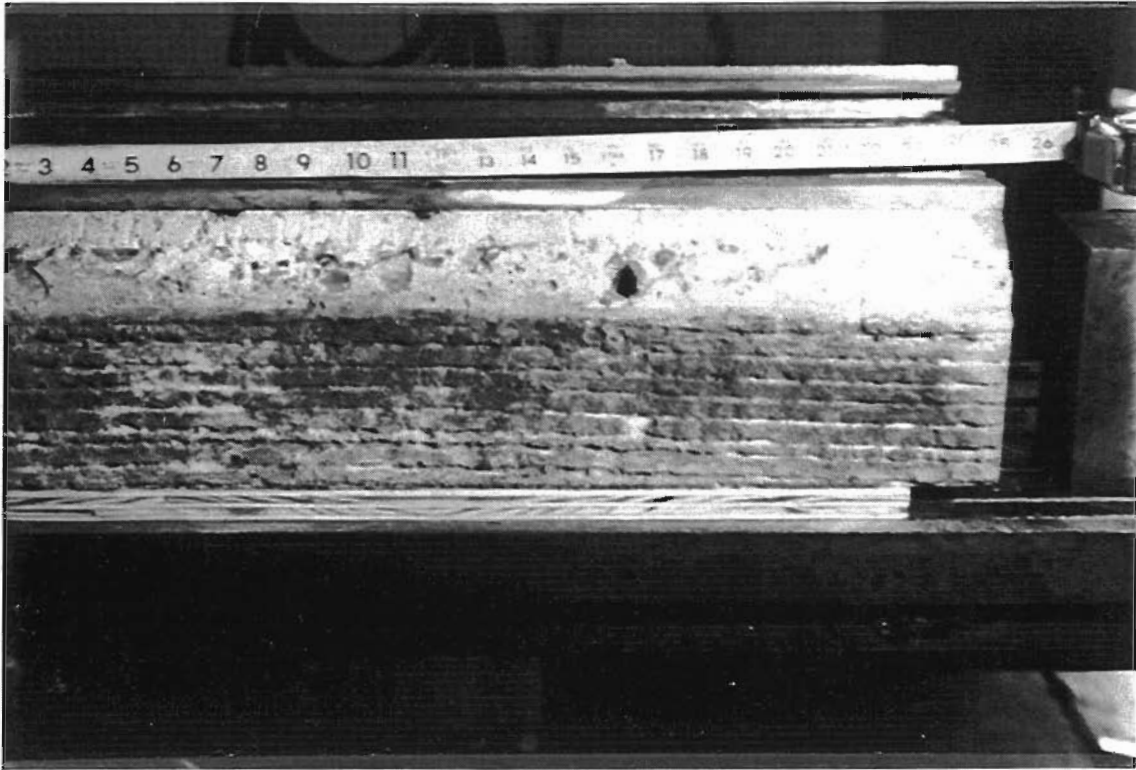
Inspection of the removed rail exhibited the same pattern of brown coloration seen in the field observations. The coloration along the rail was compared to the humps and voids along the block edge, a direct correlation was found. This correlation is that brown patches along the rail indicate a lack of concrete in these areas. This is in agreement with the observations of brown areas and stud failures made during the trip to McAllen. Upon completion of the observation of the rail, the stud at 7" in Figure 46 was excavated.

The second stud was then excavated from the section. It was assumed that this stud was already fractured at the time of the section's removal from the bridge deck. The location of the stud is indicated by the hole at the 431 mm (17") point in Figure 46. Excavation of this stud did not show any signs of improper consolidation along the stud section remaining in the block, Figure 55. This stud was a bent stud, but fracture occurred in a

Figure 46 Studs were located at 7-in. and 17-in.

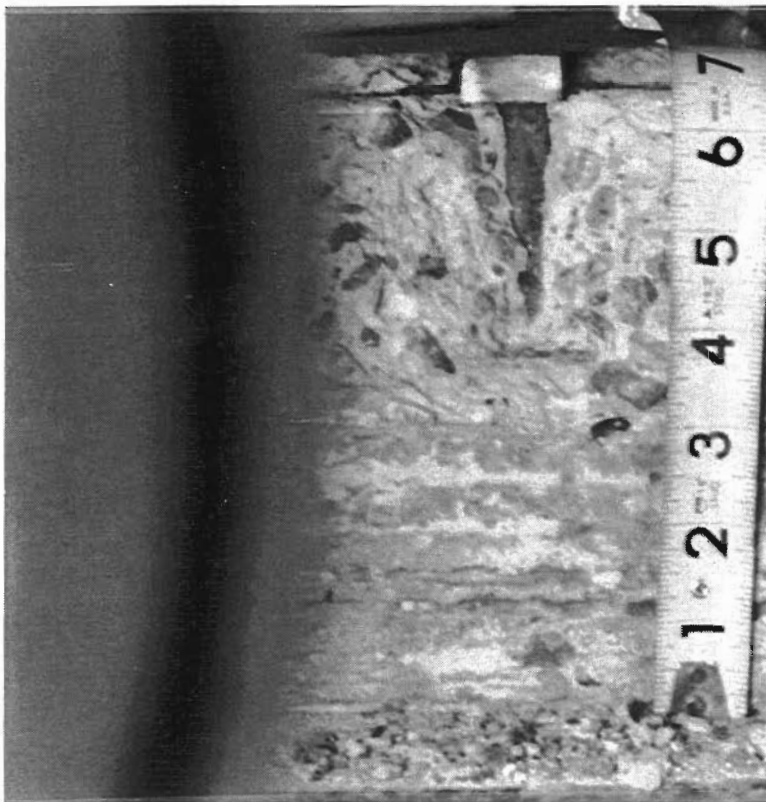
Before excavation of the stud, the excess rail on both sides of the stud was removed from the block. It was also noted that the area near the base of the stud had a void. This void is shown in Figures 47 and 48. The stud was excavated as shown in Figures 49 and 50. Excavation revealed that there was a small open area around the base of the stud. After completely exposing the stud it was removed from the block by cutting the reinforcing bar shown in Figure 50. The removed stud was then placed in a vise and the stud was bent over using a hammer. This bending over of the stud was done to test the soundness of the stud weld. The stud failed in this test and revealed an interesting fracture surface. By examining the fracture surface, Figures 51, 52 and, 53, it is apparent that the smooth semicircular region is a fatigue crack propagating through the stud. This type of crack would ultimately lead to failure of the stud. Figure 54 shows the orientation of the stud, fatigue crack, rail and roadway.

Figure 49 Excavation of stud in roadway section

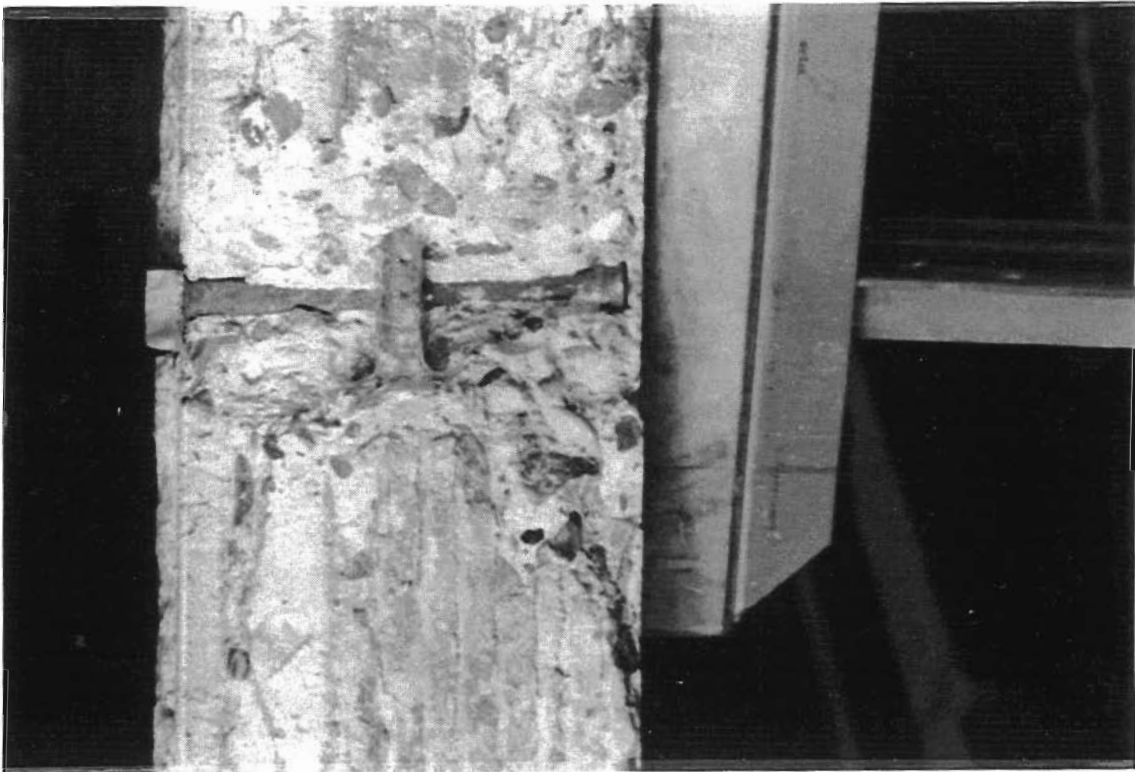
Figure 50 Excavation of study in roadway section
