**STUDIES ON DAMAGE AND CORROSION PERFORMANCE OF
FABRICATED EPOXY-COATED REINFORCEMENT**

Research Report 1265-1

Structural Integrity of Epoxy-coated Bars
Research Project 3-5-91/3-1265

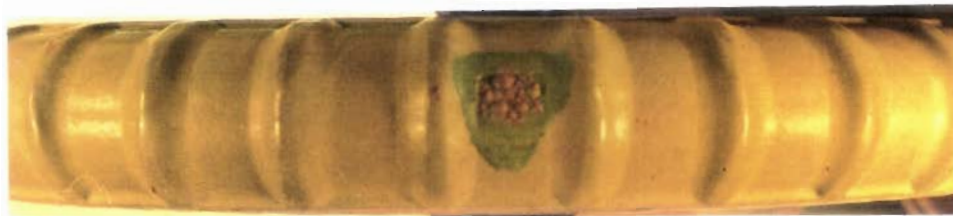
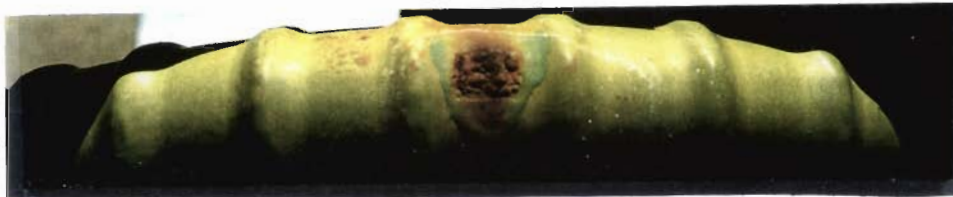
Figure 3.7 Progression of corrosion in the damaged areas.

Signs of corrosion were evident on the bars where damage had been introduced. Conspicuous brown corrosion products accumulated on the damaged areas. Figure 3.7 shows the progression of corrosion in the damaged areas after 8 months of testing. It can be seen that corrosion was severe and a considerable amount of corrosion products built up on the surface.
