1. Report No. FHWA/TX-96/1370-1		2. Government Accession No.		3. Recipient's Catalog No.	
4. Title and Subtitle CURRENT PRACTICE IN THE REPAIR OF PRESTRESSED BRIDGE GIRDERS				5. Report Date August 1993 Revised June 1996

CURRENT PRACTICE IN THE REPAIR OF PRESTRESSED BRIDGE GIRDERS

Research Report Number 1370-1

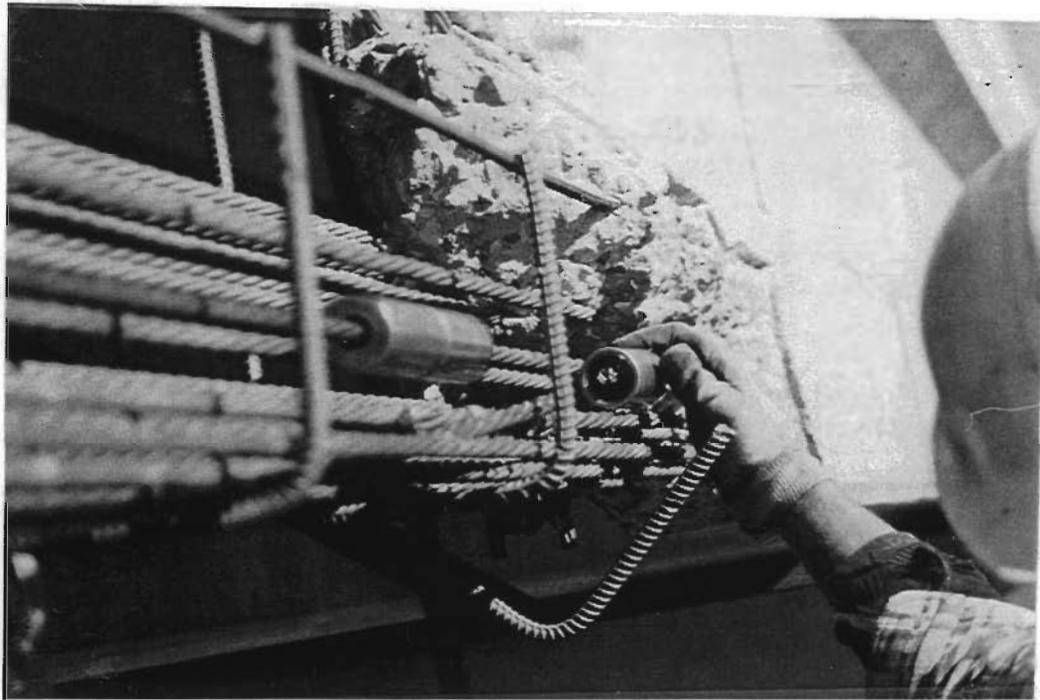
Figure 5- 14 Installation and restressing anchors to ends of severed strands

Internal Splices are inexpensive, comparatively easy to install, and restore girder appearance since all splicing hardware is embedded within the repaired girder. The splices can be torqued to achieve the desired stress level in the tendons. However, internal splicing mechanisms take up space inside of the girder. Although some internal splicing methods allow more than one tendon to be spliced at a given location along the girder, it may not be possible to repair girders with a large number of severed strands due to the congestion caused by the splicing hardware. The internal splicing mechanism itself is shown in Figure 2.2. Figures 5.14 and 5.15 demonstrate an internal strand splicing operation to a severely damaged girder in Regina, Saskatchewan, Canada. Figure 5.14 demonstrates the installation of the restressing anchors to the ends of the severed strands, while Figure 5.15 shows the retensioning operation of the severed strand.

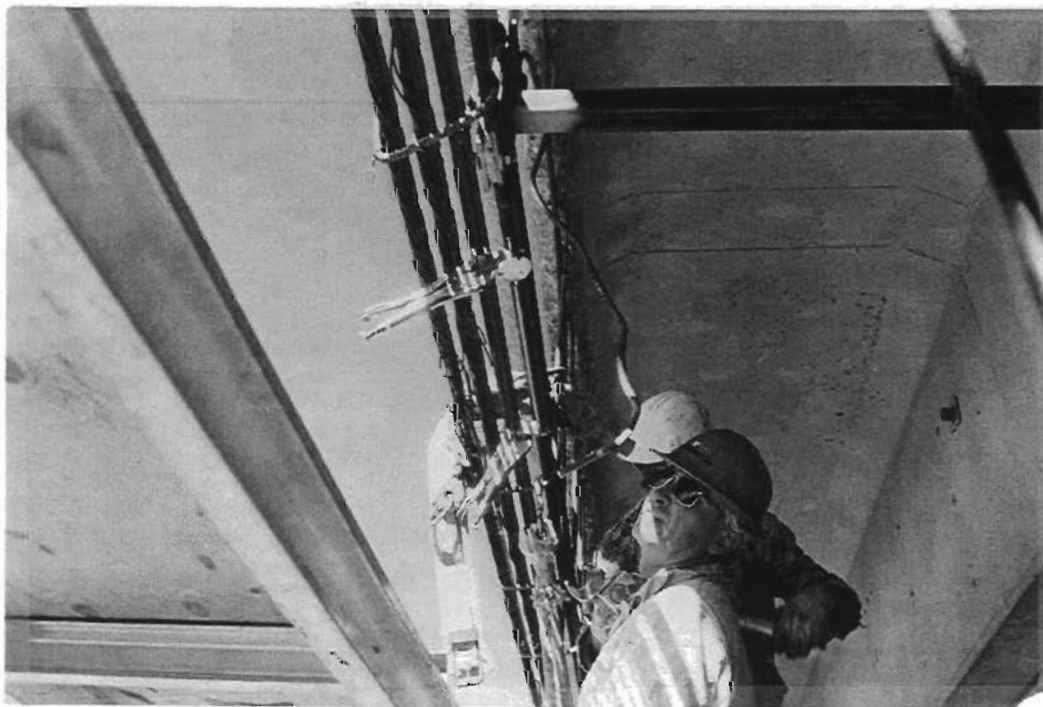
Figure 5- 15 Retensioning operation of severed strands

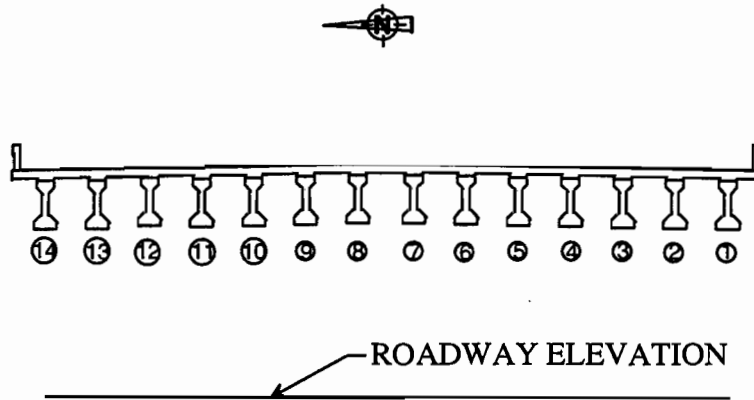
Figure 5-16 Transverse section of College Station bridge

A prestressed concrete bridge in College Station, Texas was damaged in early 1993, and inspected on April 15, 1993 by the researcher team. The bridge carries FM 60 over FM 2818, and has a posted minimum vertical clearance of 15 ft. 8 in. (4.8 m) occurring at the northern exterior girder. However, the vertical clearance of the bridge increases to a maximum of approximately 16 ft. 3 in. (5 m) at the center of the roadway. Seven girders were damaged by an overheight load travelling north under the bridge. A transverse section of the bridge is shown in Figure 5.16, as well as the numbering system for the girders on the bridge.
