**A LABORATORY AND FIELD EVALUATION OF REQUIRED MATERIAL  
PROPERTIES FOR CONCRETE REPAIRS**

Research Report 1412-2

Research Project 0-1412  
*Repair of Structural Concrete*

October 1996

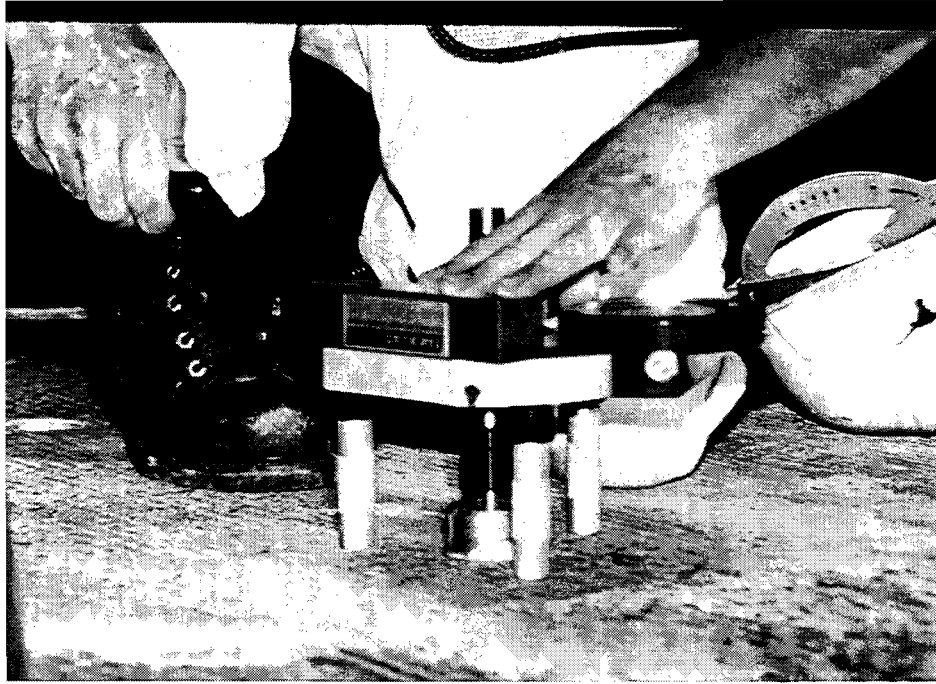
*Figure 6.2 Pull-off test being conducted on horizontal surface — Austin No. 2*

The original source of damage was similar to that found at location No. 1. Excessive grinding in the roadway had resulted in a need for repair work. This overlay is located on the interchange from northbound MoPac Boulevard (Loop 1) to US 183 north. Reportedly, excessive water was added to the latex-modified concrete used to make the repair. The thickness of the overlay varied from 25 mm to 76 mm in depth. A visual inspection found no signs of deterioration, such as delamination, abrasion, or cracking. The average pull-off strength was 1.0 MPa ( $\sigma = 0.4$ ), with the failures occurring at the interface. Figure 6.2 shows a pull-off test being conducted.

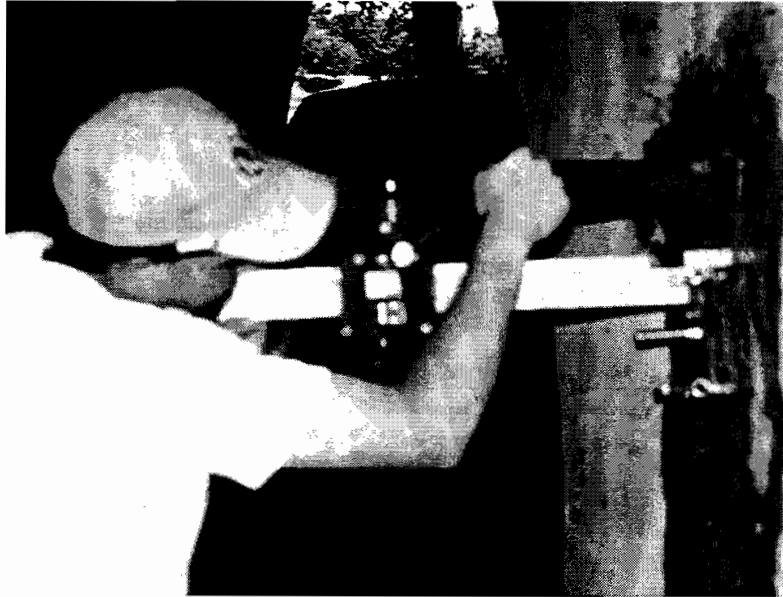
*Figure 6.9 Vertical coring of column — San Angelo*

The repairs were 5 years old and in good condition. The average pull-off strength was 1.0 MPa ( $\sigma = 0.4$ ), with the cores failing at the bond interface. Figures 6.9 and 6.10 show typical vertical coring and vertical pull-off test being conducted.

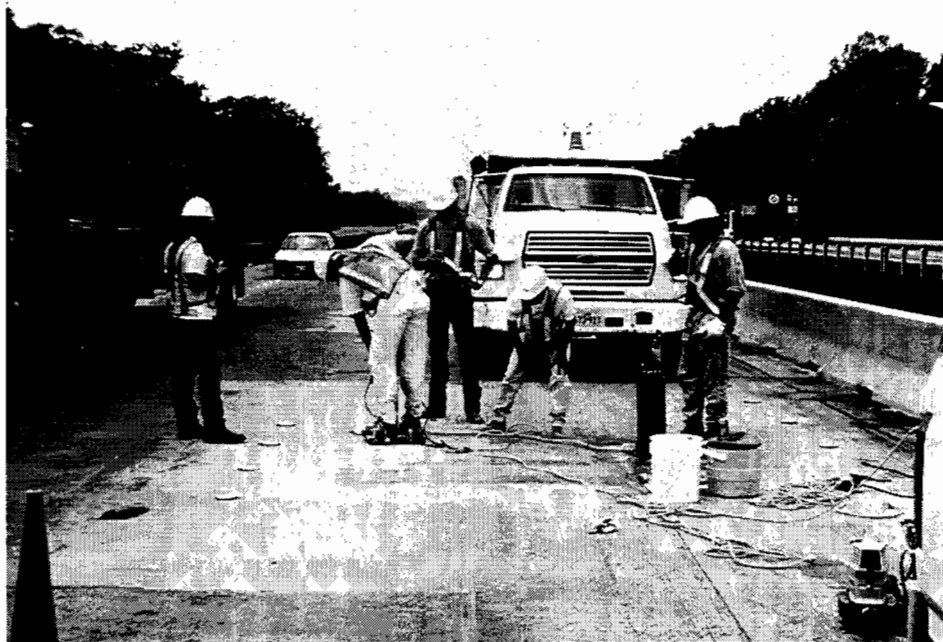
*Figure 6.11 Horizontal coring of repaired bridge deck — Lufkin No. 1*

The repair is located on a bridge deck along US 59 at the Trinity River (Figure 6.10). The damage was caused by a truck fire 8 years ago. A damaged concrete area 1.5 m by 6.0 m had been removed to a depth of 51 mm. A rapid-setting cementitious material had then been placed down. The repair was visually in good condition. Five cores were taken and had an average pull-off strength of 0.9 MPa ( $\sigma = 0.2$ ). Two of the cores failed along the bond interface, two failed in both the substrate and repair materials, and one failed within the substrate.

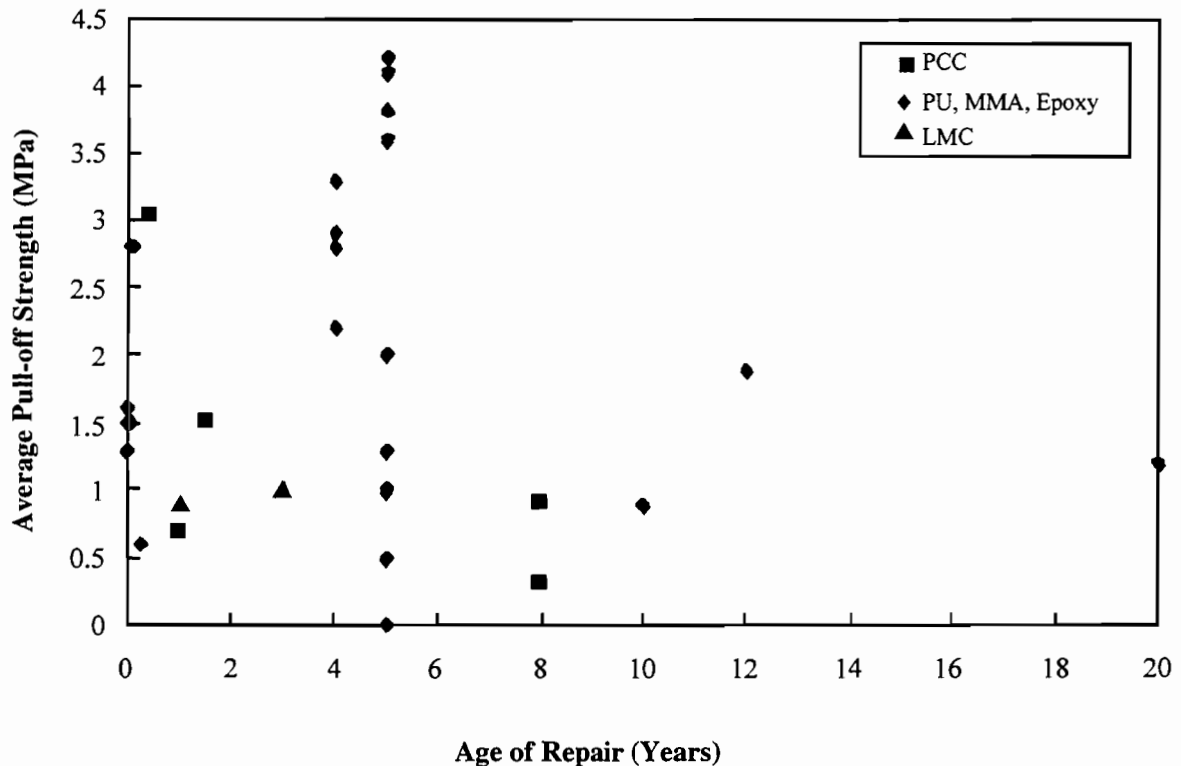
*Figure 6.16 Effect of age upon pull-off strength*

Figure 6.16 shows the effect of age on the average pull-off strength measured during the field site visits. The plot has also been broken down by the type of repair material evaluated at each location. From the figure it is obvious that the pull-off strength can vary widely for all types of repair materials, independent of the repair age. This shows that there are factors other than age that have more influence on the bond strength. Two other factors that may influence the bond strength not accounted for in this figure are the quality of workmanship and the environmental conditions. Given identical repair materials, it is possible for an 8-year-old repair to have a bond

strength higher than that of one that is only a couple of years old. This can be attributed to the quality of workmanship or environmental conditions that the repair is subjected to during its service life. Excluding a few new repairs and some polymer-based materials that exhibited a high pull-off strength even after 5 years, the majority of repairs had pull-off strengths below 2.0 MPa regardless of age.
