ENERGY SAVING METHODS OF RESTORING PAVEMENT SURFACE CHARACTERISTICS

Report No. 204-1F

Research Study 1-10-75-204

June 1977

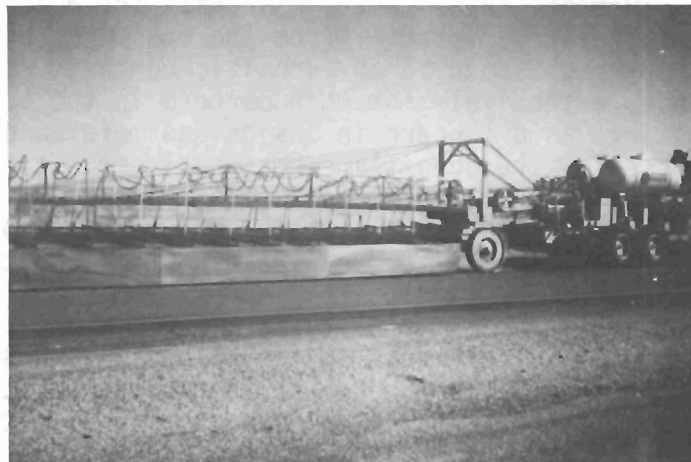
Figure 1
Open-Flame Heater-Planer

One Texas Highway District has recently experienced a condition not unique in that region of the country, but a normal occurrence all over the United States. This is the condition of flushed asphaltic pavement. These pavements had flushed to such an extent that a very small amount of rainfall caused a large increase in the number of skidding incidents. In an attempt to correct this problem, the decision was made to add some additional aggregate, heat the aggregate and the surface of the roadway, and embed this aggregate into the heated surface. An open-flame heater-planer was used to supply the heat (See Figure 1).

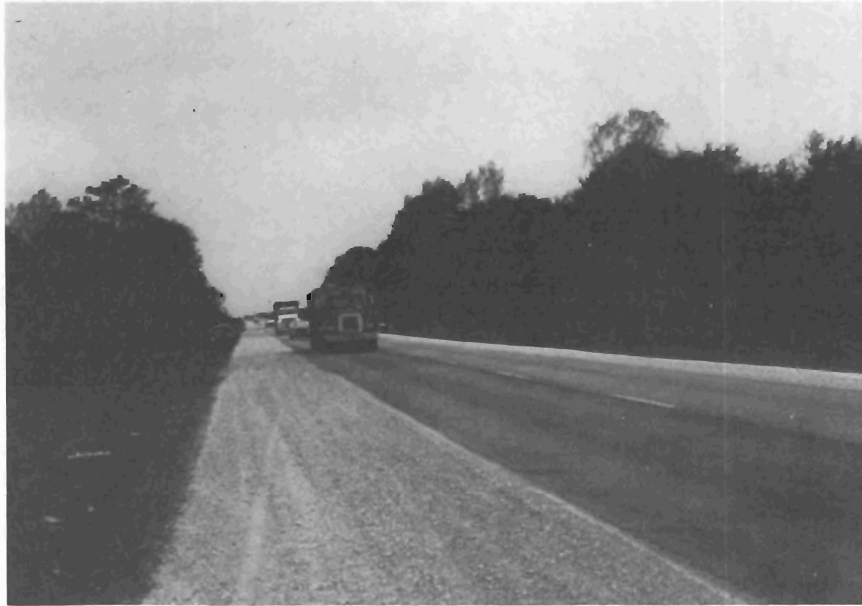
Figure 5
Traffic on Recycled Roadway

The experiment was an attempt at in-place hot recycling of asphaltic concrete pavement using an open flame heater-planer. The asphalt-rich roadway was heated, scarified to approximately 5/8" depth, and relaid without removal of the material from the roadway. Relaying was accomplished by use of a vibratory screed attached to the heater-planer.

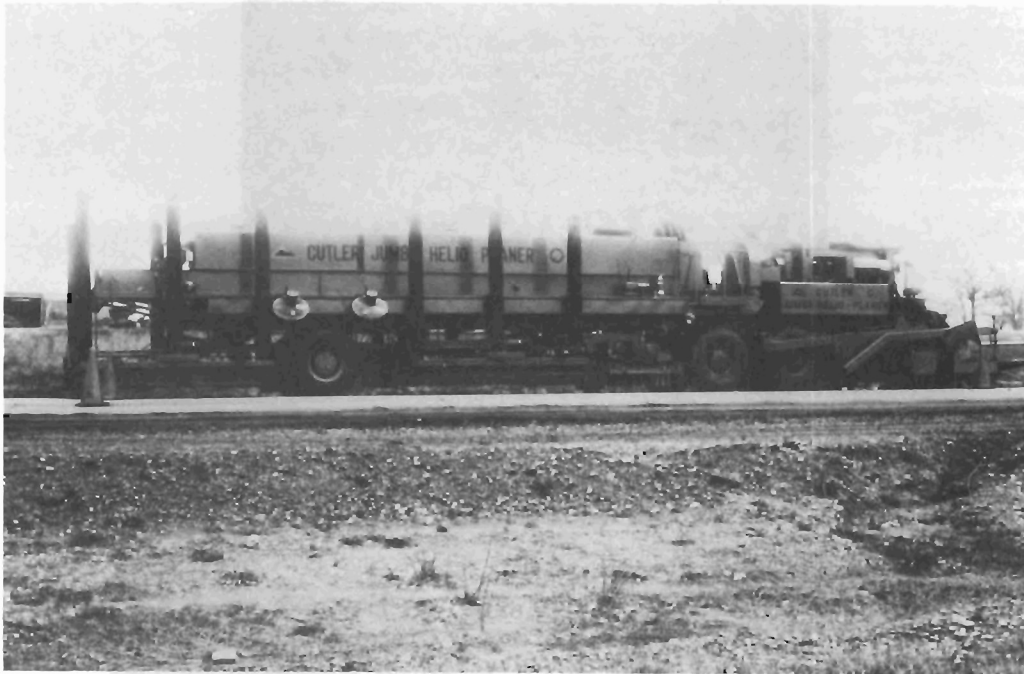
Figure 11
Radiant Heat Surface Recycling Apparatus

The pavement was heated with radiant heat instead of an open flame. It was then scarified, mixed by mixing augers, emulsion added, and the recycled material relaid with a laydown machine vibratory screed. Compaction was achieved with three passes of a ten-ton tandem steel wheel roller. Additional steps or operations were performed on various sections and are explained for each section below.

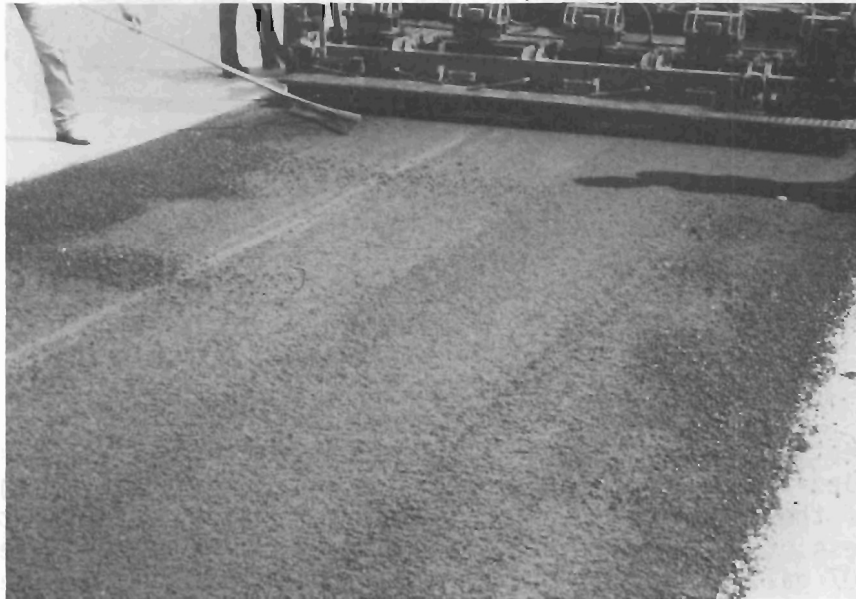
Figure 16
View of Recycled Pavement Surface Prior to Rolling

Prior to compaction by the vibratory screed and rolling operation, the asphaltic concrete was sampled and tested in the laboratory. The asphalt was extracted and tested, and a screen analysis was performed. The extraction test showed the recycled surface to have an asphalt content of 6.7 percent. The penetration at 77° F. was measured to be 24. As indicated by the following "after recycling" gradation, a slight aggregate degradation occurred in the process.

There was 6.7% residual asphalt in the mixture and the average HVEEM stability of the recycled mix was 38. The stability ranged from 34 to 41.

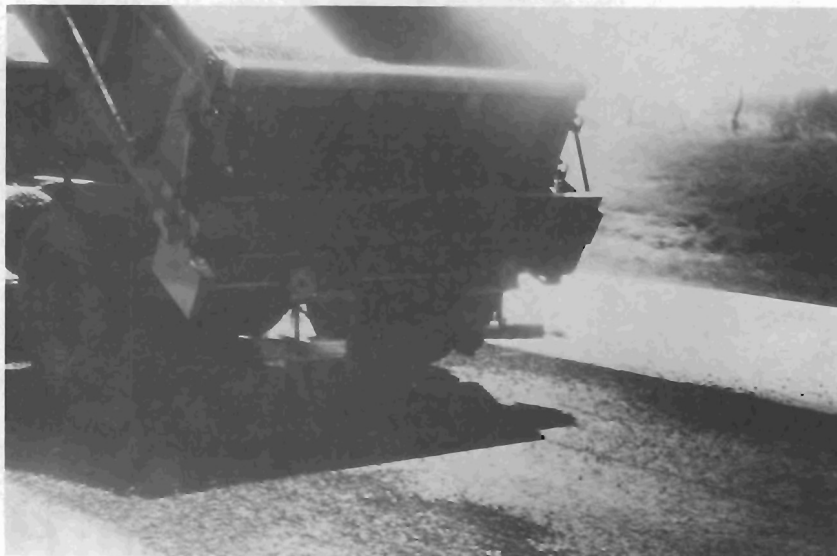
Figure 23
Sprinkle Treatment Application Using Salt Spreaders

Also in an effort to prolong the skid resistant life of the pavement, a sprinkle treatment was added to the roadway surface. This sprinkle treatment involved the placing of asphalt coated synthetic lightweight aggregate to the surface immediately after the passage of the vibratory screed and prior to the commencement of any rolling operations.

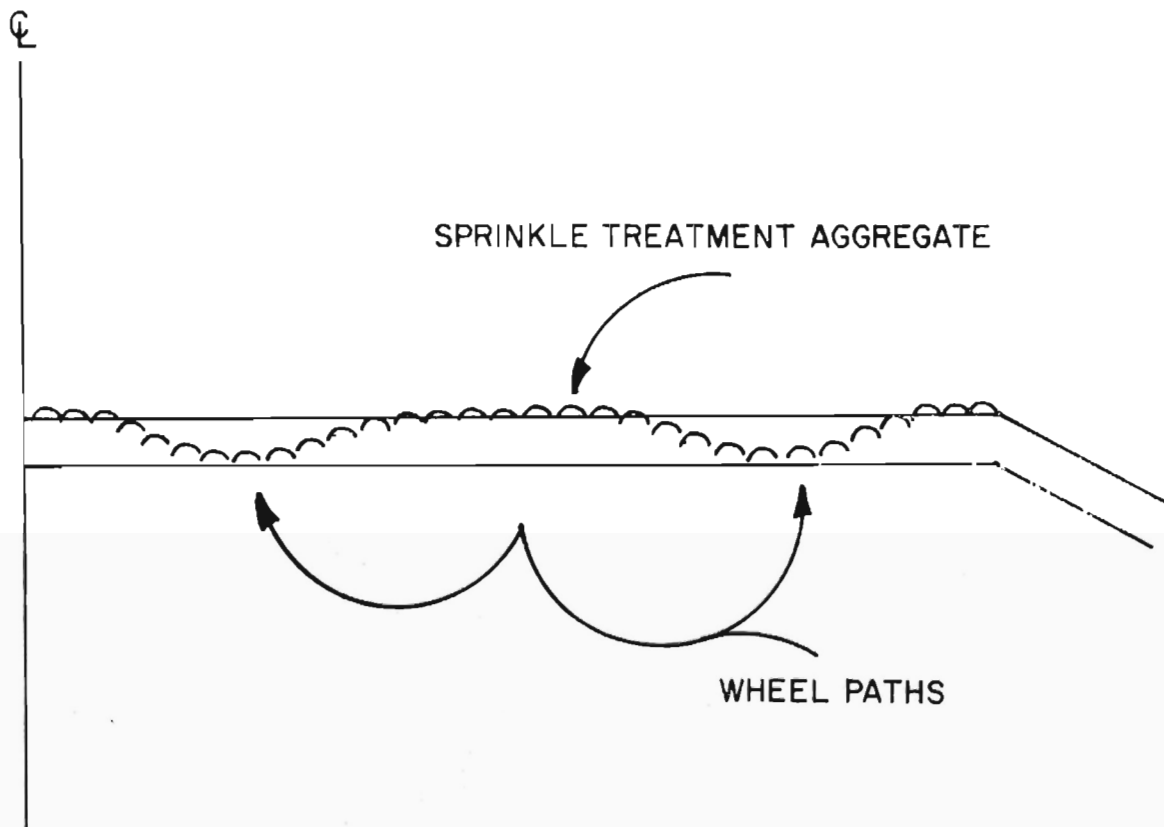
SCHEMATIC OF HOT MIX ASPHALTIC CONCRETE
MAT WITH SPRINKLE TREATMENT AGGREGATE

The initial feeling was that the sprinkle treatment aggregate had been whipped from the roadway by traffic, but a closer examination of the pavement surface revealed that the unexpected had occurred. The cause of the lowered skid test values was determined to be a combination of the following:

1. The asphalt rejuvenator and July sunshine had made the asphaltic surface very soft.
2. Traffic had pushed the skid resistant sprinkle treatment aggregate into the asphaltic mat, leaving only small tips of the aggregate exposed in some cases.

3. The skid test tire was actually testing, to a large degree, a test section similar to section #5 but one that was richer in asphaltic materials.

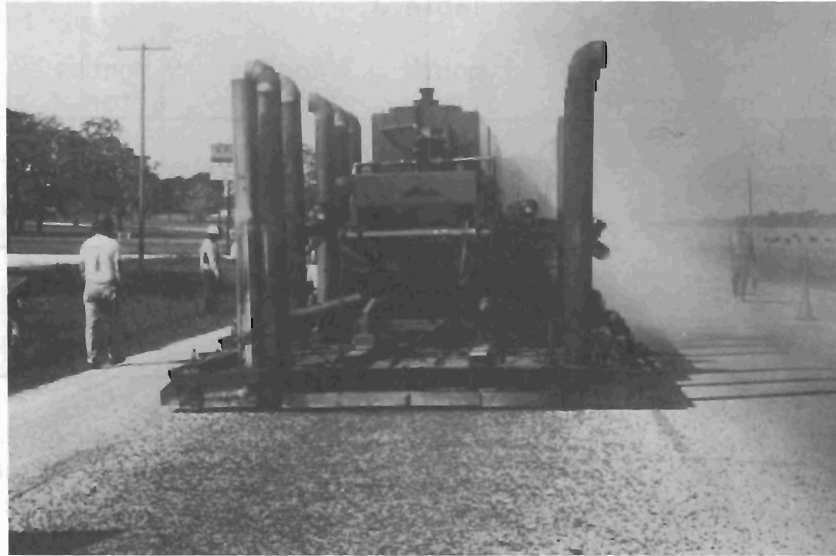
Figure 28
Skid Resistant Aggregate on Roadway Prior to Recycling

The construction of this experimental section involved using the same procedures as those utilized in test section #5. A different procedure, however, was used to improve the skid resistant life of the roadway surface. Skid resistant synthetic lightweight aggregate was placed on the existing roadway surface prior to heating and recycling. After a decision was made to increase the coarse aggregate (+10 sieve size) portion of the existing hot mix by 10%, tests were performed to determine the amount of skid resistant aggregate necessary to effect this 10% increase. A spread rate of 1 cubic yard of aggregate per 225 square yards of surface area was used. The skid resistant aggregate was then thoroughly mixed throughout the asphaltic concrete prior to laydown.

Due to an oversight during construction, no attempt was made to increase the amount of emulsion being added to the mix. Therefore a drier mix occurred than had been originally planned.
