ROUGHNESS AT THE PAVEMENT-BRIDGE INTERFACE

Research Report Number 213-1F

Roughness at the Pavement-Bridge Interface
Research Project 3-8-76-213

Texas
State Department of Highways and Public Transportation

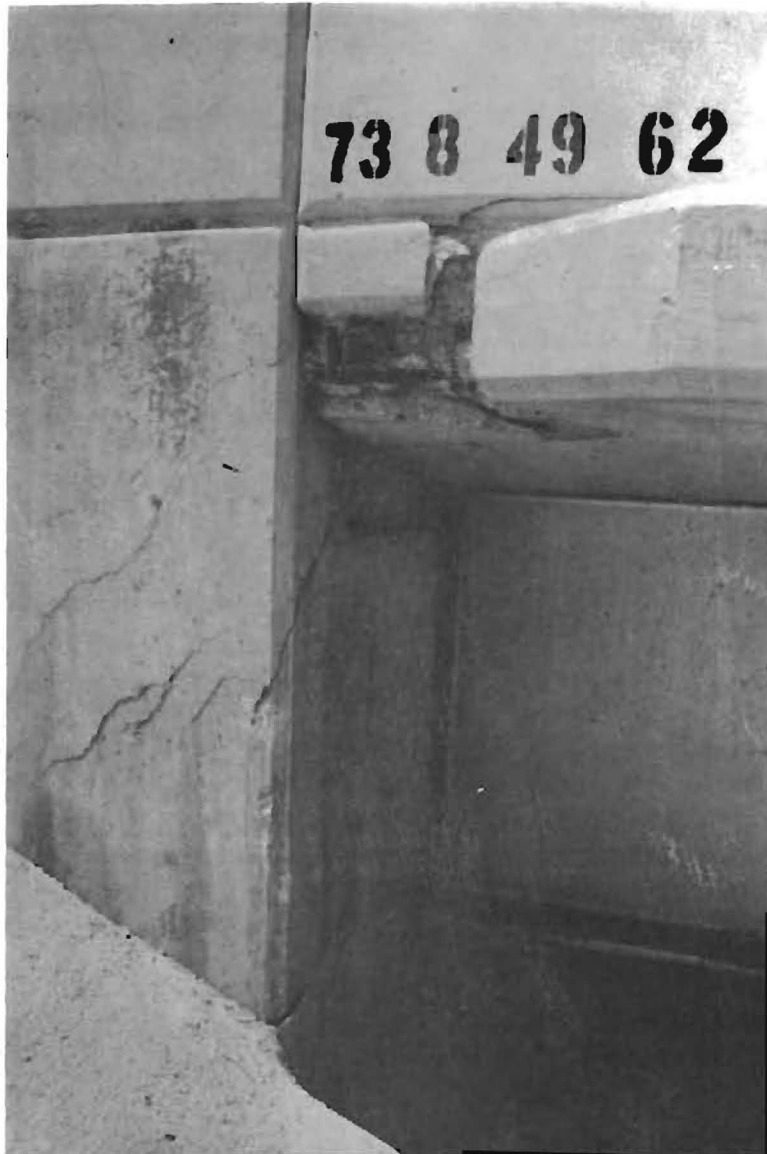
Fig 3.4. Tilted rocker, Southcross St. over
IH 37, San Antonio, Texas.

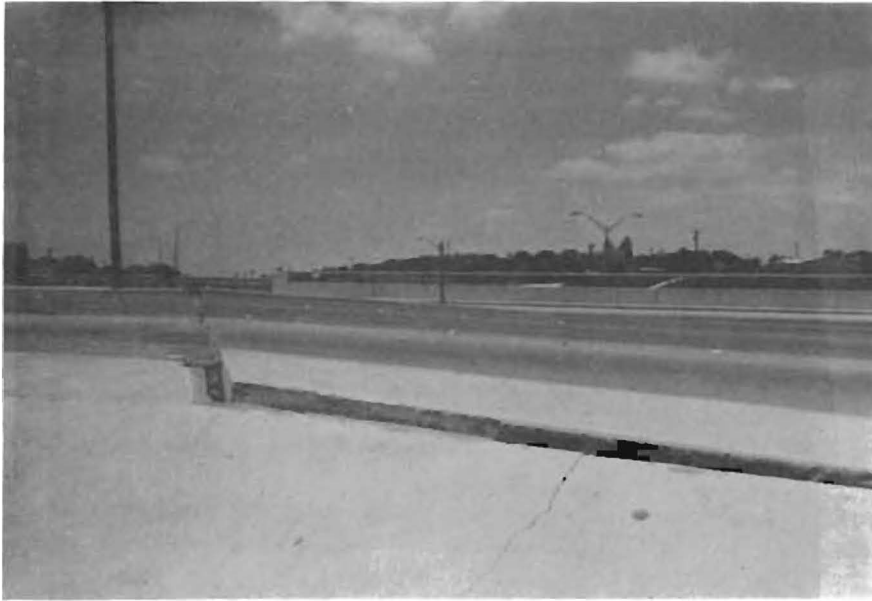
Fig 3.5. Lifted curb, Southcross St. over
IH 37, San Antonio, Texas.

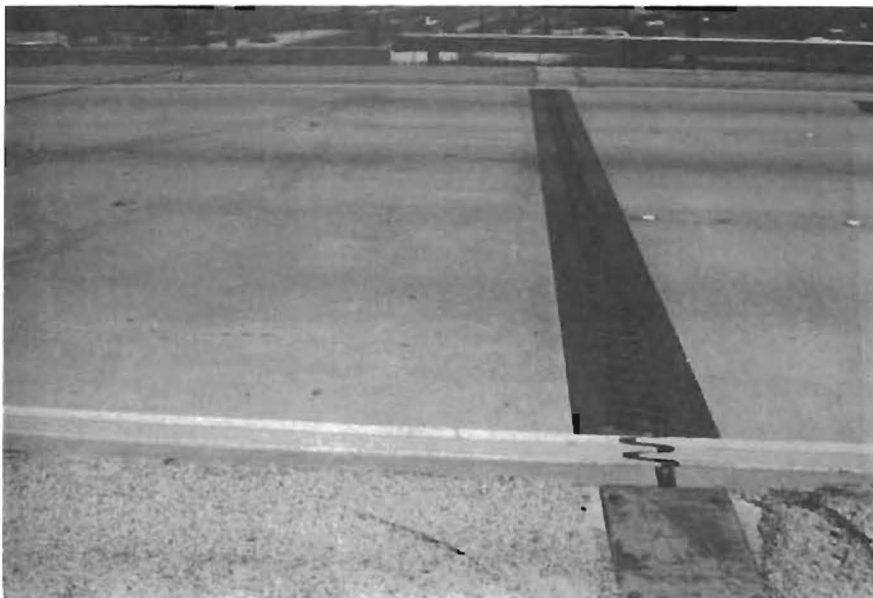
Fig 3.6. Finger joint and drain, IH 10 over W. W. White
Blvd., San Antonio, Texas.

Engineers in District 15 feel that approach slabs are necessary, but that special designs which keep moisture on the roadway surface from penetrating into the fill material are needed. Finger joints with a lateral drain have been effective at several sites (Fig 3.6) and the expansion joint has been eliminated between the pavement and the approach slab with good results at other locations (Fig 3.7). Granular backfill materials have been used for drainage at some sites.

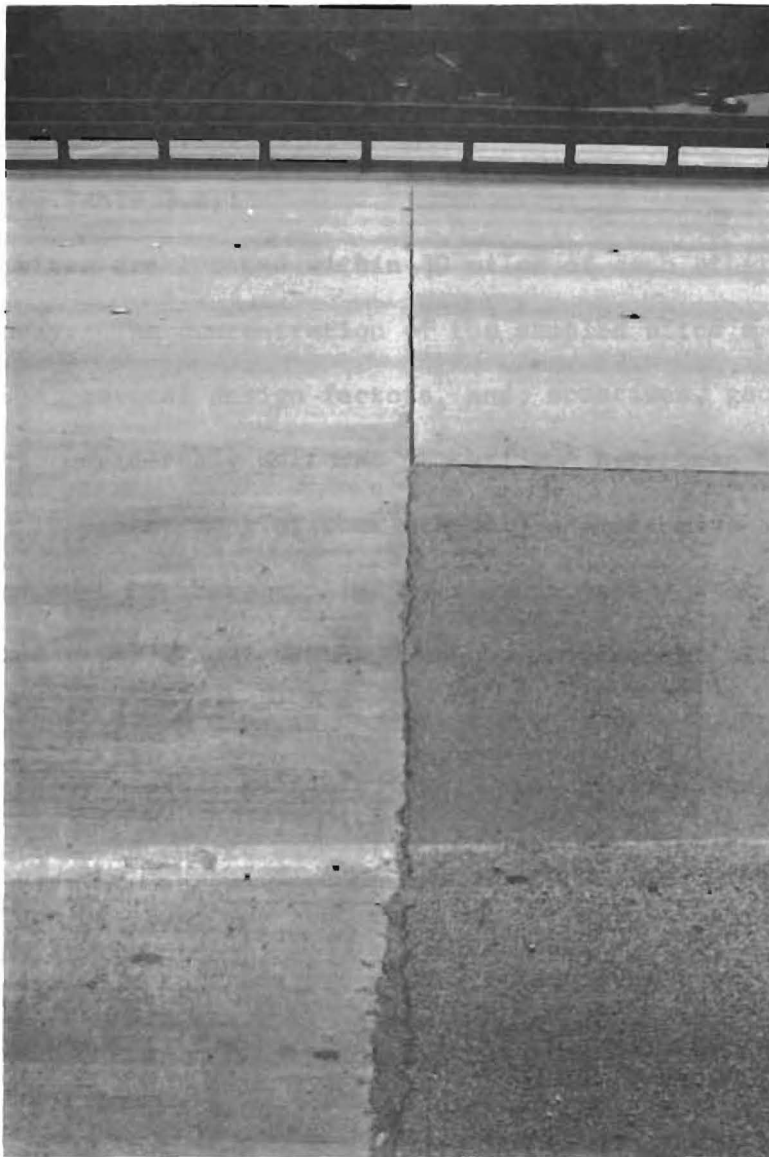
Fig 3.7. Joint deletion between the pavement and the approach slab, IH 37 over Durango St., San Antonio, Texas.

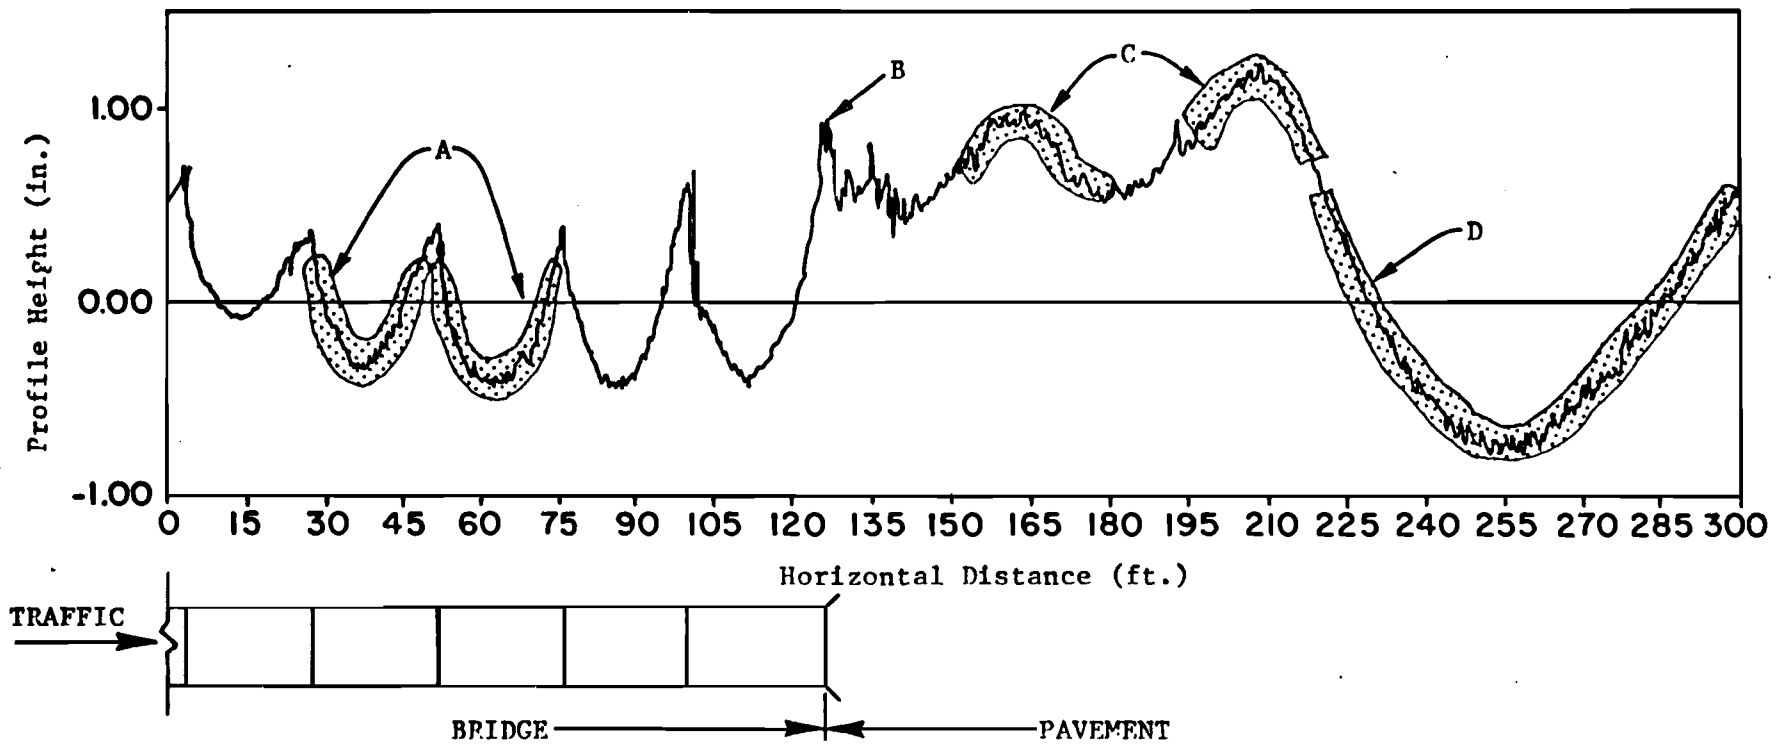
Fig 3.8. Bridge profile, FM 1065 over Los Linguish Creek (Lubbock), end of bridge.

A. Sag formed by each span

B. Discontinuity at bridge-pavement interface

D. Long waves on bridge approach

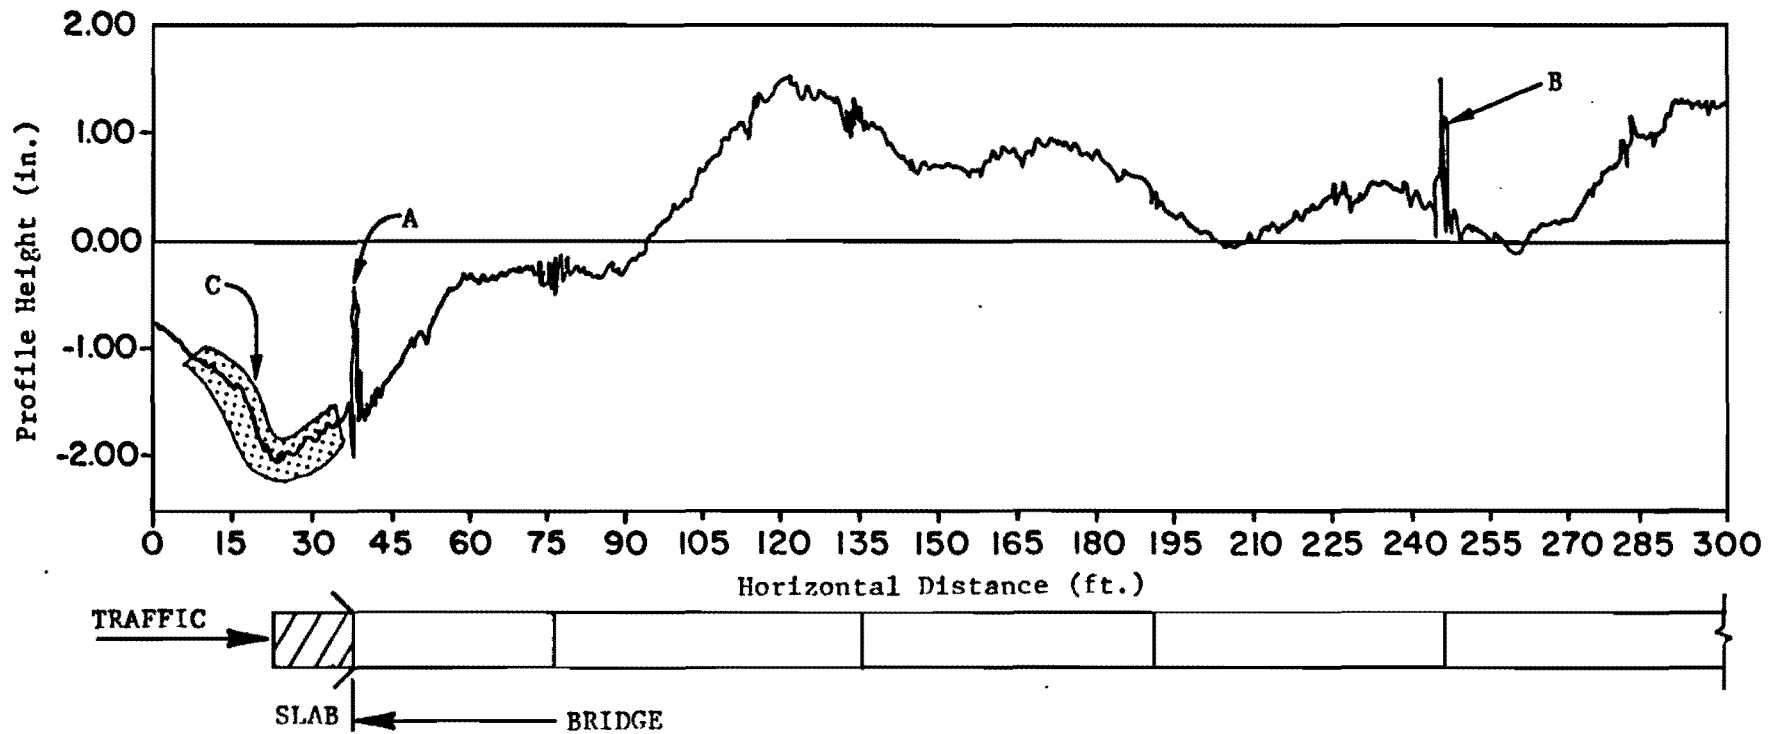
Fig 3.9. Bridge profile, Loop 289 over US 87 South (Lubbock), start of bridge.

- A. Discontinuity between approach slab and bridge
- B. Open joint between bridge decks
- C. Sag near bridge end

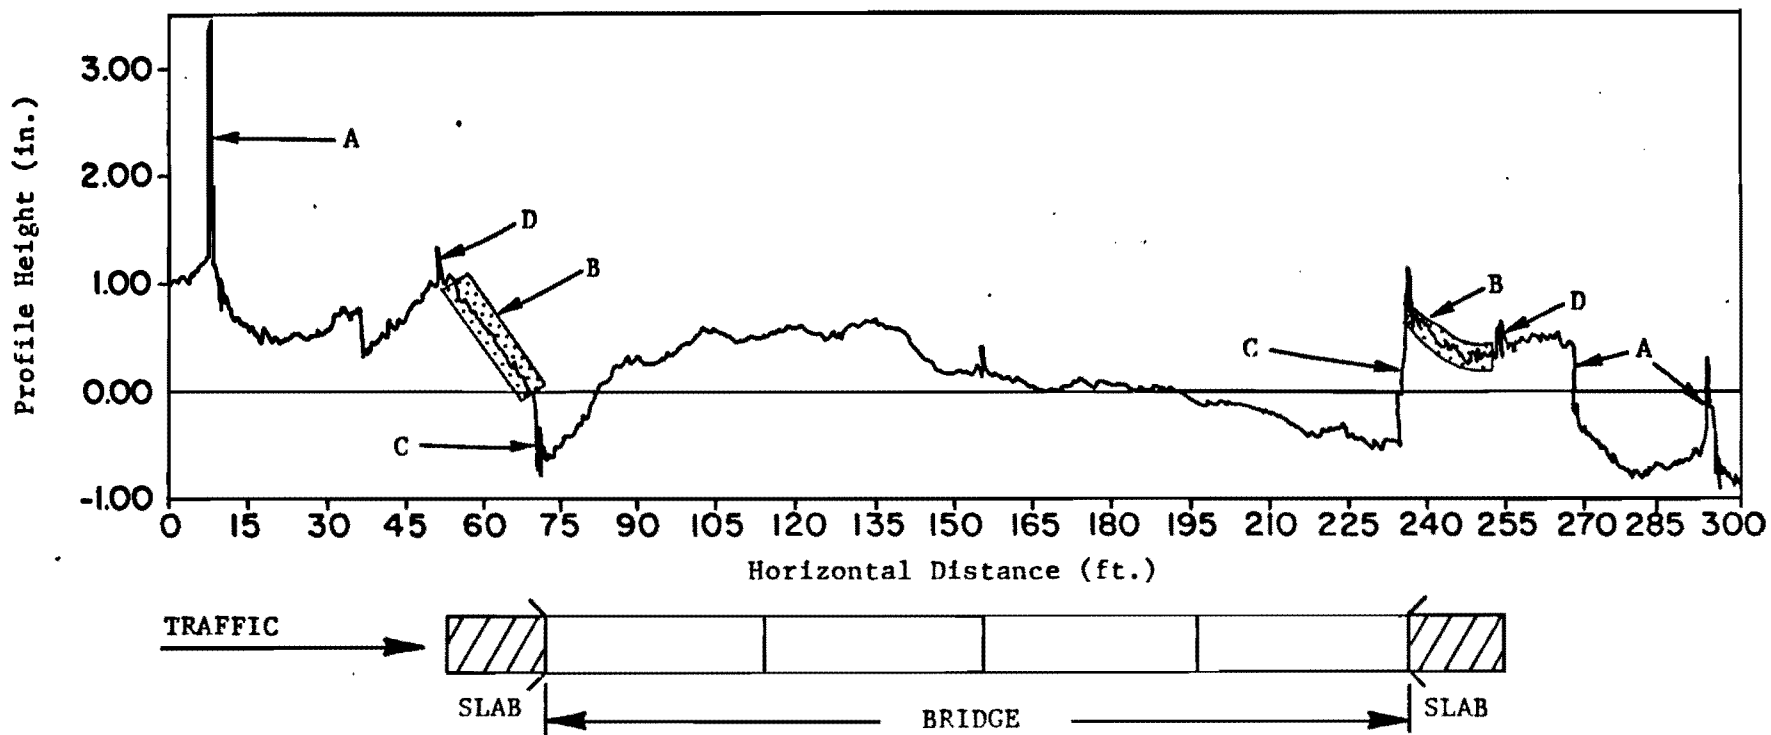
Fig 3.10. Bridge Profile, SH 225 over Scarborough Lane (Houston).

- A. Gap at pavement joint
- B. Tilted or distorted approach slab
- C. Joint between approach slab and bridge
- D. Joint between approach slab and pavement

A combination of several types of roughness, not an isolated discontinuity, normally creates maximum dynamic loading. The section of Scarborough Lane (Houston) exemplifies this statement. A detailed analysis of that site is shown in Fig 3.10. Besides the previously mentioned gap at the pavement joint, there are at least three other types of roughness present.

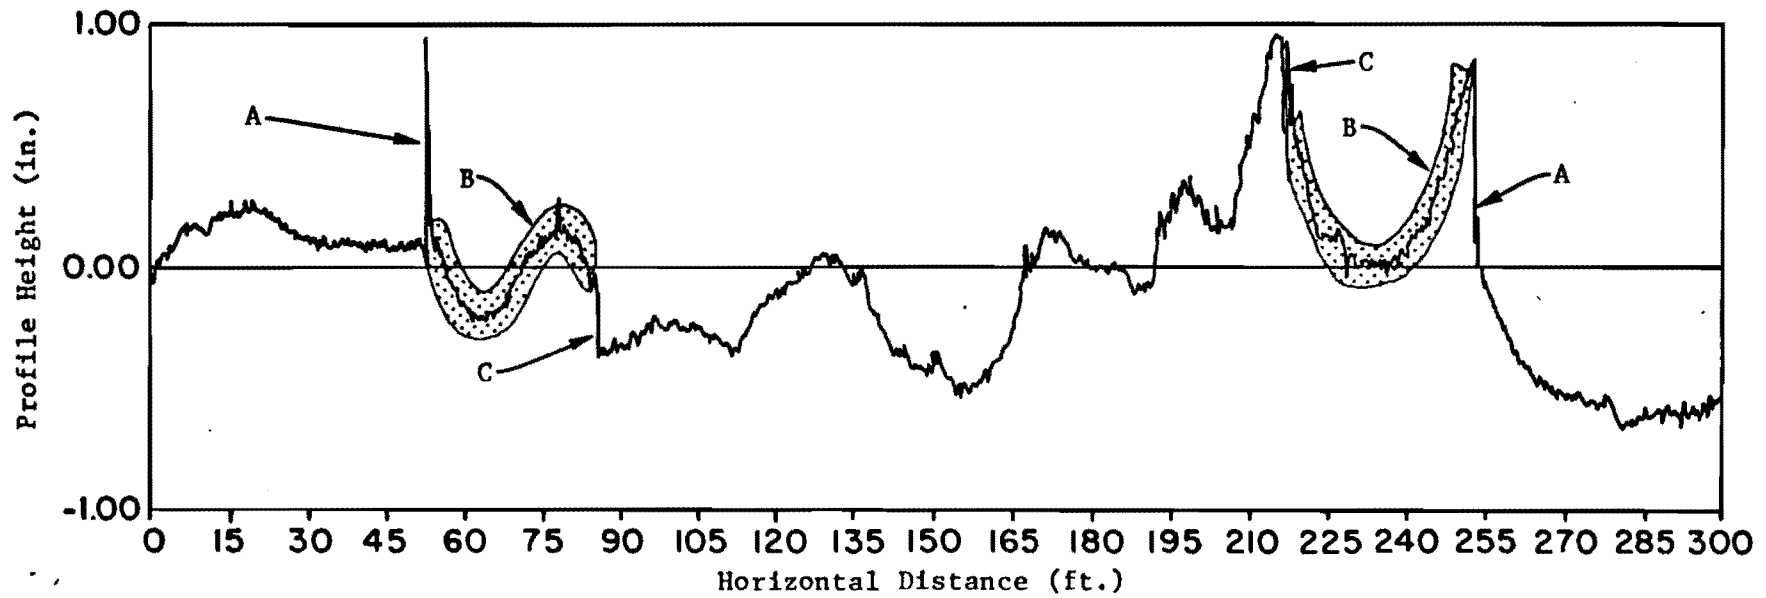
Fig 3.11. Bridge profile, South Loop over Calais Street (Houston).

- A. Discontinuity between approach slab and pavement
- B. Distorted approach slab
- C. Discontinuity between approach slab and bridge

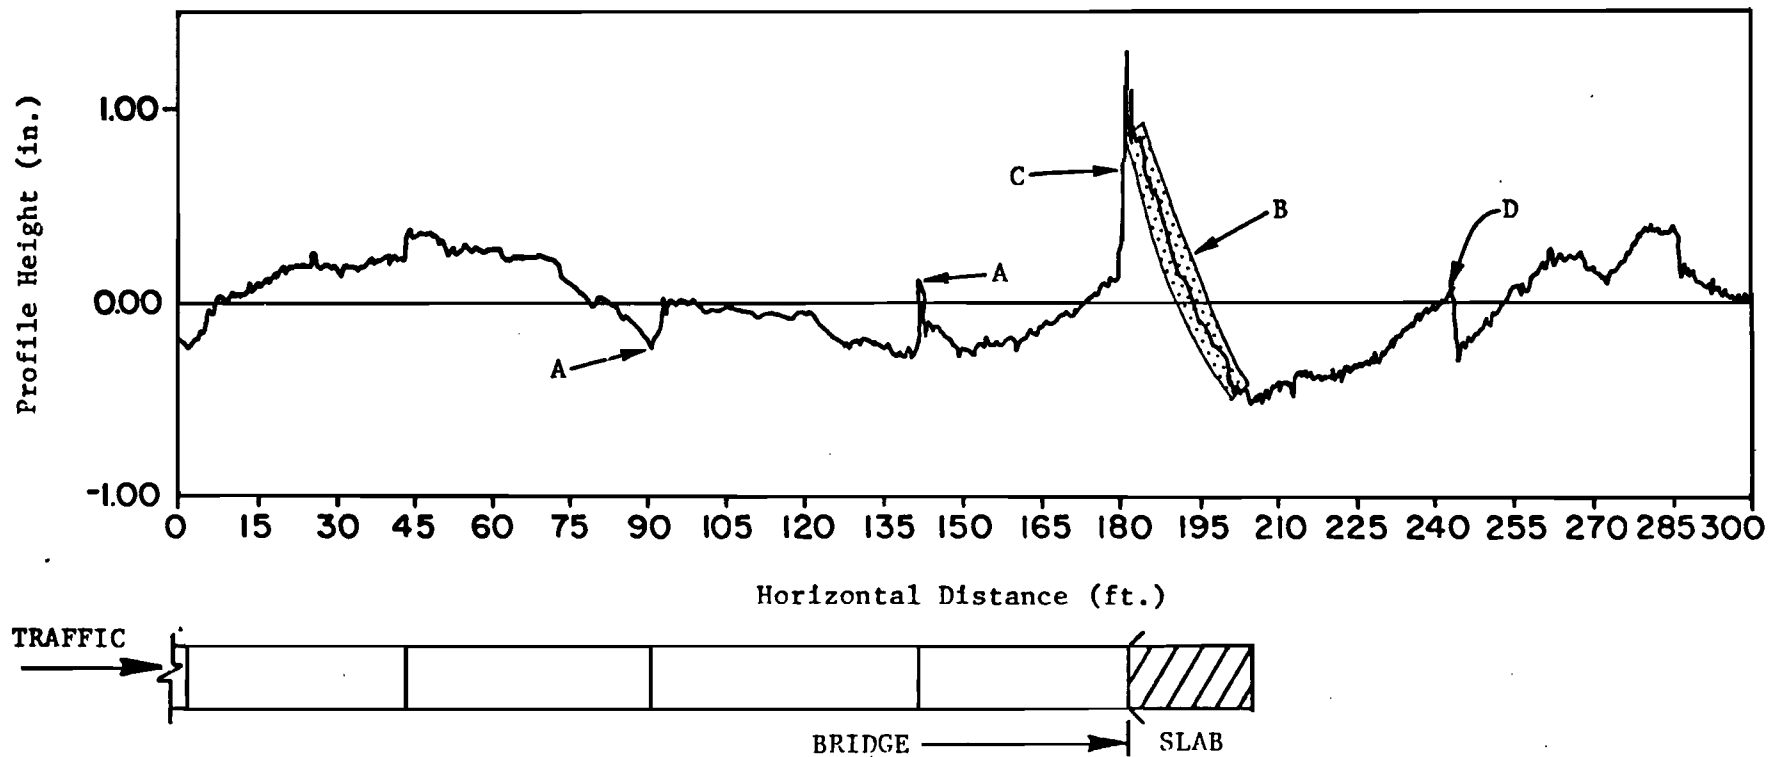
Fig 3.12. Bridge profile, IH 10 over West Belt (Houston), end of bridge.

- A. Opening between bridge decks
- B. Tilted approach slab
- C. Discontinuity between approach slab and bridge
- D. Gap at pavement joint

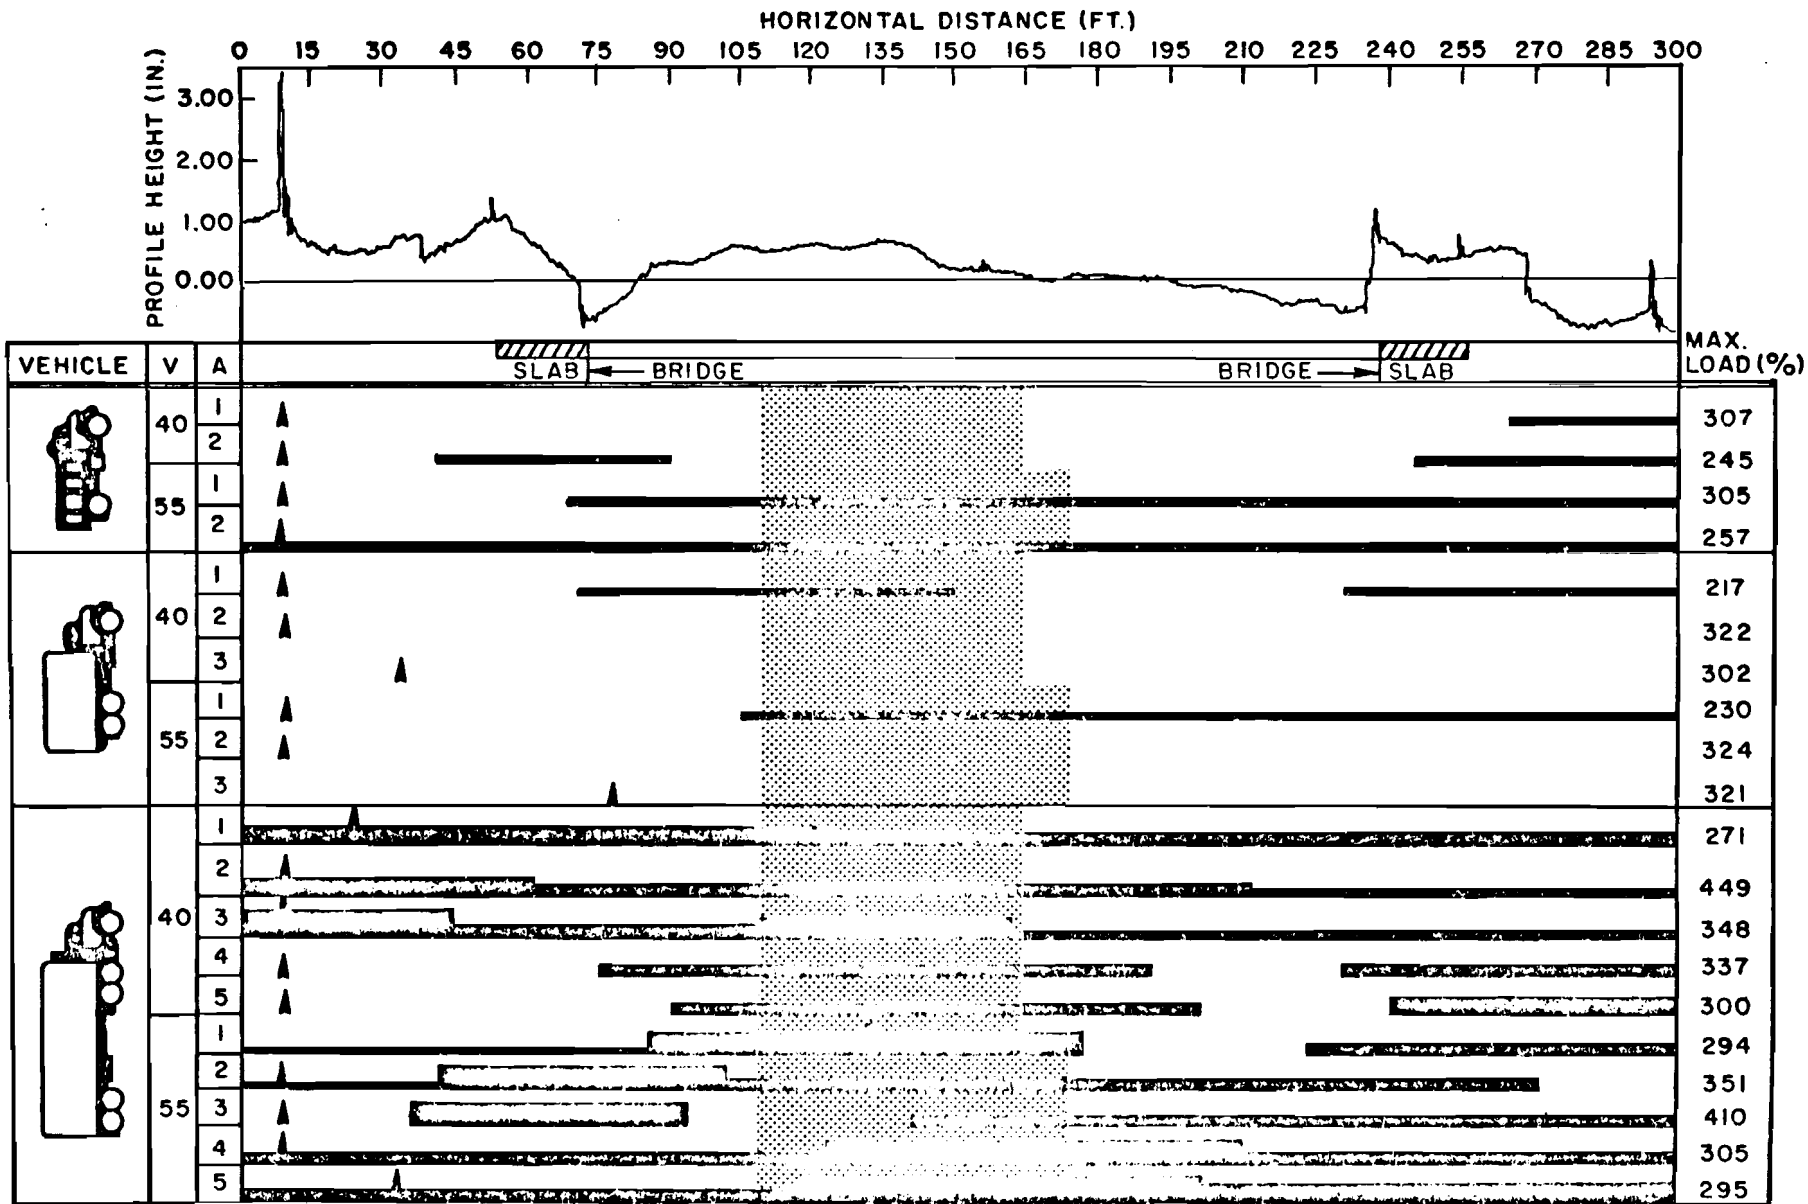
- (10) The most serious case encountered in this study is SH 225 over Scarborough Lane (Houston). The primary roughness pattern, consisting of a wide gap at the pavement joint, induced peak dynamic axle loads of 4.5 times static weight. If a normal distribution is assumed for dynamic loading, about 98 percent of the dynamic axle loads will be twice their static weights. The importance of joint sealing or repair cannot be overlooked.

Fig A4.28A. Dynamic wheel load diagram, high frequency oscillation, SH 225 over Scarborough Lane (Houston).
