**EVALUATION OF THE PERFORMANCE OF THE BONDED CONCRETE  
OVERLAY ON INTERSTATE HIGHWAY 610 NORTH, HOUSTON, TEXAS**

**Research Report 920-2**

Evaluation of Thin Bonded Concrete Overlay in Houston

December 1987

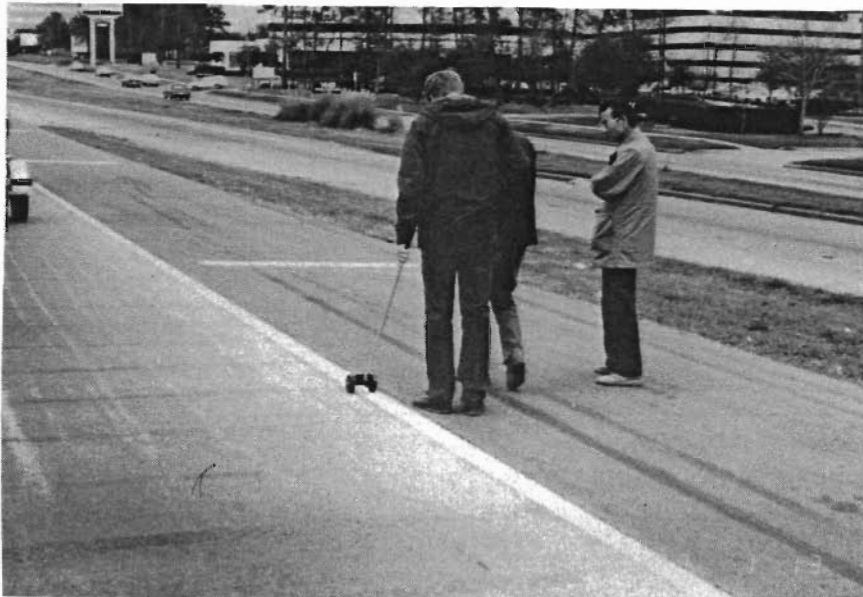
Fig 3.2. CTR personnel are conducting condition survey on the 10 test sections, IH 610 North, Houston.

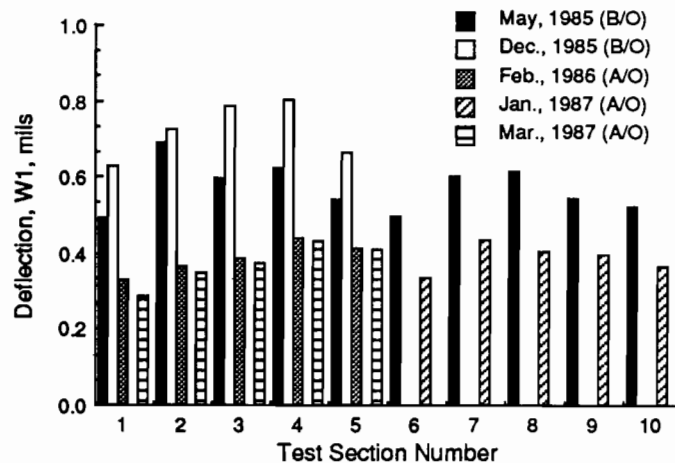
Figure 5.1. Comparison of before and after-overlay average deflection of Sensor 1, IH 610 North, Houston.

The average deflection before and after overlay of each experimental section is presented in Chapter 3 of this report. Plotting the before and after-overlay deflection with the experimental section number, it may be clearly seen that the average deflection after overlay construction decreased significantly for all test sections (see Figs 5.1 through 5.5). Tables 5.1 through 5.5 show percent decreases in deflection (relative to May 1985 deflection data) of Sensors 1 through 5, respectively.

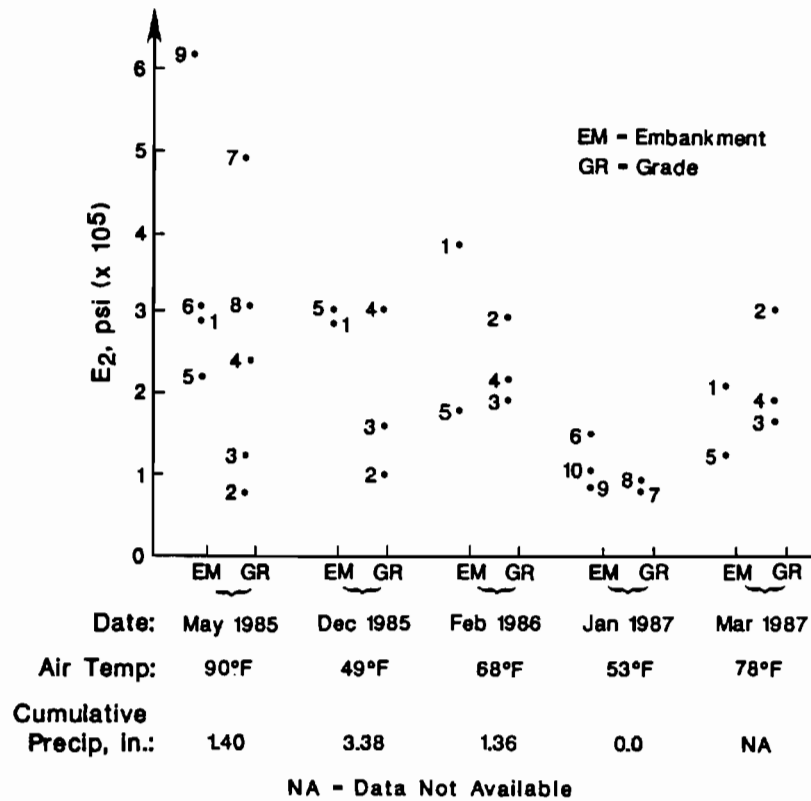
Fig 5.11. Moduli of elasticity of concrete layer,  $E_2$ , vary with air temperature.

As can be seen in Fig 5.10, modulus values of the CRC layer ( $E_1$ ) of the first five sections were higher in May 1985 than in December 1985. It also may be noted that the moduli of Sections 6 through 10 in May 1985 were higher than in July 1987. This trend may have been the result of higher temperatures in May 1985. A high temperature condition will result in a decrease in pavement deflection due to pavement expansion and narrowing of transverse cracks in CRC pavement. As the cracks narrow, the load transfer increases, which results in stiffer CRC (see Fig 5.11).

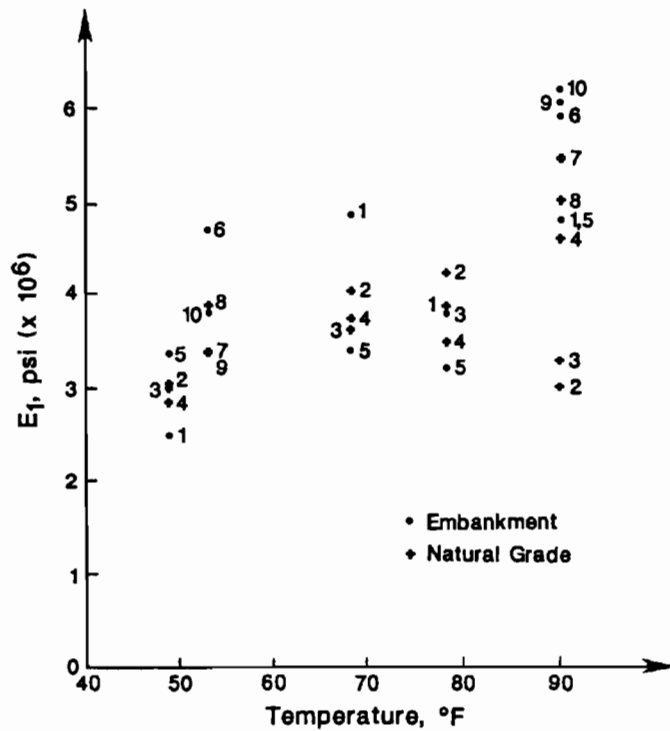
Fig 5.13. Moduli of elasticity of subgrade layer,  $E_1$ , vary with test section locations and the environmental conditions.

Pavement in cut and fill areas may have different subgrade moduli. As can be seen in Fig 5.13, most of the sections on the embankment have higher moduli. This may be caused by free drainage on the embank-

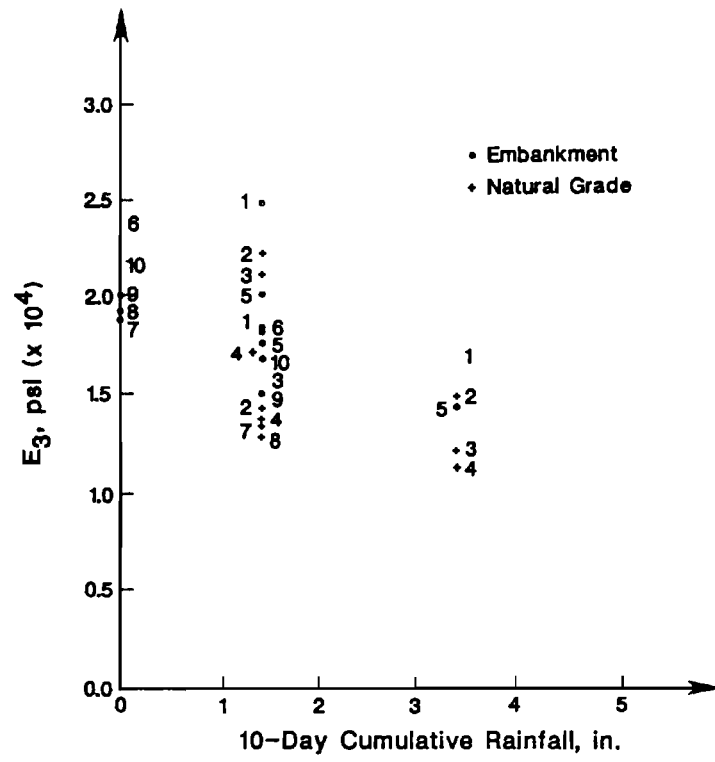
Fig 5.14. Moduli of elasticity of subgrade layer,  $E_g$ , vary with 10-day cumulative rainfall.

It can also be seen, in Fig 5.14, that the subgrade moduli vary with seasons. Periods of higher rainfall result in higher moisture content in the subgrade and a corresponding lower subgrade modulus.

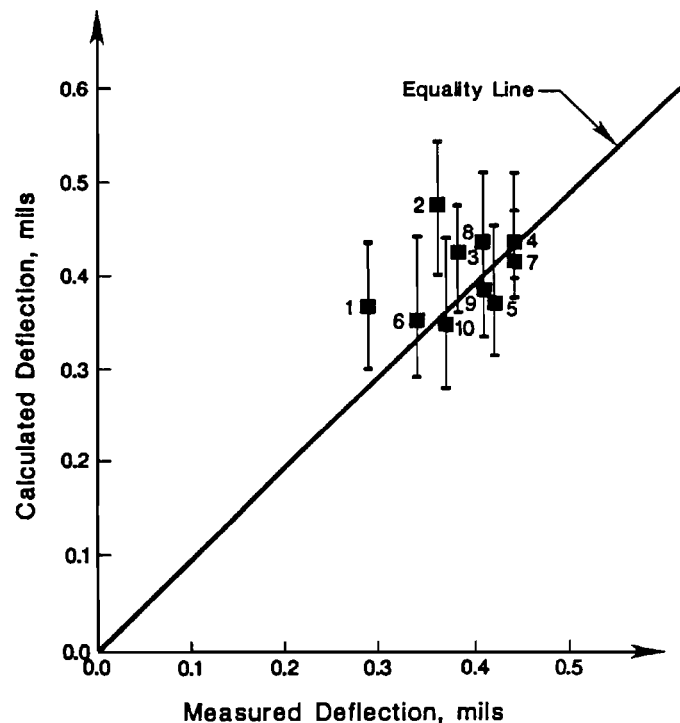
Fig 6.1. Comparison of calculated and measured after–overlay deflection of Sensor 1.

The accuracy of this method is reflected by the results presented on Fig 6.1 (deflection of sensor 1) and Fig 6.2 (deflection of sensor 5). As can be seen from these figures, the calculated deflections were a little above the equality line.
