DETERMINING VIBRATIONAL FORCES
EXPERIENCED BY HIGH PRESSURE
SODIUM VAPOR LAMPS IN
ROADWAY LUMINAIRES

Research Report Number 273-1F
FINAL REPORT
Research Project Number 1-8-81-273

August 1988

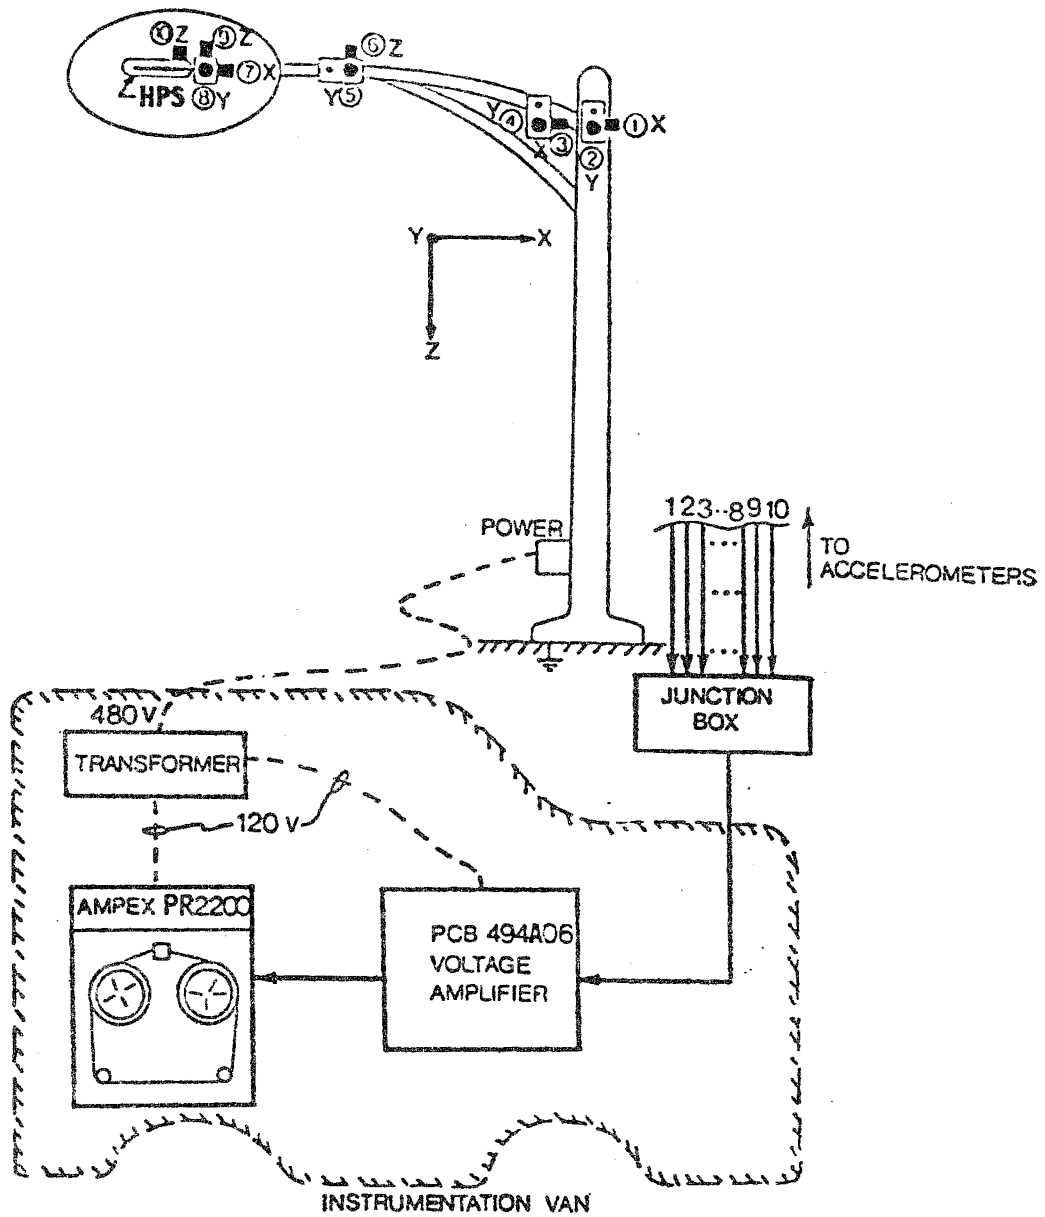
Figure 1 - Instrumentation

Figure 1 identifies the accelerometer locations and instrumentation used to acquire the accelerometer time histories. The instrumentation van, fondly named the "yellow-elephant" was insulated and air-conditioned to protect the temperature sensitive instrumentation. At each test site the van was placed to be the least visual and disruptive to traffic.

Of the ten accelerometers, channels 1-8 used accelerometers having sensitivity of 100mV/g and a frequency range of 1-3000Hz. Two high temperature accelerometers, channels 9 and 10, were used to monitor the vertical (Z) accelerations on the tube surface and at the lamp base.

Comparing the PCB312A mass, including mounting components (approximately 50 grams), to the mass of the HPS tube (approximately 165 grams), it was considered permissible to mount one accelerometer on the lamp surface. The accelerometer was mounted on the tube surface near the lamp socket. The tube surface temperature here falls within the PCB 312 limitation of 400°F. Also, this location enabled the researchers to discern the vibration transmissibility across the lamp socket. Since the lamp tube is protected from direct wind loading by a glass shield, the socket provides the only means of tube excitation.
