INVESTIGATION OF FAILING
CONCRETE IN HOUSTON,
TEXAS, CAUSED BY
UNSOUND CEMENT

TEXAS HIGHWAY DEPARTMENT

Materials and Tests Division
Texas Highway Department

5-20-72-057
October 1972

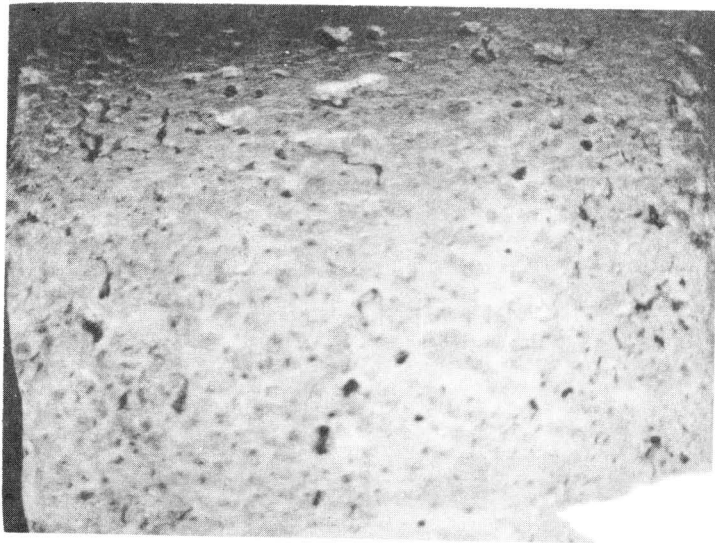
Fig. 23
(Mag. 4X)

Figures 21 and 22 illustrate the effect of 5 hours of steam on briquettes made with the unsound cement. An untreated briquette is shown on the far right for comparison in Figure 21. Photomicrographs taken at 4X show details of the crack pattern as observed on the curved sides of specimen #2321 in Figure 22; a close-up of the untreated sample showing a crack-free condition is illustrated as Figure 23. Briquettes containing the bad cement (#2321 and #2349) cured 7 days in water and left exposed in the laboratory for 5 months still showed to be unsound by the autoclave and steam-bath tests.
