**EFFECTS OF OVERHEIGHT AND HEAVY LOADS
ON TEXAS HIGHWAYS**

**Prepared by the
State Department of Highways and Public Transportation
Austin, Texas**

July, 1978

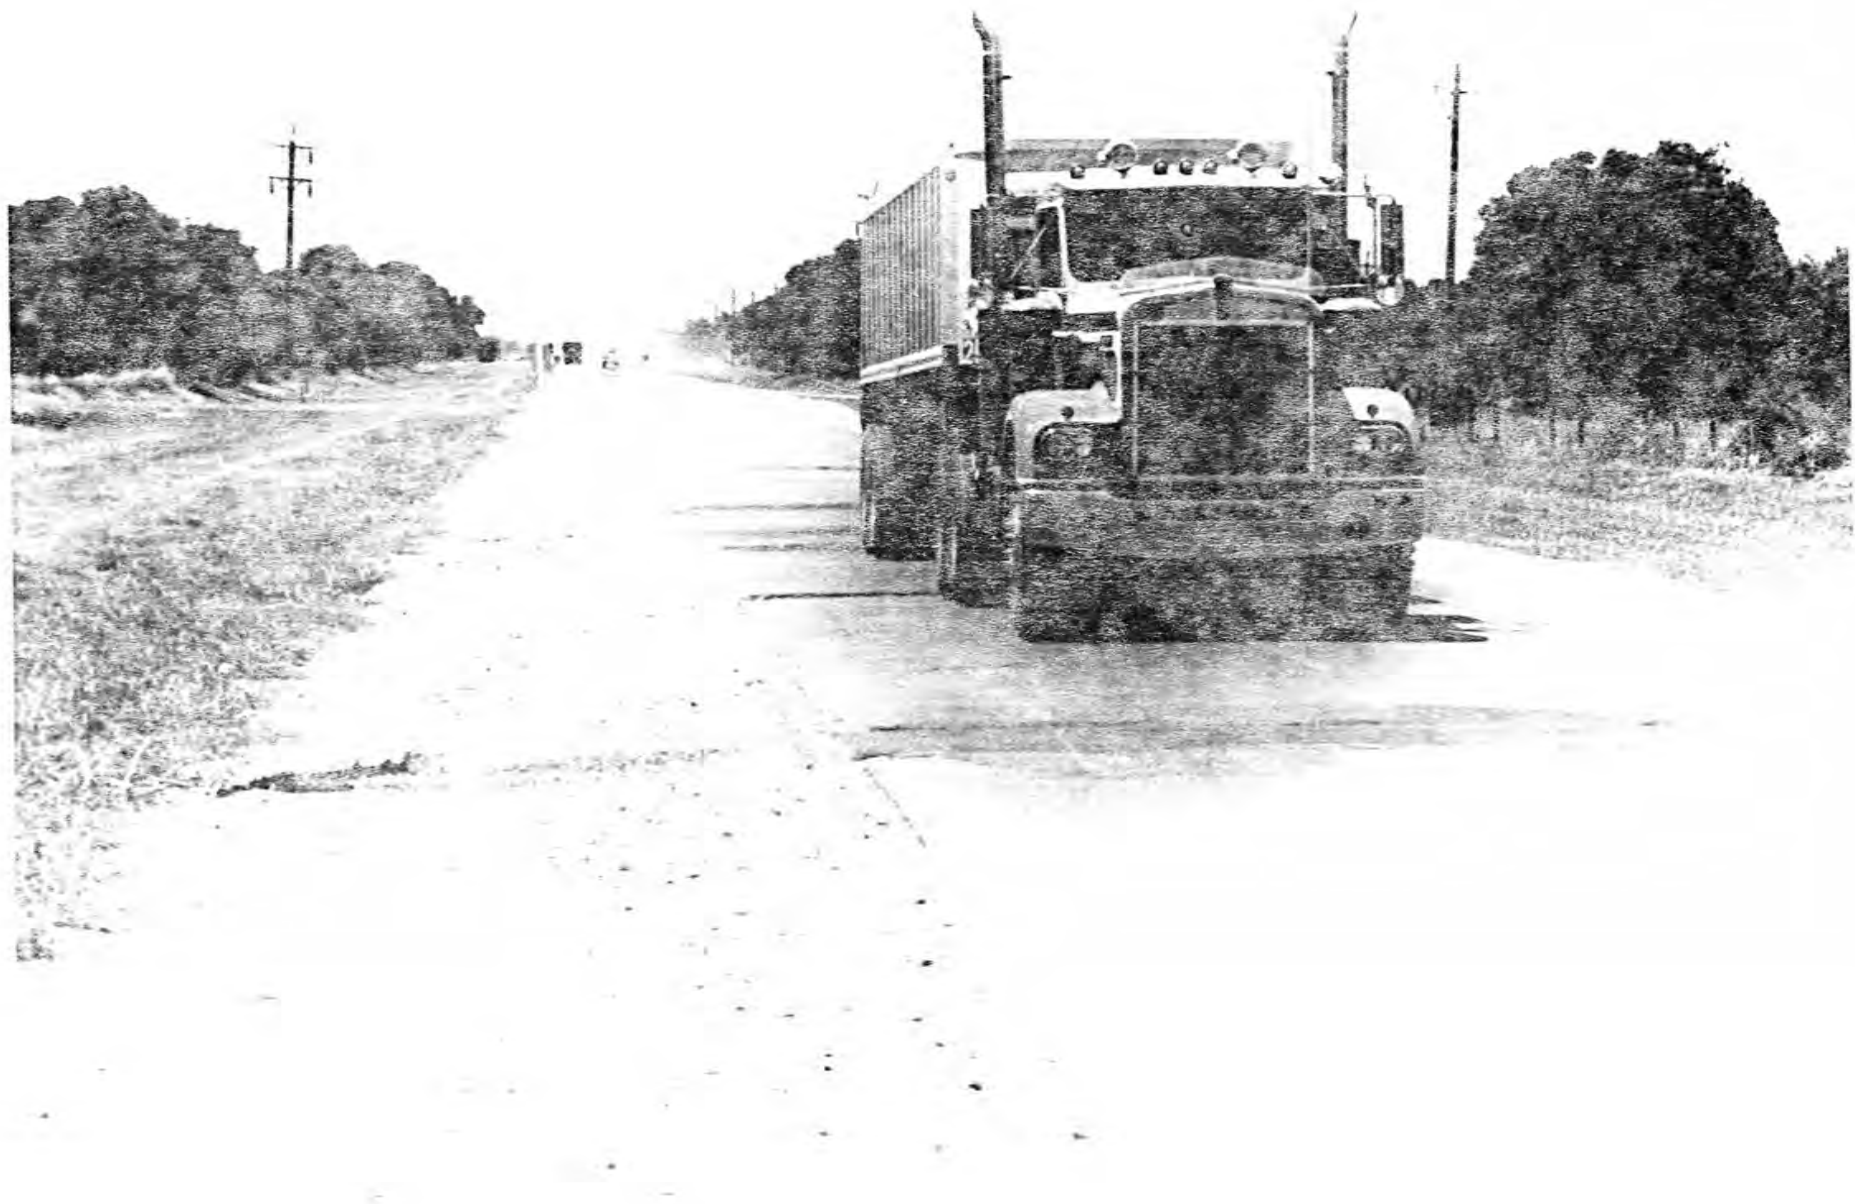
Picture 2

Picture shows some of the repair areas which are dominant on the South-bound or loaded lane. The concrete slabs have faulted. The surface is uneven and rough. Traffic must slow down and trucks are straddling the centerline or traveling with the right wheels on the shoulder as shown in Picture 2. Maintenance costs have increased by a factor of seven in three years.

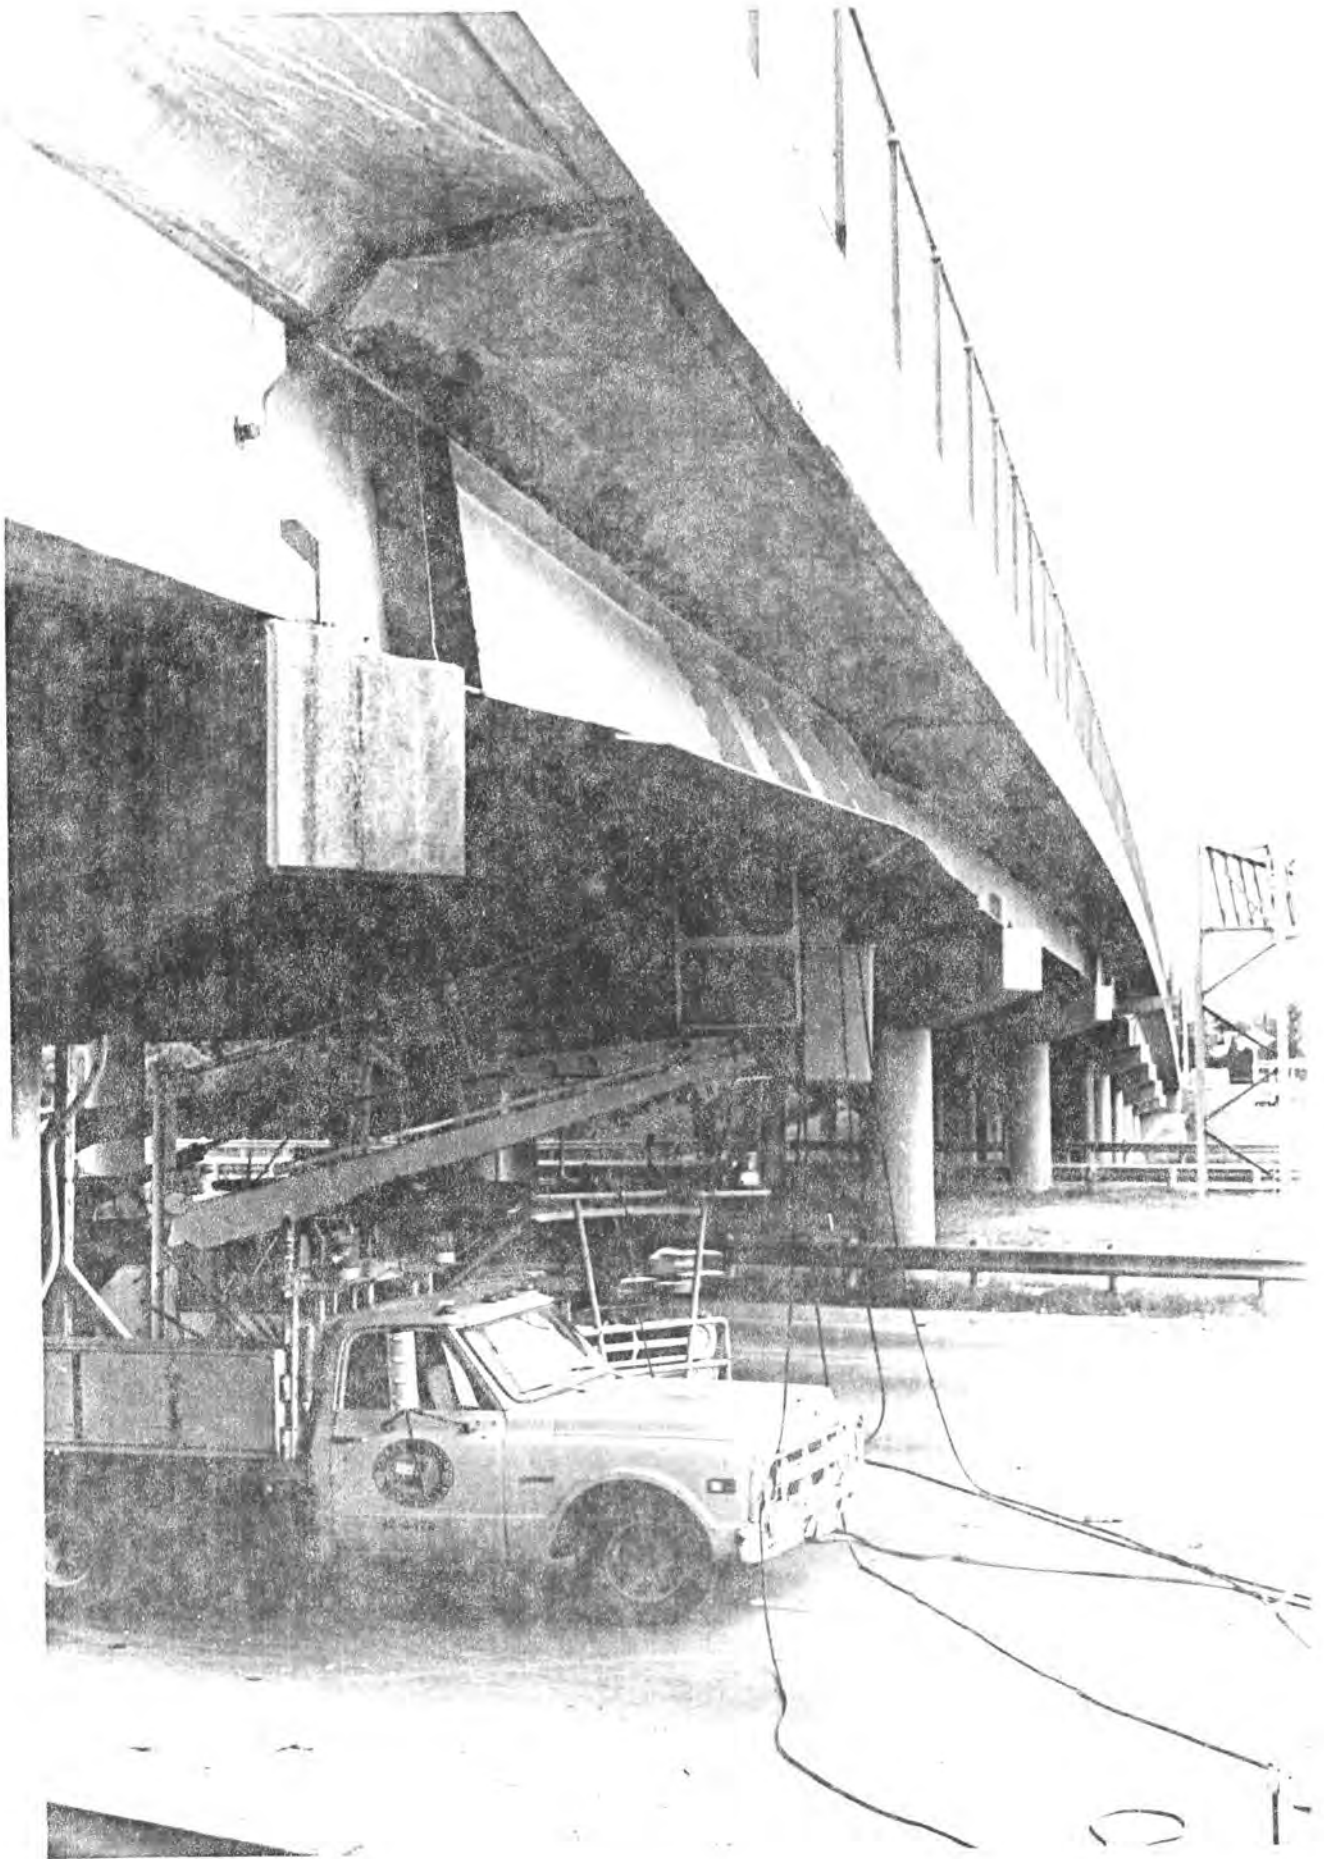
While pavement distress due to heavy loads is most readily observable in suburban and rural areas, structural damage to bridge and overhead sign structures is a common occurrence in urban areas such as Houston. The degree of the problem is shown in Tables II and III. The severity of the damage is illustrated by the photographs in Appendix D. The concern felt by the community is illustrated by the newspaper articles found in Appendix A. The legal height without permit is 13'-6". However, clearance signs have been posted because of overheight loads. Also the photographs illustrate that measures have been employed in an attempt to reduce damage to bridges--but without success. Picture 12 shows warning tattle-tales at one location which have been struck. Picture 13 shows warning lights which are activated by high loads--and still the bridge has been struck. Such bridge damage usually results from overheight loads carried without a permit. In some cases, loads which have passed under a given clearance at low speed have damaged succeeding structures with the same or higher clearance when passage was attempted at high speeds. This occurrence probably results from greater vertical oscillation (bounce) at higher speeds. Pictures 14 and 15 show heavy damage to a structure with the load bearing reinforcing steel exposed. Picture 16 shows a bridge with a clearance of almost 15-feet which has been struck about ten times. Picture 17 shows damage to a steel girder which has been hit after the load passed under similar preceding girders.

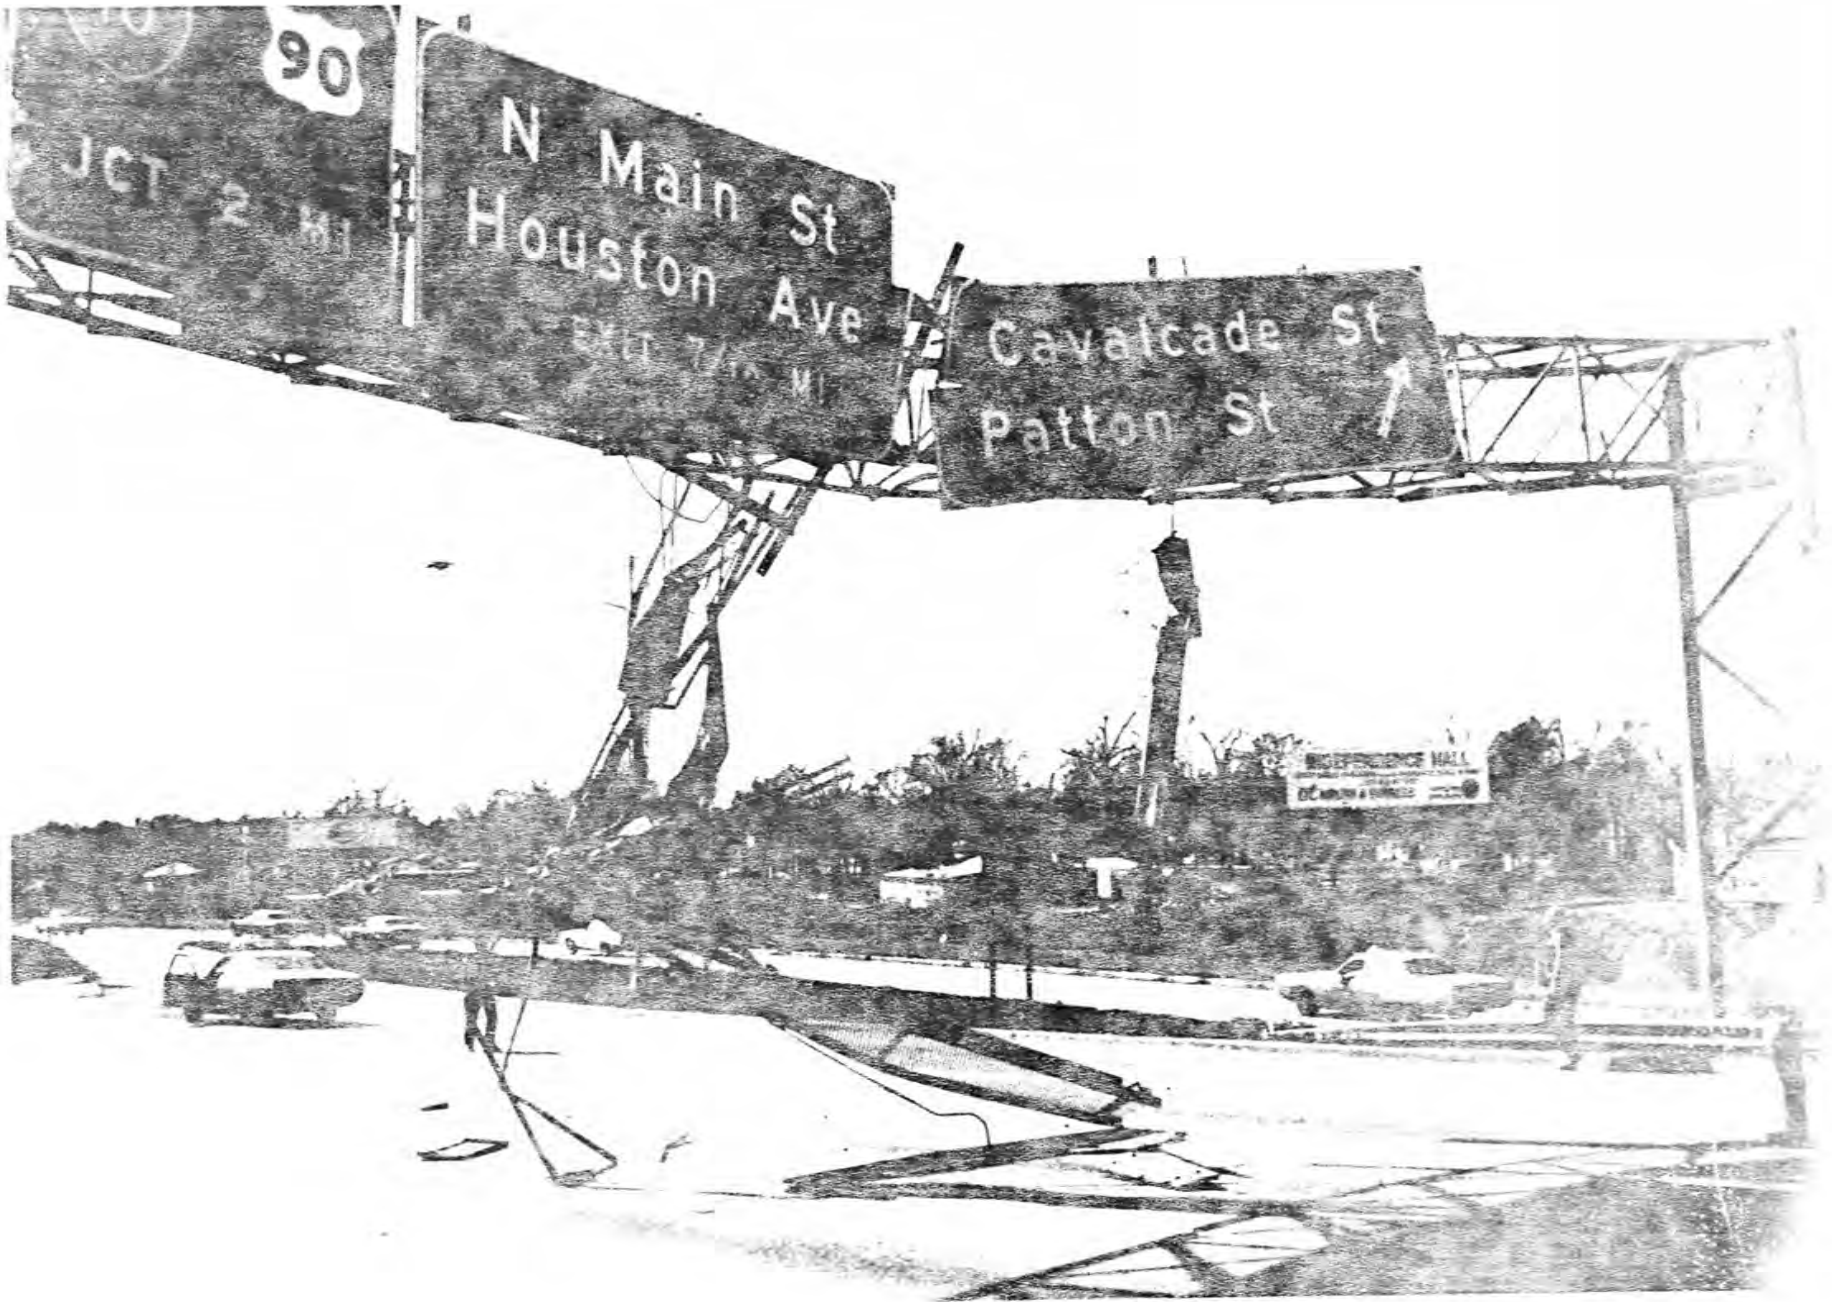
Damage to overhead sign structures recently is almost solely due to dump trucks whose beds have sprung-up while the truck was in motion. Table III lists only those overhead sign structures which currently are down in the Houston area. Picture 18 shows a catwalk and lighting dangling in a position which is hazardous to following traffic. Picture 19 reveals damage to both overhead sign and the truck which struck the sign.

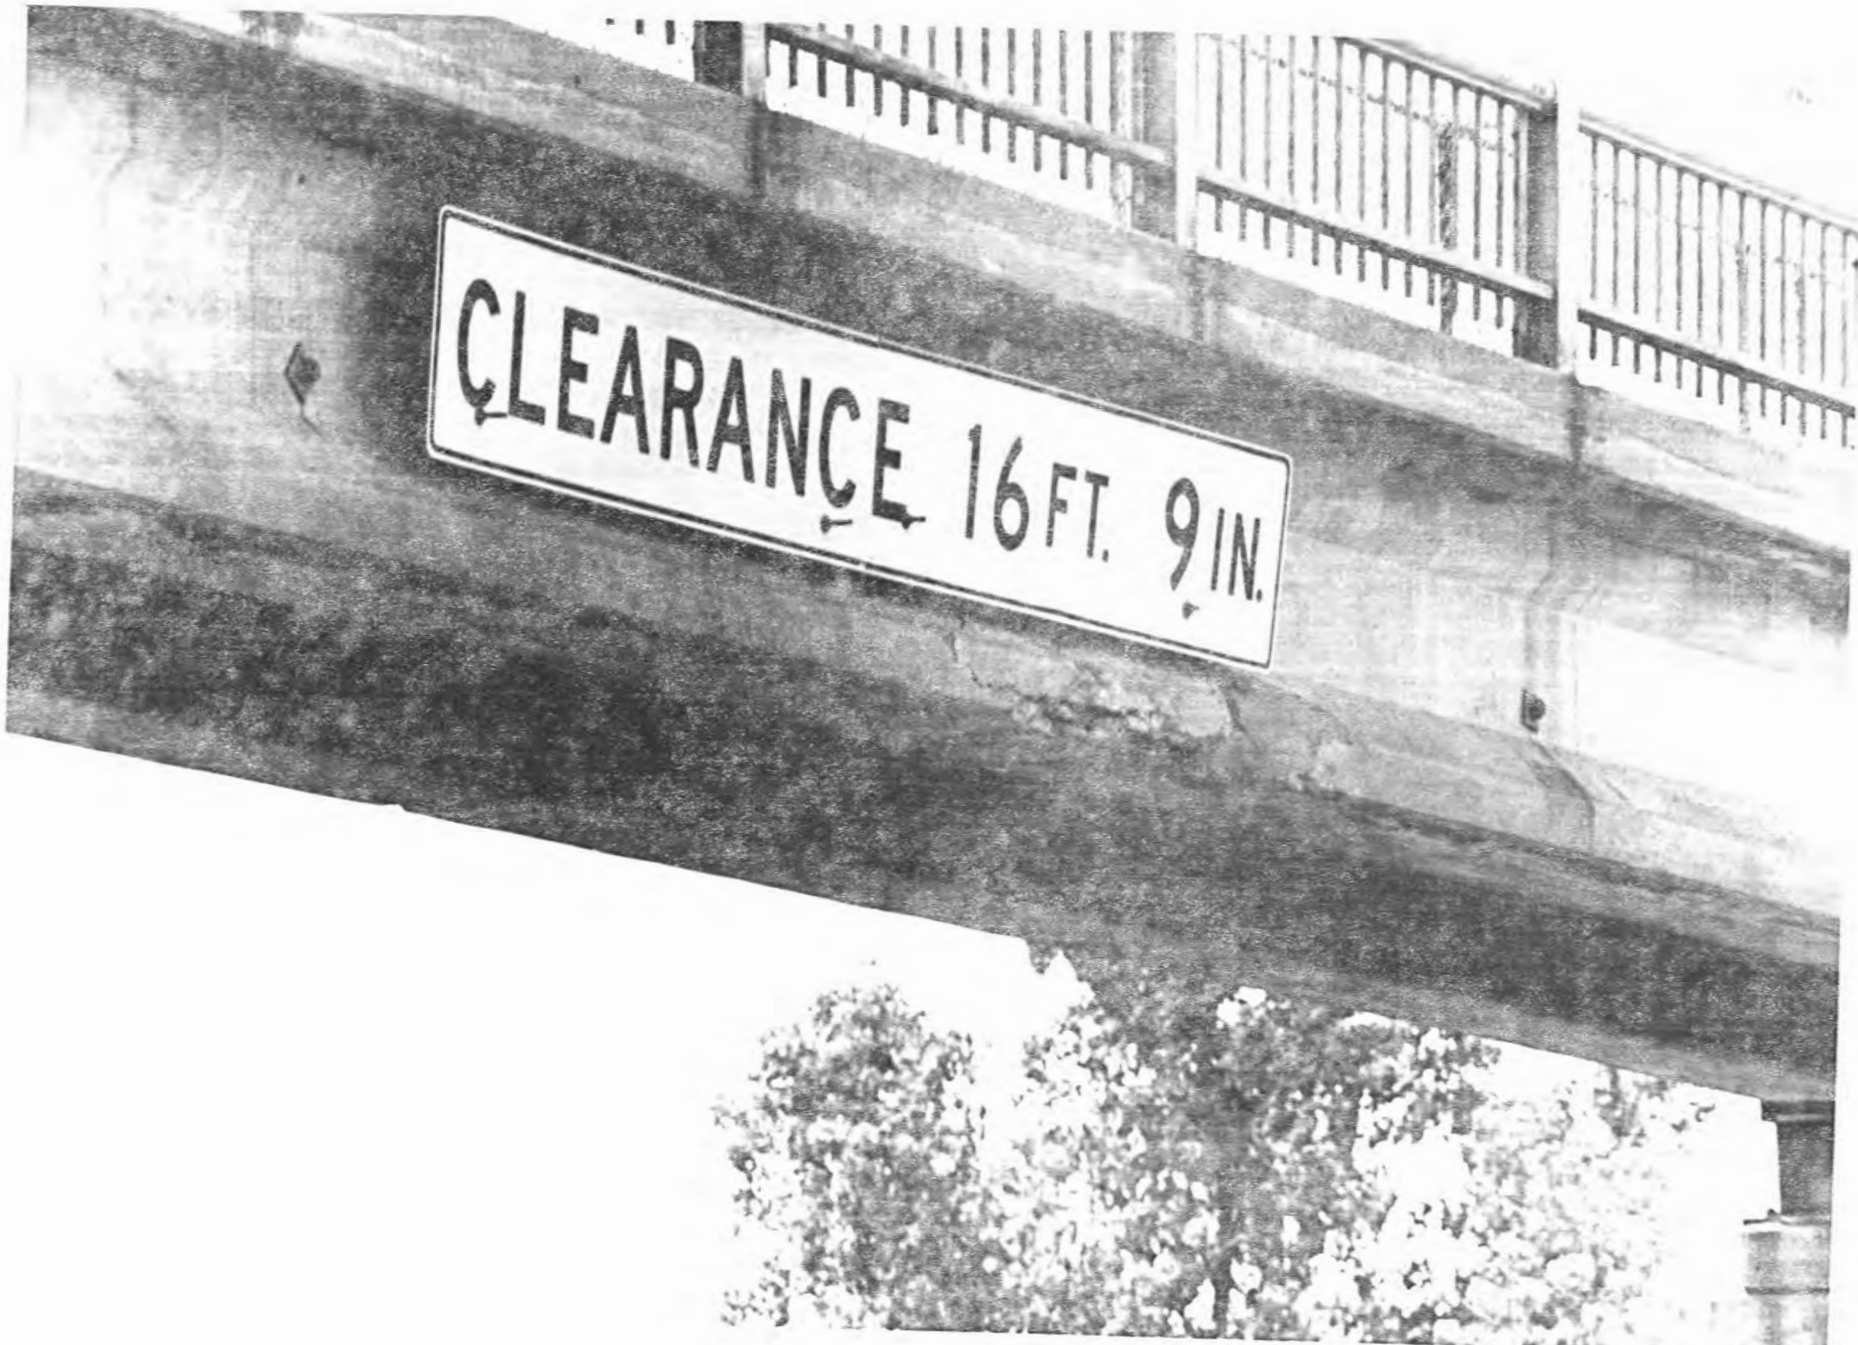
Picture 21

Some of the structures with the higher clearances are the pedestrian crossings. Though by no means a weak structure, they are weaker than a vehicular bridge when impact loaded from the side. Pictures 20 and 21 show pedestrian crossing structures with well over a 10-foot clearance. Both have been hit with overheight loads.
