INVESTIGATION OF PAVEMENT FAILURES

INVESTIGATION OF PAVEMENT FAILURES
ON IH10 IN DISTRICT 13

Report Number SS 3.0

Conducted by
The Research Section of
The Highway Design Division
Texas Highway Department
April 1966

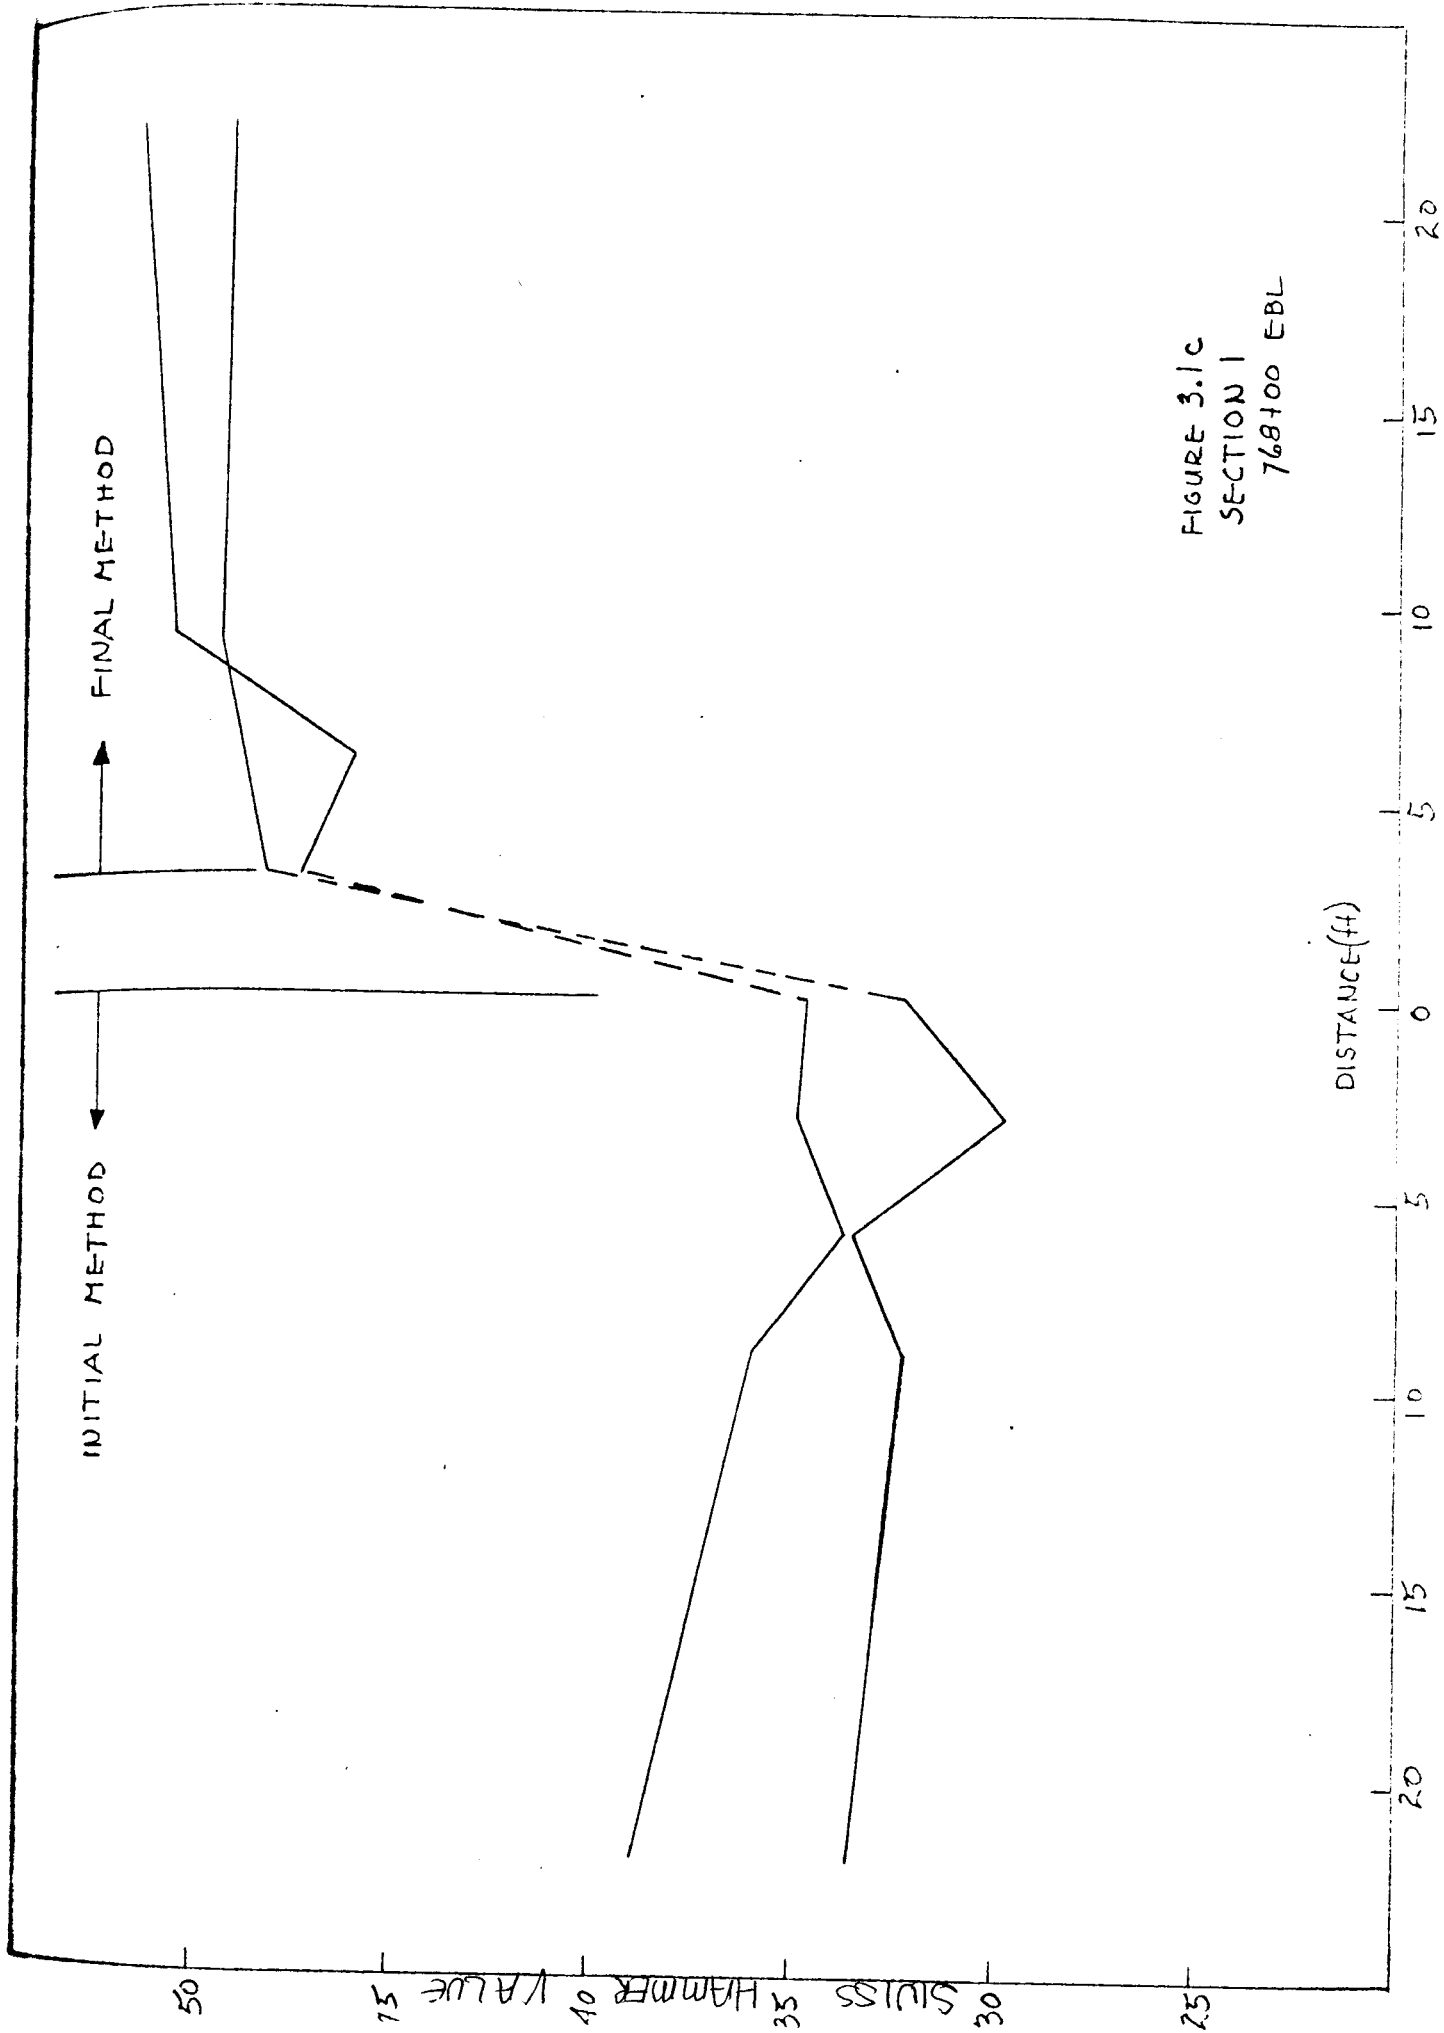
FIGURE 3.1c
SECTION I
768100 EBL

The general pavement condition is portrayed in Figures 3.1a
and 3.1b. Section I was the section on which the Swiss Hammer test
procedure was developed, consequently the plot of hammer test value
to the left of the failure area is different from that to the right
of the failure area. This is clearly shown in Figure 3.1c. The
data from the Swiss Hammer is relative but it does indicate that
there is some question as to the strength of the concrete in the
center of Section I.

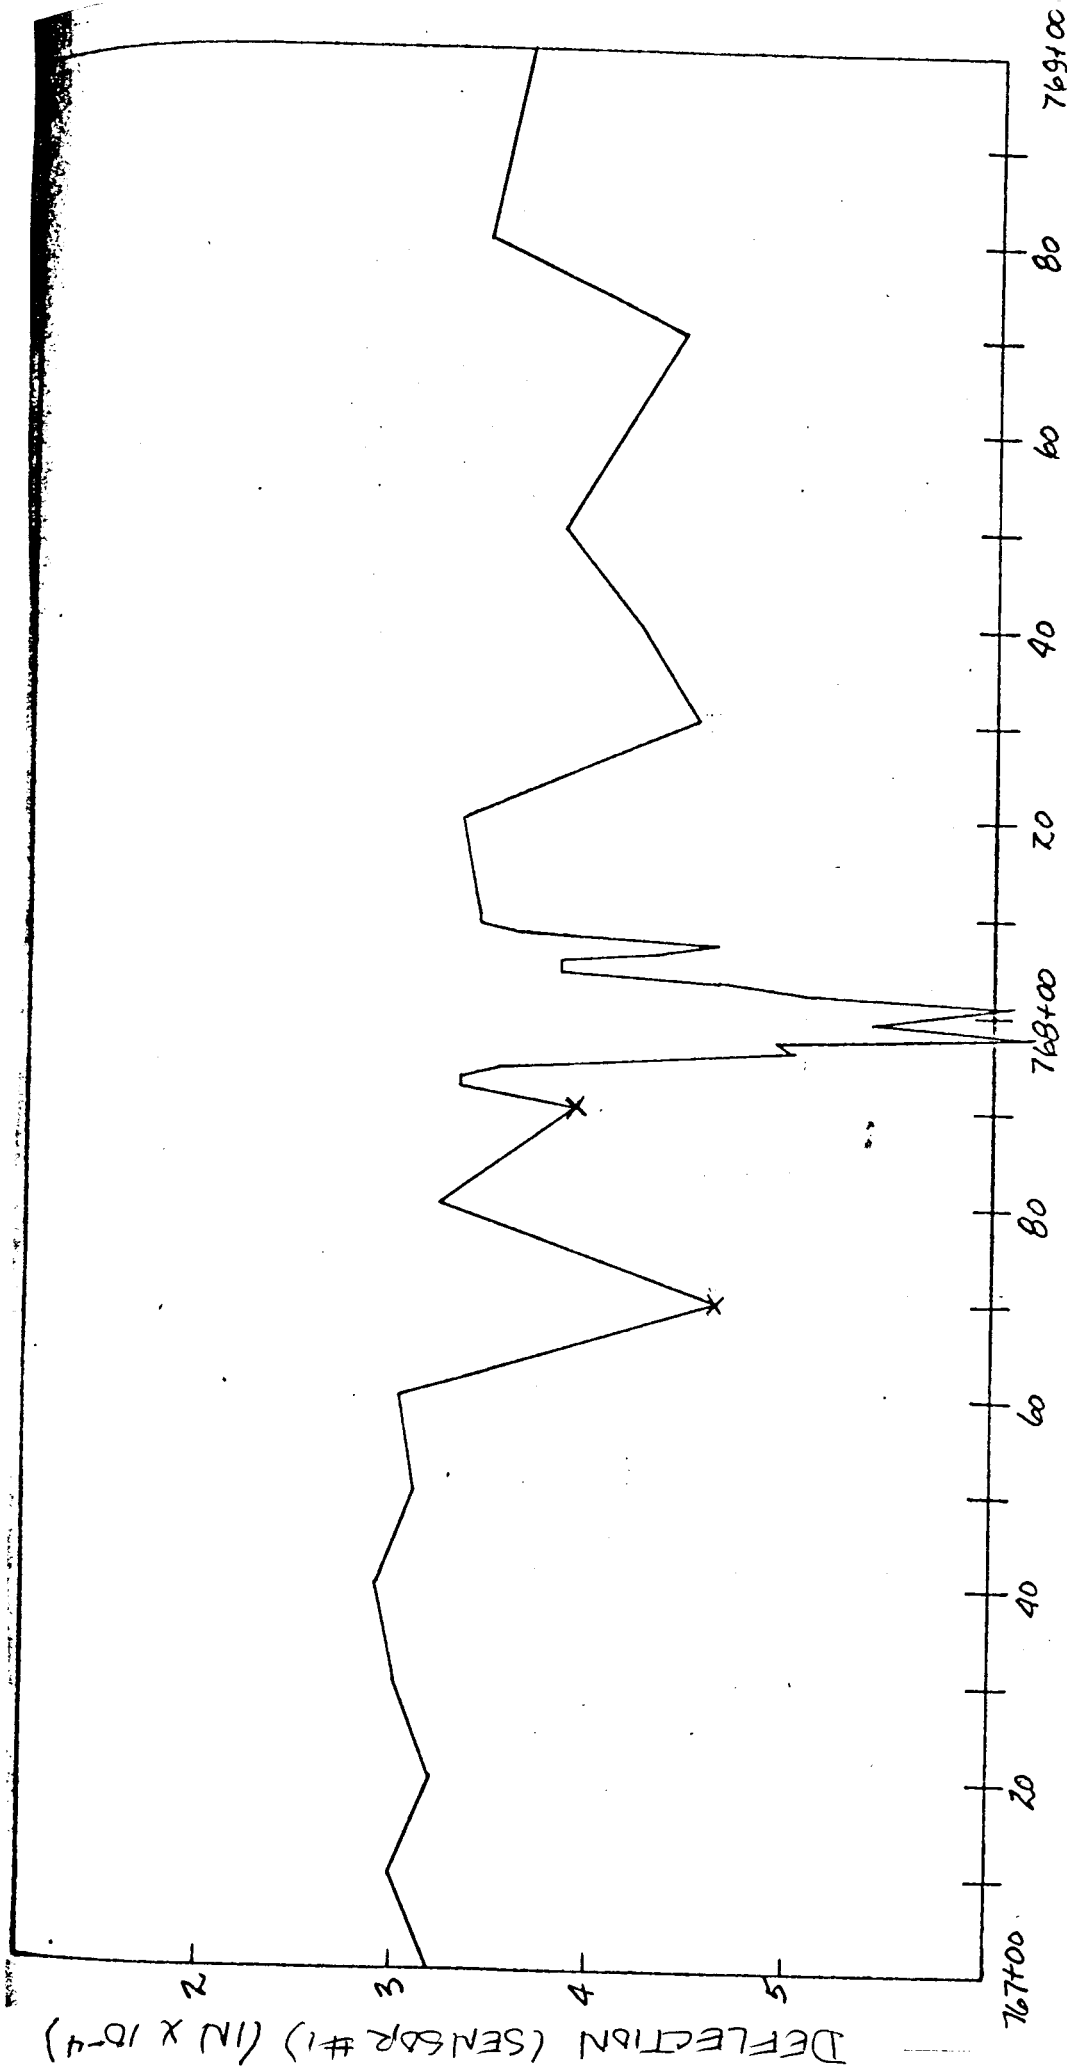
FIGURE 3.1d
SECTION 1
STA 768+00 E-BL
4' RT. OF ϕ

Figure 3.1d and 3.1e show the deflection profile at four feet right of center line and four feet from the edge respectively. It is rather evident from a deflection standpoint that there is an area of weakness at station 768 + 00. Another method of presenting the deflection data is by plotting the difference in deflection by sensor #1 and #2 and sensor #1 and #3 as a profile instead of deflection. Figures 3.1f and 3.1g show this difference in deflection as a profile over 200 feet. This difference in deflection is really a measure of the radius of curvature. Note in the two figures that the pavement at station 768 is having a large difference in deflection or in other words, a short radius of curvature.

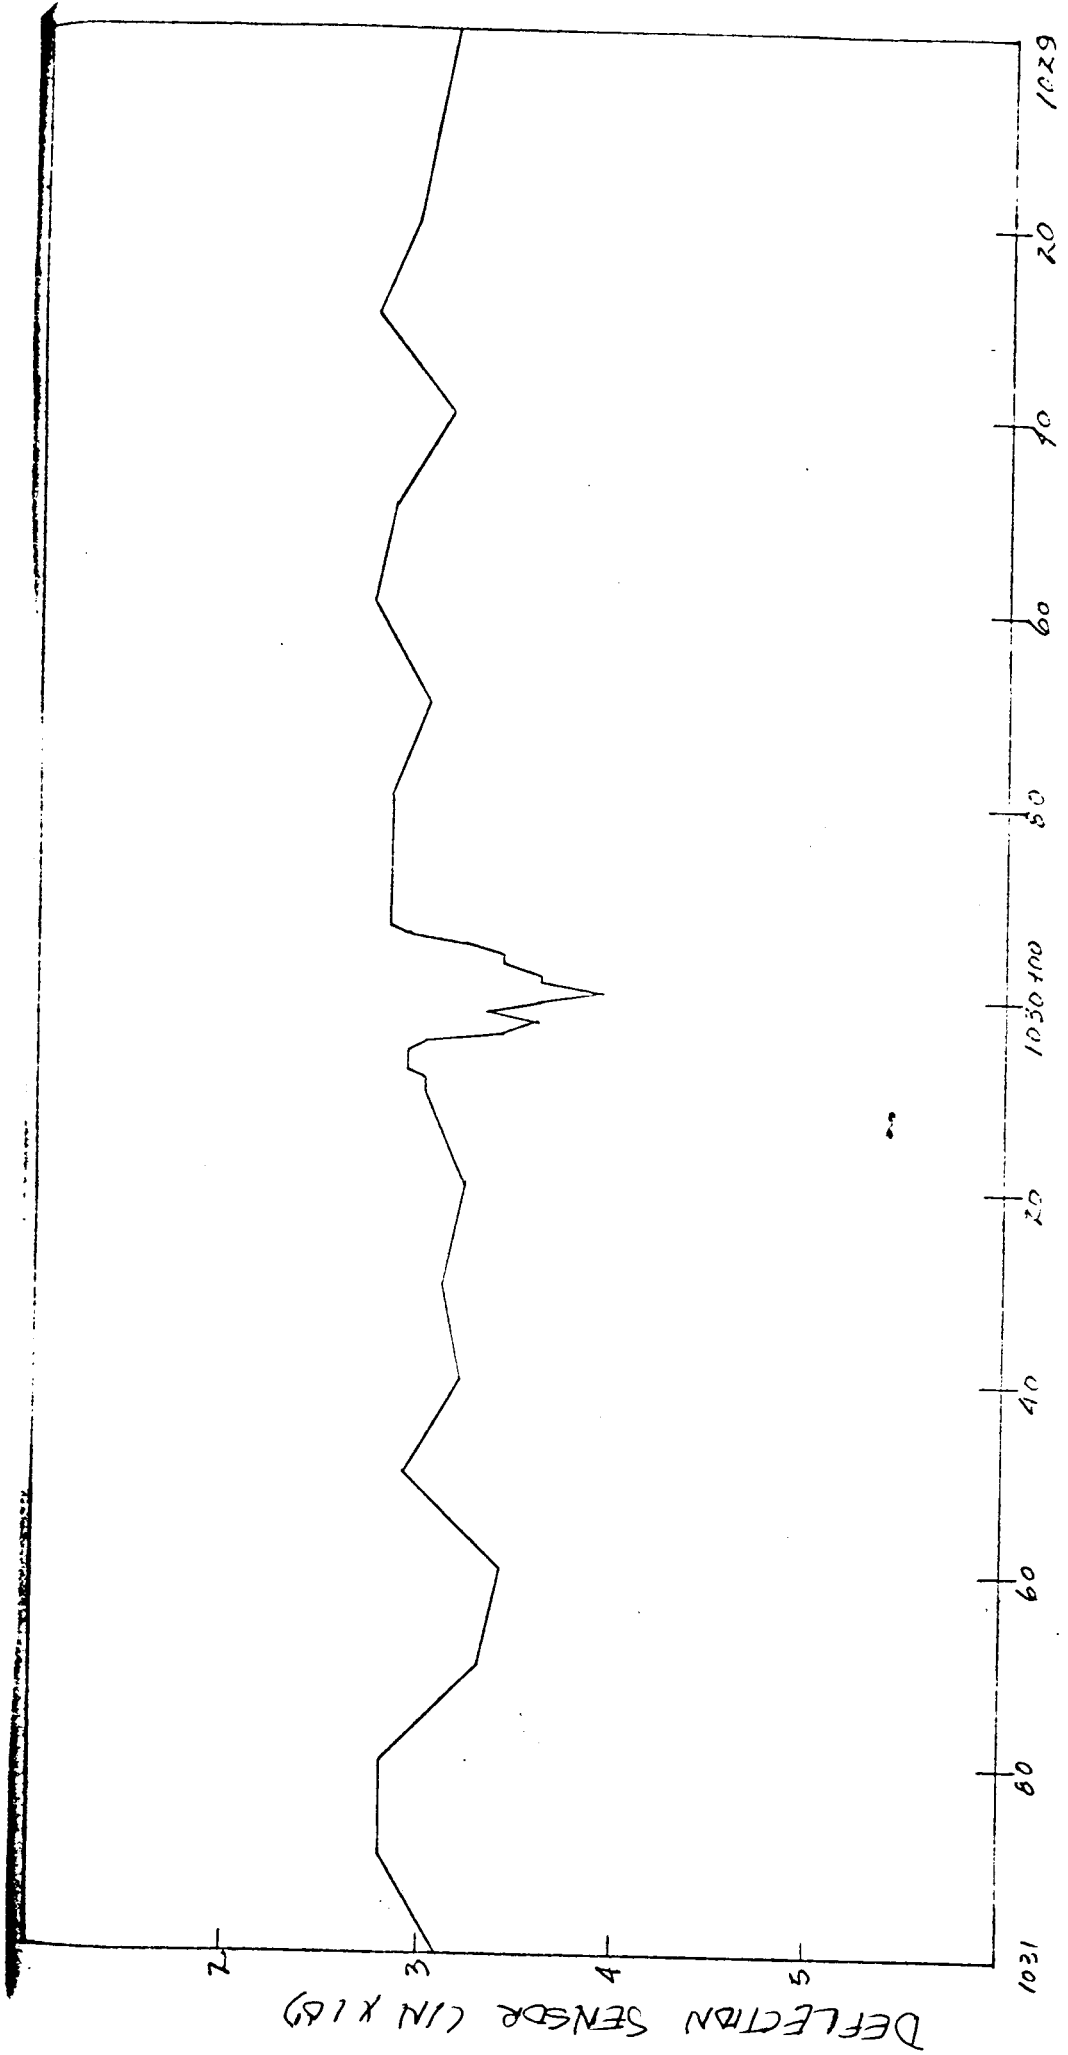
FIGURE 3.2 d

The deflection study also revealed the weak or poor concrete at station 1030. The deflection profile shown in Figure 3.2d portrays the failure area along a line four feet from the pavement edge. Figure 3.2e is a deflection profile four feet right of center line. Deflection alone on this section would not be a measure of the condition of the pavement.

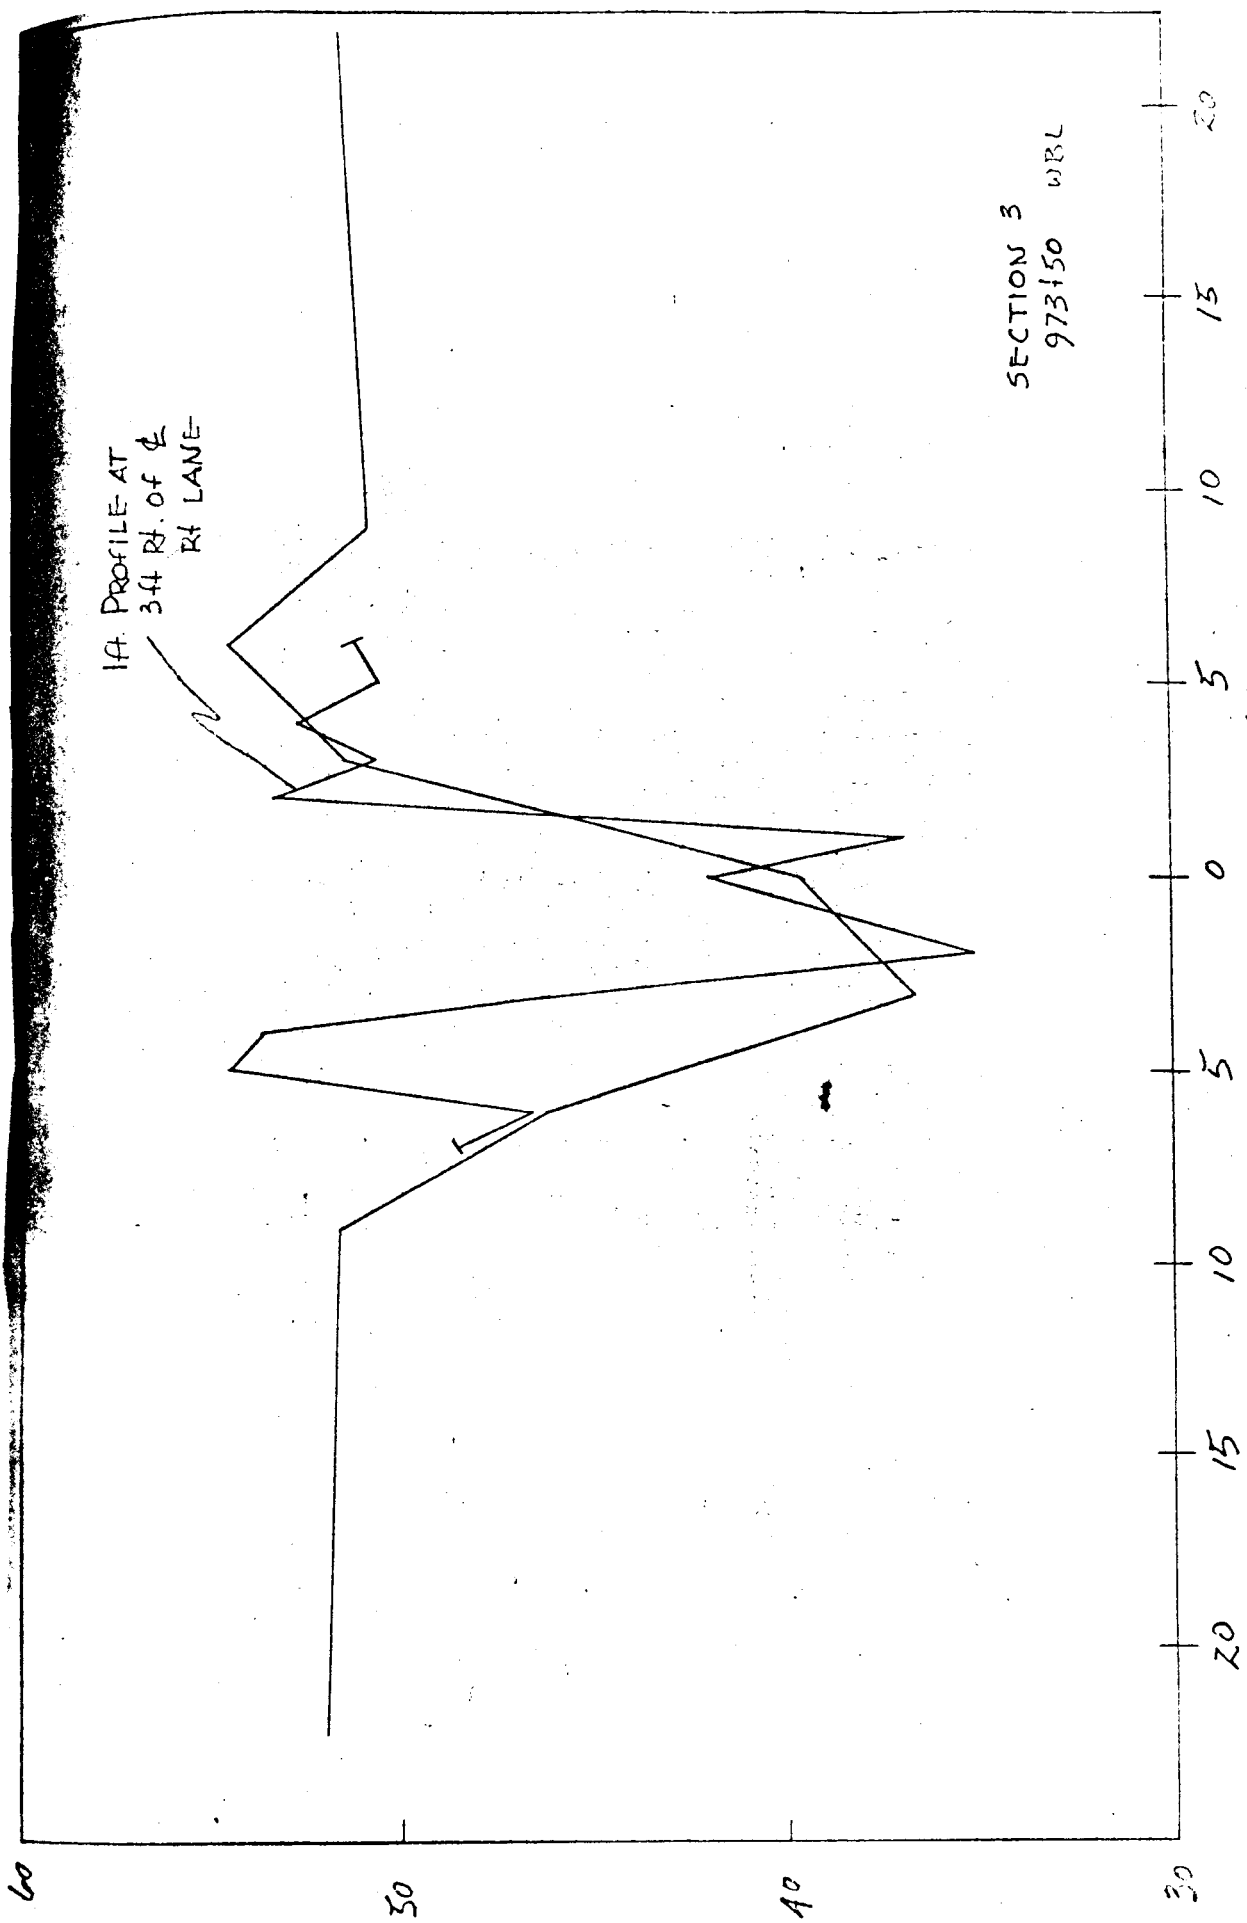
FIGURE 3.3C

The Swiss Hammer investigation on this section revealed that there is definitely some low strength concrete in the failure area. Figure 3.3c shows a profile of the Swiss Hammer value through the failure area.

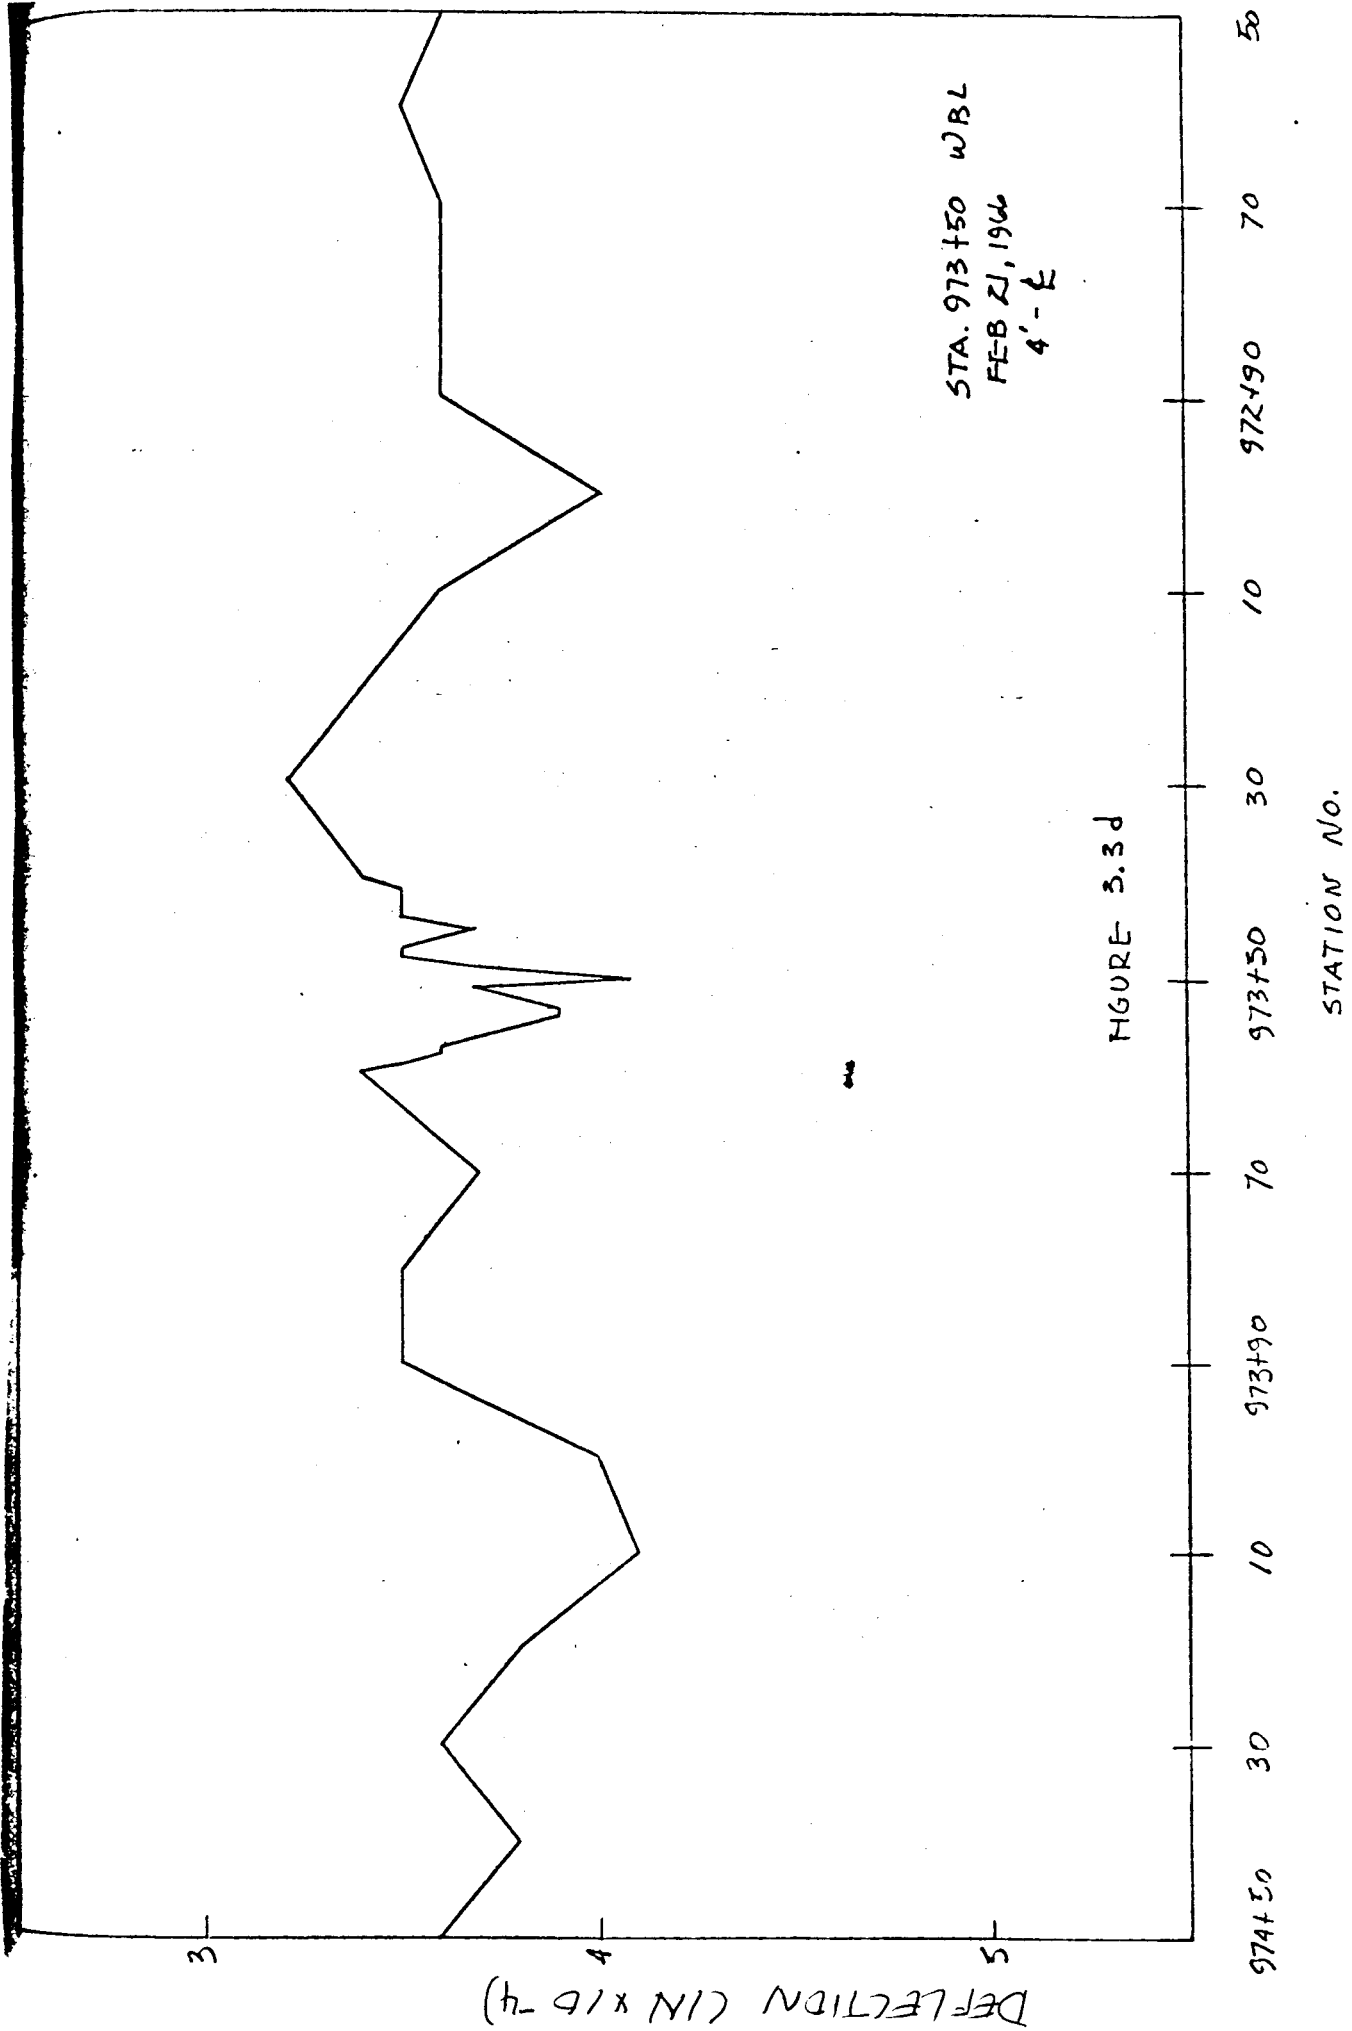
FIGURE 3.3d

Deflection in the failure was not very significant as can be seen in Figures 3.3d and 3.3e. The variations down the roadway were just as great as were the deflections in the failure area.

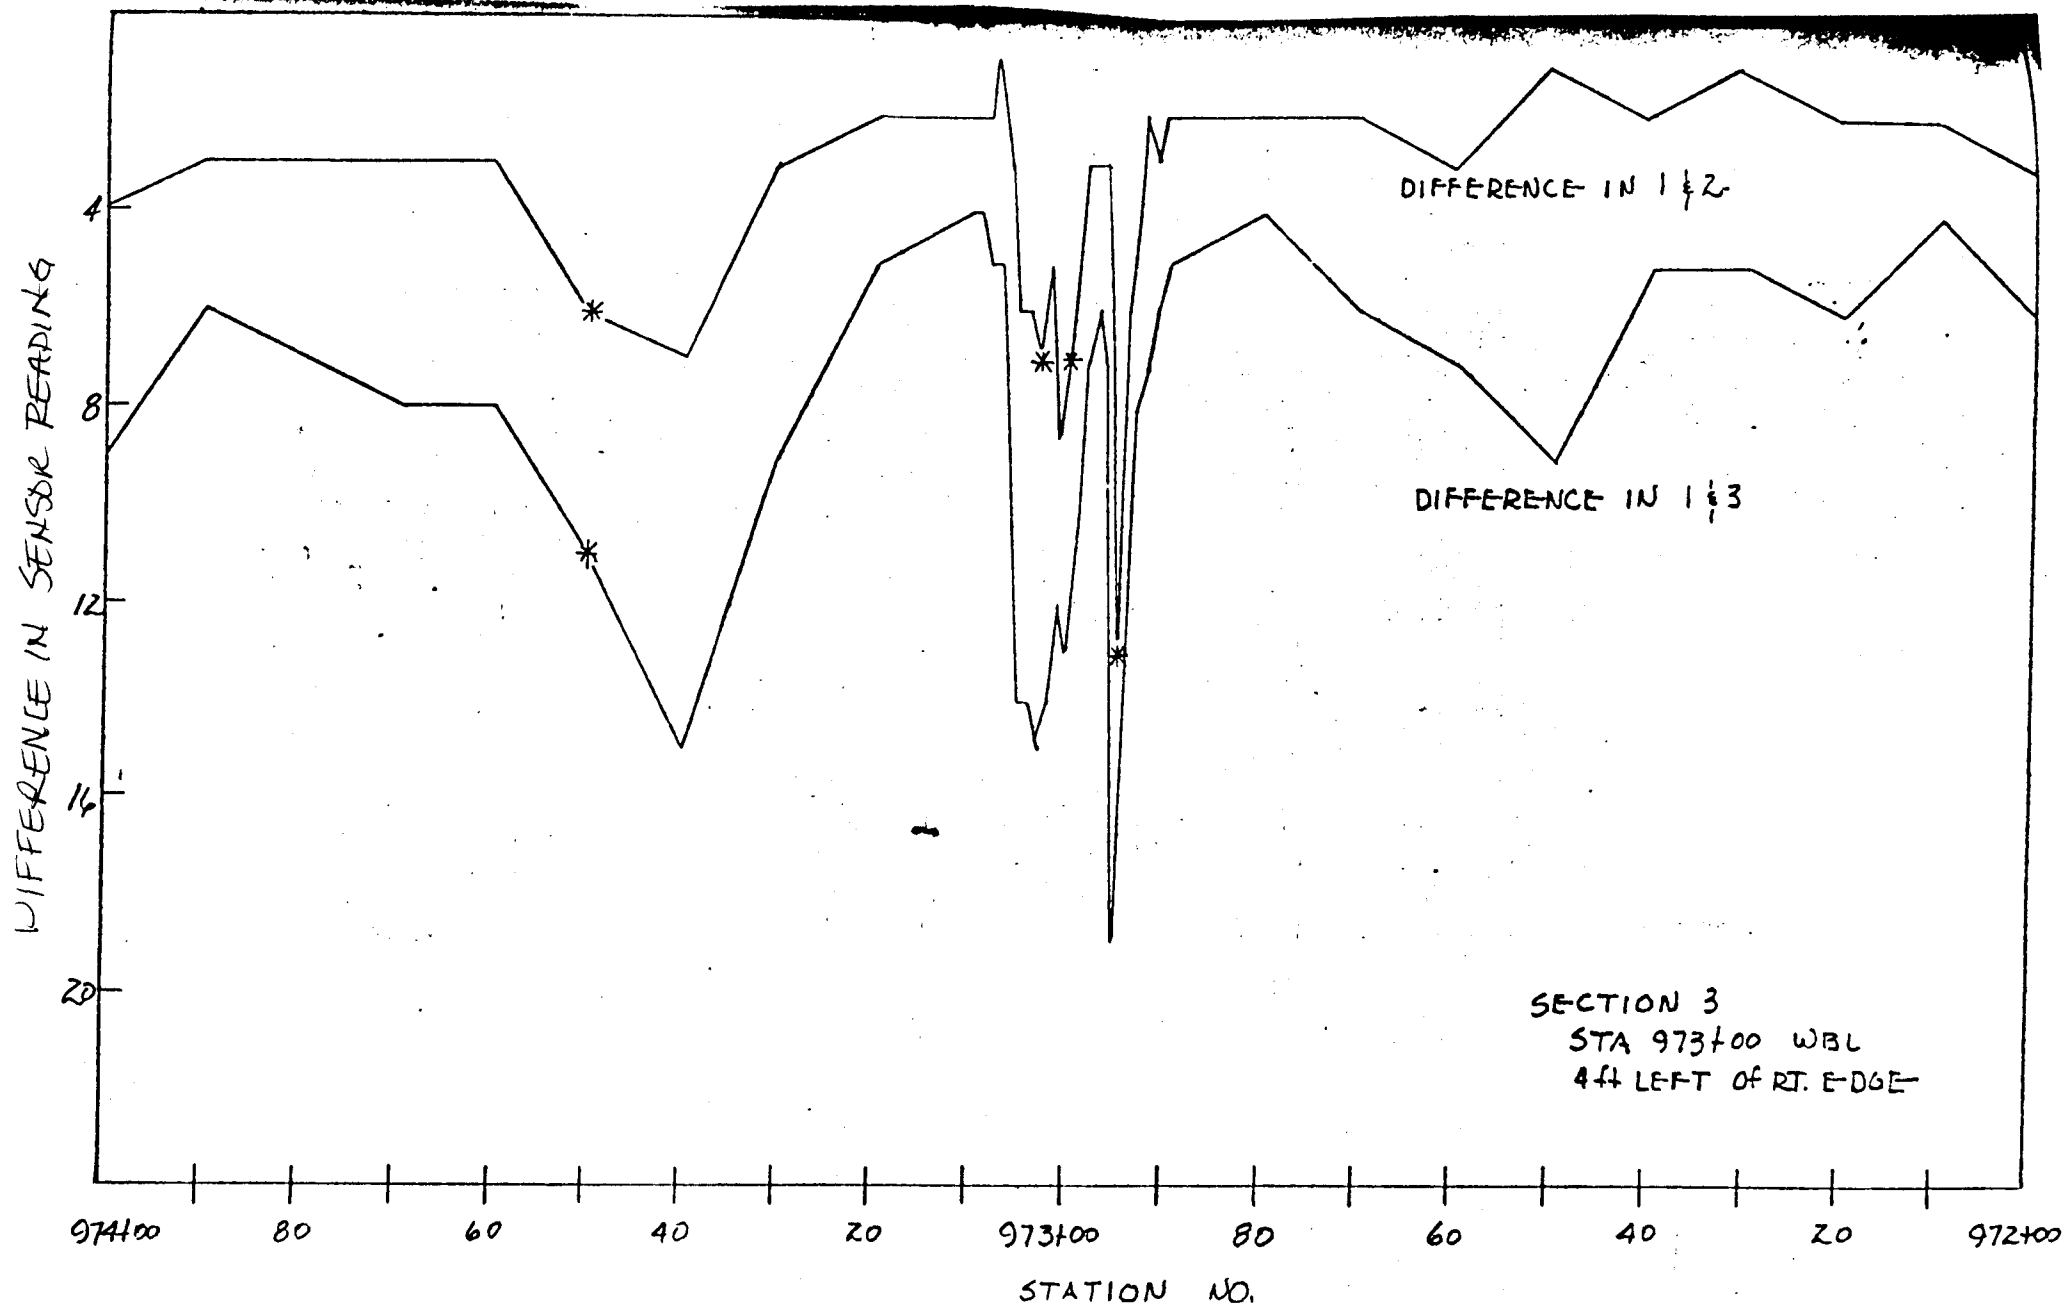
FIGURE 3.3 f

The difference in deflection, radius of curvature profile more definitely outlined the failure area as is clearly shown in Figure 3.3f. The above studies were used locate places to drill cores. The core drilling showed that the concrete was not as design intended it to be. The core taken in the failure area broke while drilling. The core was very rough and showed that the batch quantities may not have been right or the cement may not have been real good. The broken core is shown in Figure 3.3g with a good core from the same general area; note the difference in texture.

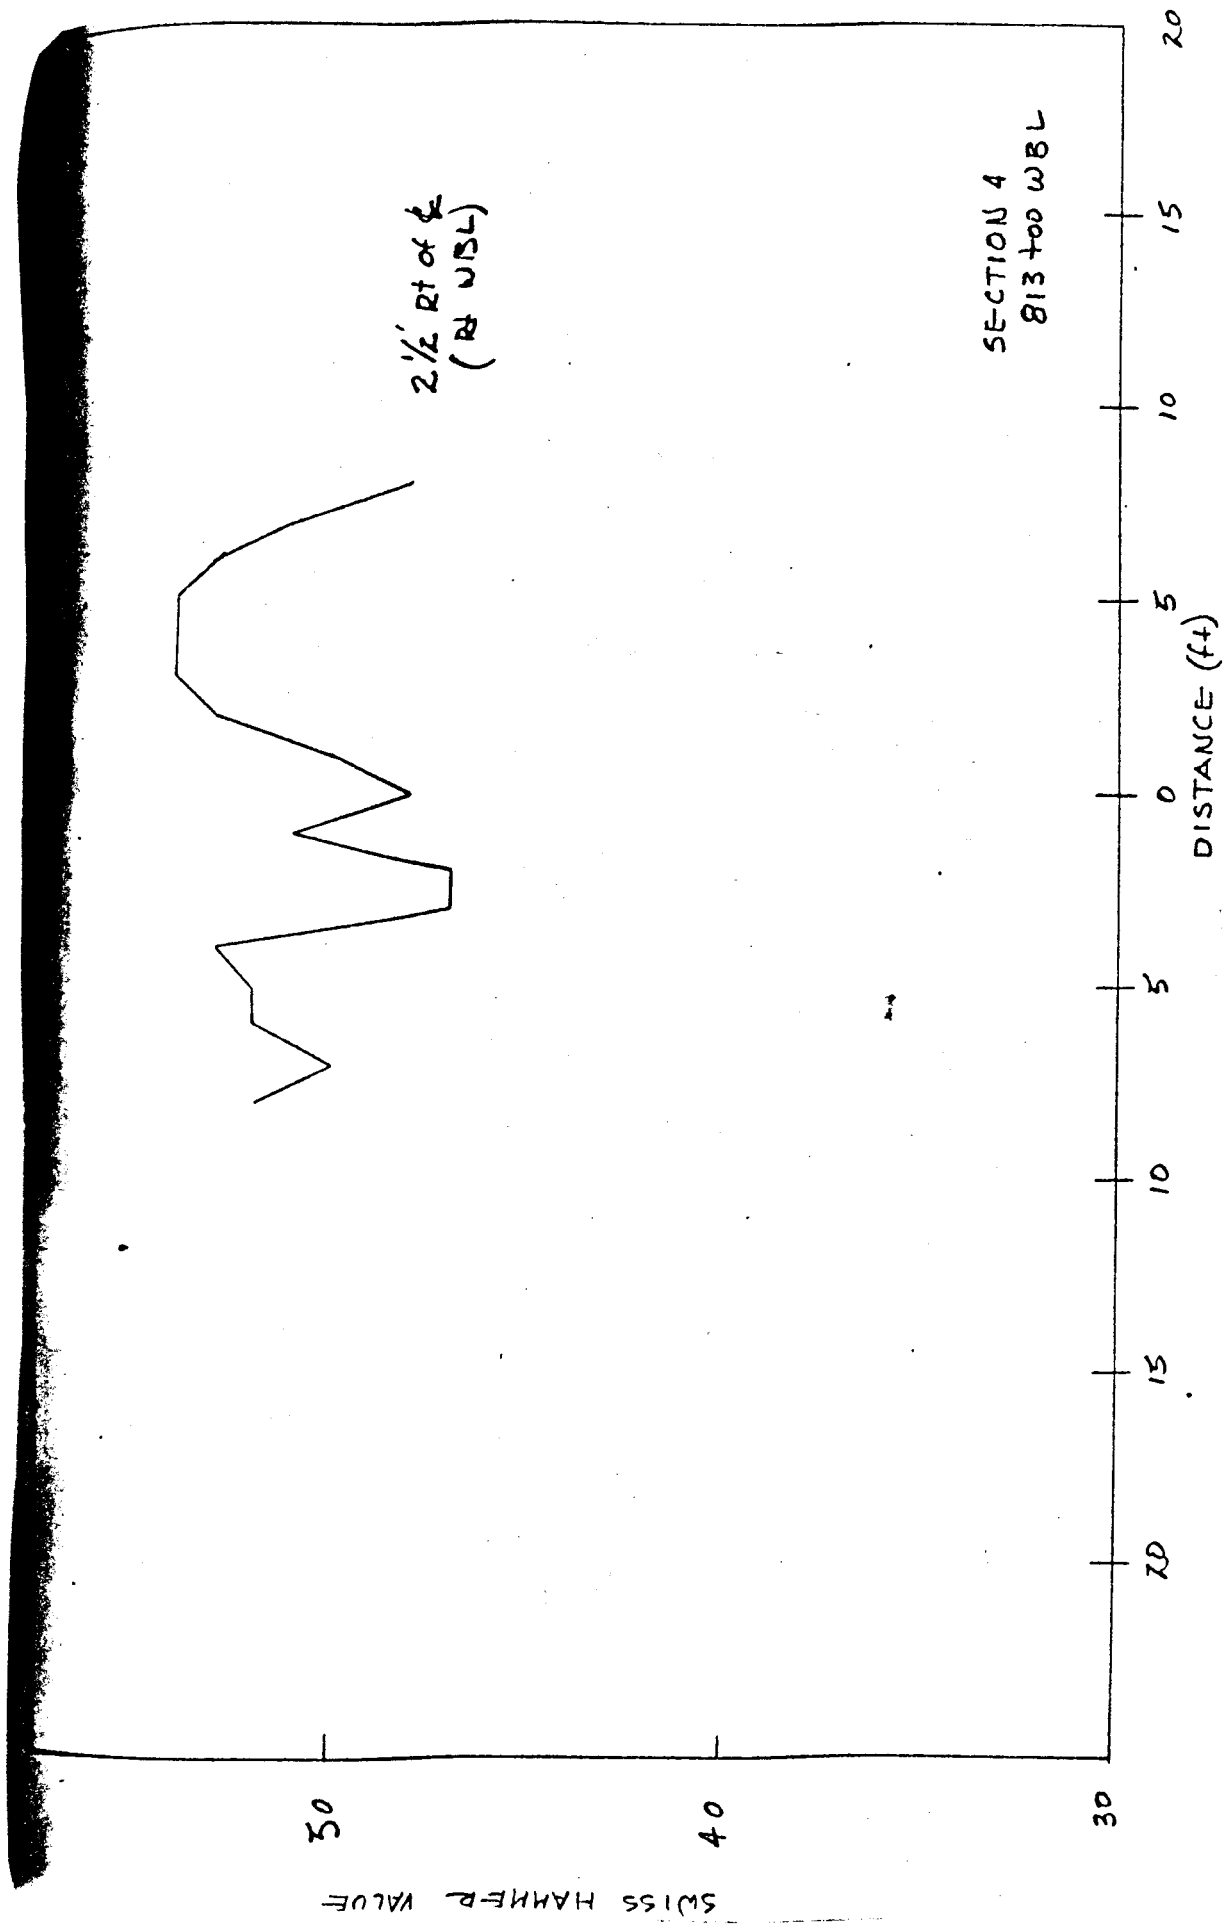
FIGURE- 3.4C

The Swiss Hammer study showed that this section was not weak in strength. Figure 3.4c is the Swiss Hammer Profile.

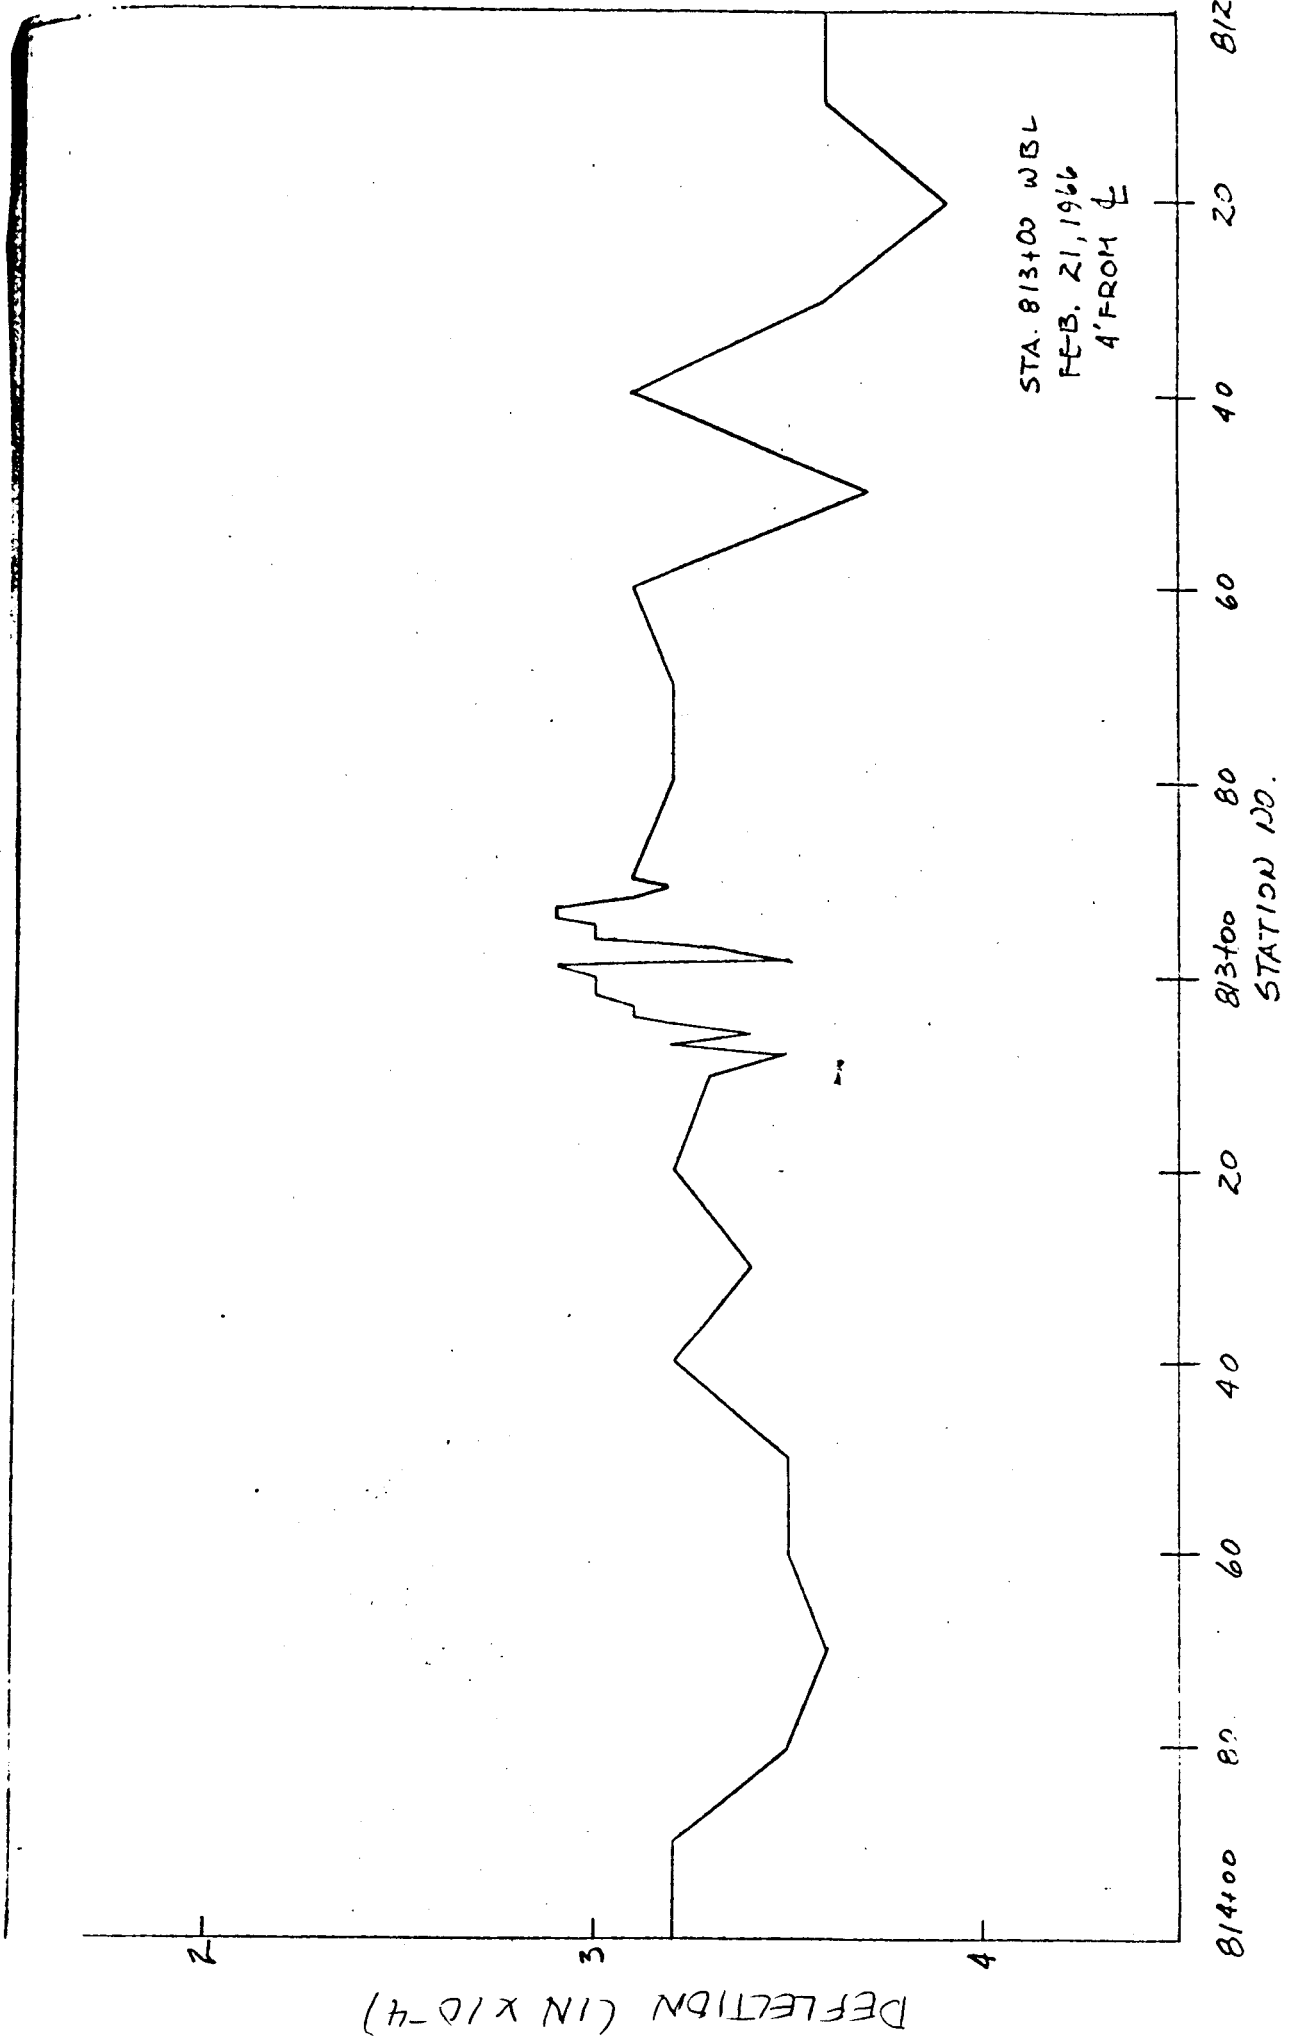
FIGURE 3.4d

The deflection study showed that the variations in the severely cracked area were no greater than the point to point variations along the roadway. Deflection profiles four feet right of center line and four feet from the right edge both show that the cracked concrete is not deflecting more than the concrete which is in good condition. Figures 3.4d and 3.4e show these deflection profiles.
