INVESTIGATION OF PAVEMENT FAILURES

INVESTIGATION OF PAVEMENT FAILURES
ON IH10 IN DISTRICT 13

Report Number SS 3.0

Conducted by
The Research Section of
The Highway Design Division
Texas Highway Department
April 1966

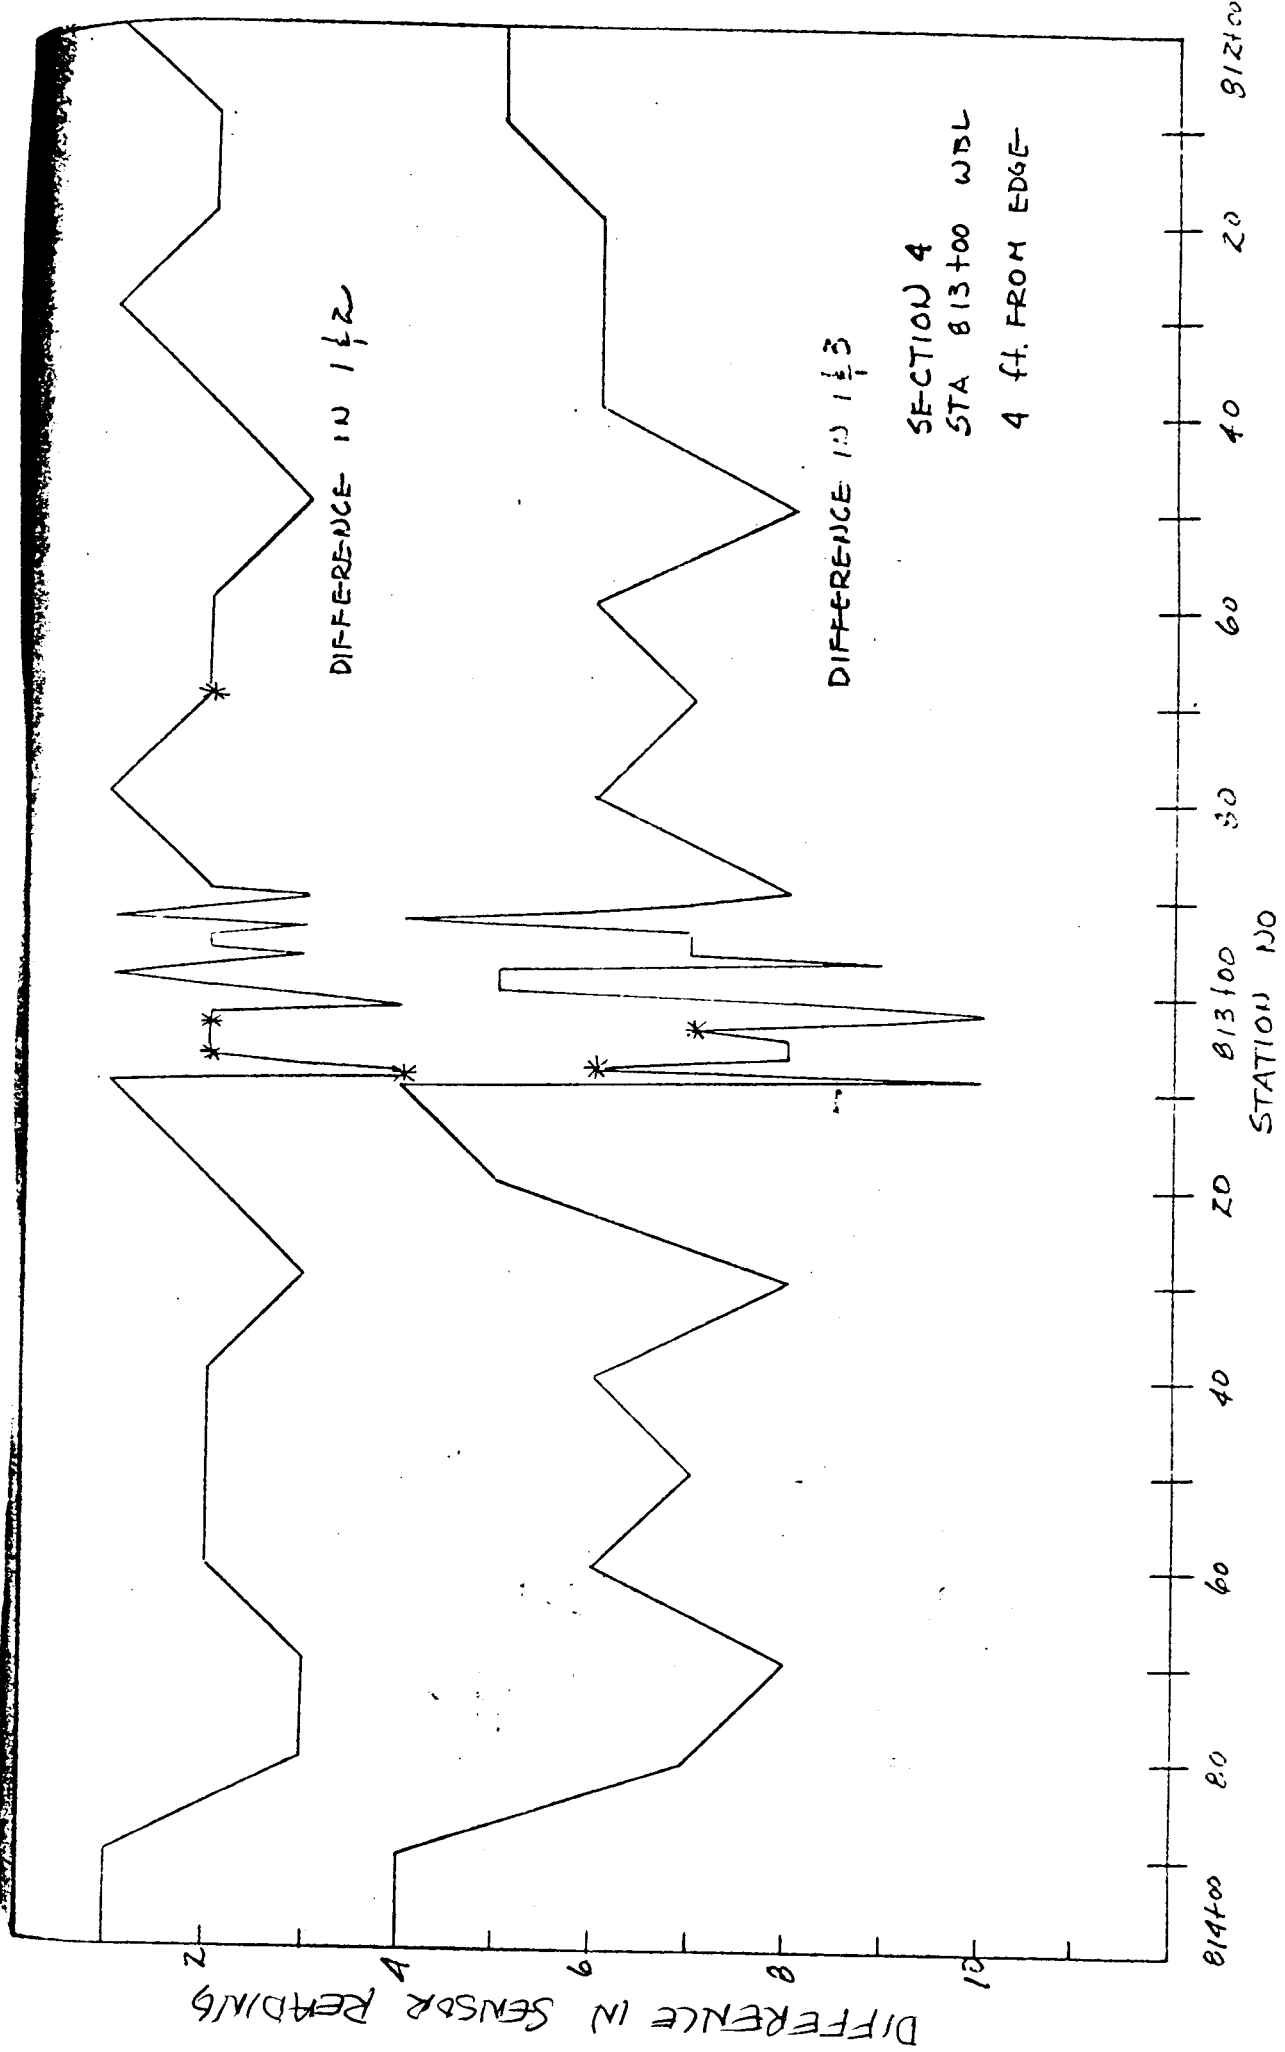
FIGURE 3.4f

gives a more clear indication of the presence of the narrow crack spacings. Figure 3.4f shows the radius of curvature profile.

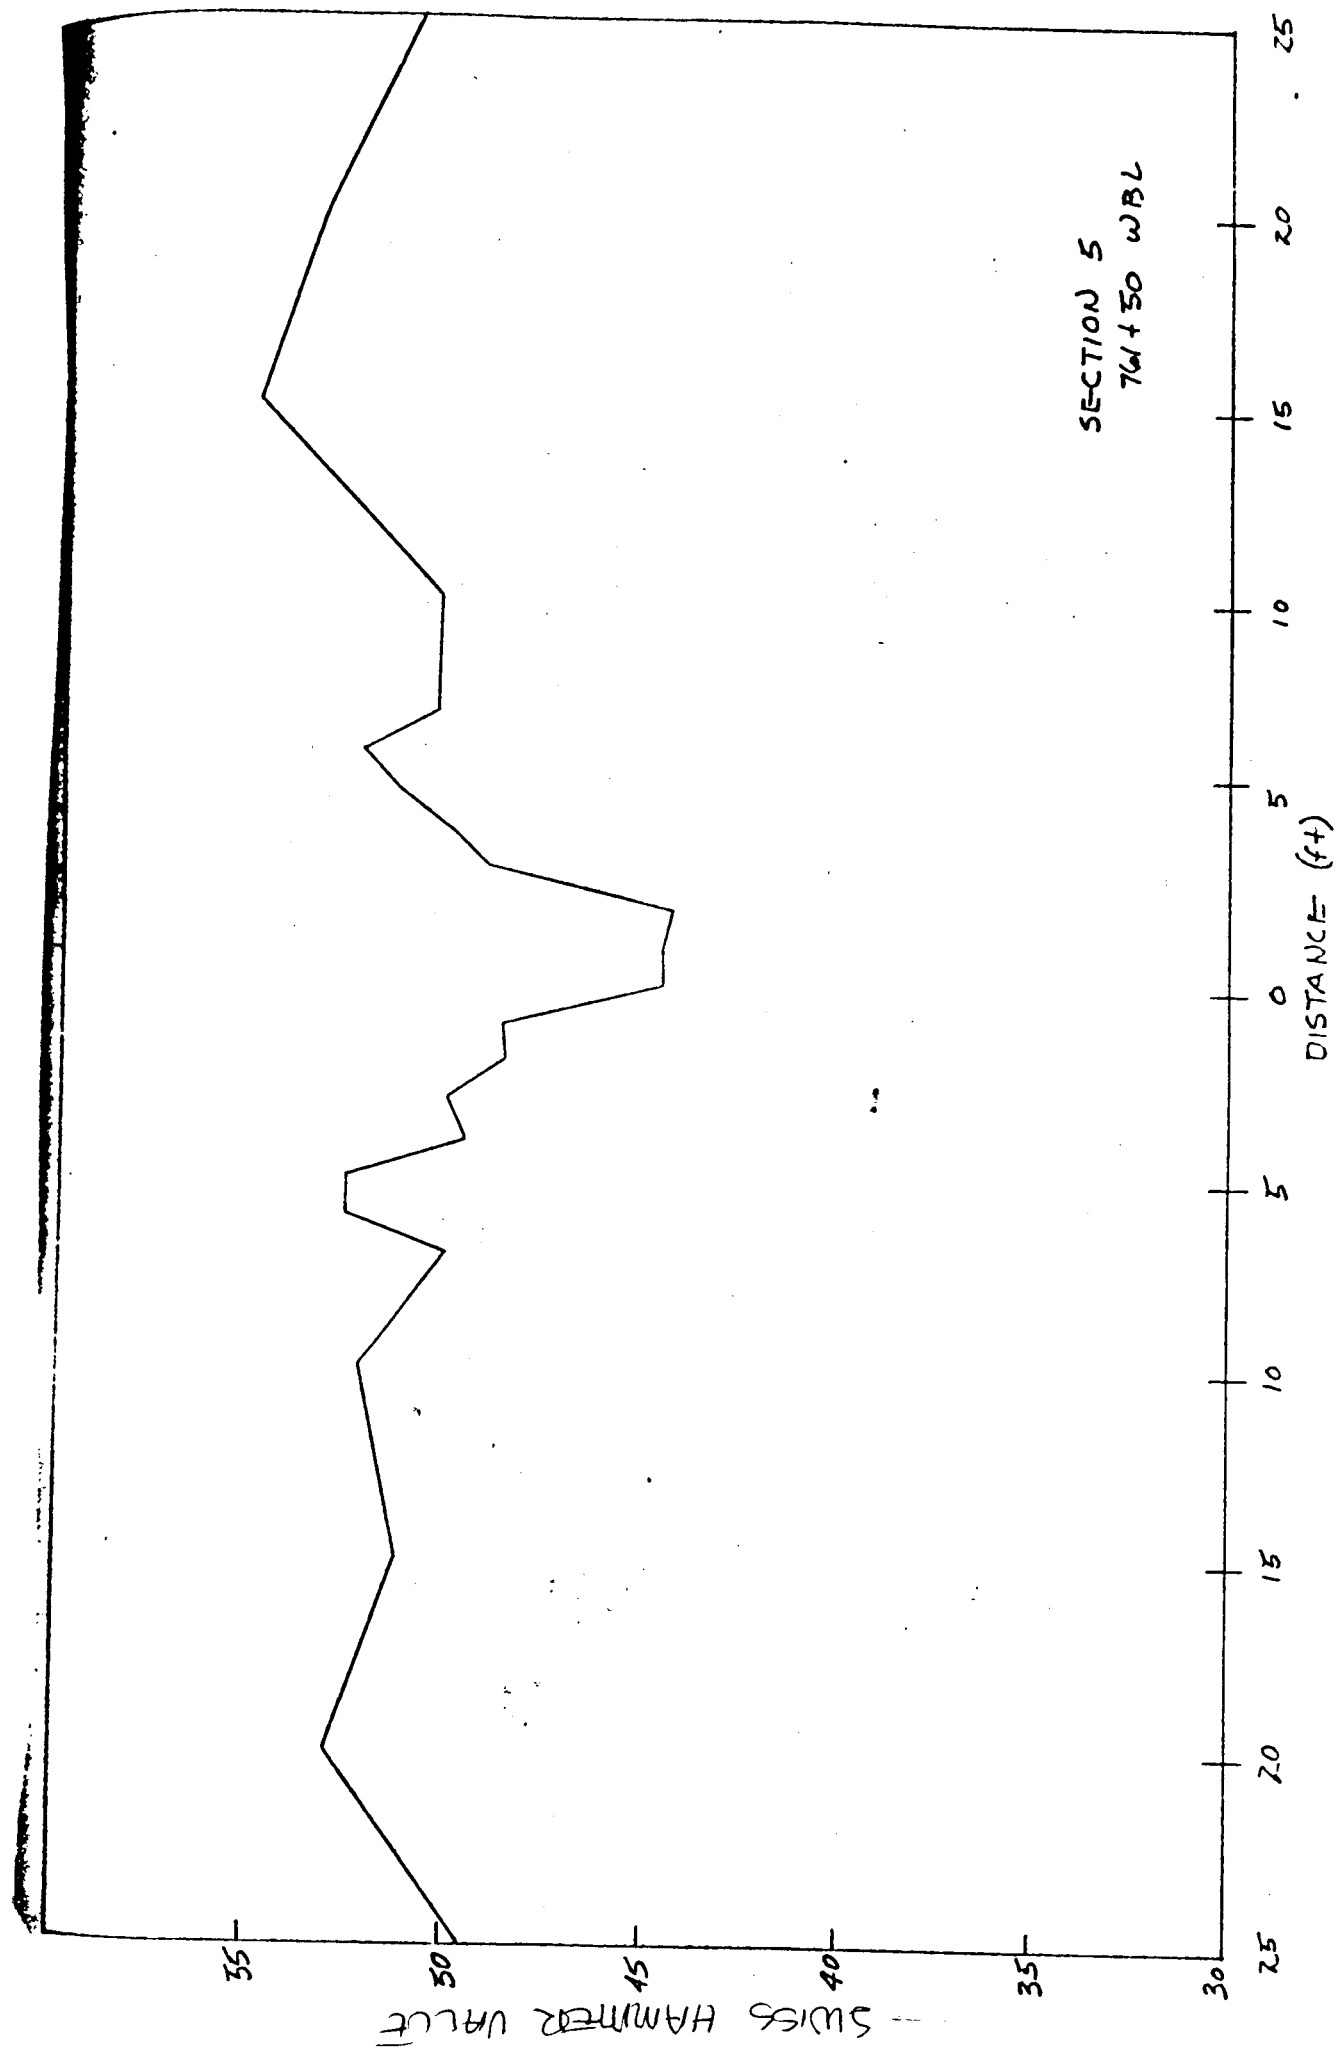
FIGURE 3.5C

The Swiss Hammer investigation showed that there was an area of slightly weaker concrete in the center of the section. This is shown on the profile of the Swiss Hammer value shown in Figure 3.5c. The deflection was no greater in the failure area than the point to point variation. Figures 3.5d and 3.5e show deflection profiles. The difference in deflection in the failure area was not as great as some of the point to point variations. Figure 3.5f shows the large variations along the roadway. The core drilled in the failure area did not show any significant differences from the core taken from the good area.

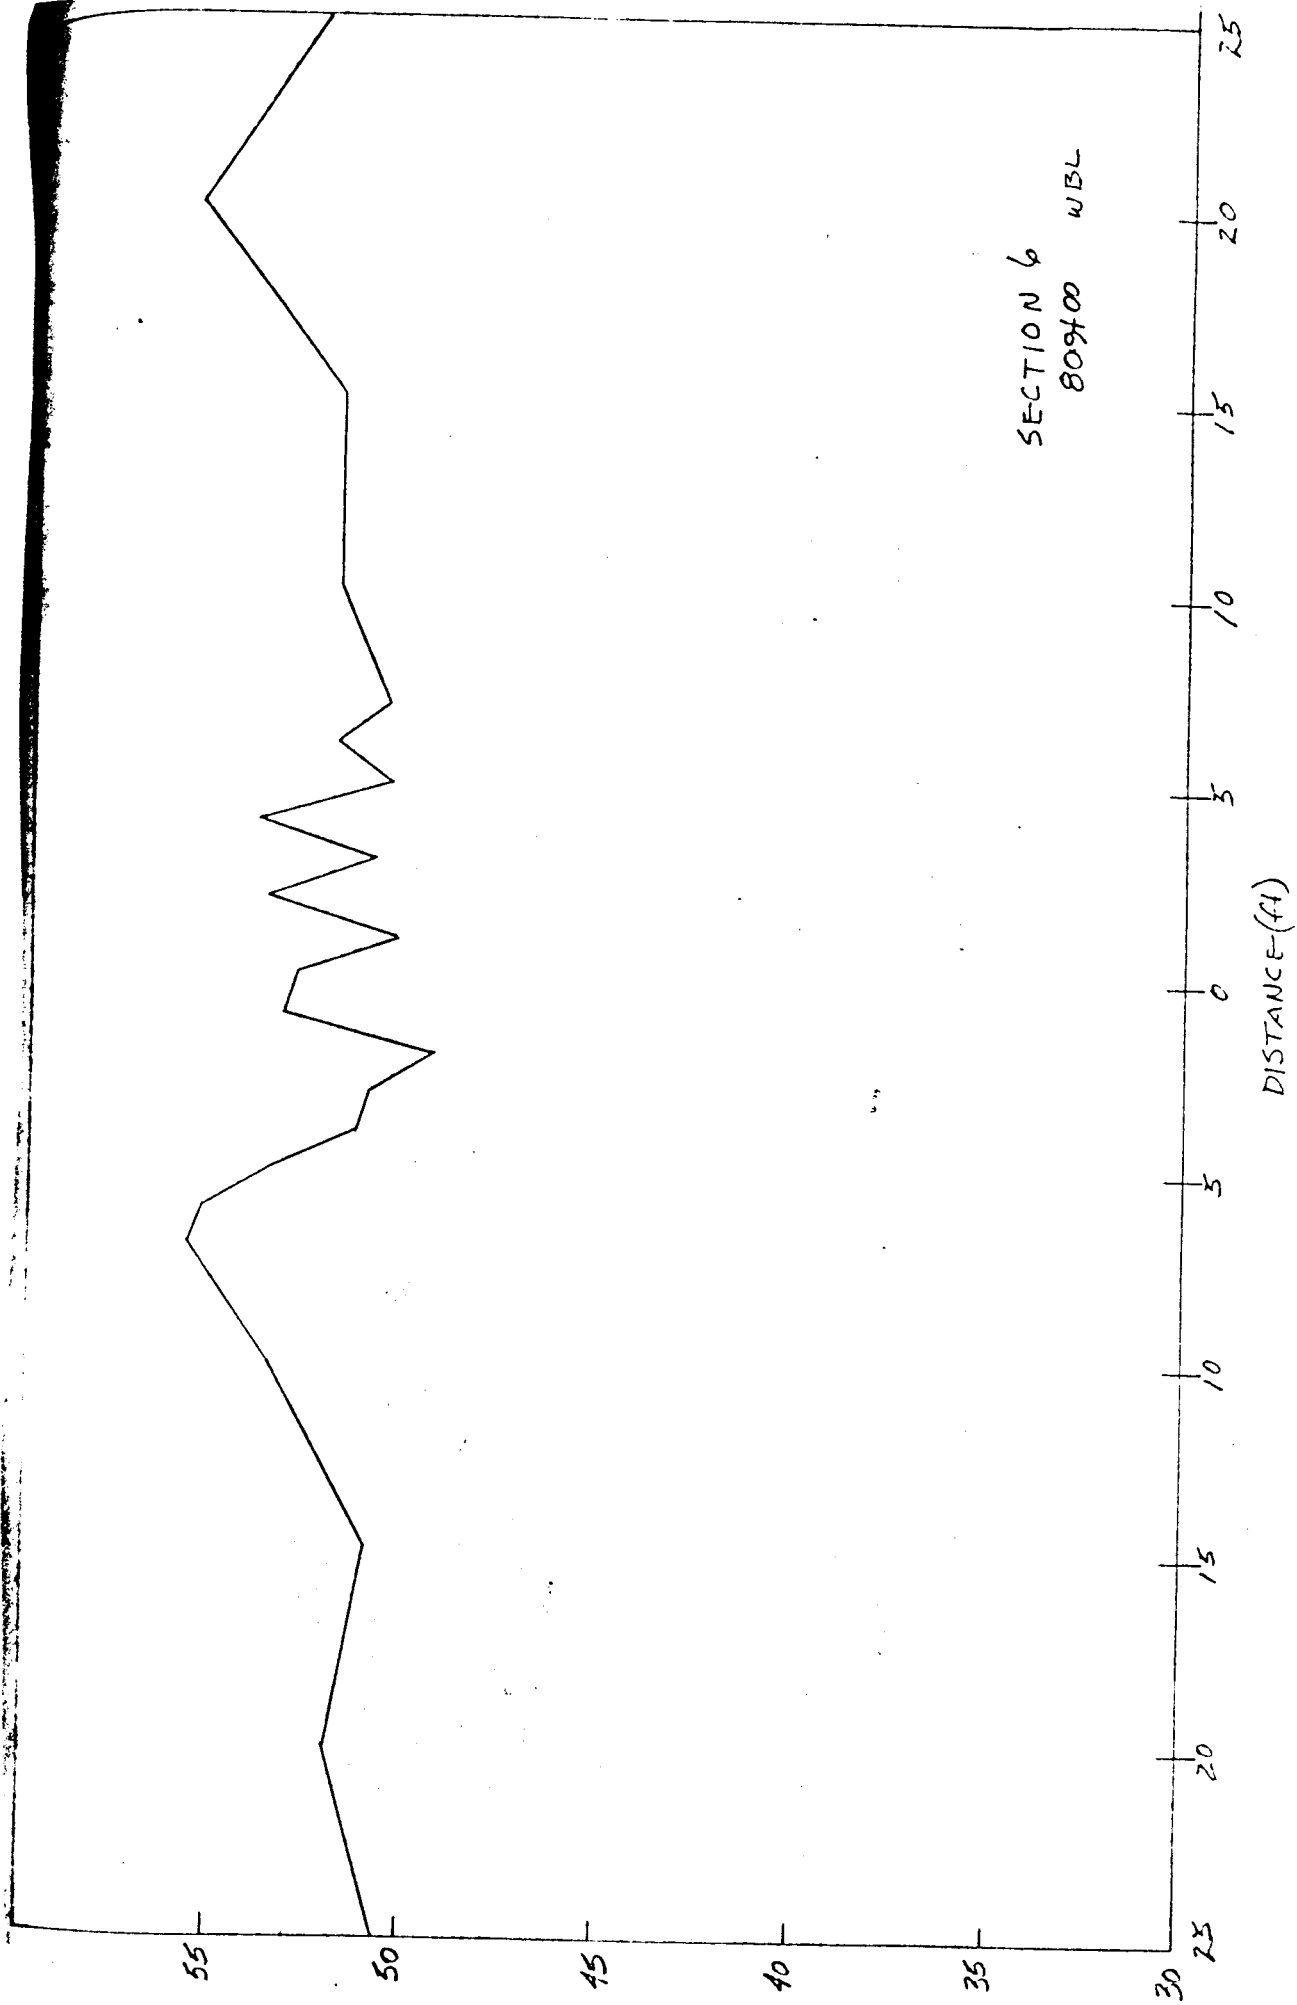
FIGURE 3.6b

The Swiss Hammer study showed that there was no weak concrete in the cracked area. Figure 3.6b is profile of the Swiss Hammer value which shows no weakness in the failure area. Deflection did

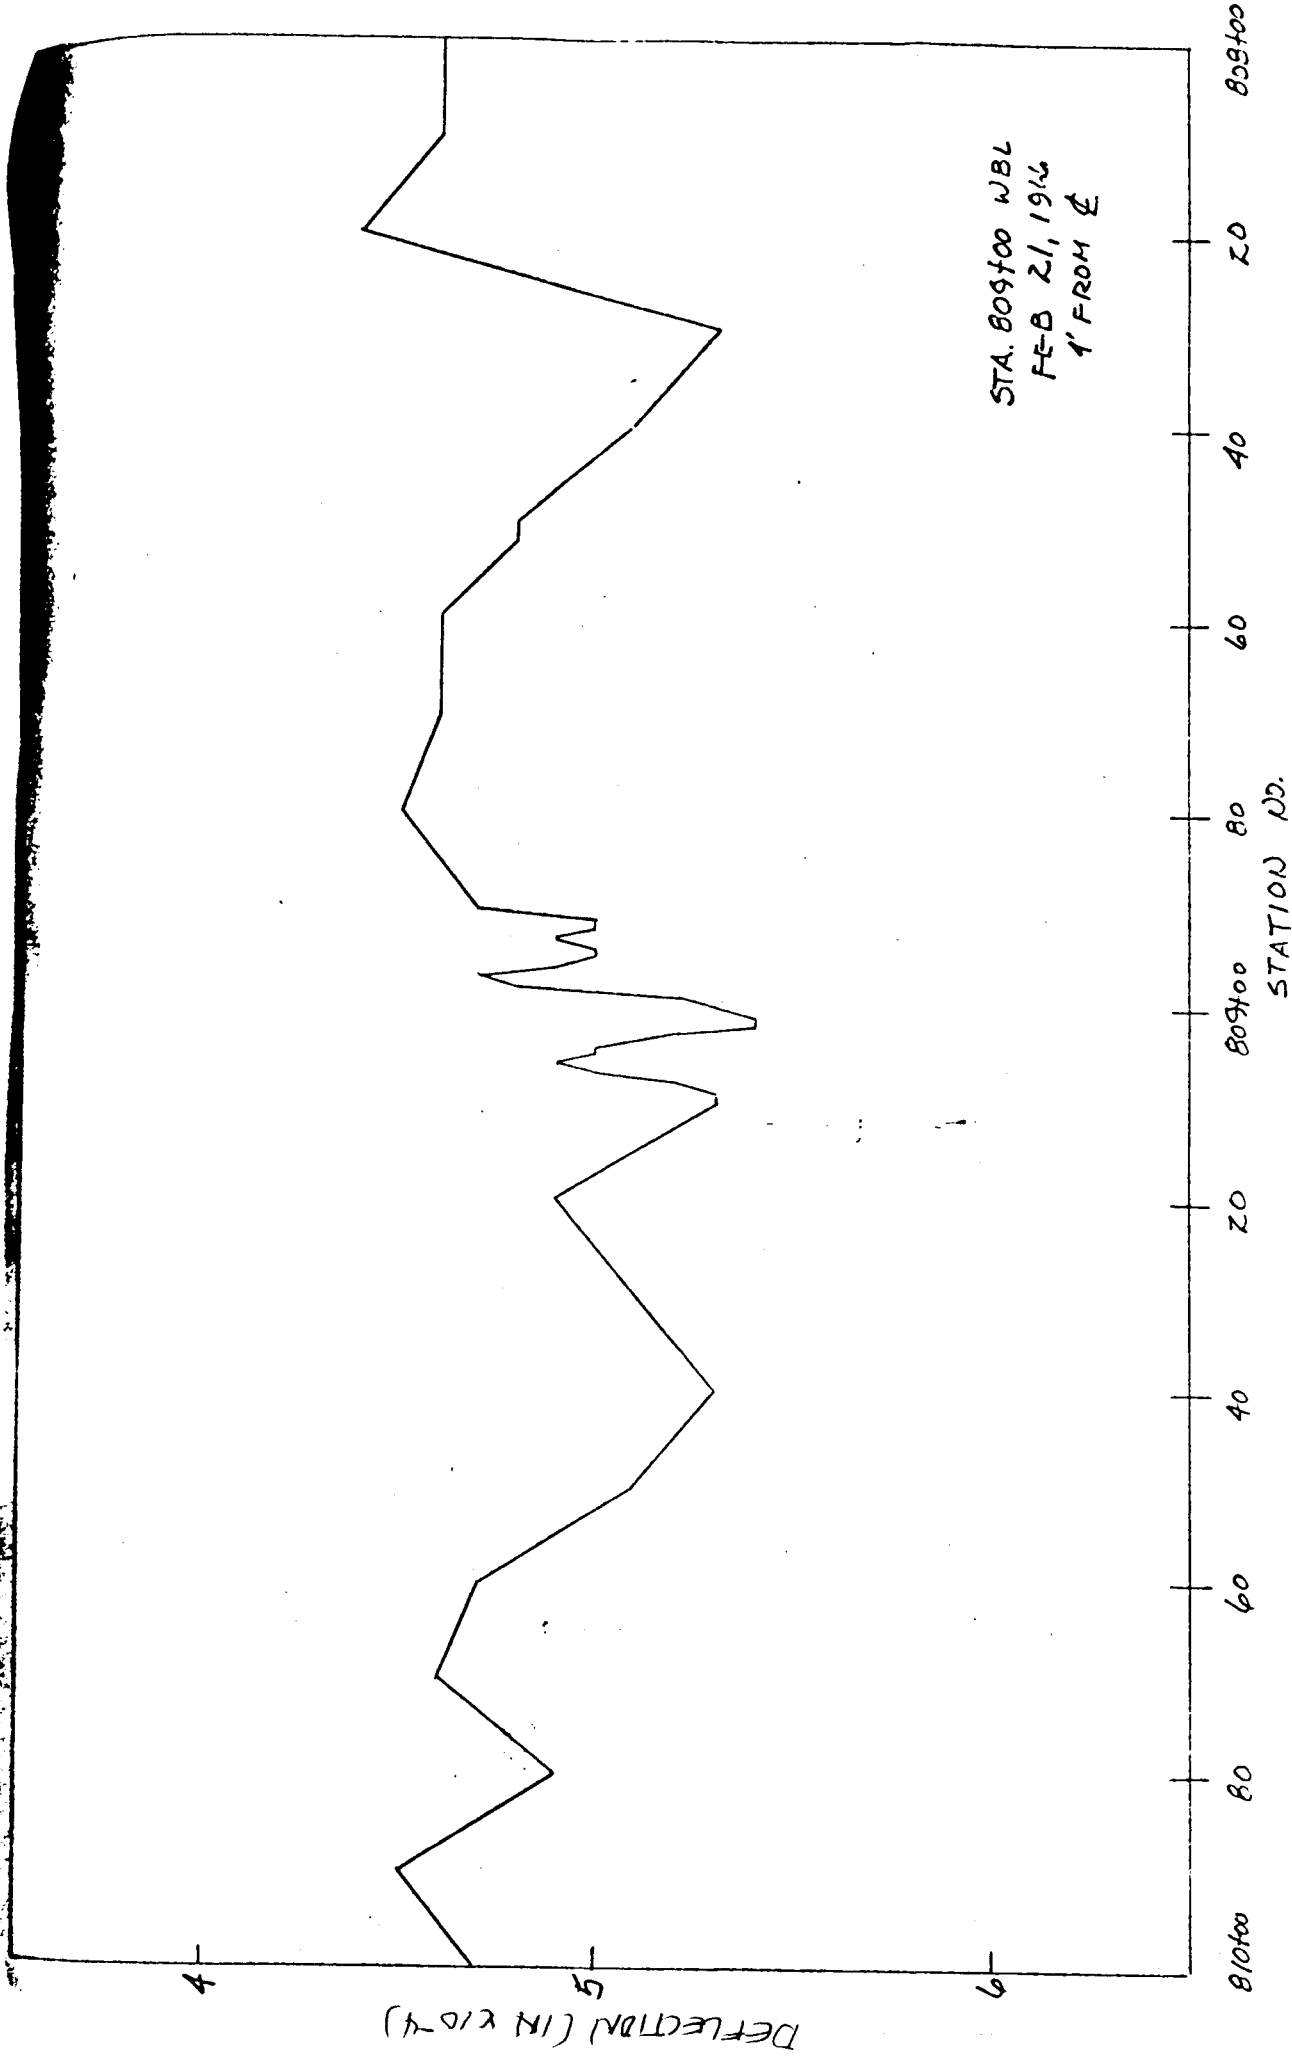
FIGURE 3.6C

show the failure area either as can be seen in the deflection profiles in Figures 3.6c and 3.6d. The difference in deflection profile in Figure 3.6e shows that there is an area in which the concrete is performing slightly different than away from the cracked area. The core drilling operation did not show the presence of any weak concrete either. The large differences in deflection were probably caused by the close crack spacing.

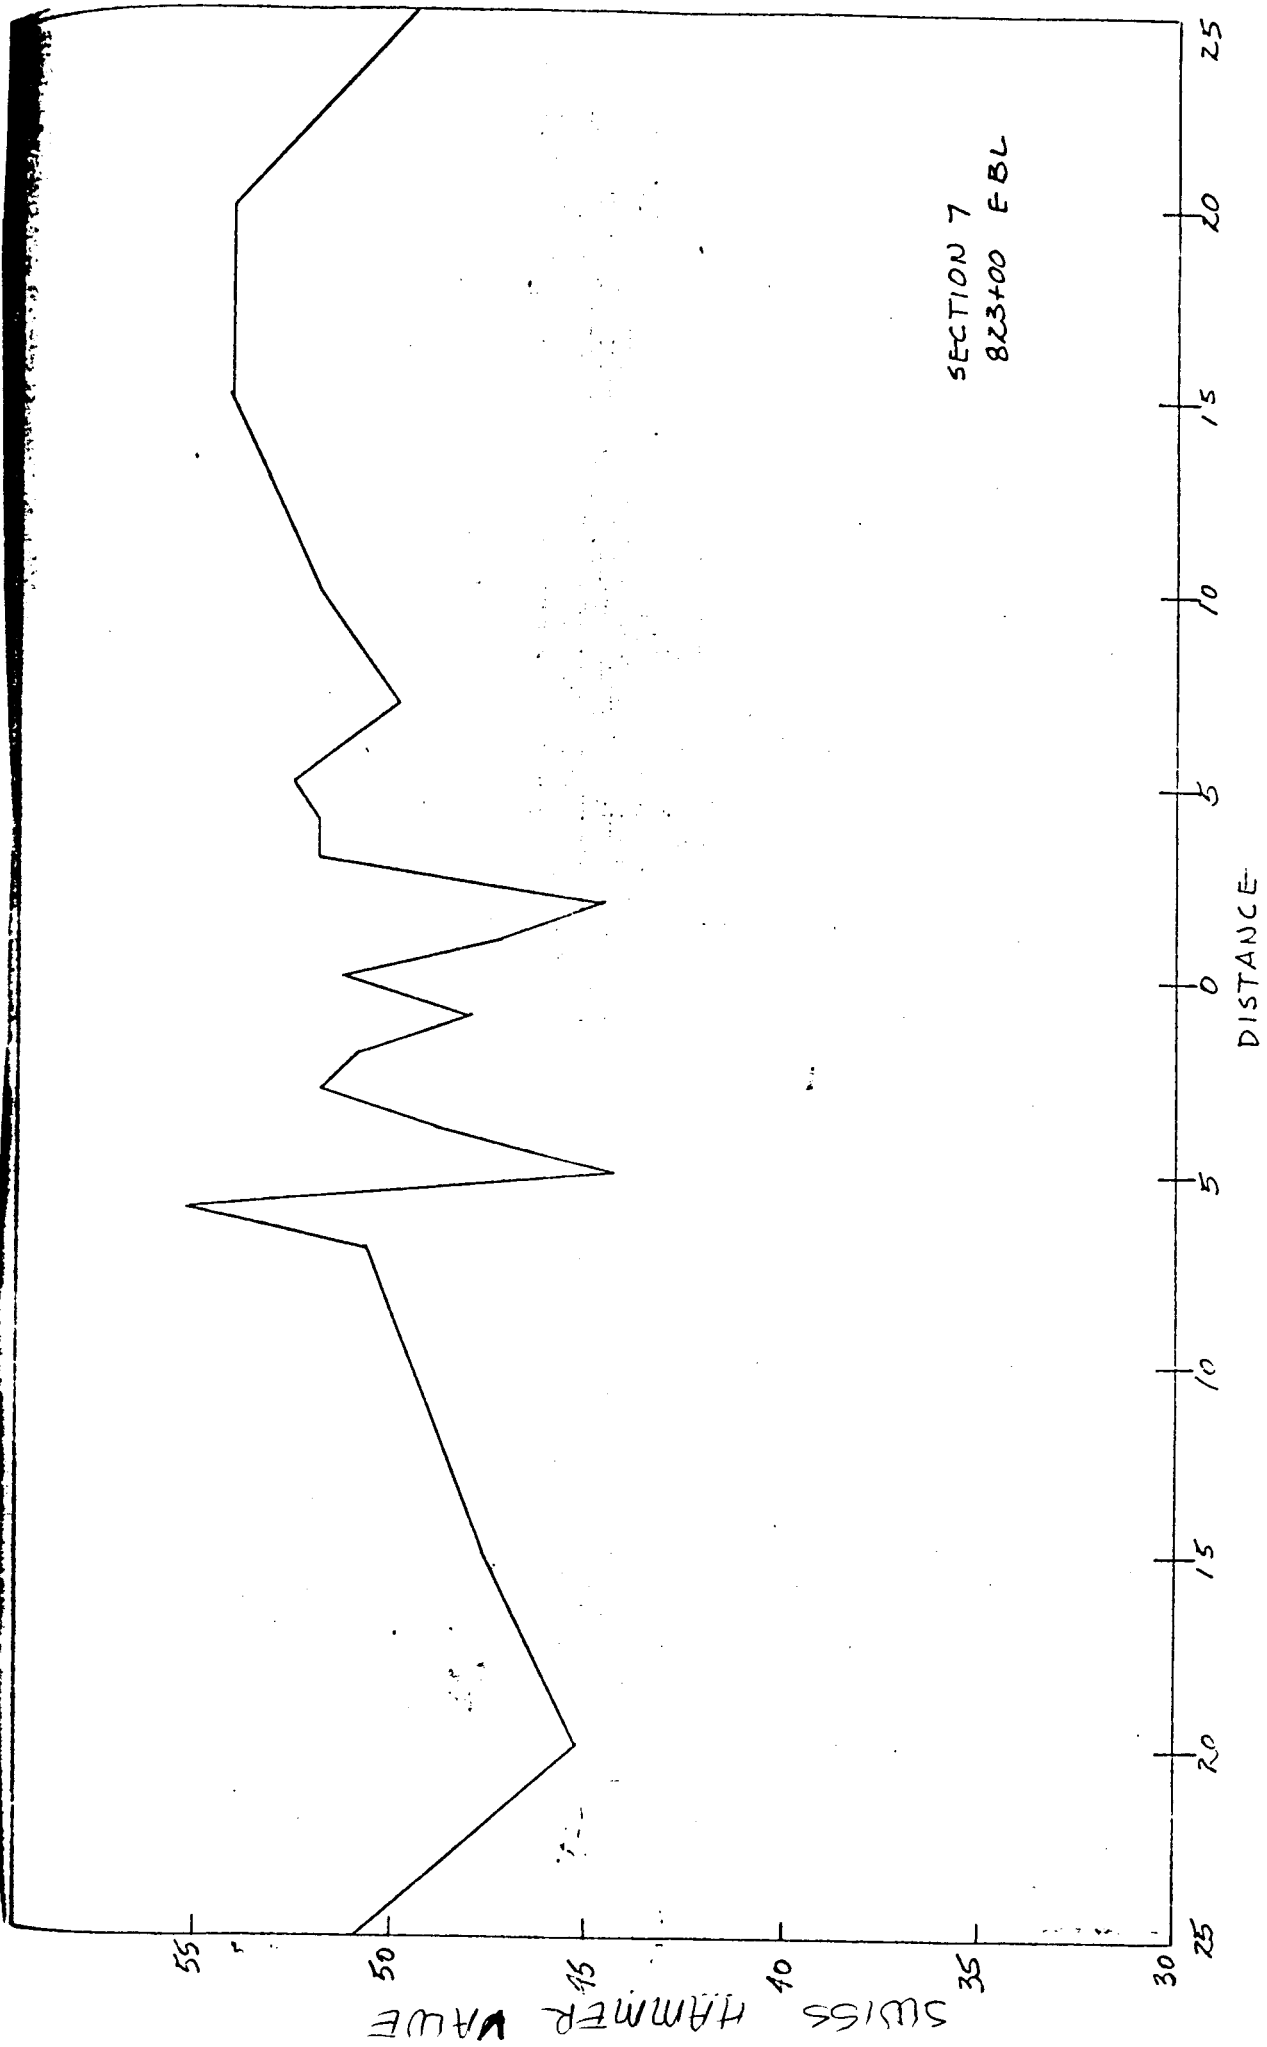
FIGURE 3.7c

The Swiss Hammer study showed that the severely cracked concrete was not particularly weaker than the good concrete. The variations in the failure area were similar to the point to point variations along the road as is portrayed in Figure 3.7c. Deflections varied through the same range in the failure area as they did down the roadway as is shown in Figure 3.7d. The difference in deflection or radius of curvature variations showed to be slightly greater in the cracked area than along the roadway as is shown in Figure 3.7e. The core drilled from this area also showed the concrete to be in good shape.

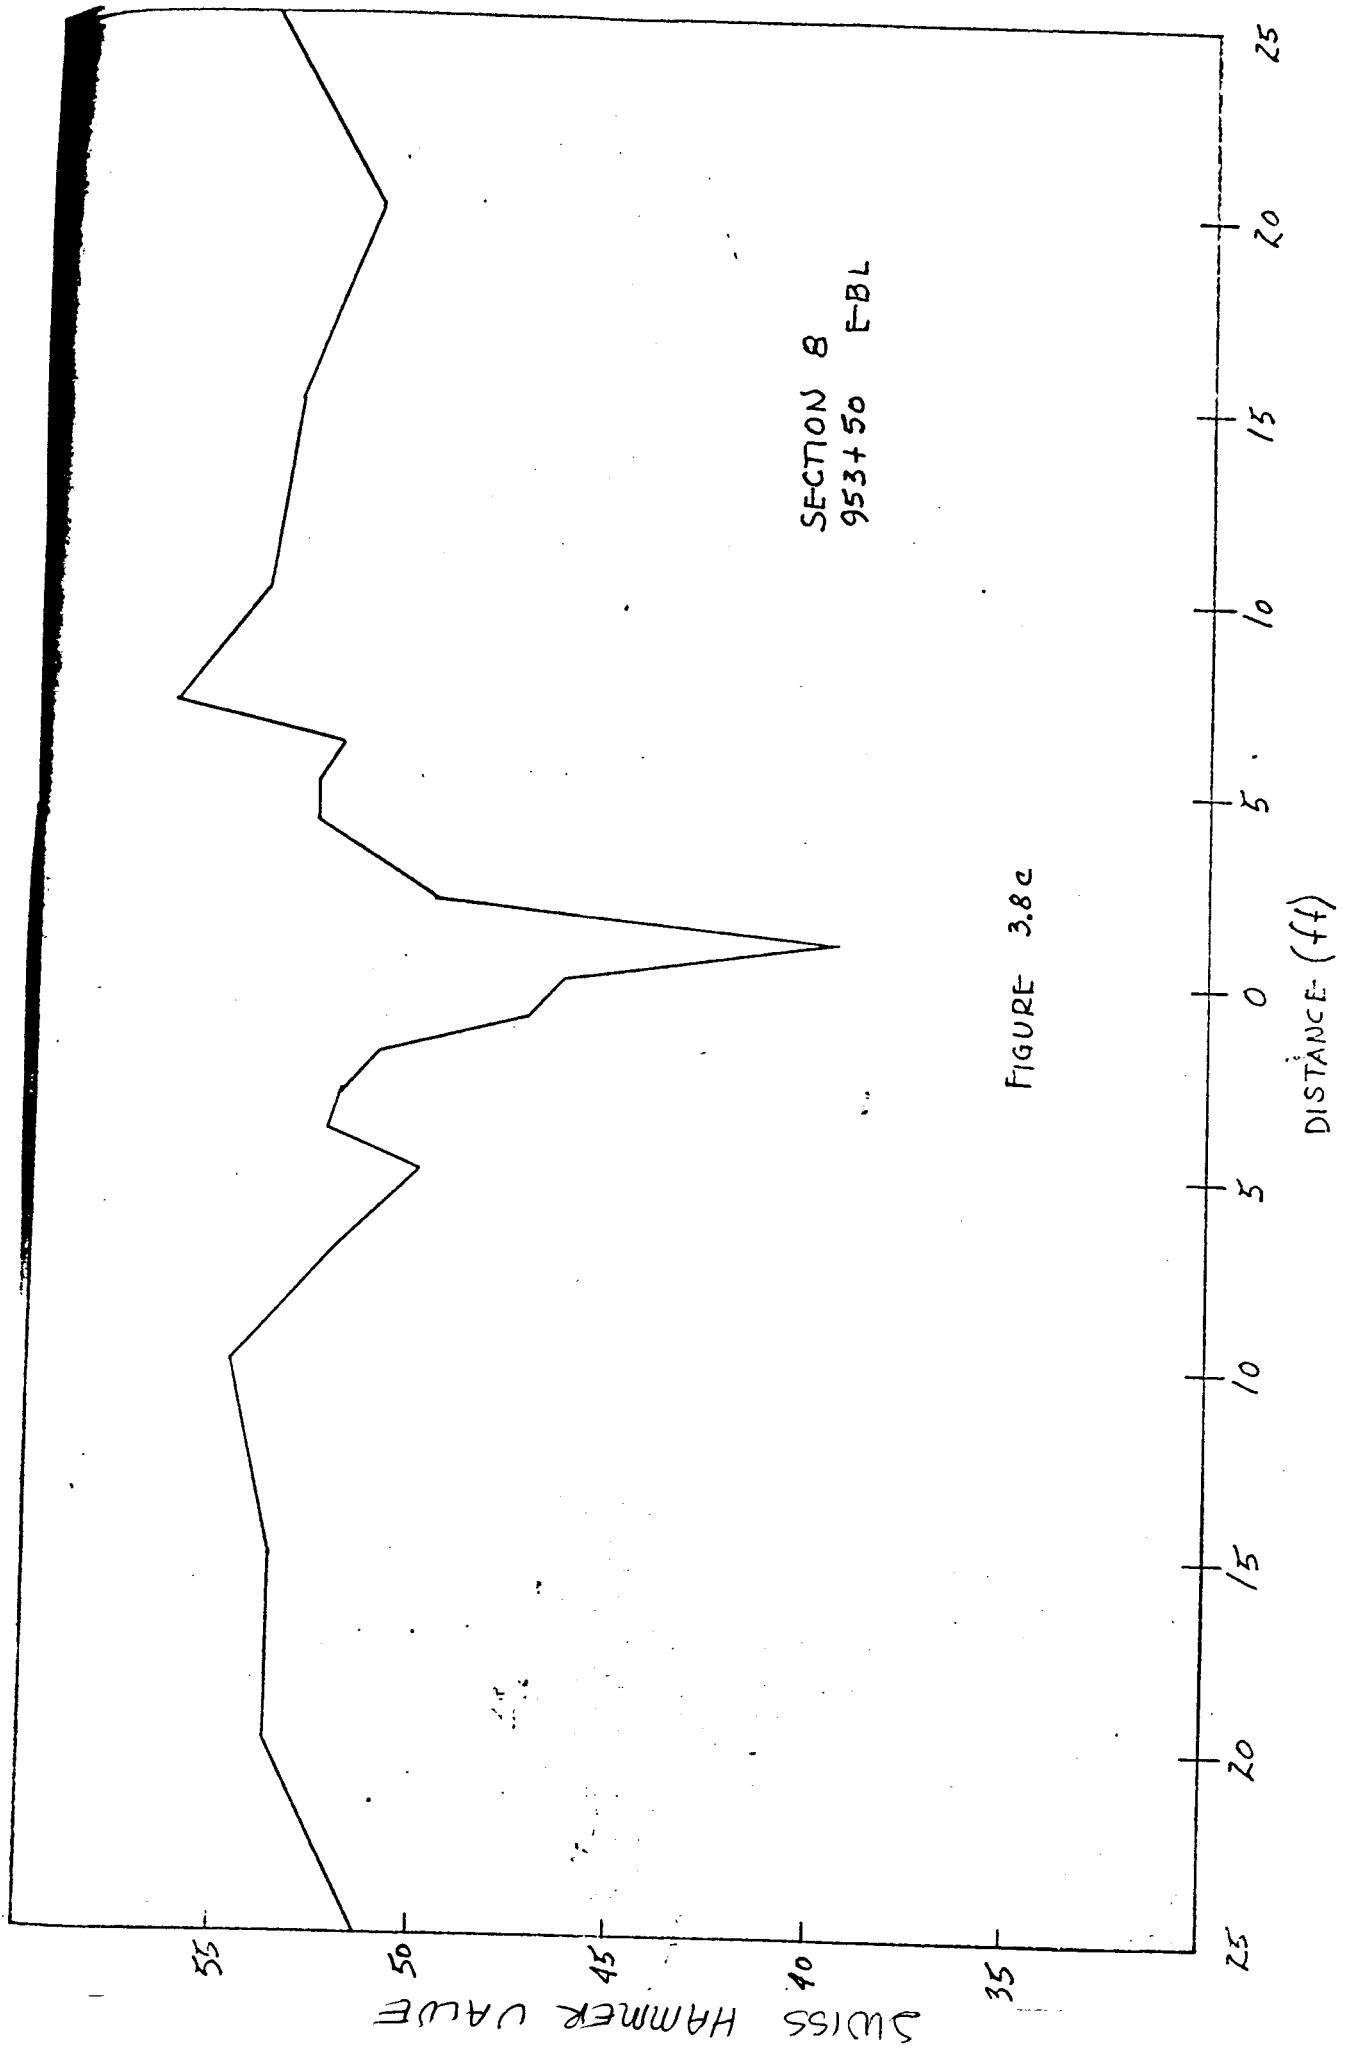
FIGURE 3.8c

The Swiss Hammer study definitely showed that the concrete is weak in the area of severe cracking. Figure 3.8c is a profile of the Swiss Hammer value through the section. Deflection and difference in deflection profiles are shown in Figures 3.8d and 3.8e respectively. The variations in the failure area are not especially larger than they are in the good areas. Coring operations at Section 8 did show the concrete to be weak. The core from the failure area looked as if the batch quantities might have been in error or the quality of the cement may not have been real good.

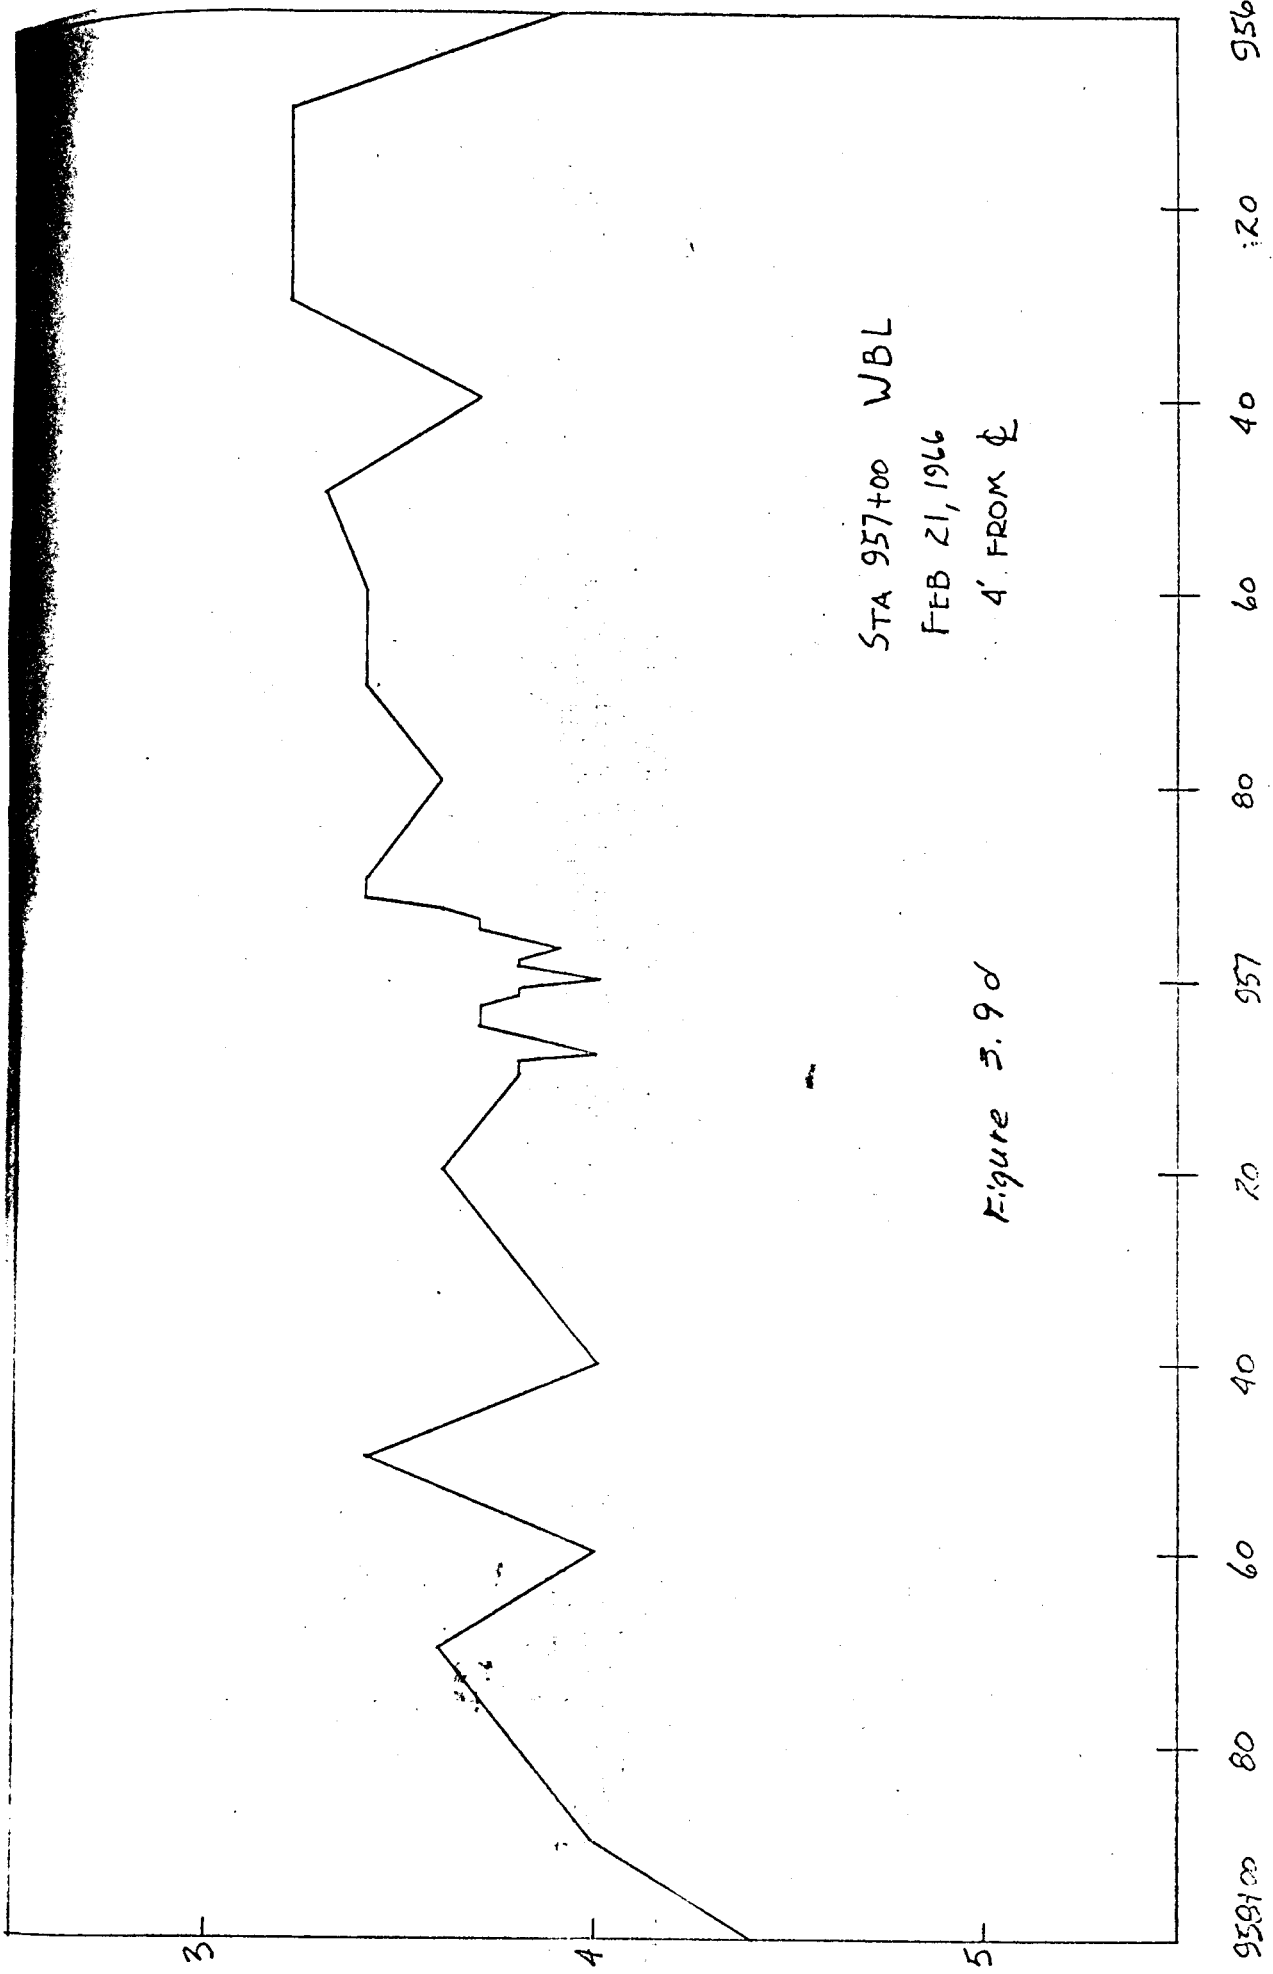
Figure 3.9d

The Swiss Hammer study indicated the presence of some weak concrete as is shown on the profile of Figure 3.9c. Deflections and differences in deflection were no greater in the failure area than other points along the slab as is shown in Figures 3.9d, 3.9e, and 3.9f. The core drilled in Section 9 did not look bad but it was not quite as smooth as the good core.

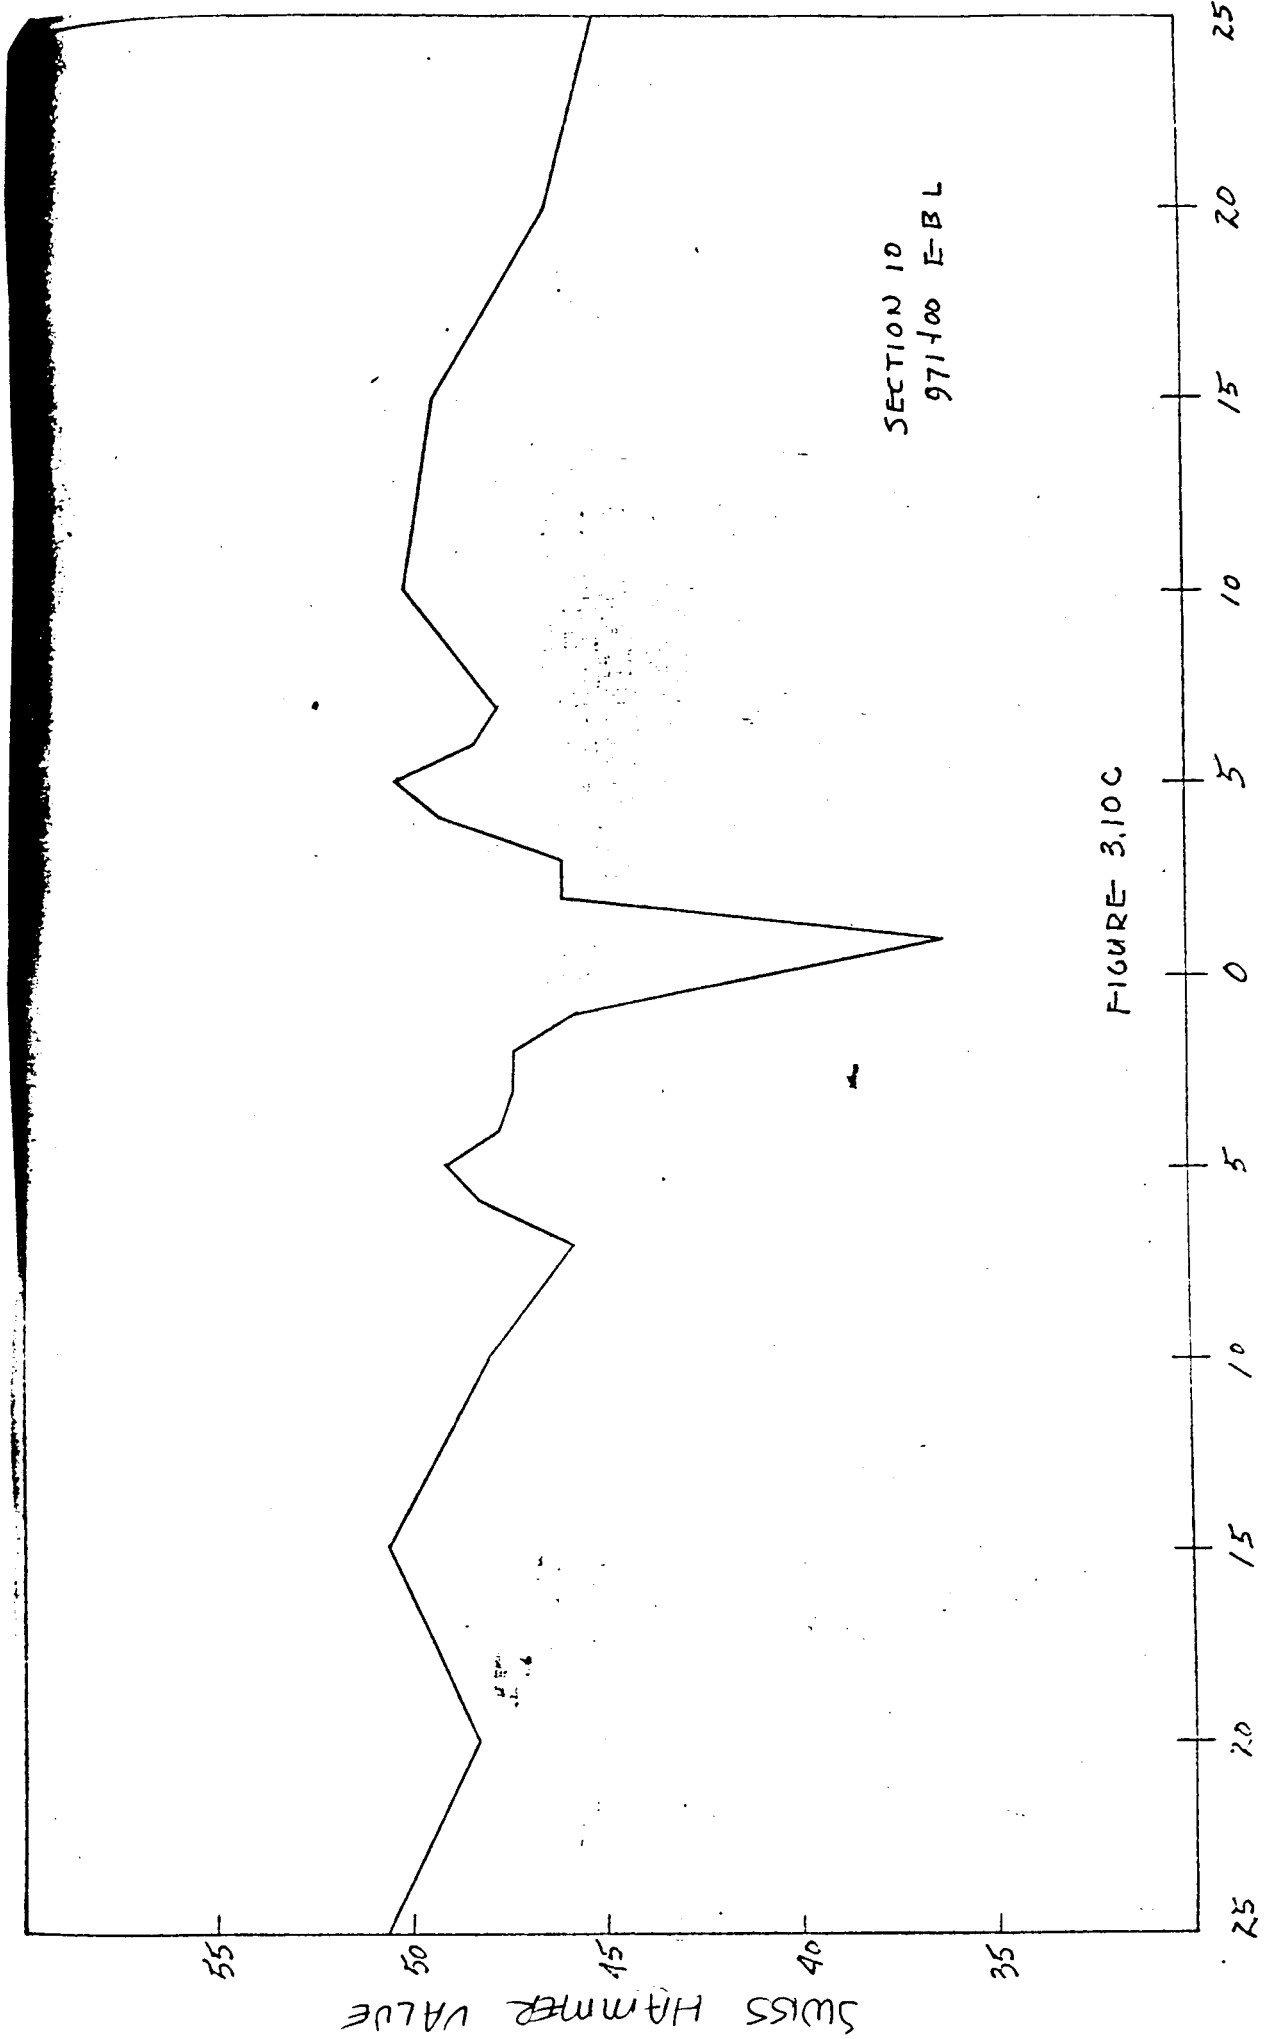
FIGURE 3.10C

The Swiss Hammer profile in Figure 3.10c shows that there was some concrete with low strength. Both deflection and difference in deflection show the failure area in Figures 3.10d and 3.10e respectively. The core drilled in the failure area had a rough texture indicating that the intended design was probably not attained. Figure 3.10f shows the core from the failure area and the one from good section.
