INVESTIGATION OF PAVEMENT FAILURES

INVESTIGATION OF PAVEMENT FAILURES
ON IH10 IN DISTRICT 13

Report Number SS 3.0

Conducted by
The Research Section of
The Highway Design Division
Texas Highway Department
April 1966

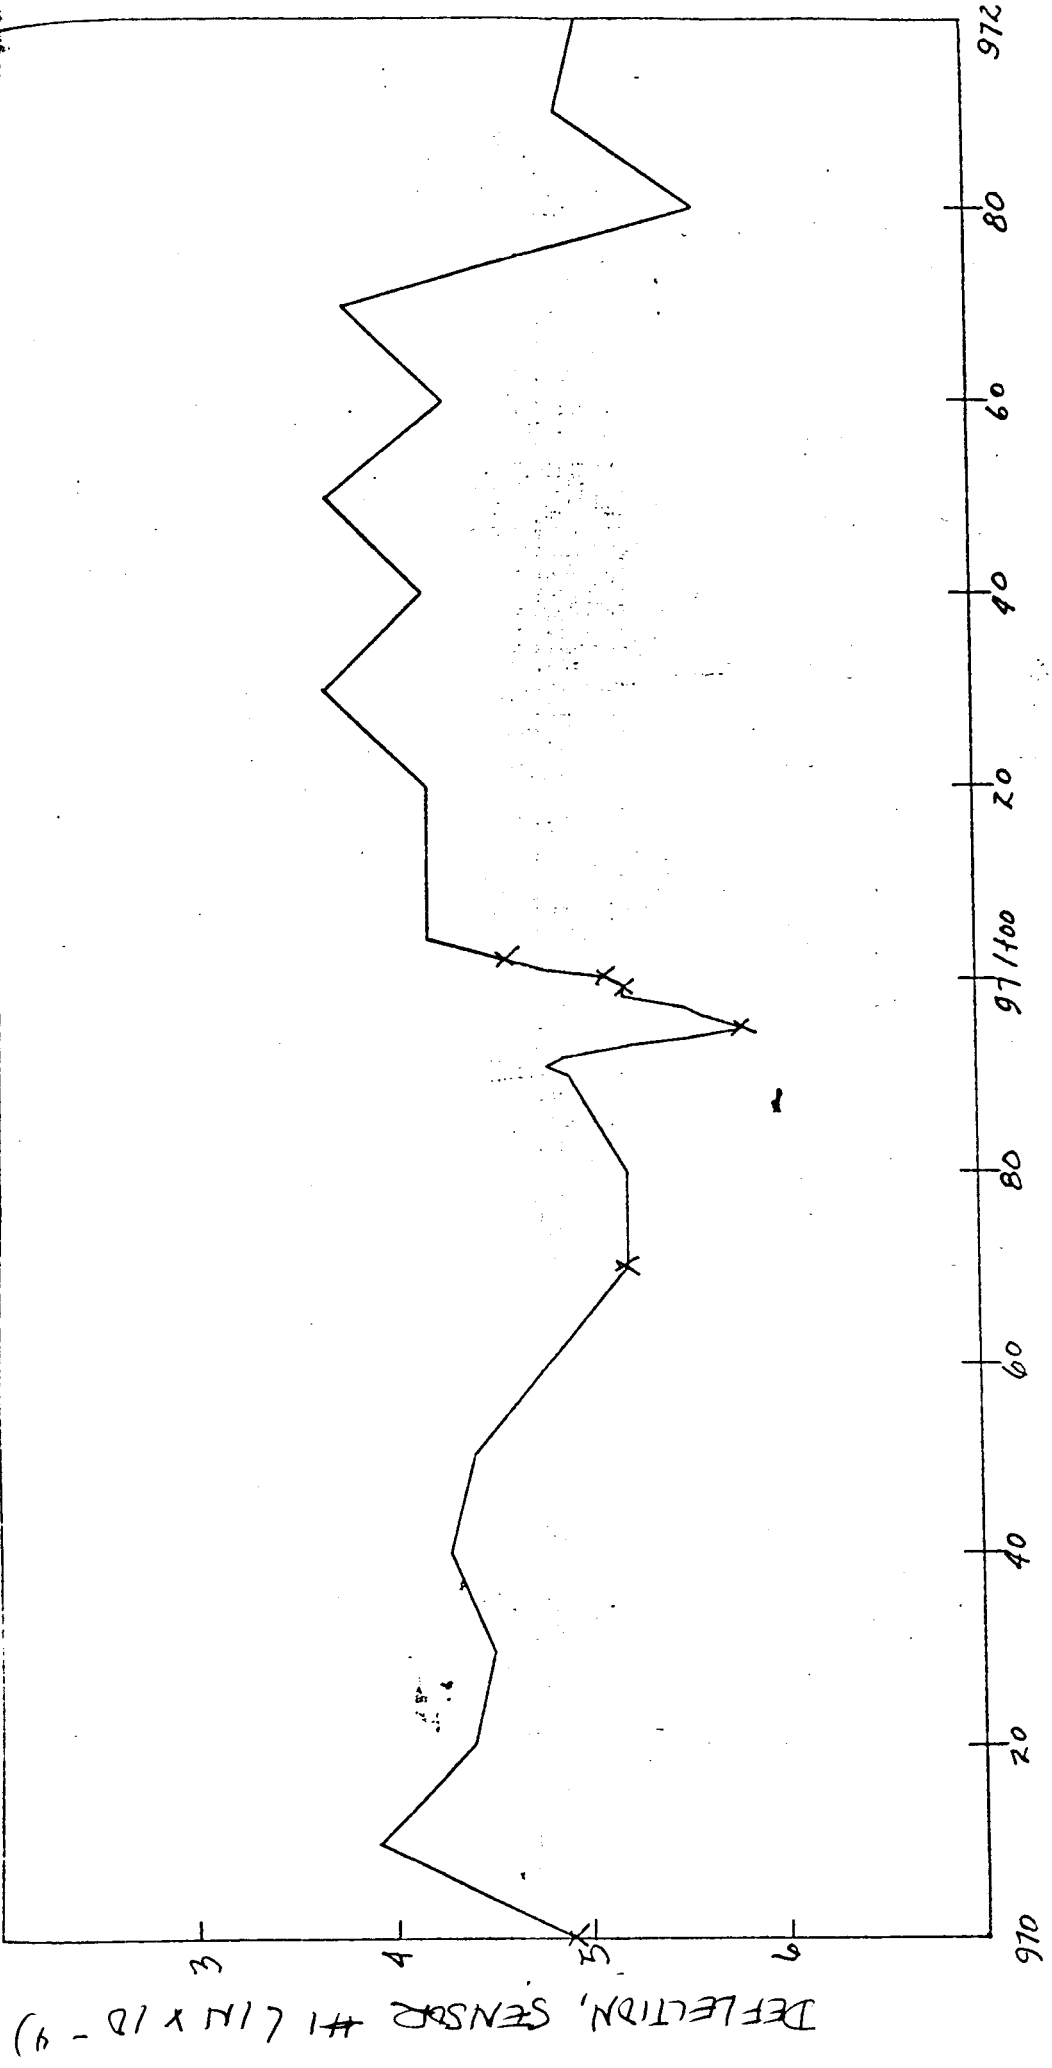
Figure 3.10d

The Swiss Hammer profile in Figure 3.10c shows that there was some concrete with low strength. Both deflection and difference in deflection show the failure area in Figures 3.10d and 3.10e respectively. The core drilled in the failure area had a rough texture indicating that the intended design was probably not attained. Figure 3.10f shows the core from the failure area and the one from good section.

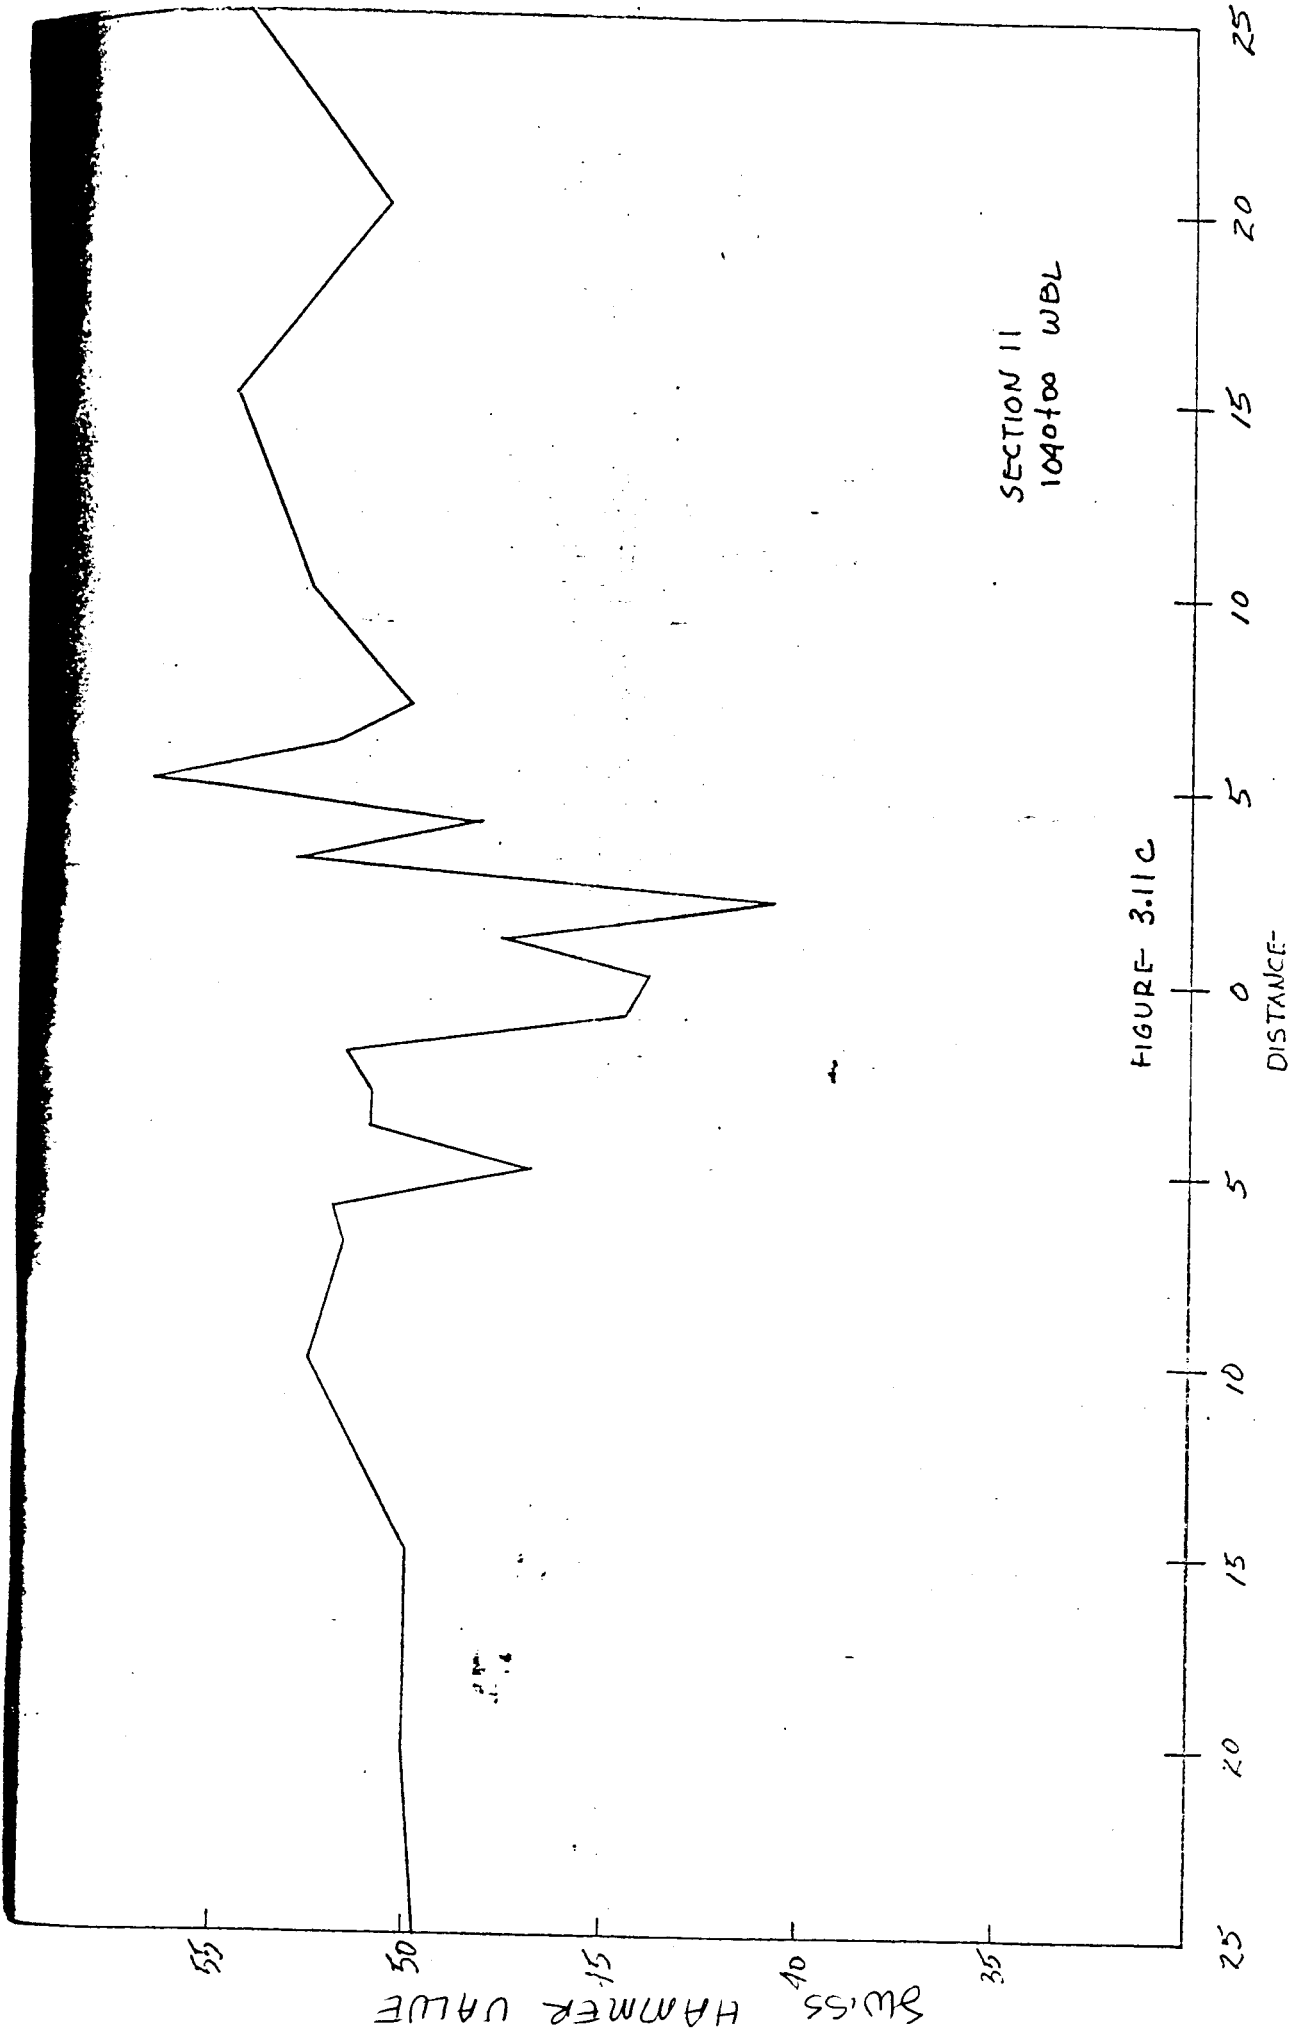
The Swiss Hammer Value Profile in Figure 3.11c shows that the concrete which is severely cracked was weaker than the good concrete.

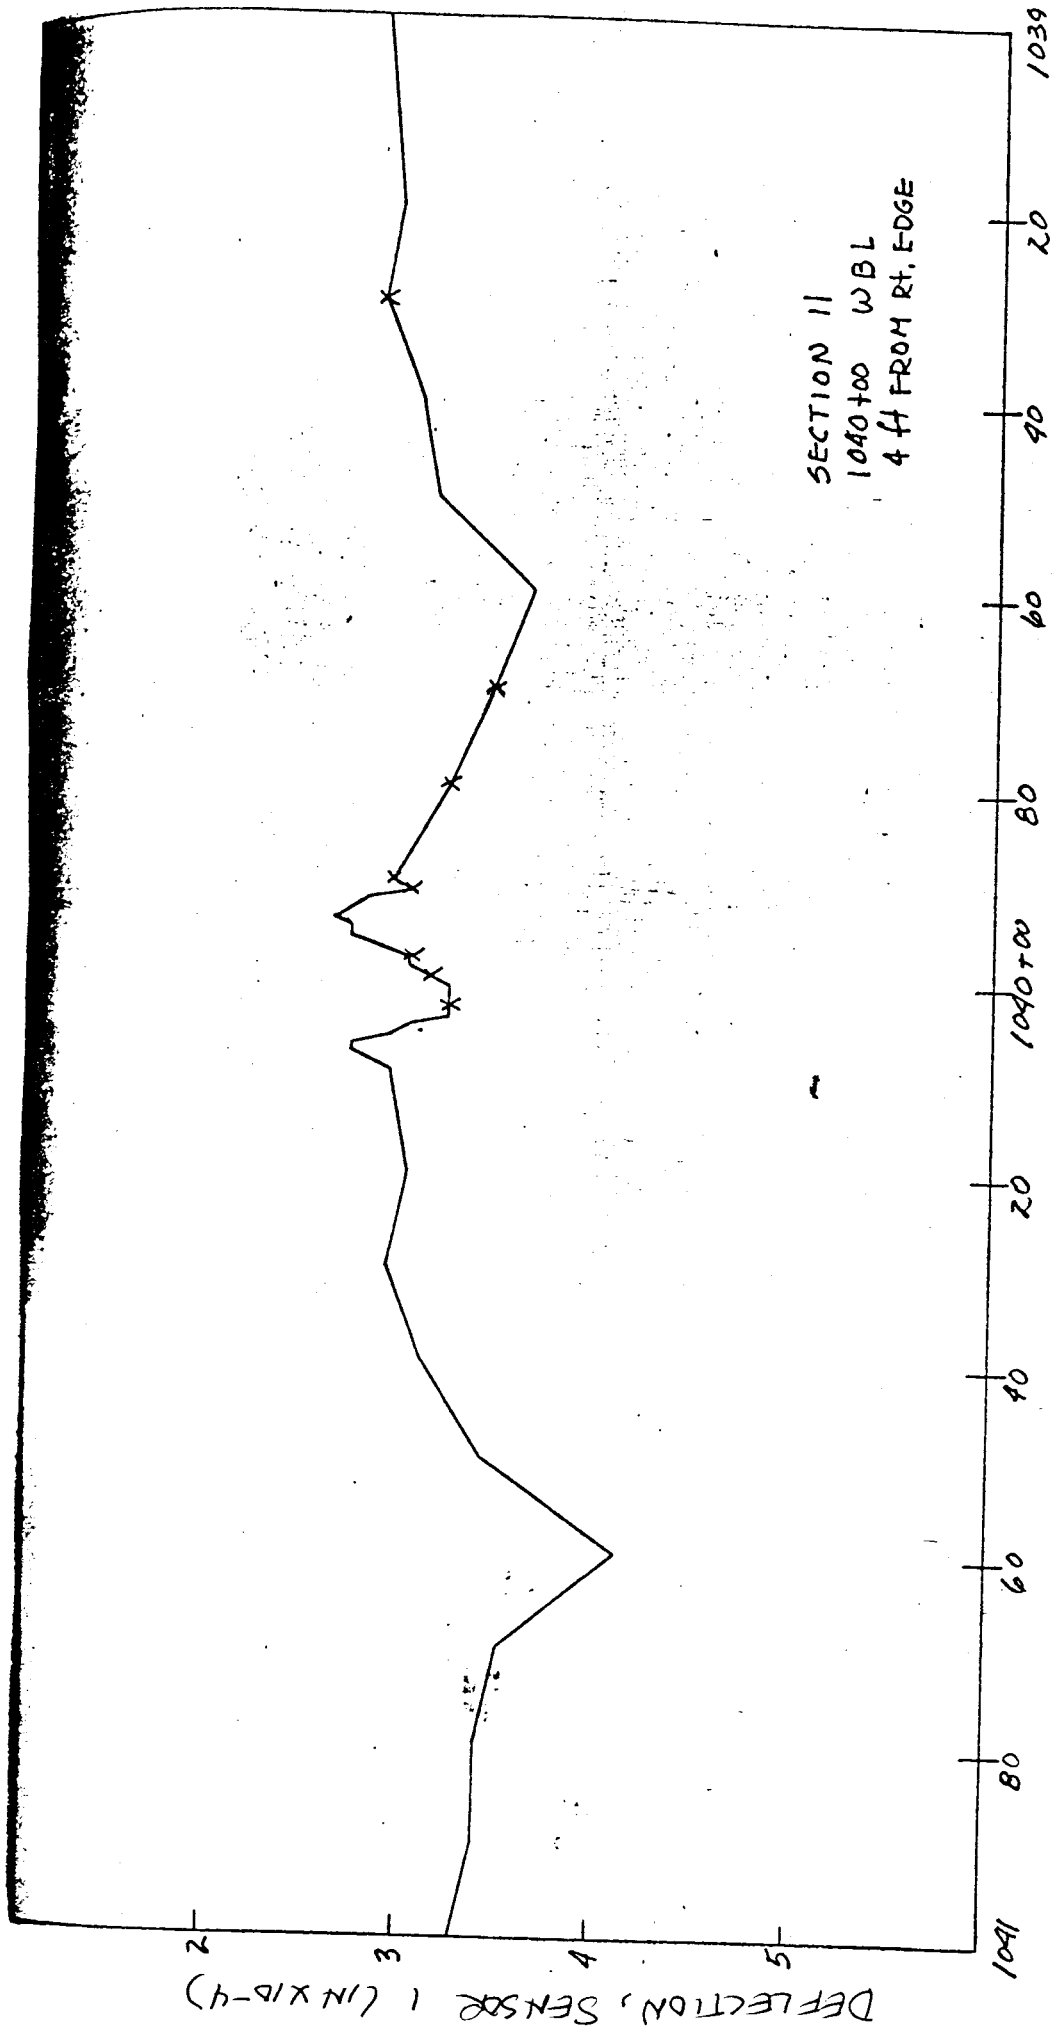
Figure 3.11d

Deflection and difference in deflection did not show the failure area very distinctly because of the large point to point variations which were as large as those in the failure area as shown in Figures 3.11d and 3.11e respectively.
