FURTHER MONITORING OF TWELVE GEOMEMBRANE SITES IN TEXAS

DHT-18

STATE DEPARTMENT OF HIGHWAYS
AND
PUBLIC TRANSPORTATION

By Malcolm L. Steinberg

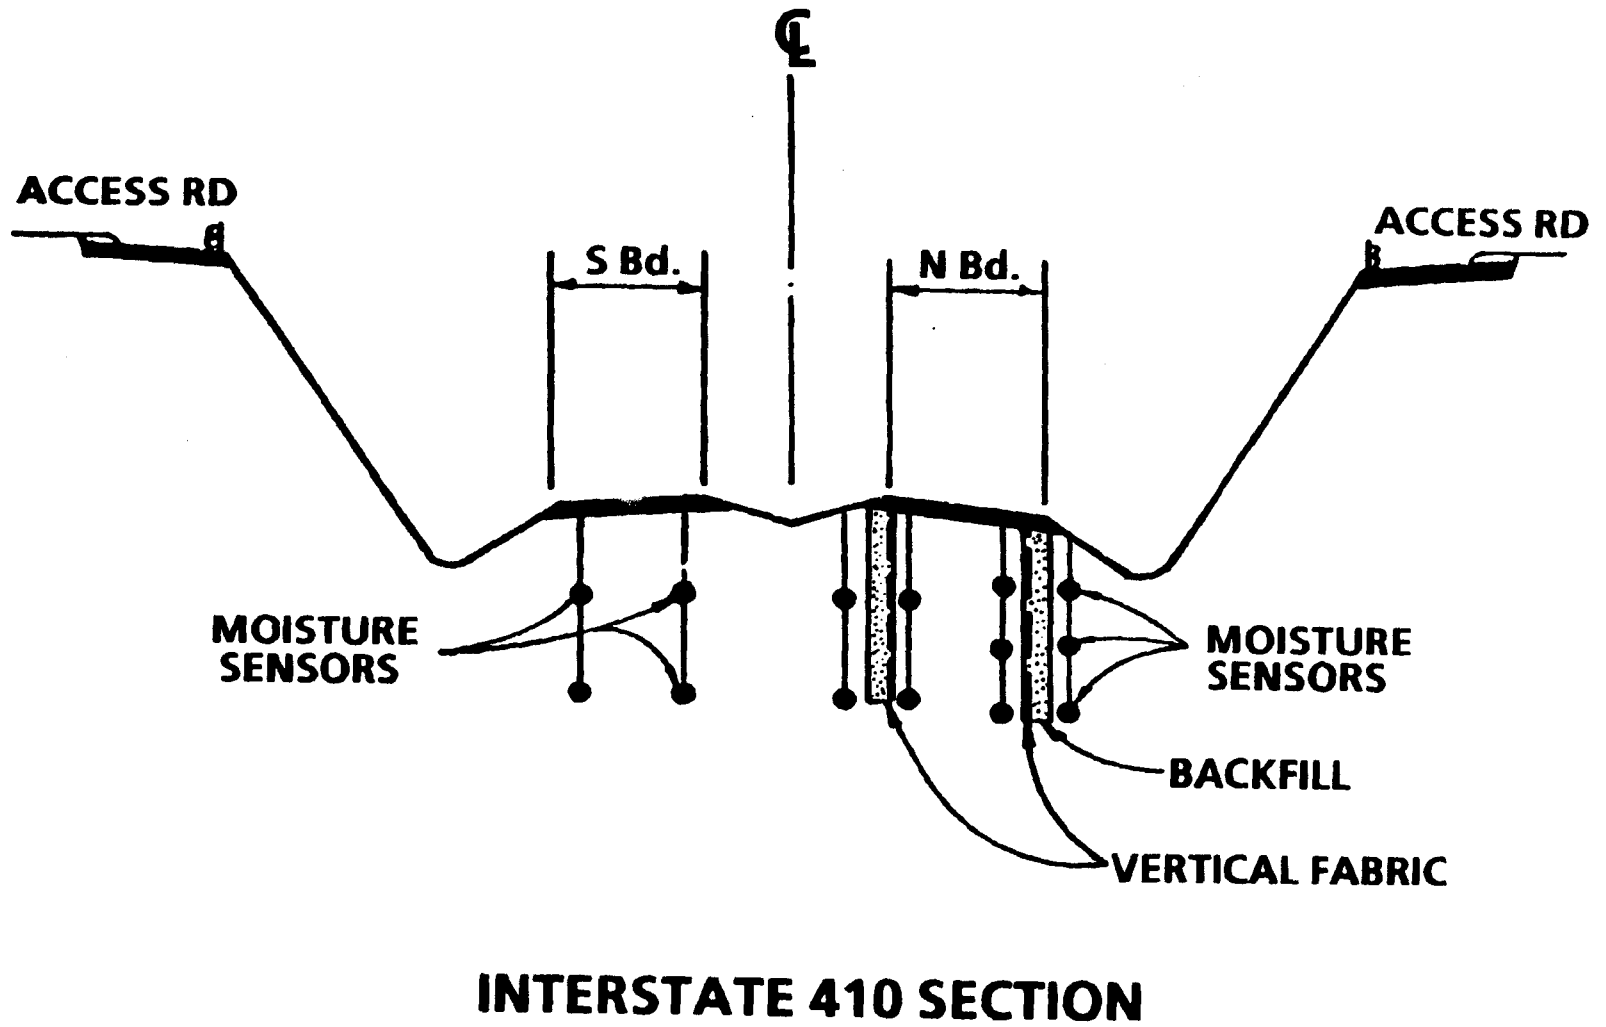
Figure 4: Interstate 410 Section

Interstate 410 in the vicinity of Valley High Drive undercrossing in San Antonio was the first Texas SDHPT section where the deep vertical fabric moisture barrier (DVFMB) was used.⁽¹⁵⁾ Subgrade Atterburg limits included liquid limits (L.L.) of 50 to 79 and plasticity indices (PI) from 28 to 48. In 1978, a half-mile long section of the northbound lane of the four-lane divided highway had fabric placed 8 feet deep along both shoulders (fig. 4). Bid price for the fabric in place was \$20 per lineal foot. The median ditch remained, and the adjacent southbound lane without the fabric was used as the control section. The contractor excavated the trench with a backhoe. A sliding shoring was developed that held the roll of a

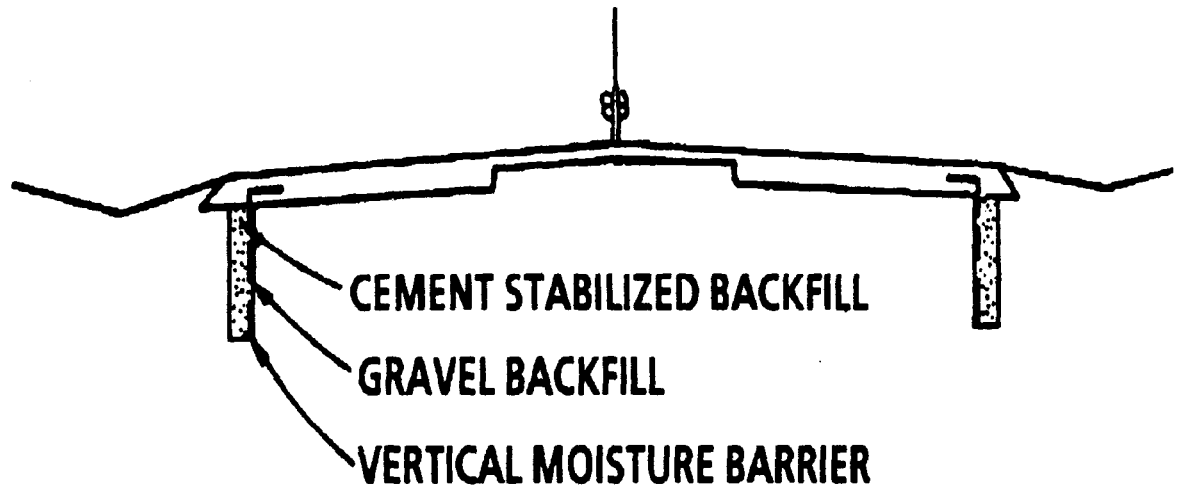
Figure 6: Interstate 37 Section

Interstate 37, from South Hackberry Street to Pecan Valley Drive in southeast San Antonio, is a two-mile section that had proved to be a significant maintenance problem. A minimum of \$50,000 a year had been spent on leveling up the concrete pavement severely distorted by the expansive soils. The section had an excavated depth up to 25 feet below natural ground and had subgrade PI's between 34 and 59 with LL's ranging from 56 to 92. This rehabilitation project in 1980 had the median ditch removed, positive drainage established across the roadways, an asphalt seal followed by asphaltic concrete level up and 23,750 feet of a deep vertical fabric moisture barrier, Dupont Typar T063, placed along the outside shoulders of both mainlanes (fig. 6). The
