## THIRD CALIBRATION OF THE SKID TEST TRAILERS

Texas Highway Department

Research Report SS 11.8

March 1970

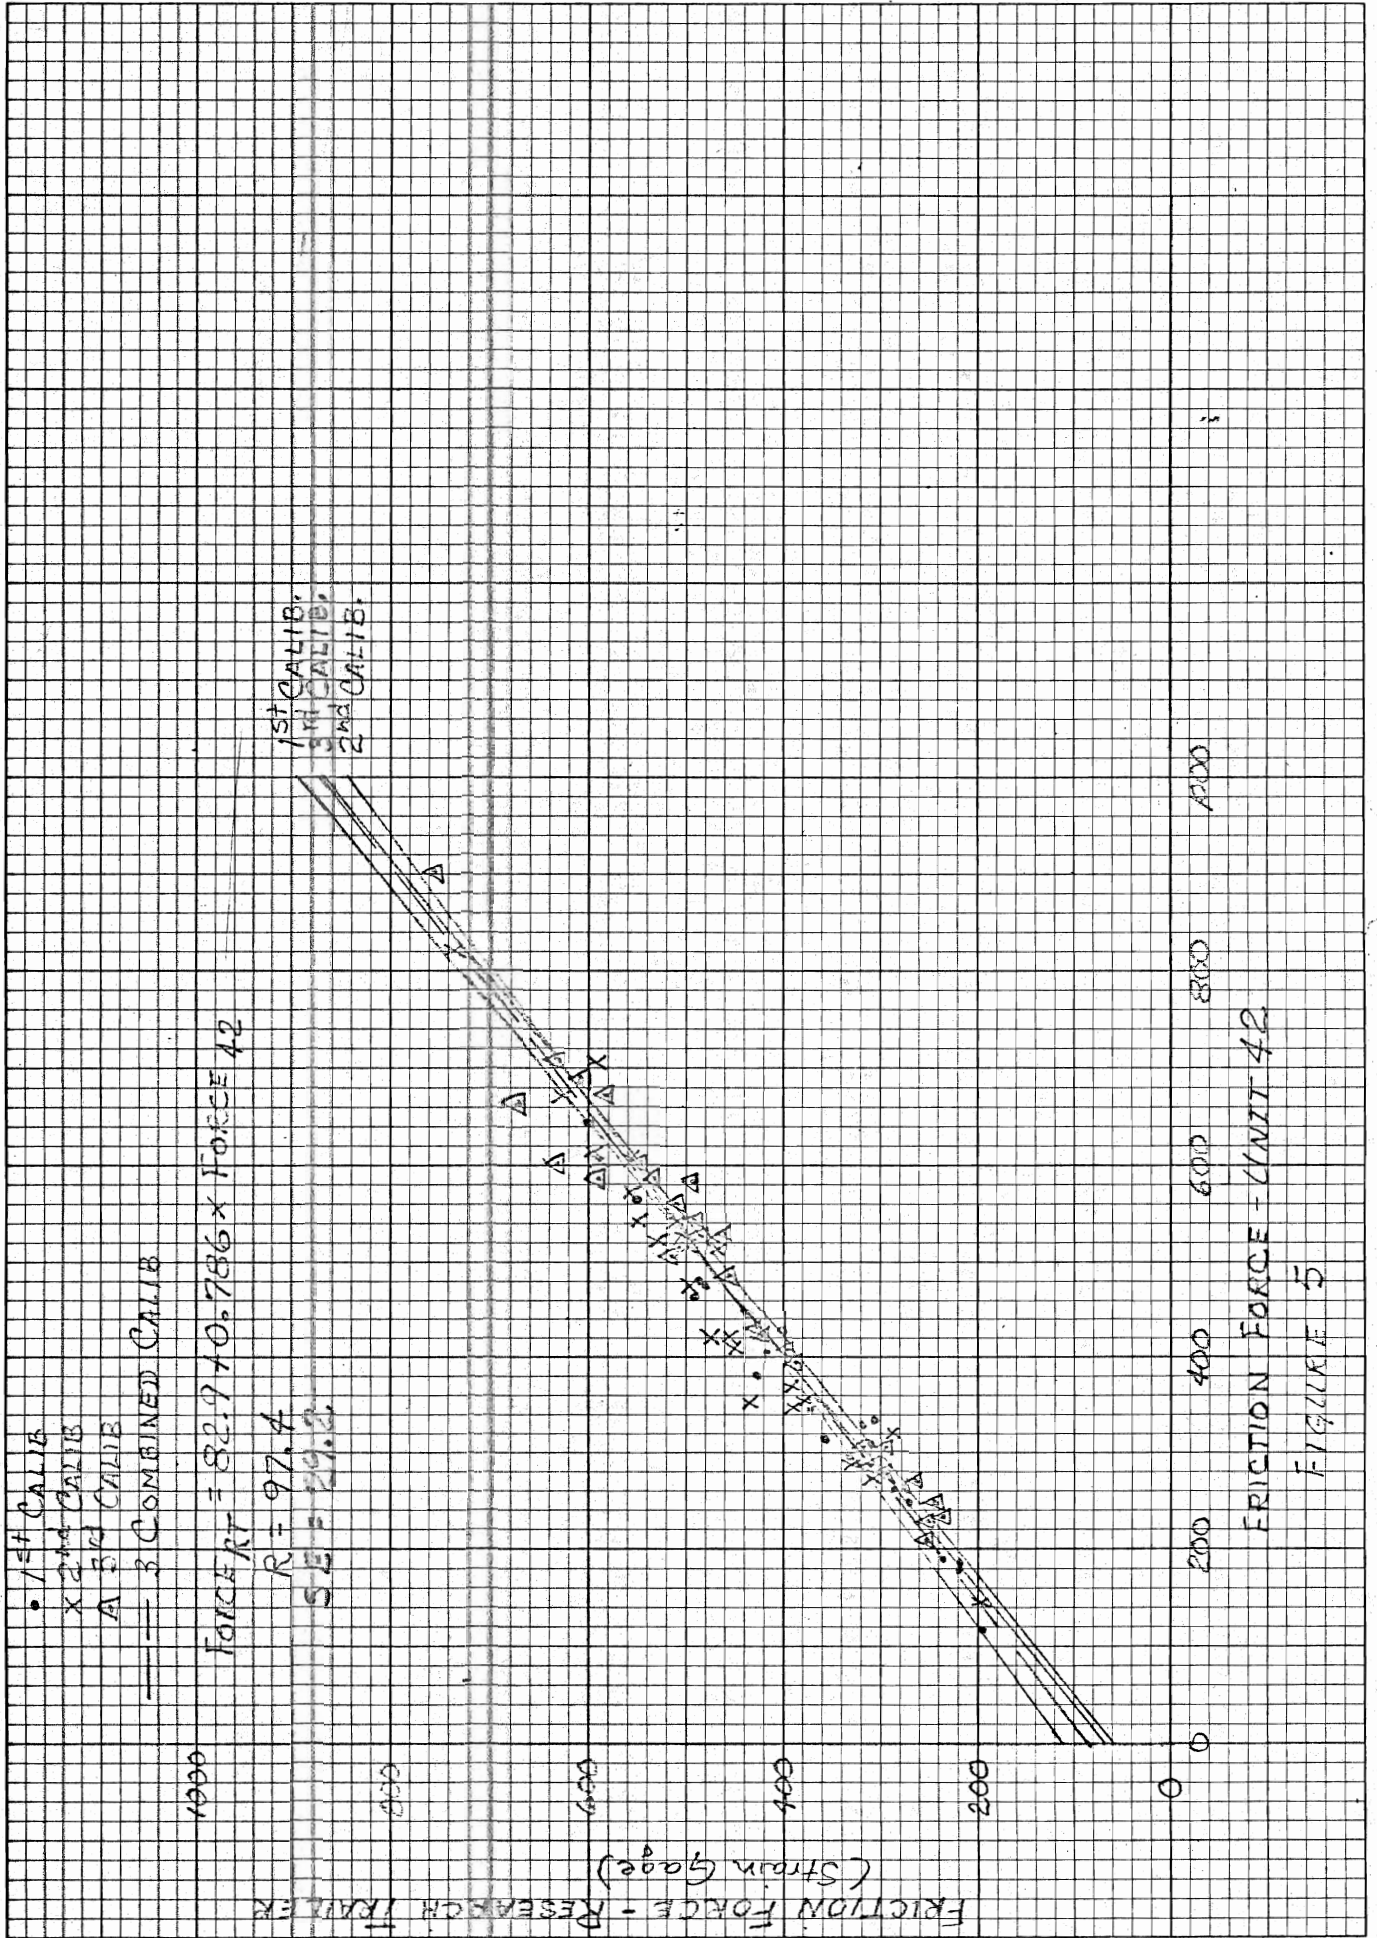
Attached for reference are the combined correlation plots of the three friction force correlations that has been obtained since May, 1968 (See Figures 4, 5 & 6). The equations, coefficient of Correlations - R, and the Standard Error of Estimate - SE are given for the three correlation tests. The coefficient of Correlation might be termed a statistical measure of the "goodness of fit" of data points around a line or curve of best fit. A value of 90 or above is considered excellent. The Standard Error of Estimate is a statistical measure of the scatter of data about the line (the larger the number the worst the correlation).

We note that two of the three trailers have slopes of the correlation line which are increasing with each calibration (that is:  $0.806 < 0.826 < 0.967$  for trailer 41). Also in two of the three trailers the scatter about the line is continuing to increase (that is:  $SE = 25.2 < SE = 29.4 < SE = 34.5$ ). We have not been concerned about the slopes of the correlation line because we believed they should be around 0.8 with the Maintenance trailers reading higher than the Research Trailer. The reasoning here is because of the difference in force measuring instrumentation. After the third calibration test we find that two trailers have rather large slopes (0.967 and 0.937). This fact is beginning to be disturbing.

The increase in scatter about the line is also disturbing. We would have thought that the scatter would be mainly due to the fact that the trailers cannot skid in the same spot (That is, one or the other would be positioned slightly transverse longitudinally along the road from the others at the time of skid and there are large differences in friction within 2 to 3 feet of a given area.) It would seem that the scatter would become slightly better chronologically because the operators would be more familiar with the equipment and could better skid on a given spot on the pavement. Instead, the scatter has worsened indicating that it may be associated with equipment wear. However we still feel that much of the scatter must be due to the trailer positioning in attempting to skid on the same spot.
